Lessons Learned from
Accidents Involving
Remotely Piloted and
Autonomous Aircraft

Crash Course

Peter W. Merlin

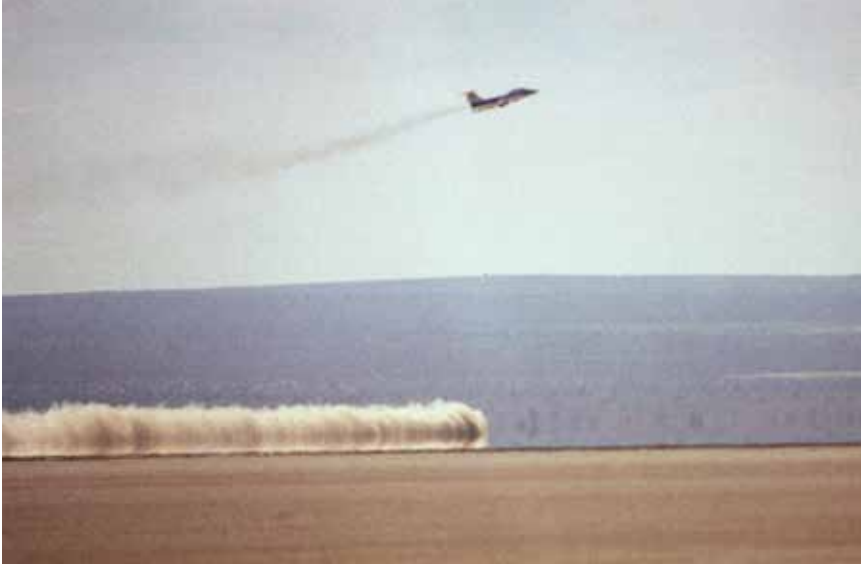
Observers aboard the TF-104G chase plane watch as the HiMAT slides across the dry lakebed on its belly. NASA

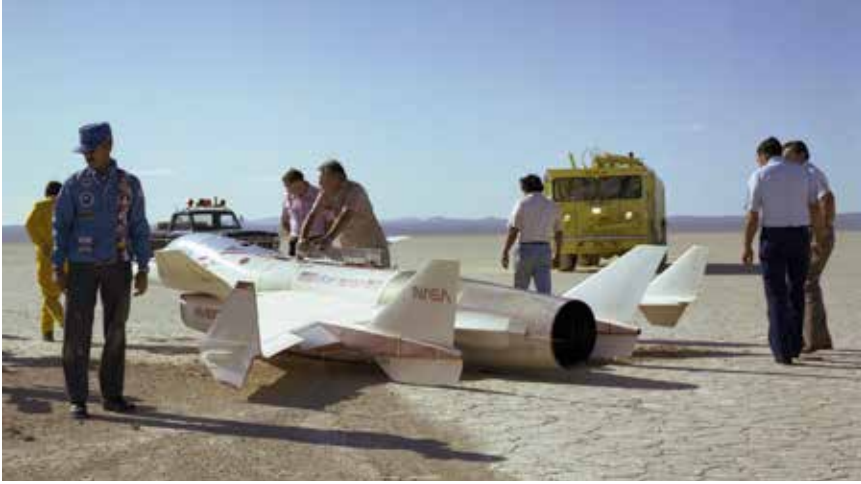
Investigators examine the HiMAT following its belly landing. Fortunately, damage was not extensive. NASA

The HiMAT PCS failure was caused by a mechanical malfunction. The landing gear malfunction stemmed from a software issue.

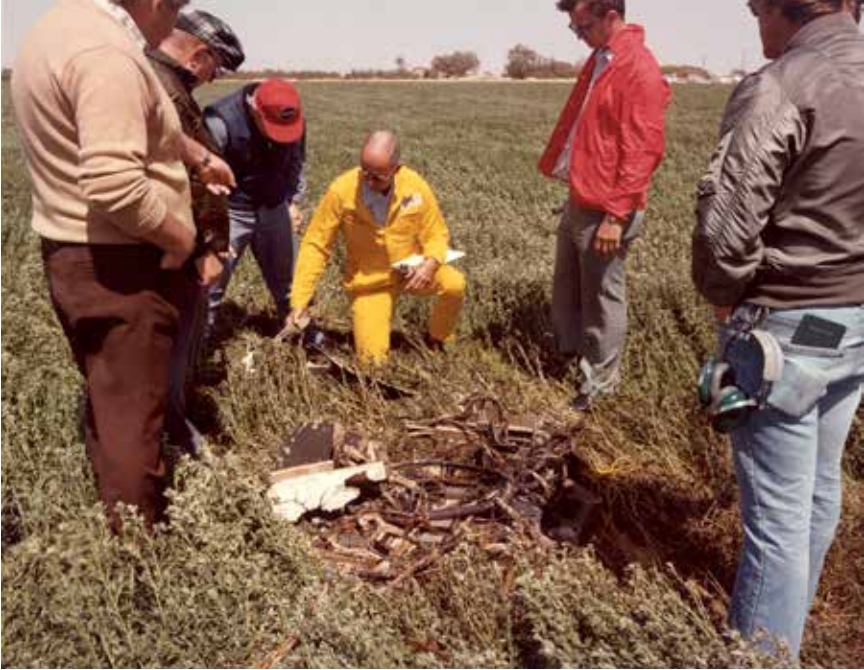
Investigators examine the DAST-2 wreckage at the crash site. The primary cause was traced to an electrical problem. NASA

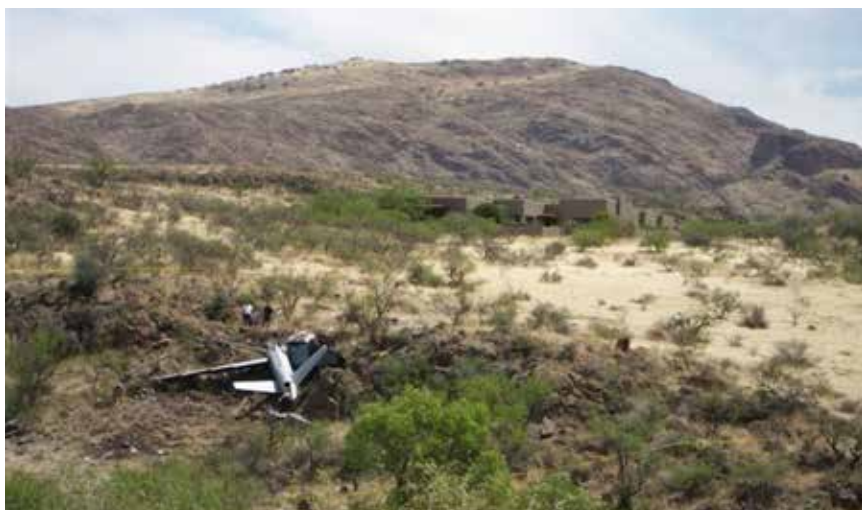
The MQ-9 crashed in a sparsely populated residential area, but there were no injuries or damage to private property. Mae Duggin
