Freezing Damage to Coolers at the NASA-GRC 10x10 Supersonic Wind Tunnel

Prepared by: Jim Roeder, 10x10 SWT Facility Engineer
Jonathan Kubiak, 10x10 SWT Facility Manager

For the 130th Semi-Annual Meeting of the Supersonic Tunnel
Association, International (October 7-10, 2018)

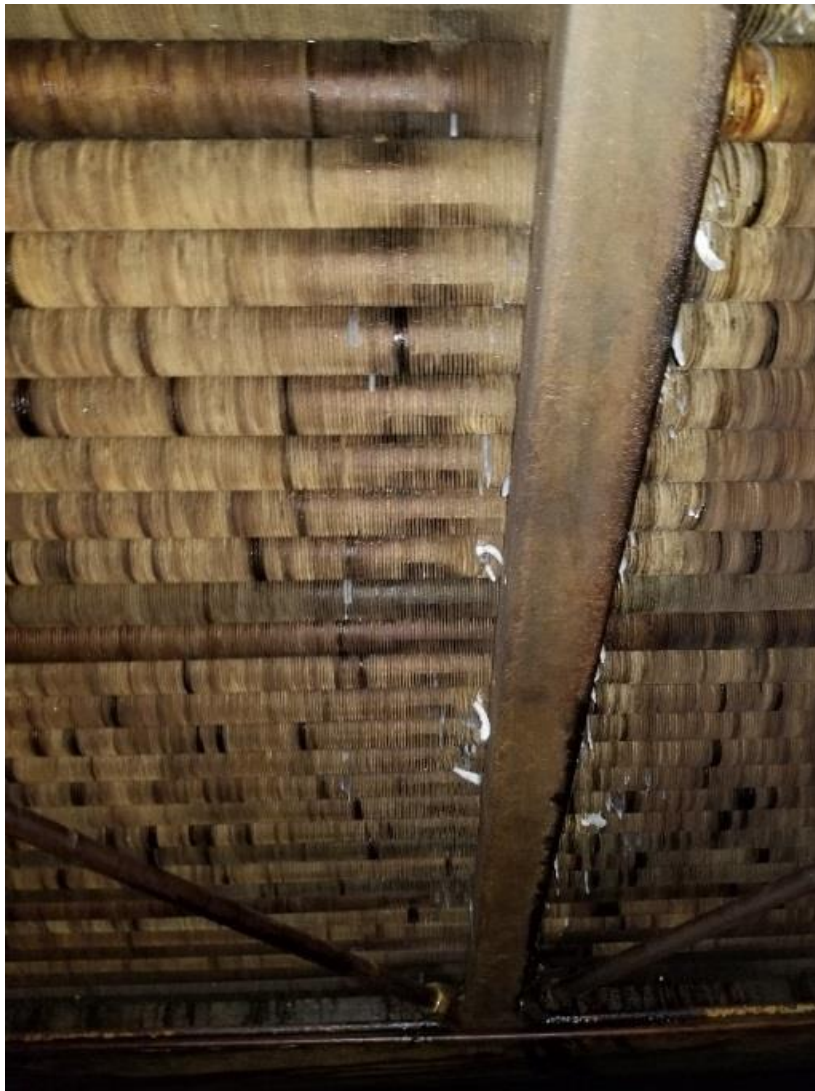
Damage Found

- Visual inspection of Cooler 2 found multiple signs that freezing damage had occurred (icicles, split tubes).
- A water level sensor in the air-side of the Ross cooler indicated that it too sustained damage.

- Underground water leak & resulting shutdown of cooling tower caused loss of freeze protection flow through 10x10 coolers.
- Cooler 2 and Ross Cooler were not drained sufficiently before freezing occurred.
- Contributing factors...
 - CTW system supply and return valves leaked, which prevented the coolers from being isolated from the cooling tower and slowed the draining process.
 - The pitch of some (possibly all) cooler tube bundles is slightly away from the waterboxes. It is likely the tubes do not fully drain.
 - Unusually cold air & water temperatures at cooler tube bundles at the time of cooling tower shutdown, caused by two conditions: extreme weather cold spell; CTW supply temperature much colder than usual.

- Seven (of 14) tube bundles from cooler 2 and all three Ross cooler tube bundles have been removed from service and sent off-site for repairs.
- Replaced all supply and return valves on Cooler 2 and the Ross Cooler.
- Bundles are being completely re-tubed (copper tubes with embedded aluminum fins)
- Impact to wind tunnel test schedule: ~14 months.
- Current schedule anticipates completion of cooler repairs by end of February 2019, including one month of checkout and tunnel reactivation.

- Additional low temperature monitoring (24/7) being implemented around coolers.
- Evaluate existing pitch of cooler tube bundles (Lidar survey in process) and (if possible) correct to allow proper drainage.
- Implementing preventative maintenance tasks to check for CTW valve leakage.
- Engineering study needed to evaluate alternatives (air purge, vacuum, backup circulation, heat, etc.), followed by implementation.
