The X-15 3-65 Accident: An Aircraft Systems and Flight Control Perspective

ABSTRACT

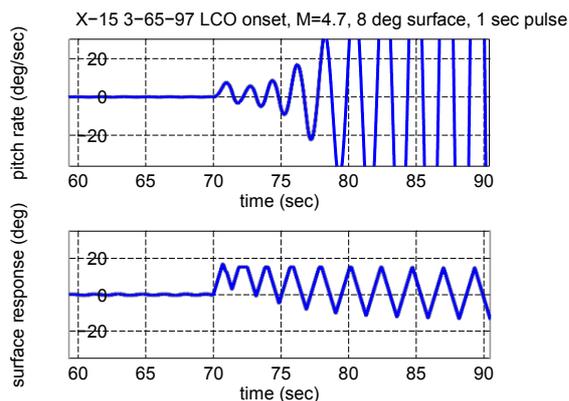
Figure 5.0-1. Flight 3-65 Divergent LCO Reproduced in Nonlinear Simulation ($M=4.7$, $q=390$ psf)

Nonlinear time-domain simulation and nonlinear frequency domain (describing function) analysis of a detailed model of the X-15-3 AFCS revealed that transition from the small-amplitude desirable LCO to the large-amplitude destructive LCO was caused by an

inner-loop instability due to large system lag in the structural notch filters coupled with the the rate-limited power actuator (Figure 5.0-1). The structural filters differed from the filters used in the fixed-gain SAS on the other aircraft, since the loop shaping requirements were different for the MH-96 adaptive mode. The mechanism by which a destructive limit cycle could be introduced involved an abrupt maneuver at relatively high forward gain, where the power actuator would reach rate saturation while inducing large angular acceleration on the rigid body. If this event occurred at a flight condition where the rigid-body short period damping was particularly low, as it did during Flight 3-65, the rigid-body oscillation was then divergent, even with fixed adaptive gains. This failure mode is not unlike a classical pilot-induced oscillation (PIO), where the pilot acts as the adaptive gain.

The investigation following the Flight 3-65 accident concluded from simulation studies that the LCO could have been avoided had the pilot disabled the MH-96 and reverted to fixed-gain operation prior to entry. It is important to emphasize that simply disabling the adaptive mechanism would not have enabled the pilot to recover stability, but since the fixed-gain backup mode also used the lowest acceptable gain setting, the gain was below the threshold that would sustain rate limiting.
