# A Tale of three capacitor problems

GSFC Safety and Mission Assurance

Jesse Leitner, Chief Engineer  
Jack Shue, Senior Applications Assurance Engineer

Presentation to SCAF Workshop  
December, 2016

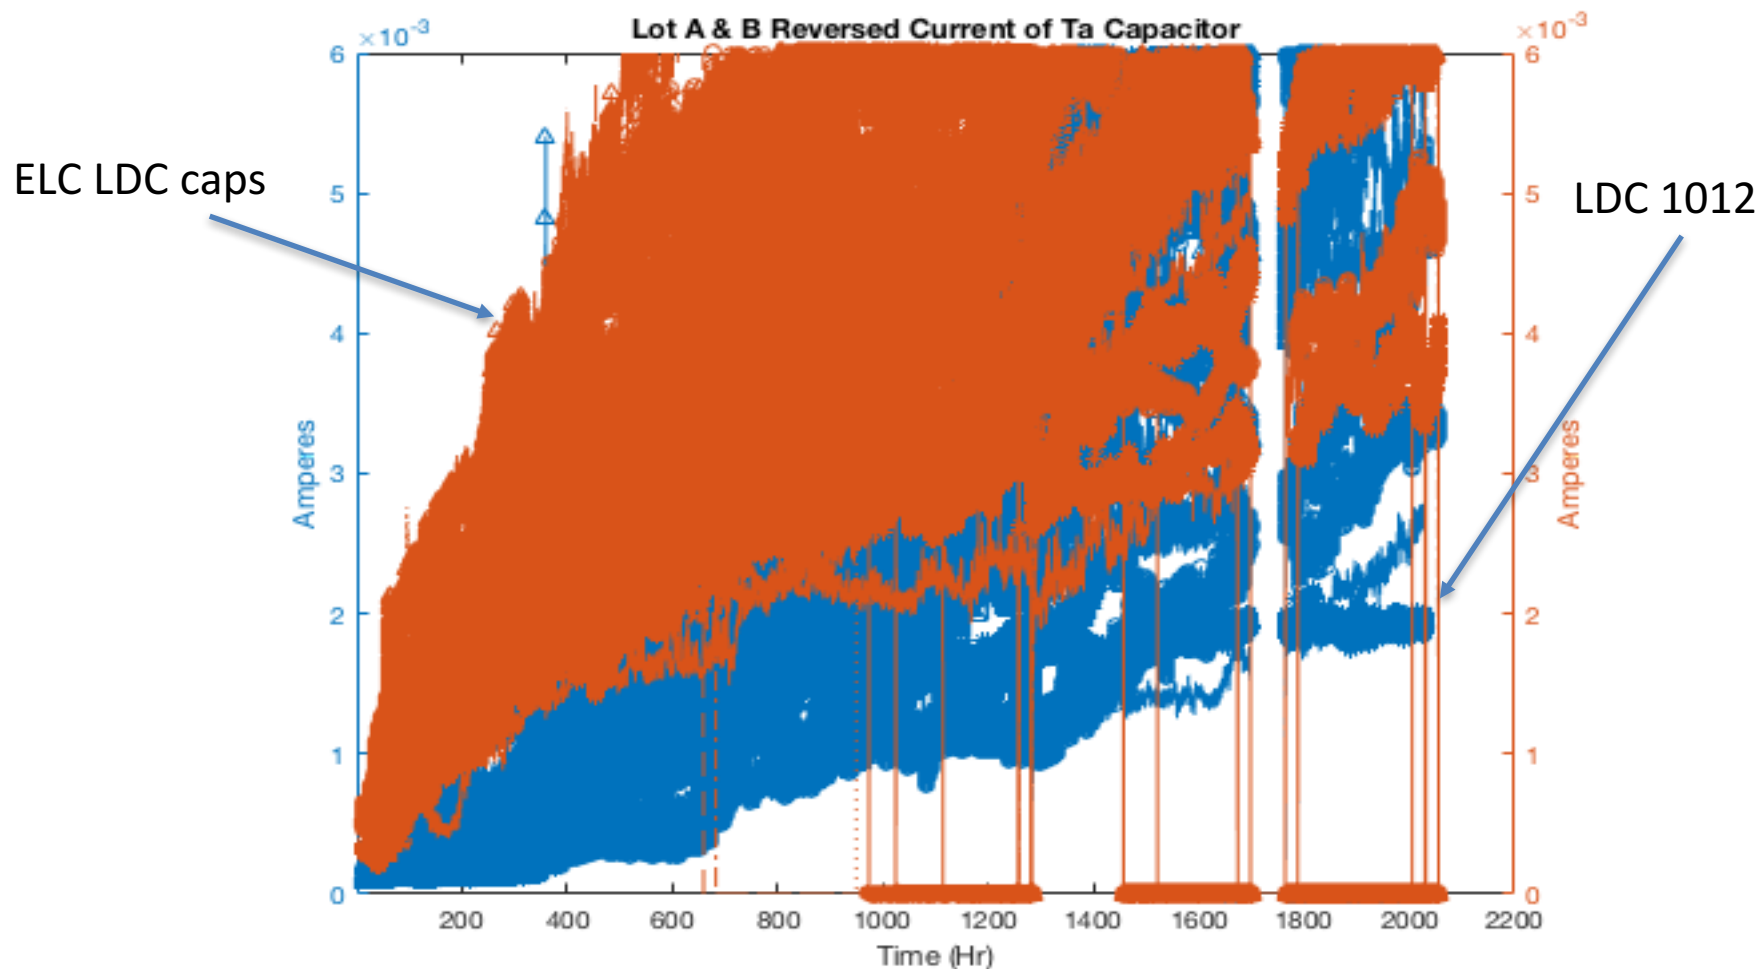
# Phase 1 – all caps go to failure in ambient temperature/pressure

- Our initial hypothesis based on previous testing
  - Based on manufacturing variability, capacitors will roughly bin into two groups, one of which will head off to failure within about the first several hundred hours and the other will either recover after some time or stabilize
  - Groups may vary by temperature or by voltage across the cap
- Result: At room temperature (23 deg C), all caps either reached max allowable leakage current (surpassed 6 mA) or were on path to failure even below 5 V. Given results, no further temperatures were tested.
- Observation: data viewed at high resolution showed a weak weekly periodicity, perhaps due to weekend reduction in HVAC
- **We were a bit baffled because our ground testing is not representing what we are seeing on-orbit.**

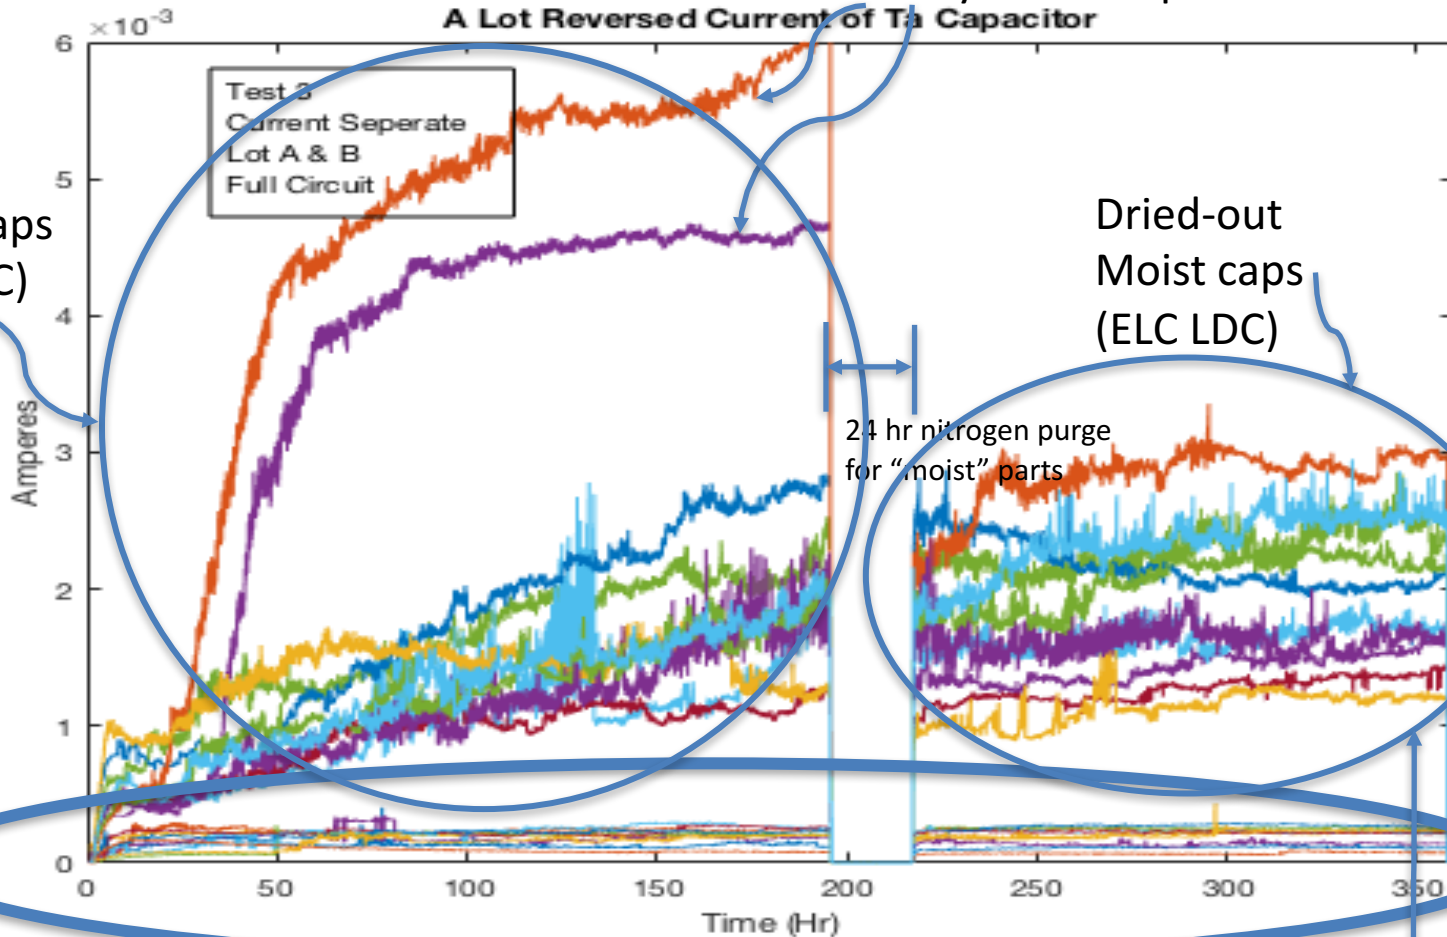
# Phase 2: Proof of concept – drying out caps

Severely stressed parts

Moist caps  
(ELC LDC)

Dried-out  
Moist caps  
(ELC LDC)

24 hr nitrogen purge  
for "moist" parts

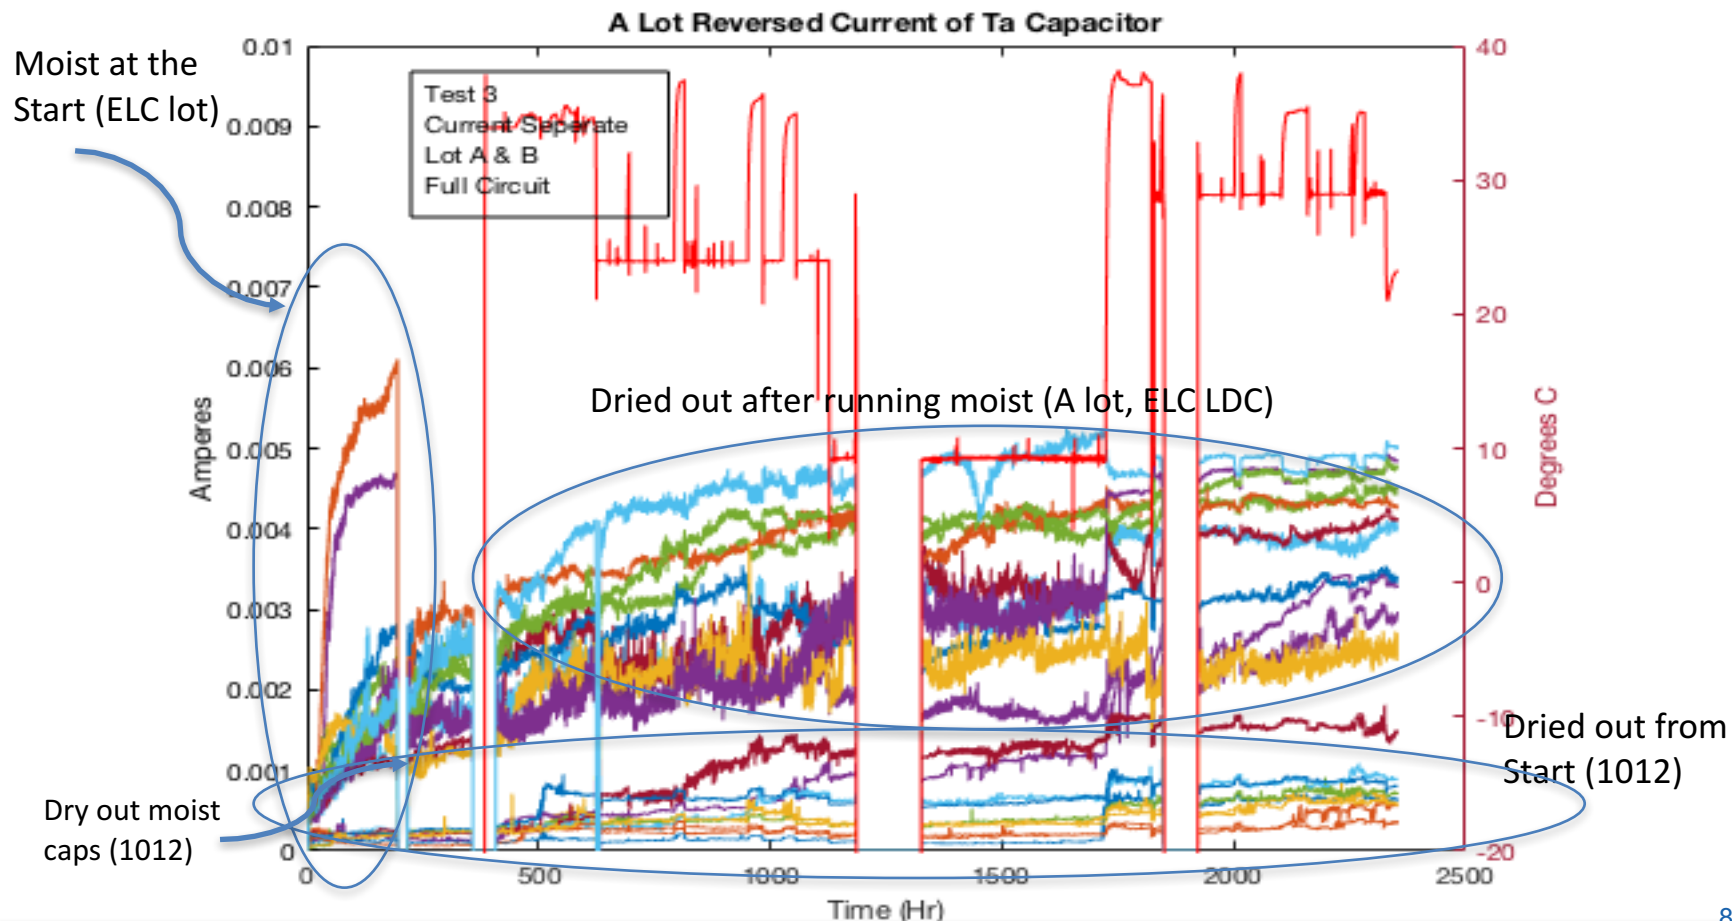
# Phase 3 (ambient pressure)

Behavior of wet/dry caps is comparable to Aerospace vacuum testing at 22 deg C

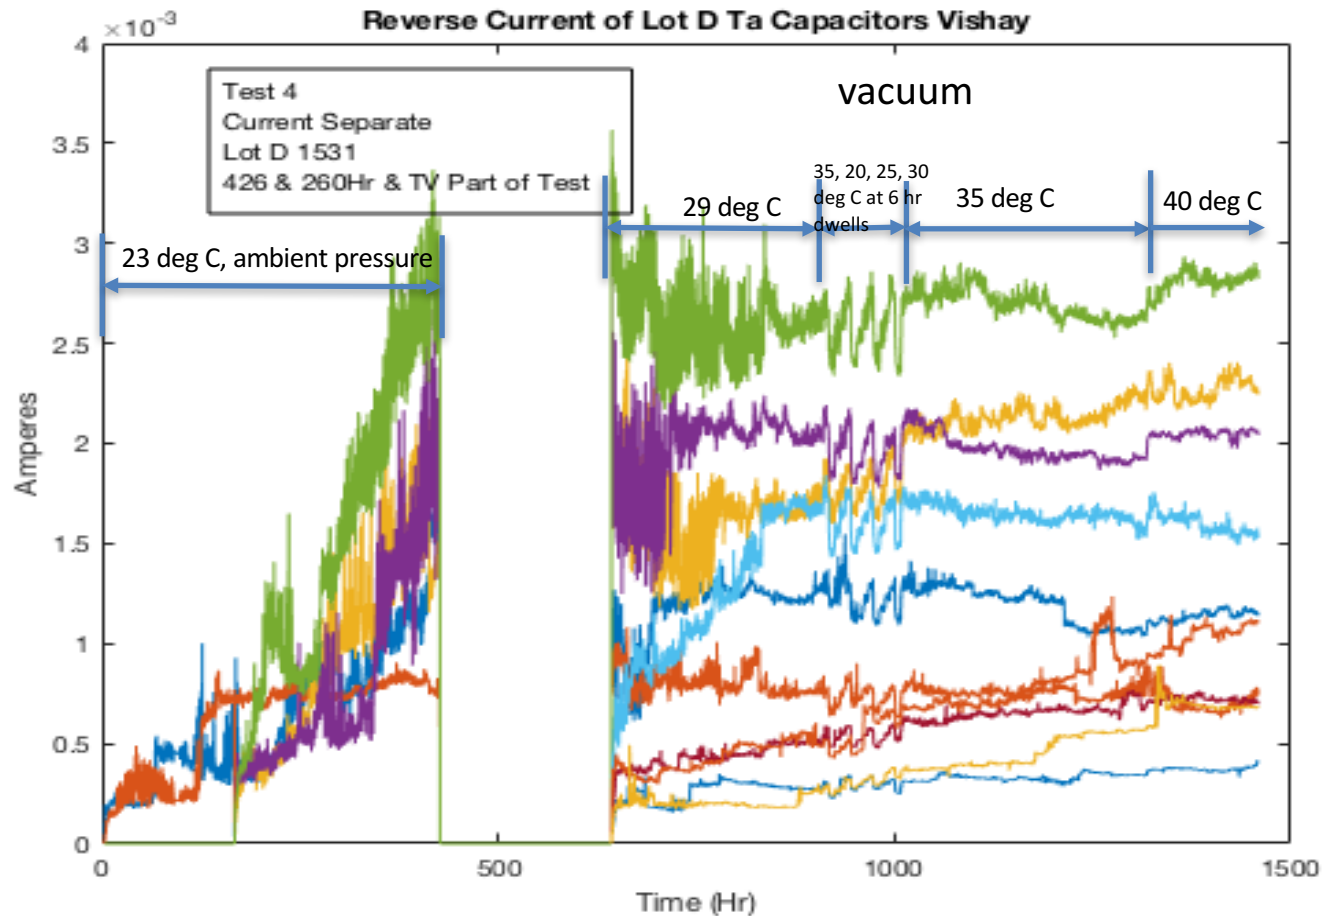
# Phase 4 TVAC results (ambient, then vacuum), LDC 1531

- Vacuum operation and drying through purge induces recovery in failing caps
- There is temperature dependence in vacuum but it is mild, at least below 35 deg C
- Only one or two caps even appear to indicate a slight climb at the end in early results
  - First and second derivatives indicate that there is no long-term climb in the GN2 purge results, the vacuum results, or in the original Aerospace vacuum results.
- No failures have occurred in any application in a fully-dry environment at any temperature due to the reverse caps
  - Aerospace testing – 4000 hrs
  - On-orbit – 4+ years
  - Our testing – 1500+ hours

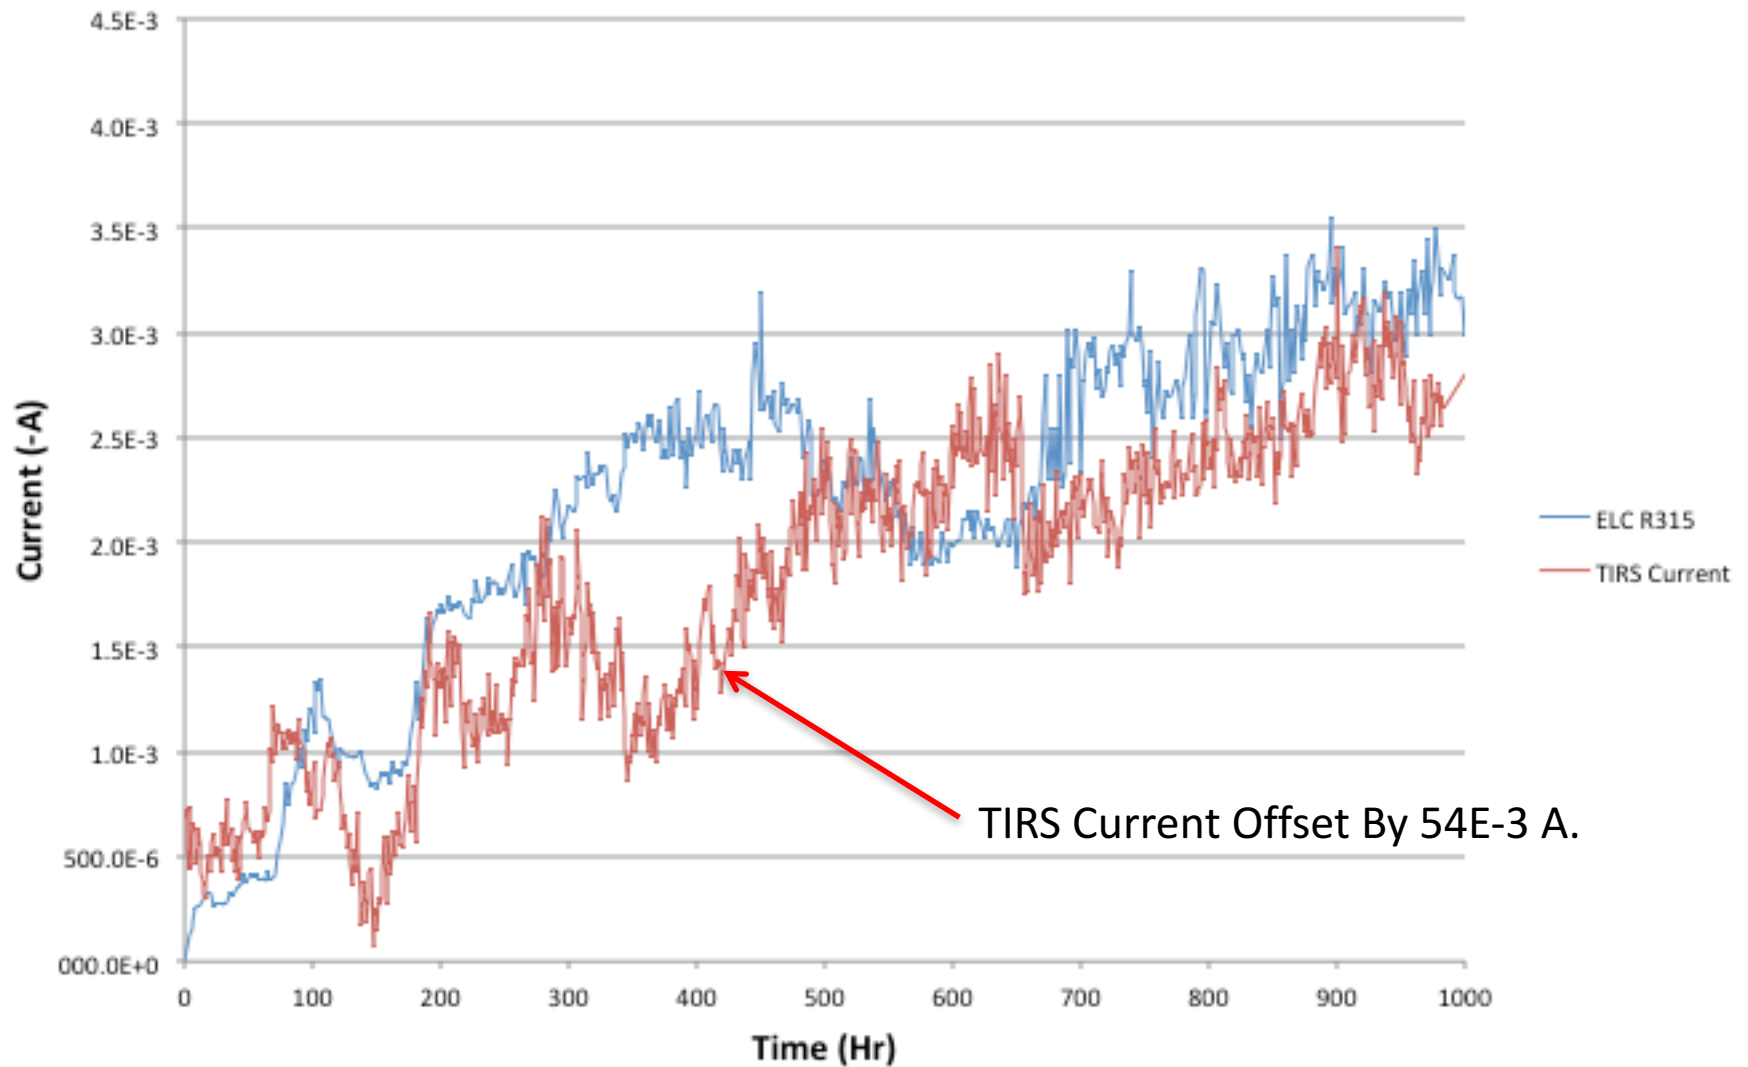
## ELC & TIRS at 1000 Hr

- In preparation for TIRS-2 (LandSat-9), GSFC S&MA (Code 300) was reviewing anomaly history of TIRS, noting the behavior and open items on the fishbone
- Behavior of the on-orbit leakage currents on TIRS bore a striking resemblance to the reverse bias capacitor performance in our ELC ground testing
- A thorough examination was performed of the capacitor polarities in all related components on TIRS
  - Polarity was correct at all levels
- Code 300 requested that spare boards be brought out of storage to be powered up
- Not long after power-up, the board started to exhibit the leakage current reflective of the on-orbit behavior
  - Many attempts were made to power cycle the boards, induce recovery, or otherwise affect the profile, with mixed results
- We placed a thermal camera over the board to watch for hot spots

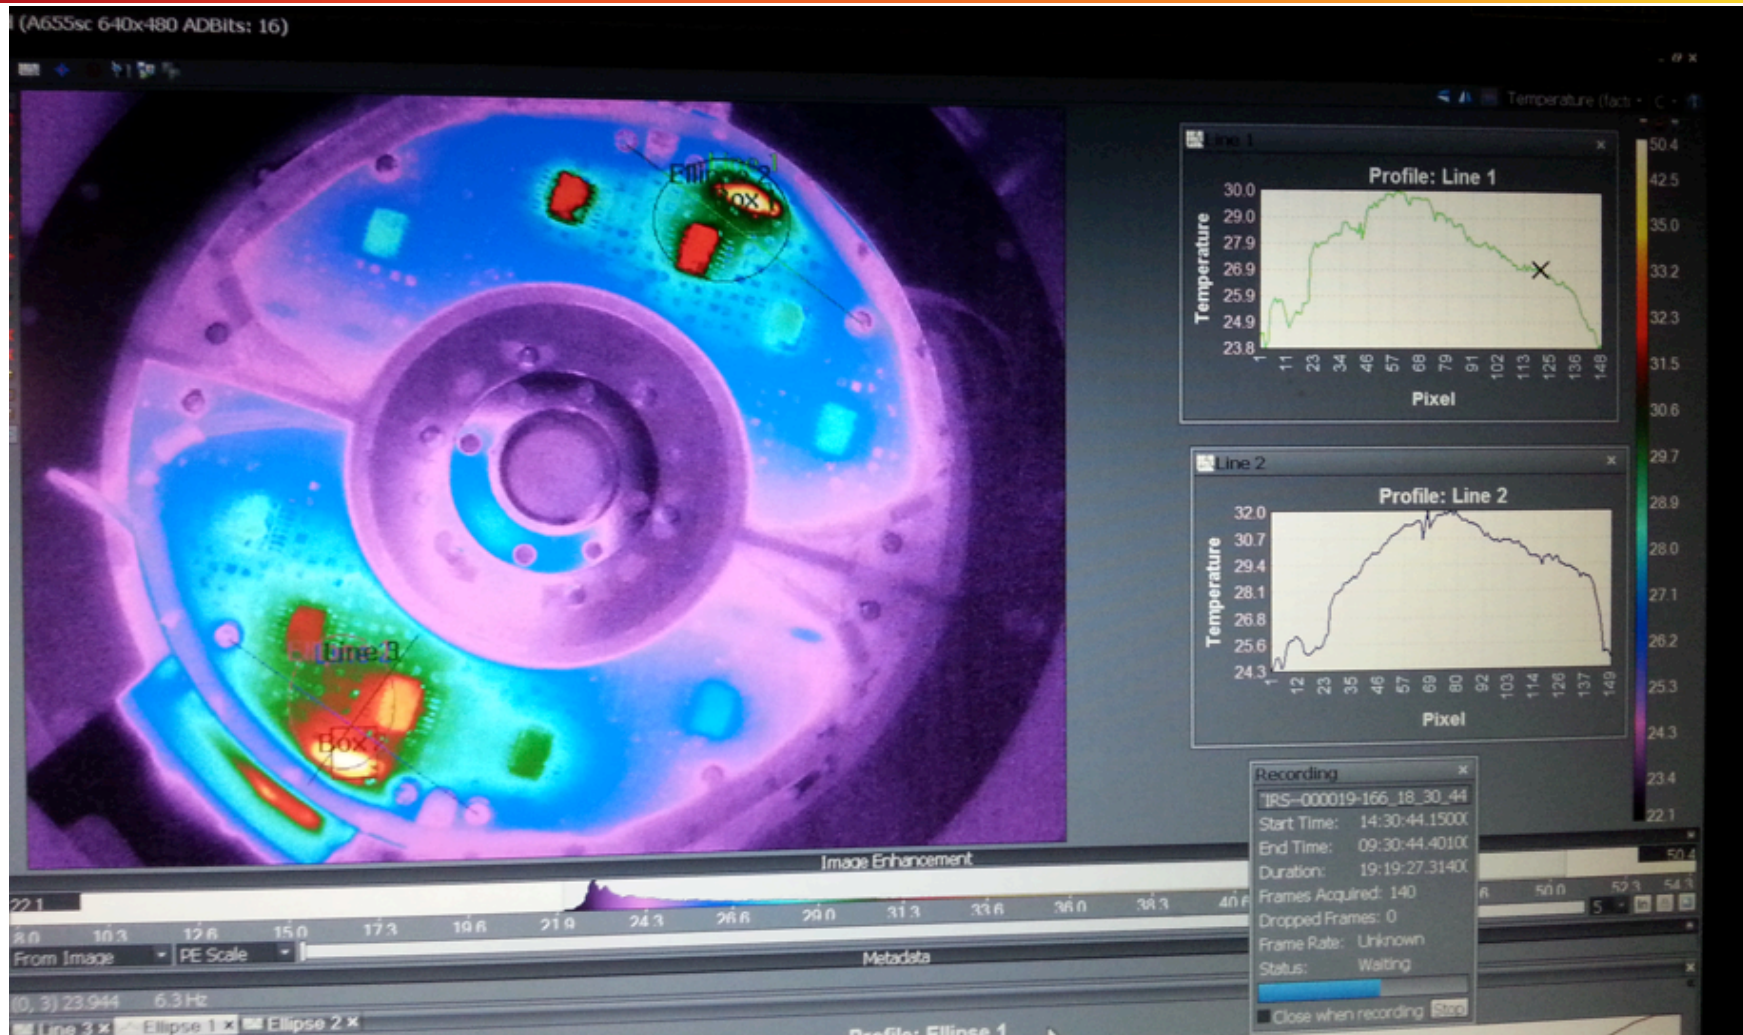
# Initial IR image showing mirror in Lower LHS

- After weeks of operation, noticeable locations of excessive temperature rise were seen on the board
- These were located in the vicinity of some RC filters feeding into amplifiers on the board
- Probe measurements were taken at points on the bank of filters that indicated reduced voltage (and hence current leakage) at at least two of the caps.
- GSFC parts branch brought in a thermal camera with high spatial resolution that identified that the hot spots were unequivocally located on two of the capacitors themselves.
- The focused heating combined with the fact that the capacitors are hand-soldered ceramic caps (not recommended for handsoldering) give a strong indication that they are cracked.
- Inspections of the board and x-rays performed did not show signs of cracking
- The process then began to remove the suspect parts from the board for failure analysis and replacement.

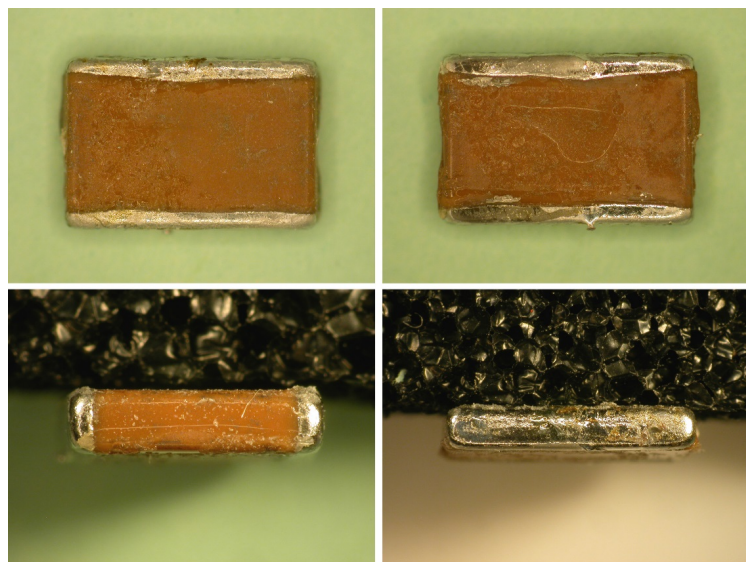
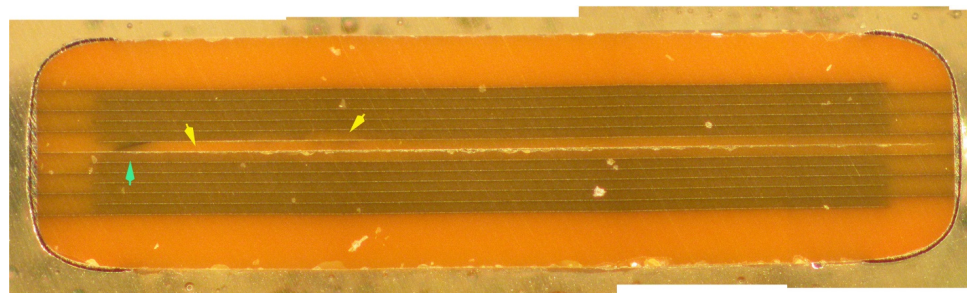
Electrical testing confirmed that the capacitor exhibited a 1500-ohm short. Cross sectioning found a delamination along one side of the center electrode, extending across the entire part from termination to termination. This defect was probably due to a problem during fabrication. A smaller, crack-like defect located near the floating end of the center electrode was found, apparently a secondary effect of the delamination. This diagonal crack appeared to connect opposing electrodes and is a likely candidate for the location of failure.

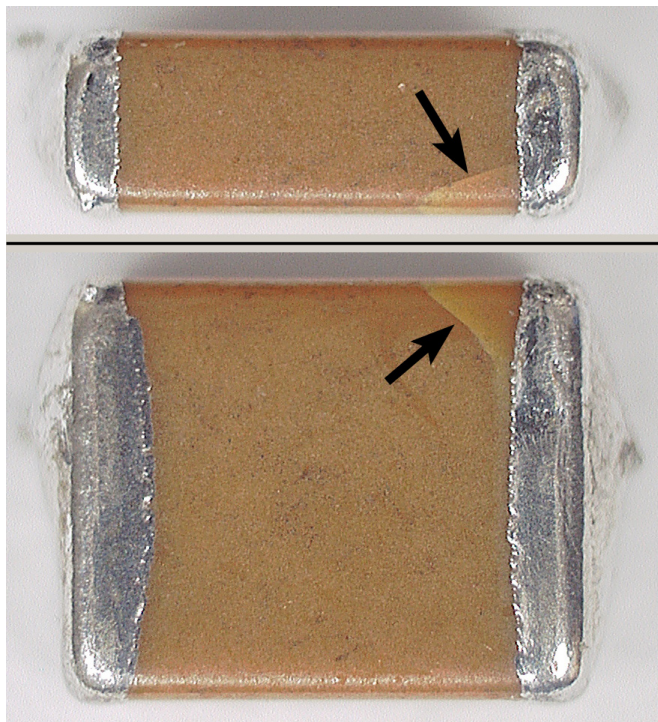
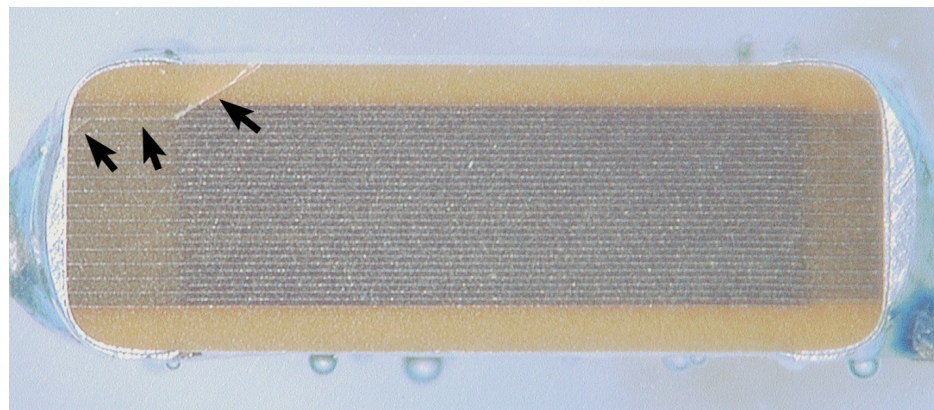
The capacitor was most likely damaged during or as a result of the attachment process. No extrinsic defects were observed in this capacitor nor the three DPA samples (see report J10748DPA).

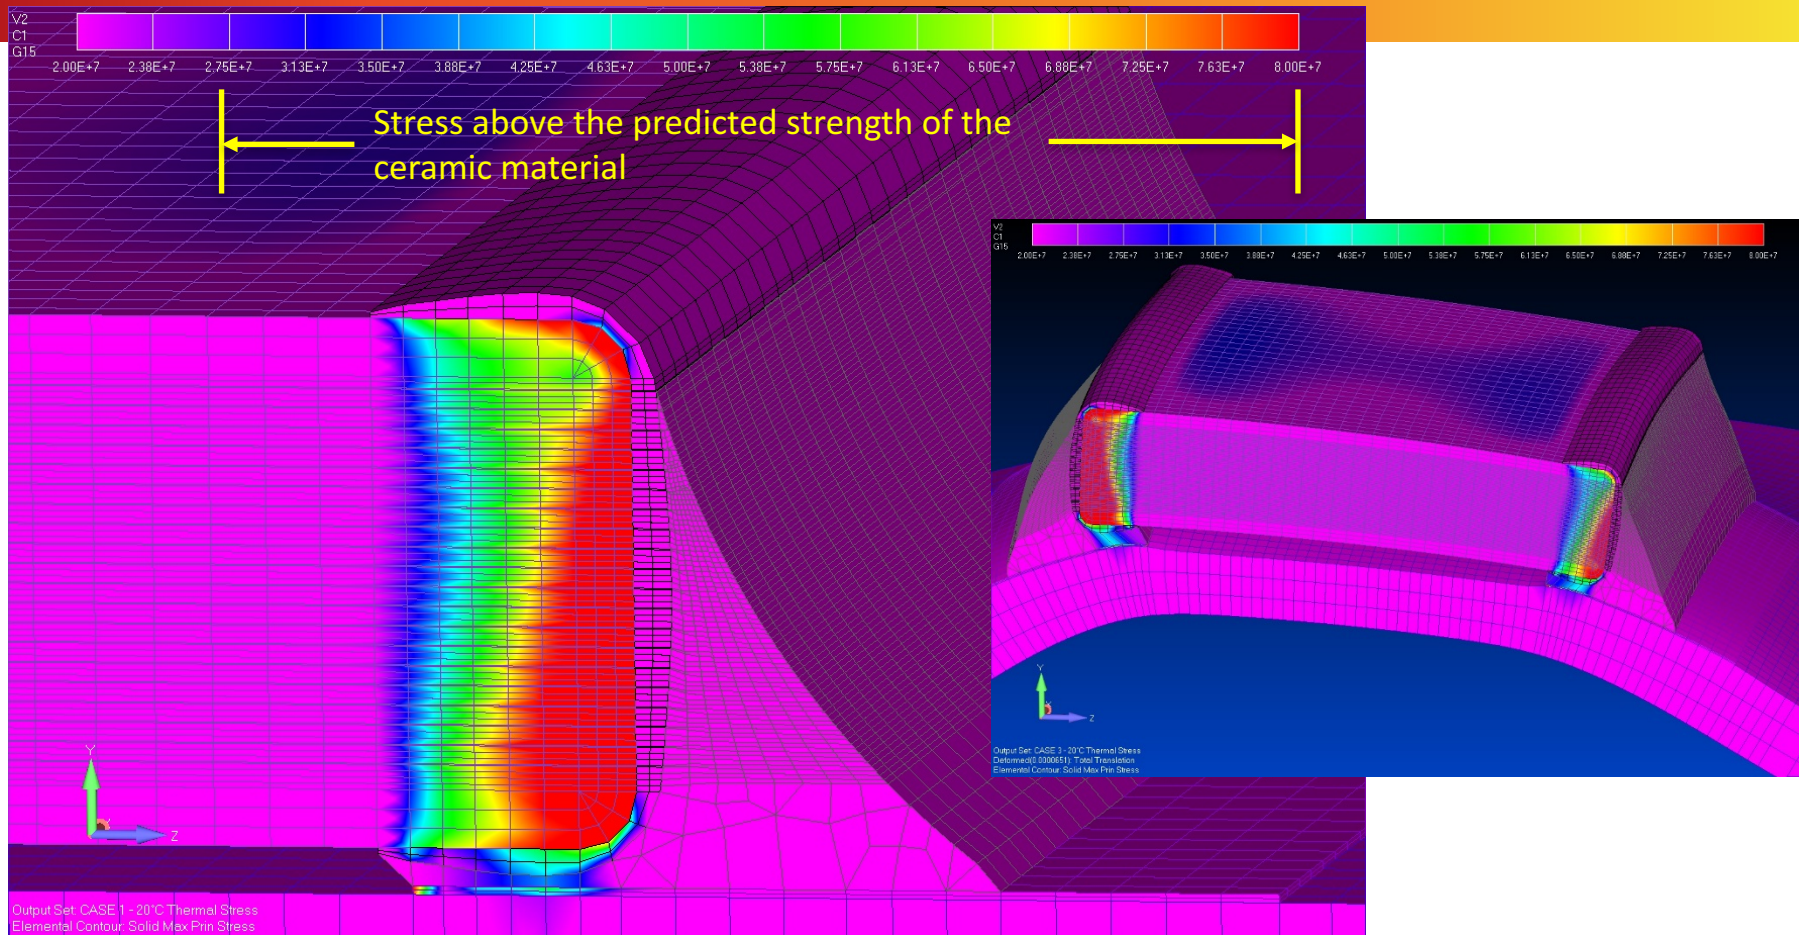
# Stress Model of MLCC Capacitor

The capacitor was most likely damaged during or as a result of the attachment process. No extrinsic defects were observed in this capacitor nor the three DPA samples

- Parts not installed
  - Avoid handsoldering, but if necessary, carefully follow and monitor process
  - If machine soldered, avoid solder joint touch-ups and rework in vicinity
- Installed parts, machine-soldered
  - Review leakage currents or nearby voltages where feasible
  - If possible, identify critical and/or non-FT applications
  - Avoid any risky interrogations, do not pull parts without risk comparison
  - Avoid rework in vicinity, and take note of any that has occurred
  - Take note of any solder touch-ups that have occurred (ask techs)
- Installed parts, hand-soldered
  - Carefully review process used (thermal conditioning, timing) and prior experience
  - If possible, identify critical and/or non-FT applications
  - Perform inspections from separate package. where not risky
