NASA/TM—2019–220176

The Role of Alerting System Failures  
in Loss of Control Accidents  
CAST SE-210 Output 2  
Report 3 of 6

March 2019

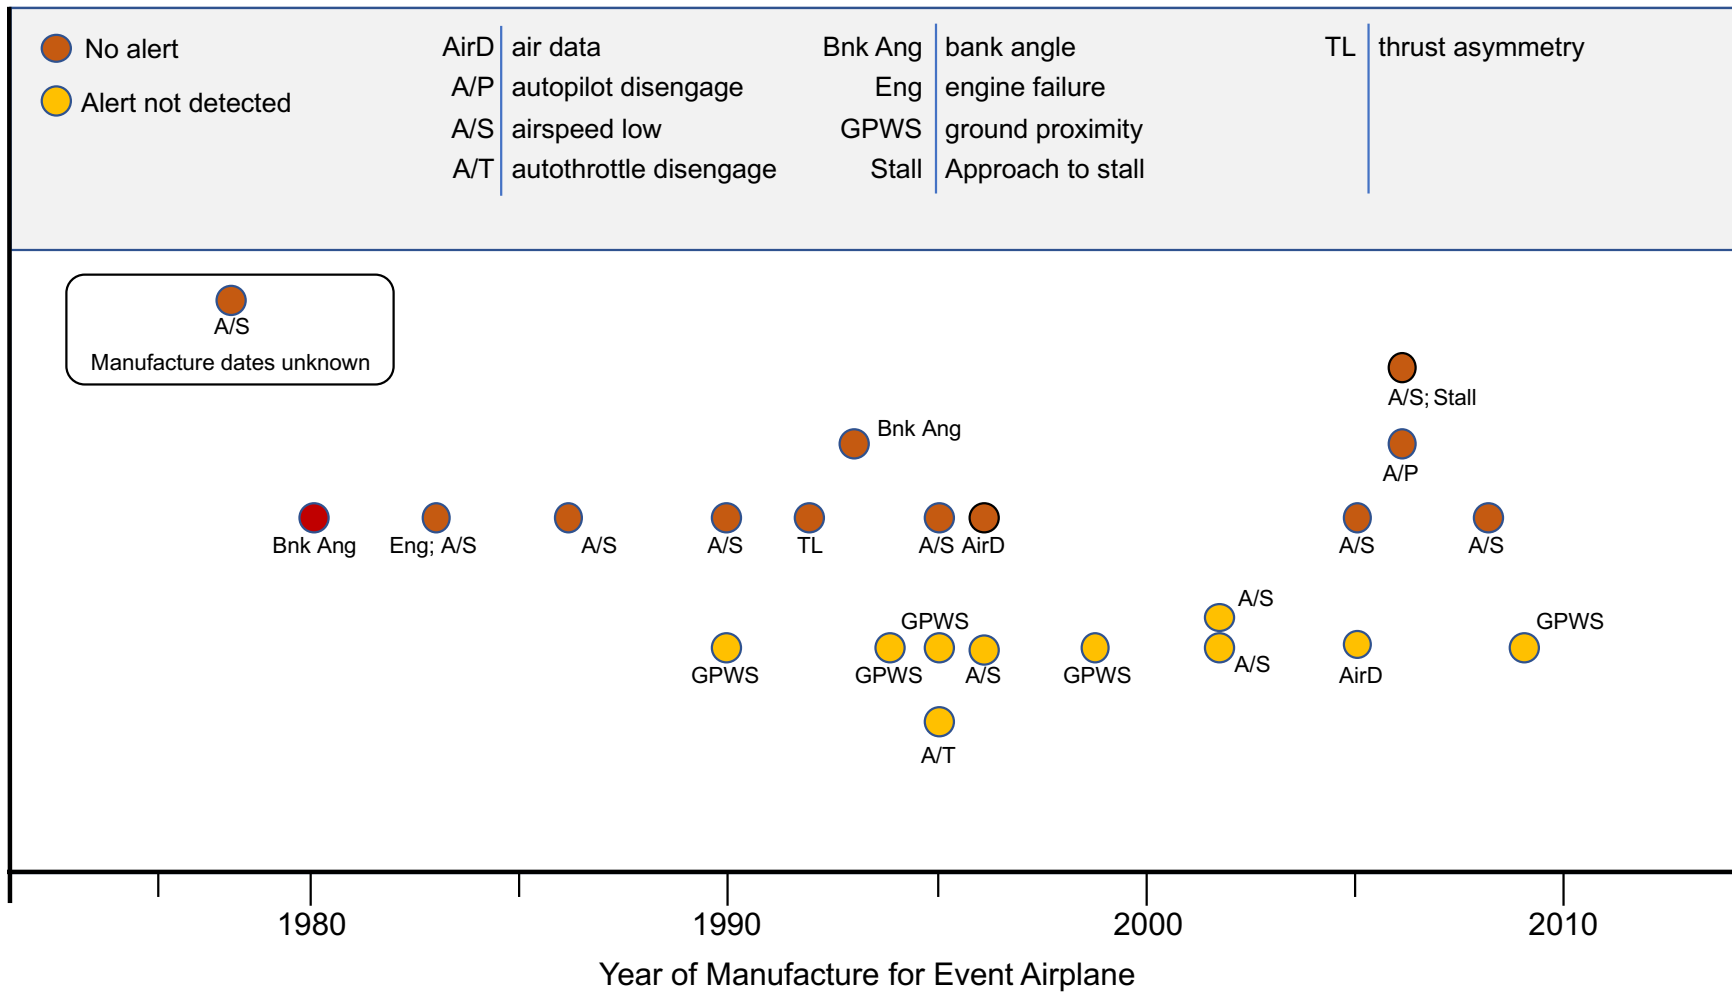
Figure 2a. Fail to orient as it relates to year of manufacture (marked for hazard).

Figures 2a and 2b organize the events according to when the event airplane was manufactured instead of when the accident occurred. The specific focus is on the events in which there was no alert or the alert was not detected to determine the extent to which only older airplanes fail to orient the flight crew. The oldest airplane in the event set was manufactured in 1980, and the newest airplane was manufactured in 2009.

Each dot on the figure represents an alerting failure from one of the 28 events. A red dot is used when there was no alert; the orange dot is used when the pilot did not detect the alert. Note that several events had two relevant alerting failures (for two different hazards).

Figure 2a shows the hazard associated with each red and orange dot. Figure 2b shows the airplane make and model for the same set of events. These figures show that red and orange dots continue to occur for more-recently manufactured airplanes. Summed by decades—for failure to alert—there were:

7. *Newer airplanes have problems as well.* Figures 2a and 2b show that the orientation failures were not just an issue with airplanes built more than 30 years ago, or just with unsophisticated, 2<sup>nd</sup>-generation airplanes. The majority of these failures occurred in airplanes built in 1990 or later. More than one third (8/22) of the airplanes that failed to present an effective alert for hazards such as low airspeed or ground proximity were built after 2000!

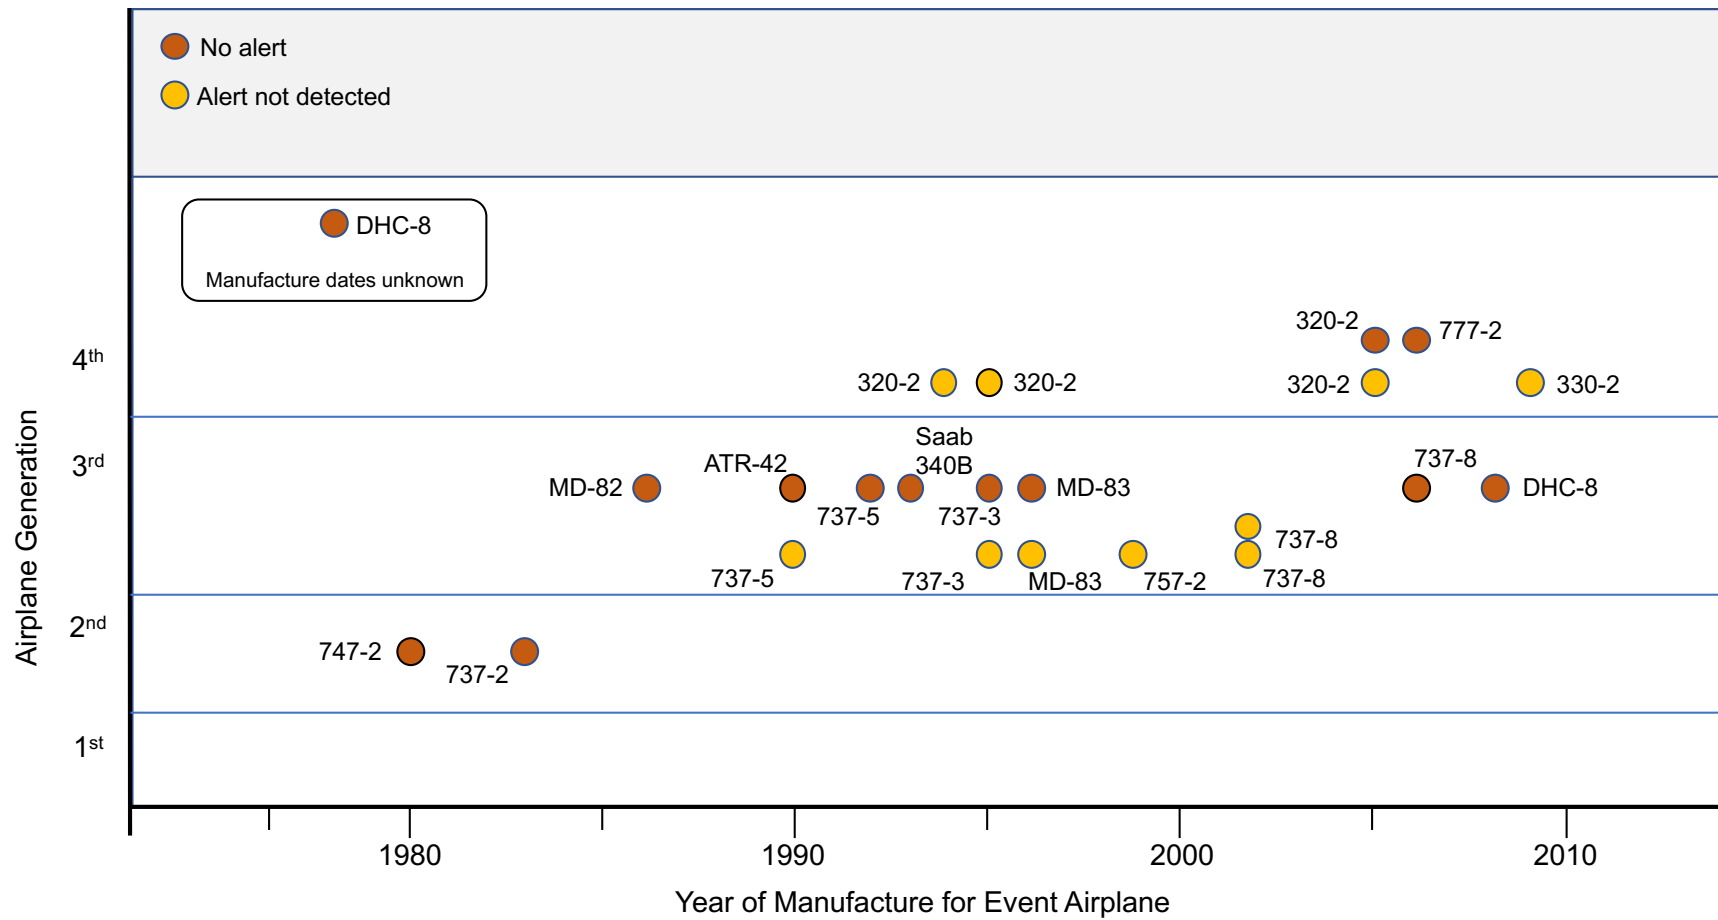
Figure 2b. Fail to orient as it relates to year of manufacture (marked for airplane model).

It is also possible to sort these airplanes into four technology-development generations (see Figure 2b); each generation adds sophistication in the airplane systems (definitions taken from <http://www.airbus.com/content/dam/corporate-topics/publications/safety-first/Airbus-Commercial-Aviation-Accidents-1958-2016-14Jun17.pdf>):

Using these generational definitions, the events from Figure 2b were re-classified by airplane generation. For failure to alert, there were:
