LESSONS LEARNED FROM FLIGHT OBSERVATIONS OF THE GOES-R MAGNETOMETER

The The Geostationary Operational Environmental Satellite (GOES)-16 observatory was launched on 19 November 2016. During daily on-orbit operations, shadowing of the inboard magnetometer sensor unit occurs due to spacecraft geometry and solar angle. Throughout the shadowing periods of the inboard magnetometer, anomalous excursions of 20 nanotesla (nT) are observed. In addition to the excursions during shadow events, the measurement difference between the inboard and outboard magnetometer varies over the day, indicating erroneous measurements by one or both magnetometers. In addition, based on the deployment rotations, the zero offsets of the X and Y axes were found to be significantly different, ~30nT, from ground calibration data.

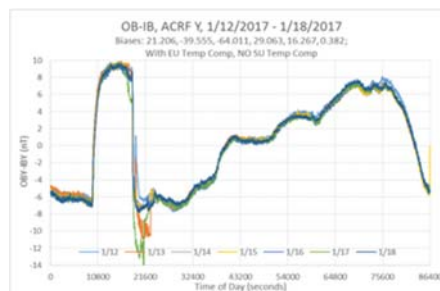
Figure 2. Daily trend of anomalous signature over 1 week period

magnetometer boom deployment. During daily on-orbit operations, shadowing of the inboard magnetometer sensor unit occurs due to spacecraft geometry and solar angle. Throughout the shadowing periods of the inboard magnetometer, anomalous excursions of 20 nanotesla (nT) are observed. In addition to the excursions during shadow events, the measurement difference between the inboard and outboard magnetometer varies over the day, indicating erroneous measurements by one or both magnetometers. Fig. 2 shows the variation in the difference between the inboard and outboard magnetometers over multiple days. For a nominal system the difference between the two magnetometers should be small (<2 nT) with small variances in the spacecraft field causing diurnal variation [1].

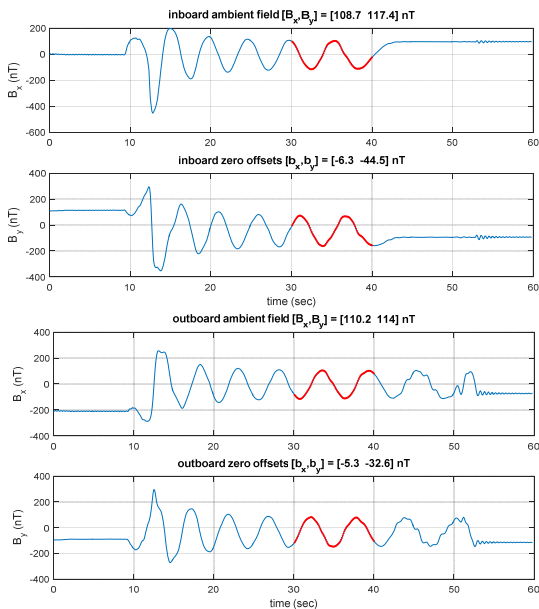
Figure 3 Inboard and Outboard Magnetometer X and Y Axes during deployment

Furthermore, based on the deployment rotations, the zero offsets of the X and Y axes on both inboard and outboard magnetometers were found to be significantly different, ~30nT, from ground calibration data as shown in Fig. 3. Subsequent calibration maneuvers confirmed the large zero offsets in all three axes.

Additionally, subsequent ground testing of the follow-on GOES-S magnetometer revealed cable lengths used on the spacecraft were different from those used in testing performed by the magnetometer manufacturer, resulting in zero offsets different than those determined in ground testing. This is likely a contributing root cause to the large zero offsets observed at boom deployment and subsequent calibrations.

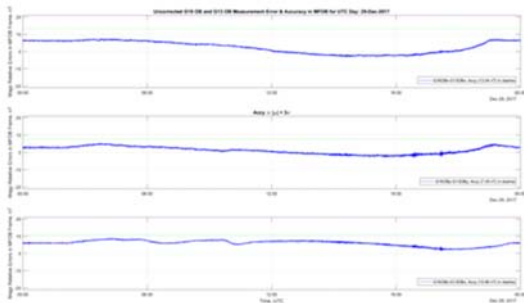
Figure 4 GOES-16 wrt GOES-13 Magnetometer Measurement Diurnal Error Curves

A comparison of both the inboard and outboard magnetometers to other on-orbit GOES (GOES-13, GOES-14, and GOES-15) shows the diurnal variation in the differences is not solely due to erroneous inboard magnetometer readings. Fig. 4 shows the outboard magnetometer has a diurnal error variation of +/- 5 nT as compared to the GOES-13 outboard magnetometer. [2][3]. The comparison was performed when GOES-16 was collocated with GOES-13.

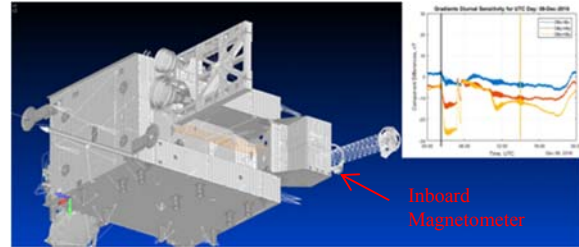
Figure 5 Start of GOES-16 inboard Magnetometer Shadowing by Observatory

As stated, the large 20 nT rapid excursions in the inboard magnetometer are correlated to shadowing of the inboard magnetometer by the spacecraft. Figs. 5 through 7 show the inboard being shadowed by the spacecraft body and subsequently by the high gain antenna wing [2].

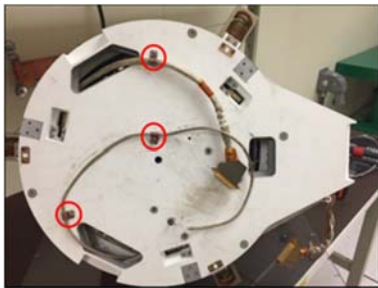
- The harness p-clamps wrapped in copper tape in contact with vapor deposited aluminum (VDA) on the magnetometer sensor epoxy composite mounting plate creating the possibility of voltage difference along the loop formed by the

harness, cooper tape, and VDA. Also, the copper tape in contact with the harness silver coated overbraid is another source of voltage difference (Fig. 8),

Figure 8 Copper wrapped P-clamps in contact with harness and VDA creating possible current loop

plate replicating the flight configuration. One P-clamp was heated with a heat gun to generate a thermal gradient between the junctions (Copper/Silver or Copper/Aluminum). Once again, no magnetic field was generated. From additional testing of different configurations including replacing the plate with an aluminum foil covered block, the investigation team concluded the VDA is too thin, approximately 600 μin , to provide an appreciable conductive path between the P-clamps.

- scoring the inboard and outboard VDA-coated mounting plates to decrease the potential of thermally induced eddy currents
- replacing of the copper tape on the p-clamps with non-conductive GBK tape to prevent electrical contact between the harness and the VDA
- isolating the multiple harnesses from each other to prevent the possibility of current loop through the metallic braid
- replacing the chrome-plated pin of the plate mounting bracket with a ceramic pin to prevent the Seebeck effect and path for current loops
- replacing the metallic backshell and grounding plug cover with non-conductive polymeric 3-D printed parts to eliminate any metallic material near the sensors.

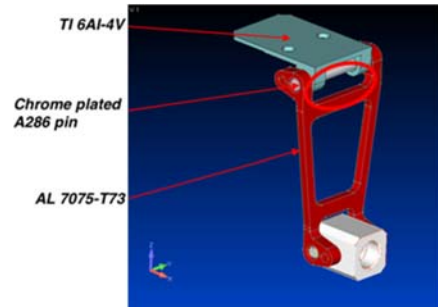
Figure 9 Mounting bracket with chrome in contact with Aluminum creating possible current loop

An audit of all materials near the magnetometers looking for dissimilar metals in contact found the mounting bracket of the inboard plate has a chromium plated pin in contact with aluminum and titanium. Since the Seebeck coefficient for chromium and aluminum is 20.1 and -2.9 $\mu\text{V/K}$ [6][7], there is a possibility for large voltage with relatively small temperature gradient. Treating the loop in Figure 9 as circular, Eq. 1 is used to estimate the magnetitic field as a function of temperature gradient.

The distance from the bracket to the magnetometer is only 0.076 m. However, the effective radius (R in eq. 1) for the loop area is only 5.5E-3 m. This yields a field at the magnetometer of 0.26 nT/K. To be the primary contributor of the magnetic contamination during shadow transition, the thermal gradient needs to be $\sim 77\text{K}$. Given the thermal conduction and thermal mass of the bracket, it is unlikely such a gradient can be achieved.

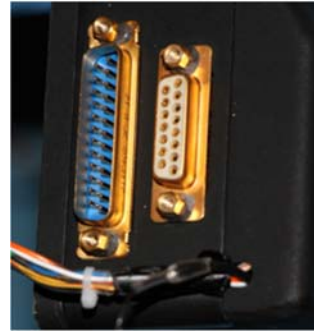
Figure 10 Metallic Backshells

- The mounting bracket chrome-plated pin in contact with an aluminum bracket creating a voltage source around the loop in the bracket (Fig. 9),
- The metallic backshell and grounding plug allowing eddy currents to form near the magnetometer (Fig. 10),
- Two thermal blanket copper ground wires emanating from the thermal blanket in contact with aluminized Kapton inner layers of the sensor multi-layer insulation creating a possible current loop.

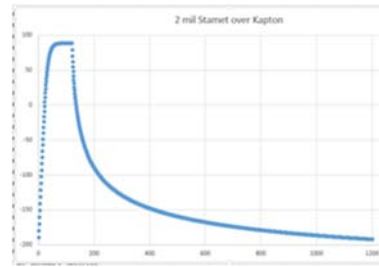
Figure 12 Predicted Temperature of Outer Layer of Thermal Blanket During Entry and Exit of Shadow.

While this finding partly explains the large static bias, it does not explain the varying field. The outer layer of a thermal blanket will vary between -175 $^{\circ}\text{C}$ and 75 $^{\circ}\text{C}$, as shown in Fig. 12, which will cause the magnetic field density to vary as the tape on the blanket goes in and out of shadow.

The change in the field over the test temperature was approximately 0.05 nT/C. For the cited temperature range, a change in field of approximately 12 nT is possible.

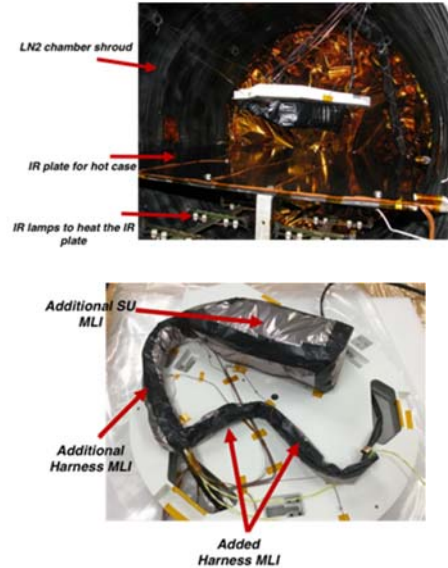
Figure 15 Thermal Balance Test Setup with Thermal Changes.

Since the temperature swings were well outside what was predicted by the thermal model, a standalone (magnetometer sensor mounted on flight plate) thermal balance (TB) test was defined and performed to create a correlated model. During the TB test several design changes were tested, including the addition of another blanket over the existing blanket, the addition of blankets over the harnesses, and the addition of a heater and control thermistor to the harness adjacent to the sensor unit to reduce heat loss through the harness. Fig. 15 shows the test set up for the TB test.

The TB test demonstrated the proposed changes would significantly improve the thermal control of the magnetometer. Tab. 1 shows the seasonal gradients of the bobbins for the GOES-16 design and for the redesign.

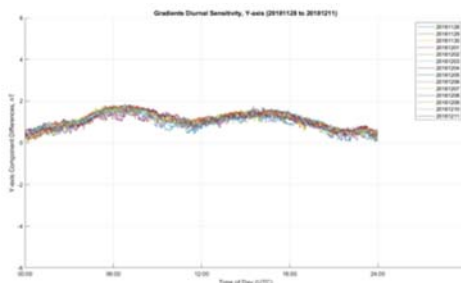
Figure 16. GOES-17 daily trend of difference between inboard and outboard over a 2 week period showing no anomalous signature

Whatever the root cause of the anomalous signature on GOES-16, the steps taken greatly improved the performance of the magnetometers on GOES-17, which was launched March 1, 2018. Fig. 16 shows the difference in the y-axis inboard and outboard magnetometers during a shadowing period. The large swings evident in Fig. 2 are no longer present and the diurnal variation is greatly reduced.
