Troubleshooting Challenges on the James Webb Space Telescope (JWST)

July 23, 2019

John McCloskey

NASA/GSFC Chief EMC Engineer

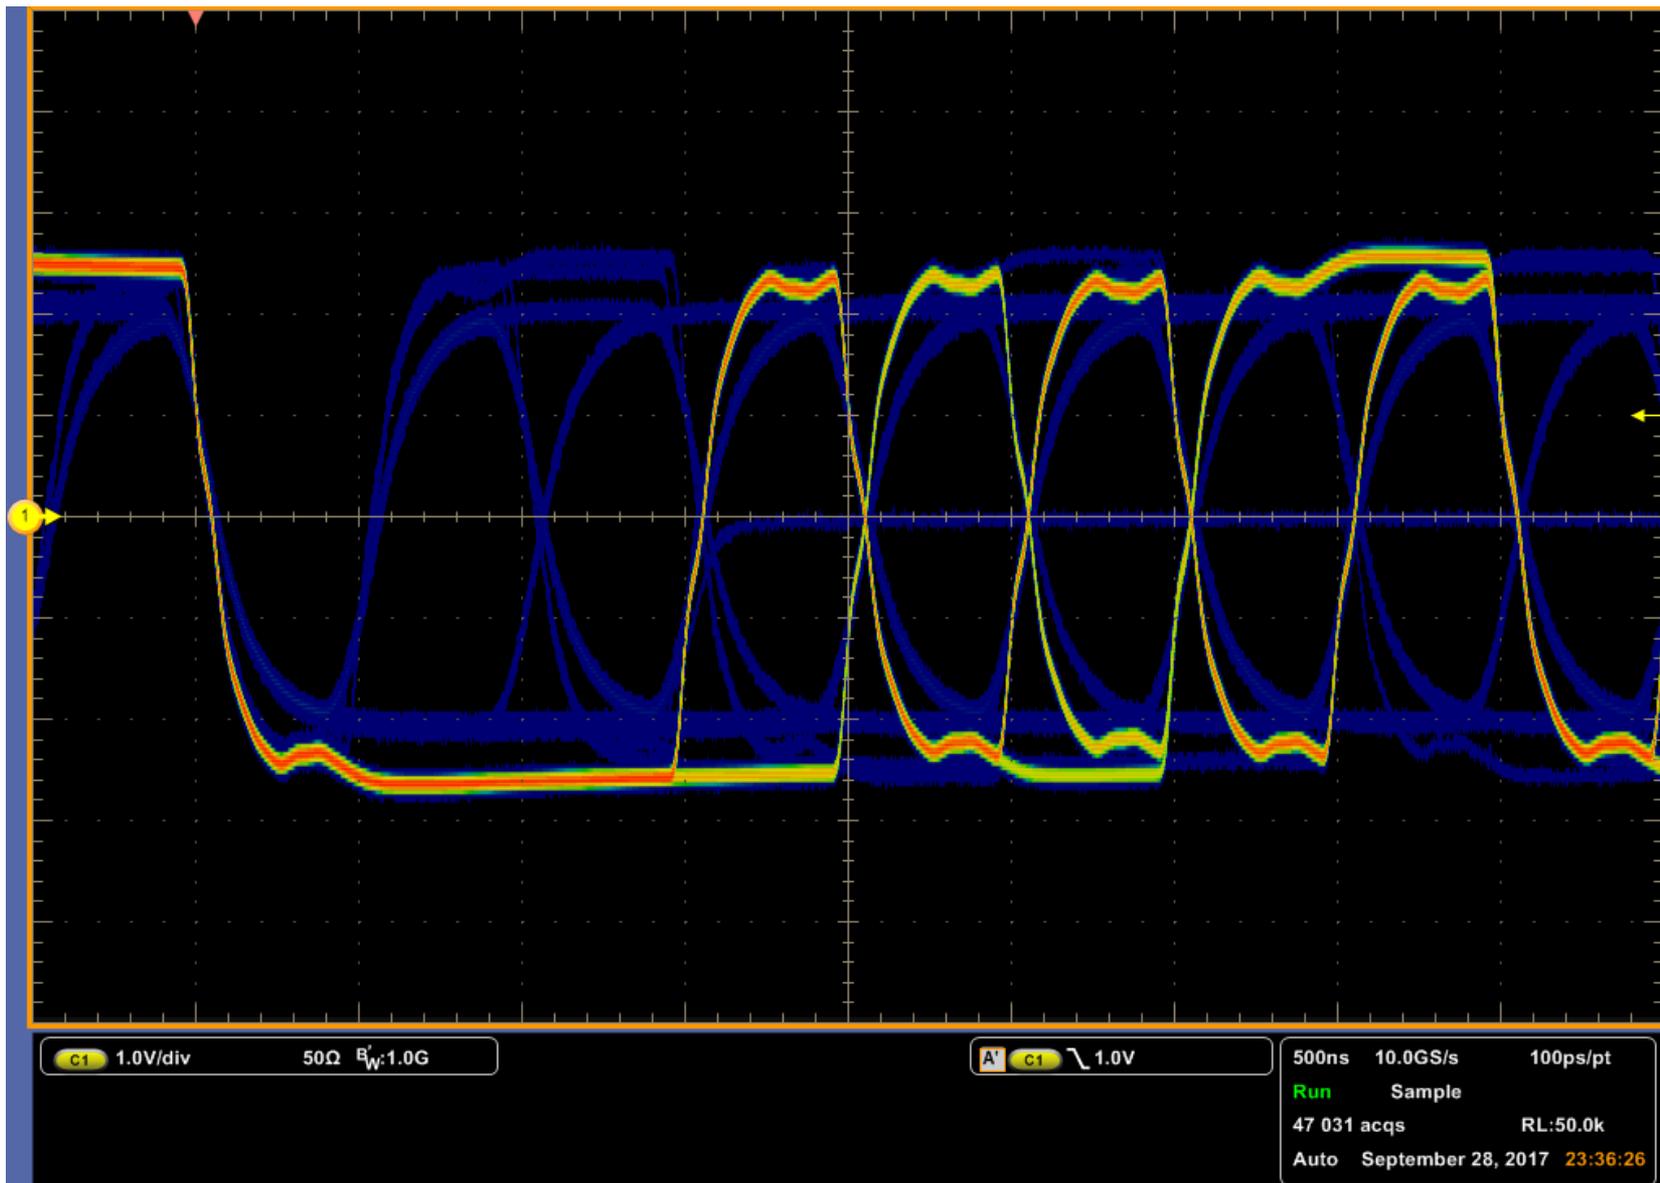
1553 Bus Signals

- **Possible 1553 bus problem (ruled out quickly)**
 - Bus signal quality looked good on oscilloscope (next slide)
 - All other 1553 I/F's work fine; points away from 1553 problem
- **Combed through telemetry surrounding events for clues**
 - Correlation observed to unexpected changes on current on primary power feed to box in question (MIRI ICE-B)
- **Looked at power interface of MIRI ICE**
 - Limited e-mail and phone support from ESA contractor
 - Hardcopies of schematics provided to local ESA representative
 - Includes undervoltage shutoff function ($V < \sim 18\text{ V}$)
 - Robust multi-pole filter with roll off frequency of a few kHz
- **Took closer look at power interface between spacecraft simulator (SCSim2A) and MIRI ICE-B**
 - Focus of investigation and this presentation

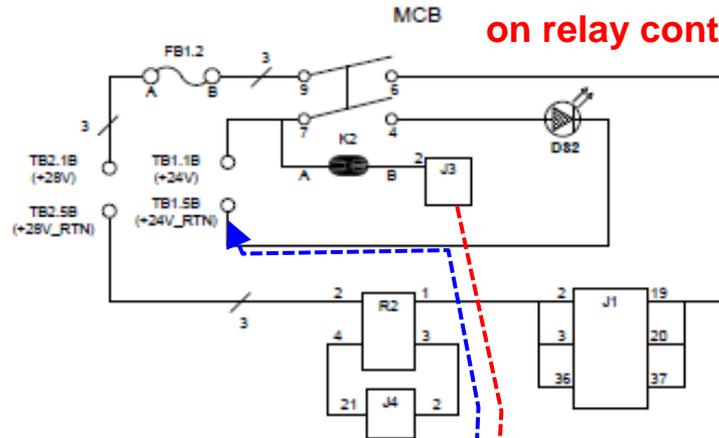
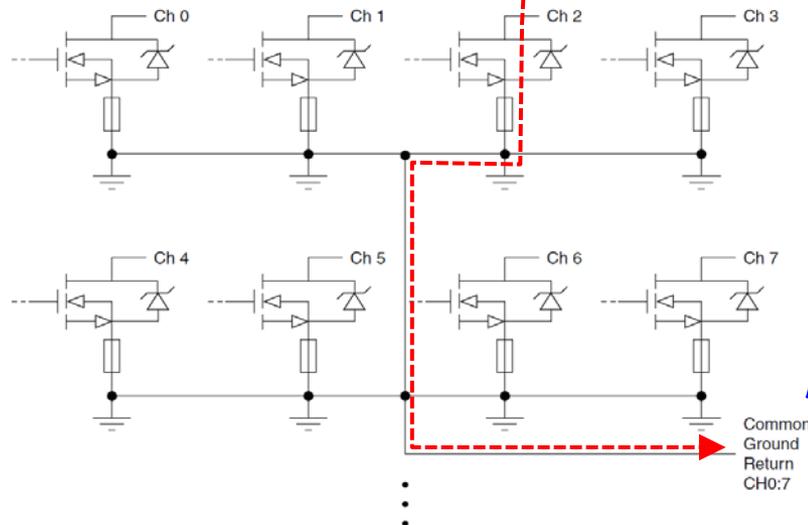
SI Redundant Power Drawer Block Diagram

No transient suppression elements on relay contacts or coils

~3 meters of cable provides ample opportunity for transient energy to couple throughout SCSim rack

Limited transient suppression (~3 meters of cable from relays)

- **Mechanical relays**
 - Inherently noisy (contact bouncing, etc.)
 - No transient suppression elements (transorbs, etc.)
- **Long cables and large current loops**
 - Increased risk of coupling
- **Measurements show significant noise generated by relay switching transients, but...**
 - These relays were not operating when 1553 events occurred (relays close to turn on box and stay closed)
 - Transient energy couples EVERYWHERE; no credible explanation for why only one side of one box would be affected
 - Ringing in switching transients has resonant frequency of ~1 MHz
 - MIRI ICE B has robust input filter with lots of attenuation at 1 MHz
 - **RELAY SWITCHING TRANSIENTS UNLIKELY ROOT CAUSE**

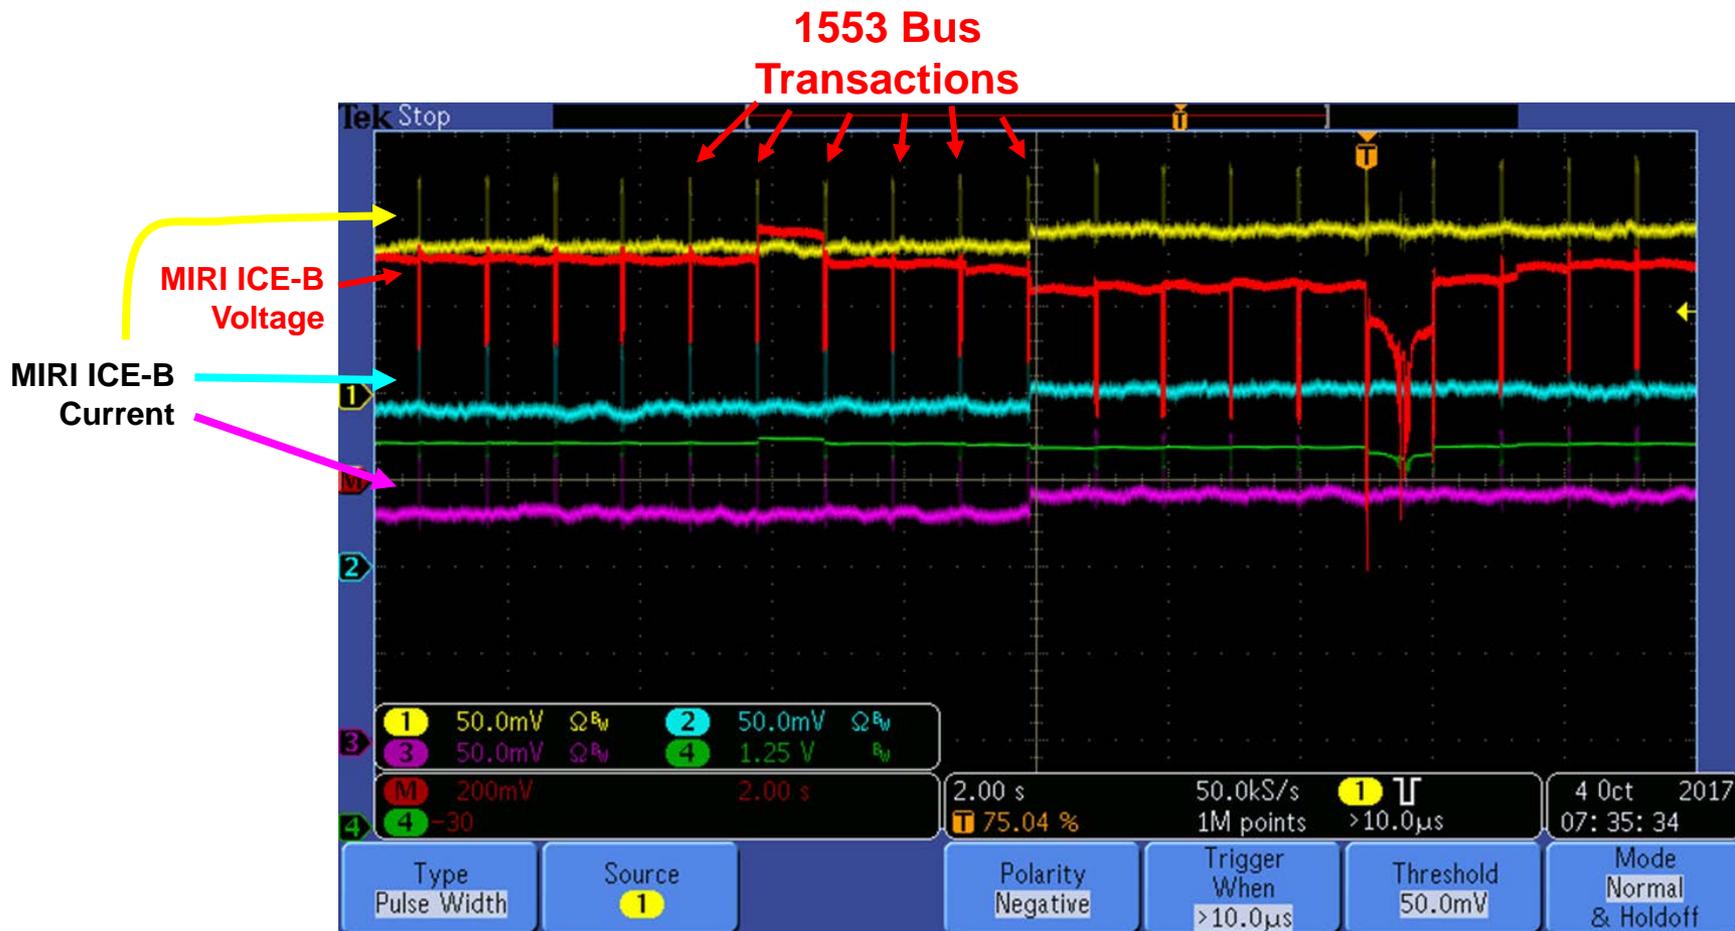
MIRI ICE B Power Feed (measured at RIVETS)

- **During 1553 transactions:**
 - $\Delta I \approx 120 \text{ mA}$, $\Delta V \approx 200 - 300 \text{ mV}$
- **Effective $Z \approx 1.7 - 2.5 \Omega$**

- AWG20 wire, 30 mΩ/m
- MIRI ICE feed
 - 3 AWG20 pairs in parallel
 - ~50 feet (15 m) between SCSim and feedthrough plate
- Total resistance on MIRI ICE power feed
 - $(0.03 \text{ } \Omega/\text{m}) \times (15 \text{ m}) \times (2) / 3 = 0.3 \text{ } \Omega$

- **HARNESS RESISTANCE DOES NOT FULLY ACCOUNT FOR OBSERVED VOLTAGE DROPS**

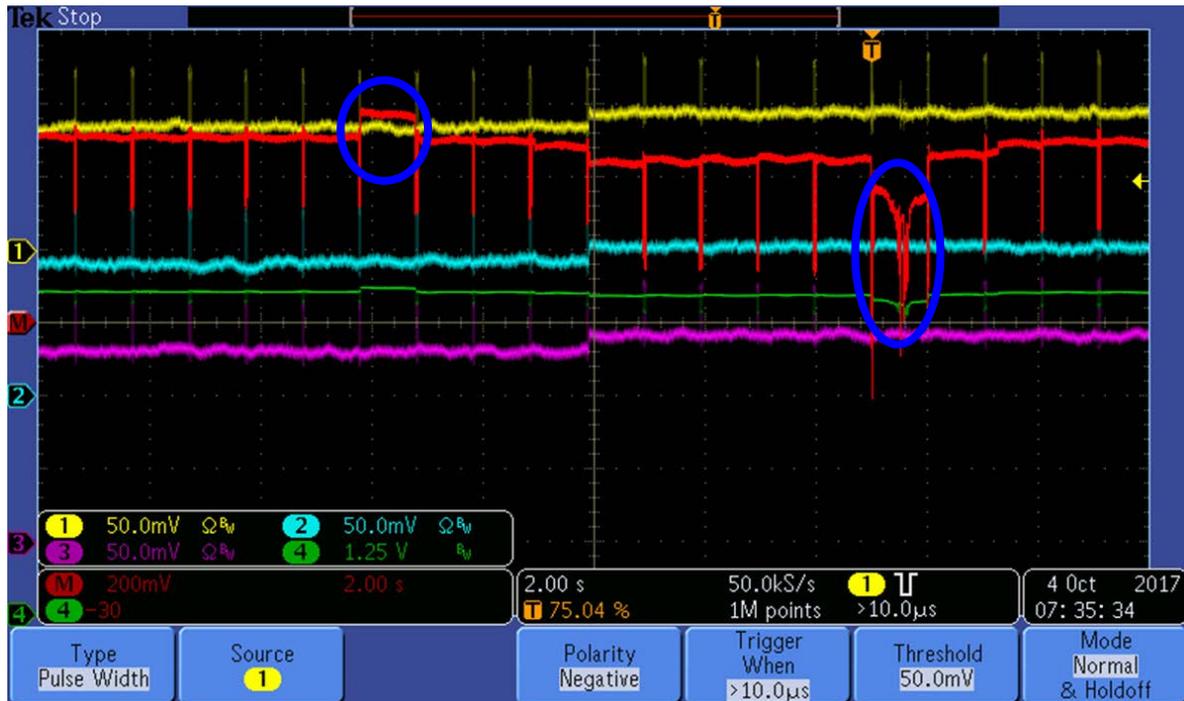
Unexplained Voltage Shifts

- Occasional shifts in voltage with no corresponding change in MIRI ICE-B current
 - Did not coincide with 1553 events, but indicated erratic behavior on power bus
- IEC heaters only equipment switching on/off power bus
 - Voltage shifts did not coincide with switching events
 - Most switching events produce no such transients
 - **NOT CREDIBLE CAUSE OF VOLTAGE SHIFTS**

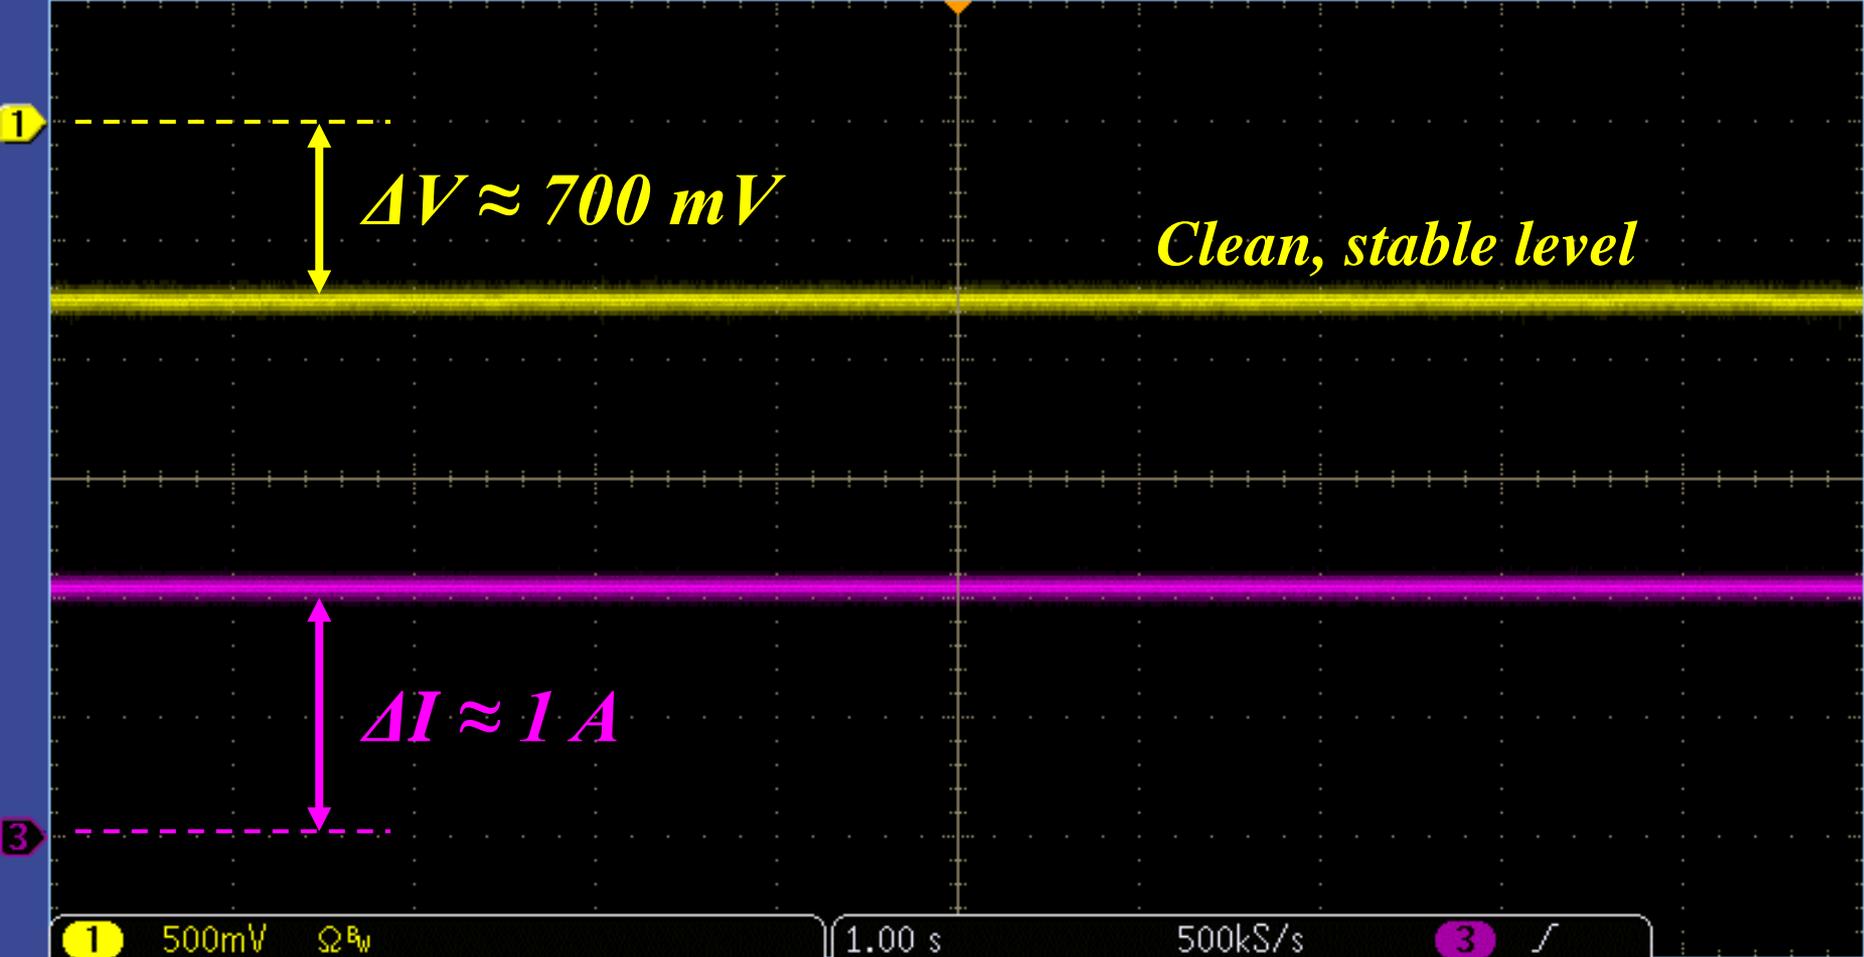
MIRI ICE A

Higher than expected ΔV

Not so clean, not so stable...

This noise will easily get through input filter

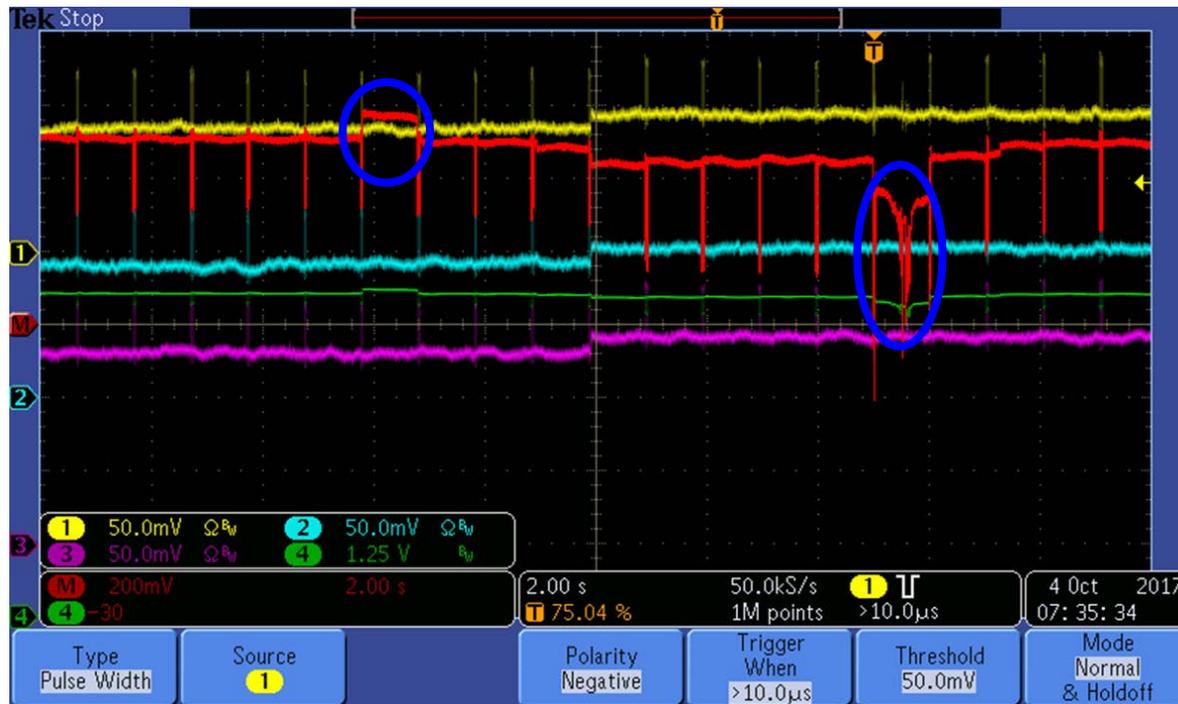
Possible Relay Corrosion

- Per GSFC Parts Branch (Code 562), erratic behavior is consistent with previously observed behavior of corroded relay contacts (SCSim has been in near continuous use for > 5 years)
- May contribute to instability in power interface
- May correlate to previously observed events

- **All relays and sockets replaced in SCSim2A**
 - All power feeds now “clean”; show no trace of erratic behavior
 - Relays provided to GSFC parts branch for evaluation; could not reproduce erratic behavior 🙄

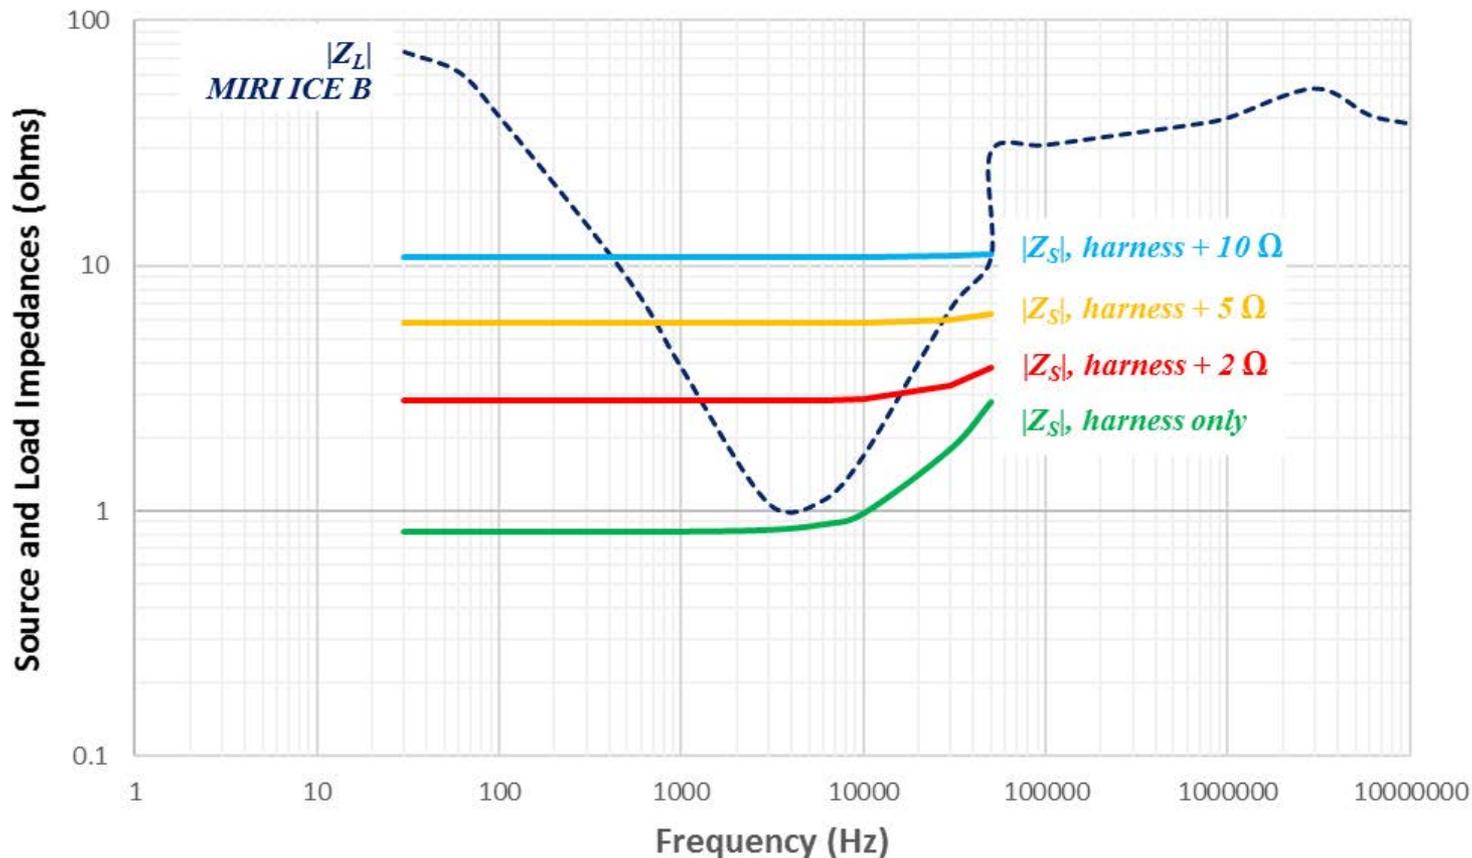
$|Z_S|$ vs. $|Z_L|$

- Middlebrook magnitude criterion met when $|Z_S|$ curve is under $|Z_L|$ curve at all frequencies (curves never cross each other)
 - Met for harness only with not much margin
- Violated for increasing values of relay contact resistance – need to look at phase at frequencies where violated (next slide)

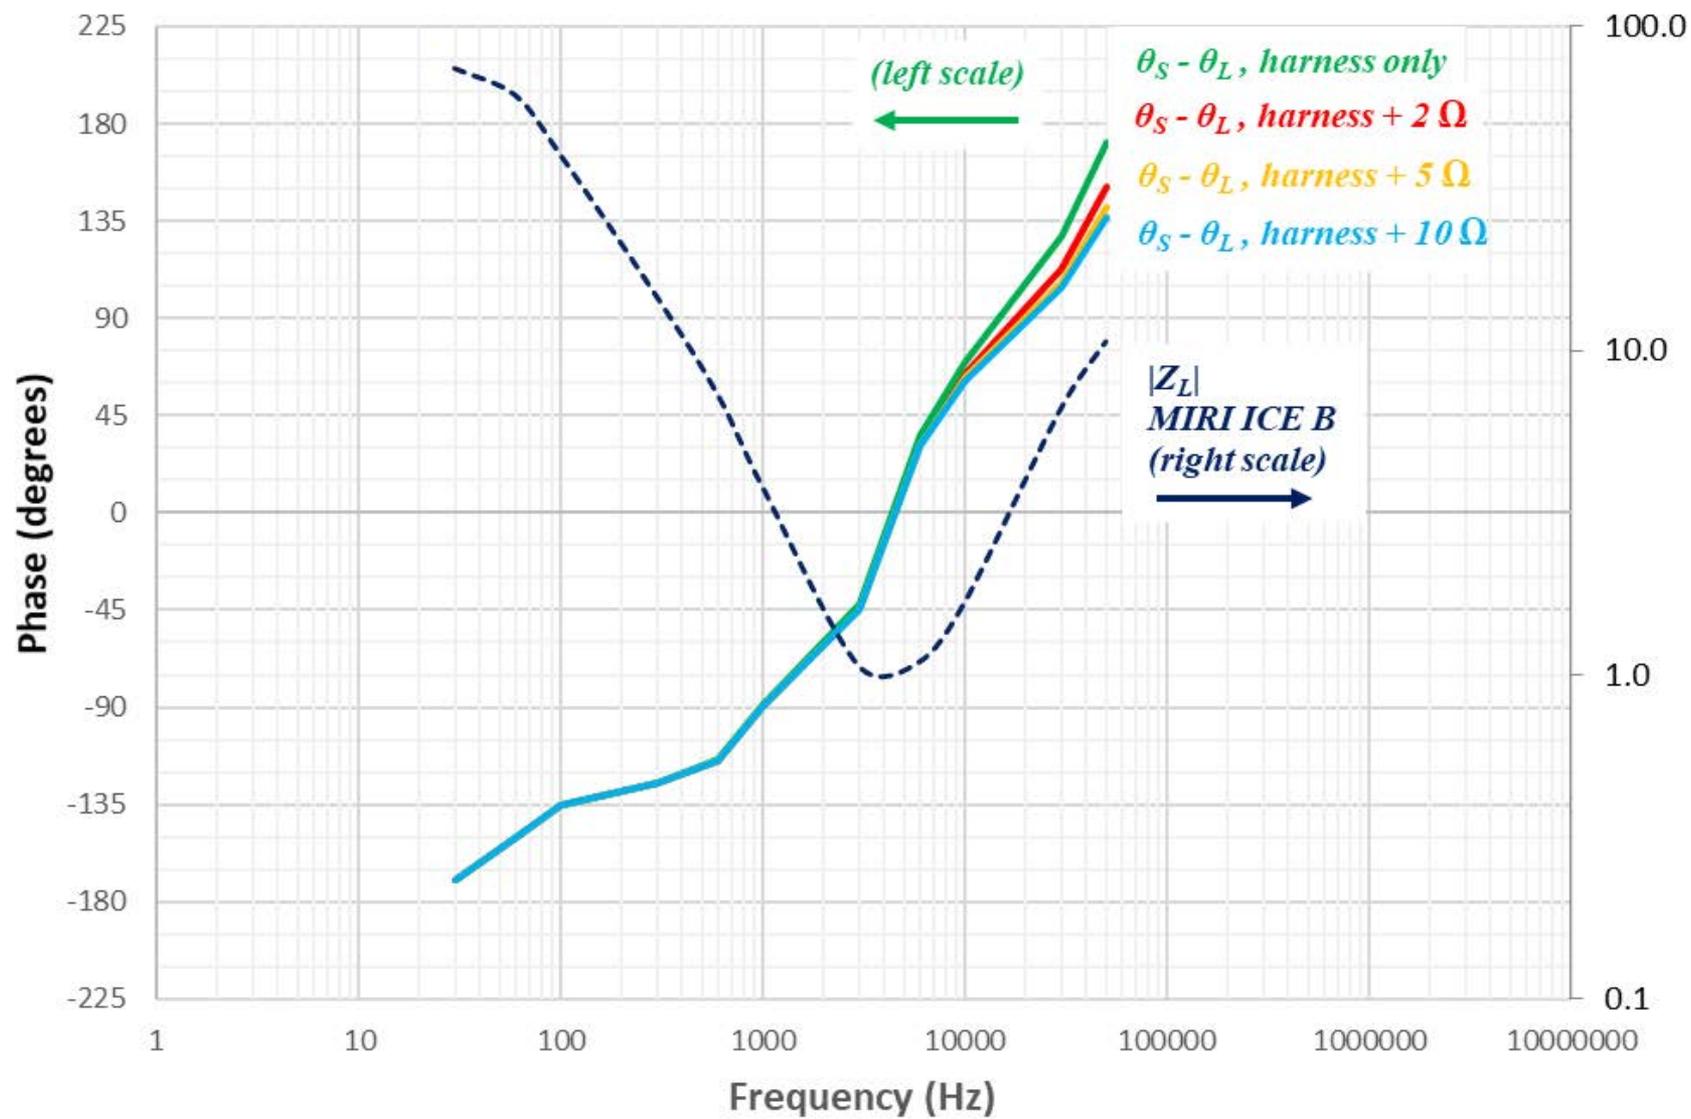
$$\theta_S - \theta_L$$

- **Though not proven, instability is leading theory for root cause**
 - Middlebrook magnitude criteria violated from ~500 Hz to ~50 kHz for increasing values of relay contact series resistance

- Decent phase margin (difference between $\theta_S - \theta_L$ and 180°) for most of frequency range where magnitude criteria violated
 - Could violate magnitude and phase criteria with temporary large increase in resistance

- Narrow frequency range of potential instability is consistent with intermittent nature of original problem under investigation
- **If true, places problem squarely on SCSim2A and exonerates MIRI ICE-B**
