# NASA ASRS Maintenance Reports - Part Installation Issues

InfoShare – Maintenance

April 2019

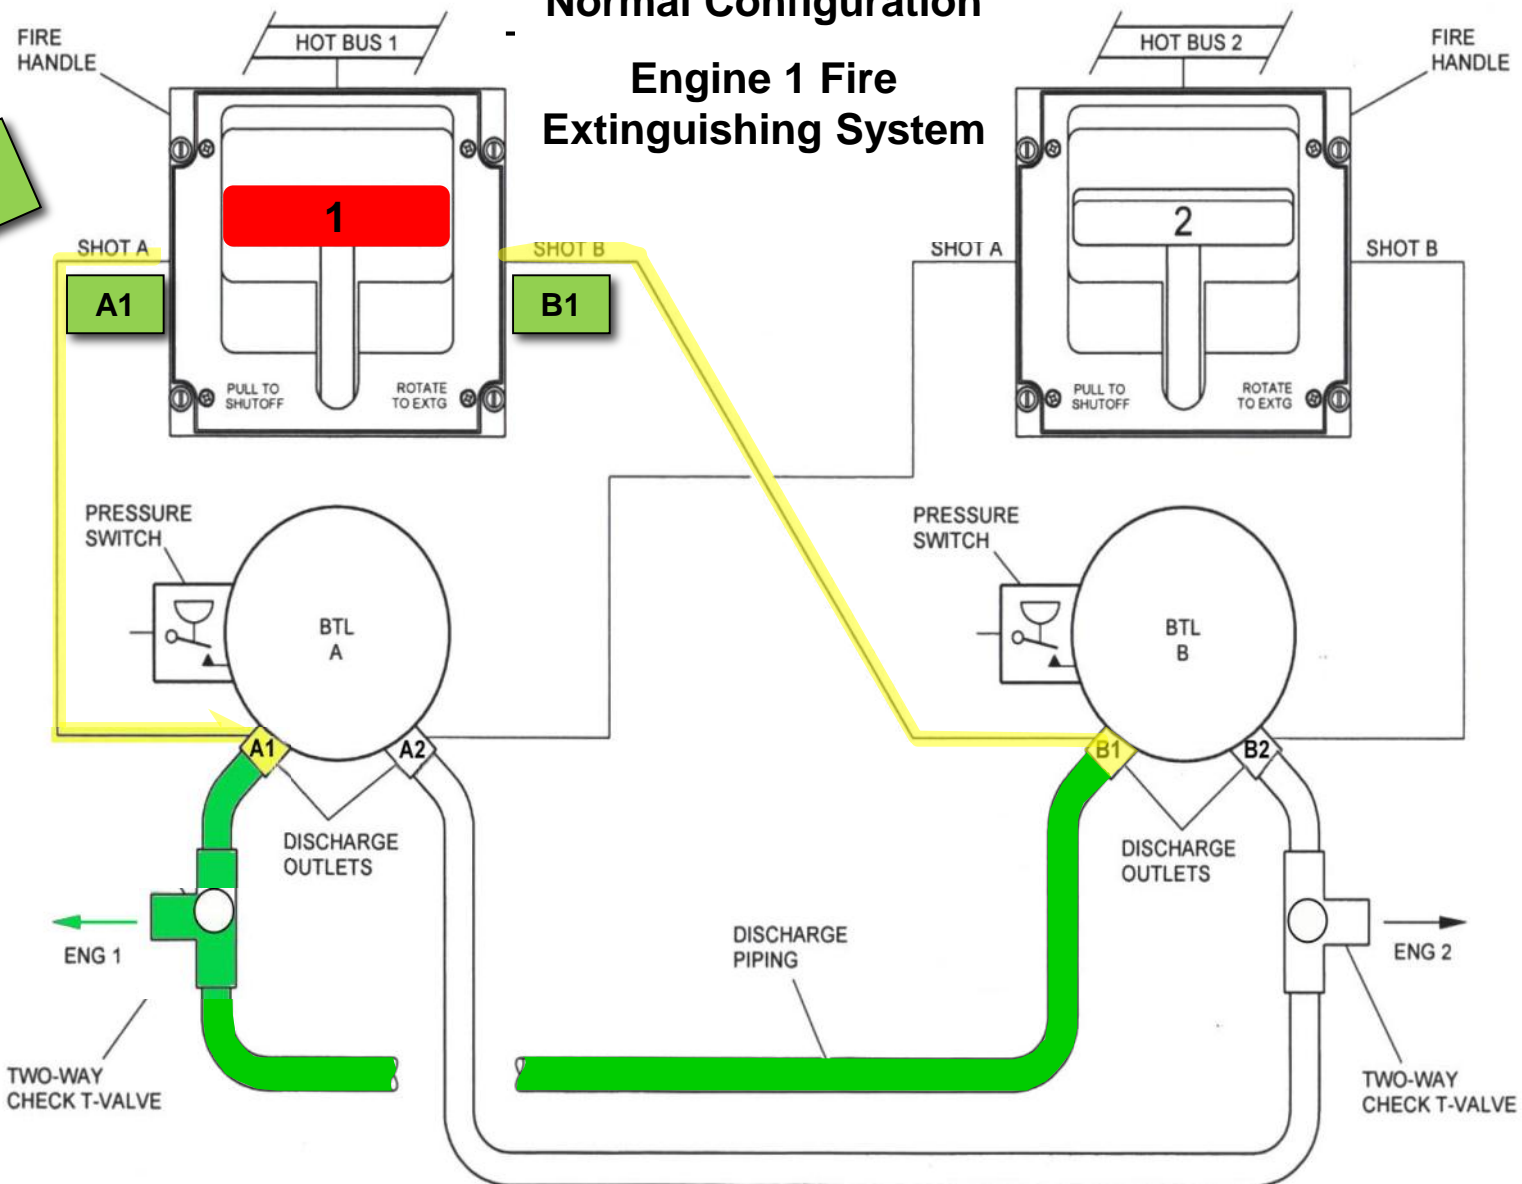
ENGINE FIRE EXTINGUISHING SYSTEM - SCHEMATIC

## Normal Configuration Engine 1 Fire Extinguishing System

Normal Operations

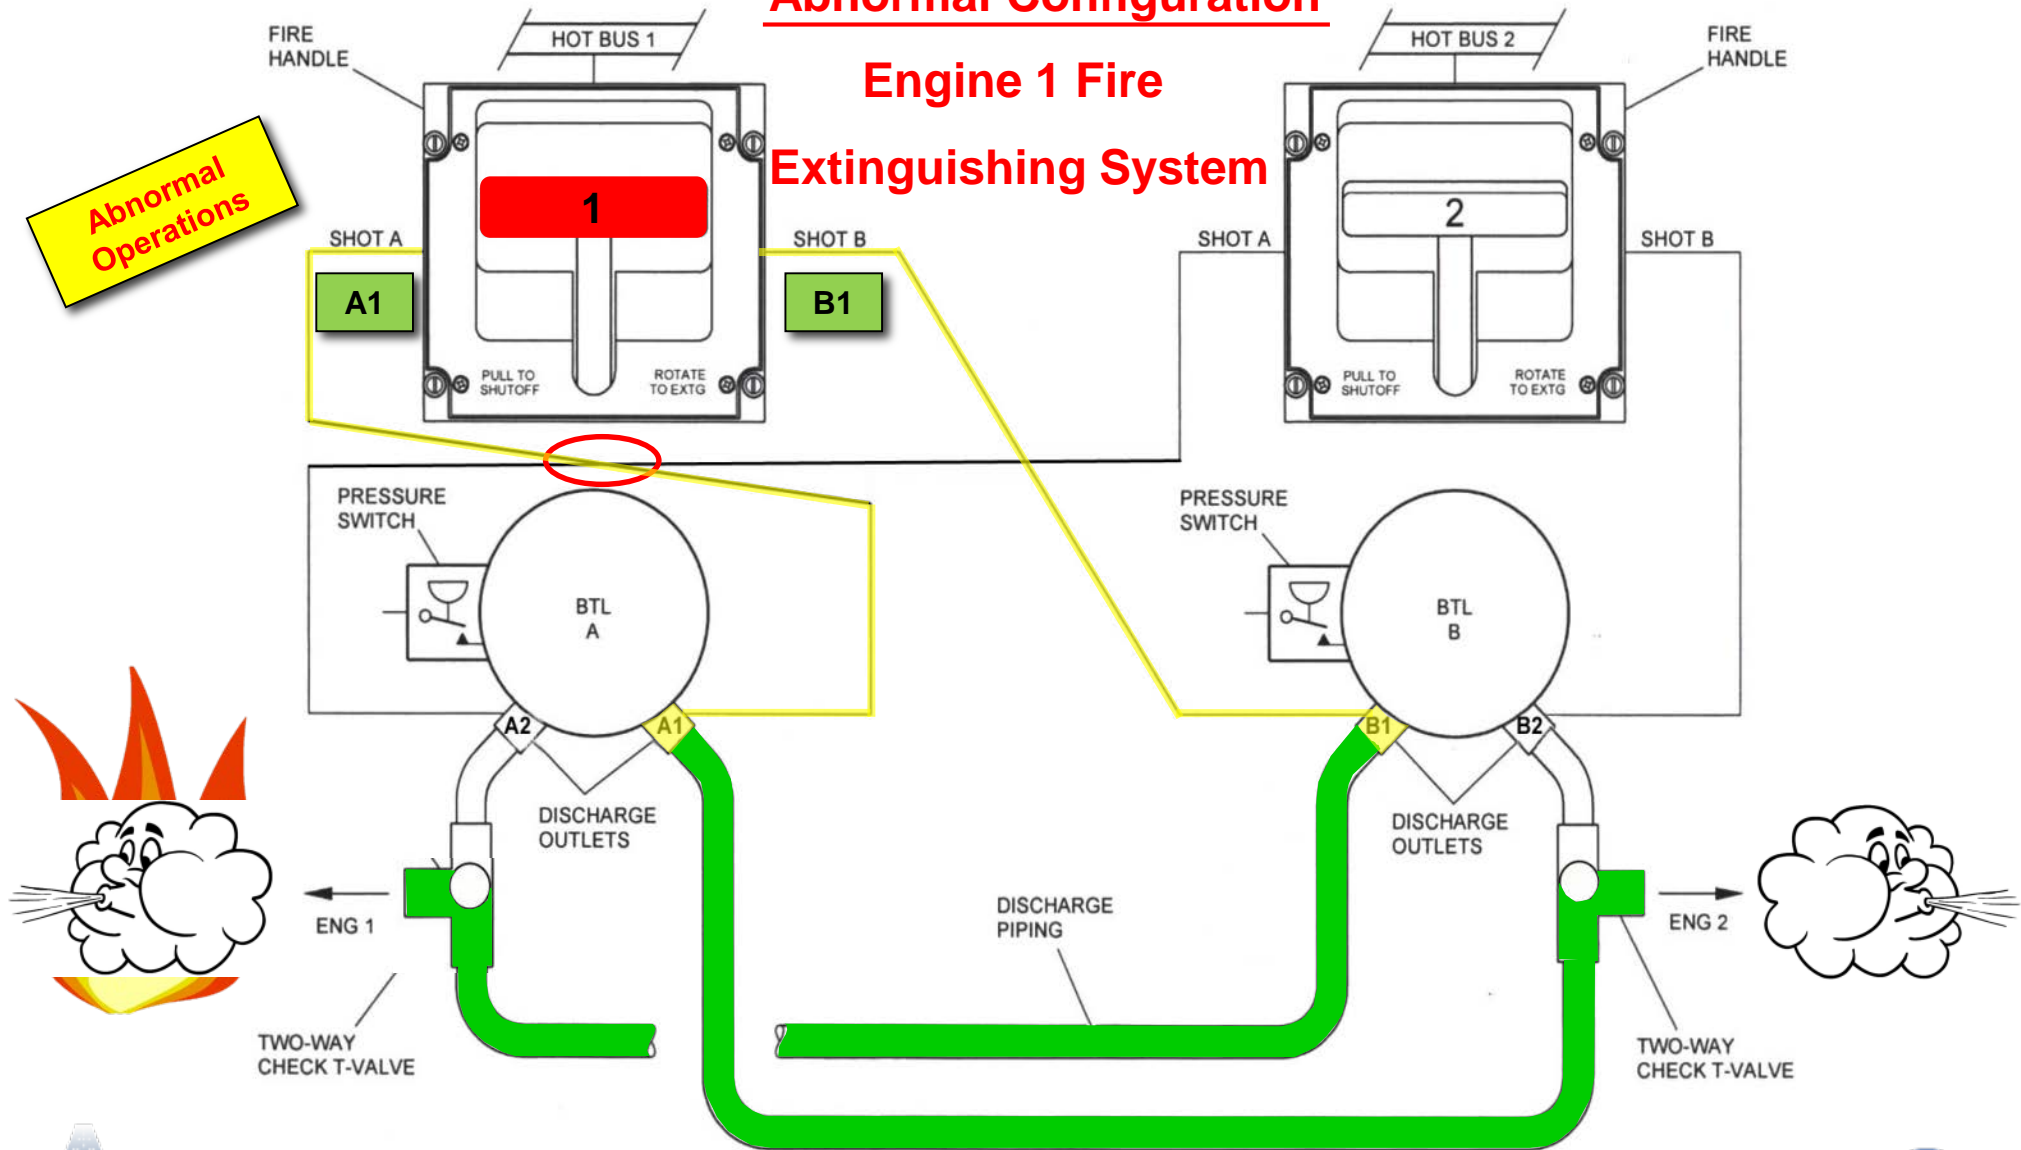
ENGINE FIRE EXTINGUISHING SYSTEM - SCHEMATIC

- The configuration of the fire extinguishing agent plumbing system can pose a potential challenge to maintenance personnel
- Several design features appear to have been used to mitigate a possible system misconfiguration
- However, this report shows it is still possible to install the components in the wrong position
- The reporter indicated that “in the worst case, if both bottles were affected, neither engine would have fire protection, with extreme risk for loss of life.”

## Abnormal Configuration

### Engine 1 Fire Extinguishing System

- Currently, there is no AD for the E170 Engine or APU Fire Extinguishing System
- AD 2013-05-12 for the E170 addresses the similar problem for the forward and aft cargo compartments
- AD 2004-23-19 is applicable to E135 and E145 series airplanes to prevent the inability to put out a fire
  - General visual inspection to detect incorrect wiring
  - Modify electrical harnesses by adjusting the length
  - Install identification sleeves on the harness and connectors and matching color-coded stickers on the fire bottles

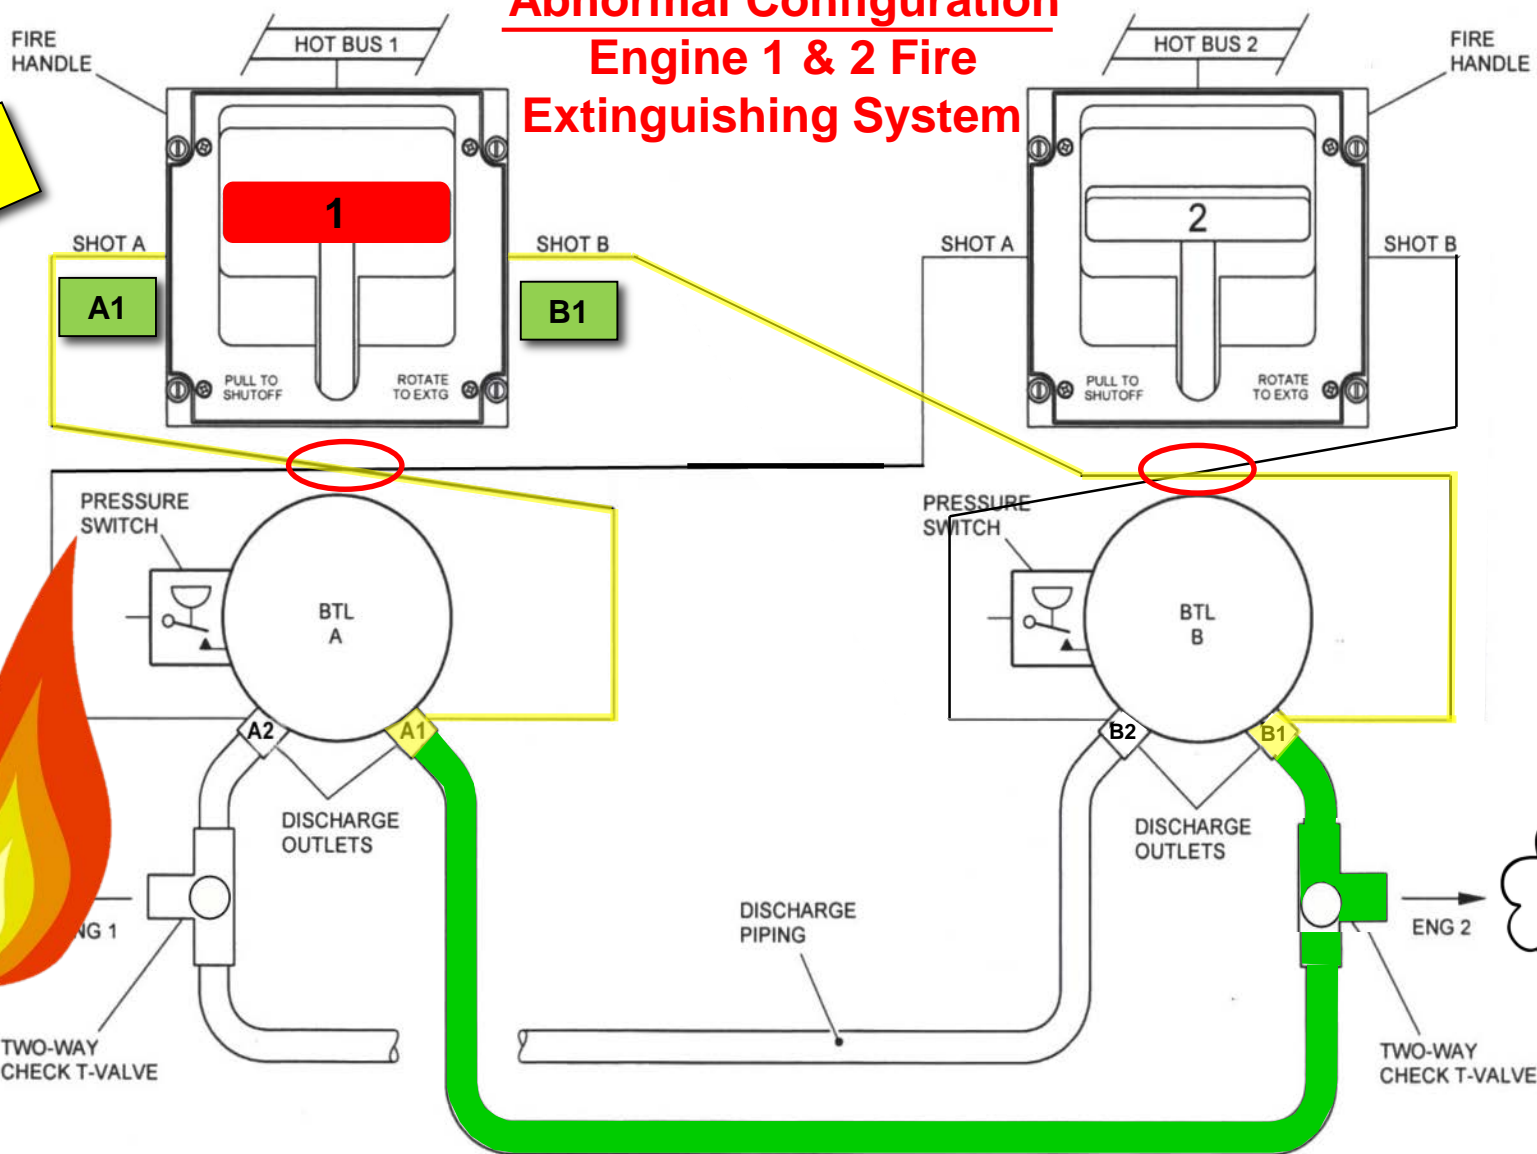
ENGINE FIRE EXTINGUISHING SYSTEM - SCHEMATIC

## Abnormal Configuration Engine 1 & 2 Fire Extinguishing System

Worst Case Scenario
