NASA Electronic Parts and Packaging (NEPP) Program

Cracking Failures in Ceramic Capacitors and the Existing Screening and Qualification Procedures

Alexander Teverovsky

This presentation gives a review of recent project failures caused by cracks in ceramic capacitors and discusses deficiencies of the existing screening and qualification procedures that can reveal the propensity to cracking and effects of soldering stresses.

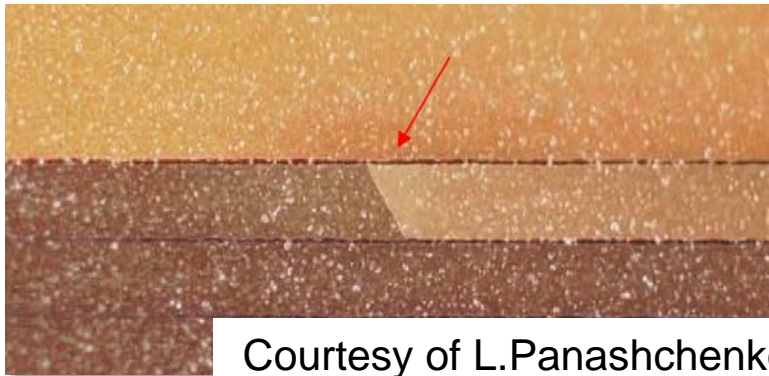
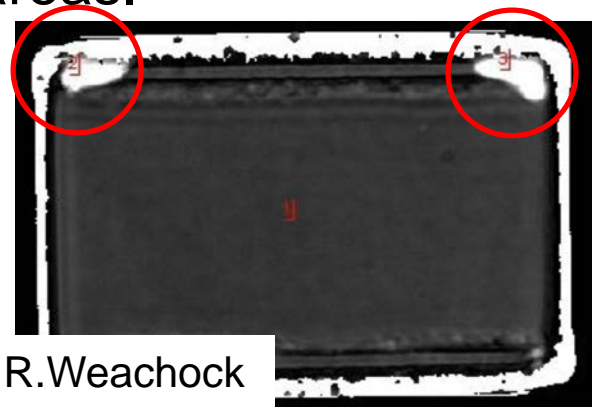
History Case 1

- ❑ On-orbit anomalies after months of operation were attributed to excessive leakage currents in CDR35 capacitors.
- ❑ The parts were soldered manually and suspected of having cracks.
- ❑ Testing of a spare unit on the ground also showed increasing leakage currents after several weeks of operation.
- ❑ FA: the failure was due to delaminations and cracking in the part.
- ❑ No external cracks on the failed lot were observed.
- ❑ Acoustic microscopy showed that a substantial proportion of parts had delaminations at the termination areas.

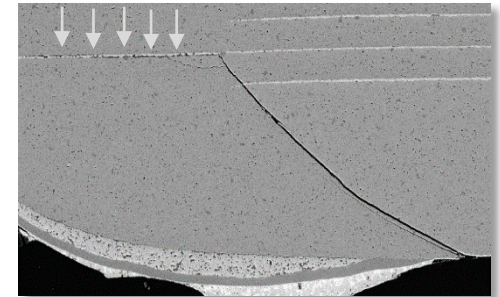
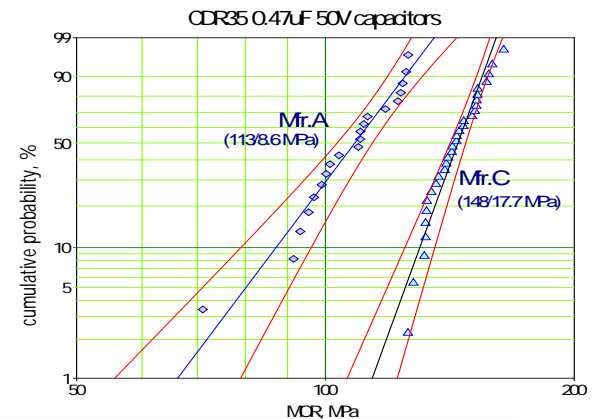
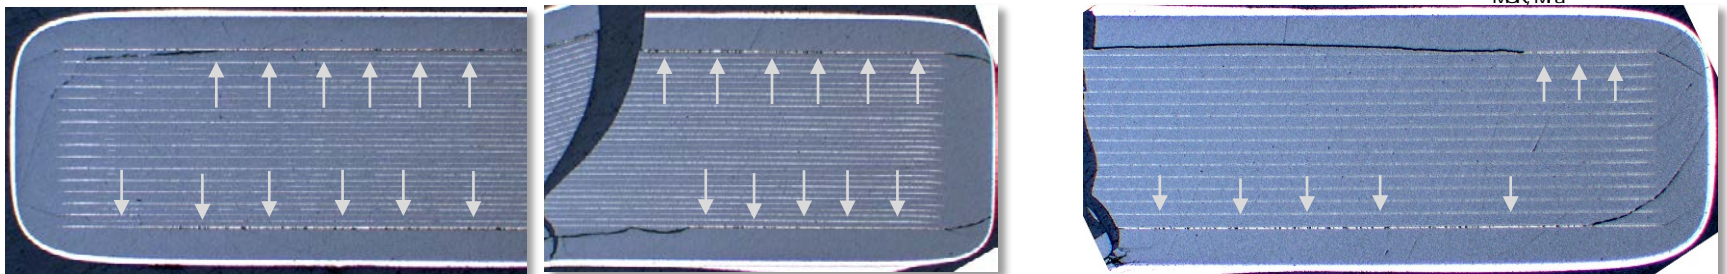
Fractured post-TSD samples

- ❑ Cracks in lot A started from the surface and continued as metal/ceramic delamination.
- ❑ To evaluate interaction of cracks with delaminations, virgin and post-TSD samples were fractured in the middle.
- ❑ No delaminations on virgin samples from lot A and on both virgin and post-TSD samples from lot C.

- ✓ TSD testing and fracturing revealed delaminations located mostly at electrodes close to the surface of capacitors.

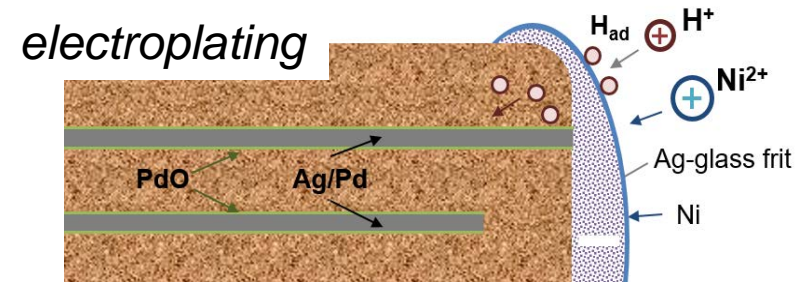
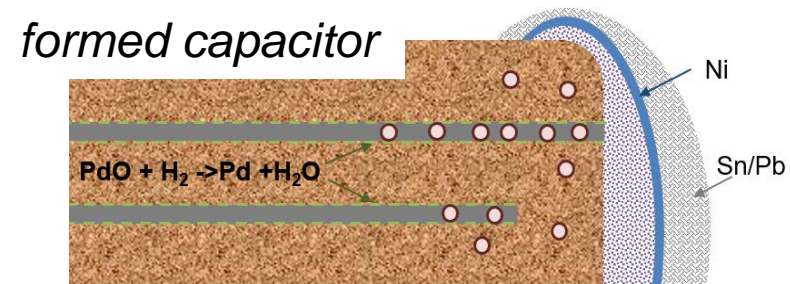
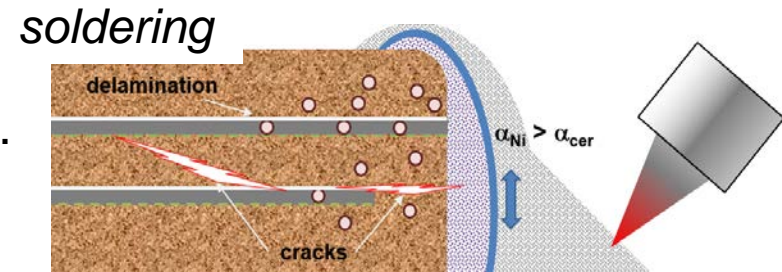
History Case 1, Failure Mechanism

- ❑ The probability of failures after manual soldering was increased due to the presence of delaminations.
- ❑ Corner location indicates that delaminations might be due to formation of terminals.
- ❑ Reasons for corner delaminations:
 - Generation of H_2 during electroplating:
 - Decreases fracture toughness of ceramics;
 - Removes PdO barrier on Ag/Pd electrodes, weakens the interface and facilitates ECM of Ag.
 - Fast evolution of H_2 might cause pop-corning during soldering.

- ✓ Failures were likely due to anomalies in electroplating processes that resulted in excessive H_2 generation
- ✓ Cracking and delaminations caused by electroplating occur more often with PME than with BME capacitors.

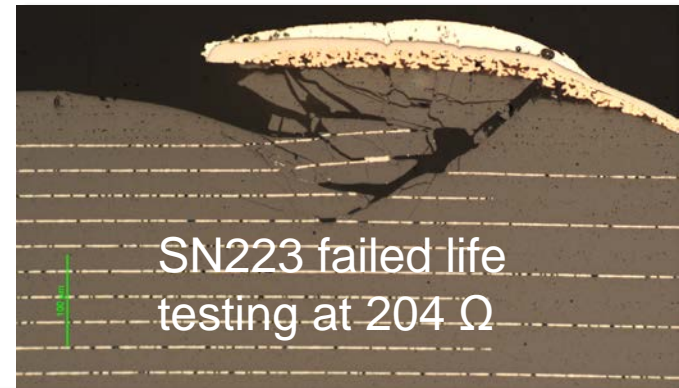
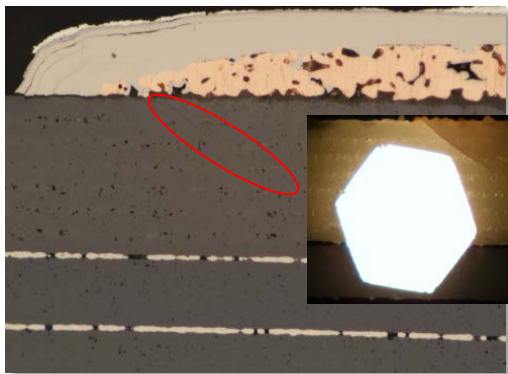
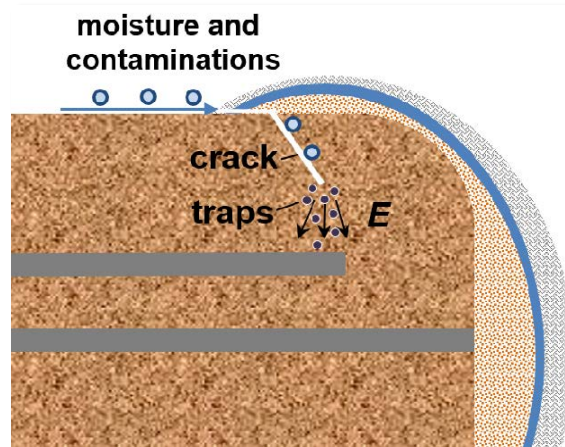
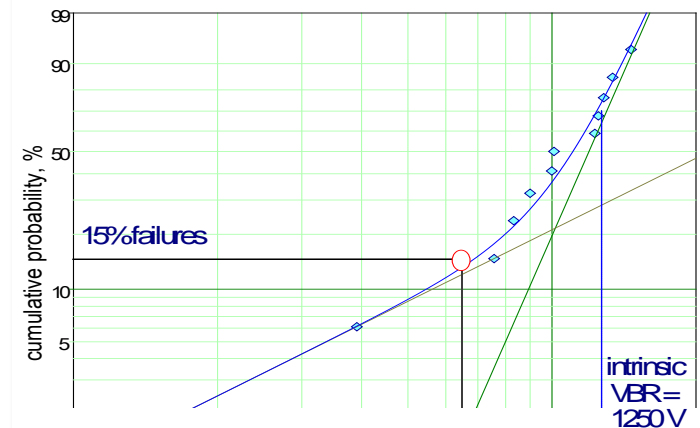
History Case 2

- ❑ A lot of commercial BME capacitors rated to 250V that had reduced microphonic noise was intended to use at low voltage (~ 5 V) applications.
- ❑ The lot had multiple failures during qualification life testing.
- ❑ Analysis of distributions of VBR revealed a substantial proportion ($\sim 15\%$) of defects.
- ❑ Failures at voltages close to the rated can be explained by the presence of shallow cracks near terminals.

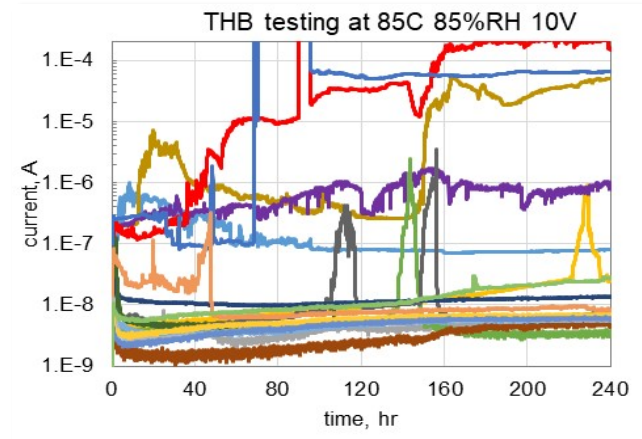
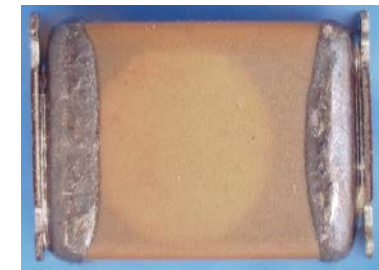
Post-THB delamination

- ❑ The parts passed HSSLV testing at 85C/85% RH, 1.3V for 240 hr increasing the hope that they can operate reliably at low voltages.
- ❑ Contrary to PME, HSSLV testing is not effective for BME capacitors.
- ❑ THB testing at 85C/85% RH and 10V for 240 hrs resulted in 3/18 failures.
- ❑ Post-THB examinations revealed delaminations that might be due to hydrogen generated by electrolysis of water penetrated through cracks.
- ❑ Anodic dissolution of Sn or Cu from terminations provide materials for conductive deposits or dendrites in cracks.

✓ Derating might not help in cases of failures related to cracking.

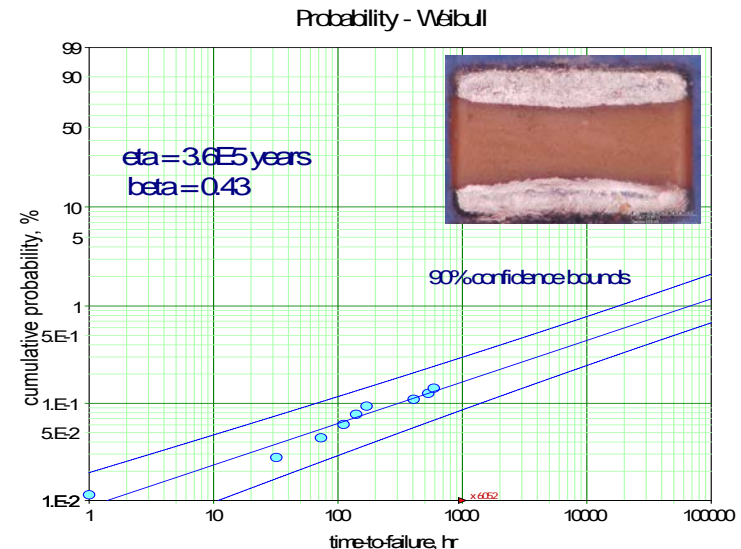
History Case 3

- ❑ Several failures were observed during system-level testing in a project that employed ~5700 commercial PME MLCCs upscreened to an SCD.
 - ❑ Extensive evaluations and testing of parts from the failed lot revealed three more failures in the suspected lot and no failures in a reference lot.

- ❑ FA revealed delamination in one case and a delamination with a connected tiny crack between electrodes that allowed for silver electromigration in another.

- ❑ In the third case, a part had a delamination and anomalies during testing at room conditions, the recovered after soldering and failed eventually during THB testing.

- ❑ Distribution of TTFs corresponds to IM failures and indicate the presence of preexisting defects that likely further developed after soldering.
- ✓ No failures during life testing and 1/24 failure during THB testing.
✓ All failures occurred after soldering, at derated voltages and low temp.

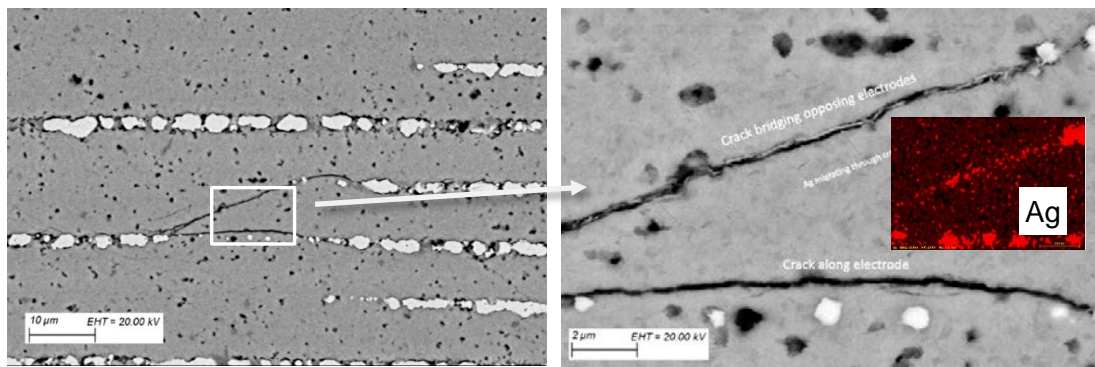
A sample failed after 55 hr at 6V and 60C

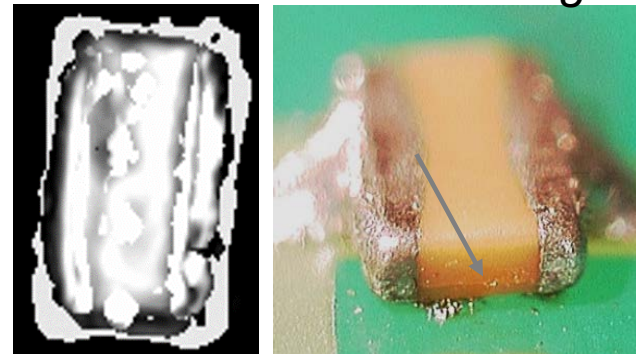
CSAM before THB and a crack after THB testing

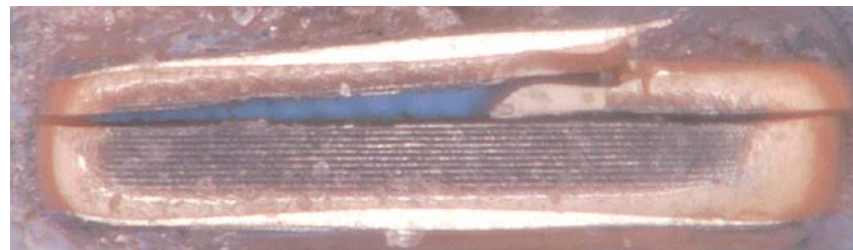
Failed capacitor cleaved along the crack

- ✓ Comparative testing of the failed and a reference lot with another LDC showed that this is a lot-related problem.
- ✓ Why S&Q testing per SCD that followed military specifications did not reveal defective parts?

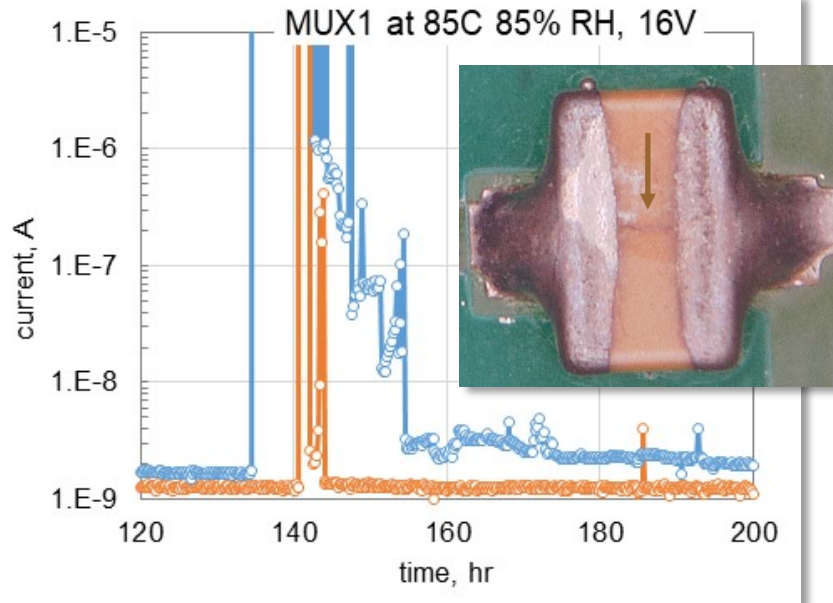
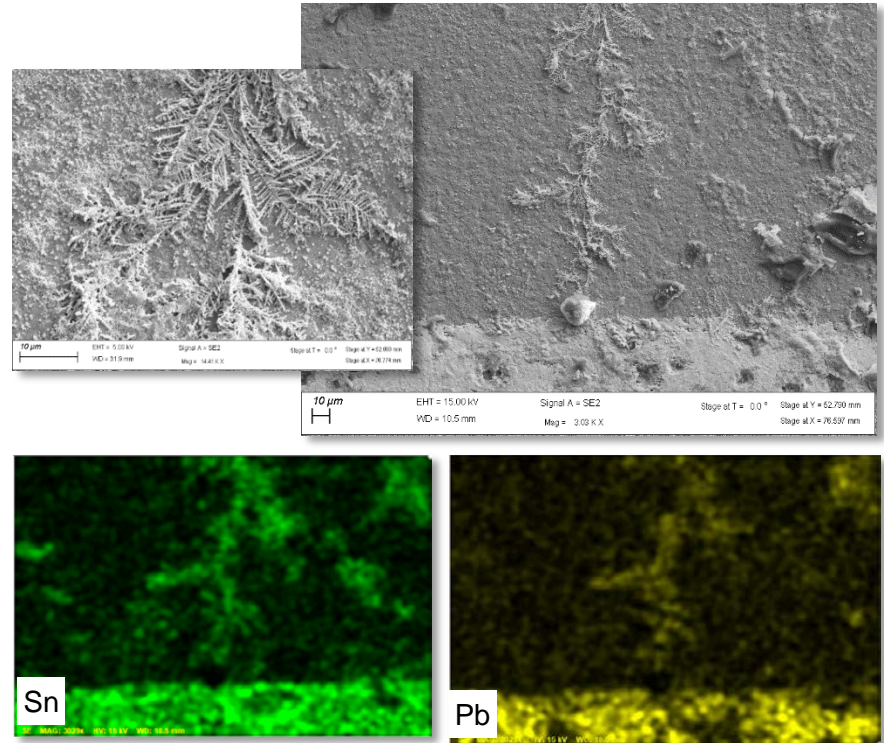
Leakage currents in 2 failed MLCCs

- ❑ Two out of 164 tested samples had anomalies during THB testing at 85 °C 85% RH, 16V.
- ❑ FA revealed Sn/Pb dendrites on the surface of the parts.

- ✓ THB is effective for revealing cracks in the parts, but has a risk of resulting in shorts on PWB or the surface of MLCCs.

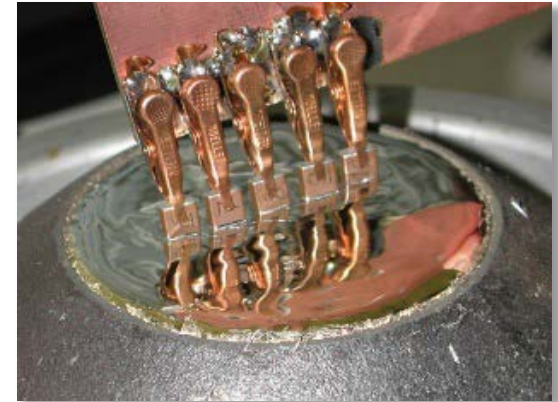
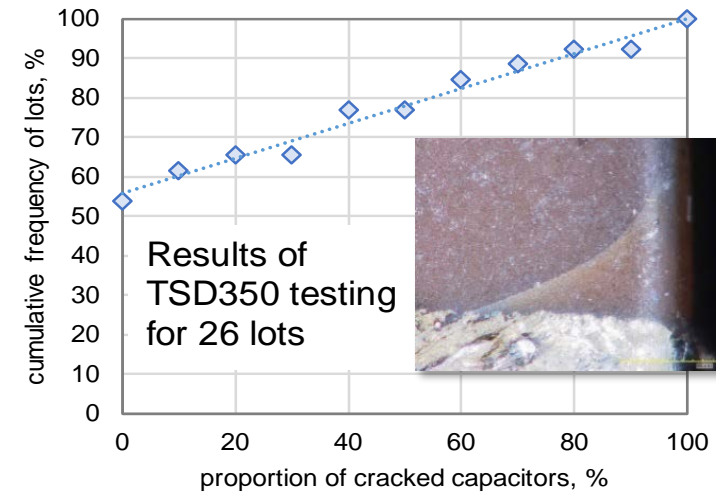
Terminal Solder Dip testing

- ❑ Tests and inspections that can be used:
 - (i) TC after soldering onto test boards followed by monitored humidity testing, (ii) TSD350, and (iii) ultrasonic inspections (C-SAM).
- ❑ Depending on the project level or criticality of application, different combinations of tests are suggested.
- ❑ Visual examinations and electrical measurements after TSD350 to mitigate risks for L3 projects:
 1. Initial C, DF, and IR measurements (20 pcs.)
 2. TSD350, 2 sides 3 cycles
 - Visual examination. Reject if >10% of parts have cracks.
 - EM (C, DF, IR) – no failures allowed.
