FAILURE of Nd:YVO₄ AMPLIFIER CRYSTALS

Jon Salem
NASA GRC
Cleveland, Ohio

Fractography of Advanced Ceramics VI
2019

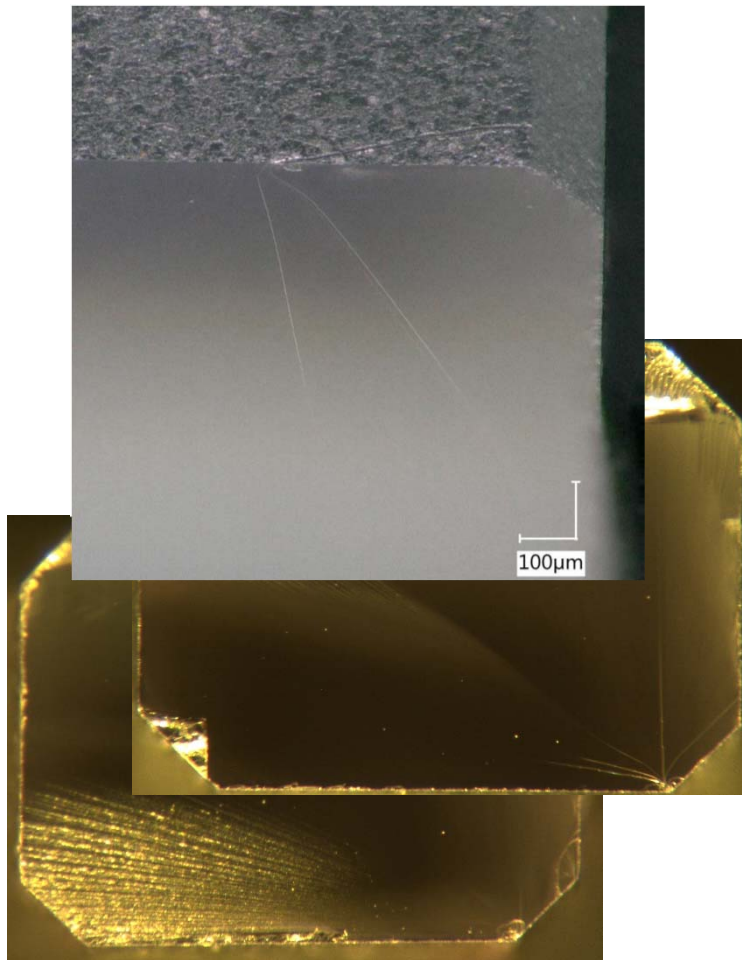
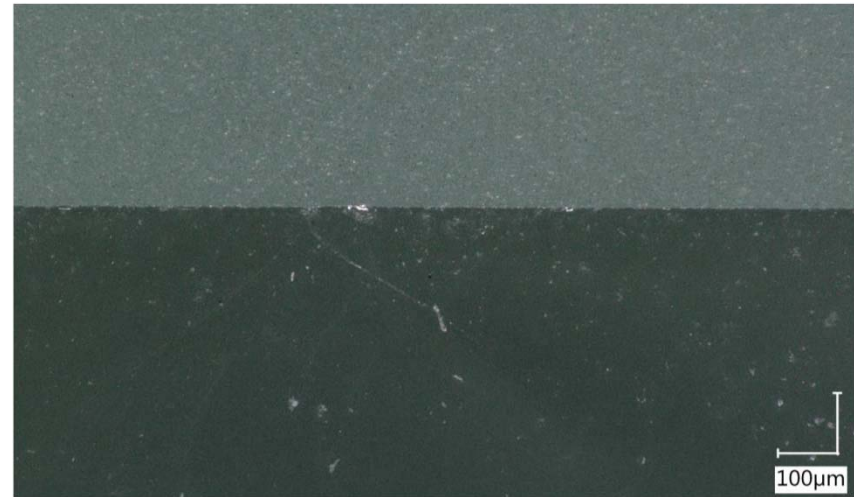
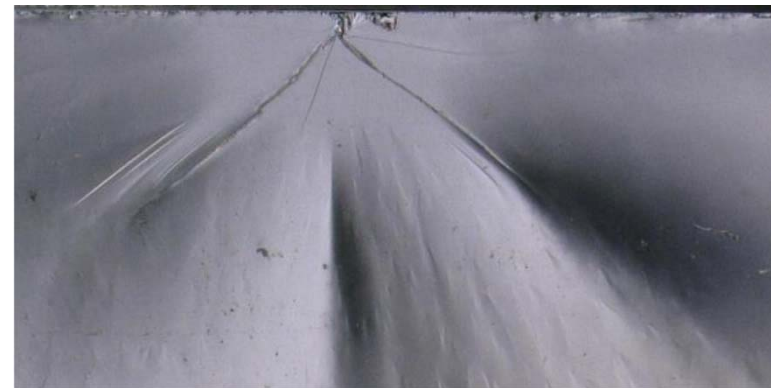
- Indeed, strength test specimens fail from surface flaws:

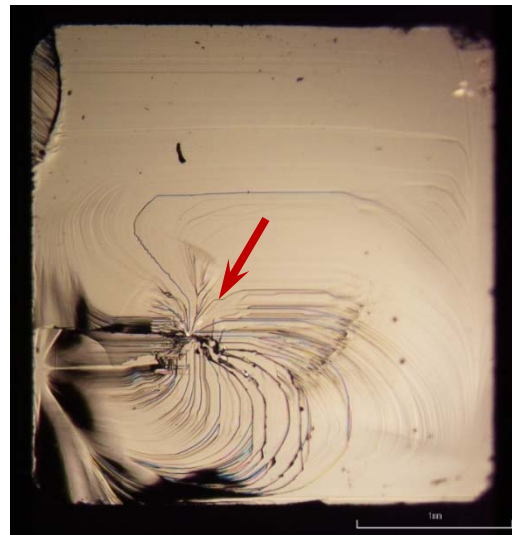
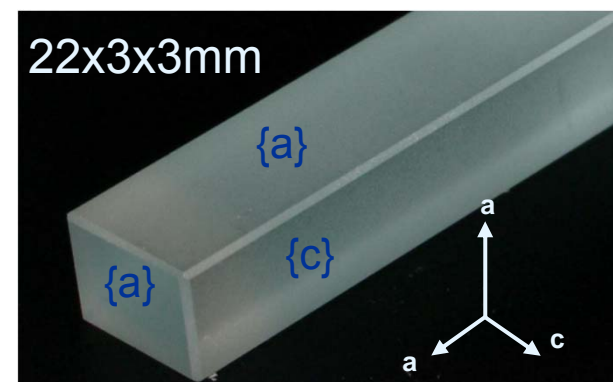
First Pump-to-Failure Amplifier Crystal

- During routine bench testing of a laser amplifier slab, the control loop was lost and the crystal over-pumped until fracture occurred.
- Disassembly revealed a fracture near one end, with the location of fracture thought to be near the center.

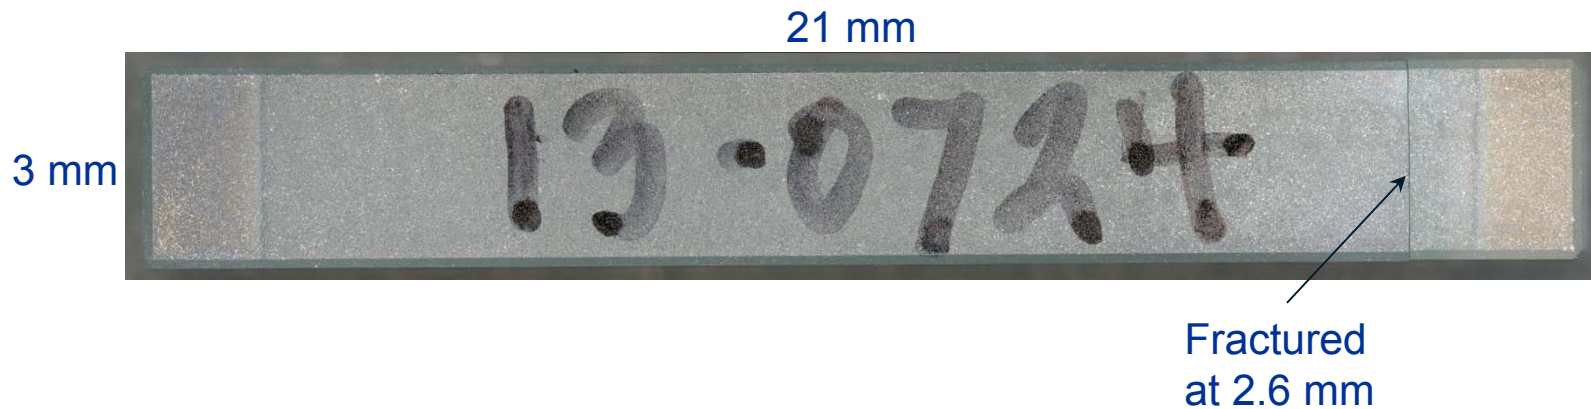
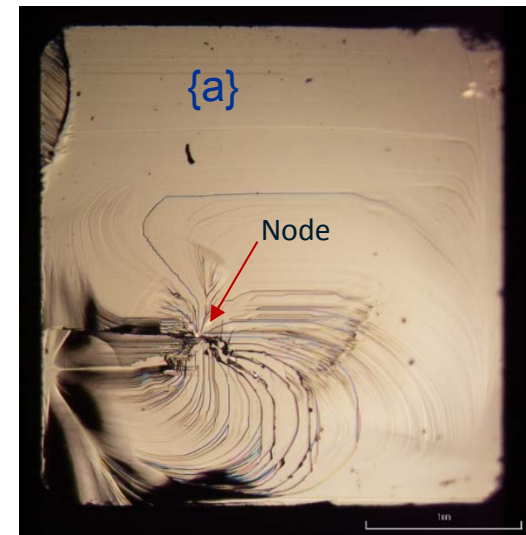
Over-pumped Crystal:

- Pronounced swirl at a central “node:”
- Failure located on the {a} crystal plane without macroscopic rotation from the {a} plane.
- Some felt that failure occurred from the center “node”

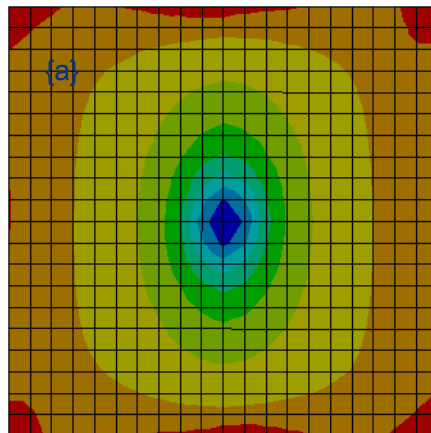
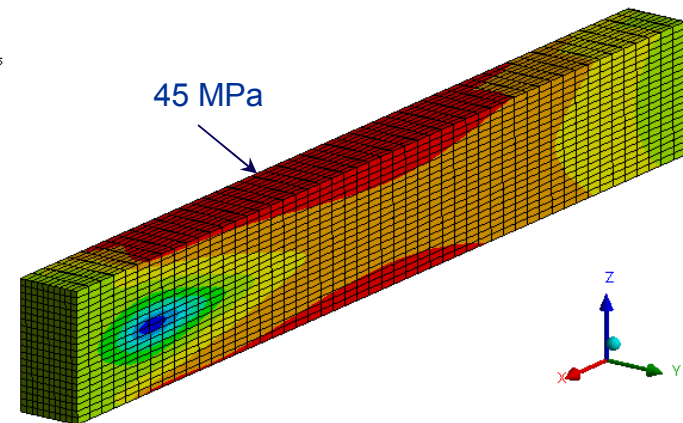
Stress State at High Power

- Center compression with edge tension, where the worst flaws are often located.
- Compressive strength is \gg tensile strength.

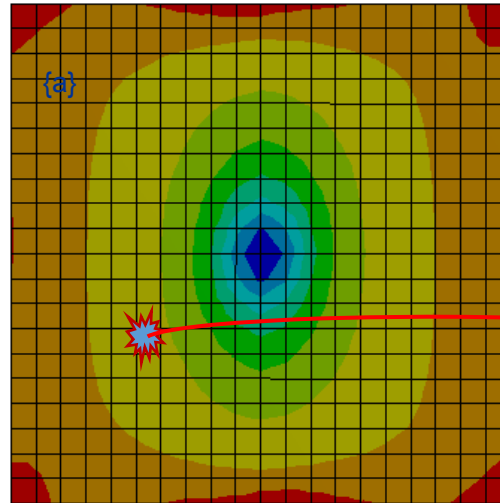
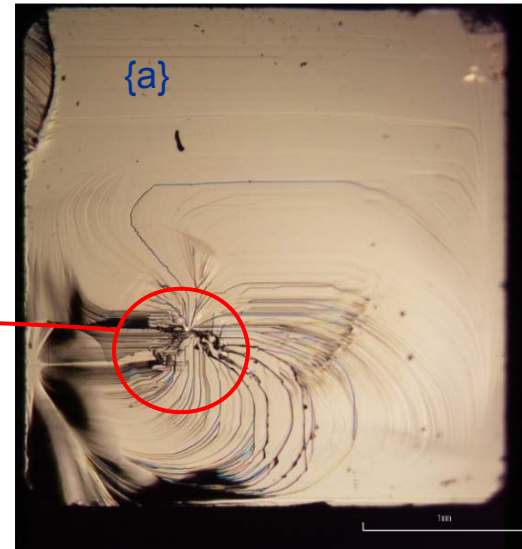
Location of Speculated Origin

- Speculated origin is on the border of compression and tension, with low tensile stresses (5 MPa):

- Could the origin be elsewhere? The surface?

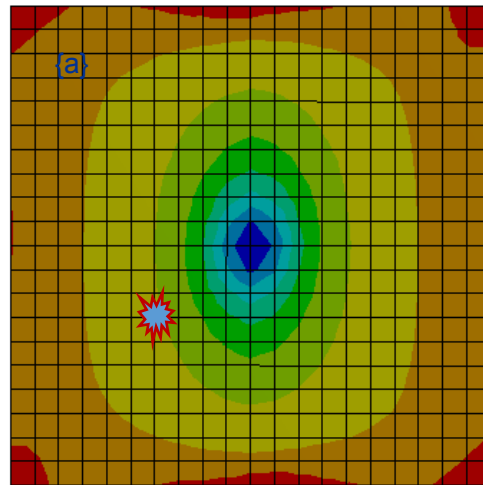
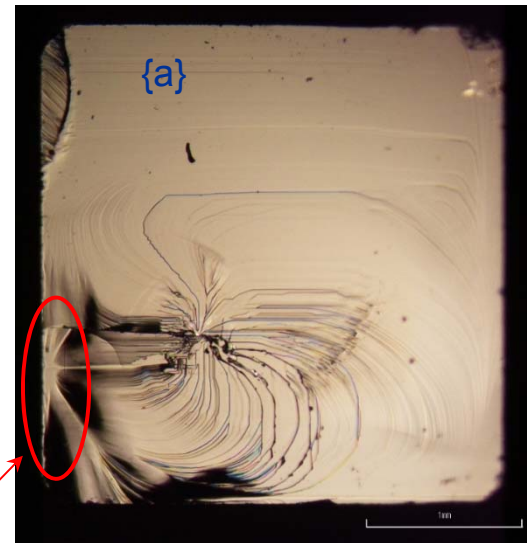
Other Fracture Features

- At the surface a star-like feature is apparent – single crystal mirror?

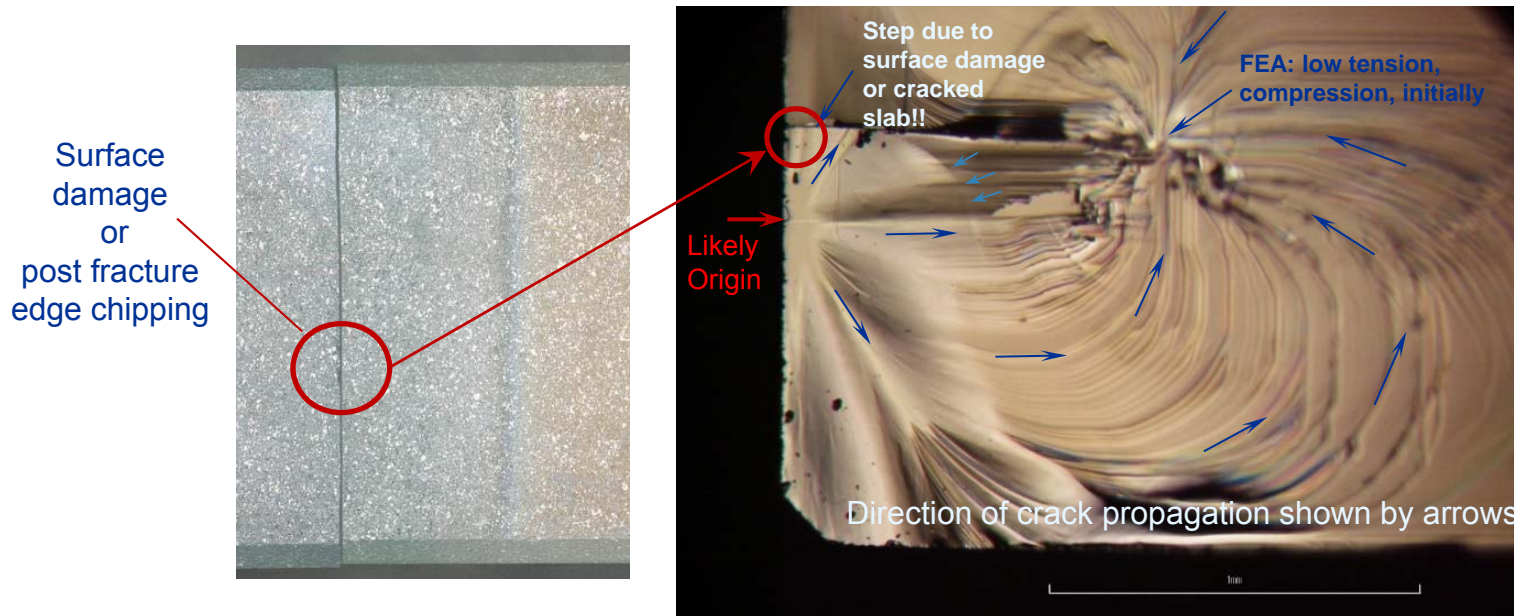
Surface Damage and Classic Mirror

- But why the coalescence of rivers marks to a central region of compression??

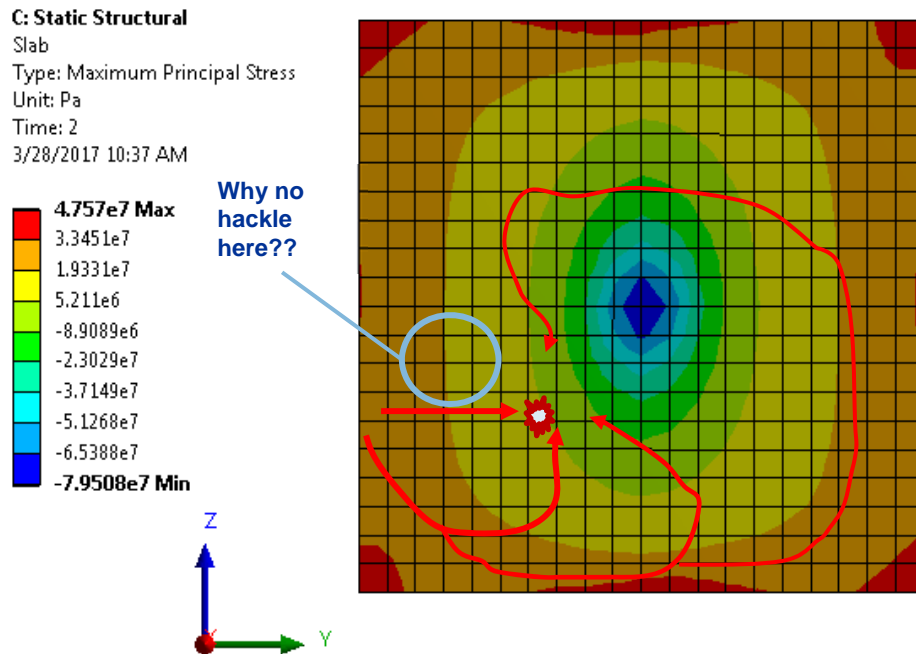
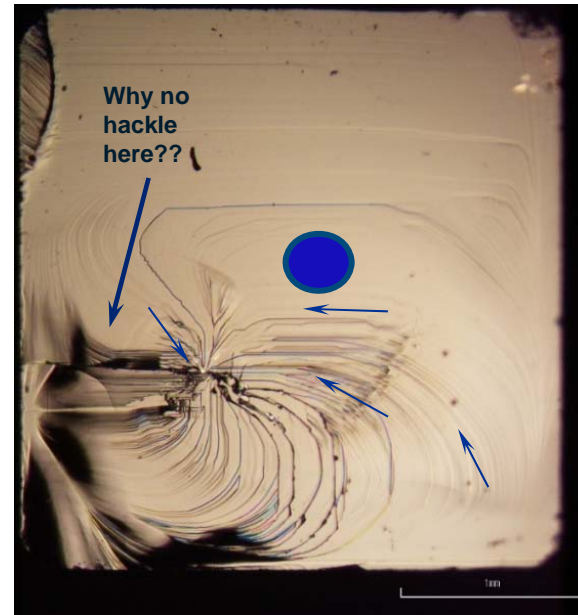
River Marks Follow Tensile Stress Pattern...

- As the crack grows, it spirals, avoiding the center compression, changing the center to tension until the cracks paths converge (?).
- The crack remains on the cleavage plane rather than tracking along the beam long axis:

- No mirror or hackle markings on one side of the origin.....

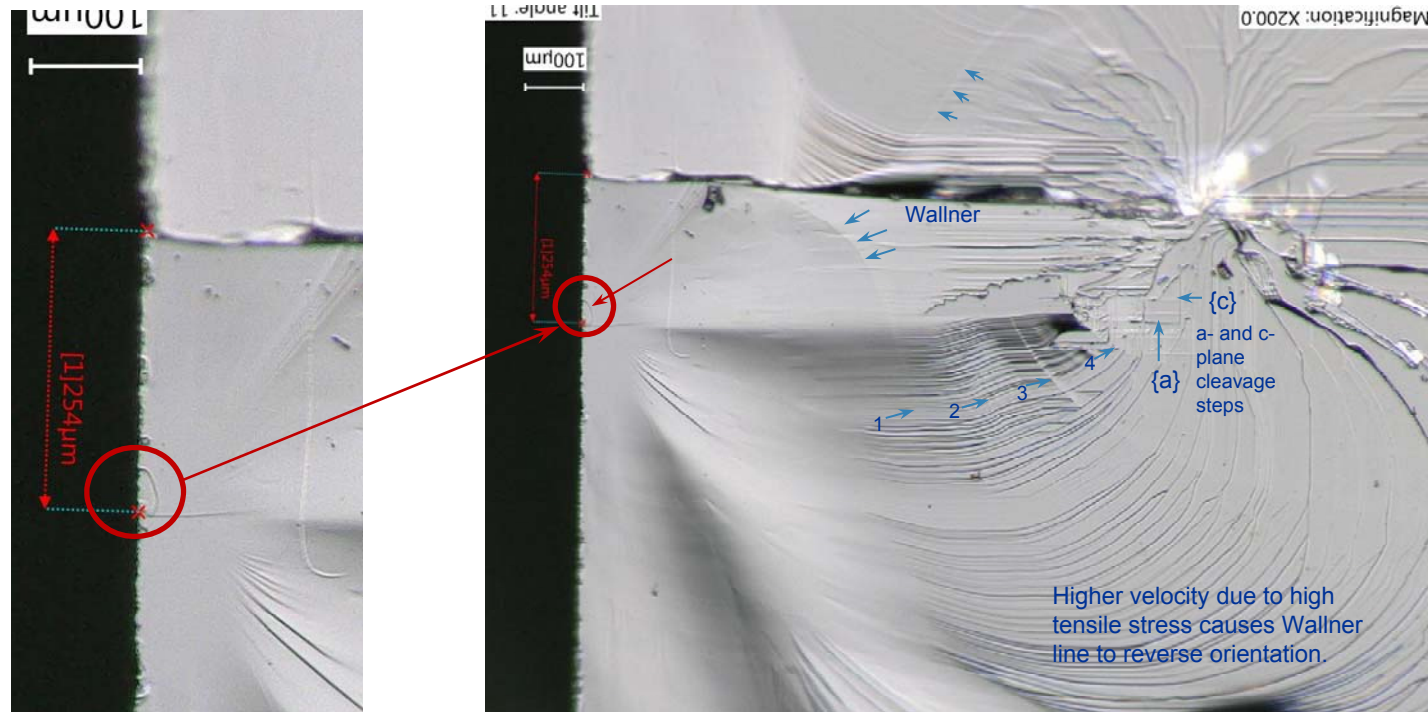
“All Roads Lead to Rome” (or away!)

- Origin appears to be the corner of a small, semi-circular surface crack.
- Growing crack wraps around one side of the step.....Unusual pattern:

- “Rome” is the interface between tension and compression where the crack front stalls? But that hackle.....

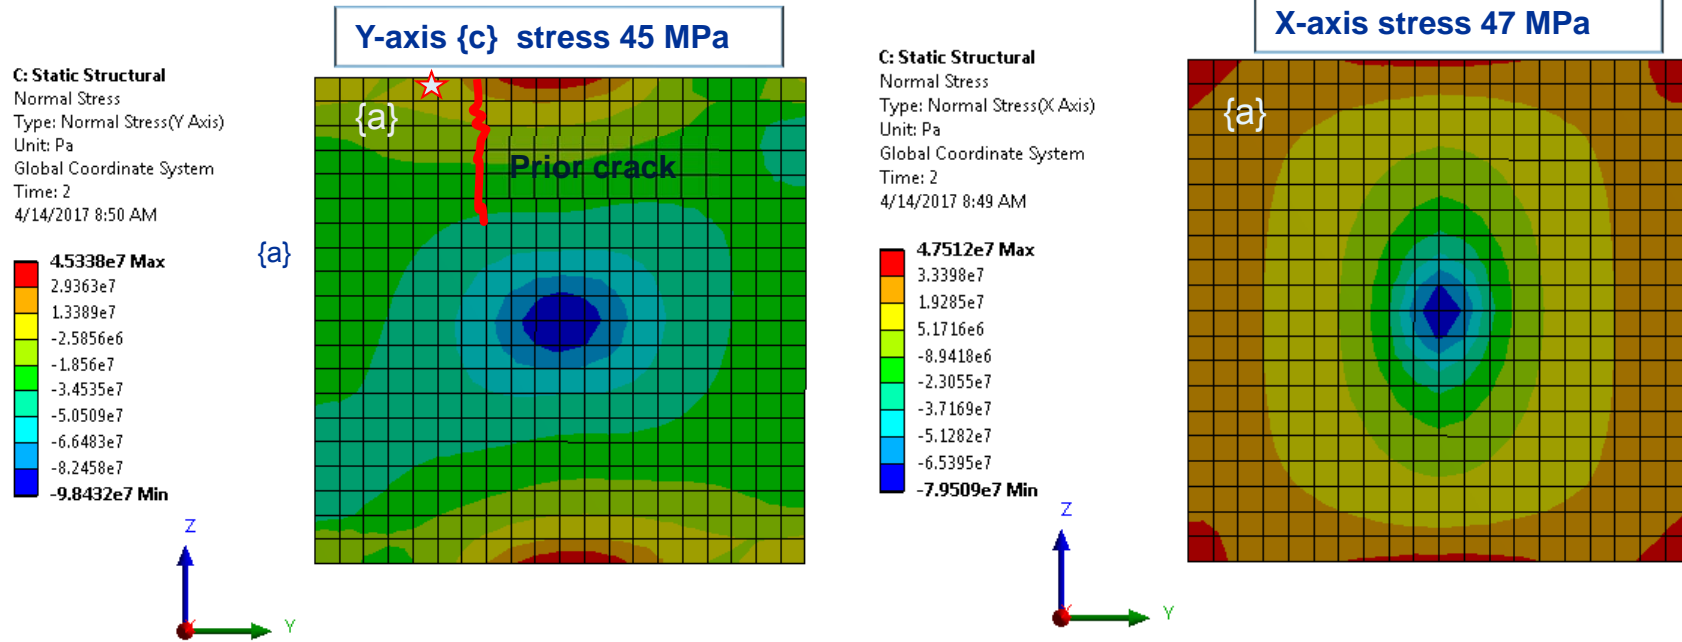
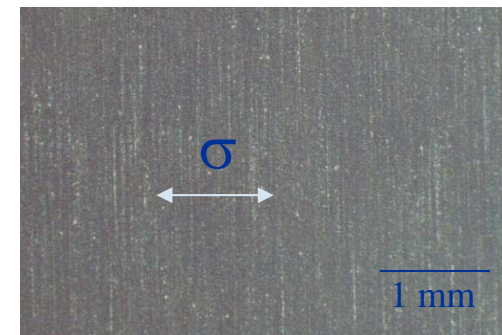
X and Y Direction Stresses are Similar:

- Grinding is usually in the x-direction, and the stresses are similar on both the x- and y-directions, so longitudinal cracking is likely.
- Longitudinal crack was in tension, drawing in the propagating crack.....creating the “node.”

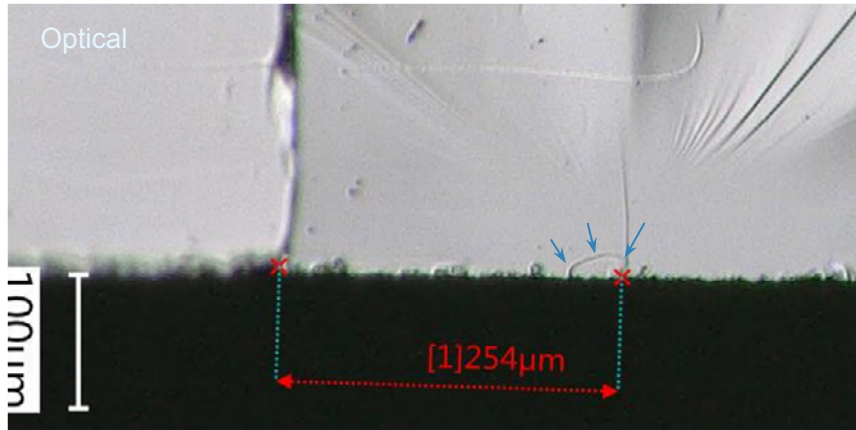
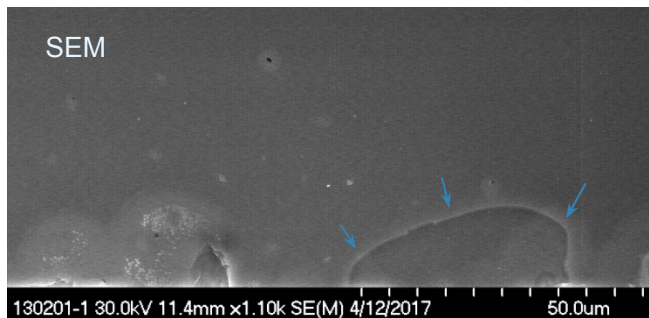
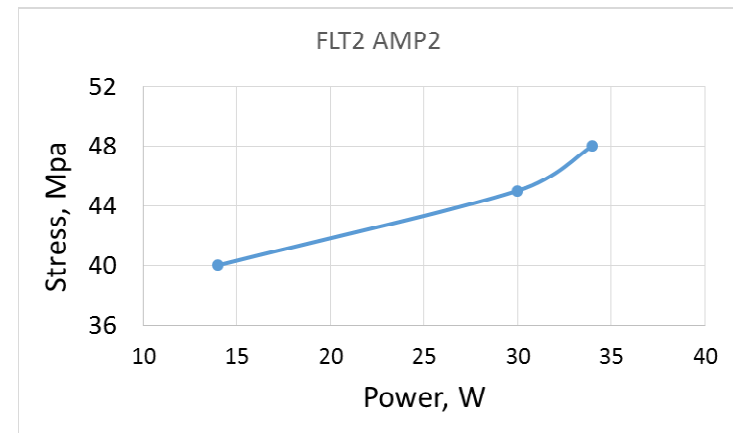
Estimated Stress (Fractographic and FEA)

Stress (MPa)	Meas. Type	a (mm)	2c (mm)	Y surface	Y depth	KIc MPa√m
70.0	OPT	0.021	0.052	1.30	1.30	0.42

- High stresses are estimated, implying that the stresses were higher due to the prior longitudinal crack or that the pump level, which was unknown, was very large.

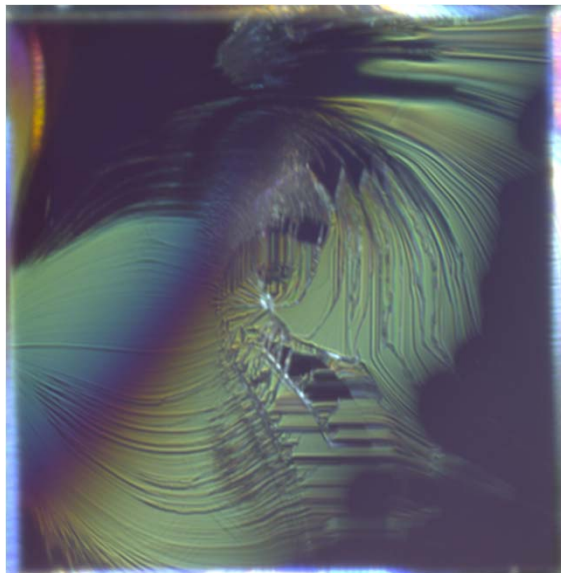
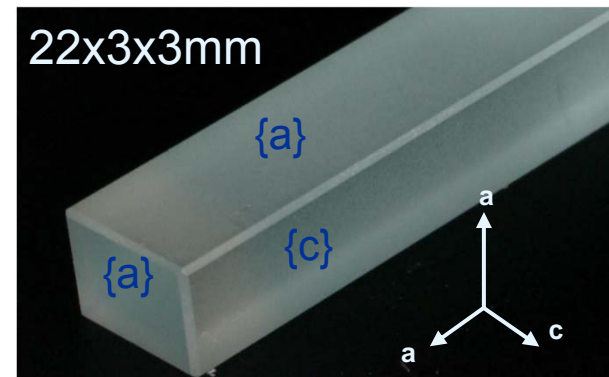
Second Pump-to-Failure Amplifier Crystal

- Controlled bench test of a laser amplifier slab (single crystal) to induce crystal failure via over-pumping.
- Disassembly revealed a fracture near one end, with the location of fracture thought to be near the center.

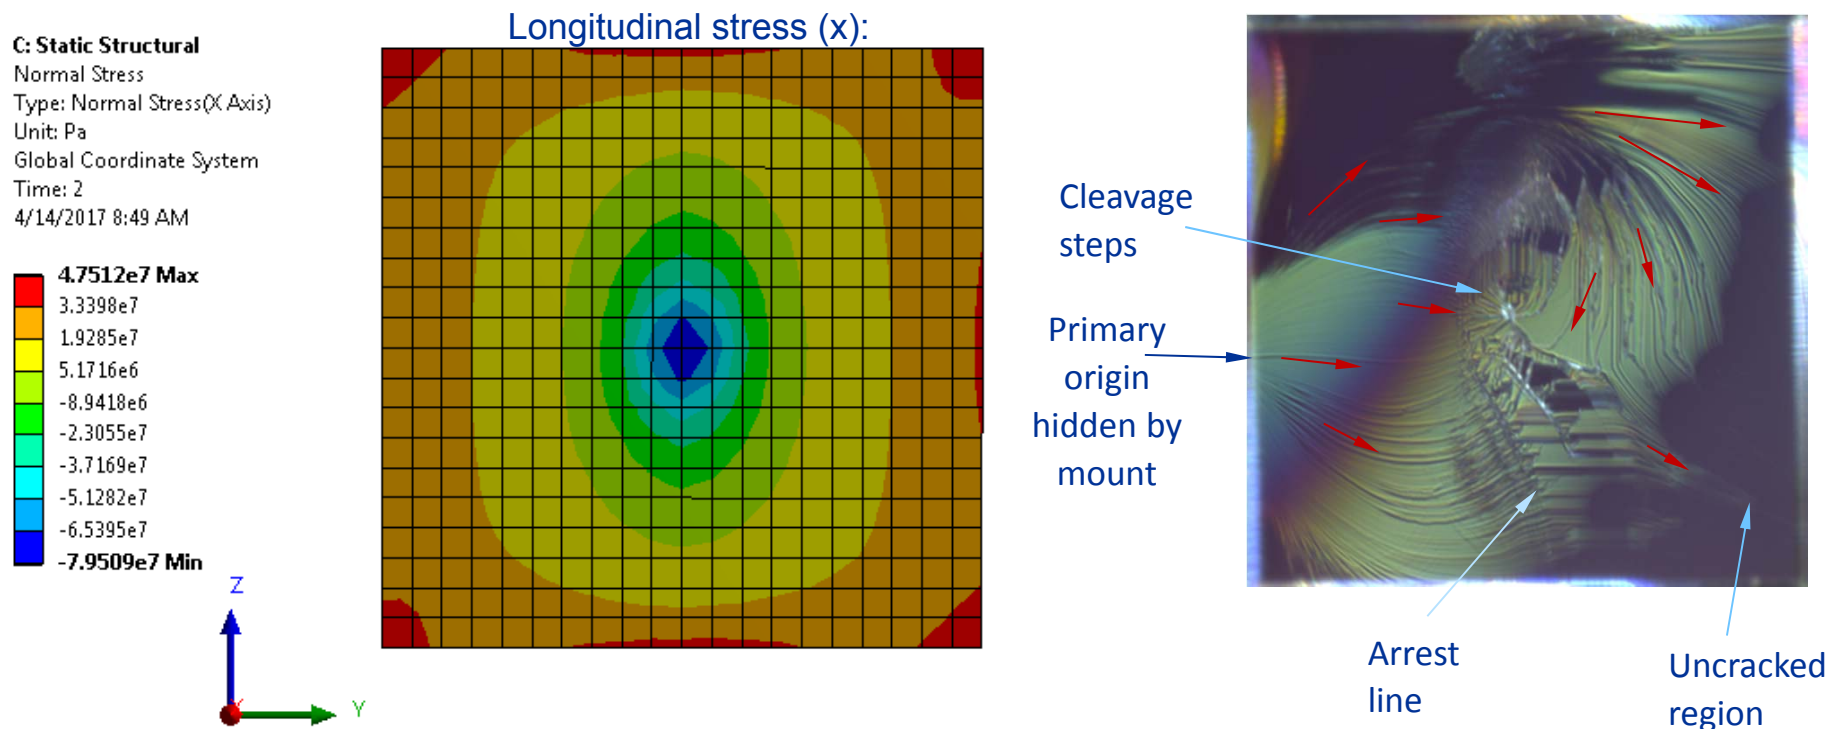
Slab: Pump-to-Failure Fracture

- “Node” is more centrally located (compression) and no cleavage step or prior longitudinal crack is apparent:

- Crack wrapped around central compression region and stalled.
- Stress state changed and fracture continued by failing central ligament.

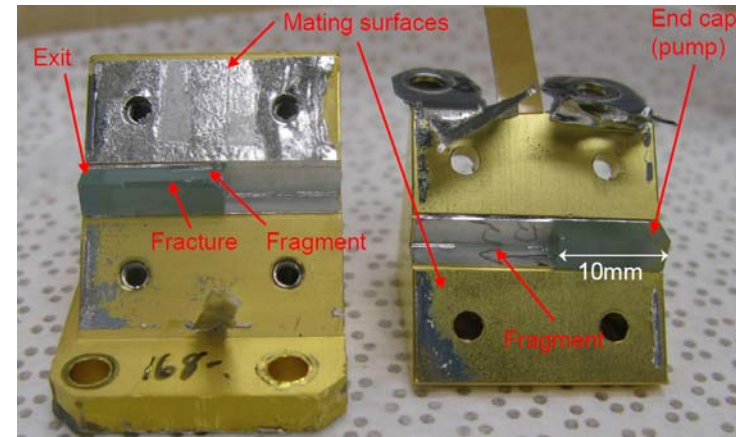
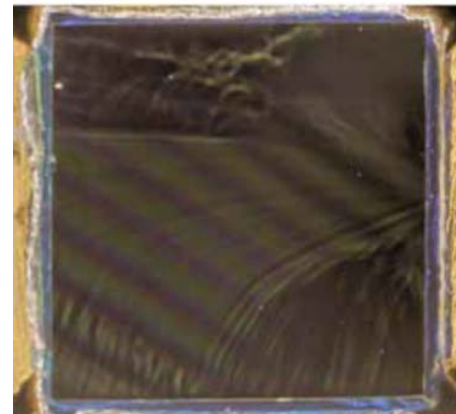
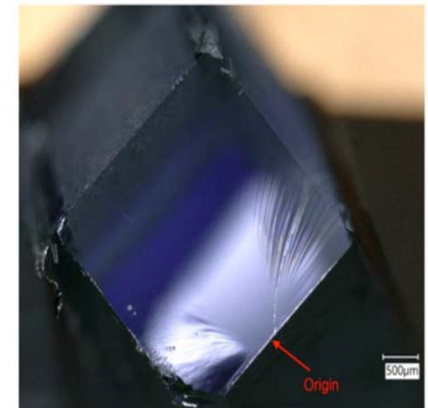
First Flight Amplifier Fracture

- The crystal fractured about 10 mm inboard of the input face and originated in the middle of the c-facet.
- There were no obvious surface defects or corresponding mount defects at the fracture origin.
- Applied stresses were low.
- Implies that the crystal was under higher mechanical loads (pressure).
- But why?
