FAILURE of Nd:YVO₄ AMPLIFIER CRYSTALS

Jon Salem
NASA GRC
Cleveland, Ohio

Fractography of Advanced Ceramics VI
September 9th, 2019
Smolenice, Slovakia

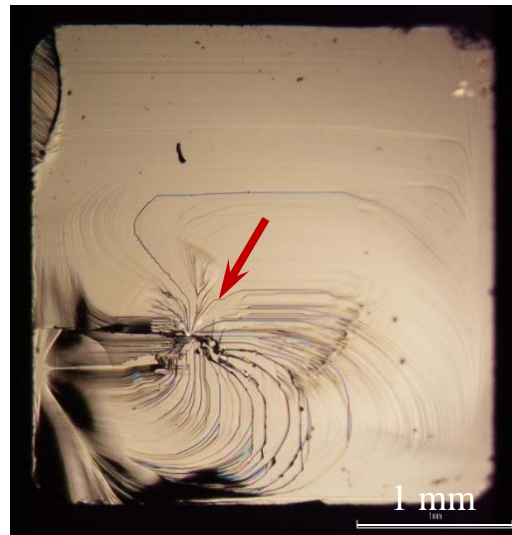
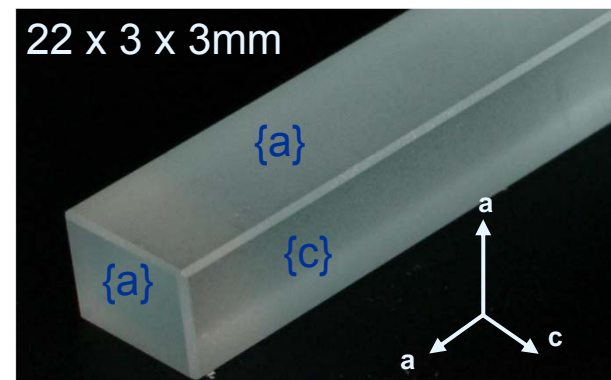
First Pump-to-Failure Amplifier Crystal

- During routine bench testing of a laser amplifier slab, the control loop was lost and the crystal over-pumped until fracture occurred.
- Disassembly revealed a fracture near one end, with the location of fracture thought to be near the center.

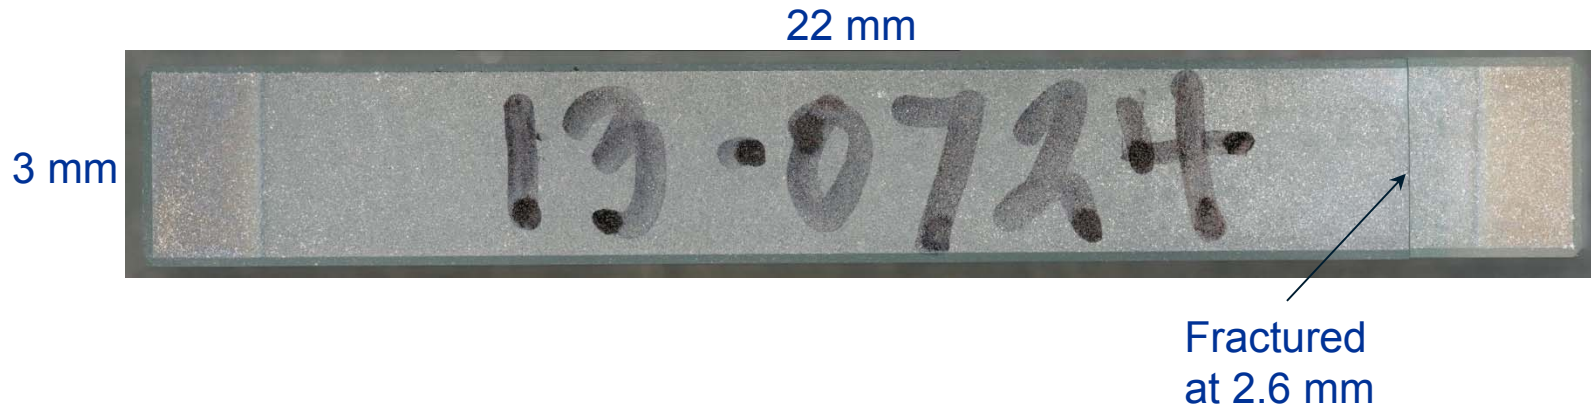
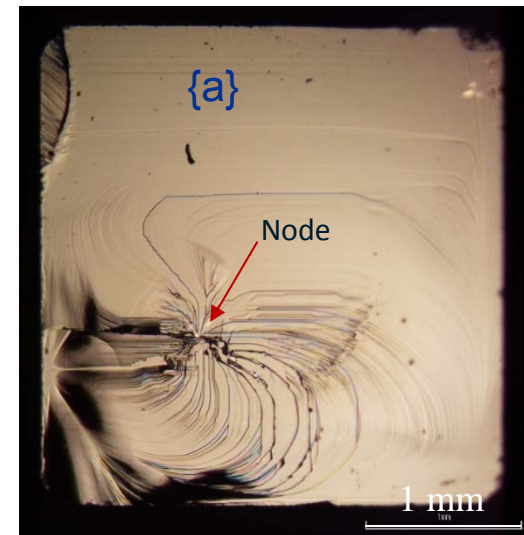
Over-pumped Crystal:

- Pronounced swirl at a central “node:”
- Failure located on the {a} crystal plane without macroscopic rotation from the {a} plane.
- Some felt that failure occurred from the center “node”

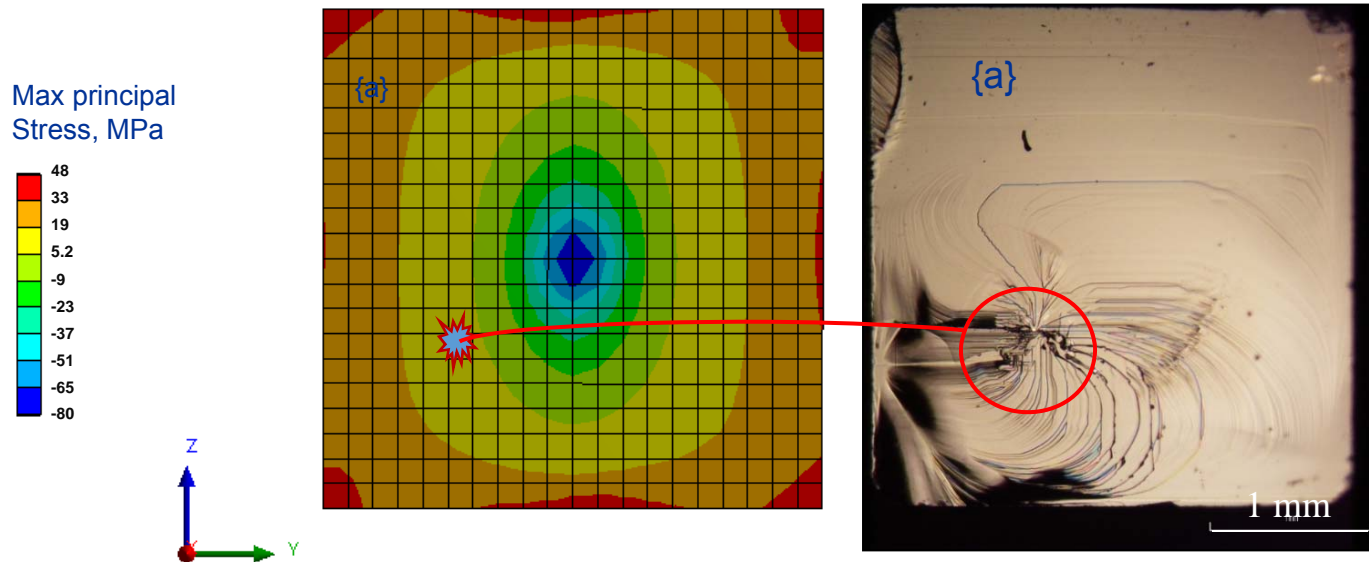
Location of Speculated Origin

- Speculated origin is on the border of compression and tension, with low tensile stresses (~ 5 MPa):

- Could the origin be elsewhere? The surface?

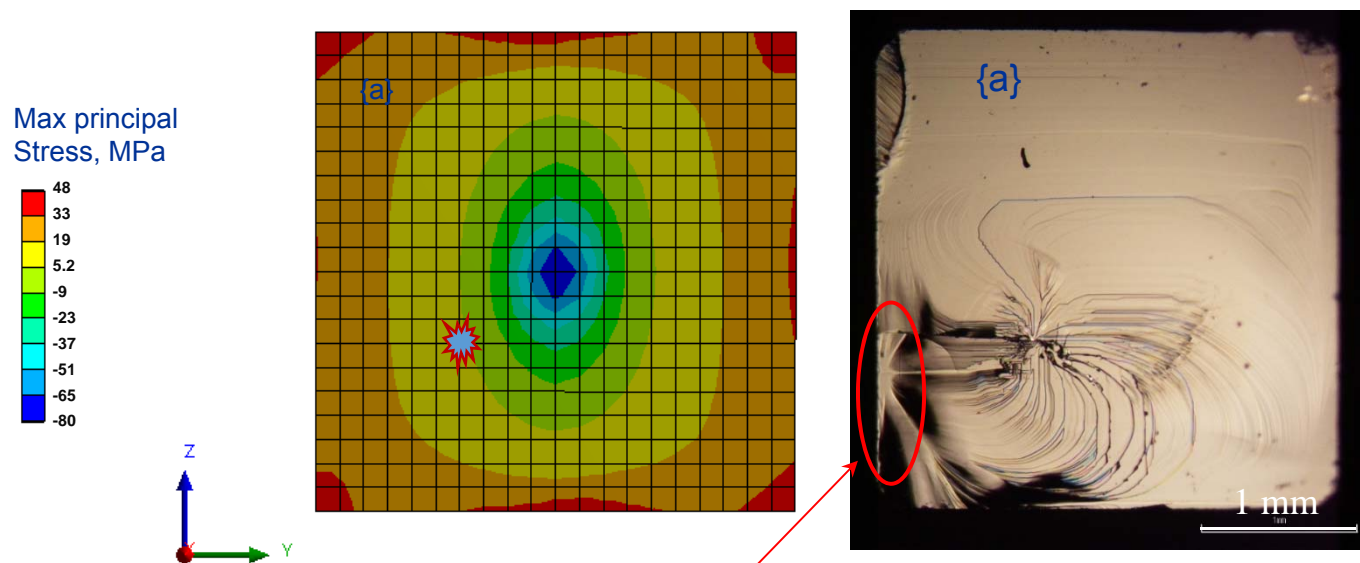
Other Fracture Features

- Let's consider surfaces where stresses and damage are high:

- At the surface a star-like feature is apparent – single crystal mirror?

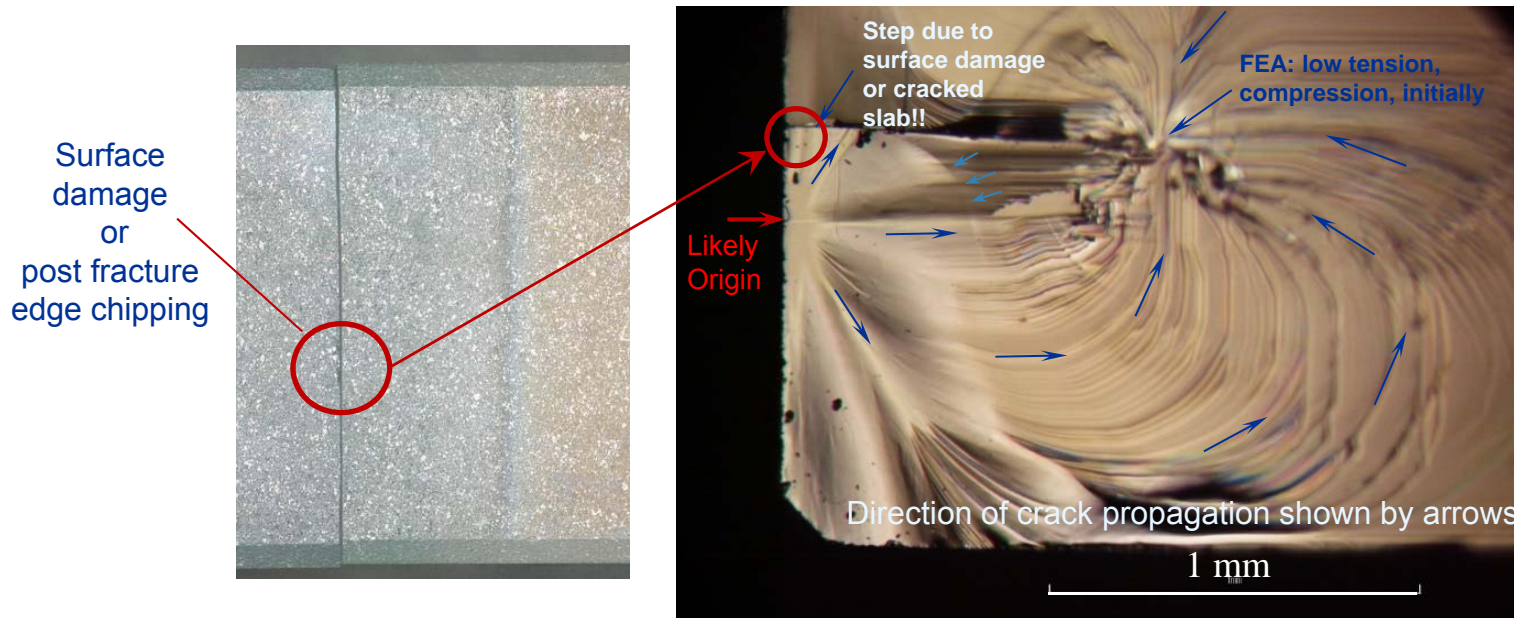
Surface Damage and Classic Mirror

- But why the coalescence of river marks to a central region of initial compression??

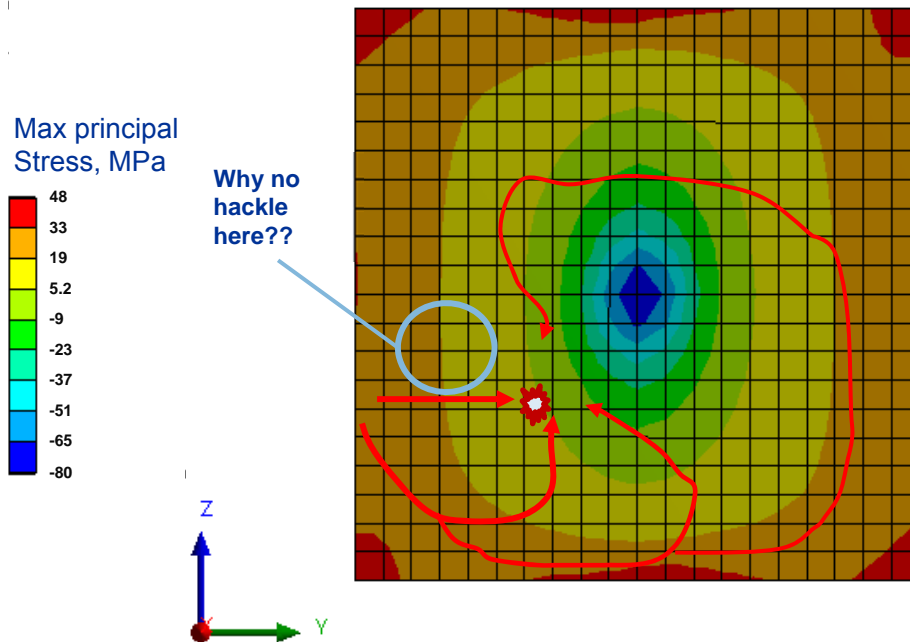
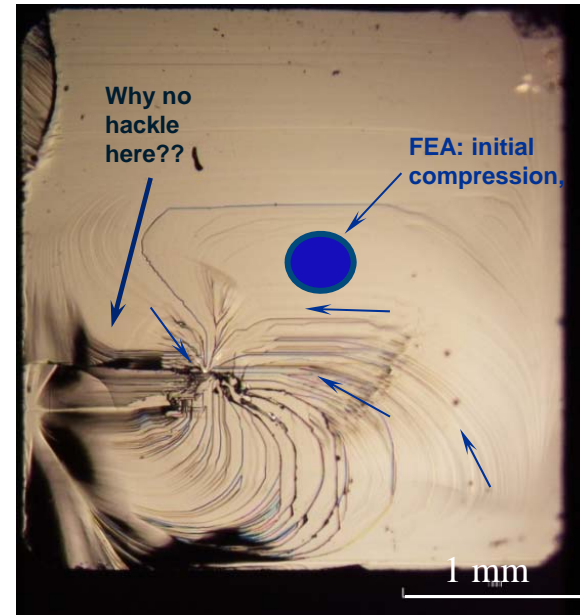
River Marks Follow Tensile Stress Pattern...

- As the crack grows, it spirals, avoiding the center compression, changing the center to tension until the cracks paths converge (?).
- The crack remains on the cleavage plane rather than tracking along the beam long axis:

- No mirror or hackle markings on one side of the origin!!??.....

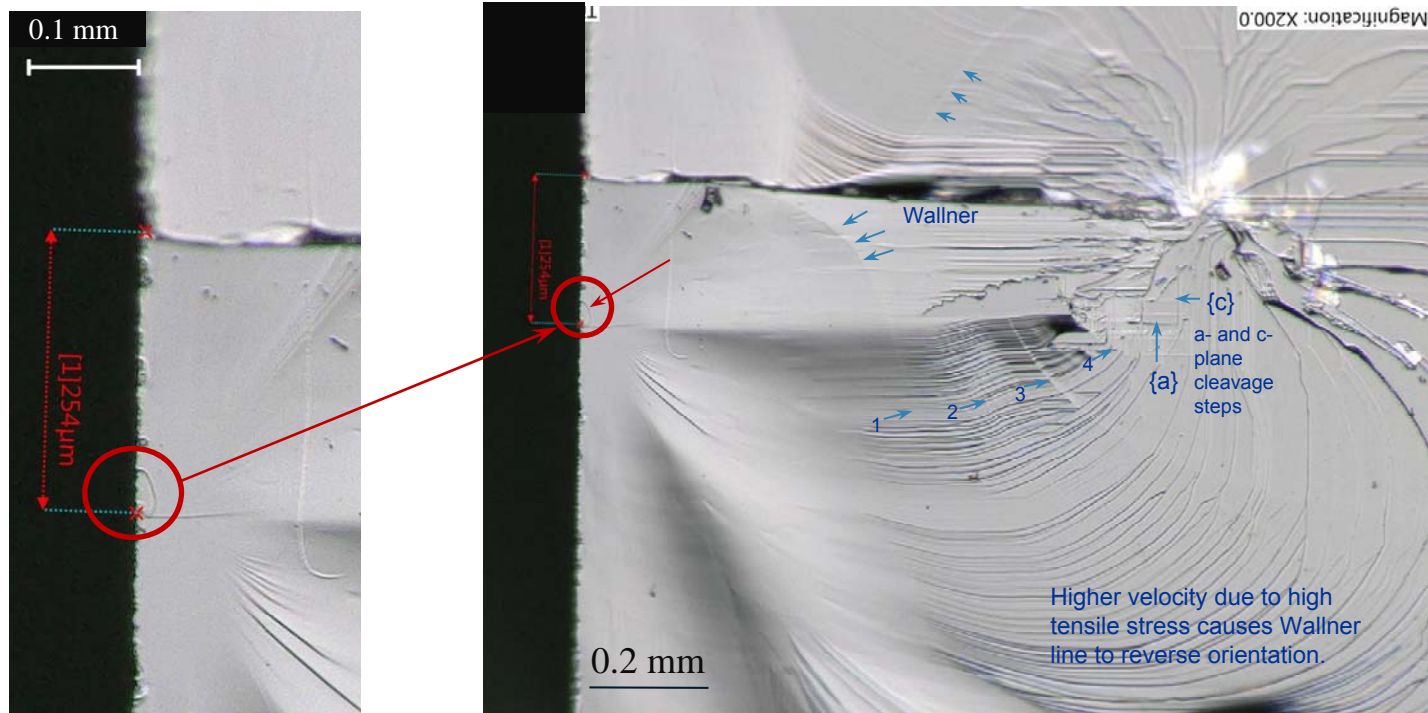
“All Roads Lead to Rome” (or away!)

- Origin appears to be the corner of a small, semi-circular surface crack.
- Growing crack wraps around one side of the step.....Unusual pattern:

- “Rome” is the interface between tension and compression where the crack front stalls? But that hackle.....

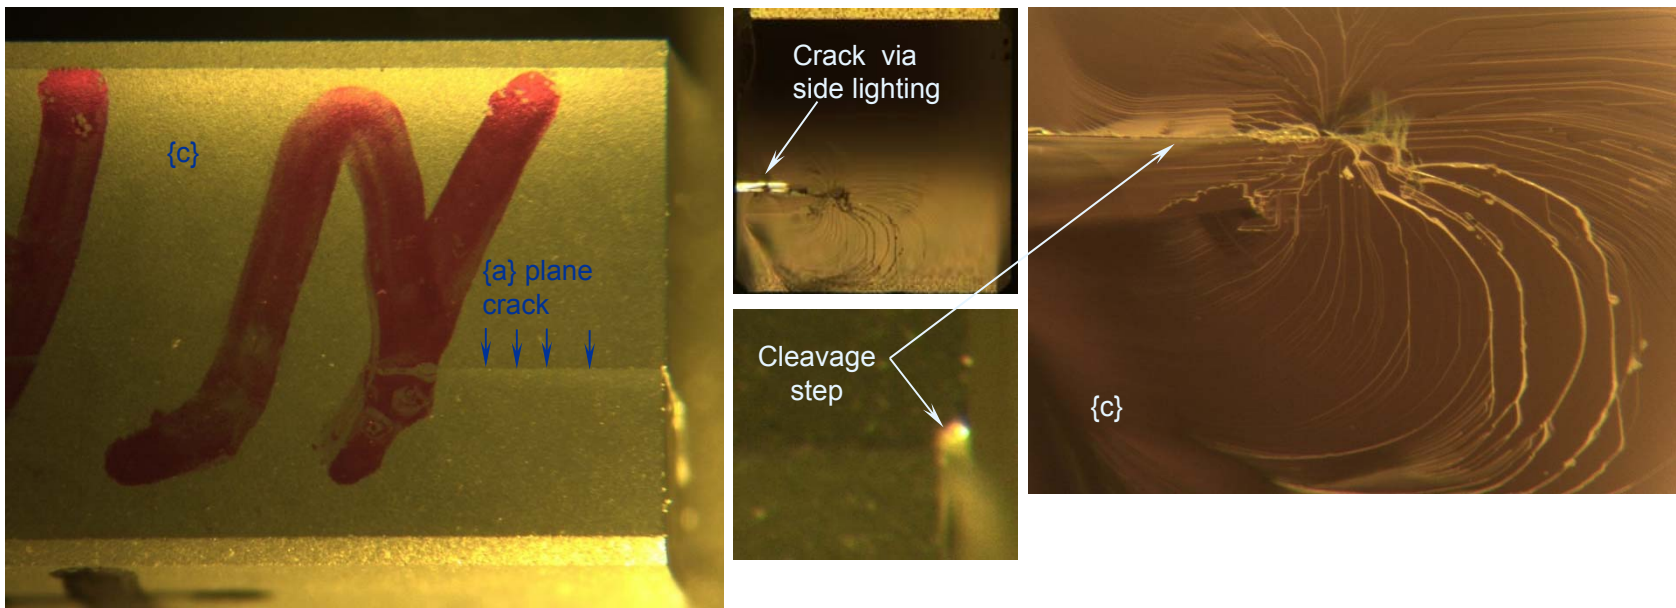
Why No Hackle on one Side of the Origin?

- By side lighting, we see that the slab was cracked, likely prior to the fracture:

- Crack wrapped around the prior, longitudinal crack plane like a screw, creating the cleavage step and “node.”

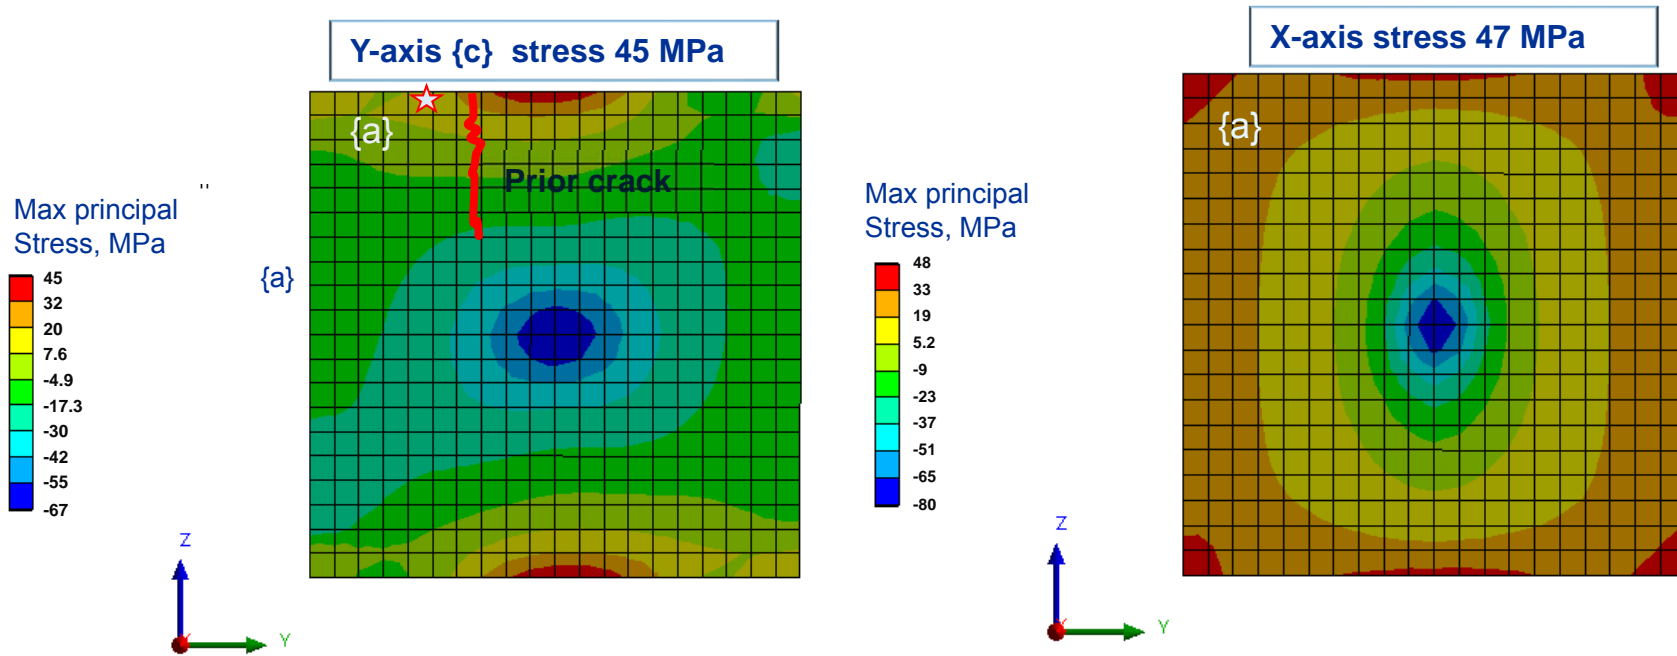
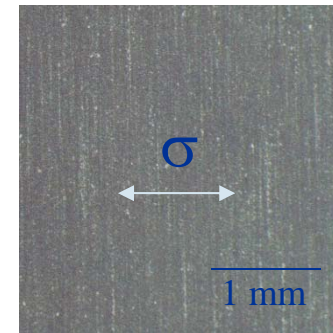
X and Y Direction Stresses are Similar:

- Grinding is usually in the x-direction, and the stresses are similar on both the x- and y-directions, so longitudinal cracking is likely.
- Longitudinal crack was in tension, creating a stress concentration and drawing in the propagating crack.....creating the "node."

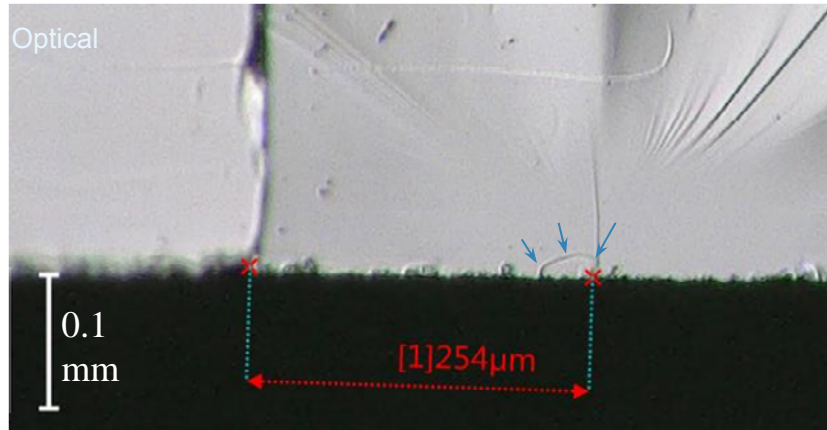
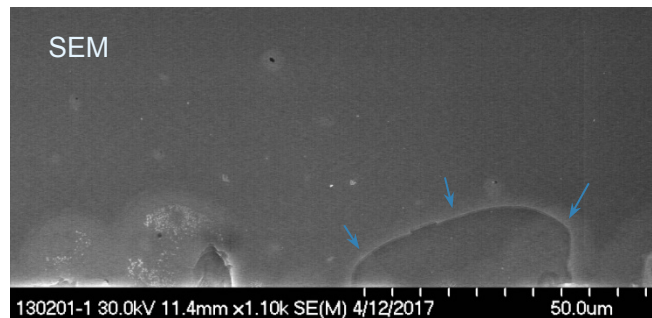
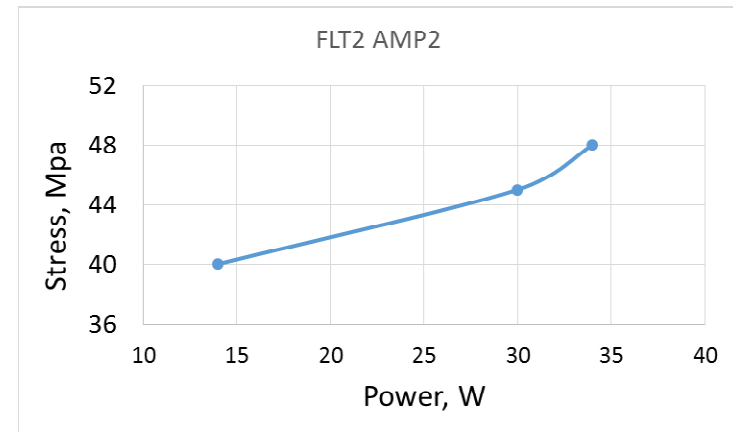
Estimated Stress (Fractographic and FEA)

Stress (MPa)	Meas. Type	a (mm)	2c (mm)	Y surface	Y depth	KIc MPaVm
70.0	OPT	0.021	0.052	1.30	1.30	0.42

- High stresses are estimated, implying that the stresses were higher due to the prior longitudinal crack or that the pump level, which was unknown, was very large.

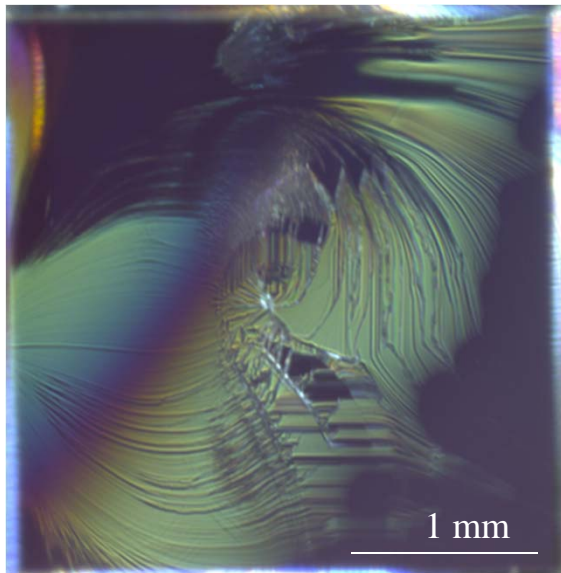
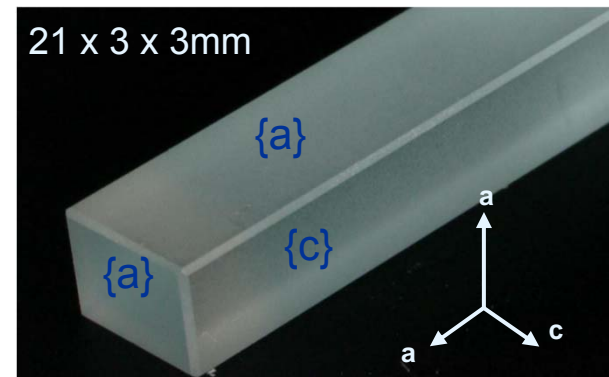
Second Pump-to-Failure Amplifier Crystal

- Controlled bench test of a laser amplifier slab (single crystal) to induce crystal failure via over-pumping.
- Disassembly revealed a fracture near one end, with the location of fracture thought to be near the center.

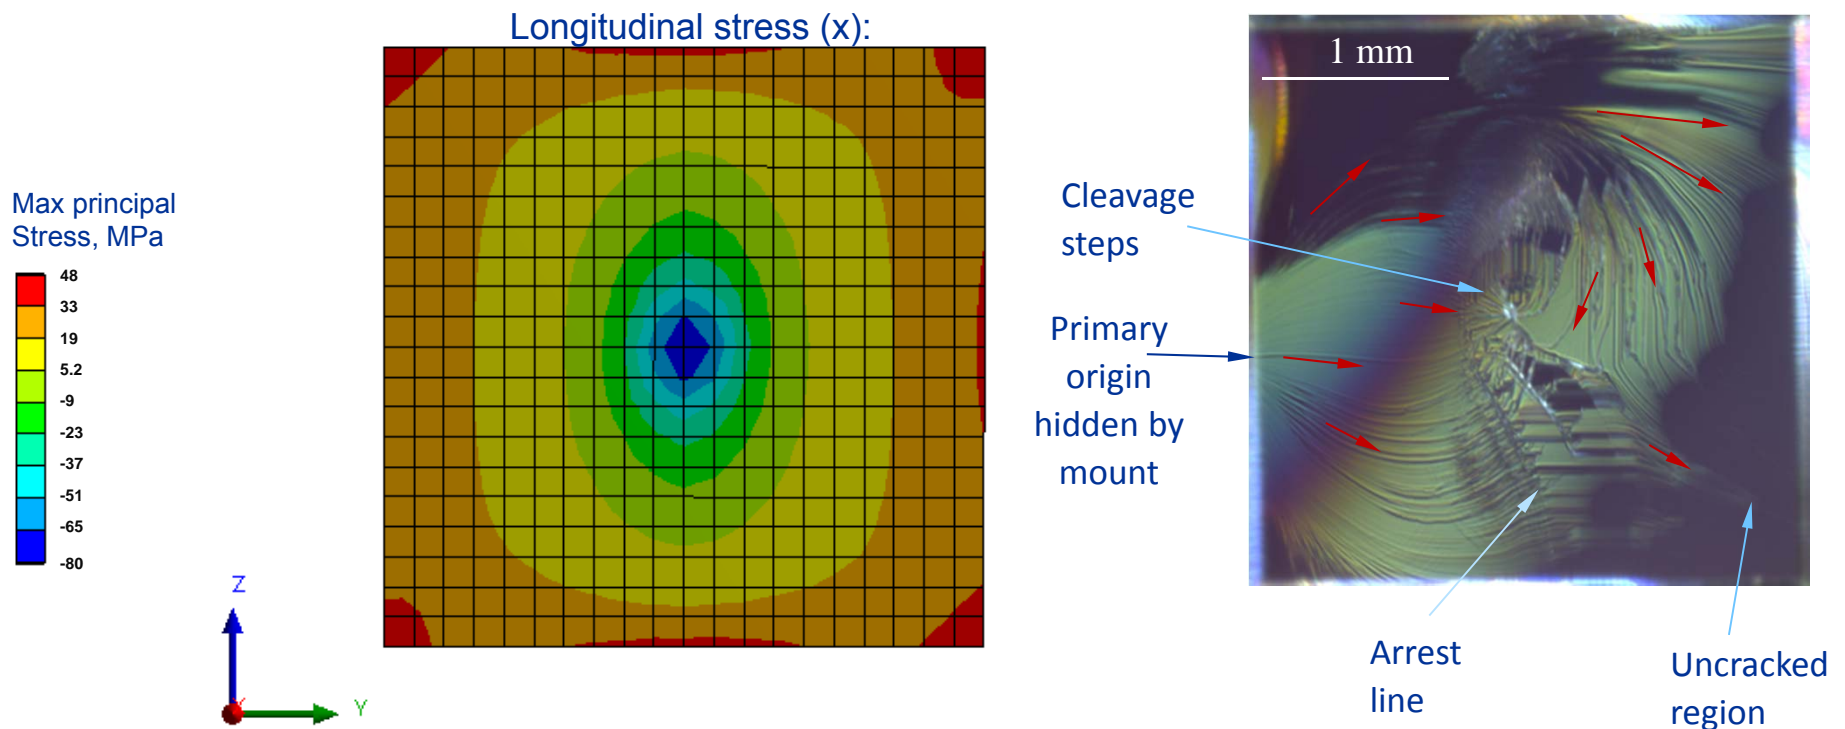
Slab: Pump-to-Failure Fracture

- The “Node” is more centrally located (compression) and no cleavage step or prior longitudinal crack is apparent:

- Crack wrapped around central compression region and stalled.
- Stress state changed and fracture continued by failing central ligament as regions of compression became tension, creating the node.

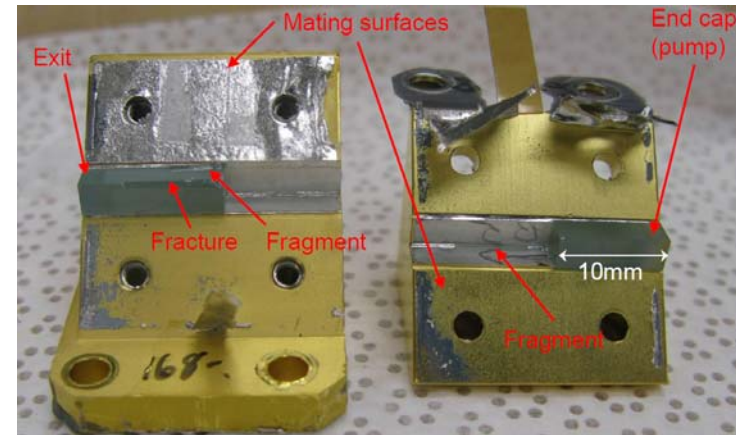
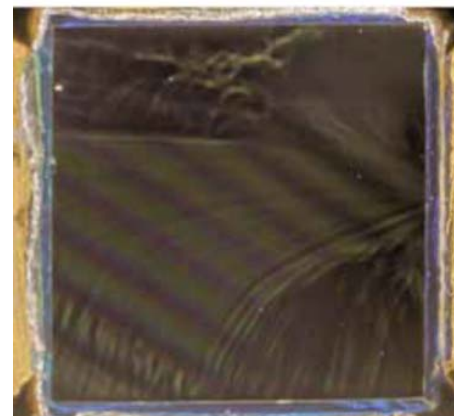
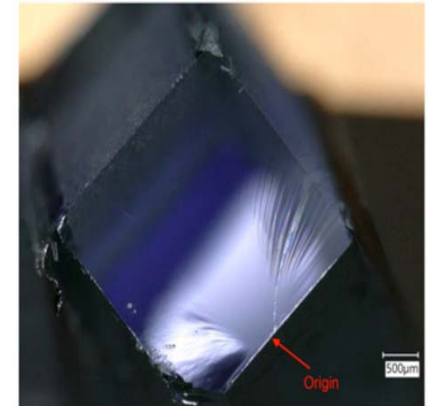
First Flight Amplifier Fracture

- The crystal fractured about 10 mm inboard of the input face and originated in the middle of the c-facet.
- There were no obvious surface defects or corresponding mount defects at the fracture origin.
- Applied stresses were low.
- Implies that the crystal was under higher mechanical loads (pressure).
- But why?

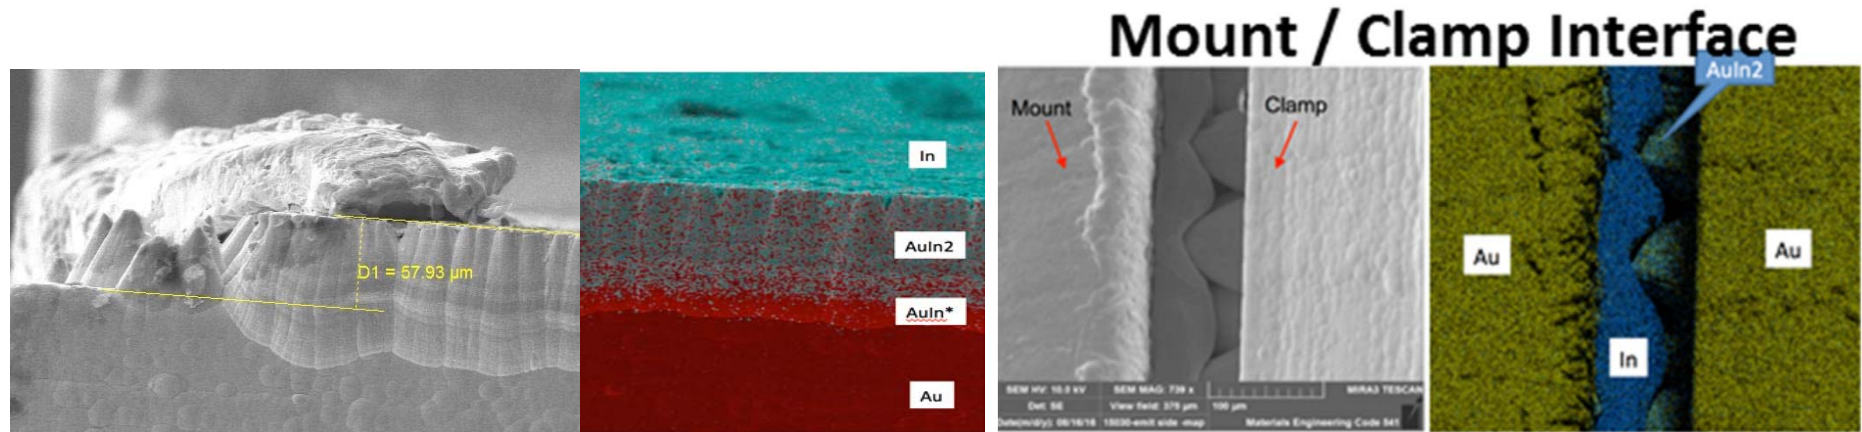
Time Dependent Crystal Loading

- Fractography indicated that gold and indium were forming gold-indide (AuIn_2) over time.
- The resulting AuIn_2 material is stiffer, harder and more brittle than indium; and more significantly, occupies 15% more volume.
- Intermetallic and indium are incompressible. The additional volume is displaced, resulting in higher preloads on the crystal, and eventual fracture.
- Failure was not due to overpumping...

- Failure resulted from several sources:
 - Au-In reactions (worst element)
 - poor crystal finishing and handling
 - low toughness and slow crack growth

- Re-design & qualification was needed:
 - Lowered the stresses
 - Quantified the transient reliability:
