LCF Life of As-Deposited and Annealed NiCr-Y Coatings for Oxidation and Hot Corrosion Protection of Disk Alloys

*James A. Nesbitt, Timothy P. Gabb, and Susan L. Draper
Glenn Research Center, Cleveland, Ohio*

Abstract

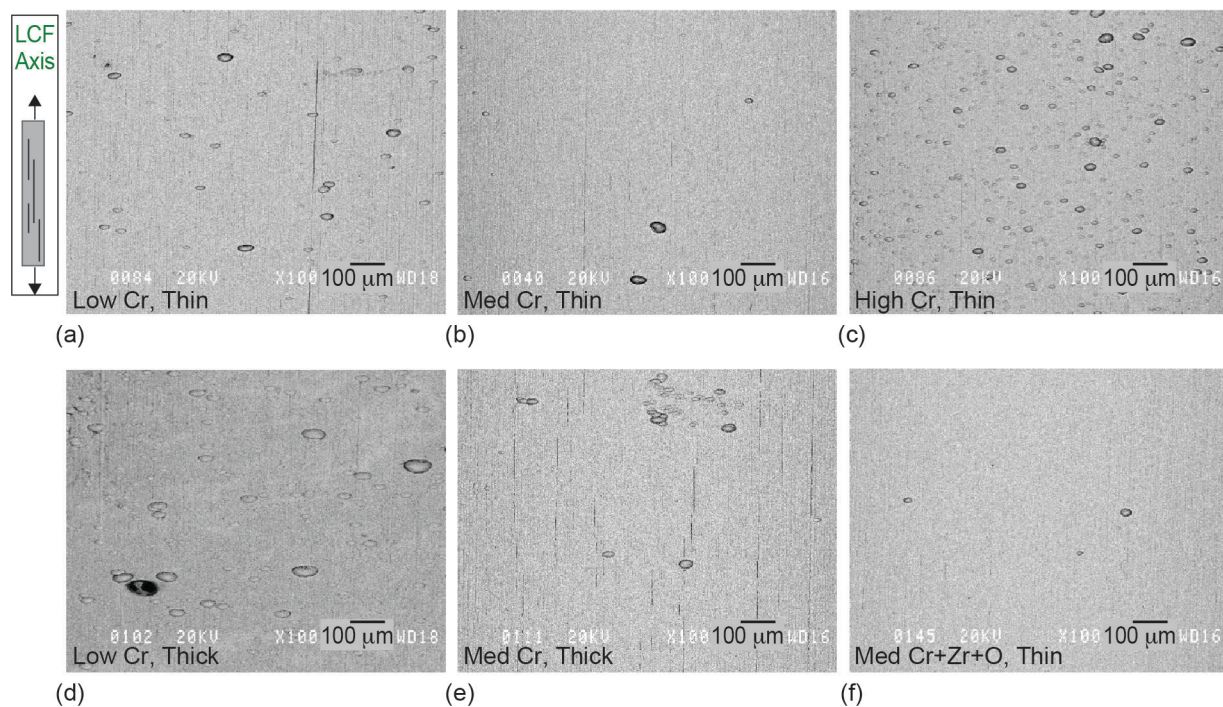
SEM images of the as-deposited surface of each coating are shown in Figure 3. Small oval defects, commonly referred to as spits (a.k.a. droplets, nodules or macros) (Ref. 76) are evident on each of the coatings with the largest number on the High-Cr, Thin coating. These spits are believed to occur when molten droplets of the target material are ejected due to arcing within the sputtering gun. They are often poorly bonded and lost from the coating becoming a source of a common “pinhole” defect (Ref. 76). It is also apparent in Figure 3 that some of the coatings show fine black lines along the LCF specimen axis. Higher magnification images in Figure 4 show that, in addition to the spits, there is a distinct coating texture following the rod axis with the presence of what appear to be occasional fine cracks along the axis. Since these fine “cracks” form during coating deposition, they will be referred to as linear gaps to differentiate them from fatigue cracks which form perpendicular to the specimen axis during fatigue testing. It appears that the fine texture in the coating, apart from the linear gaps, is reflecting the longitudinal polishing marks originally on the surface of the LCF specimen. This reflection of the substrate surface by the coating was further confirmed by examining the surface of some of the characterization pins, which did not receive a final longitudinal polish but had fine polishing marks

Figure 3.—Low magnification BSE-SEM images of the coated surface for each of the coatings. (a) **Low Cr, Thin**, (b) **Med Cr, Thin**, (c) **High Cr, Thin**, (d) **Low Cr, Thick**, (e) **Med Cr, Thick**, (f) **Med Cr+Zr+O, Thin**. The LCF loading axis is vertical for each of the images as indicated in the inset.

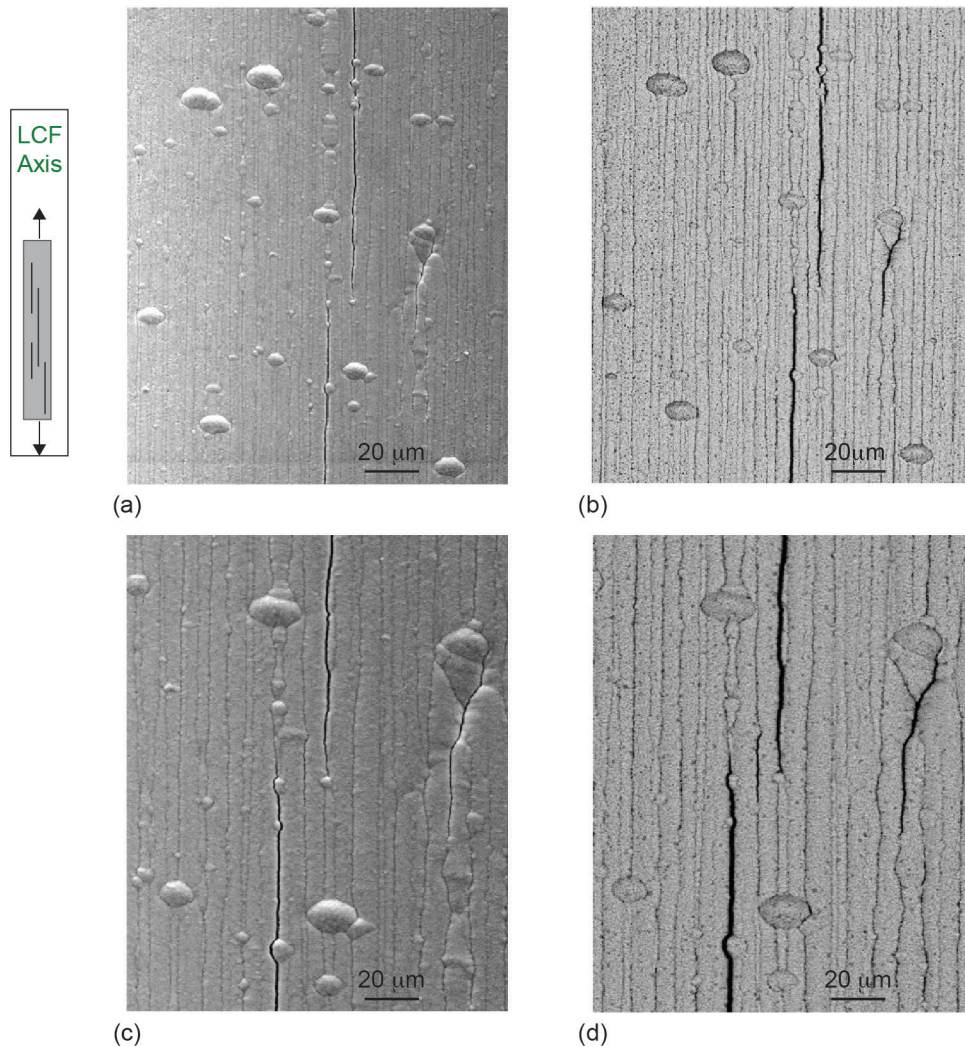
Figure 4.—Higher magnification (a,c) SEI and (b,d) BSE SEM images of the coating surface for the **Low Cr, Thin** coating showing the “cracks” and coating texture oriented along the loading axis. The LCF loading axis is vertical for each of the images.

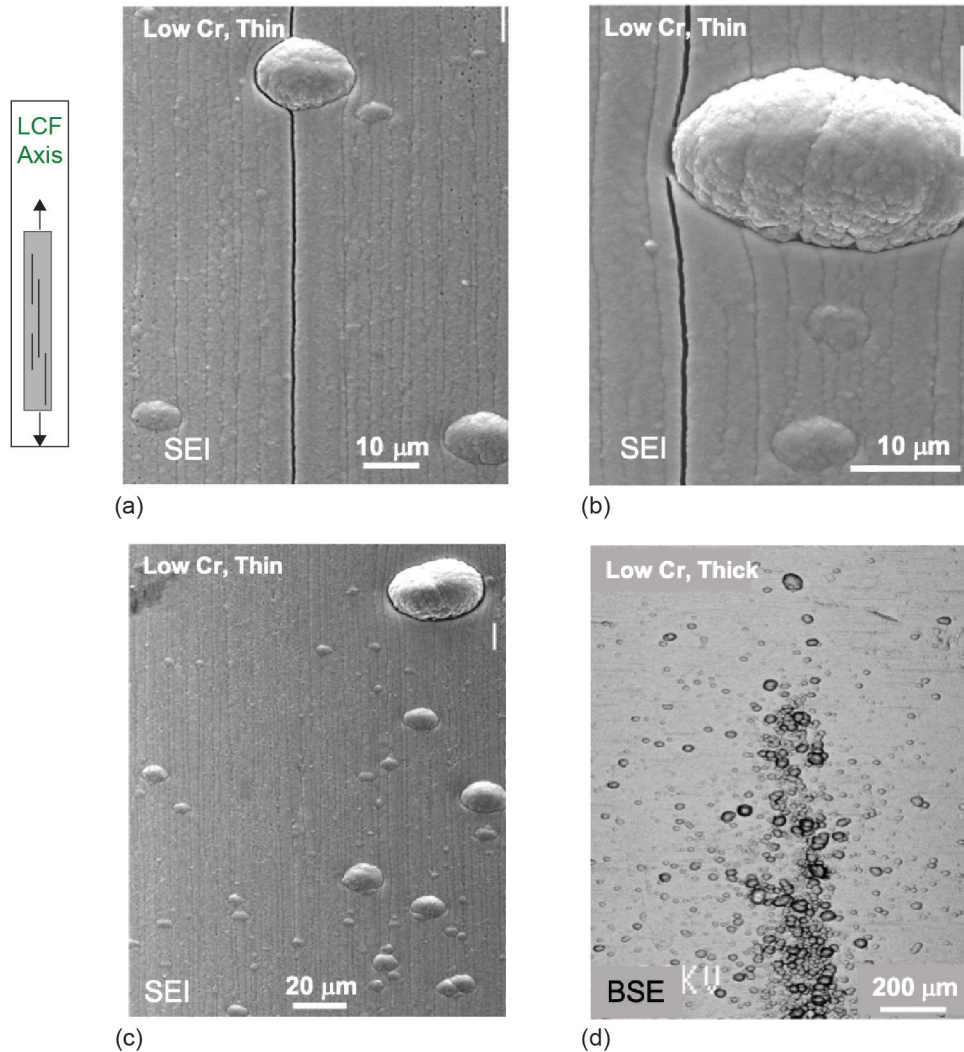
The spits, as is commonly observed, did not appear to be well bonded to the surrounding coating and later processing indicated that they were sometimes dislodged and lost from the coating. Figure 5(a) shows a linear gap passing around a spit indicating a weak bond with the coating. A linear gap passing at the edge of a spit, shown in Figure 5(b), shows little interaction between the spit and the linear gap. The spits were not uniformly located across the specimen surface. Varying densities of spits on the surface are shown in Figure 5(c) and (d). For environmental protection (oxidation and hot corrosion), both the linear gaps and the weak interface at the spits were a concern, especially if loss of a spit during later processing could expose the substrate to corrosive reactants. Since the linear gaps ran parallel to the specimen loading axis, it was not known if these defects would have a detrimental effect on the LCF life. Certainly any cracks or linear defects in an orientation perpendicular to the specimen loading axis would be a major concern.

Figure 5.—SEM images (a,b) showing the linear gaps interacting with spits, and (c,d) showing the non-uniformity of spits on the surface. The LCF loading axis is vertical for each of the images. Coating ID's are shown in the upper left corner of each image.

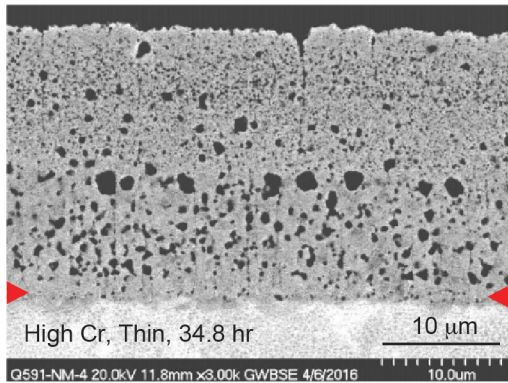
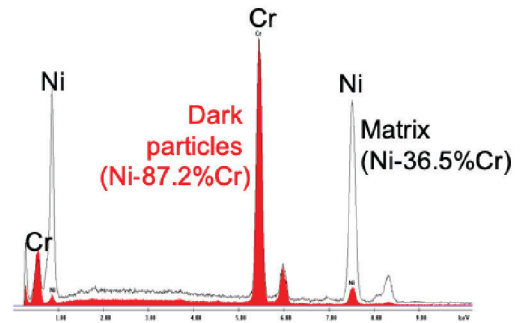
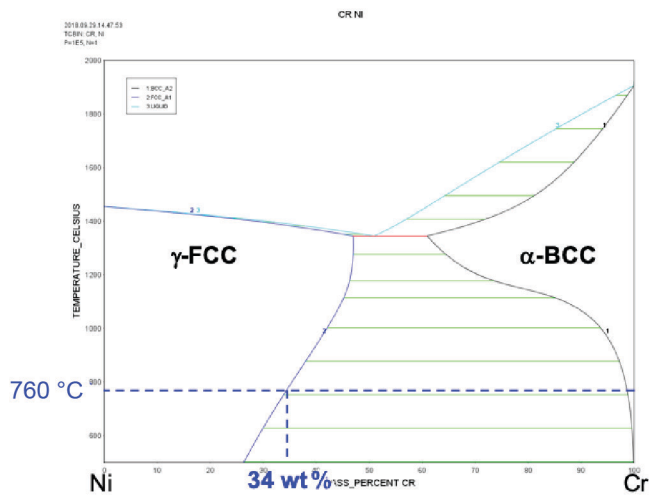
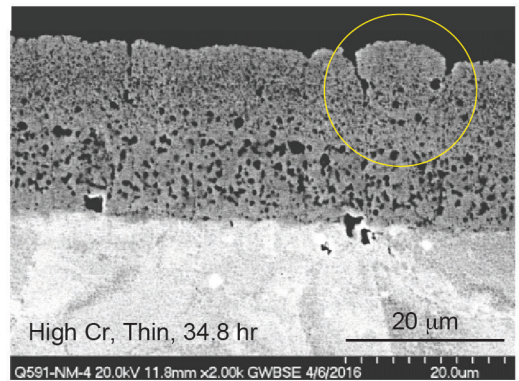
Figure 7.—(a) BSE image of the **High Cr, Thin** coating showing the second-phase particles (dark). (b) Comparison of EDS spectra, normalized to the same Cr peak height, and ZAF analysis results showing that the dark particles are high in Cr (~87%) while the matrix is ~36 %Cr. (c) Ni-Cr phase diagram showing that the high-Cr particles are the BCC α -Cr phase and the Cr concentration in the γ -FCC matrix phase is ~34 wt. (d) Image showing a spit (circled) and the uneven distribution of the α particles.

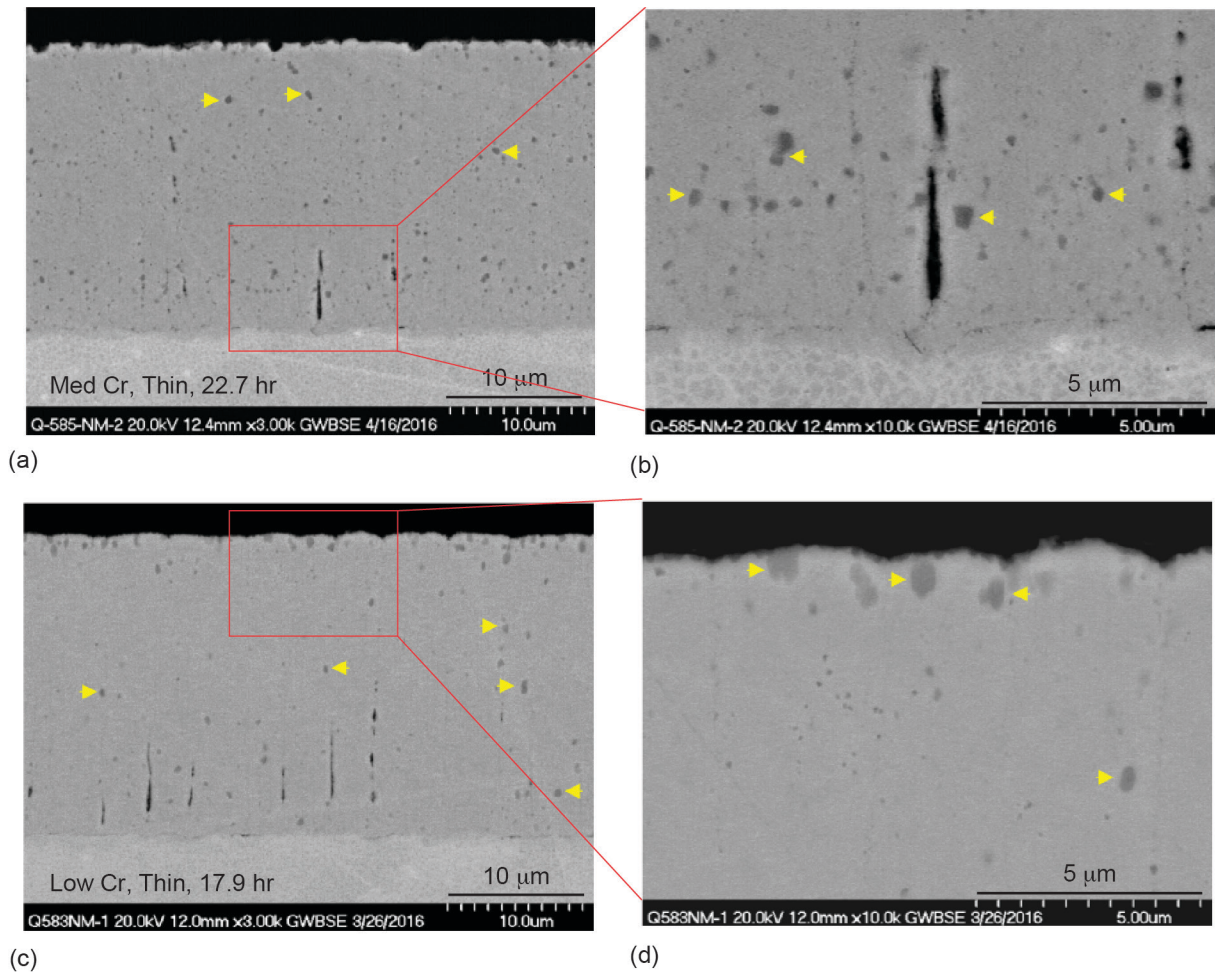
Figure 8.—BSE images showing the second phase α -Cr particles (medium gray) distributed throughout the (a,b) **Med Cr, Thin** coating, and (c,d) **Low Cr, Thin** coating. Yellow arrows indicate the location of some of the particles. (b,d) Magnified views of the red boxes shown in (a,c), respectively. The total time at 760 °C, including the 8 hr diffusion anneal and the LCF testing, is shown with the coating ID in the lower left of images (a,c).

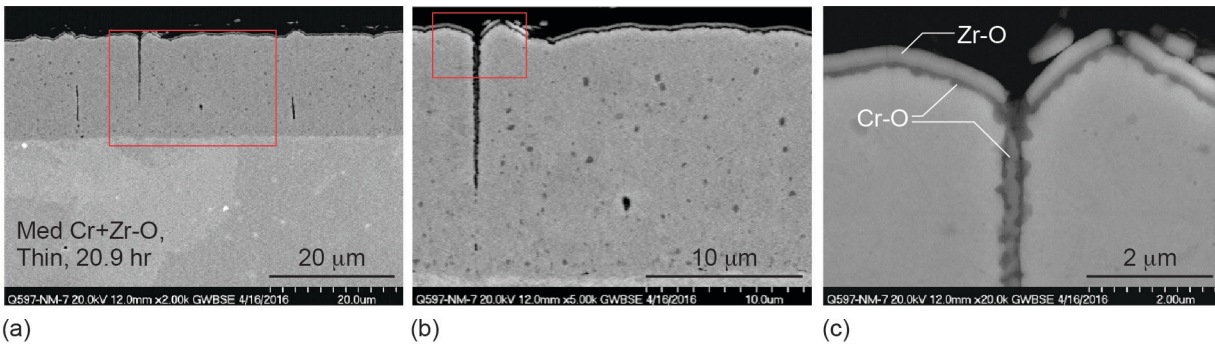
The thin Zr-O layer on the **Med Cr-ZrO₂, Thin** coating is shown in Figure 9(a) to (c). EDS analysis of the outer layer showed a high Zr and O concentration and was likely ZrO_{2-x} where the x indicates the possibility of some oxygen deficiency. There was a very thin, dark layer of Cr-rich oxide below the ZrO₂ layer. It is not known if this layer formed during deposition of the Zr, or by oxygen transport through the ZrO₂ layer during the low PO₂ anneal or during LCF testing. Cr-rich oxide was apparent in one of the linear gaps that intersected the surface. The cusps bordering the top of this gap further suggest that these linear gaps develop during growth of the Ni-35Cr-Y coating and not by some fracture or cracking of the coating following coating deposition. The Cr₂O₃ formation in the gap (Figure 9(c)) may have formed as a result of excess oxidation during the deposition of the ZrO₂ layer or during the 8 hr low PO₂ diffusion anneal.

Figure 9.—(a-c) BSE images of the **Med Cr+Zr-O, Thin** coating showing progressively higher magnifications of the thin Zr-O layer and one of the linear gap defects which contains some Cr-rich oxide. There is also the indication of a Cr-rich oxide (thin dark layer) below the Zr-rich layer.

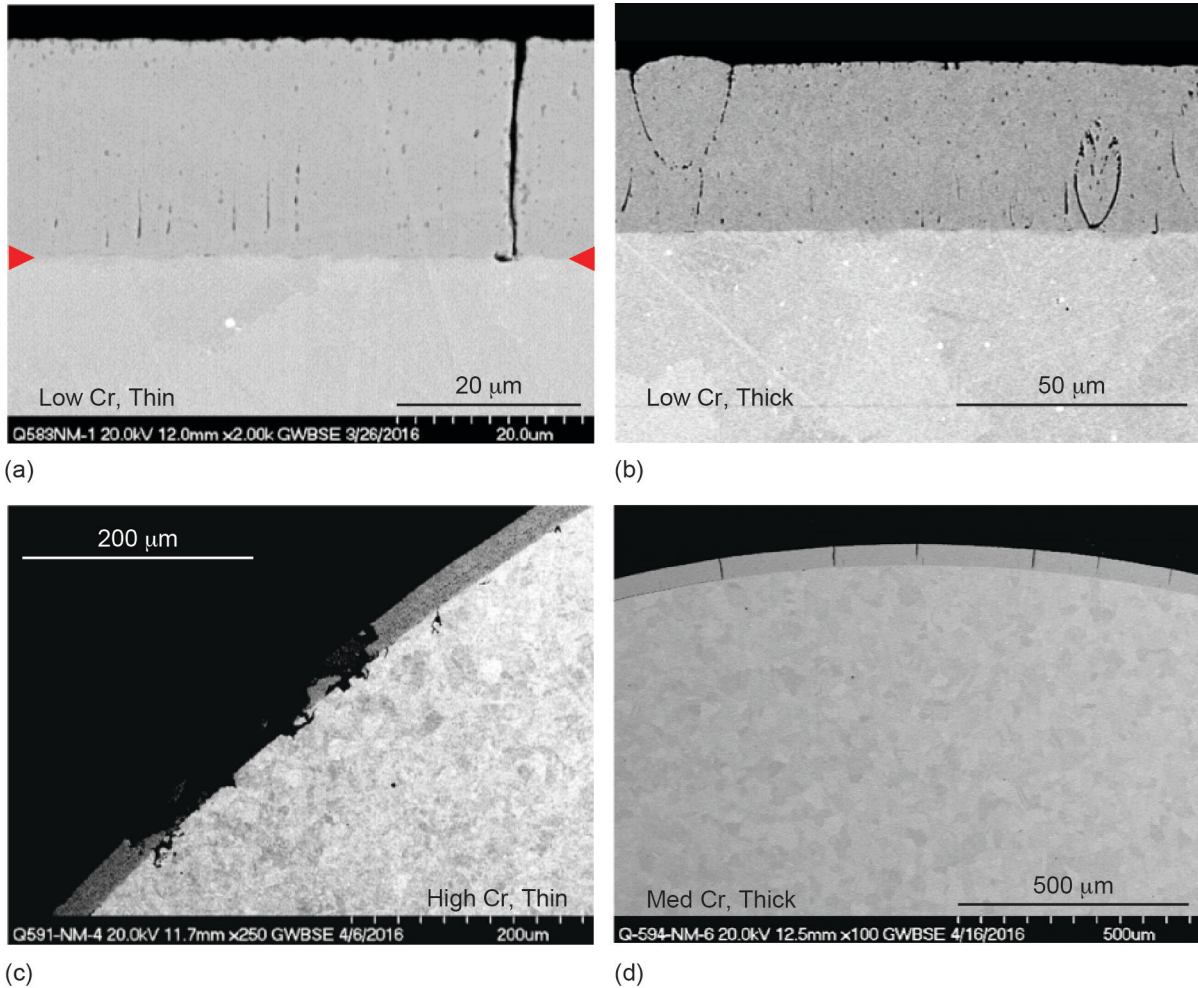
There were many other coating defects observed in these coatings. Some of the linear gaps were observed to penetrate to the substrate (Figure 10(a)). Spits were observed at the surface as well as interior to the coating (Figure 10(b)), and on the *High Cr, Thin* coating regions were observed where the coating appeared missing/lost (Figure 10(c)). The *Med Cr, Thick* coating showed regions with large numbers of wide linear gaps (Figure 10(d)).

Figure 10.—(a-d) BSE images showing various defects observed on several of the samples. LCF specimens were sectioned after the 8 hr low PO_2 diffusion anneal and LCF testing. The section was made perpendicular to the LCF loading axis away from the fracture surface.

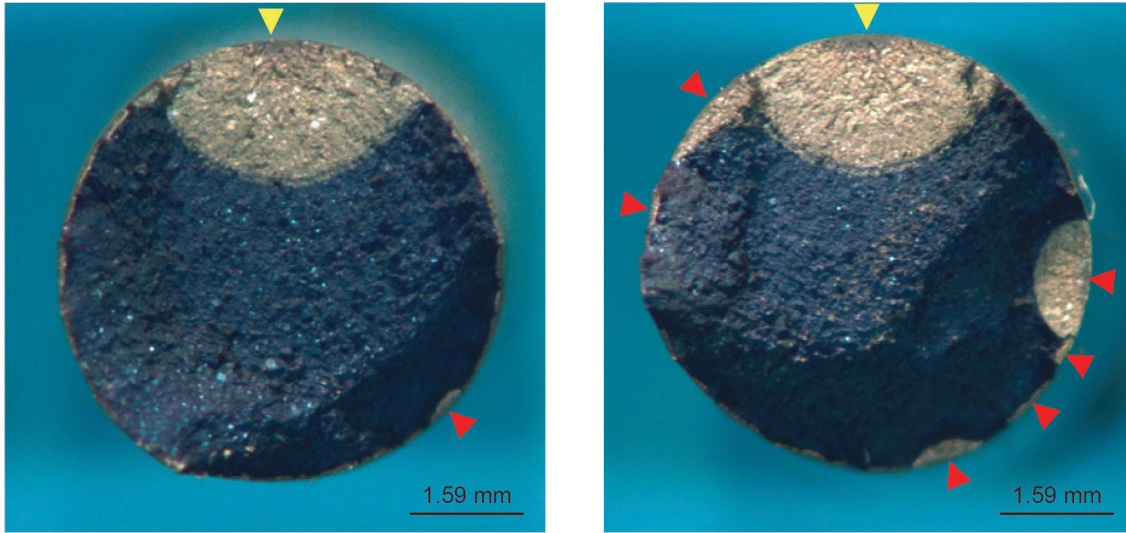
Following the LCF testing, failure initiation sites were identified for each failed specimen. For these specimens, crack initiation sites were relatively easy to identify optically at relatively low magnifications, as shown in Figure 12. In both specimens shown in this figure, failures were initiated by a single crack identified as the primary failure crack. The initiation site for this crack is indicated by the yellow triangle in the figure. However, in Figure 12(b), several other secondary cracks (red triangles) had obviously initiated at different locations in addition to the primary failure crack. SEM was used to follow typical crack growth patterns for fatigue failures to identify and examine the initiation site of the primary failure crack. The intent was to identify whether the crack initiated at the surface, or at an internal flaw within the substrate. The failure initiation site of one of the *Low Cr, Thin* coated specimen is shown in Figure 13. The initiation site for this specimen was at the surface. A closer examination of the site indicated the presence of two spits in the coating, which are seen to penetrate nearly through the coating (Figure 13(c)). It is likely that these spits initiated the fatigue crack which grew to become the primary failure crack.

Figure 12.—a,b. Optical images of the fracture surfaces after LCF testing showing crack initiation sites with the primary failure crack initiation site oriented to be at the top (yellow triangle). Other significant cracks are indicated with red triangles.

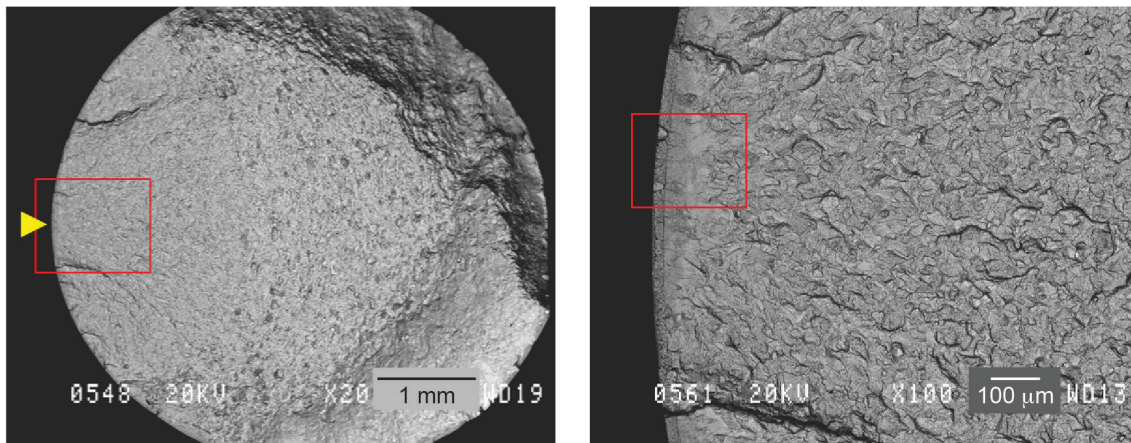
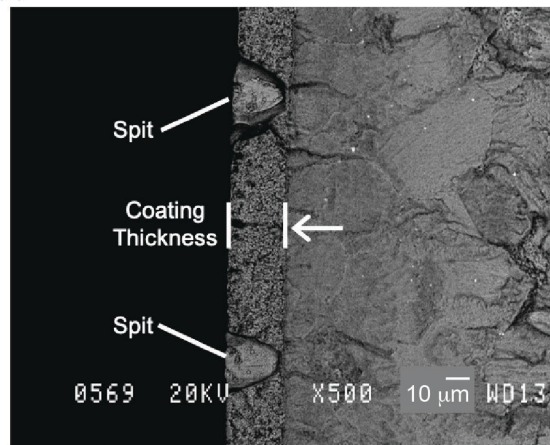
Figure 13.—BSE images of the fracture surface showing the crack initiation site (yellow triangle). Clearly visible in (c) is the location of two spits in the coating which appear to penetrate most of the coating. (**Low Cr, Thin** coating).

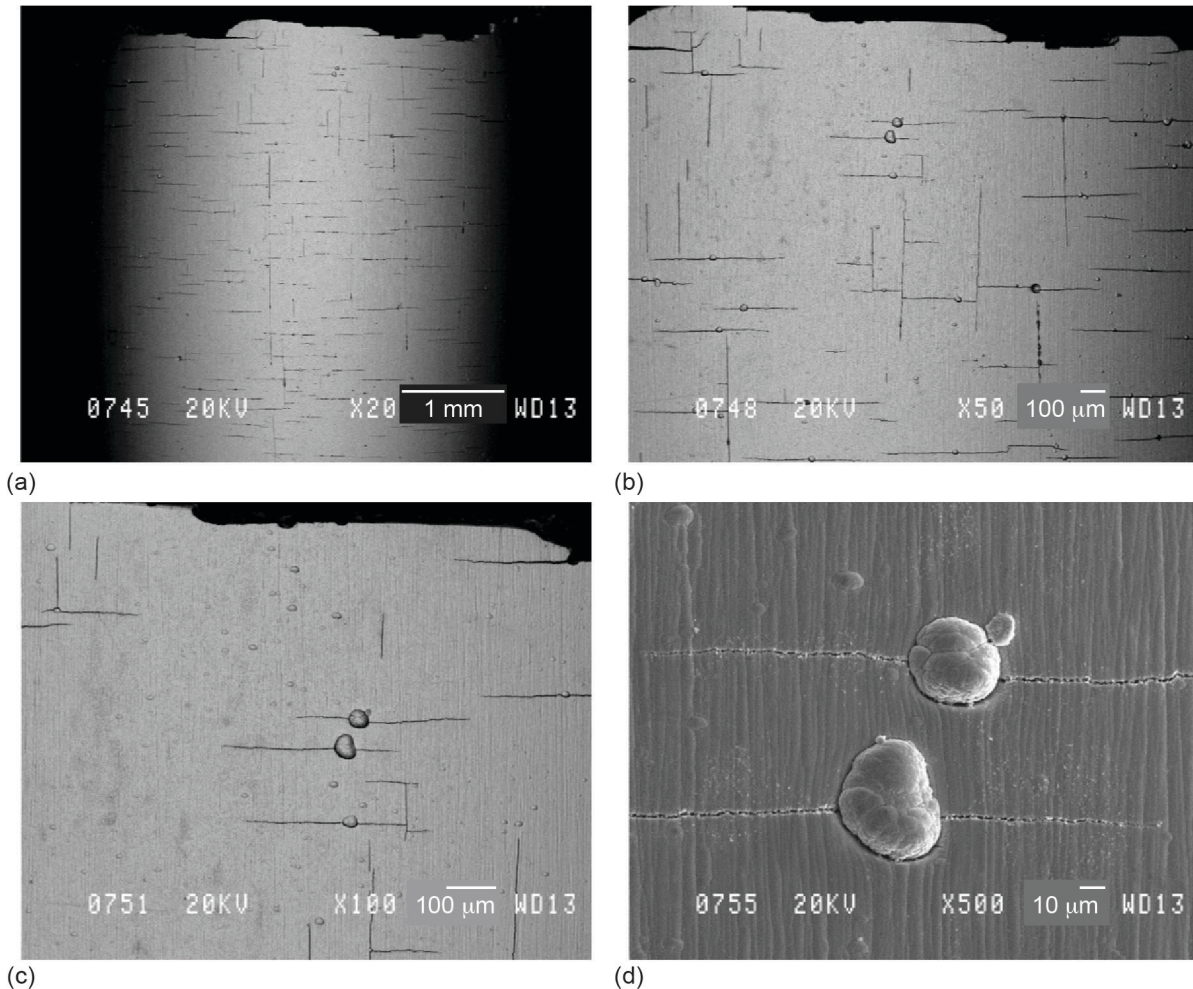
Figure 14.—BSE (a-c) images of the surface of the LCF specimen after testing showing the formation of cracks parallel and perpendicular to the LCF loading axis. (d) SEI image showing cracks associated with two spits. (**Low Cr, Thin** coating).

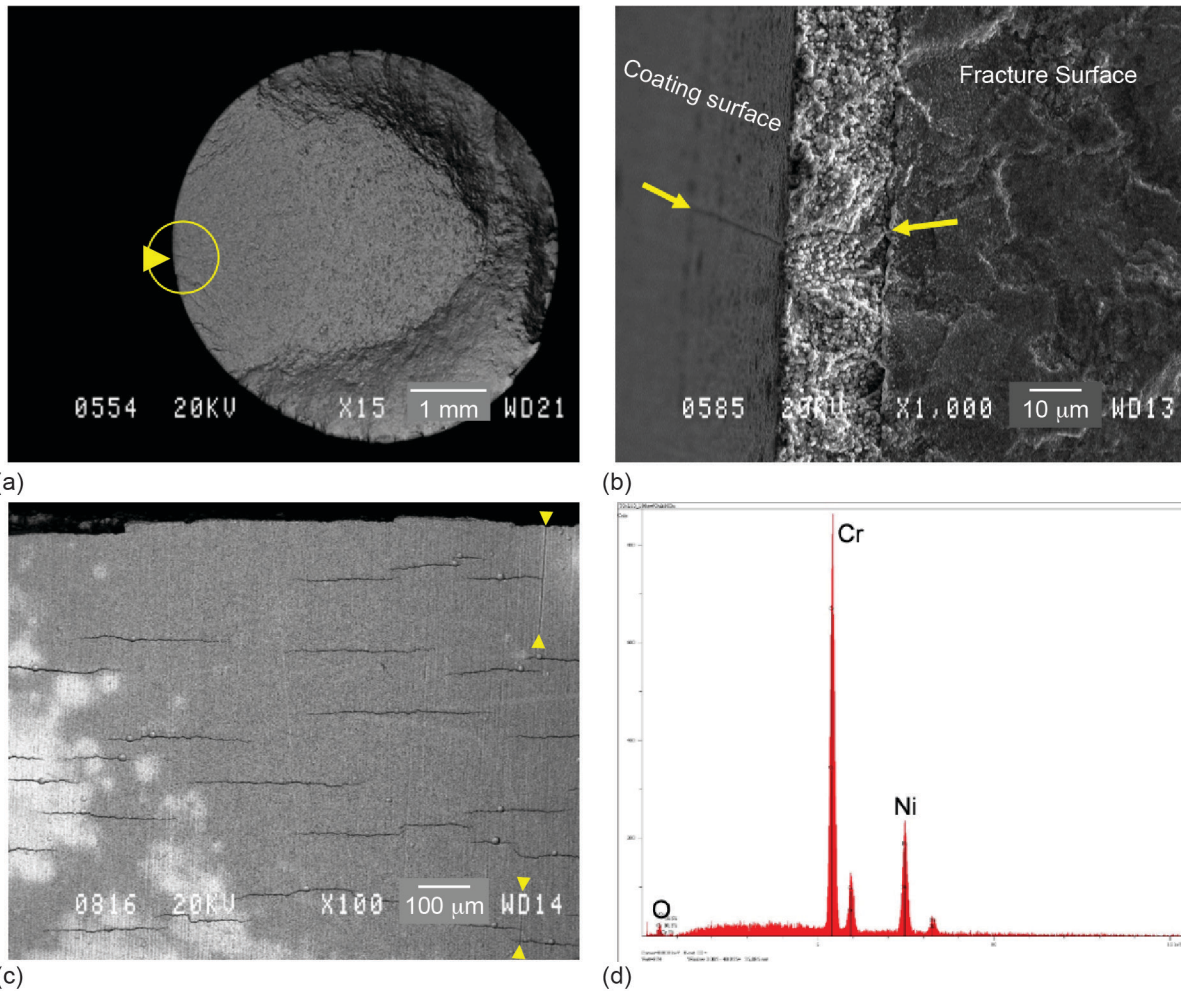
precipitated crack initiation of a perpendicular fatigue crack, as suggested in Figure 15. However, it is not certain whether the linear gap initiated the primary fatigue crack, or was simply present near the primary crack initiation site. EDS of the specimen gage surfaces indicated elevated Cr and O levels, consistent with the formation of principally chrome oxide on both uncoated and coated specimen surfaces.

Figure 15.—BSE (a,c) and SE (b) images of the fracture surface of the LCF specimen showing the site of crack initiation at a linear gap parallel to the loading axis which has penetrated through the coating (see arrows in (b)). Fatigue cracks perpendicular to the loading axis are shown in (c) where two of the linear gaps parallel to the loading axis (vertical in the image) are highlighted by the yellow arrows. An EDS spectra (d) of the surface in (c) shows that the surface oxide is high in Cr. (**Med Cr, Thin** coating).

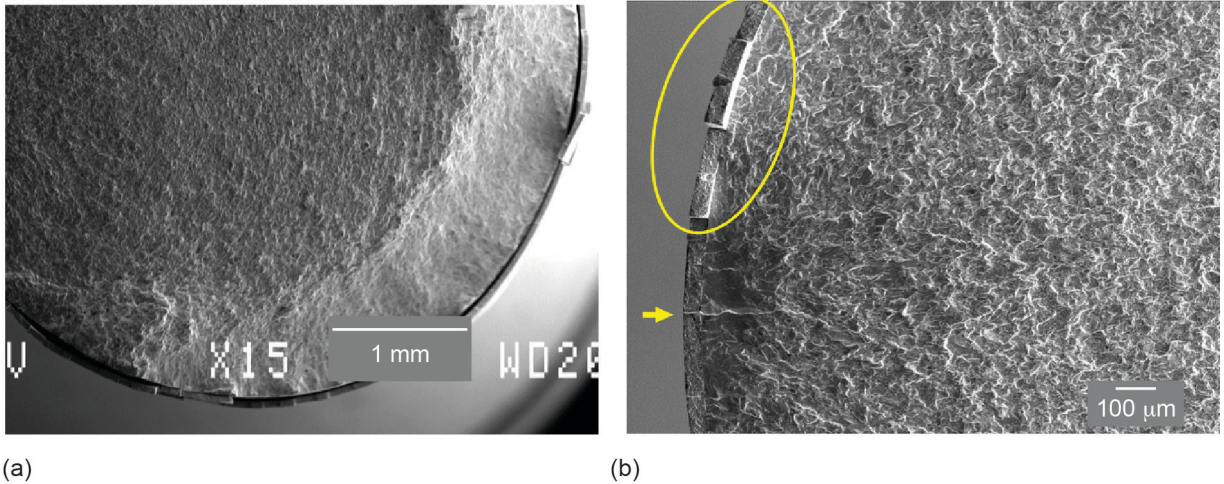
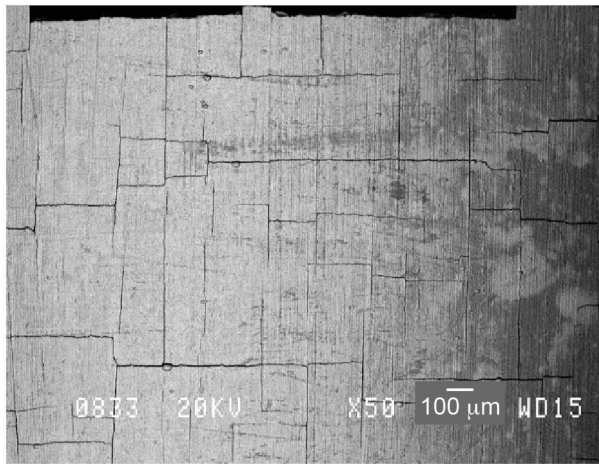
(a) (b) (c)
 Figure 16.—SE images of the fracture surface of the **Med Cr, Thick** coated specimen showing (a) a gap between the coating and substrate, and (b) coating sections indicating a poor bond to the substrate (yellow oval) at a location near the crack initiation site (yellow arrow). (c) BSE image showing large numbers of longitudinal cracks parallel to the loading axis in addition to the expected perpendicular fatigue cracks.

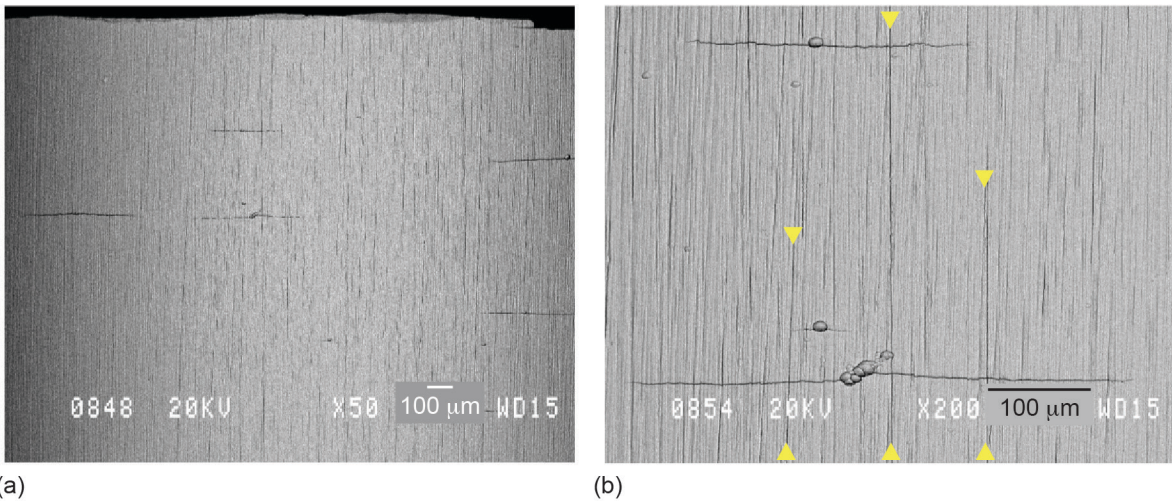
the **Med Cr, Thick** coating, far fewer perpendicular fatigue cracks were observed with the **Med Cr+ZrO₂, Thin** coating (Figure 17). This thin, two-layer coating again mirrored the pattern of the longitudinal polishing marks on the LCF specimen (Figure 17(b)). Fine, linear gaps (vertical in the image) were present but could only be discerned at higher magnification (see yellow arrowheads in Figure 17(b)).

(a) (b)
 Figure 17.—BSE images of the coated surface of the **Med Cr+Zr-O, Thin** coating after LCF testing showing few spits, few perpendicular fatigue cracks, and fewer vertical (parallel to loading axis) cracks (indicated by the yellow arrowheads).

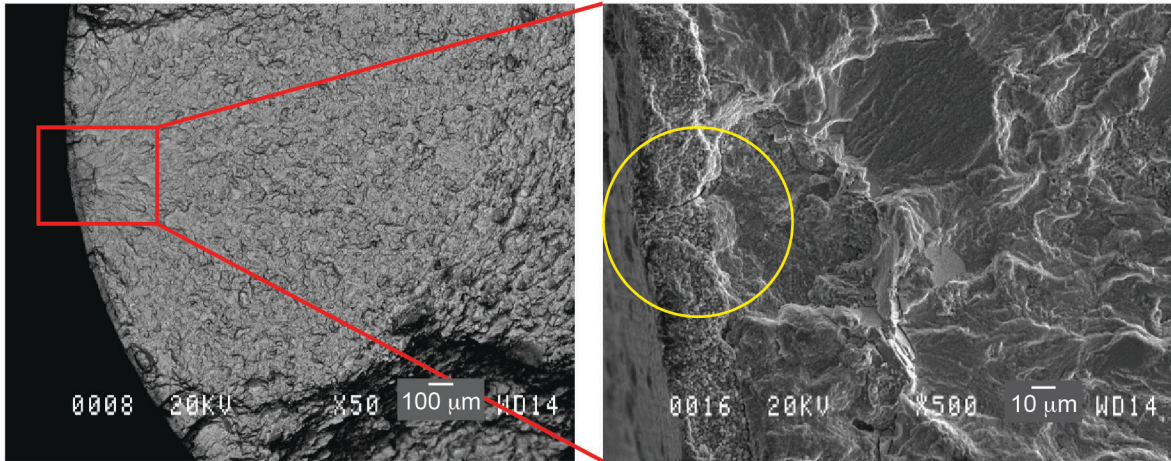
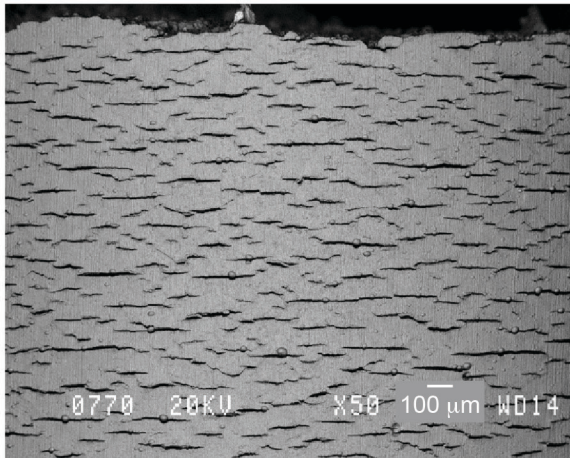
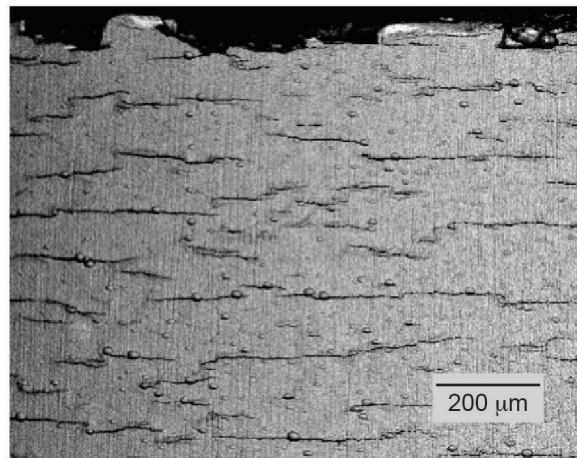
For the two specimens with the **High Cr, Thin** coating, which exhibited the highest LCF lives of the coated specimens, a spit-like defect was observed in the coating at the primary crack initiation site in one of the specimens (Figure 18(a) and (b)) but no obvious spit or linear gap was observed in the second specimen. Examination of the coated sides of both specimens showed an unusually high number of perpendicular fatigue cracks (Figure 18(c) and (d)). In the one specimen (Figure 18(c)), the cracks appear much wider than for other specimens. Since these two specimens experienced nearly twice the number of fatigue cycles as other specimens, the high number of fatigue cracks may be related to this higher number of cycles. However, it may be that the **High Cr** coating has a higher propensity for developing fatigue cracks.

Figure 18.—BSE (a,c,d) and SE (b) images of the fracture surface and coated surface after LCF testing of the **High Cr, Thin** coating. A defect in the coating (yellow circle in (b) was located at the primary crack initiation site. An unusually large number of perpendicular fatigue cracks are shown in (c,d) which were taken on different tested LCF specimens with the **High Cr, Thin** coating. (Note the difference in magnification between (c) and (d).)

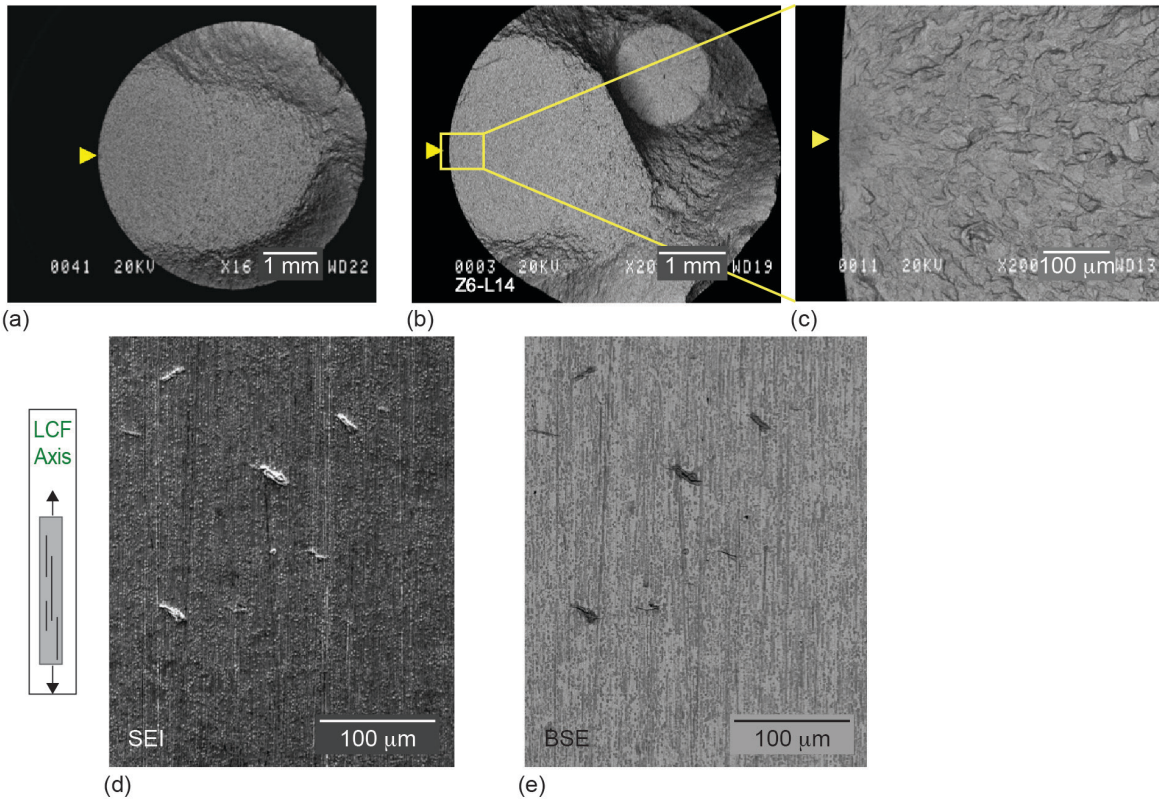
For comparison, the fracture surfaces of the three uncoated specimens were also examined, and the fracture surfaces of two specimens are shown in Figure 19(a) and (b). The primary crack initiation site for all three specimens was at the surface, similar to the coated specimens, although a second, smaller internally initiated site was observed for one of the specimens (circular area in Figure 19(b)). On the surface of the specimens, very small cracks were apparent which were easily identified by the growth of oxide protruding from the cracks (Figure 19(d) and (e)). Magnified views of the surface (Figure 20) shows that the oxide formation follows the pre-test texture of the longitudinal polishing lines aligned with the loading axis. This oxide formed during the LCF testing since it should be noted that the uncoated specimens received no low PO_2 diffusion anneal prior to testing. The hot exposure time at 760 °C for each of the uncoated specimens was 38.4 to 45.9 hr (Table 3). Because the oxide scale was relatively thin, EDS spectra of the overall surface at lower magnifications (e.g., Figure 19(d) and Figure 20(a)) generally reflected the overall alloy composition with somewhat enhanced peaks for Cr, Ti and Al (Figure 21(a)). EDS spectra of the somewhat thicker oxide at the cracks showed dominant peaks for Cr with enhanced peaks for Co or Ti (Figure 21(b)). It was unknown what role the fine, longitudinal polishing marks had, if any, in helping to initiate the fatigue cracks. The location of the primary failure crack initiation site for one of the specimens is indicated with the yellow arrowhead in Figure 22(a). The most distinguishable polishing marks in this image are indicated by red arrowheads and lie on either side, but not at the site of crack initiation suggesting the longitudinal polishing marks may play little or no role in the initiation of the primary failure crack. Magnified views of the surface show that small polishing marks are present across the surface and typically pass through most of the fatigue cracks. Hence, for the uncoated specimens, it is not expected that the fine polishing marks play any significant role in initiating the fatigue cracks.

Figure 19.—BSE (a-c) images of the fracture surface of two of the uncoated specimens after LCF testing. The primary crack initiation site is indicated with yellow markers. Note the second, smaller internal initiation site in (b). SE (d) and (e) BSE images of the surface of the specimen near the primary crack initiation site showing oxide growths which identify cracks.

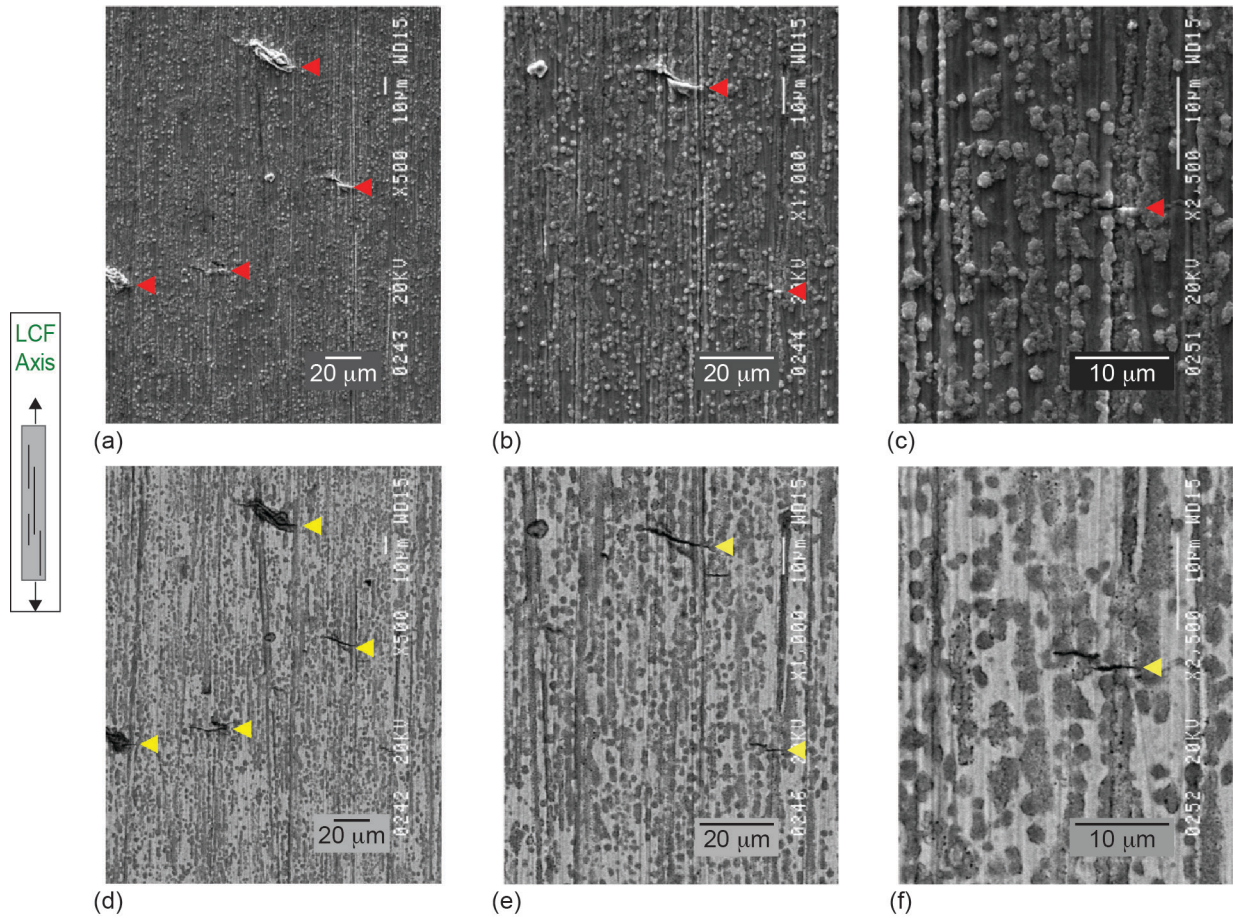
Figure 20.—SE (a-c) and BSE (d-f) images of the side of one the uncoated specimens after LCF testing. Oxide protrusions on the surface (red arrows in a,b) mark most of the cracks which are more apparent in the BSE images (yellow arrowheads in d-f). No oxide protrusion is evident for the smallest crack shown in (f). The oxide growths follow the texture of the pre-test longitudinal polishing lines (vertical in the figure).

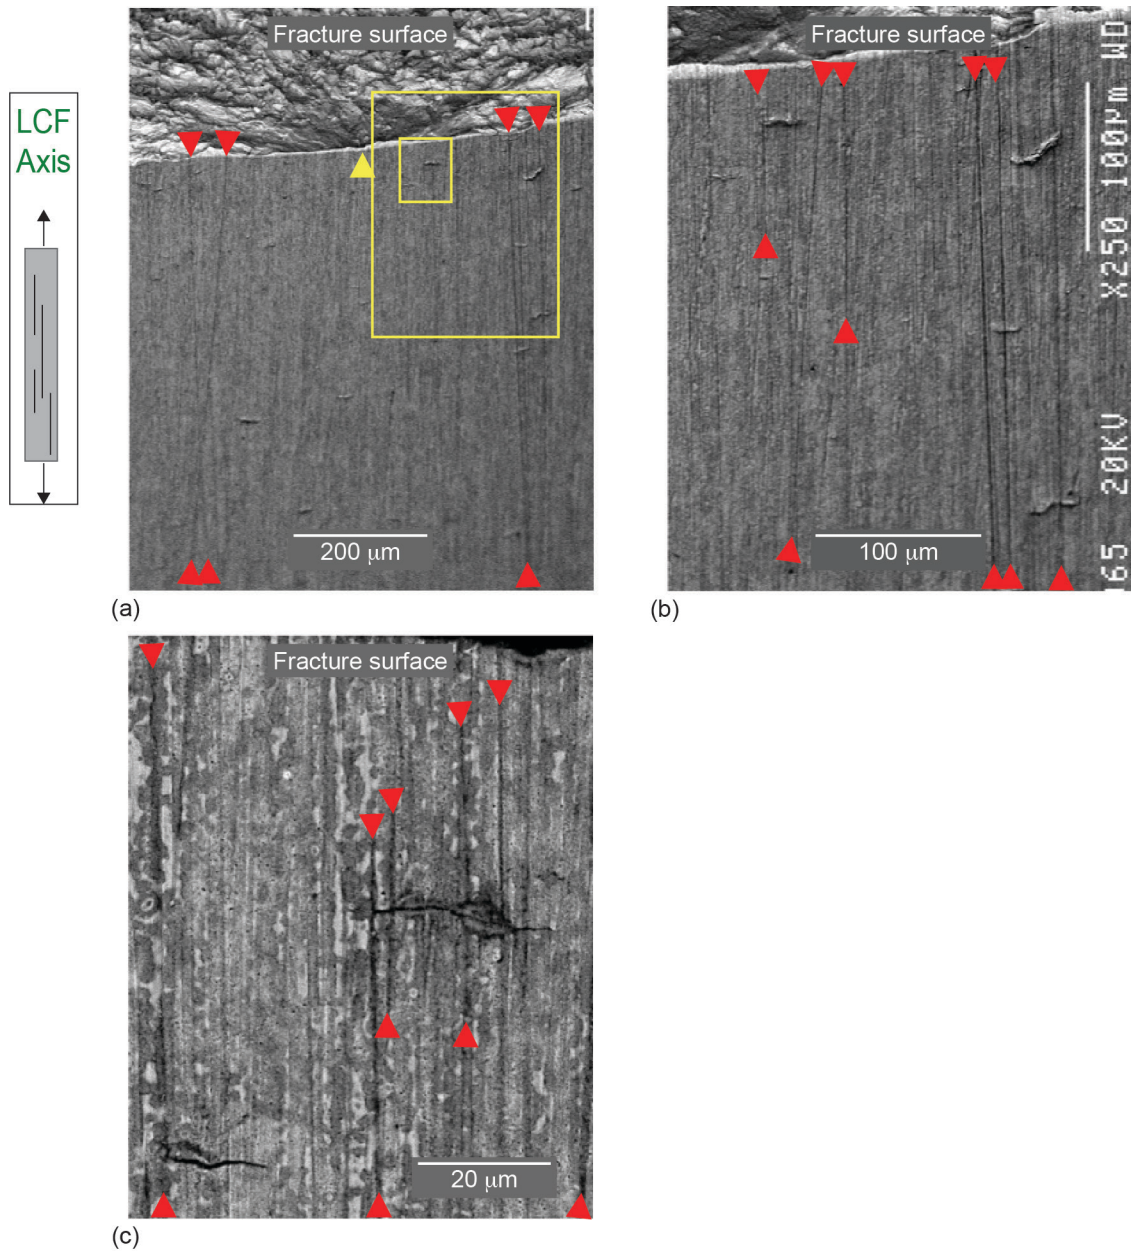
Figure 22.—BSE images (a) of the side of one the uncoated specimens showing the site of the primary crack initiation (yellow marker). The most obvious polishing marks are indicated by red arrowheads. (b,c) Magnified images of the highlighted boxes in (a).

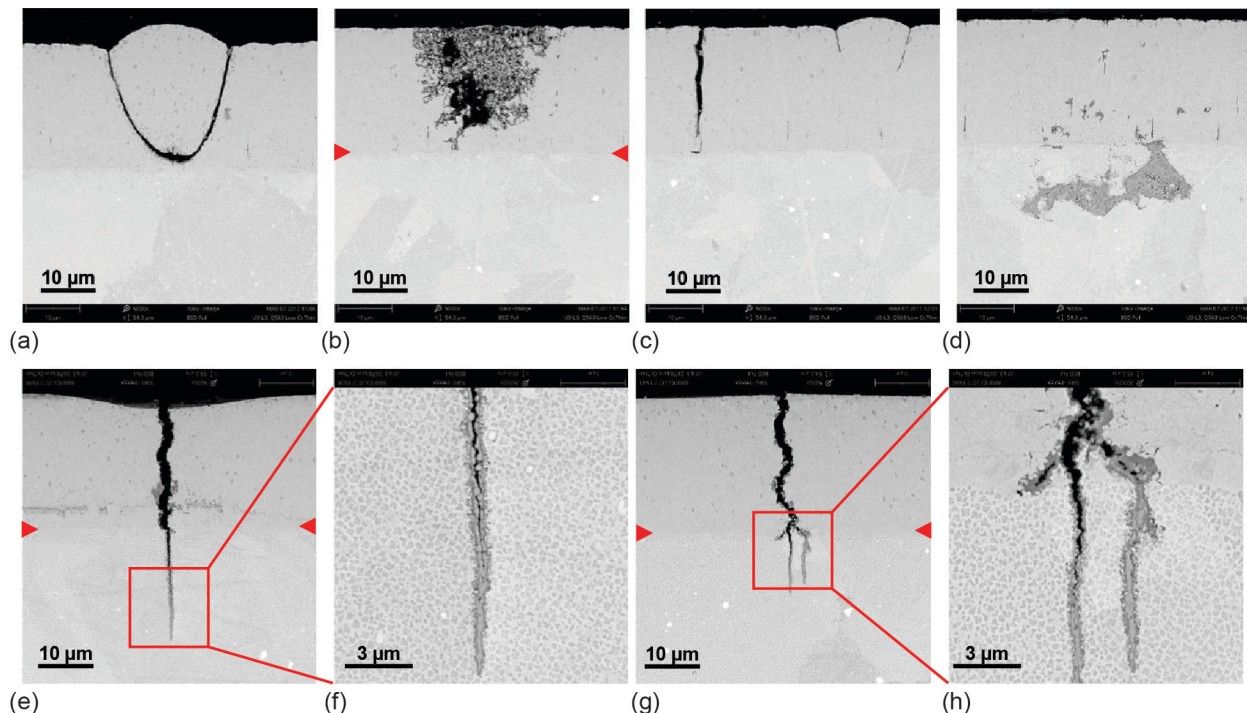
Images for the **Low Cr, Thin** coated specimen are shown in Figure 24. From the perpendicular views (a) to (d), (a) shows a cross-section of a typical spit, which penetrates nearly through the coating. Since it is unknown whether the spit was cut through the spit axis, it could have extended to the substrate. In (b), there is oxidation of an area representative of the shape of a spit. It could be that a loosely bonded spit was lost from this location and the exposed coating oxidized. The “crack” shown in (c) is one of the linear gaps running parallel to the rod axis which was present prior to LCF testing (see Figure 4). In (d), there is a large oxide formation in the substrate with scattered oxide particles in the coating. If the fatigue crack grows from the surface at an oblique angle to the rod axis, then the perpendicular cut can pass through the fatigue crack. If the crack was significantly oxidized, an image similar to that in Figure 24(d) could result. Hence, it is believed that the oxide in the substrate in Figure 24(d) is the result of the perpendicular cut, mount and polish plane passing through an oxidized fatigue crack. Images in Figure 24(e) to (h) are views taken along the parallel cut (Figure 23(a) and (b)) showing fatigue cracks passing through the coating and penetrating into the substrate. Extensive oxidation is present in the cracks, especially in the substrate. Since these cracks form during LCF testing, the oxidation occurs only during that period of LCF testing at 760 °C in air. It is apparent that oxidation has occurred at the crack tip. It should be noted that there was generally little oxidation in the coating due to the protective Cr₂O₃ formation. However, when oxygen penetrated down a crack into the substrate, significant oxidation of the substrate alloy was observed, typically filling the crack. Figure 24 also highlights the difference between the linear gaps (Figure 24(c)) and the fatigue cracks (Figure 24(e) and (g)). Since the linear gaps form during coating formation, oriented along the axis, they do not propagate during fatigue testing but remain only in the coating. Cr₂O₃, and likely some NiCr₂O₄ form on the walls of the gap, based on EDS indications.

Figure 24.—BSE images of the **Low Cr, Thin** coating after LCF testing showing (a-d) typical defects in the mount perpendicular to the loading axis, (a) spit penetrating most of the coating, (b) oxidized region (loss of a spit?), (c) linear gap defect parallel to the loading axis, and (d) large oxide formation in the substrate with some oxide particles in the coating. (e-h) BSE images from the mount parallel to the loading axis showing two fatigue cracks (e.g.) (perpendicular to the loading axis) penetrating through the coating and into the substrate. (f,h) show that the crack tip in the substrate is oxidized.

However, fatigue cracks, being oriented perpendicular to the loading axis, propagate through the coating and into the substrate, as shown in Figure 24(e) and (g). Figure 25 shows the cross-section of a polished spit also in the **Low Cr, Thin** coated specimen. The darker, high-Cr α phase is evident in the spit (Figure 25(b)). Surprisingly, EDS measurements of the FCC matrix phase in the spit and outside the spit show similar compositions. The Ni-Cr phase diagram shown previously (Figure 7(d)) indicates an equilibrium Cr concentration in the two-phase region of 34 wt%. It seems possible that the ejected spit was high in Cr resulting in the presence of the α -Cr particles, but the Cr concentration both inside and outside the spit (~28 wt%) appears lower than expected from the phase diagram but close to the measured Cr composition of the **Low Cr** coating (Table 2).
