LCF Life of As-Deposited and Annealed NiCr-Y Coatings for Oxidation and Hot Corrosion Protection of Disk Alloys

*James A. Nesbitt, Timothy P. Gabb, and Susan L. Draper
Glenn Research Center, Cleveland, Ohio*

Abstract

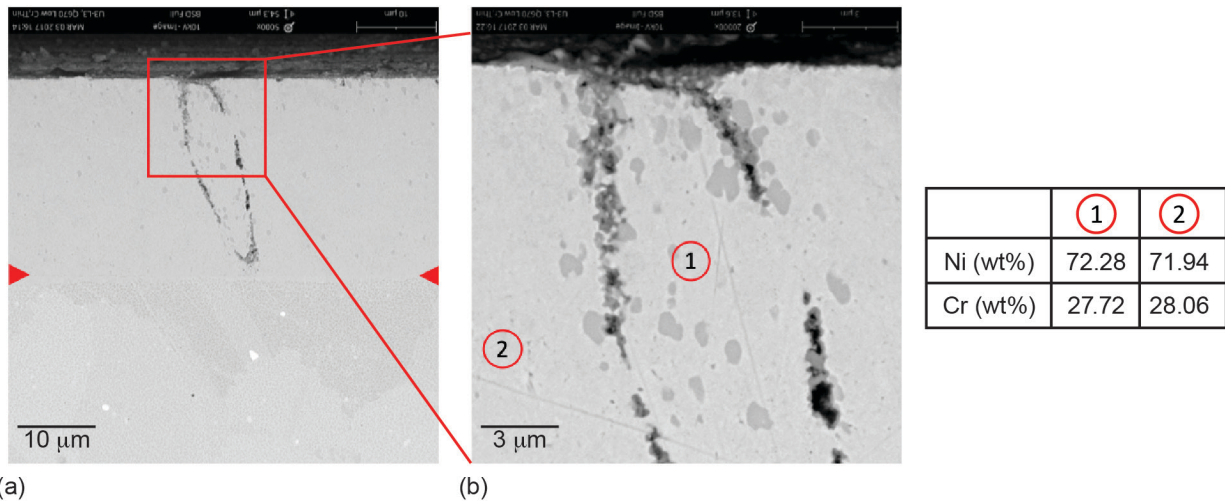
Figure 25.—BSE images of the **Low Cr, Thin** coating after LCF testing showing (a,b) a spit in the coating. The second phase high in Cr is evident in the magnified view in (b). EDS measurements (Table) show that the composition of the matrix phase in the spit is the same as that of the surrounding coating.

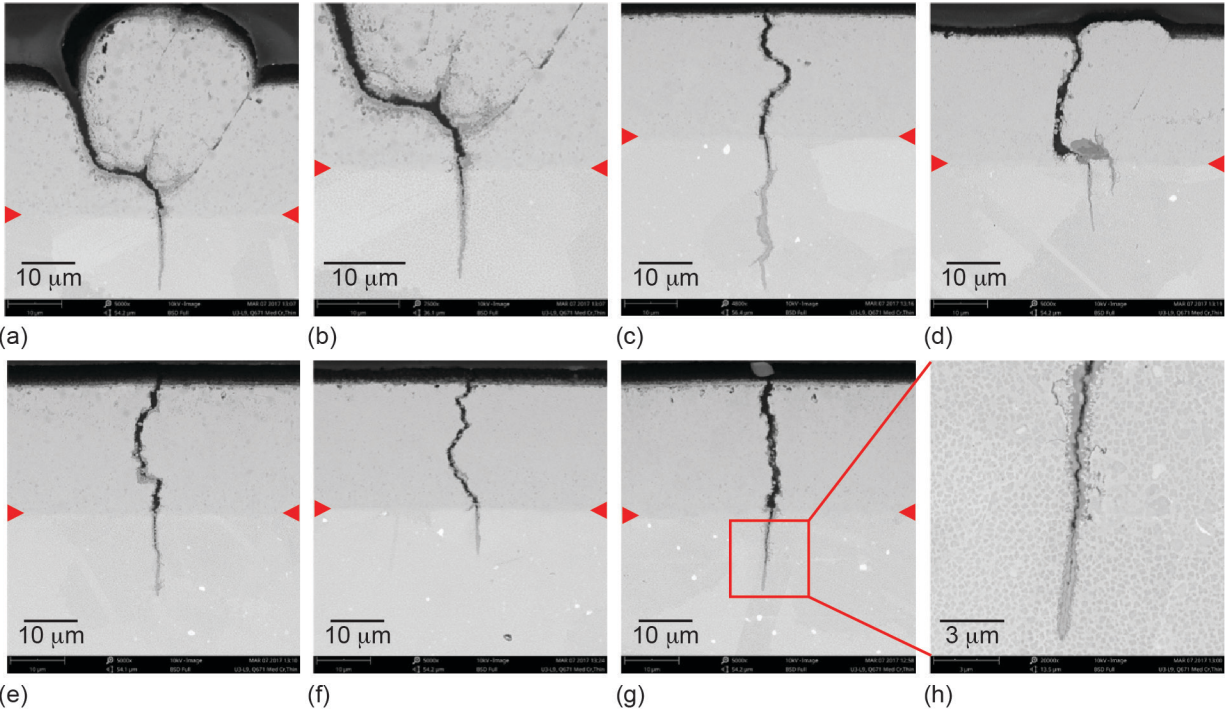
Each of the images shown in Figure 26 for the **Med Cr, Thin** coated specimen are views from the parallel mounted face and show areas of oxidation around spits (a,b,d) and fatigue cracks of various lengths. The fatigue cracks appear to follow a more tortuous path in the coating than for the **Low Cr, Thin** coating shown previously. Again, oxidation at the crack tip is evident. Images of the **High Cr, Thin** coating from the perpendicular mount are shown in Figure 27. Oxidation around and below the spit in Figure 27(a) is likely the polishing plane passing through one of the wide fatigue cracks previously shown for this coating (Figure 18). An oxidized linear gap is shown in Figure 27(b) and (c). The large crack openings and high frequency of fatigue cracks observed on the surface of the specimen after LCF testing are apparent in the images of the parallel mounted face (Figure 28). Many of the wide cracks have penetrated into the substrate and are oxidized Figure 28(b) to (d). Given the width of the cracks penetrating into the substrate, it is somewhat surprising that this coating (**High Cr, Thin**) showed the longest LCF life with 2 to 3 times the number of cycles than for the other coated specimens.

Figure 26.—BSE images taken along the parallel face of the *Med Cr, Thin* coating after LCF testing showing (a,b) oxidation around a spit and down a crack penetrating into the substrate, (c-h) perpendicular fatigue cracks penetrating through the coating and into the substrate. Oxidation of the crack in the substrate is obvious.

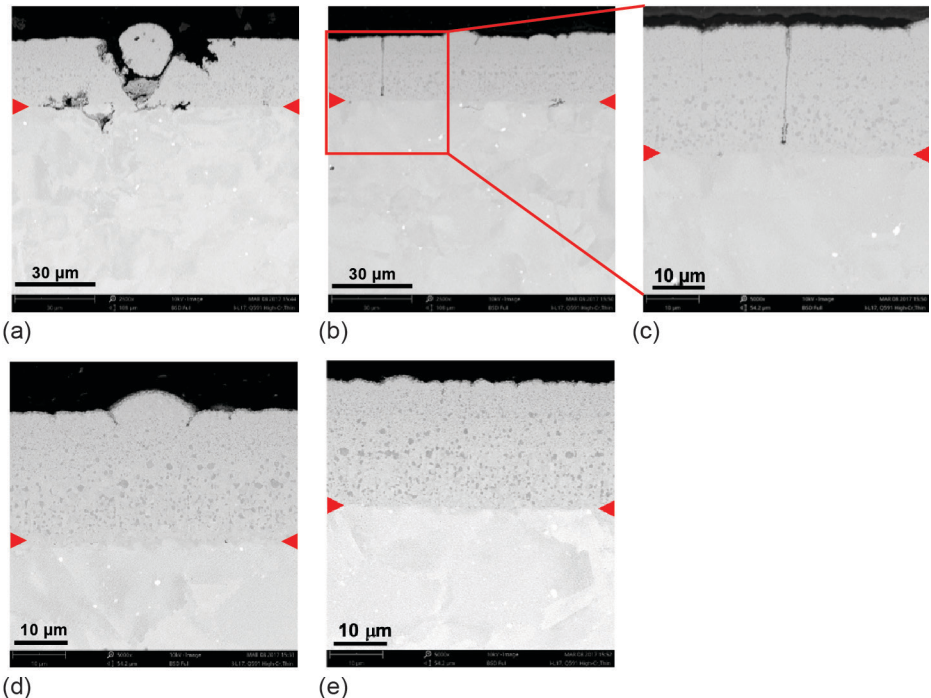
Figure 27.—BSE images of the *High Cr, Thin* coating after LCF testing (perpendicular mount) showing (a) spit with oxidation (b) linear gap defect (c) higher magnification of the linear gap defect in (b), (d) spit defect, and (e) higher magnification image of the coating showing the α -Cr particles. The red arrowheads indicate the coating/substrate interface.

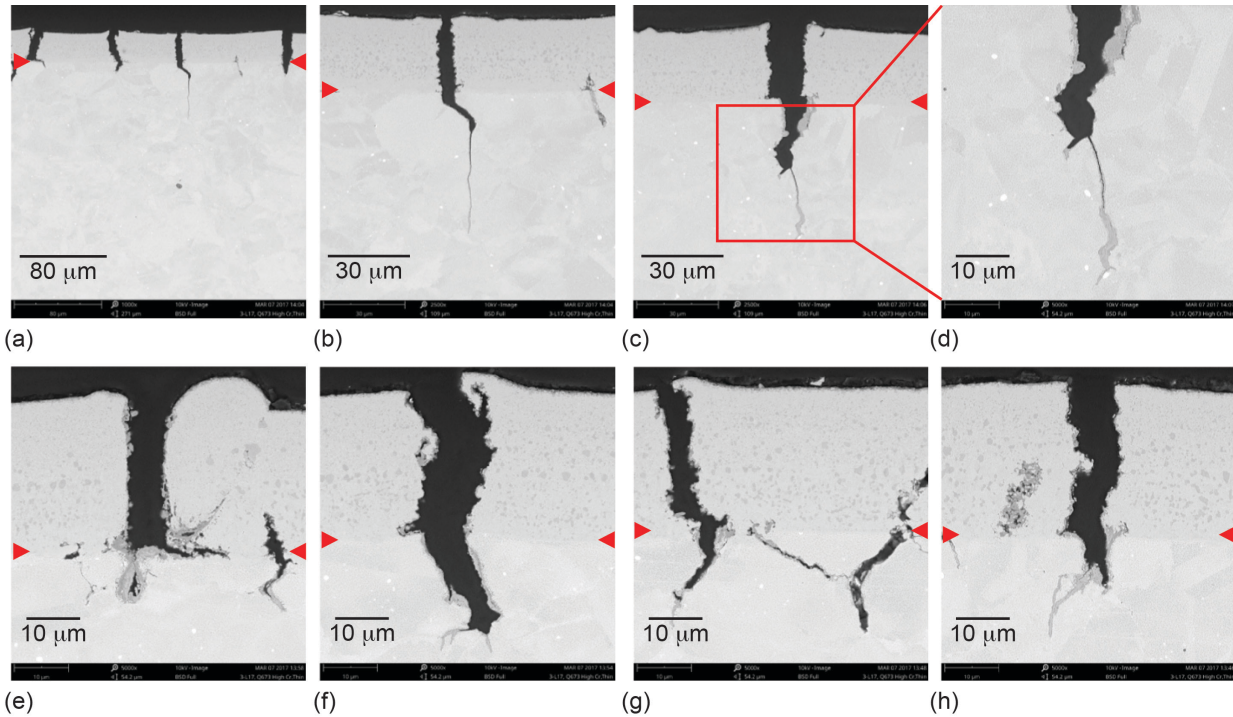
Figure 28.—BSE images of the **High Cr, Thin** coating after LCF testing taken in the direction parallel to the loading axis showing (a) the close spacing of the fatigue cracks. (b-h) Various views of the fatigue cracks showing the wide gap. Oxidation of the cracks in the substrate is evident. The red arrowheads indicate the coating/substrate interface.

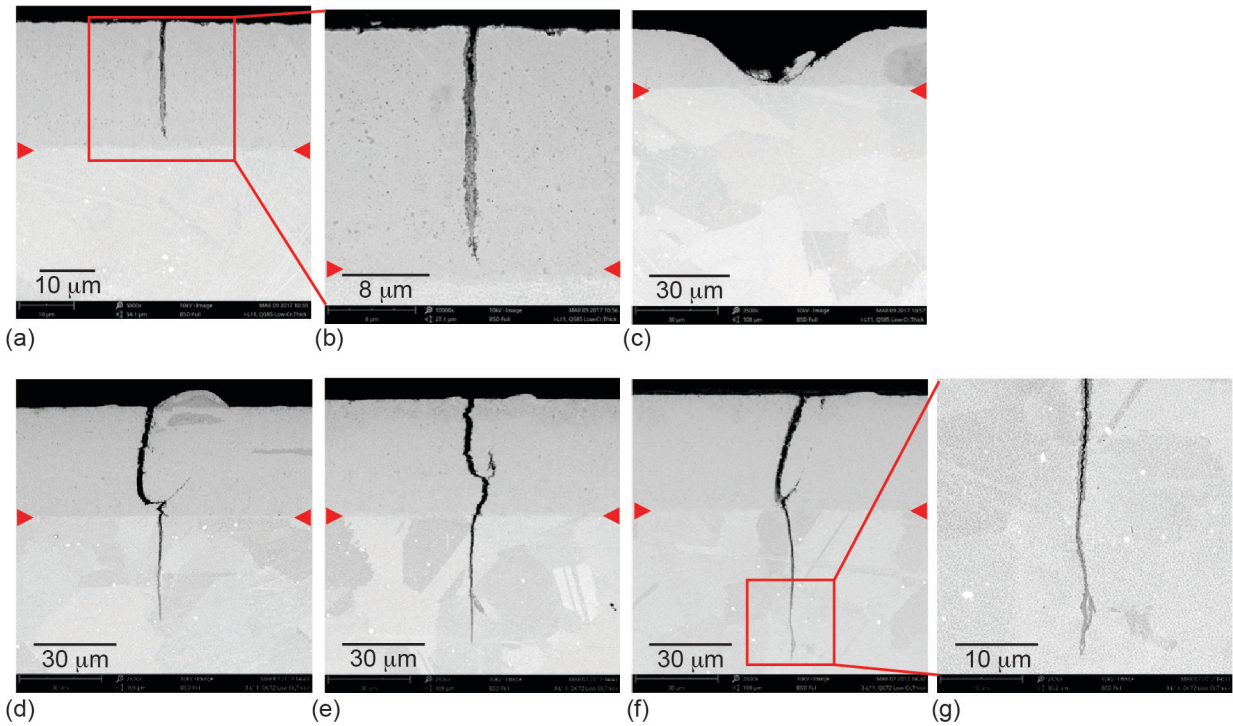
Images from the perpendicular cut of the **Low Cr, Thick** coating are shown in Figure 29(a) to (c). Oxidation of one of the linear gaps is shown in Figure 29(a) and (b). What appears to be a deep trough in the coating, likely caused by the loss of a spit, is shown in Figure 29(c). In views along the parallel face, typical fatigue cracks are shown in Figure 29(d) to (g). It was not clear whether these cracks exhibited any more or less a tortuous path than those shown previously. The large linear gap defects parallel to the loading axis in the **Med Cr, Thick** coating are seen in the views of the perpendicular mount in Figure 30(a) to (c). The poor bond between the coating and substrate is evident by the gap between the

Figure 29.—BSE images of the **Low Cr, Thick** coating after LCF testing showing (a,b) a linear gap defect in the coating filled with oxidation (perpendicular mount), (c-g) perpendicular fatigue cracks penetrating into the substrate (parallel mount).

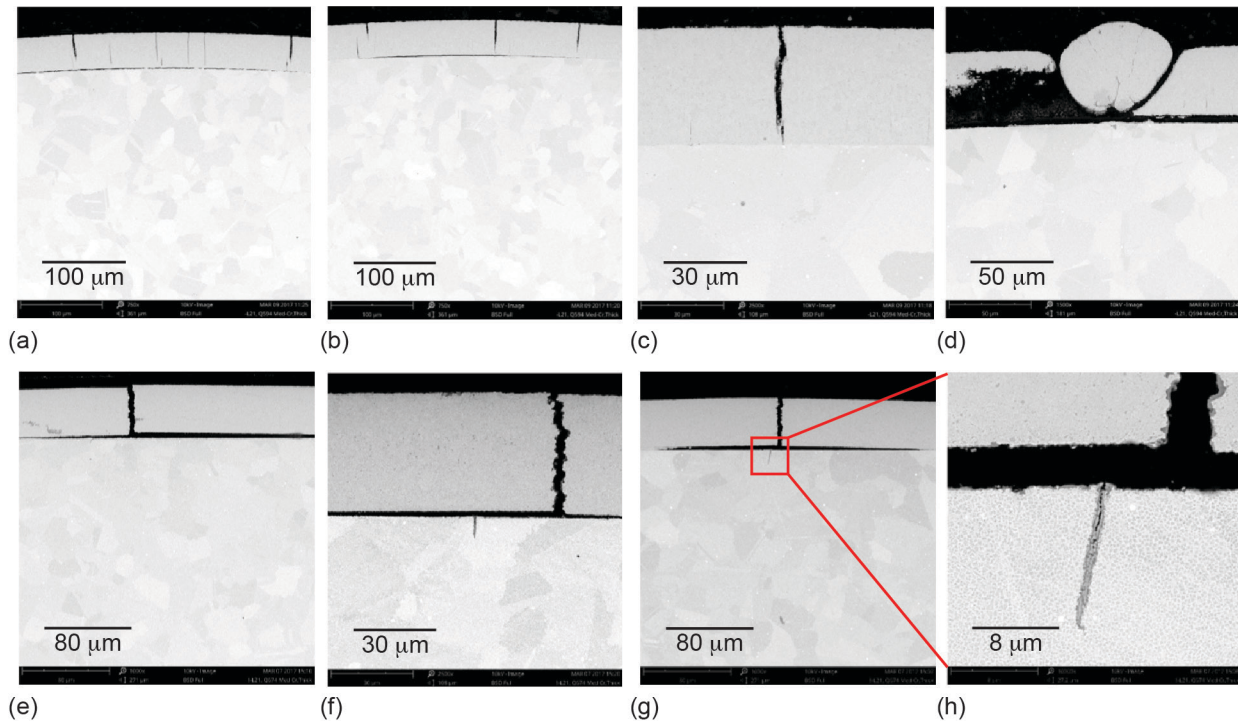
Figure 30.—BSE images of the **Med Cr, Thick** coating after LCF testing (a, b) showing a poor bond of the coating to the substrate, (c) linear gap defects parallel with the loading axis, (d) a large spit in the perpendicular mount. (e-h) Images from the parallel mount showing fatigue cracks oriented perpendicular to the loading axis. Debonding of the coating is also evident.

coating and substrate. A linear gap and spit are clearly seen in Figure 30(c) and (d). In views along the parallel mount Figure 30(e) to (h), fatigue cracks are evident but it appears some of the cracks have been blunted by the poor bond of the coating. Some smaller fatigue cracks, not aligned with the cracks in the coating, can be seen penetrating into the substrate. Lastly, similar defects to those previously observed were also apparent in the polished sections of the **Med Cr+ZrO₂, Thin** coating. Figure 31(a) shows a linear gap with the outer ZrO₂ layer, Figure 31(b) and (c) shows a spit and a highly oxidized region which appears associated with a spit. Oxidized fatigue cracks, similar to those shown above, are evident in the parallel views in Figure 31(d) to (f). There were several crack-like defects that appear totally within the coating, as shown in Figure 31(g). Most of these defects appeared to be highly angled with respect to the surface.

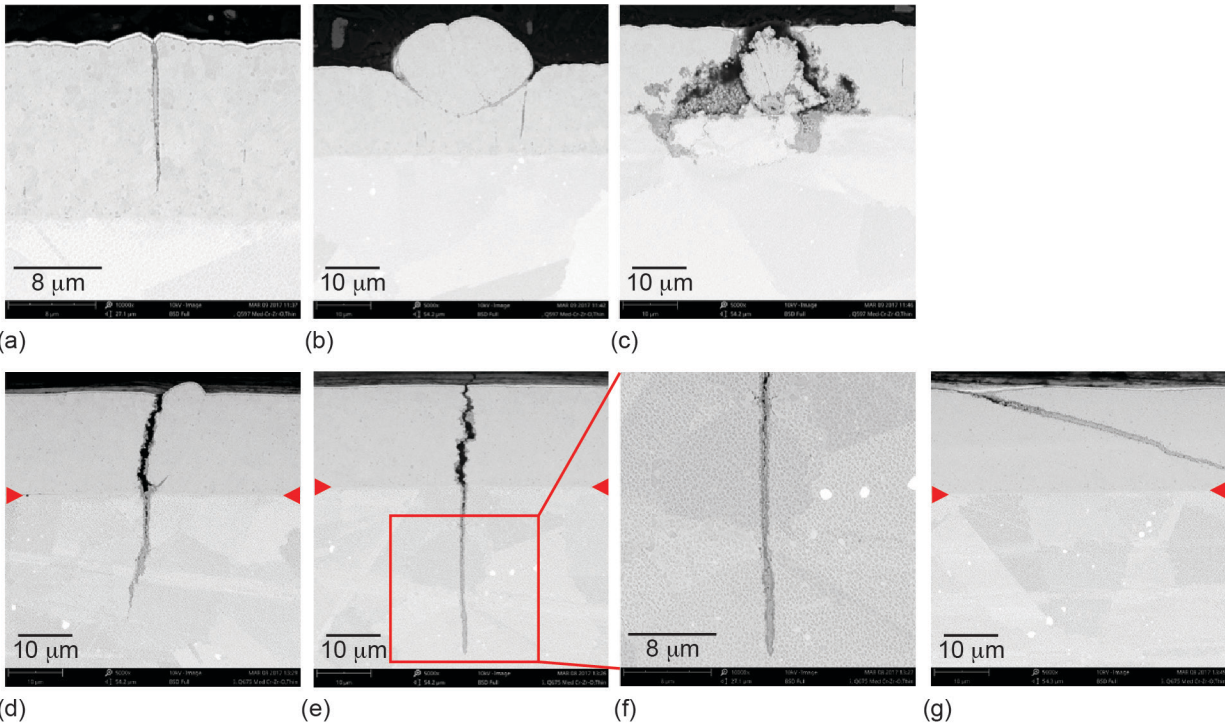
Figure 31.—BSE images of the *Med Cr Zr-O, Thin* coating after LCF testing showing (a-c) oxidized linear gap defect, spit and an oxidized defect with oxide penetration into the substrate (perpendicular mount). (d-f) Typical perpendicular fatigue cracks and (g) a linear defect in the coating seen in the parallel mounts.

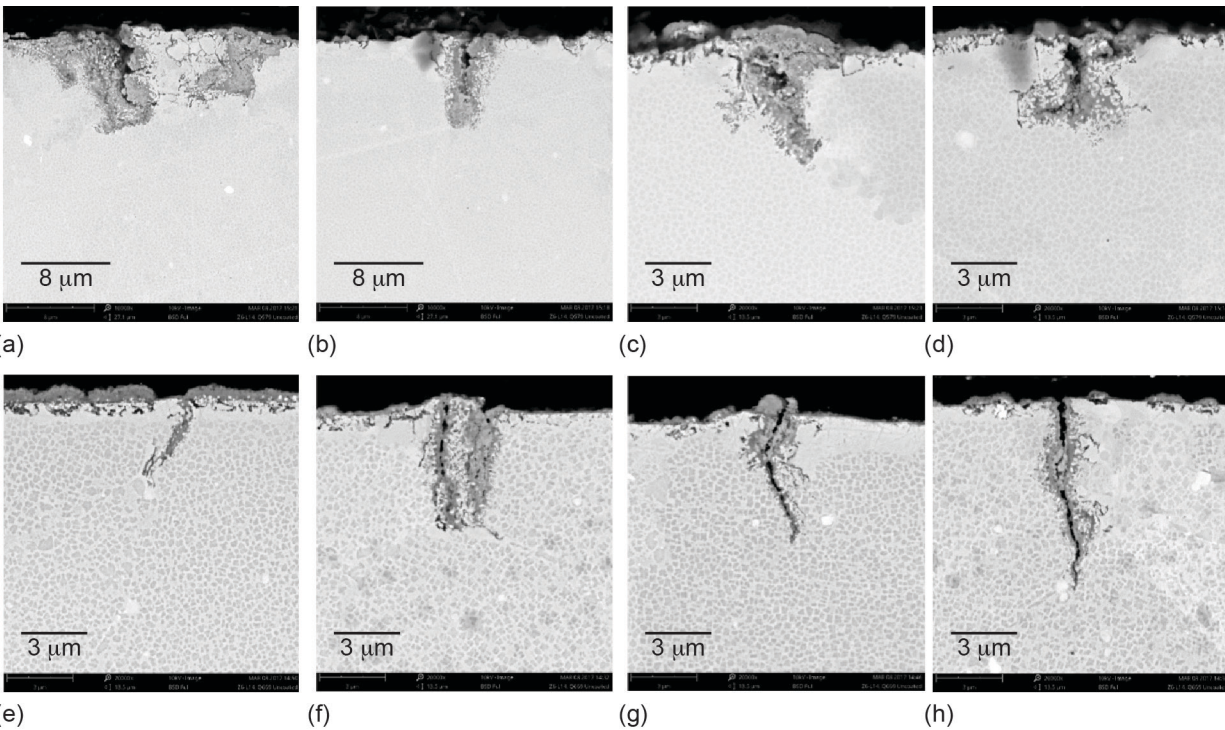
Representative images of the uncoated specimens after LCF testing are shown in Figure 32. In the views of the perpendicular cut Figure 32(a) to (d), small oxide-filled cracks or defects are obvious. The origin of these features is not clear since the depths of the polishing marks are much less than the depths of these defects. They may be the result of the polishing plane passing through a fatigue crack, or they may be related to oxidation of a substrate feature (e.g., carbide). In the views parallel to the specimen axis (Figure 32(e) to (h)), very small fatigue cracks, approximately 10 μm deep, are apparent. As indicated earlier by the views of the specimen surface (Figure 19, Figure 20, and Figure 22), perpendicular fatigue cracks on the uncoated specimens were much less frequent than for the coated specimens.

Figure 32.—BSE images of one of the uncoated LCF specimens after LCF testing, (a-d) perpendicular cut showing oxide filled axial cracks, and (e-h) parallel cut showing oxide filled fatigue cracks running perpendicular to the loading axis.
