Hypervelocity Impact of Composite Overwrap Pressure Vessels

There is a limited amount of hypervelocity impact (HVI) data on pressurized composite overwrapped pressure vessels (COPV). In recent years, NASA has performed HVI tests to characterize impact conditions resulting in either leak or burst of the COPVs representative of spacecraft hardware. This paper reports on the results of 40 tests that have been conducted on several types of COPV configurations, pressurized by inert gas to near the vessels rated maximum expected operating pressure (MEOP). These tests were used to better understand COPV response under HVI conditions and develop ballistic limit equations (BLE) related to these tests.

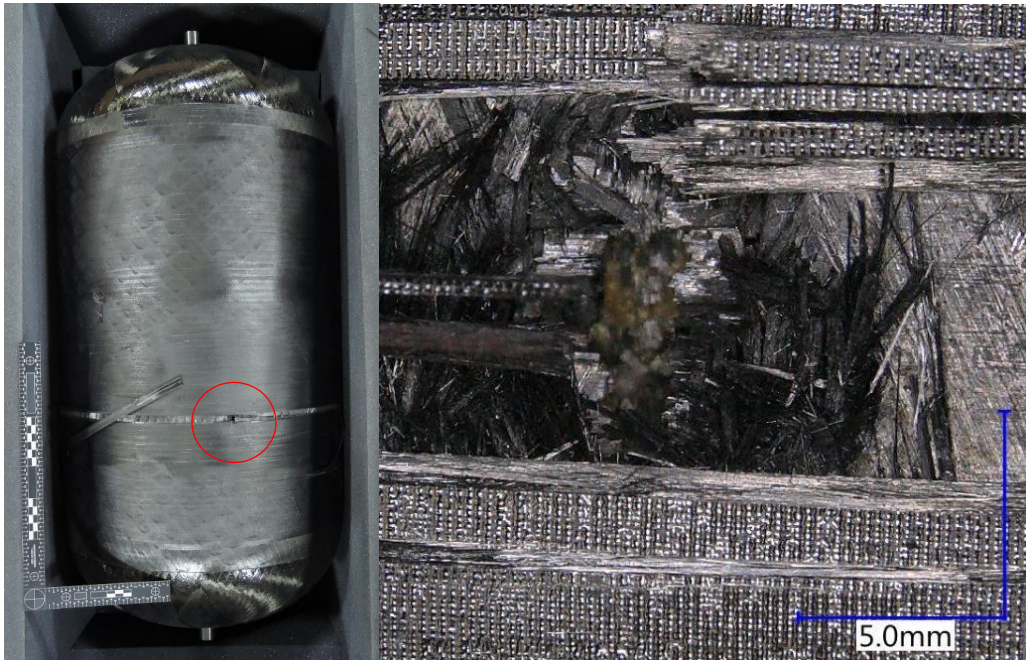
Figures 7 – 8 show the results of pressurized COPV (Type 3 tank) test HITF18435. This test illustrates a no leak.

Figure 7 Overall view of entry damage to front of sample (left) and close-up view of entry damage (right / damage located within red circle in adjacent image).

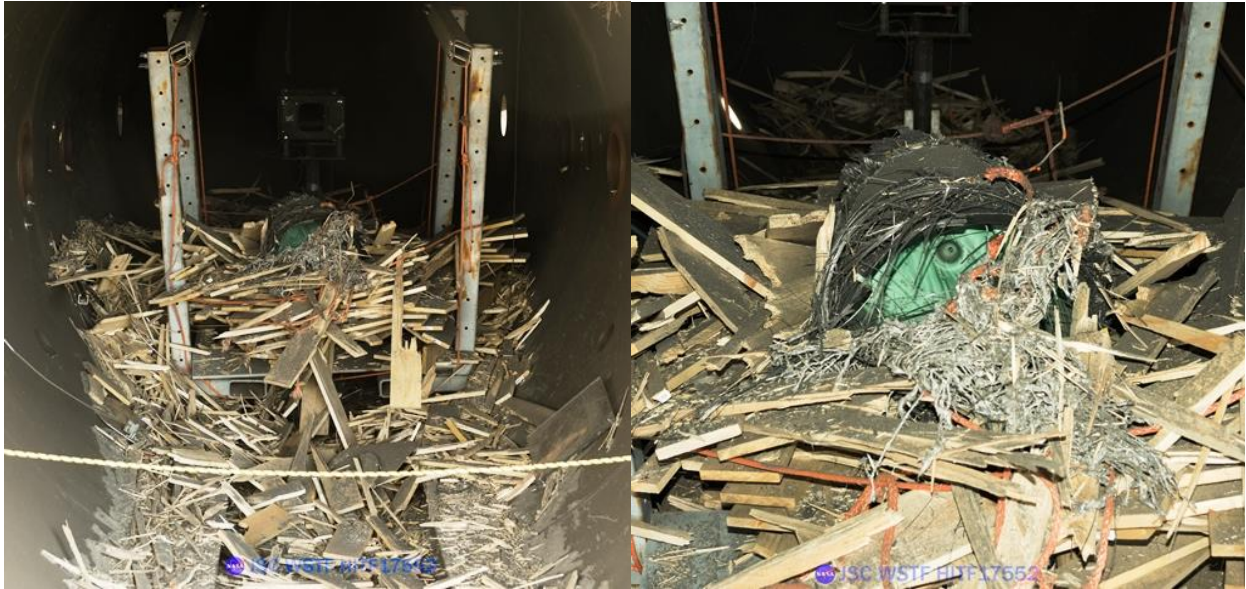
Figures 12 – 15 show the results of pressurized COPV (Type 2 tank) test HITF17552. This test illustrates how destructive a ruptured COPV can be.

Figure 13 Overall rear view of damage adjacent to test fixture within target tank (left) and close-up view of damage present within the test fixture as a result of HITF17552 (right).

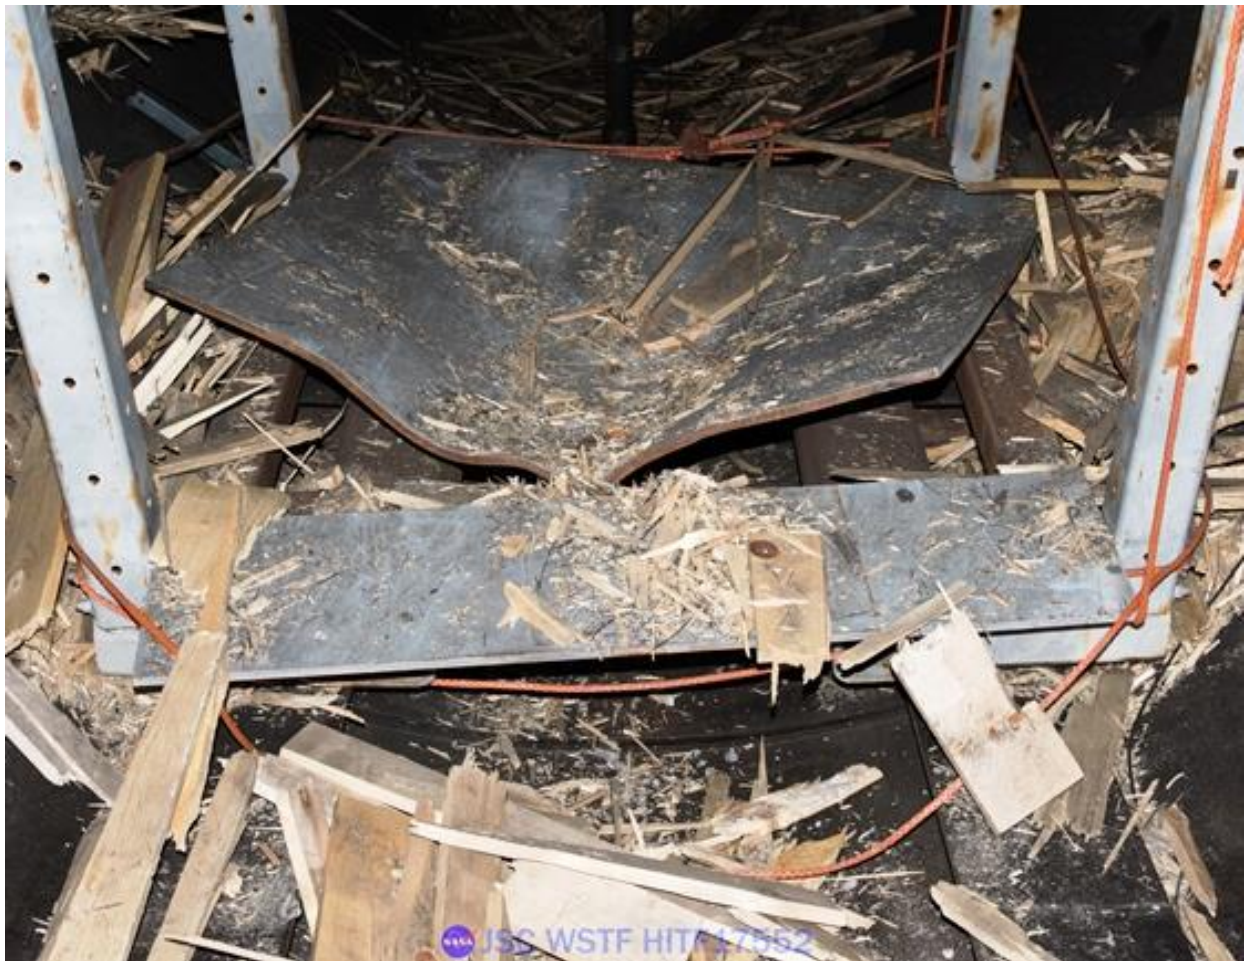
Figure 14 Close-up rear view of damage to test fixture with 16mm thick steel base plate visible HITF17552.
