# Observations of MMOD Impact Damage to the ISS

## ABSTRACT

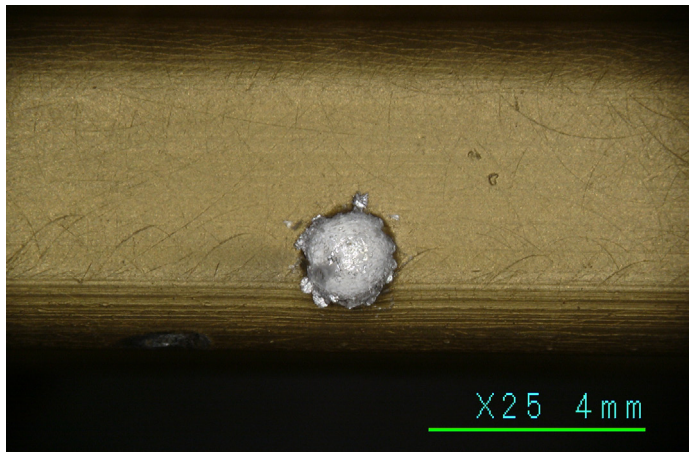
Fig. 1. MMOD impact crater on ISS handrail

Figure 1 illustrates one of the many MMOD craters observed on EVA handrails. Because the handrails are aluminum, the sharp edges that occur at the lips of the MMOD craters have caused cuts in the outer layers of EVA gloves and fingertips [6]. One cut glove example resulted in an early end to an EVA during the STS-118 mission (Fig. 11). Consequently, the EVA gloves were reinforced to reduce the risk of cuts from sharp edges of MMOD craters. In addition, a clamp was designed and used to isolate craters on handrails in highly traveled areas of ISS, such as near the airlock egress/ingress hatch. Figure 12 illustrates another MMOD crater found on a D-handle EVA tool that measured nearly 5 mm across. This tool had been stored on the ISS exterior, and was brought inside and repaired by the crew prior to use in March 2008, using adhesive tape wrapped around the MMOD damage.

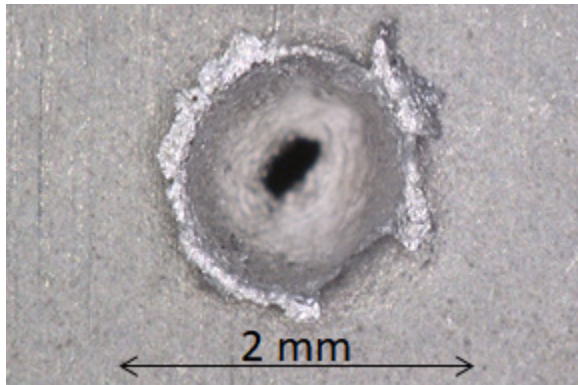
Fig. 5. Impact crater in aluminum MPLM shield

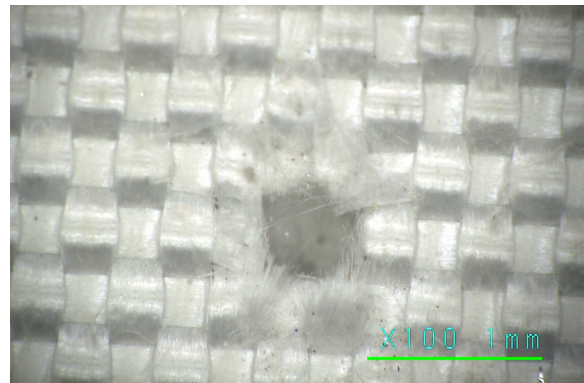
Fig. 6. Impact feature in betacloth

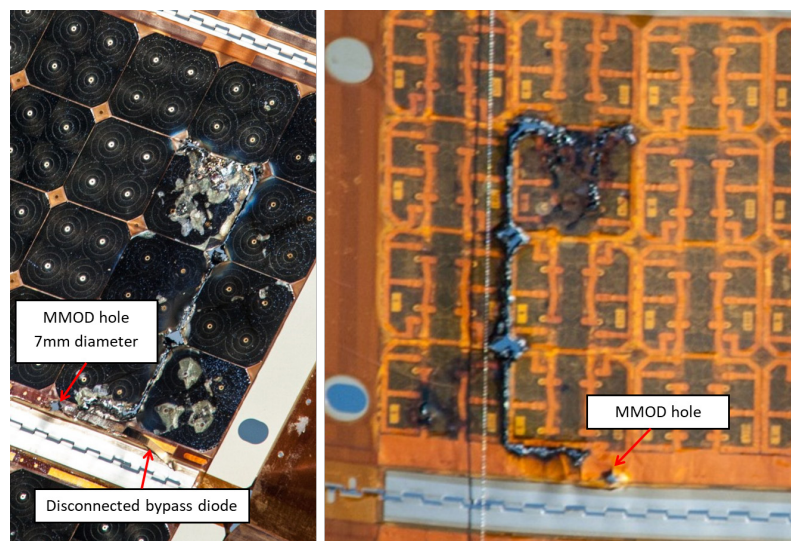
There are eight US solar array wings (SAWs) on ISS, each of which contain two solar array blankets and a supporting mast measuring 35 m long and 12 m wide. Many hundreds of MMOD craters and penetrations are apparent in high-resolution photos of the arrays. Figure 7 shows one of the largest damages observed on an ISS solar array due to MMOD impact, although most of the damage occurred from heating after MMOD impact on the solar array. A 7 mm diameter MMOD perforation resulted in a severed by-pass diode, which is a circuit device that protects a solar array string in normal operation. Because the by-pass diode was broken, a buildup of current occurred within the string and caused severe over-heating of the solar array in a local area, resulting in a nearly 40 cm long burn-through along the edges of 3 cells. The result of this excess heating was failure of an entire string of solar cells containing 400 cells. Although this is not a major loss considering there are over 250,000 cells in total for all SAWs, Fig. 8 illustrates other similar damage to the solar arrays. The steady degradation of power generated from the ISS solar arrays over time, due to MMOD and other causes, has necessitated planning to augment the ISS solar arrays in the future with additional solar array panel overlays.

Fig. 7. Damage observed to ISS solar array 3A, panel 58 (cell side on left, Kapton backside on right). Note by-pass diode is disconnected due to MMOD impact.

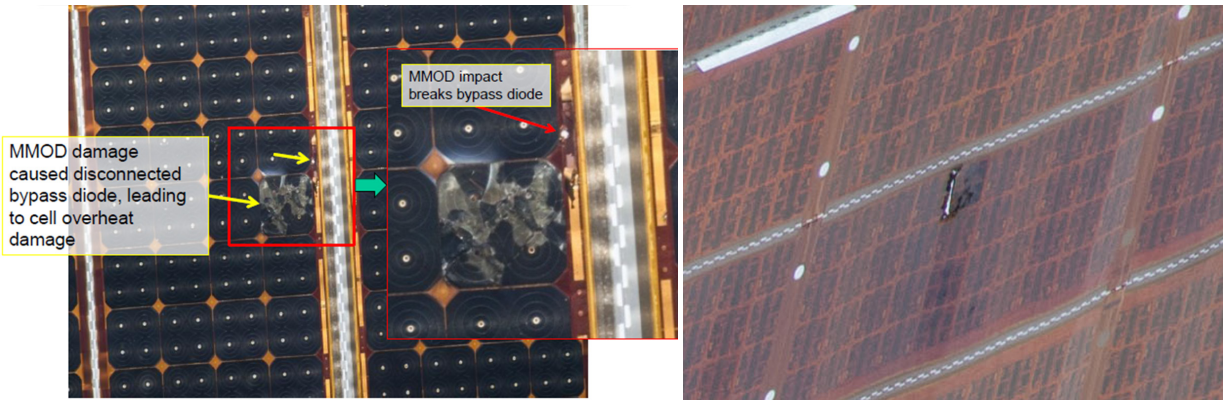
Fig. 8. Additional examples of ISS solar array overheating damage. On left, an MMOD strike caused a disconnected bypass diode resulting in loss of a string on solar array 2A panel 66. At right, an observed burn-through in solar array 3A panel 42; although no obvious MMOD damage is apparent, a failed bypass diode is a possibility.

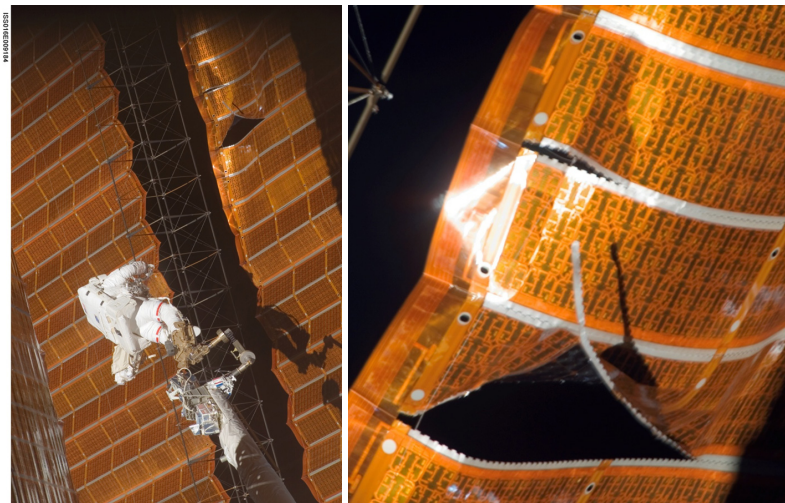
An even larger amount of solar array damage occurred from a small impact on a solar array guidewire. Figure 9 shows two large tears that developed in the 4B SAW when the solar array was being redeployed after being moved to its final location during STS-120 due to a snagged guidewire. EVA crew removed the snagged guidewire and installed “cuff-link” reinforcements to stabilize the array. The guidewire was returned to the ground where it was examined and clear evidence of MMOD impact was observed by the melted material found at the location of the snag (Fig. 10).

Fig. 9. During STS-120, two solar array wings were removed from the ISS Z1 truss and relocated to the P6 location. The 4B solar array wing tore in two places during redeployment due to a guidewire, which snagged in a grommet.

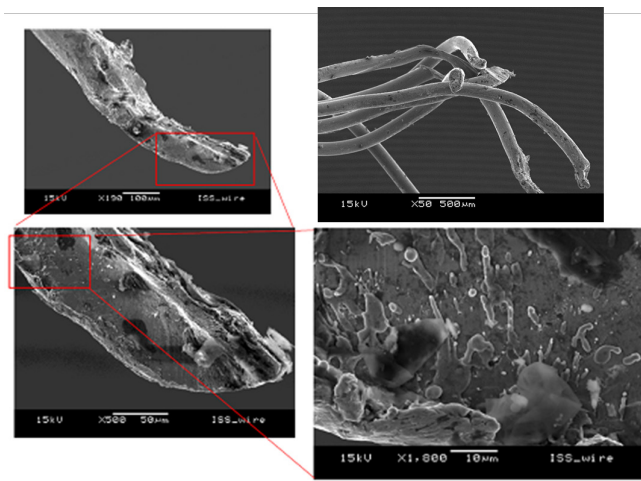
Fig. 10. The guidewire contains 21 twisted steel wires, seven (7) of which were severed. The lower images illustrate melted material at the ends of several of the severed wires, clearly indicating hypervelocity impact damage.

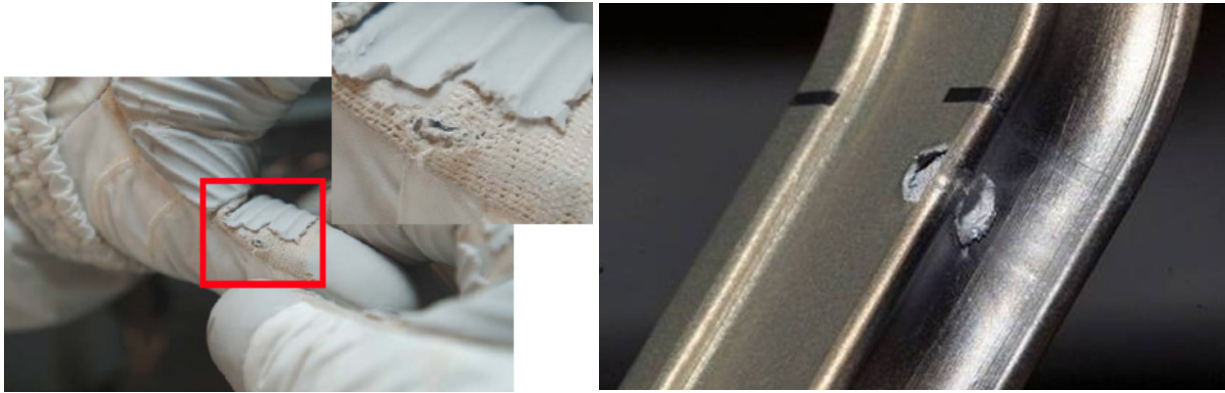
Fig. 11. Cut in outer layer of EVA glove (STS-118). Fig. 12. Crater and detached spall on EVA D-handle tool.

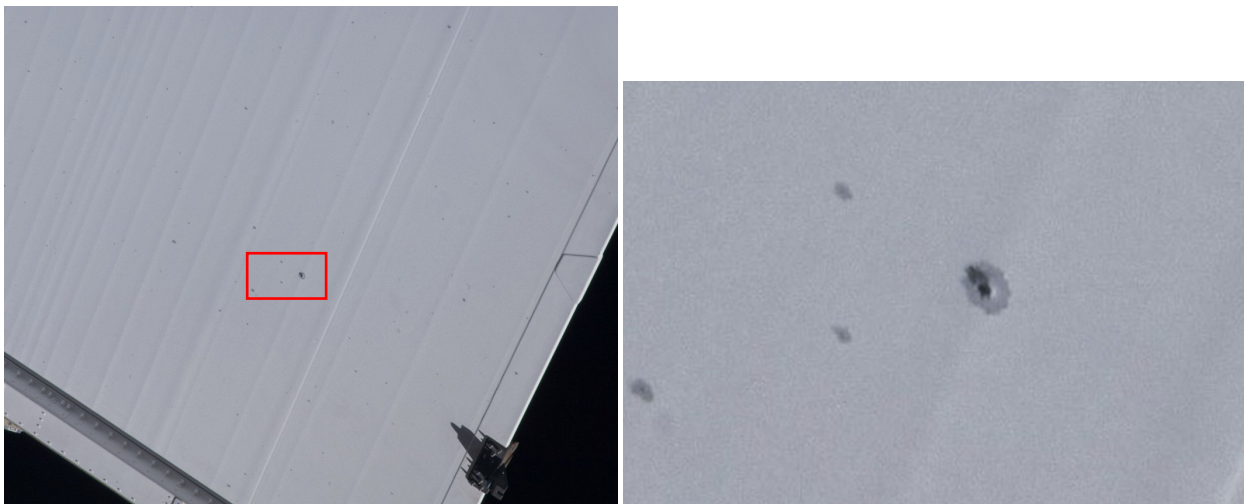
Figure 13 shows one of the ISS radiator panels, with several MMOD impacts observed on the radiator surface. The ISS radiator coolant flow-channels had been hardened before flight by locating the lines in the interior of the radiator panel [7] (not adjacent to the outer face sheet, which was common practice prior to ISS). So far, MMOD impacts have not been confirmed as the cause of any of the coolant leaks that have occurred to the thermal control system to-date. The largest damage observed on ISS radiators from MMOD impact (Fig. 14) measures 13cm by 10cm, with coolant flow channels visible, but unbroken.

Fig. 13. Surface of one ISS radiator panel photographed during increment 36 (dark spots are typical MMOD damages). Red outline area expanded on right.

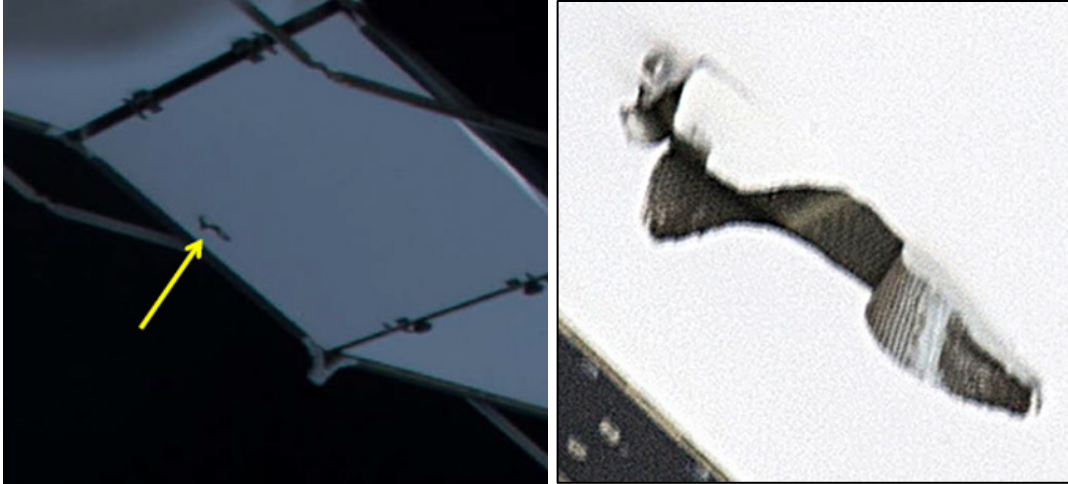
Fig.14. MMOD damage located on port photovoltaic radiator panel (exit damage).

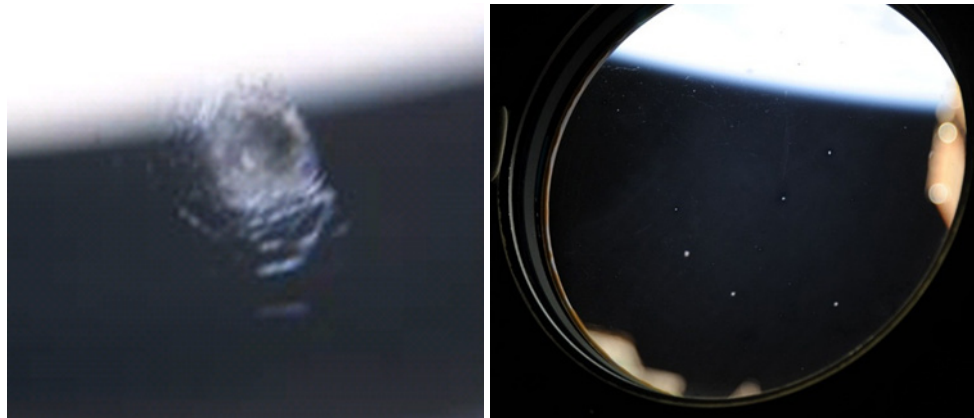
The current ISS configuration (late 2019) has 36 windows on nine different modules, usually consisting of multiple glass panes with the outer pane typically of silica glass. External shutters often (not always) protect the glass from MMOD damage [8]. MMOD strikes have occurred to the ISS windows leaving a crater on the exterior surface of the outer pane. None of these impacts have left more than a crater on the outer pane. Figure 15 shows a 3 mm to 5 mm diameter impact crater that occurred to window #7 on the Russian Service Module *Zvezda*.

Fig. 15. ISS window port on right. Service Module window #7 damage on left.

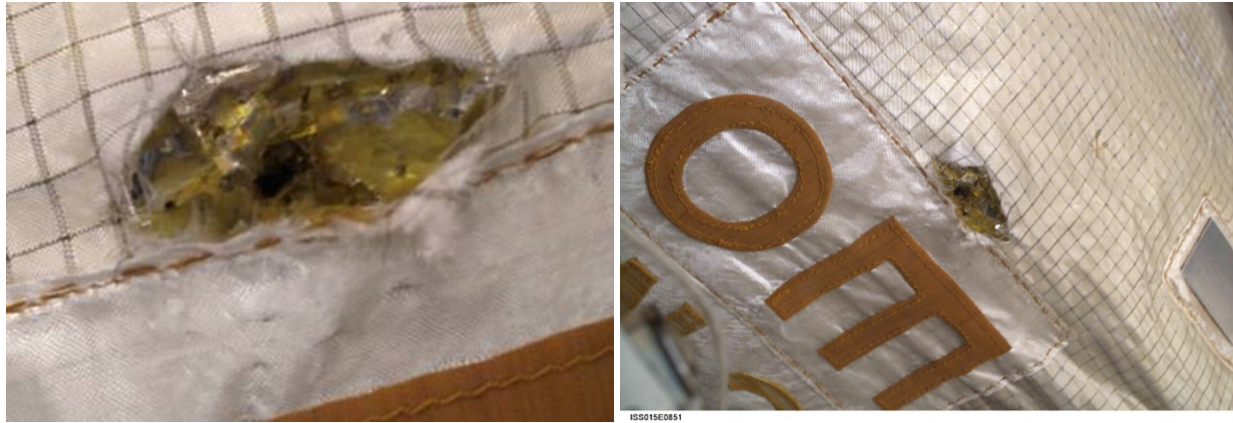
During Russian EVA-19 (7 June 2007), the crew reported MMOD damage to FGB thermal blanket over the forward compressor measuring 30mm x 60mm in the outer fabric cover of an multi-layer insulation (MLI) thermal blanket, and a 5mm x 9mm size hole in the underlying layers of the MLI thermal blanket (Fig. 16). Based on hypervelocity impact tests, the damage appears to be from an oblique MMOD impact of a millimeter or more in diameter.

Fig. 16. FGB compressor thermal blanket MMOD damage.
