**Genesis Mission Bulk Metallic Glass Solar Wind Collector: Characterization of Return Samples Available for Re-Allocation.** C. P. Gonzalez<sup>1</sup>, K. K. Allums<sup>2</sup>, J. H. Allton<sup>3</sup>, R. Harrington<sup>1</sup>, L. Le<sup>1</sup>, and K. Thomas-Keprta<sup>1</sup>, <sup>1</sup>Jacobs, NASA Johnson Space Center, Houston, TX 77058, <sup>2</sup>HX5- Jacobs JETS Contract, NASA Johnson Space Center, Houston, TX 77058, <sup>3</sup>NASA Johnson Space Center, Houston, TX 77058

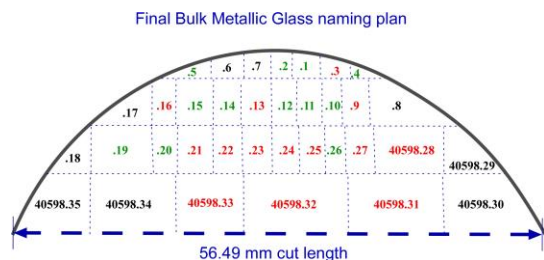
Fig. 2. Image shows the subdivision made to the Genesis BMG. Only the last two digits of samples 40598.1 through 40598.27 appear in the image. Sample numbers in green have been etched, red have been consumed, and black are available for re-allocation. The undivided piece is labeled 40598.0 (parent sample).

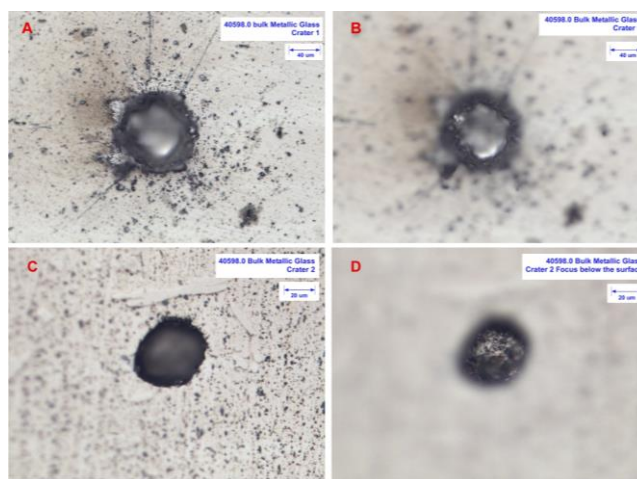
**Recent work:** The BMG parent piece was imaged using optical through-focus imaging to produce several two-dimensional images of a three-dimensional object. This imaging method was used to observe possible crater-like features shown in Figures 3 & 4. For example, in Fig. 3 two possible craters, designated as 1 & 2, are shown. Both in focus images, or those taken at the uppermost surface of the feature, and images taken at or near a possible crater floor, are shown. Possible crater 1 is ~90-100  $\mu\text{m}$  in diameter ( $\varnothing$ ). Possible crater 2 is ~40-50  $\mu\text{m}$   $\varnothing$ .

Fig. 3. A) Possible crater 1 with the optical image focused at the uppermost surface. B) Possible crater 1 optical image focused below the surface, near a purported crater floor. C) Possible crater 2 optical image focused at the uppermost surface. D) Possible crater 2 image focused below the surface, near a purported crater floor.

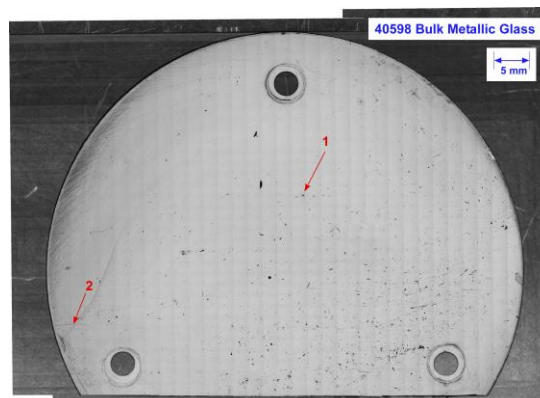
Fig. 4. Optical image taken of BMG 40598.0. Red arrows point to possible craters 1 & 2.

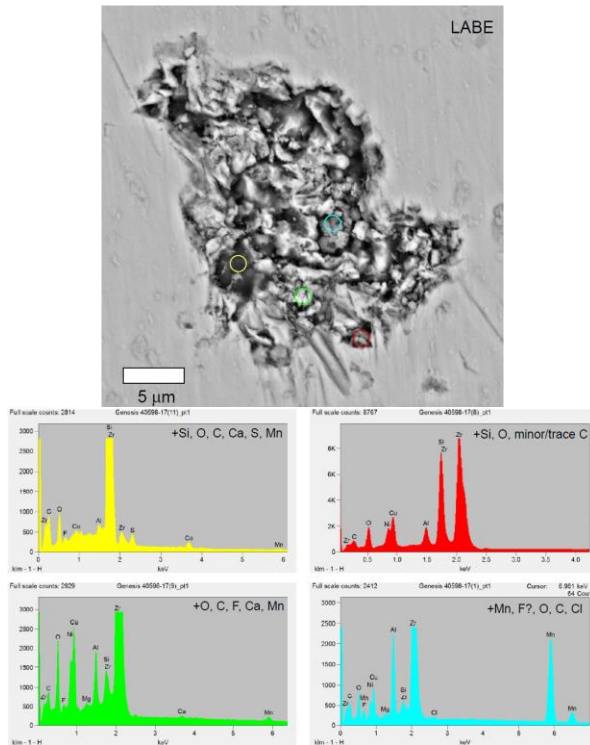
Fig. 5. *Top*: FESEM/low angle backscatter electron image of an intriguing feature,  $\sim 15 \times 25 \mu\text{m}$ , in sample 40598.17. This feature may be interpreted as a low velocity impact feature or corrosion behavior of a BMG. Circles designate regions of interest (ROIs) analyzed using energy dispersive X-ray spectrometry (EDX; 15 kV/sample uncoated). *Bottom*: Four EDX spectra of ROIs located within the feature. They are color coordinated with the circles in the upper view. The BMG is composed of Zr, Cu, Ni, Al & Nb. Additional elements detected in the feature include C, O, Si, Mn & F resulting from a possible impact event or corrosion behavior of the BMG during the reentry crash.

High magnification optical microscopy revealed semi-circular,  $\mu\text{m}$ -size features subsequent to characterization using field emission scanning electron microscopy (FESEM) on samples 40598.13, 40598.16, 40598.17, and 40598.35. No features were interpreted as possible craters with one exception in 40598.17 (Fig. 5). This feature *may be* interpreted as a possible low velocity impact crater or is consistent with corrosion behavior of the BMG substrate exposed to the Utah soil. The presence of elements within the void not associated with the background/BMG matrix pose an intriguing question as to the origin of this feature. Unfortunately the BMG surface has many voids and scratches likely acquired during reentry and crash landing.

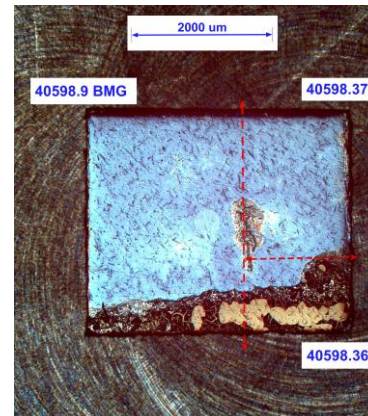
Fig. 6. Red dash line shows the cutting path followed to subdivide sample 40598.9

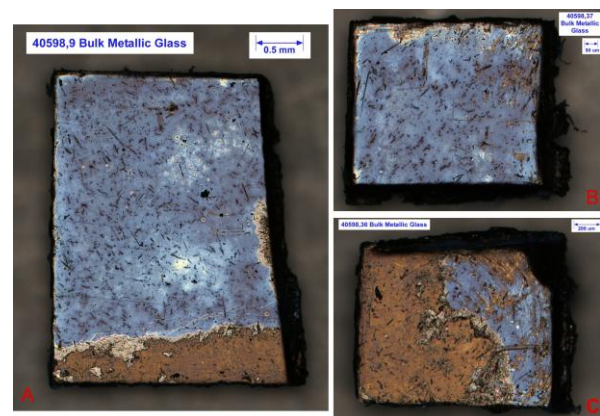
blade. Subdivision plan and final sample images are shown in Figs. 6 & 7. The partial devitrification of the BMG is visible in most optical images of the subsamples and is also evident in FESEM images.

Fig. 7. Sample image taken after subdivision with a diamond blade. A) Sample 40598.9 B) Sample 40598.37 C) Sample 40598.36
