NASA/TM-2020-220573  
NESC-RP-12-00823

# Recurring Causes of Human Spaceflight Mishaps during Flight Tests and Early Operations

An analysis of recurring causes underlying human spaceflight mishaps that occurred during flight tests and early operations was performed. Eight mishaps from the Apollo, Soyuz, Skylab, Space Shuttle, and Constellation Programs (i.e., the Ares-1X test flight) and commercial suborbital systems were included in the study. Detailed event analyses were performed for the historical mishaps and aggregate data analyses conducted to identify recurring issues. The nine most frequent issues were inadequate technical controls or risk management practices, incomplete procedures, system design and development issues, inadequate inspection or secondary verification requirements, failures of organizations to learn from previous incidents, inadequate schedule controls, inadequate task analyses or design processes, flaws in the design of organizations, and issues with organizational safety cultures.

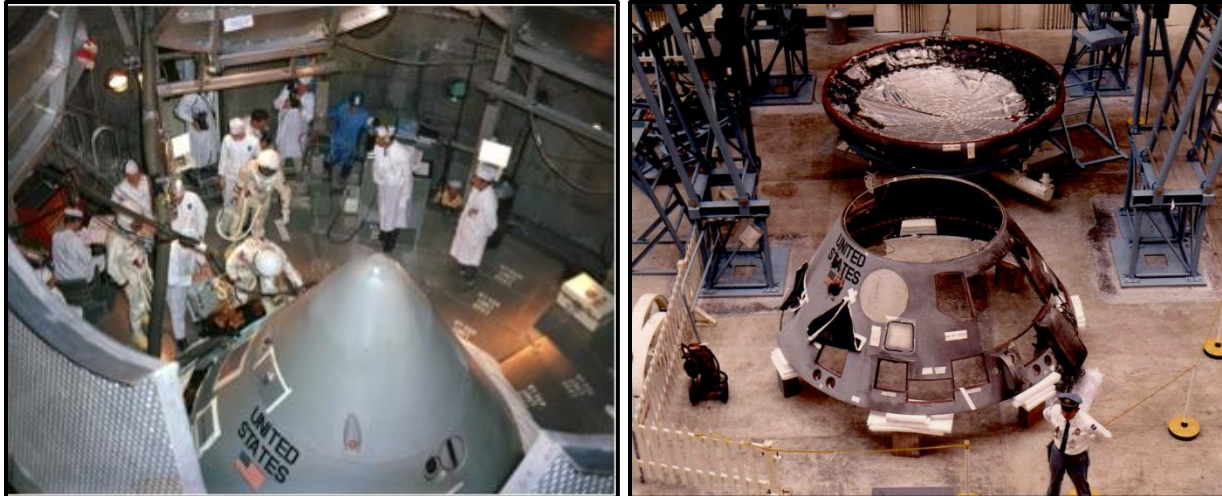
***Figure 7.1-1. Apollo 1 Command Module Fire at LC 34***

The fire that led to the loss of three astronauts on January 27, 1967, was probably caused by an electrical arc from a Teflon-coated wire near the floor of the capsule [ref. 6]. The delicate wire was powered by the main power bus. Post-mishap interviews revealed a notable amount of traffic capable of damaging wiring insulation. The choice of the insulating material (while it was a superior heat insulator) made it unusually susceptible to damage from friction. Since a decision was made to conduct Apollo operations in a 100% oxygen environment pressurized to 16.7 psi, as had been done in the Mercury and Gemini capsules, previous successes in those programs served to effectively conceal the risks of combustibles in the cabin. Images of the Apollo 1 command module before and after the tragedy are shown in Figure 7.1-1.

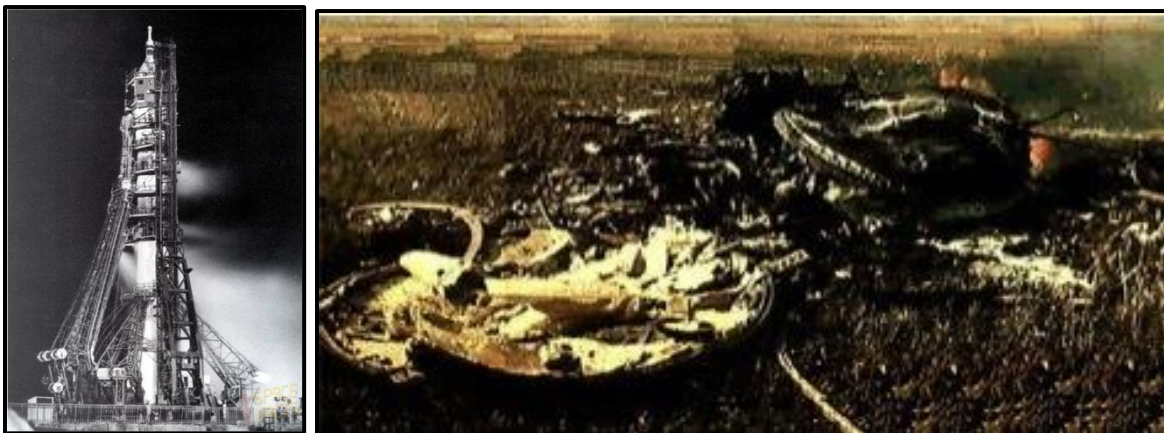
***Figure 7.1-2. Soyuz 1 at the Launch Pad (left) and Descent Module Debris (right)***

Figure 7.1-2 contains images of the Soyuz 1 mission on the launch pad and the descent module debris at the landing site.

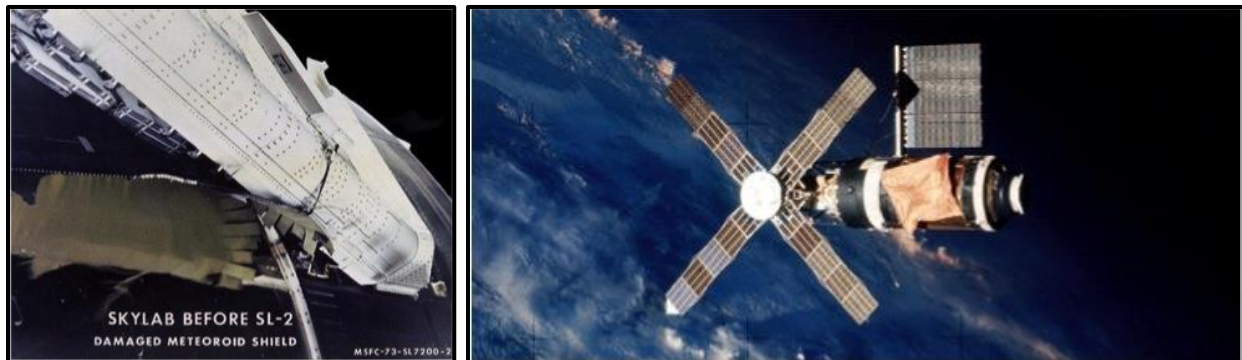
***Figure 7.1-3. Skylab 1 Damaged Meteoroid Shield (left) and Solar Array Systems (right)***

Sixty-three seconds into deployment, there was a complete loss of the Skylab 1 meteoroid shield (MS) around the orbital workshop (OWS). A shield designed to protect the lab from micrometeoroids was damaged when it came loose during launch on May 14, 1973. This resulted in the loss of one of the two solar array systems (SAS-2) on the workshop and a failure of the interstage adapter to separate from the S-II stage of the Saturn V launch vehicle. Figure 7.1-3 contains images of the Skylab 1 MS damage, the primary solar shield, and the fully deployed SAS-1 panel after it was released during an EVA.

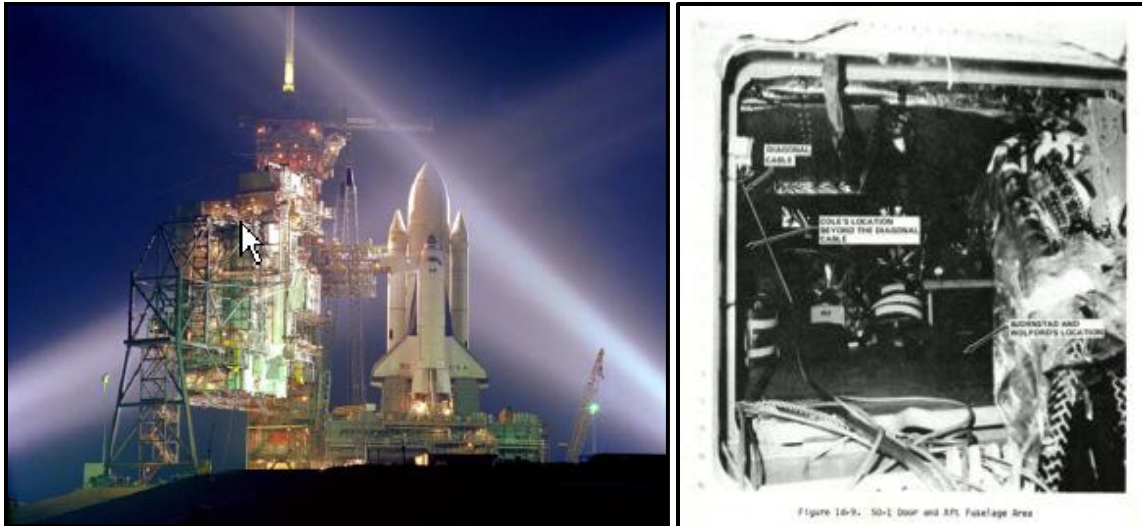
**Figure 7.1-4. STS-1 Stack at LC 39A (left) and Orbiter Aft Access Opening (right)**

During a simulated countdown involving the flight crew at the launch pad on March 19, 1981, many tasks unrelated to the simulation were being worked around the orbiter. All the tasks were managed from the firing room, but deviations to the standard procedures had to be made to accommodate the concurrent activities. In fact, more than 500 deviations were authorized. One activity was a nitrogen purge in the orbiter aft section to perform a leak check. The activity was not labeled hazardous on the schedule, so there was minimal review by safety personnel. Figure 7.1-4 contains images of the STS-1 stack at LC 39A and the opening for the orbiter aft compartment access.

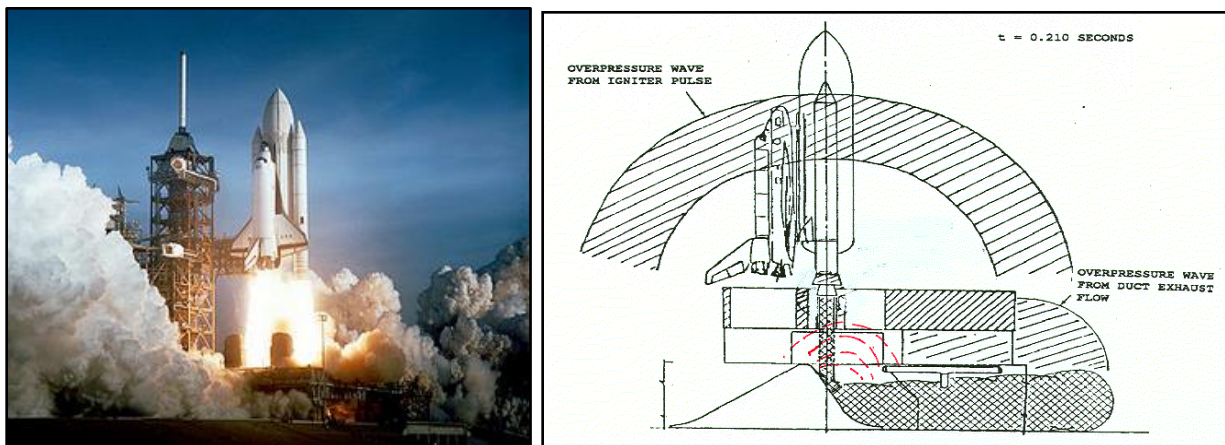
**Figure 7.1-5. STS-1 Launch (left) and Sketch of SRB IOP Wave (right)**

During the launch of STS-1 on April 12, 1981, a significantly low estimate of the pressure spike generated by the reflection of the SRB IOP wave resulted in nearly catastrophic damage to the orbiter. The SRB IOP was anticipated, but prelaunch modeling was conducted using Tomahawk missile motor data to validate the models, and the SRBs have much higher ignition pressures. Figure 7.1-5 contains an image of the STS-1 launch and a sketch of the IOP wave.

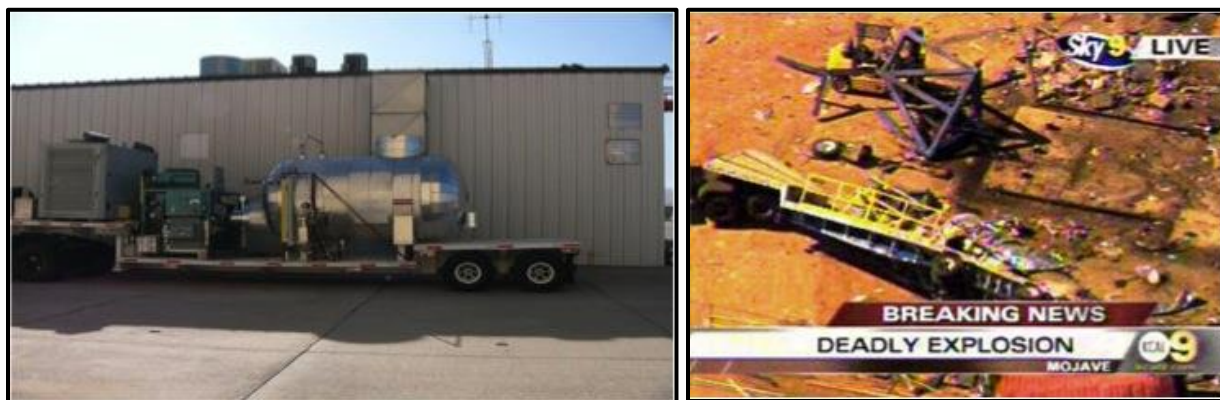
*Figure 7.1-6. Steel N<sub>2</sub>O Storage Tank (left) and Explosion Site (right)*

Ground operations for SpaceShipOne included testing a steel tank carrying approximately 10,000 lb of N<sub>2</sub>O (see Figure 7.1-6). While testing in the desert at approximately 105 °F on July 26, 2007, the N<sub>2</sub>O tank exploded, killing three ground crew members and injuring three others. The ground crew was reportedly unaware that N<sub>2</sub>O above 96.8 °F becomes a supercritical fluid and is much easier to ignite than in its gaseous state. Furthermore, the N<sub>2</sub>O was being transferred to a composite tank. N<sub>2</sub>O decomposes most composite materials and produces a vapor that is also explosive [ref. 29].

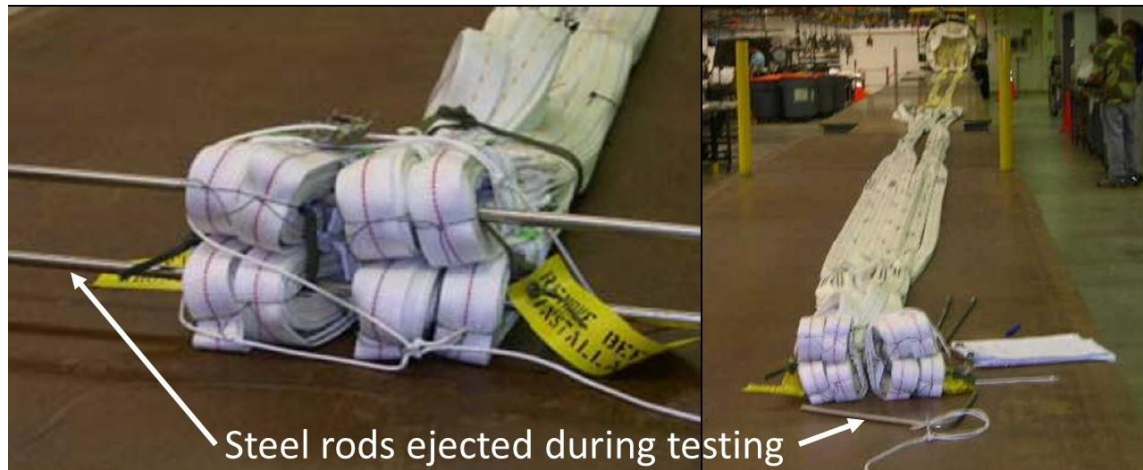
**Figure 7.1-7. Parachute Riser Strip Test Setup**

SRB recovery parachute risers were being tested on September 5, 2007, in a refurbishment facility just prior to delivery. There was a rush to complete the testing so the parachute system could be installed on the Ares 1-X vehicle and meet the planned launch schedule. It was the first time this type of test had been performed with this specific riser design, so a new test strategy and procedure had to be developed. The test procedure was a tailored version of a standard SSP test procedure. The load on the risers was generated by a winch and transferred to the riser through steel rods (see Figure 7.1-7). At some point during the test, steel rods were ejected from the risers, and one rod struck the operator at high speed across the legs. If the rod had struck the operator at a different angle or on a different part of his body, the results could have been lethal [ref. 15].

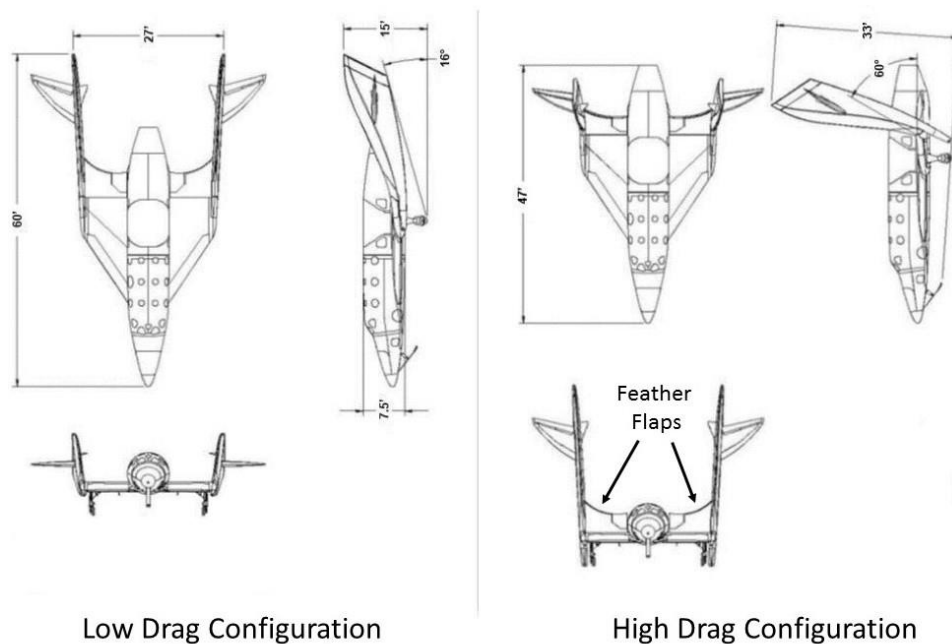
**Figure 7.1-8. SpaceShipTwo Flight Configurations [ref. 16]**

To reduce speed in preparation for a safe landing, large flaps on the trailing edges of the wings were deployed to increase drag. These flaps were called “feather flaps” and deployed upward with the tail booms, as shown in Figure 7.1-8. During boost phase, as the spacecraft passed through transonic speeds, the aerodynamic loads pushing the feather flaps and tail booms upward were more powerful than the actuators could control, so the assembly was held in the low-drag position with locking pins. Once the spacecraft reached Mach 1.4, the locking mechanism could be safely disengaged. A test flight was conducted on October 31, 2014. During a workload-intensive period for the flight crew at the beginning of the boost phase with a speed approaching Mach 0.8, the copilot unlocked the feather flaps prematurely, and the tail assembly was destroyed. As a result, the spacecraft was lost and the copilot was killed. The pilot was injured but survived [ref. 16].
