# **Recent On-Orbit Anomalies Affecting EOS Terra and Wilkinson- Microwave Anisotropy Probe (W-MAP) Missions**

Denney J. Keys, P.E.

NASA Technical Fellow for Electrical Power, NASA  
Engineering and Safety Center (NESC)

April 20, 2010

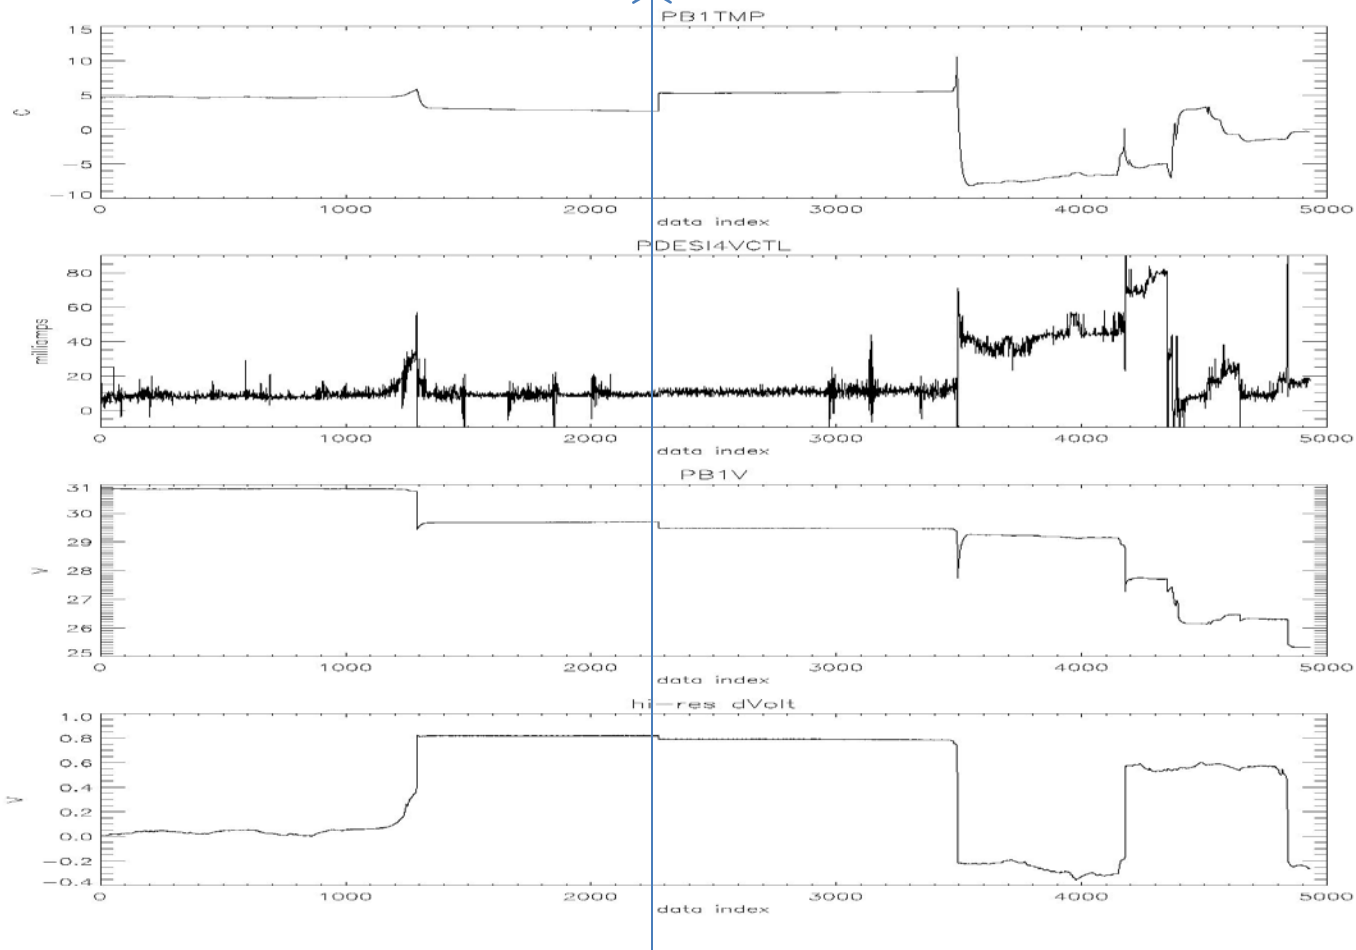
Roughly 7 year data span not shown between arrows

Temperature/Voltage/Current data from June, 2001 to October, 2009, of note battery voltage drops near end of plot.

- After examining the telemetry that was available from W-MAP, there were two basic theories as to why the battery voltage was collapsing:
  - One theory was that the cells were overcharged for an extended period and O<sub>2</sub> was being generated and degrading the performance of the cell plates (concern over potential “popping” issues and subsequent damage/blistering).
  - The second theory was that the cells were severely undercharged and merely required some form of boost charging to recover and resume nominal operations (with a higher constant trickle charge rate required).

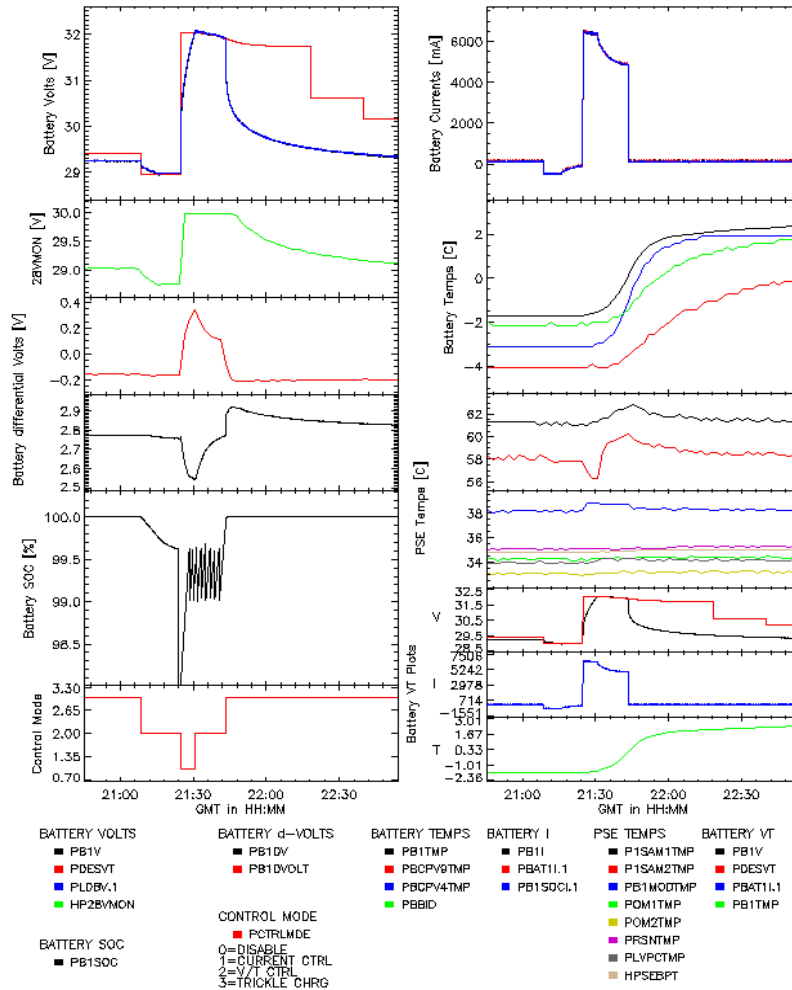
SC PWR SYSTEM STATUS (1) for period ending 2009308 (November 04) 22:53 GMT

- Despite performing multiple charge cycles on the cells (and increasing the theorized state of charge well above the low state of charge associated with the knee of the voltage curve), cells would again collapse soon after charging.
- The prevailing theory was now forced to consider additional internal chemistry disorders that might explain the apparent inability to retain capacity.

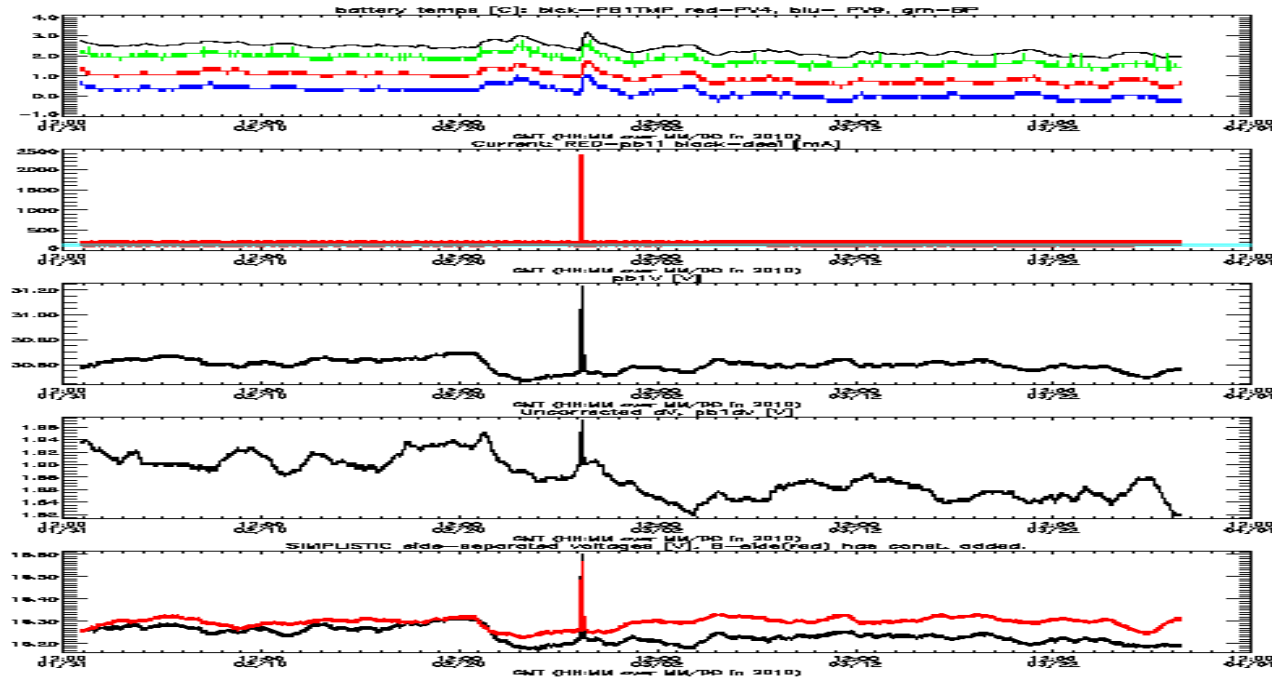
- Repeated charge cycles have provided some stability to the W-MAP Battery characteristics although voltage stability is still somewhat elusive.
- Testing is underway on spare flight battery and old Ni-H2 cells to mimic conditions experienced by the flight battery in hopes of shedding some light on chemistry mechanism experienced.

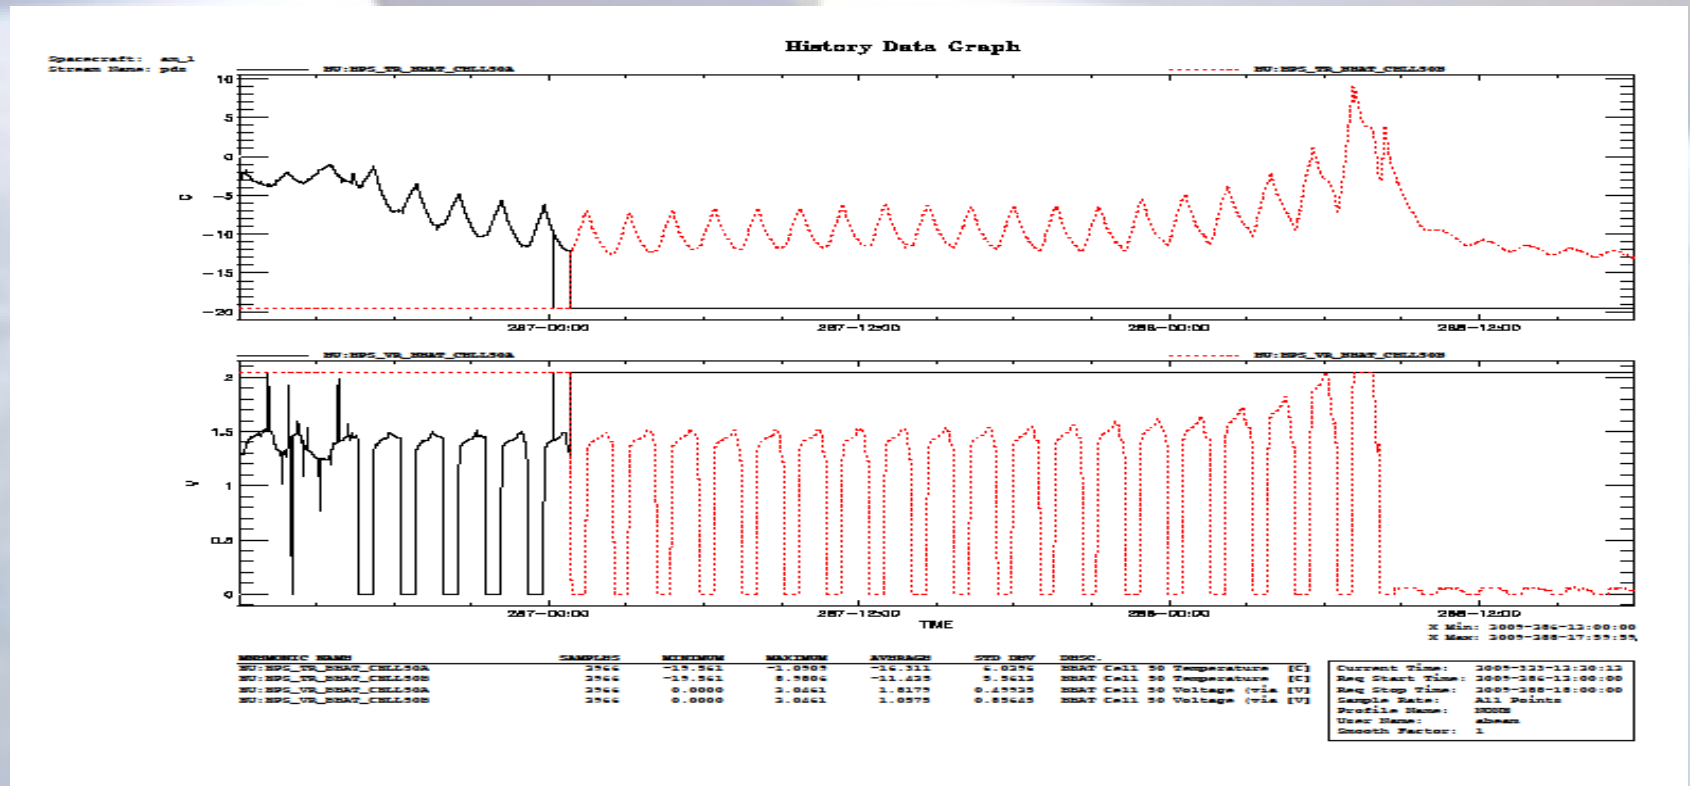
- During Day 286 (2009), the temperature control on one of the EOS Terra batteries indicated significant cooling (outside of control parameters) of multiple cells within the Hex Bay Battery.
- Flight Operations attempted both soft and hard resets of the Heater Control hardware without any change in temperature trend.
- Decision was finally made to switch sides to the redundant heater control, no significant change in thermal control occurred.

Temperature and voltage data for EOS Terra Hex Bay Battery Cell #50 for period covering on-orbit anomaly.

- Within two days Cell #50 ultimately appeared to reach a high enough internal resistance to trip the cell bypass switch.
- The only plausible explanation for an open circuit cell condition was loss of internal pressure, FOT asked to examine observatory 3-axis rate information for timeframe of anomaly.
- Working theory now involved possibility of debris/MMOD strike that could explain loss of heater control and cell response characteristics.

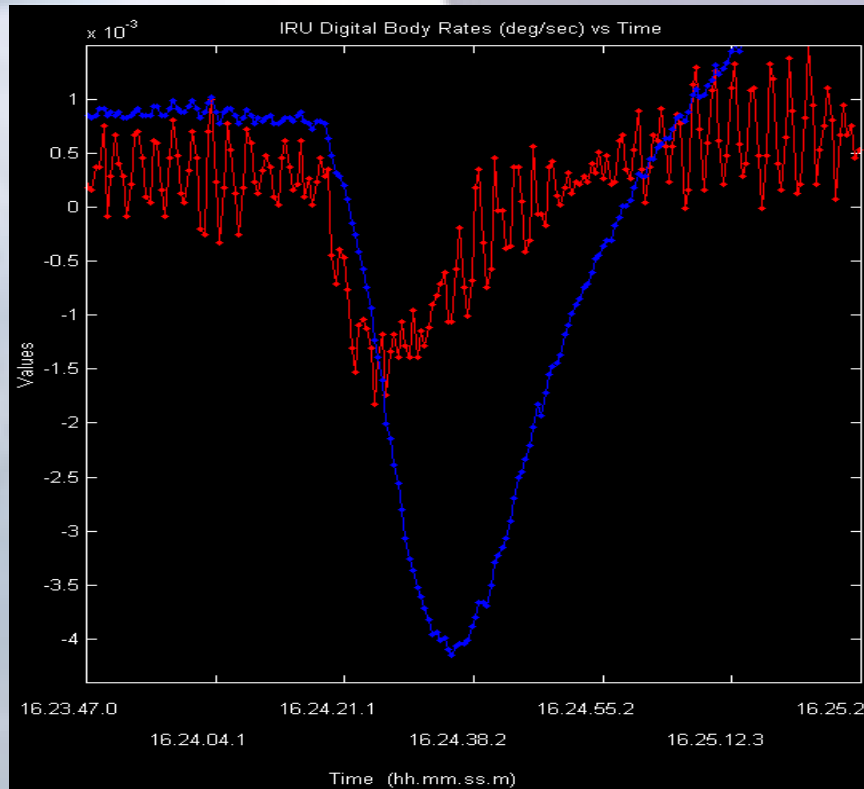
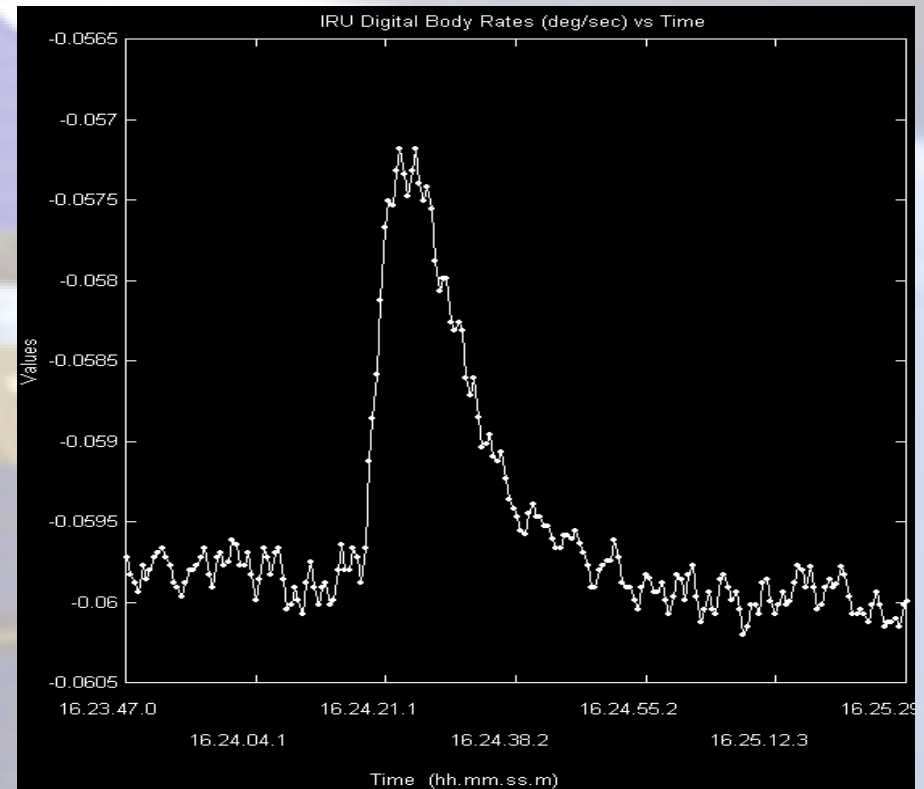
Low and behold, IRU data confirmed unexpected 3-axis movement at time of anomaly.

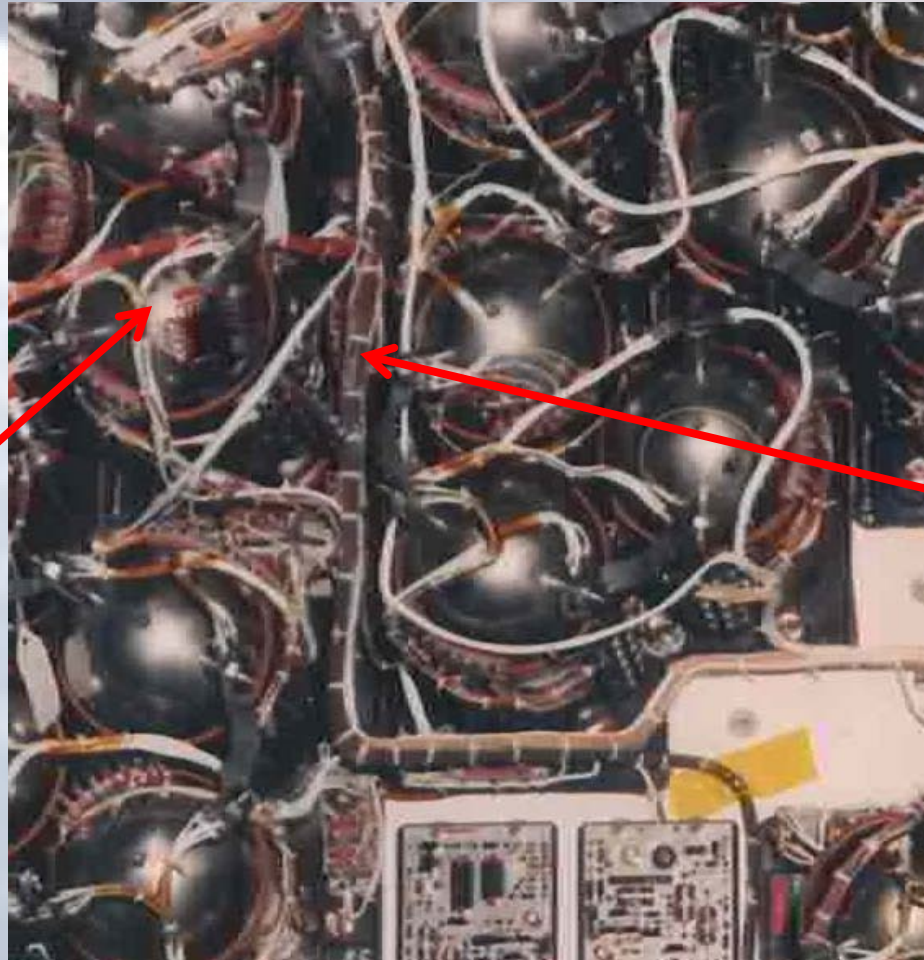
- Heater power provided to cell heater groups by way of heater harness bundles throughout the batteries.
- Close-up examination of battery close out photographs reveal the possibility of collateral damage as a result of MMOD strike.
- Although documentation found to date indicates Cell #50 located in area without harness bundles adjacent to cell, working theory is that numbering scheme for cell identification was changed.

With harness bundle so close to affected cell, likely collateral damage could have resulted in loss of partial heater control.

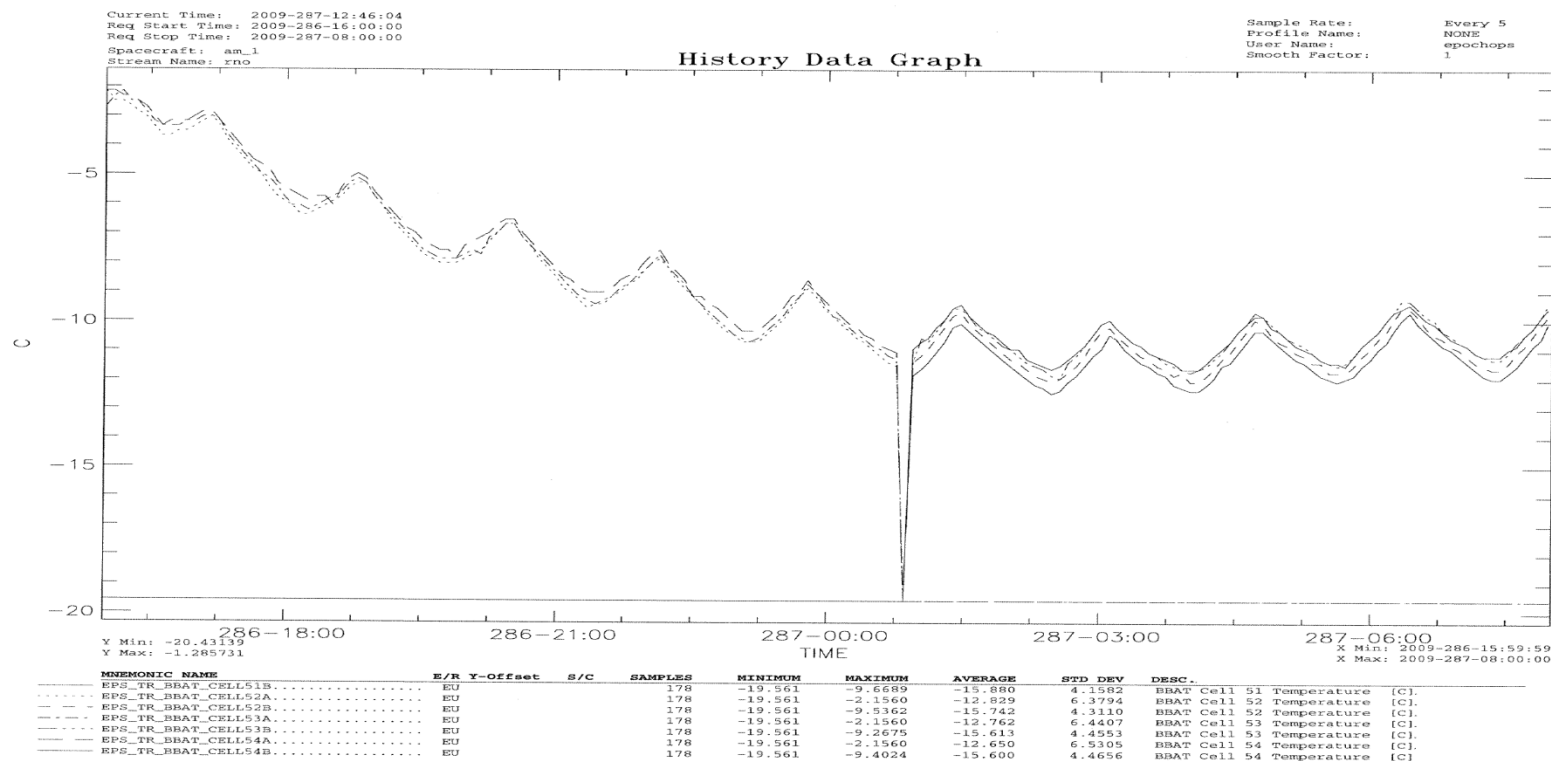
Temperature response (similar) encountered on 4 out of 9 heater groups on the EOS Terra BBAT – Group 9 shown, impact same on both prime and redundant sides.

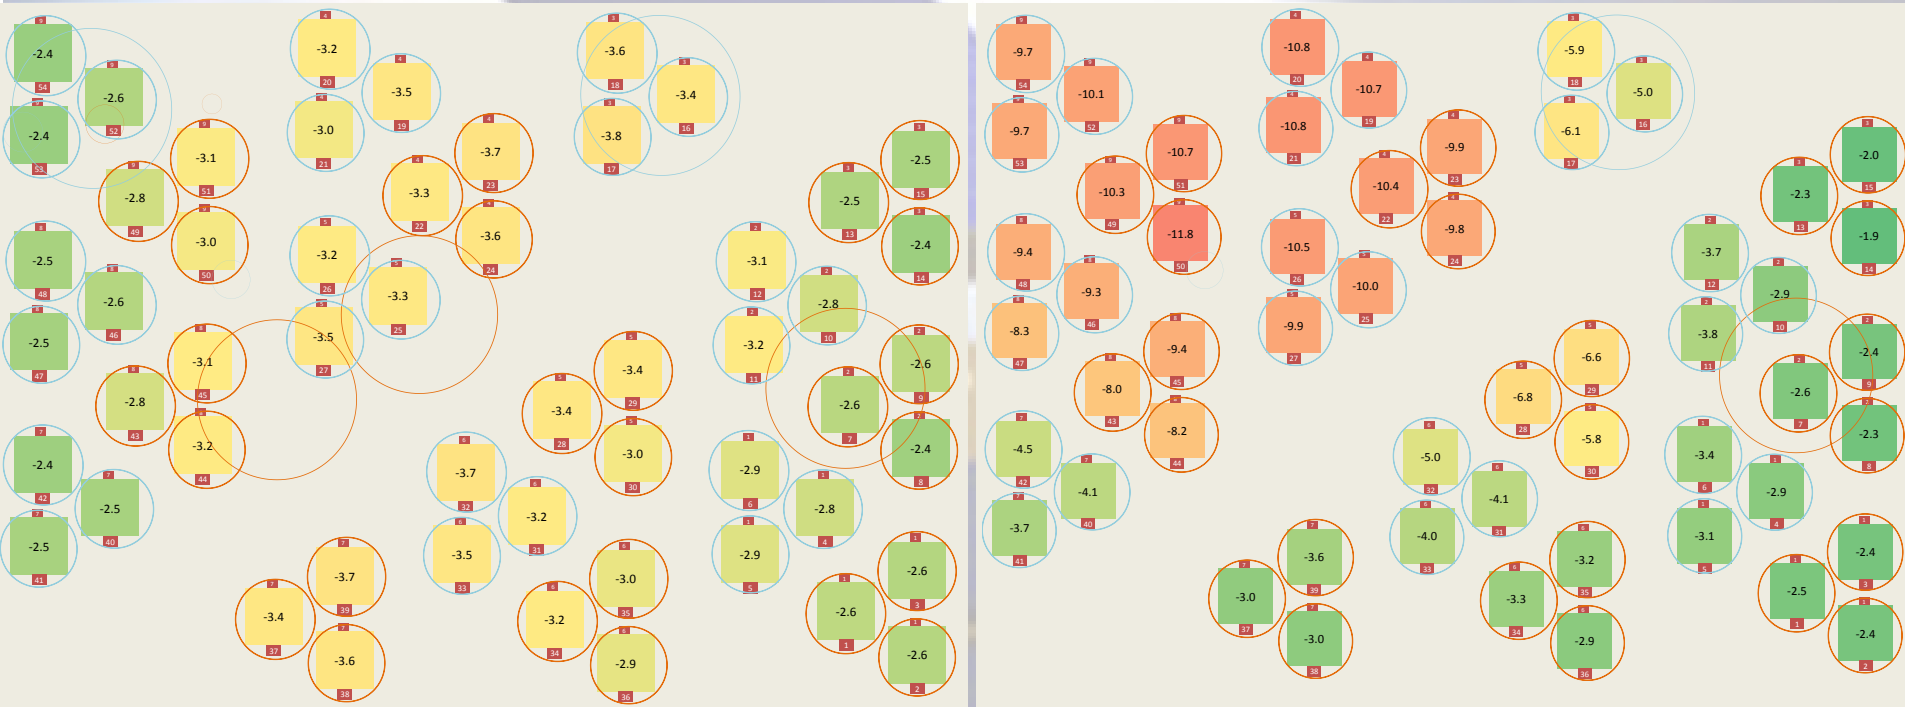
Left: Pre-anomaly typical thermal profile (1.43°C max spread).  
Right: Post-anomaly thermal profile (8.93°C max spread).

- After examining all potentially affected hardware and implementing a series of modifications to various heater group set point changes, thermal spread remained in the  $10^{\circ}\text{C}$  range with no physical configuration means identified to correct for loss of heater groups.
- Considering the exhaustion of options available for hardware correction to the thermal gradient issue, final decision to increase c/d ratio sufficiently to raise unheated cells to an acceptable range and reduce thermal gradient to within  $3^{\circ}\text{C}$  max cell-to-cell is being considered for implementation.
