Summary of Results from a Fokker F-28 Full Scale Crash Test

FAA Fire and Cabin Safety Conference

Justin Littell Ph.D.

NASA Langley Research Center

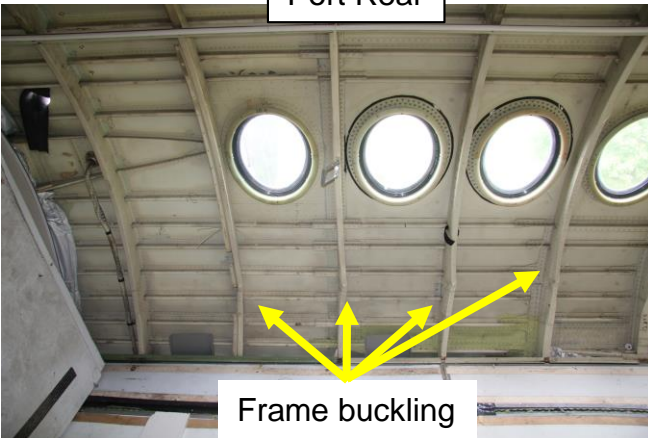
Frame buckling

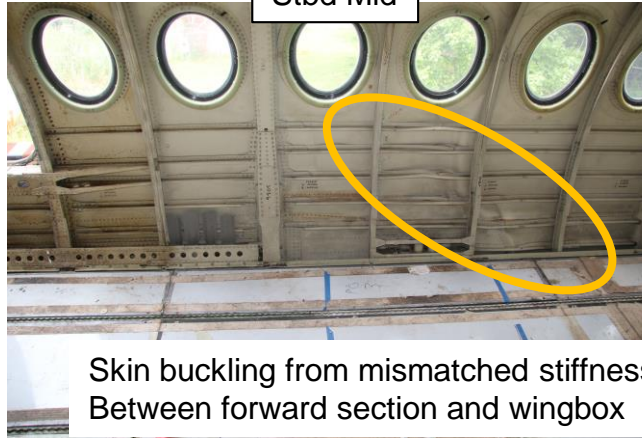
Skin buckling from mismatched stiffness
Between forward section and wingbox

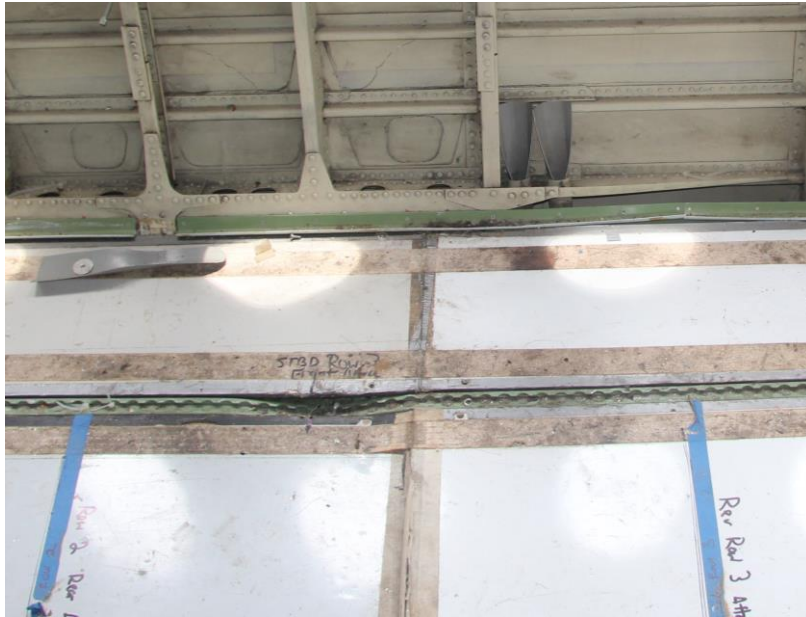
- Seat track deformation – pushes into lower structure at seat leg positions

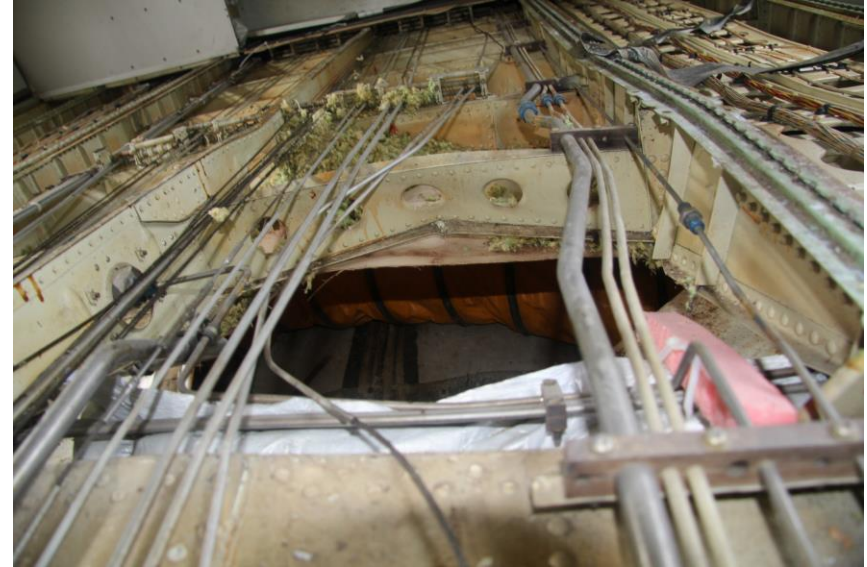
- Rear floor bulge / cabin intrusion

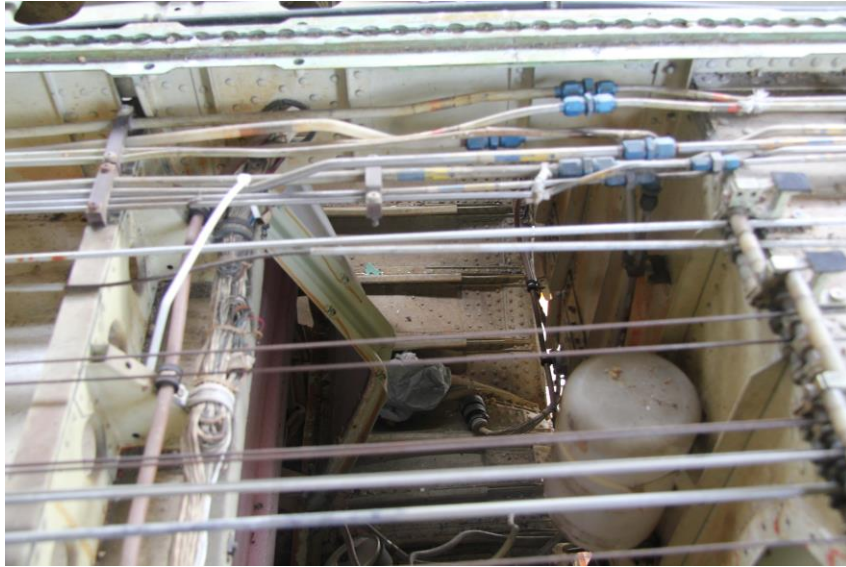
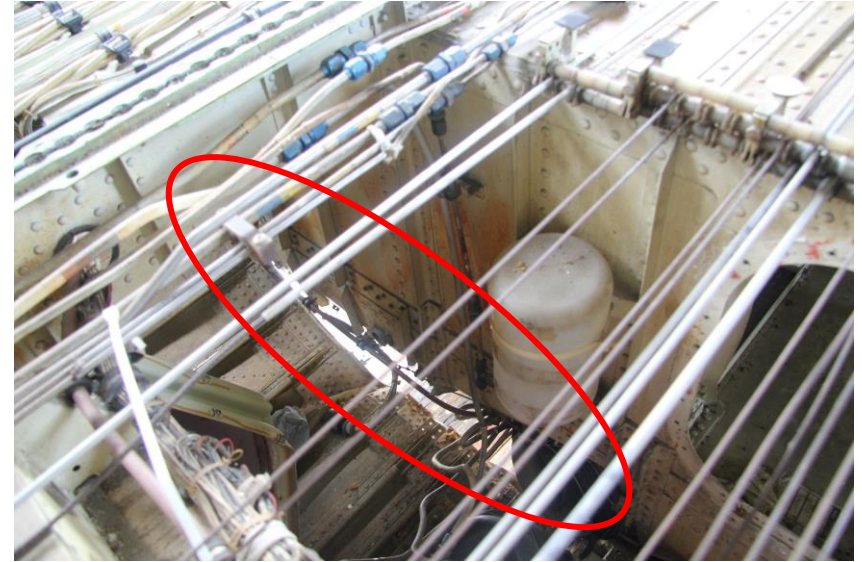
- Forward/Wingbox junction stanchion buckling
- *NOTE: Deformation still largely unknown in the sub-floor region for the forward compartment (cargo hold)*
- Wingbox detach from skin

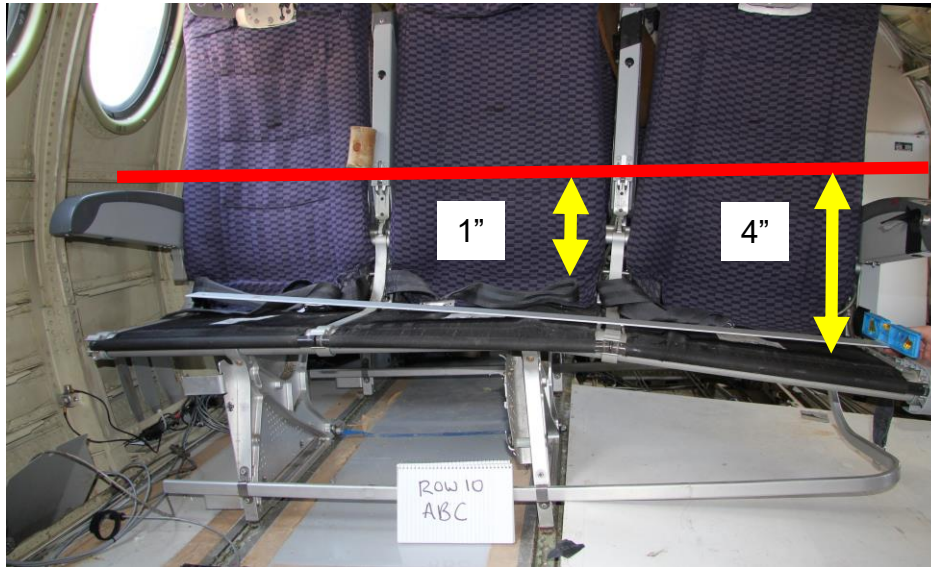
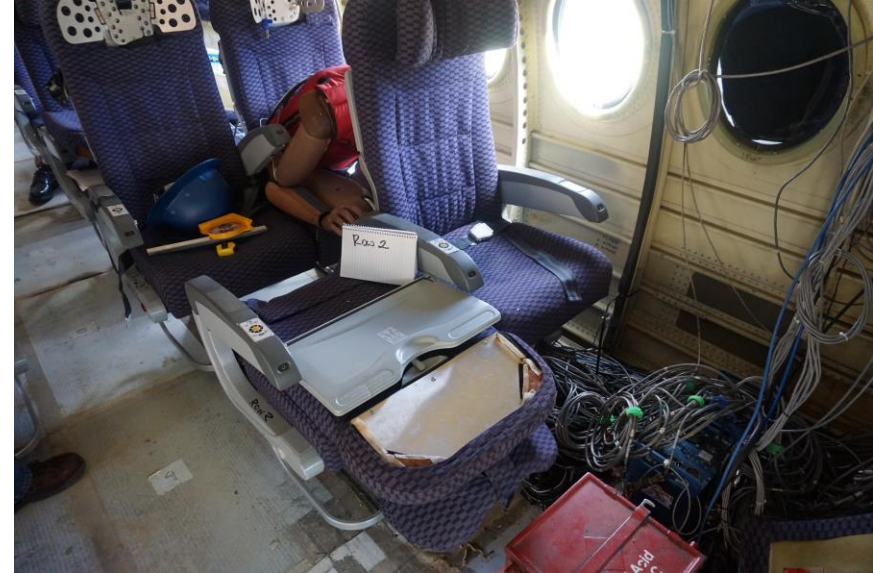
- For the triple place, only ATD seated in overhung seat was row 10 (seat C) - H3 50th

- Double seat Row 2 (seat D) seatback fail
