# Full-Scale Test and Analysis Results of a PRSEUS Fuselage Panel to Assess Damage-Containment Features

Andrew Bergan<sup>1</sup>, John G. Bakuckas, Jr.<sup>2</sup>, Andrew Lovejoy<sup>3</sup>,  
Dawn Jegley<sup>3</sup>, Kim Linton<sup>4</sup>, Albert Neal<sup>4</sup>, Greg Korkosz<sup>5</sup>,  
Jonathan Awerbuch<sup>6</sup>, Tein-Min Tan<sup>6</sup>

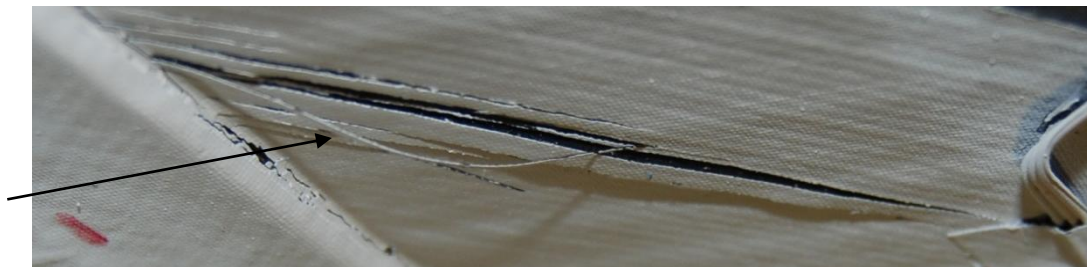
Broken  
fiber

*Clear Fiber Break Indicated BVID*

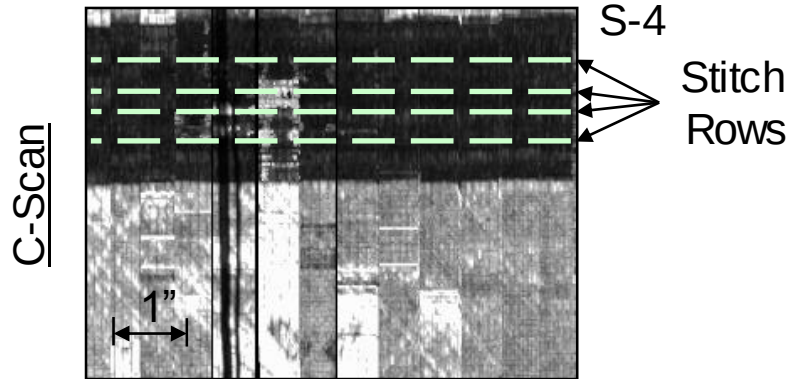
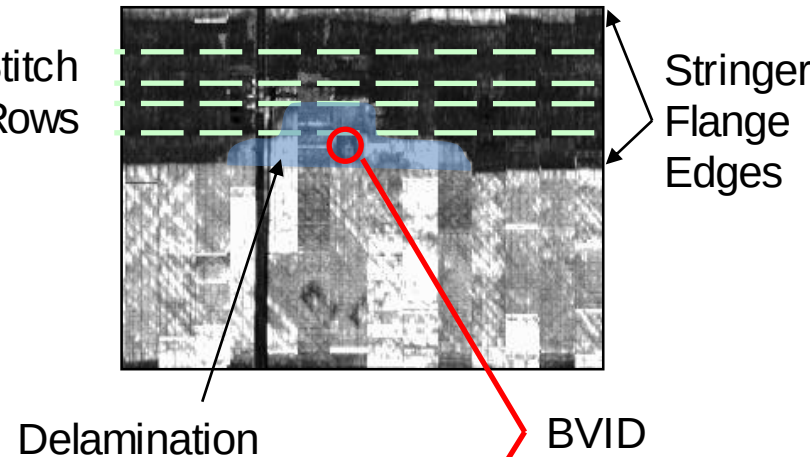
*Flange Delaminated from Skin Due to BVID*

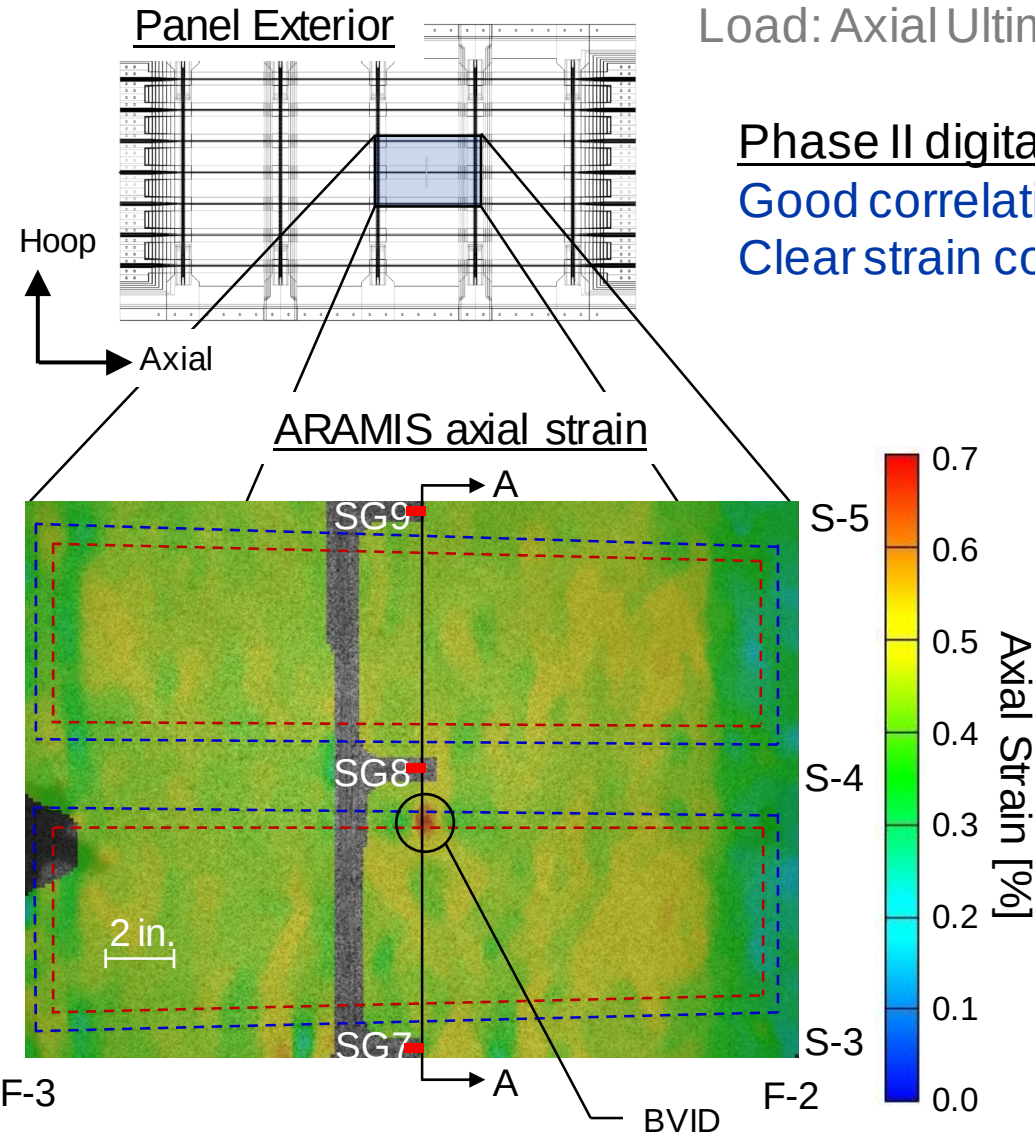
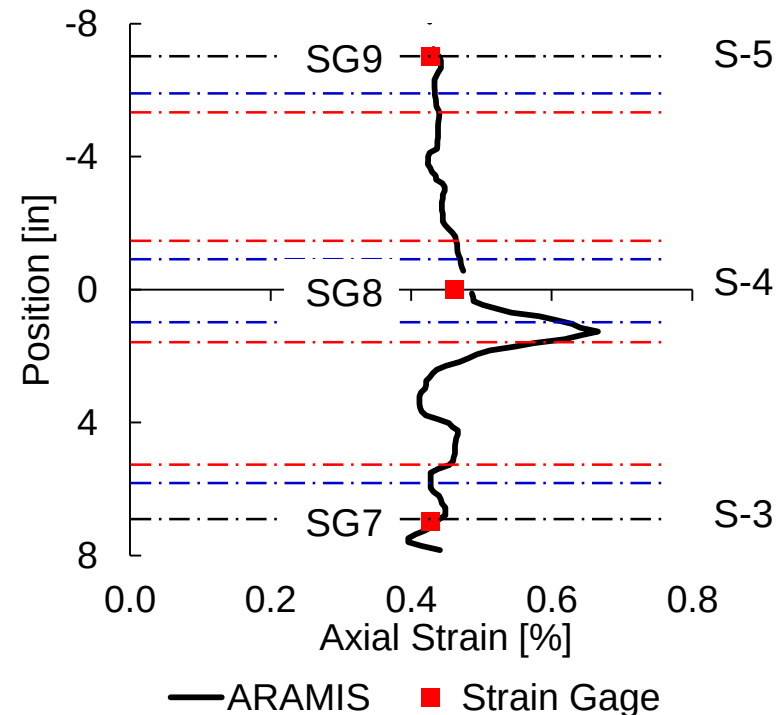
Clear strain concentration at BVID location

Local Strain Concentration below Material Failure Strains

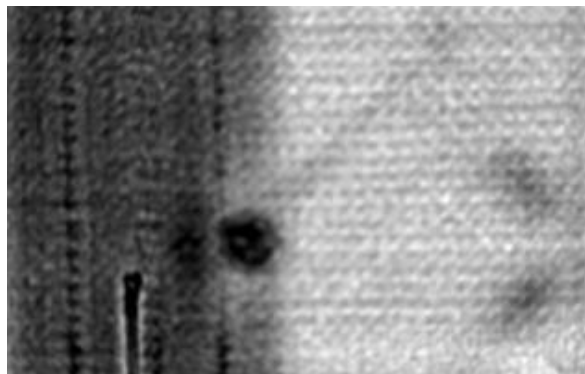
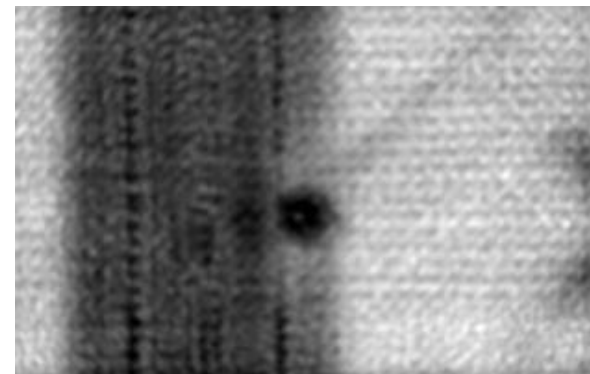
Flash  
Thermography

# Phase II: No Growth of BVID

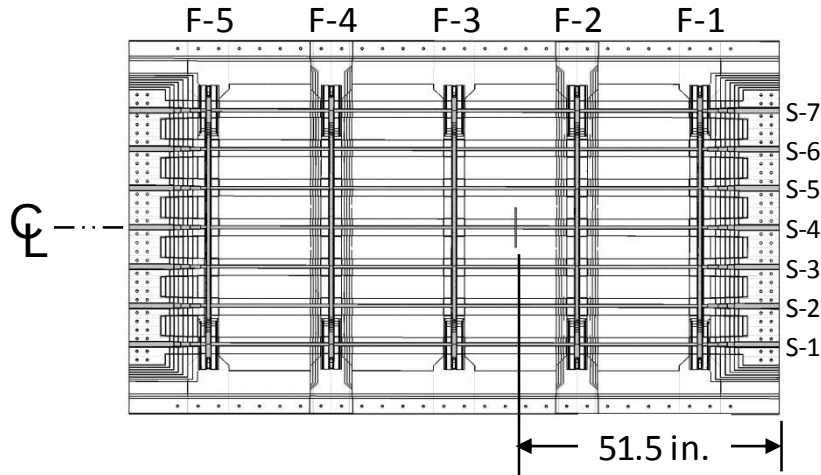
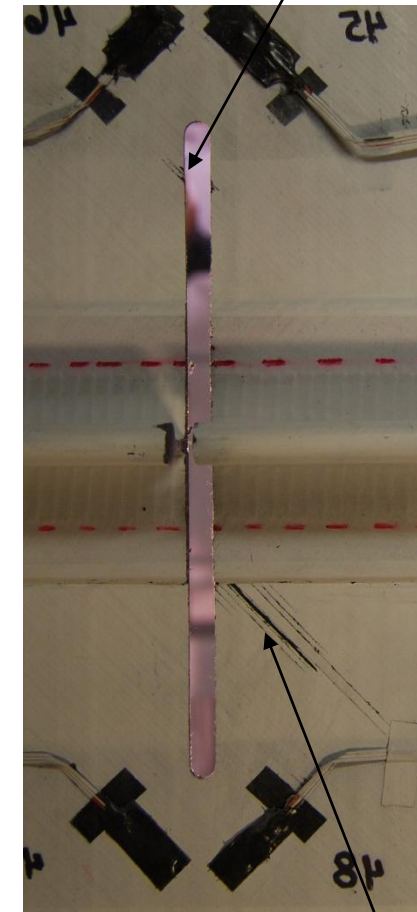
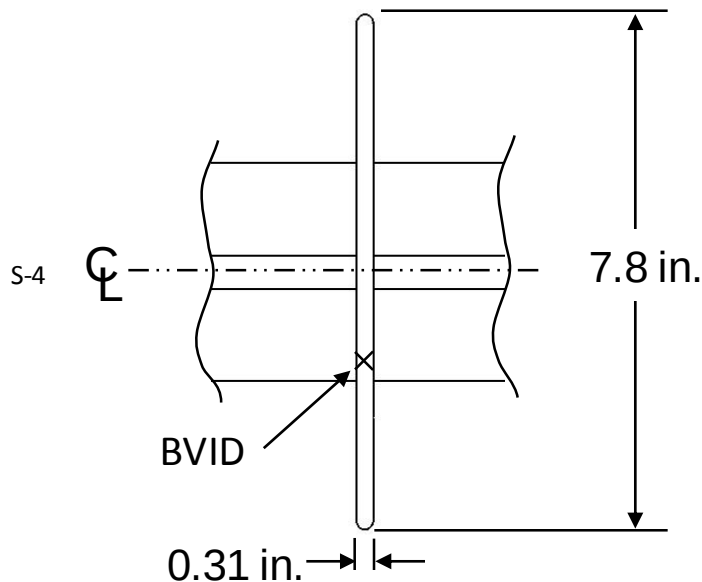
Breakout during machining

BVID Damage

*Notch Severed Central Stringer and Adjacent Skin*

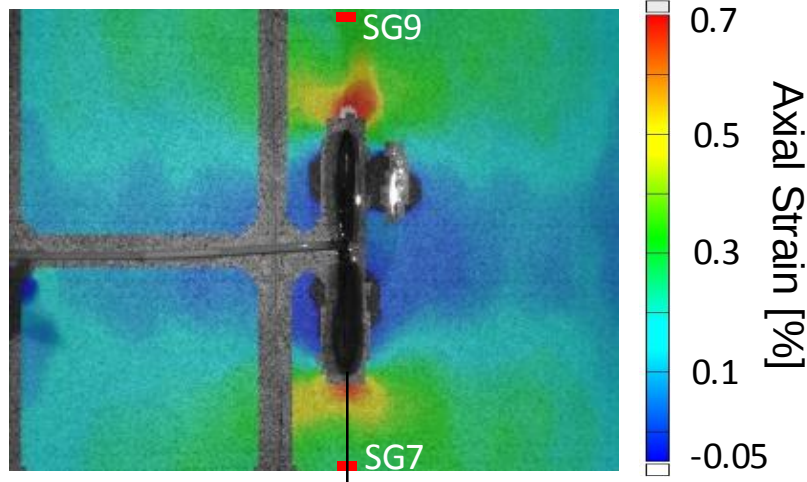
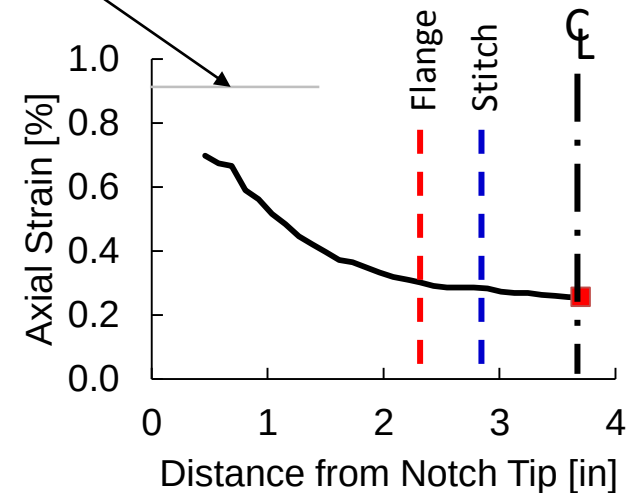
Notch Tip Axial Strain Approached Material Failure Strain at Visual Damage Initiation

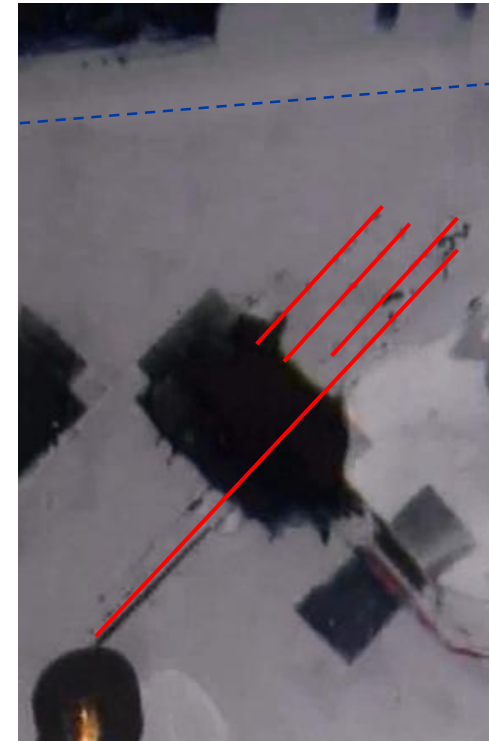
- Damage initiation: 1P + 54% DLL (interior first)
- Damage propagation slow and stable at 45° (surface ply dir.)
- Failure by matrix splitting

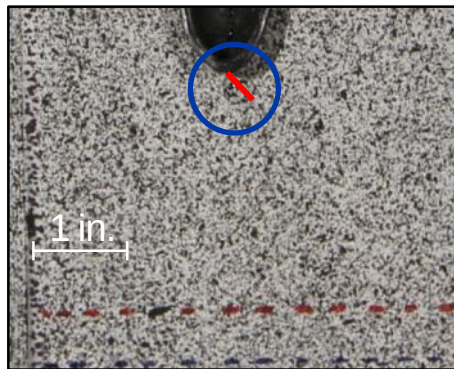
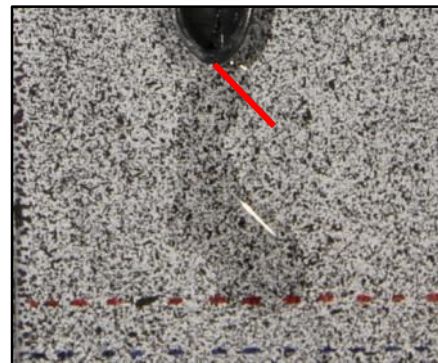
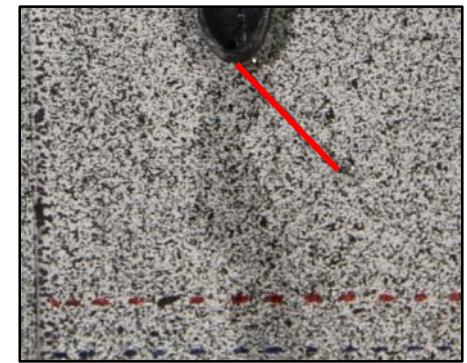
Damage Event A

Damage on Exterior Skin was 45° Splitting Propagating Slowly & Stably

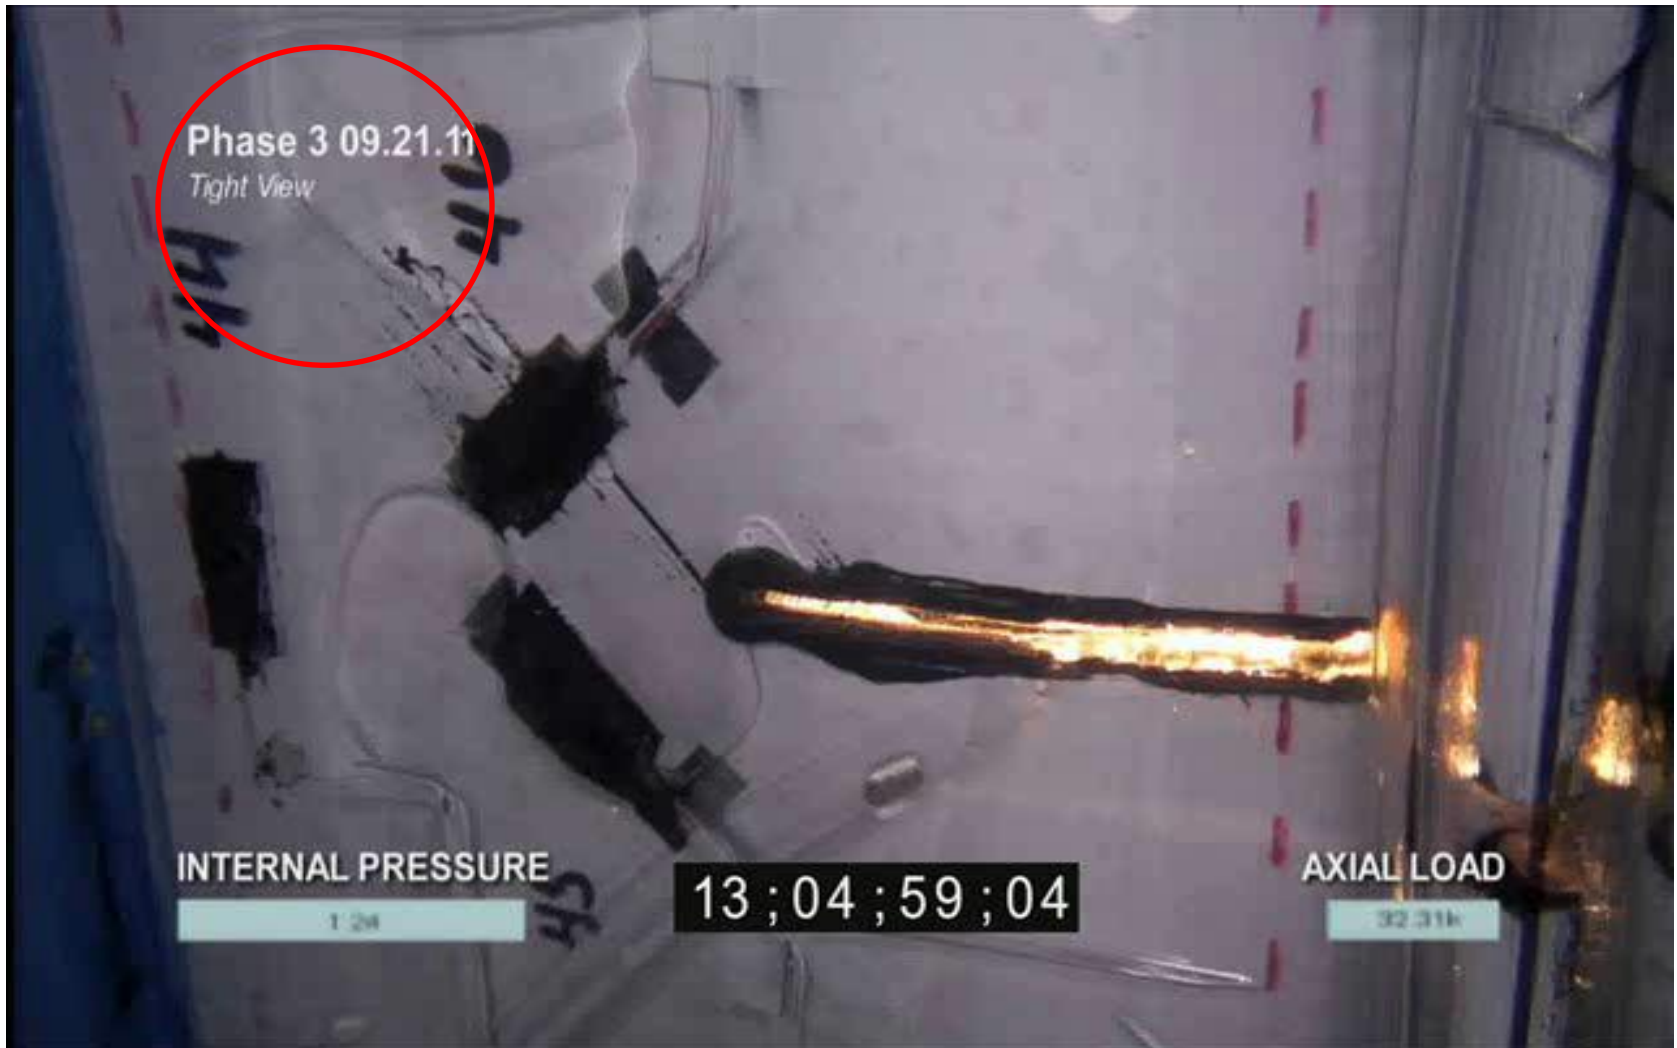
Axial Only Limit-Load Case was the Most Severe Load Condition

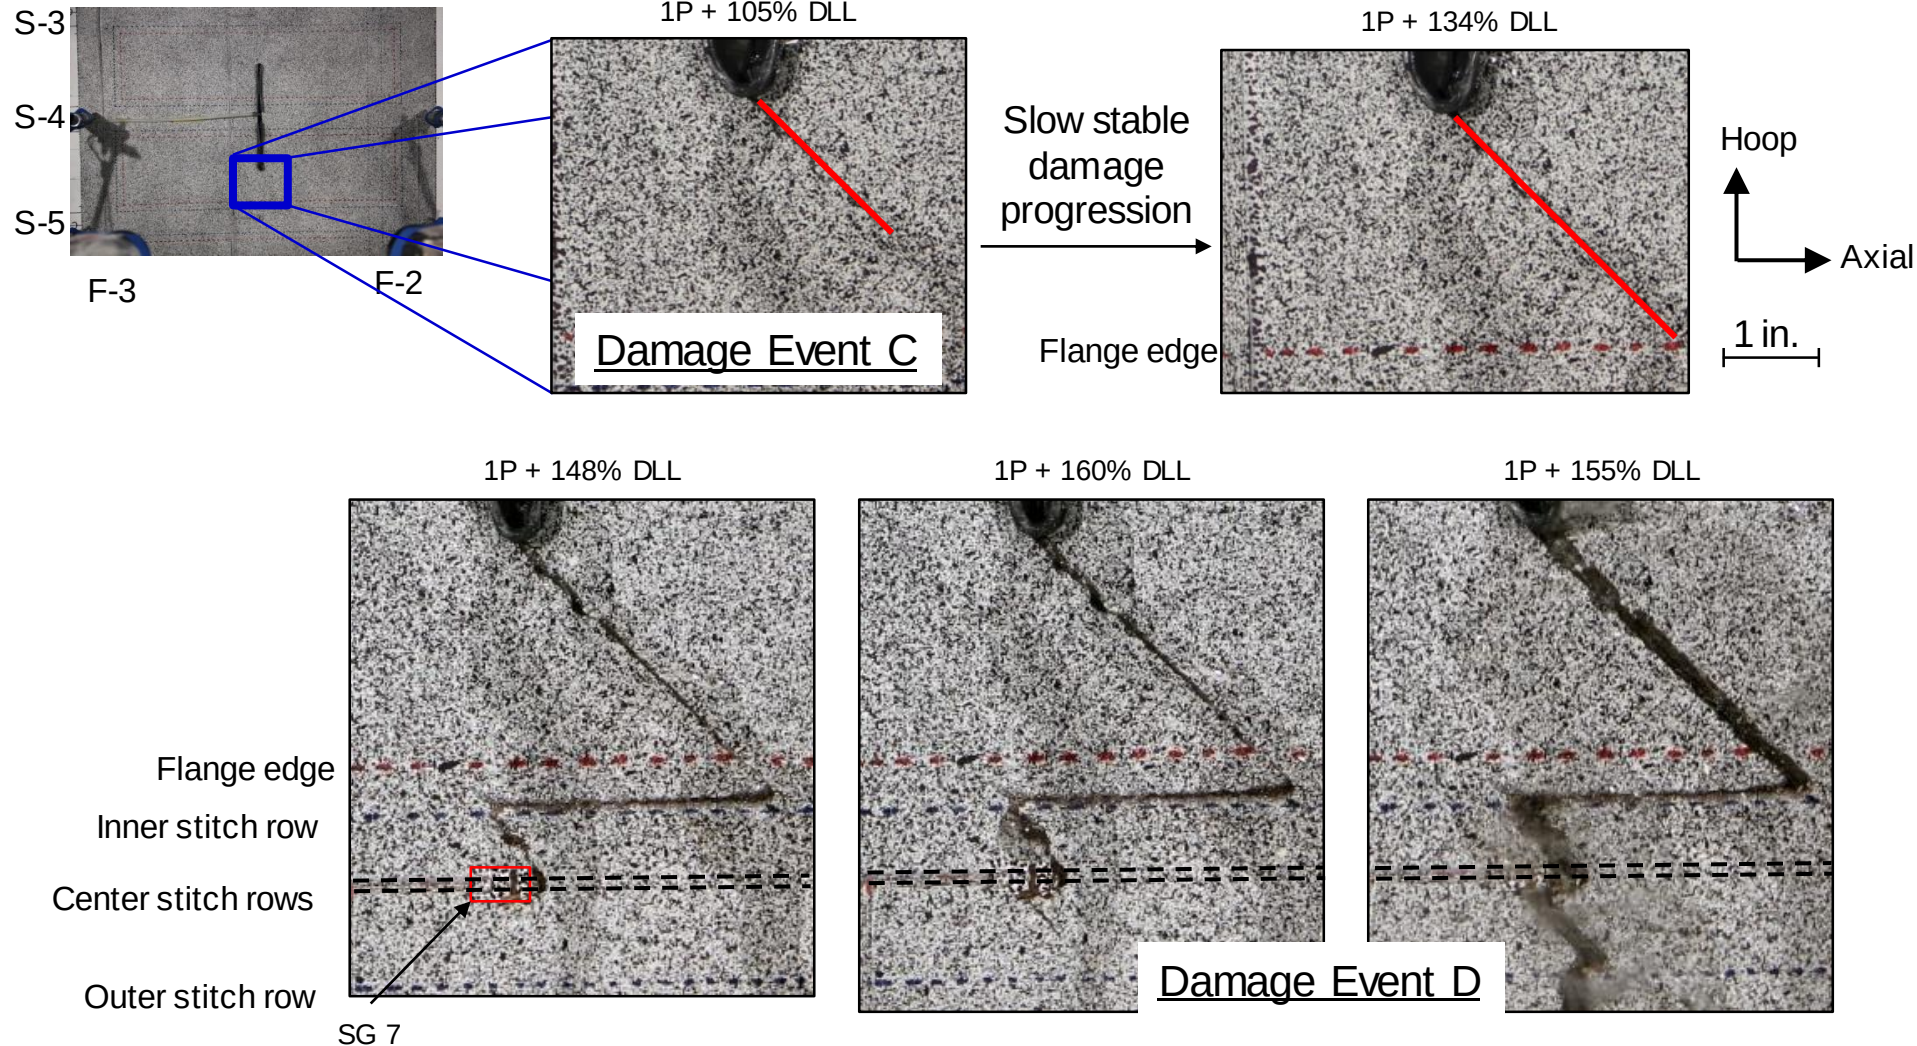
Damage was arrested by the stitches before propagating beyond the two-bay region

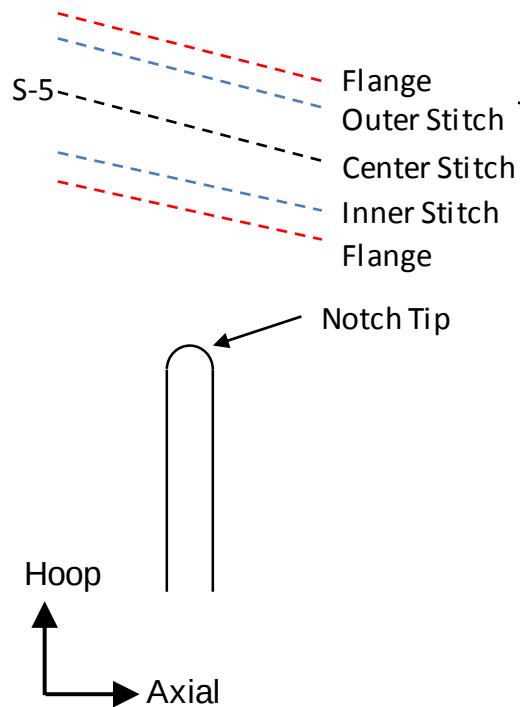
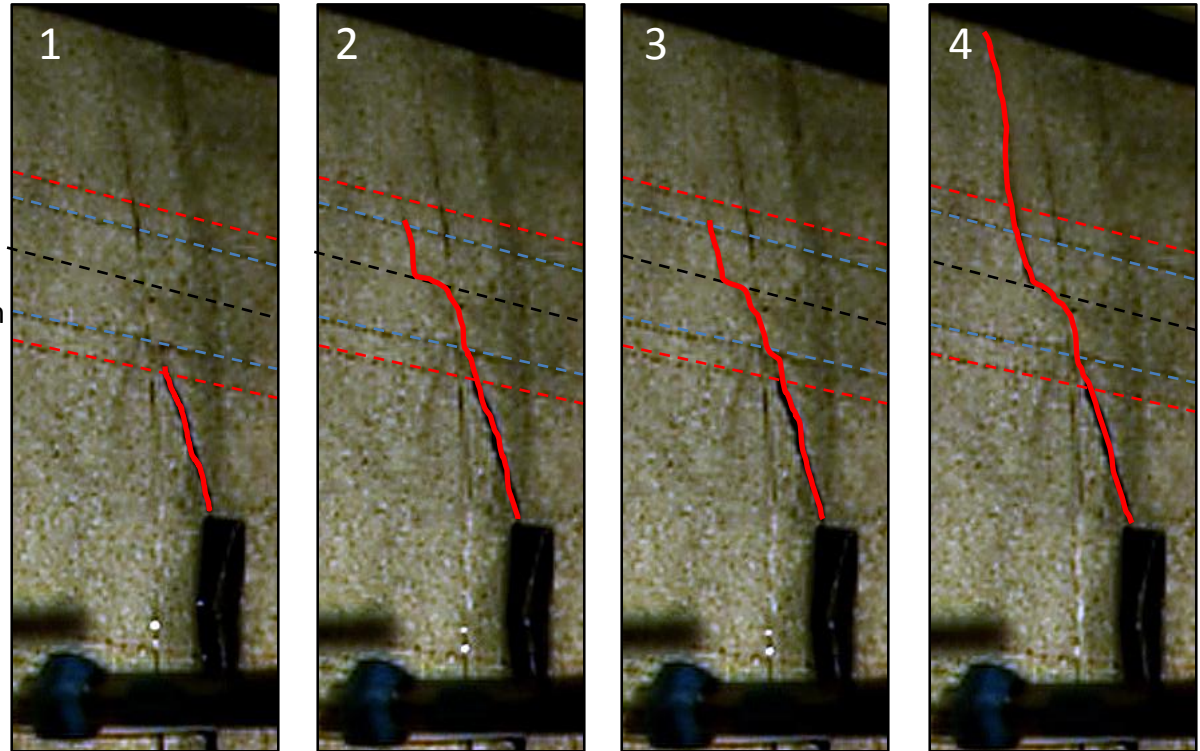
*Damage Temporarily Arrested as it  
Progressed Beyond the Adjacent Stringer*

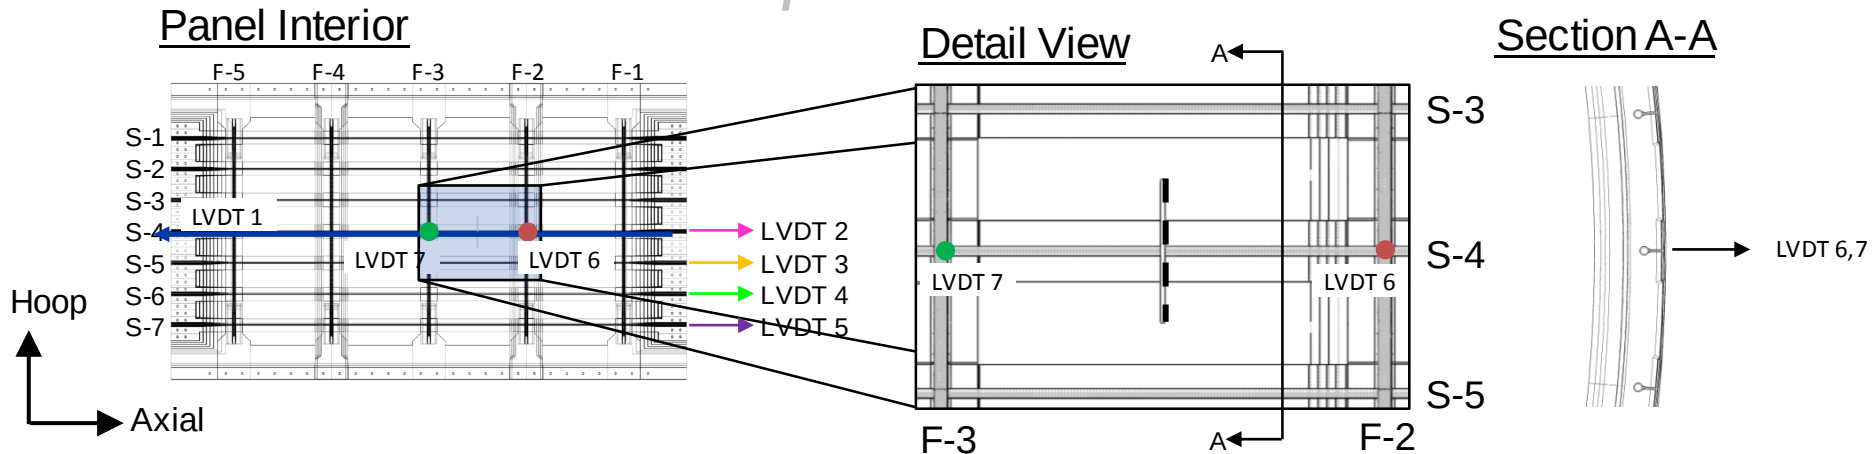
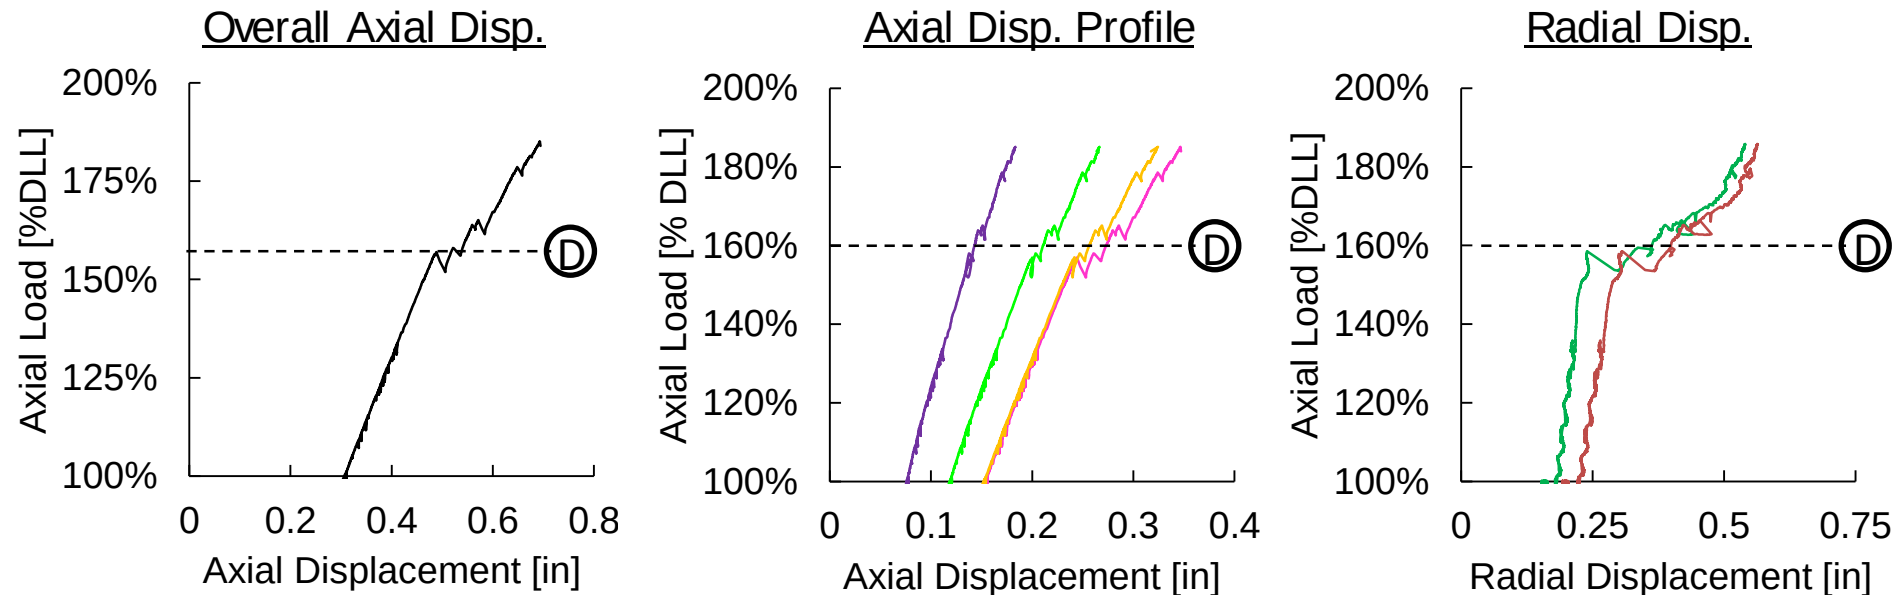
A Significant Displacement Discontinuity Occurred at Damage Event D

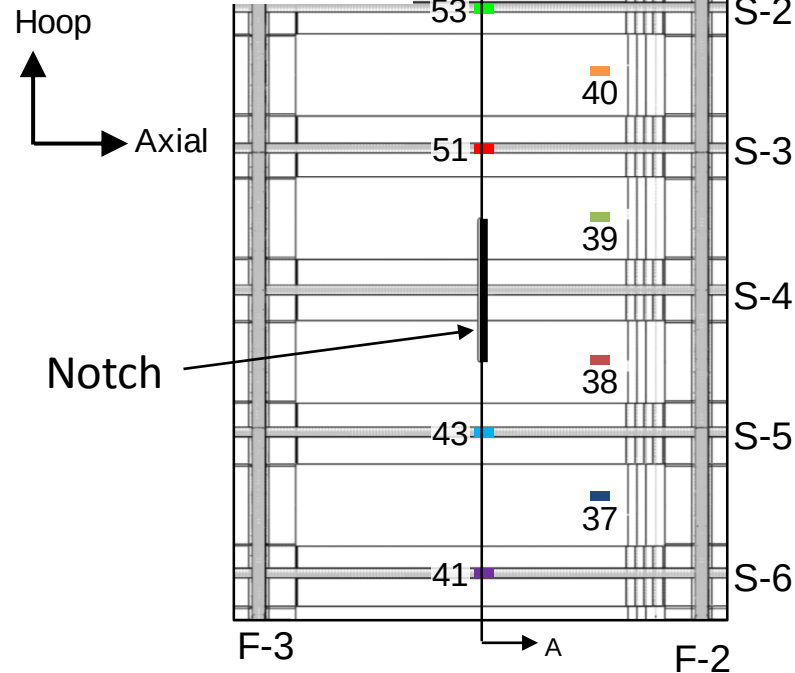
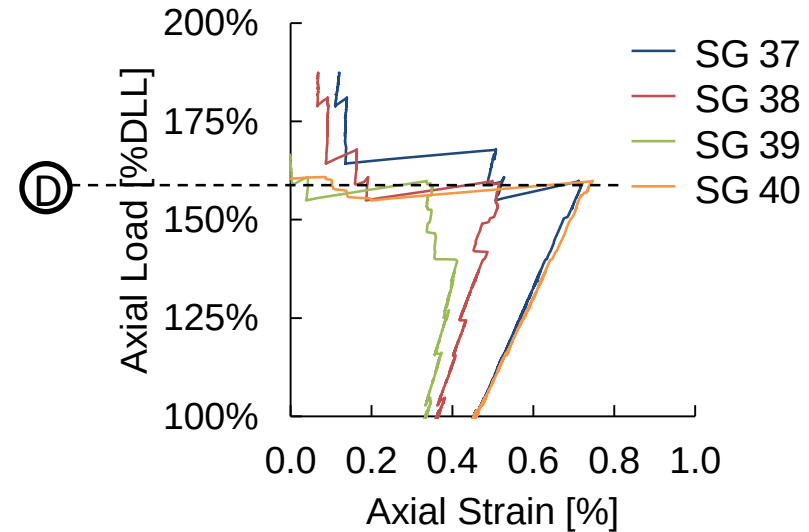
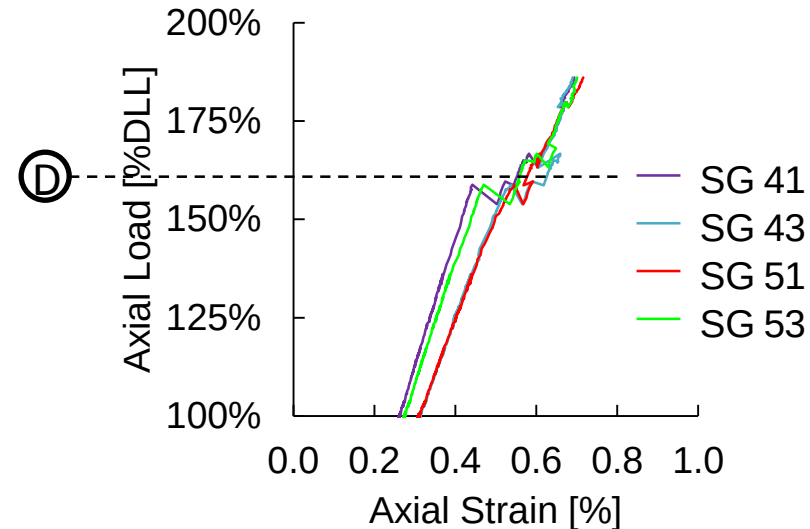
After Damage Event D, The Stringers Held Load, Bridging the Failed Skin

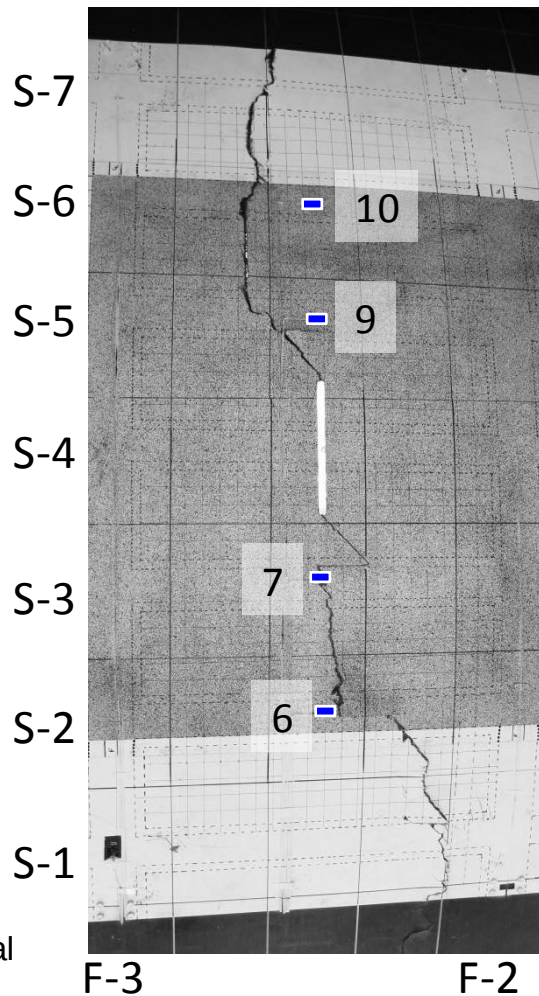
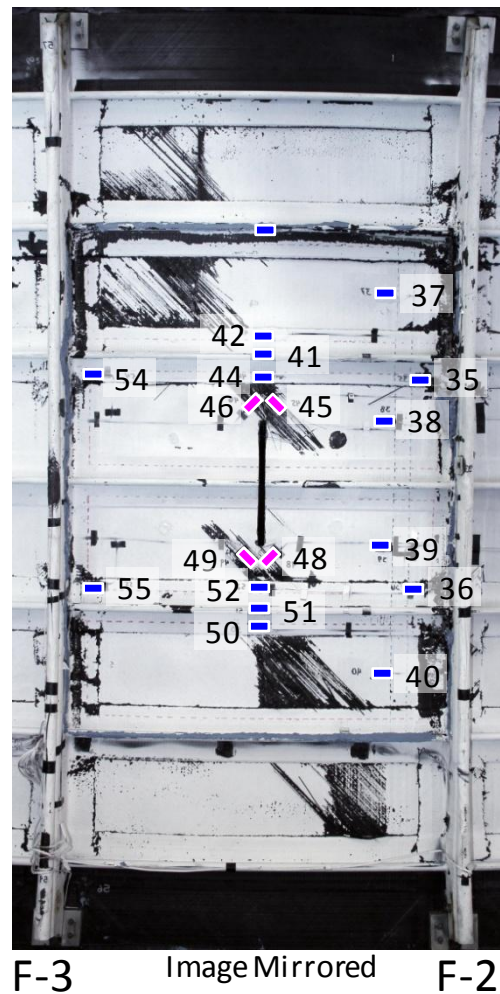
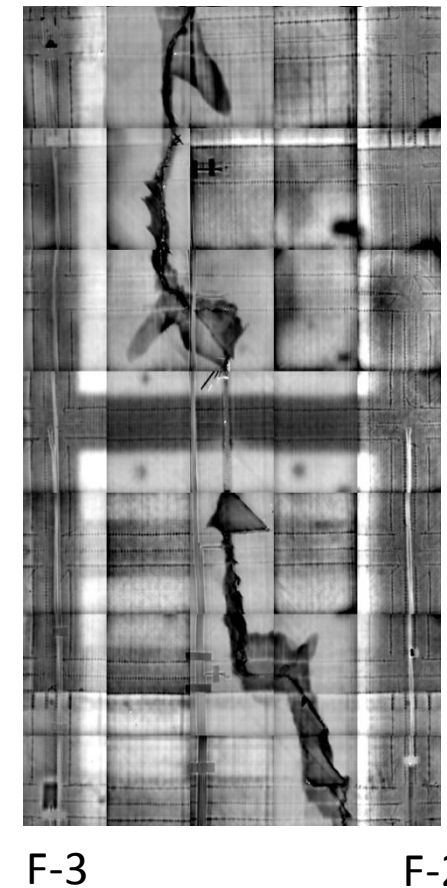
*Damage Widespread and Path Altered at Stitch Rows*
