# Emergency Locator Transmitter Survivability & Reliability (ELTSAR) *Phase 1: Research & Work Plan*

**Briefing to SC-229/WG-98  
CNES Toulouse  
3-5 Sept 2014**

**Chad Stimson, *Project Manager***  
*NASA Langley Research Center*  
[Chad.M.Stimson@NASA.gov](mailto:Chad.M.Stimson@NASA.gov)  
(757).864.3787

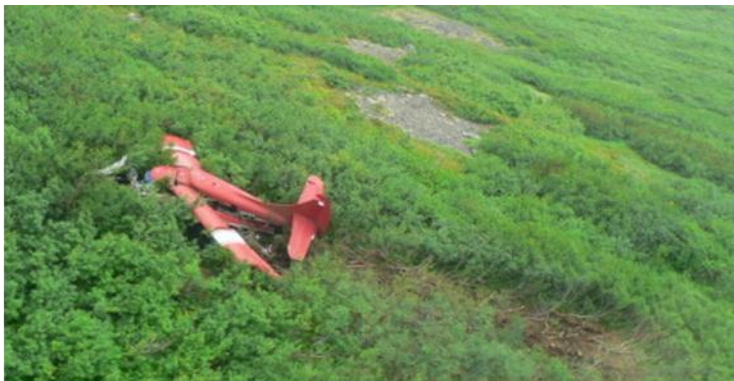
Photograph of the 2009 crash involving former Sen. Stevens and former NASA administrator O’Keefe. The on-board ELT failed and survivors were stranded on the Alaskan mountainside overnight.

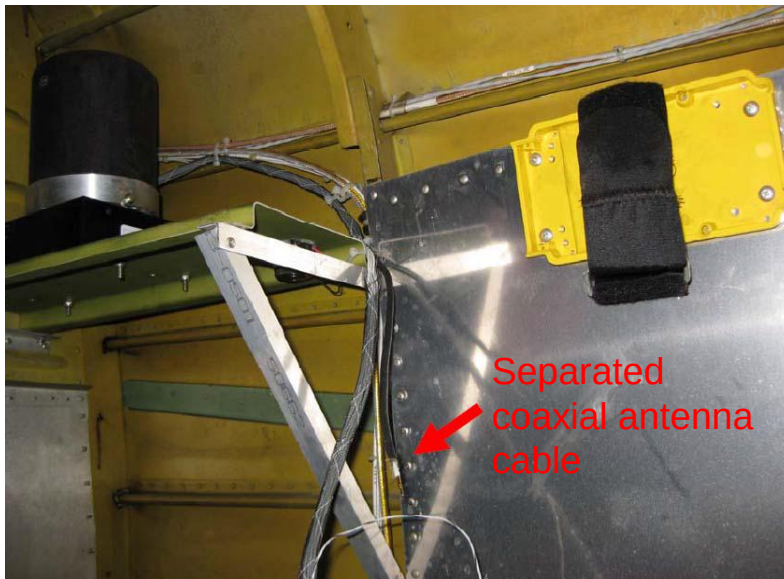
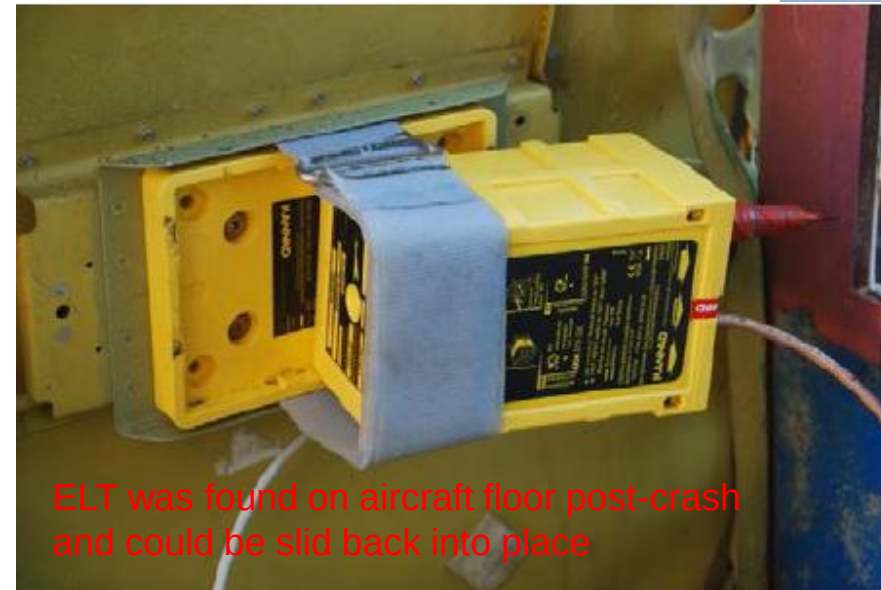
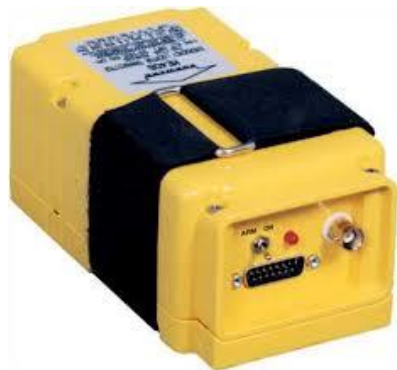
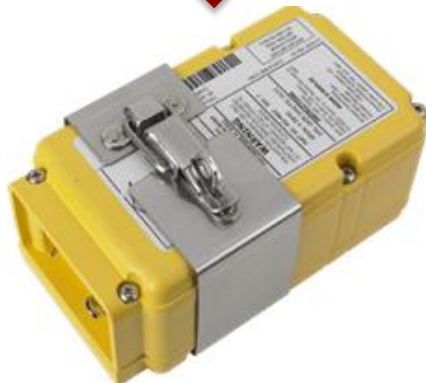
➤ Detailed investigation reports from relatively recent crashes show that ELT systems continue to fail due to the beacon being ejected from its mounting tray

- NTSB [AAR-11/03](#), 9 Aug 2010 (left, Stevens/O'Keefe)
- TSB of CA Report #[A11W0151](#), 4 Oct 2011 (right)
- NTSB Accident #[CEN12FA080](#), 23 Nov 2011
- NTSB Accident #[WPR12FA184](#), 25 Apr 2012

Identification and verification of enhanced installation requirements is a project goal

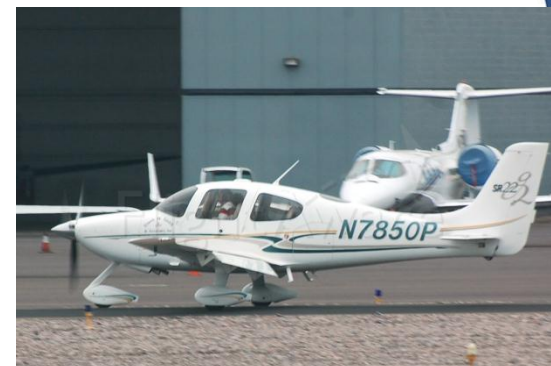
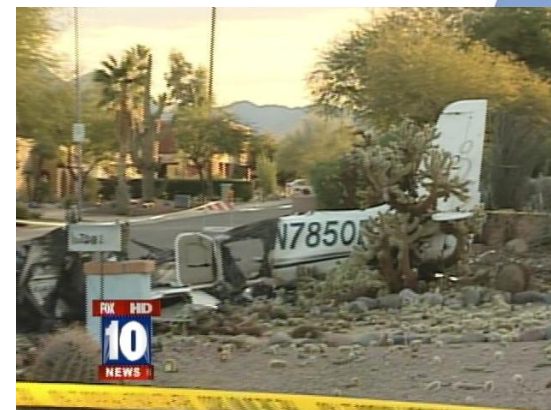
## ➤ NTSB [WPR12FA067](#)

- 15 Dec 2011, Scottsdale, AZ
- Cirrus Design Corp. SR22, N7850P
- Encountered wake turbulence and lost control
- Pilot fatally injured due to “thermal burns”
- Passenger was seriously injured, but escaped the fuselage and survived
- Airplane was consumed by post-impact fire
- Flight data was recovered from the PFD and MFD
- The survivor was fortunate not to have to rely on the ELT, which did not operate in this case
- ELT information from NTSB Factual Report demonstrates the need for enhanced collection:

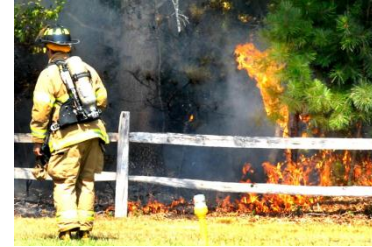
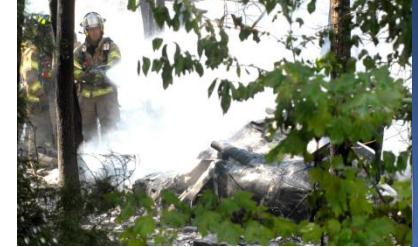
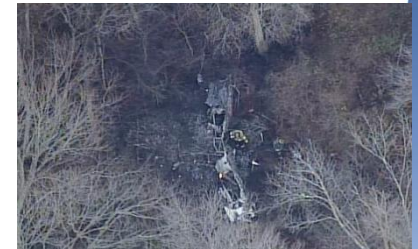
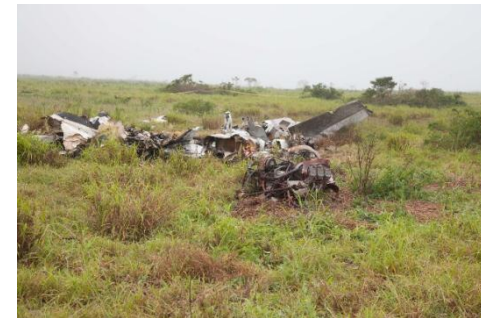
- **NTSB [ERA12FA540](#)**
  - 1 Sept 2012, 1 Fatality, 2 Seriously Injured
  - [Video](#) of postcrash fire and rescue effort
- **NTSB [ERA14LA043](#)**
  - 15 Nov 2013, 0 Fatalities, 1 Seriously Injured
  - [Video](#) of postcrash fire and rescue effort
- **NTSB [WPR14FA124](#)**
  - 26 Feb 2014, 3 Fatalities, 3 Seriously Injured
  - [Video](#) of news footage
- **Available crash data shows that ELTs were installed in each of these cases but failed to operate due to “FIRE”**

Crashes involving severe fire are sometimes survivable for passengers but not AF-type ELTs due to inadequate fire/flame performance specifications

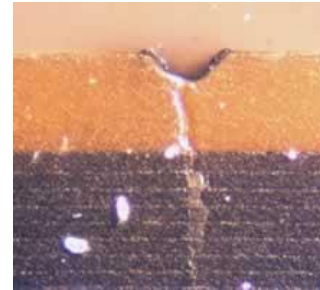
Laser Marking & Propagation

Case study: Proximity of MLC to printed circuit board fasteners caused micro-crack initiation and subsequent burn-out (failure) in automotive application after moisture penetrated the crack over time
