STS-1 FORWARD RCS OXIDIZER TANK SUBSYSTEM FAILURE ASSESSMENT

K. Chauncey Wu NASA Langley Research Center Hampton, Virginia

John J. Zipay NASA Johnson Space Center Houston, Texas

2021 AIAA SciTech Forum and Expo 11-15 January 2021

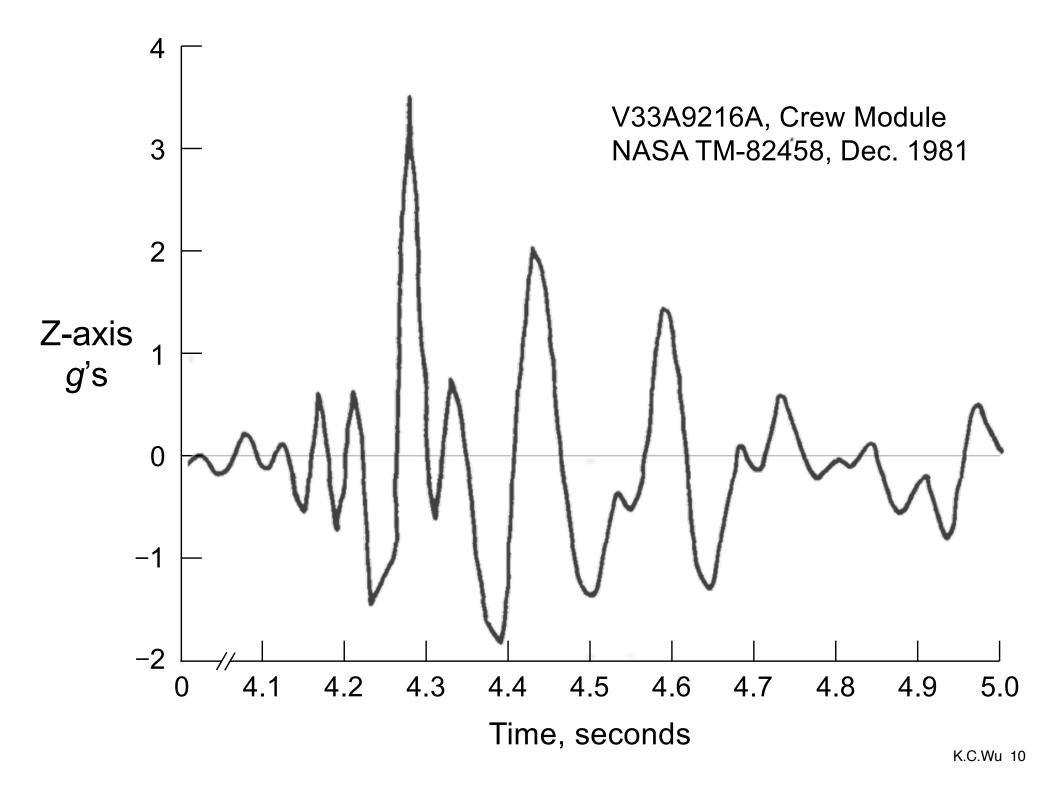
Ignition Overpressure (IOP)

- At solid rocket booster (SRB) ignition, a strong transient IOP wave was generated
- SRB IOP environment was predicted pre-flight with analyses and scale-model testing
- Orbiter frequency response to IOP was greater than pre-flight predictions, exciting vehicle bending
- Peak Z (normal) accelerations of -2g to +3.5g were measured in Orbiter cockpit
- IOP caused other issues; aft heat shield and aerosurface acoustic loading at or near design limits

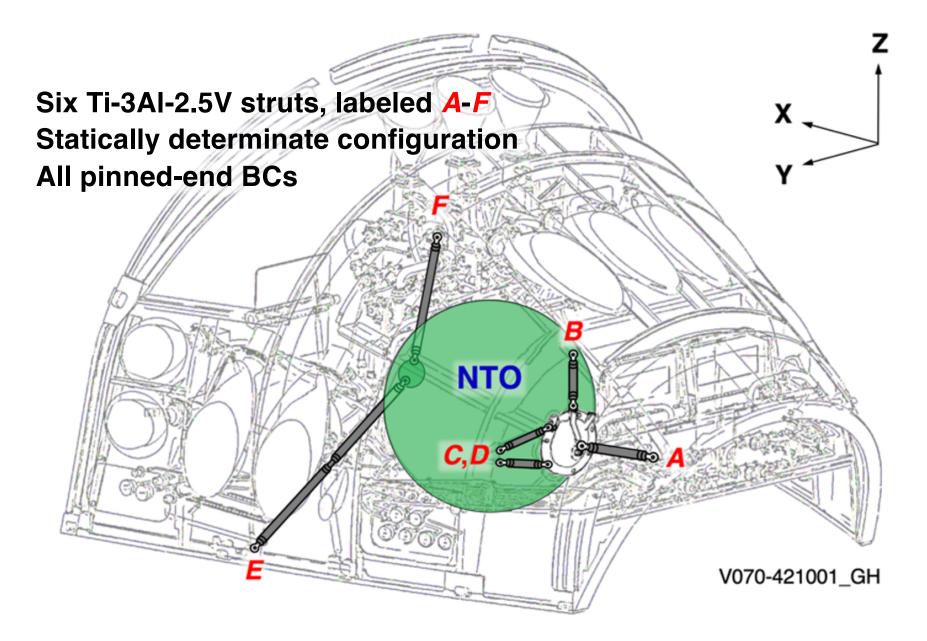
FRCS Oxidizer Tank Subsystem

FLIGHT TEST PROBLEM REPORT NO. 58	_
Statement of problem: Forward RCS oxidizer tank aft Z strut found deformed.	1
Discussion: The forward RCS oxidizer aft Z strut failed in Euler buckling due to the lift-off dynamic response from the SRB overpressure. The forward and aft Z axis tank struts on both the fuel and the oxidizer tanks were replaced with struts reinforced by plies of boron/epoxy. The rod end diameter of the fuel tank struts was increased by 1/16 in. to be the same as the diameter of the ozidizer struts.	STS-1 Orbiter Final Mission Report, JSC-17378, Aug. 1981
The base heat shield left and right struts were reinforced and replaced. All other large mass support systems were reassessed for positive margins.	
	In-Flight Anomaly STS-1-V-58 (IFA Report V-58)
Required date for resolution: CLOSED 7/22/81 Comm Cohen Personnel assigned: E. W. Sandars/ES2 X-6156, R. J. Ward/WA3 X-4323	"Forward RCS oxidizer tank

Action progress: (blank)	- <i>aft Z strut found deformed.</i> "
Effect on subsequent missions: None	"The strut failed in Euler
Conclusions: Z axis accelerations exceeded design limits due to SRB overpressure which resulted in deformation of the forward RCS oxidizer tank aft Z strut.	 buckling due the lift-off dynamic response from the SRB overpressure."
Corrective action: Forward RCS struts were modified and replaced. Base heat shield left and right struts were reinforced and replaced. All large mass structures were analyzed and found to have positive margins of safety.

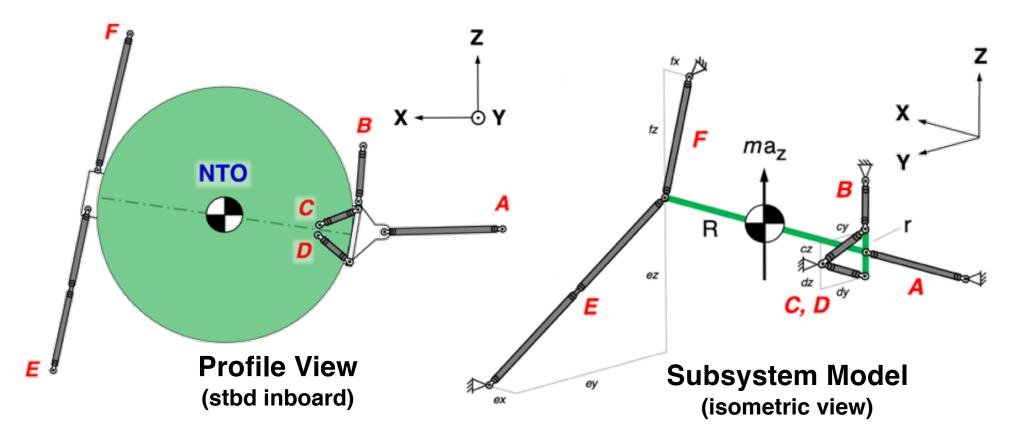
NTO Tank Subsystem Analysis Model

- Rigid tank and FRCS module structures
- Statically determinate => Solve equilibrium for individual strut forces P_i, i = A, ... F
- Calculate $P_F = -ma_Z/(2fz)$, $P_B = P_F fz$
