Spacesuit flash-fire provokes minor alterations

Lessons Learned From the EMU Fire

INVESTIGATORS FILE REPORT ON CAUSE OF SPACESUIT BACKPACK FIRE

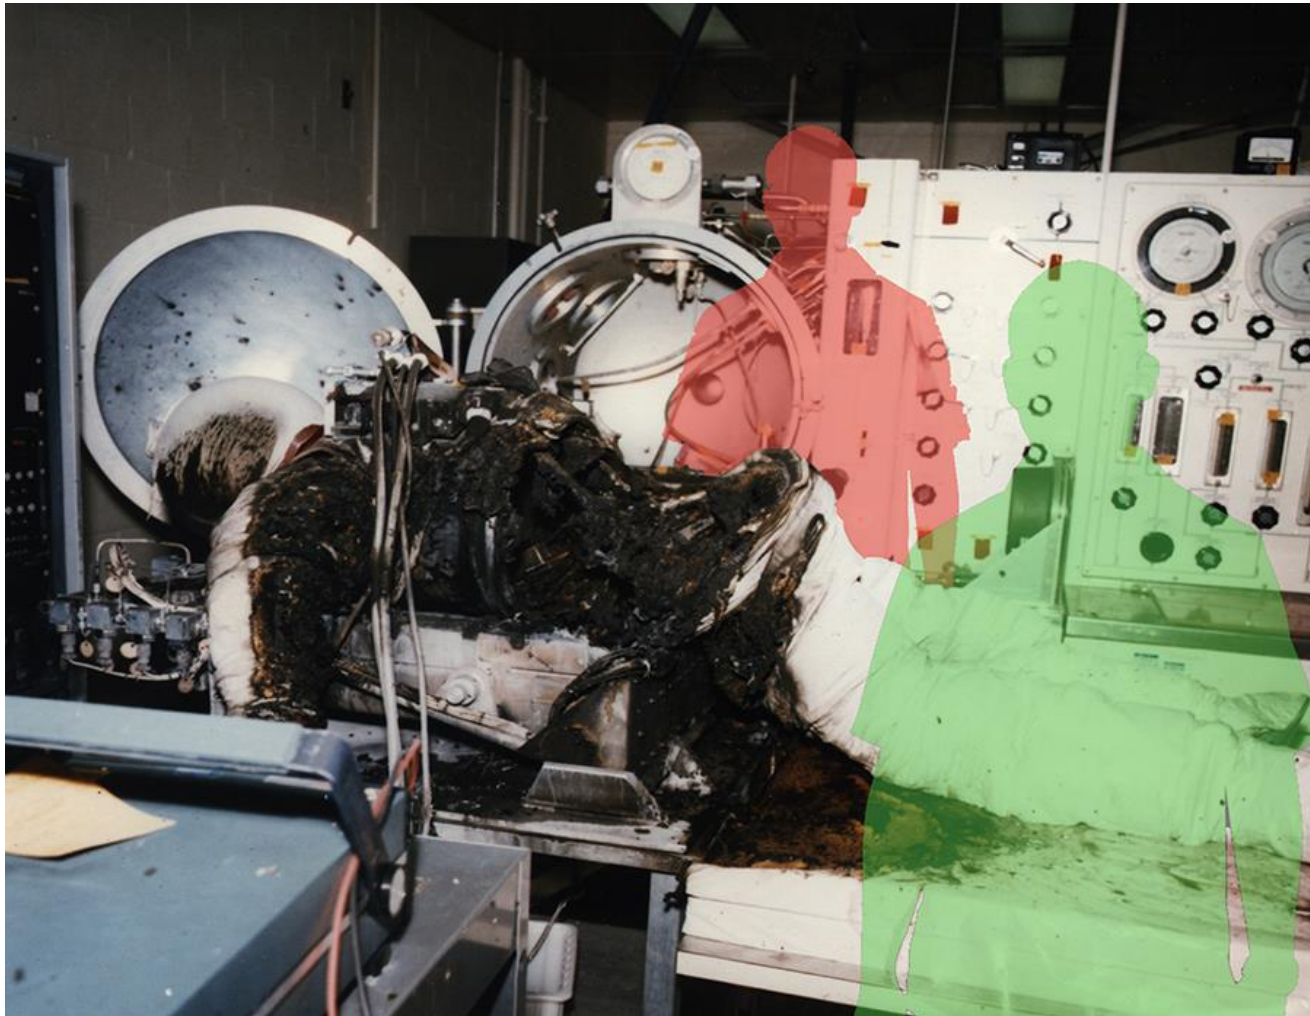
- Regulator vaporized in less than 1 second
- O₂ availability allowed for metal to burn
- O₂ depress less than 2 seconds
- Softgoods burned until extinguished - ~1-2 minutes

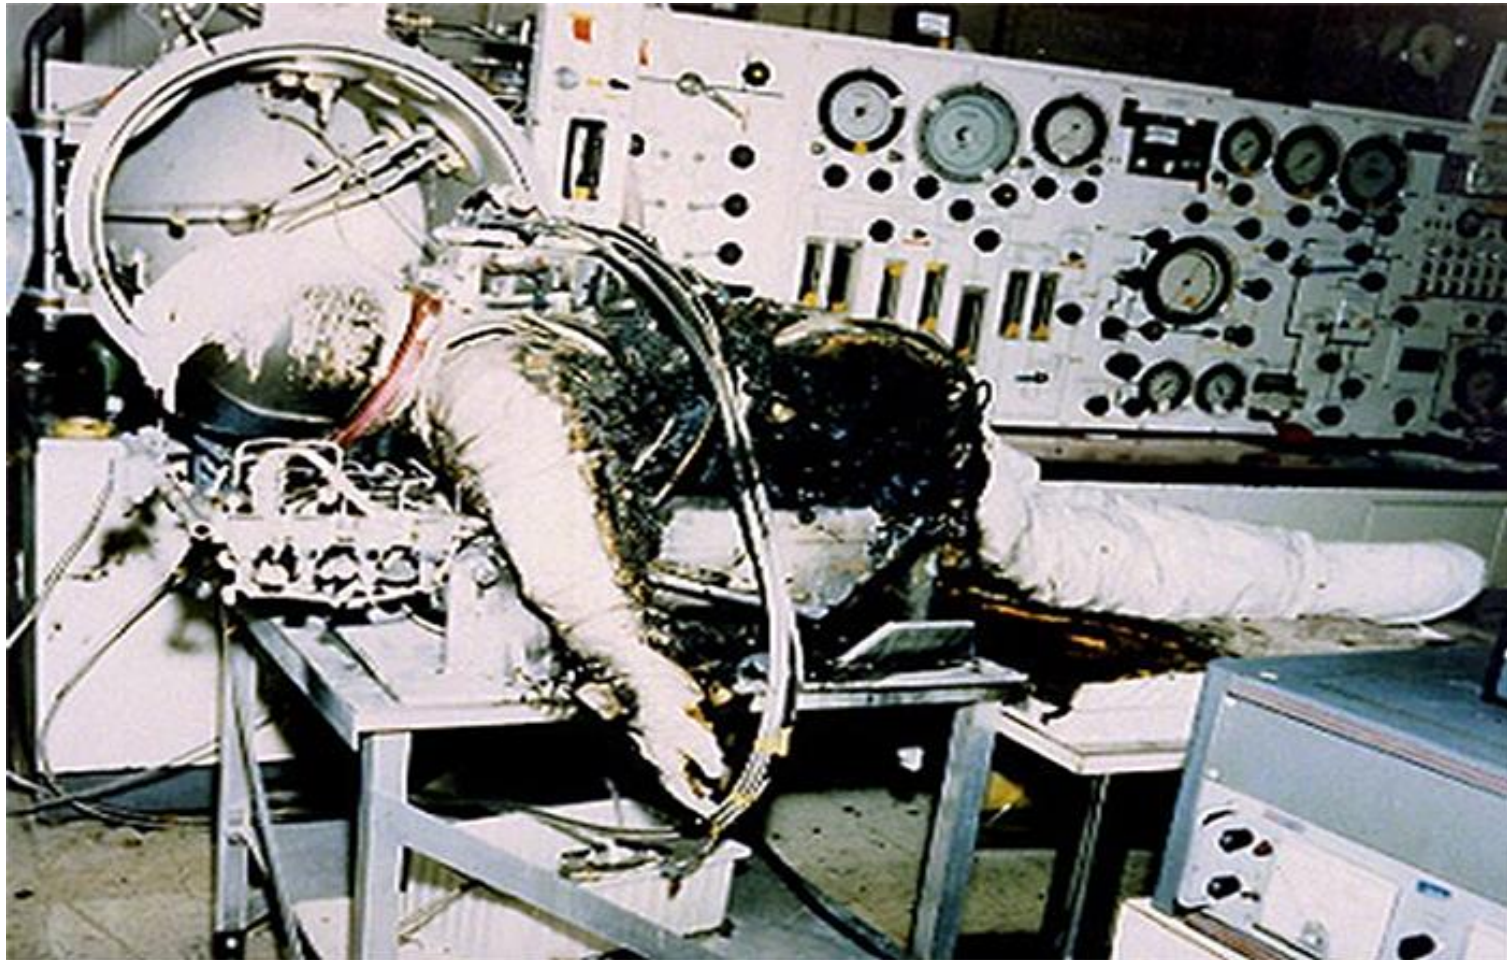
A technician was standing between the suit and test stand

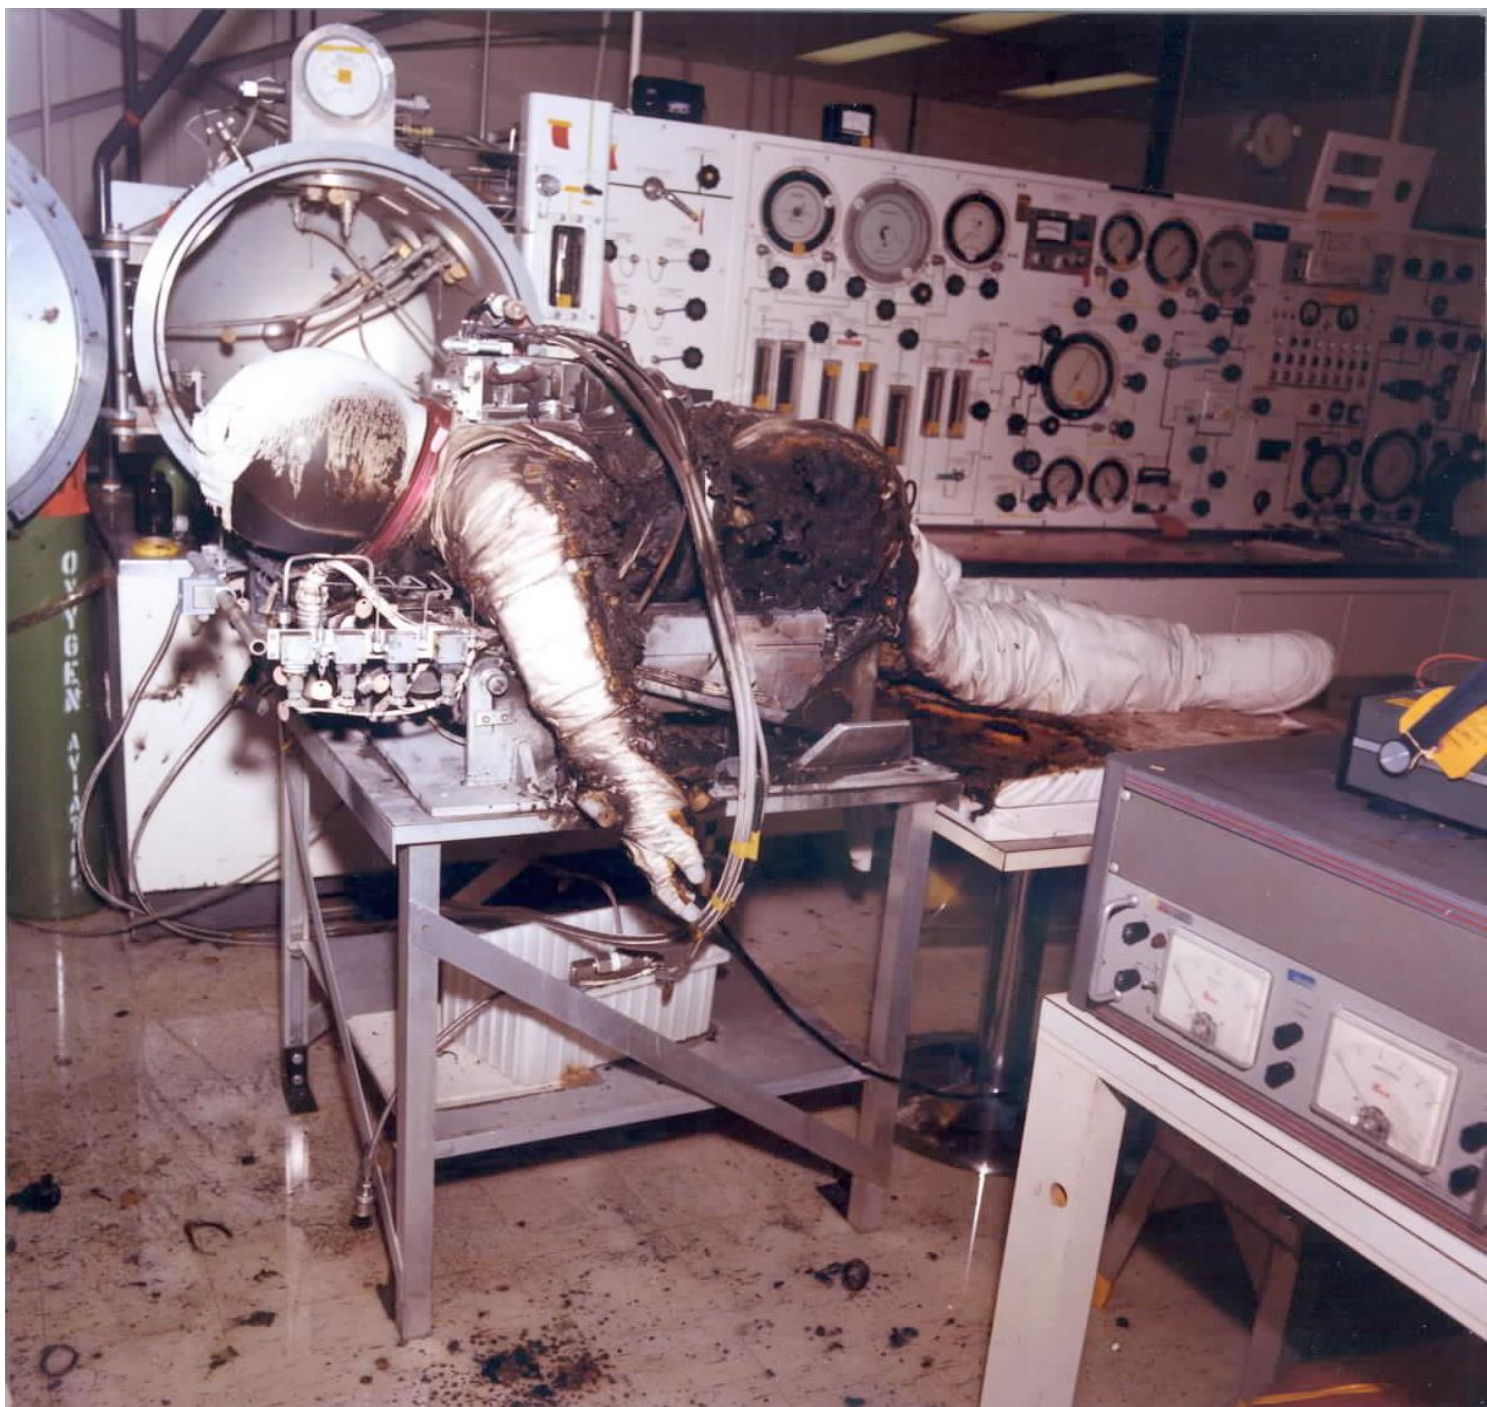
~2 million dollars worth of damage

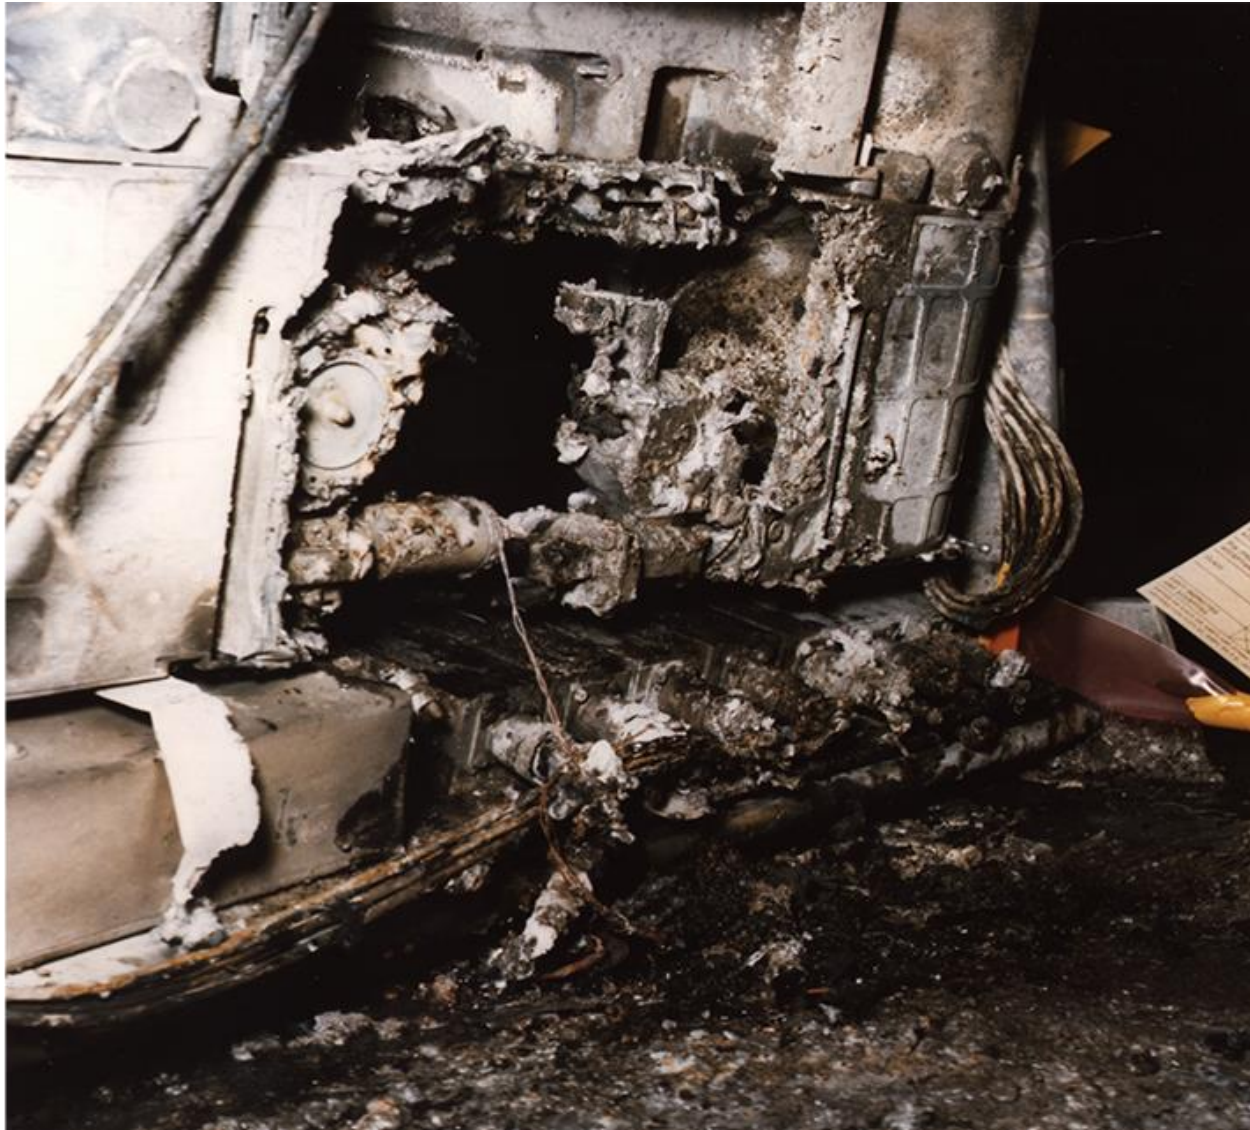
Rear View of SOP/PLSS Regulators

- The fire originated in an aluminum bodied regulator and valve assembly when 6000-psi oxygen was released through the valve into the regulator. It was postulated that the fire was probably caused by one or combination of the following:
 - Rupture of a thin, internal section of the aluminum body
 - Ignition of a silicone O-ring by compression heating of the oxygen
 - Particle impact

As a result of the post-fire investigation, the regulator and valve assembly was redesigned, and the aluminum in this assembly was replaced with Monel®.

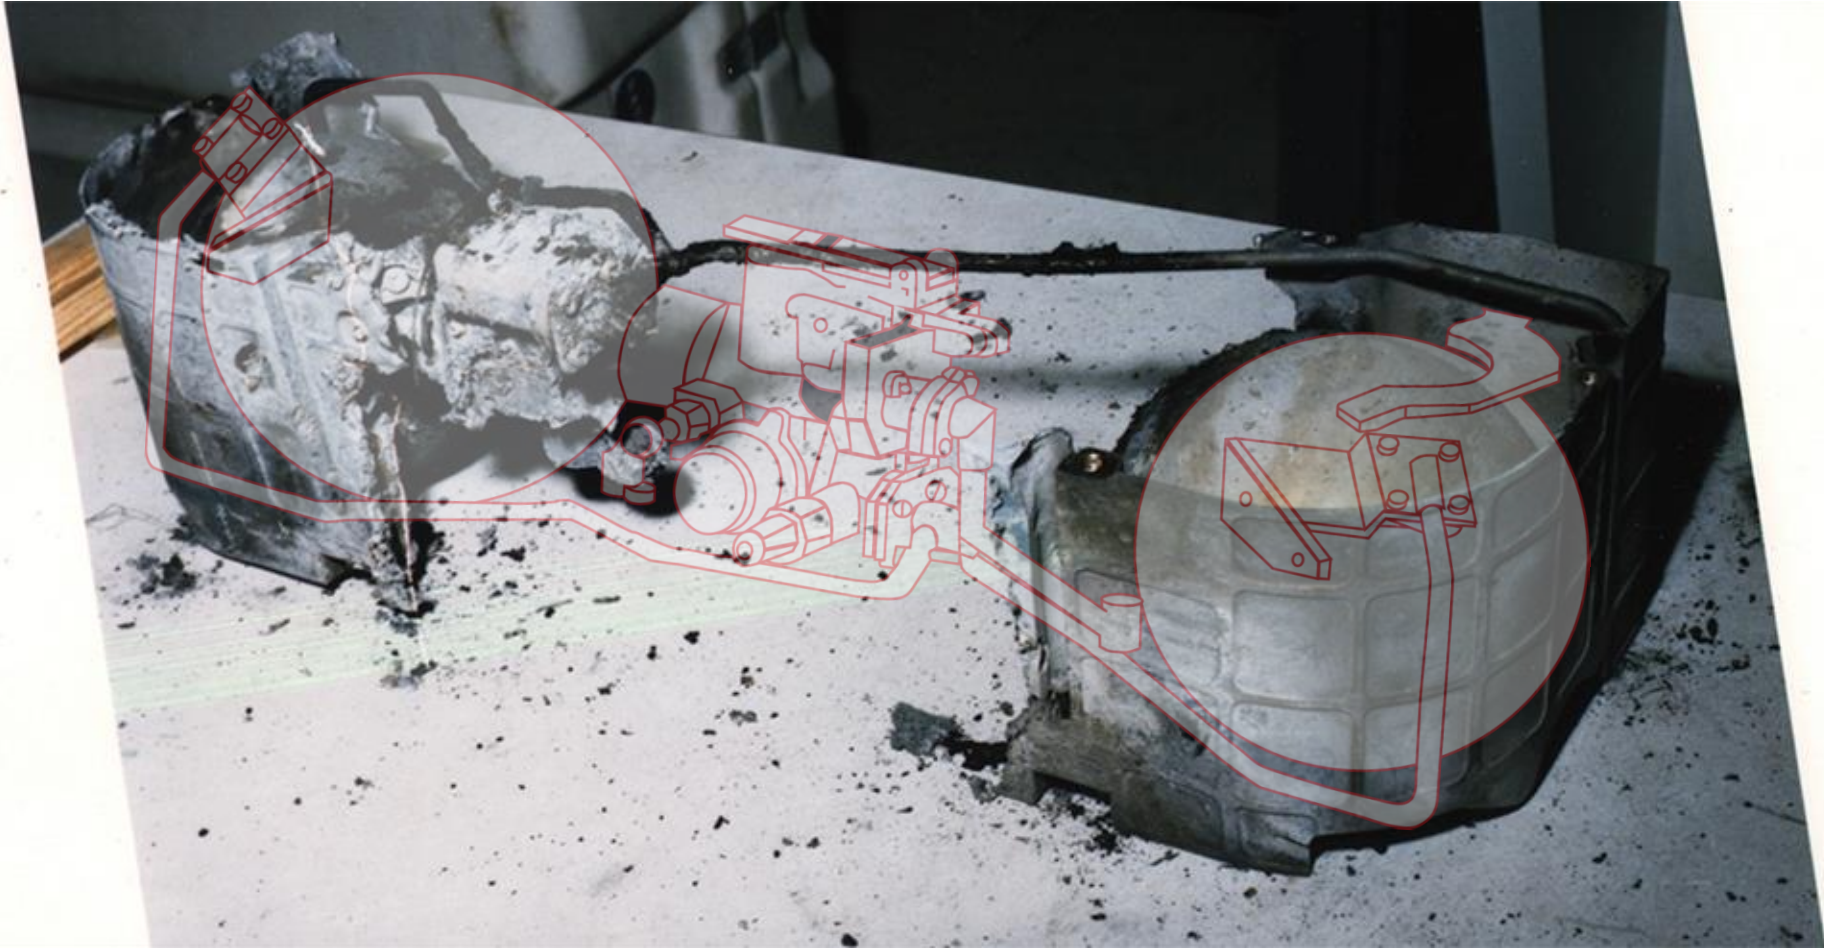
Not Much Left!
