# Short Circuiting the Controller – Missteps in Maintenance and Inspection of Process and Wiring in STS-93

**Abstract.** During the launch of the Chandra X-Ray Observatory in 1999, an in-flight anomaly occurred a few seconds after liftoff. A power fluctuation caused two Main Engine controllers to drop offline. Fortunately, due to redundancy, the Space Shuttle Columbia was able to successfully reach orbit and avoid an abort. After the successful deployment of Chandra and the safe return of the crew, investigation revealed that the controller failure was due to a wire short in the payload bay. It was suspected that the Kapton insulation on the wire rubbed off against a burred screw head, the result of overtightening of the screw during a maintenance event 4 to 5 years prior to the STS-93 mission. Vibrations led the abraded wire to short during flight. The Space Shuttle Program was grounded for 4 months while a program-wide inspection and wire chafing mitigation effort of all orbiter wiring ensued.

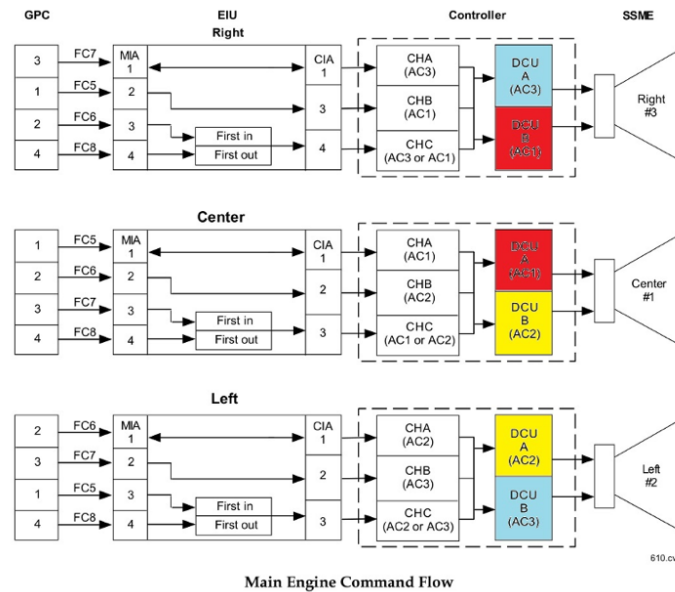
fluctuation, a primary and back-up Main Engine controller, DCU-A (digital computer unit) on the center engine and DCU-B on the right engine (highlighted in red in Fig. 1), dropped offline. Thankfully, that still left at least one working controller, AC-2 and AC-3 highlighted in yellow and blue, respectively, for all three engines.

**Fig. 1.** A diagram from the Shuttle Crew Operations Manual showing how the Main Engines were wired for redundancy. NASA image

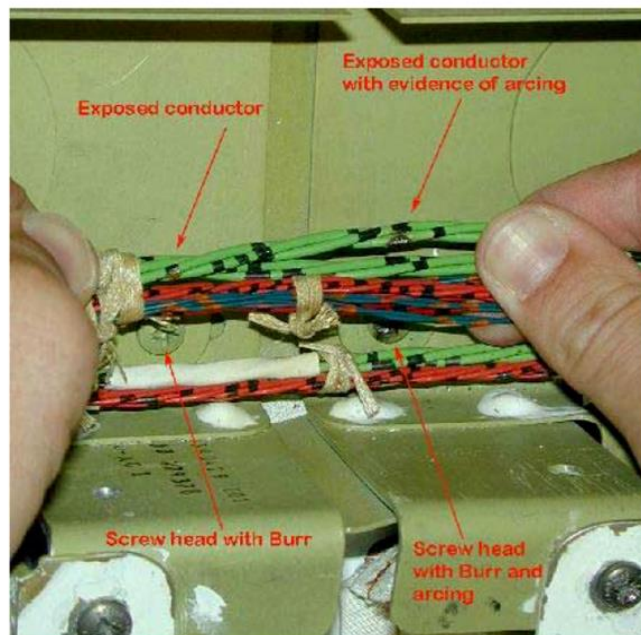
What caused the voltage drop that resulted in the loss of the electrical buses? The post-flight inspection revealed soot on a screwhead and a hole in a stretch of 22-gauge Kapton insulated wiring (Fig. 2). The single strand of AC current carrying 14-gauge polyimide wire was located nearly half-way down the payload bay. The Shuttle Independent Assessment Team (SIAT), formed in September 1999 to do an assessment of the Shuttle Program after this mission, reported that the wire had rubbed and chafed against a burred screwhead. This burr was later determined to be the result of over tightening by a technician during a maintenance refurbishment. Then, during another ground processing event possibly years after, somebody inadvertently stepped on the wiring harness causing some of the Kapton insulation to rub off against the burred screwhead. SIAT suspected the wire damage was pre-existing and was caused 4 or 5 years prior to the flight.

**Fig. 2.** Carbonized insulation due to arc damage. NASA image

Fast-forward to the launch – the power was turned on with the vehicle sitting on the launchpad, so systems confirmed there was electrical flow through those wires. What really set off the arcing of the wire was the vibrations of the vehicle during launch. A common saying amongst NASA engineers is “Test like you fly, fly like you test”. Unfortunately, in this situation, there was no way to test by recreating the vibration by a launch. See Table 1 for summary of events leading to the loss of AC buses.

Due to the in-flight wiring anomaly, the shuttle program was grounded for 4 months and led to a program-wide inspection of the wiring of all orbiters including Columbia. The NASA Space Shuttle program (SSP) determined that the root cause of this anomaly was workmanship. Corrective actions taken by the program included detailed inspection of all mid-body wiring and selected inspection of additional wiring, repair of wiring damage, redefining and standardization of wire inspection criteria to allow for less damage, and additional protection was added to selected critical wiring. The return of the Shuttle to flight status was based on repair of wire damage, wiring failure mitigation by overall Orbiter design, and maximum feasible separation of redundant systems. Other recommendations included quantifying and evaluating the current wire visual inspection processes, certifying technician/inspector by specially trained instructors, and minimizing the long-term use of polyimide wiring.

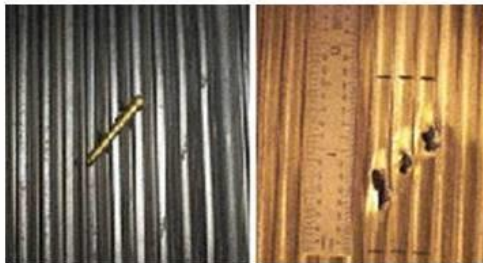
**Fig. 3.** Ejected LOX pin and 3 ruptured tubes. NASA image

After Columbia landed, post-flight inspection of the affected right engine indicated that LOX post 32 in row 13 had shot out and ruptured the narrow part of the converging nozzle and into the nozzle extension. Three nozzle coolant tubes out of five were breached (Fig. 3), causing a hydrogen leak into the hot steam of gas coming out of the engine. Consequently, triggering the premature engine shut-off. The LOX pin shot past the three tubes and also dinged the Main Combustion Chamber but there was no penetration of the coolant channels there.

To all observers – human and digital – it appeared that the right amount of hydrogen was going into the engine because the leak was downstream of the hydrogen flow meter. Analysis showed that if the shuttle had lost five or six tubes, there would be a localized hot spot on the nozzle that could potentially burn through and end in a loss of the whole engine.

The ejection of the LOX post pin incident brought on a maintenance practice change that required damaged oxidizer posts to be removed and replaced as opposed to being intentionally plugged. During the engine block changes, Main Injector manufacturing processes were improved to preclude liquid oxygen post damage. There are no pinned posts in the fleet anymore. All STS flights starting with STS-103 used either Block II or Block II-A Space Shuttle Main Engines. None of these engines had deactivation pins in any of the liquid oxygen injector posts and it was not planned to fly any more pinned posts since 1999.

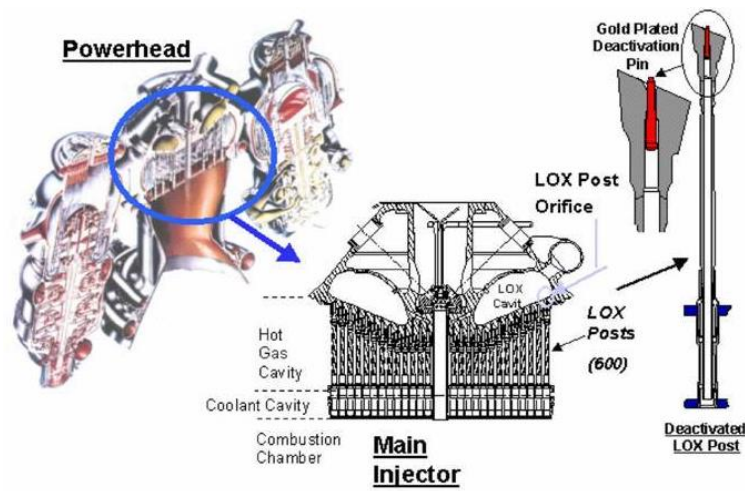
In the Space Shuttle Main Engines (SSME), hot hydrogen gas is mixed with cold liquid oxygen (LOX) in just the right way to protect the engine through the start transient, main stage, and the shutdown transient. The way this is done is the LOX is first introduced through stainless steel tubes called LOX posts (Fig. 3). The robustness of the tubes is generated from the cooling by the LOX inside and the heating by the hot hydrogen outside.

Huge forces work on the LOX posts, especially during start up when the vibration forces are high. If one were to break off there could be possible LOVC. Therefore, to eliminate the potential of a LOX post failure, inspections of posts are performed using ultrasound. It was common practice to deactivate a post if it showed signs of wear or fatigue. To deactivate a post, a gold pin was hammered into the LOX post supply orifice (Fig. 4) and a vacuum leak check was performed. The tapered gold LOX pin, measuring about 1” long and 0.1 inches in diameter, was responsible for shutting off the LOX flow through the post, reducing high-cycle fatigue loading. In the history of the program, 212 LOX posts were pinned in this way including STS-93. There had been 19 prior instances of pin loss during ground testing with no impact damage.

**Fig. 4.** Powerhead, Main Injector and Liquid Oxygen Post details. NASA image
