STUDY OF SPACECRAFT DEPLOYABLES FAILURES

Alejandro Rivera ⁽¹⁾, Alphonso Stewart ⁽²⁾

ABSTRACT

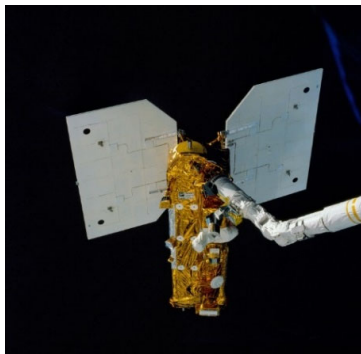
Figure 1. ERBS’ Solar Arrays were deployed with help from the Space Shuttle’s RMS during STS-41G

When in 1984, the Space Shuttle Challenger (STS-41G) was in the process of releasing the Earth Radiation Budget Satellite (ERBS) into orbit, a solar array failed to deploy while the spacecraft was still attached to Challenger’s Remote Manipulator System (RMS). Mission specialist Sally Ride had to shake the satellite with the remotely controlled robotic arm and place the stuck panel into sunlight so that it would extend [2].

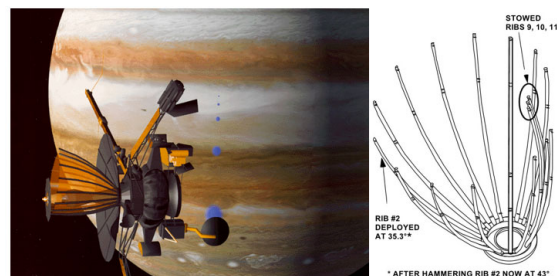
In some instances, deployables failures can result in a total or partial loss of the spacecraft and/or the mission. The Galileo Spacecraft had its 16-foot diameter HGA stowed behind a sun shield to help protect it from the intense solar radiation of the inner solar system tour. When it was far enough from the sun JPL’s flight team sent the commands to initiate the deployment sequence. The antenna only partially opened due to cold welding and excessive friction in the midpoint restraint pins and V-groove socket of the antenna ribs. Drive torques, in excess of motor capacity, would have been needed to free the pins and permit full deployment. The mission proceeded with Galileo transmitting information back to Earth using the Low-Gain Antenna, which had a much smaller bandwidth. The failure of the High-Gain Antenna full deployment and subsequent reduction in available bandwidth reduced the total amount of data transmitted through the mission. However, 70% of Galileo’s science goals were ultimately met [3].

Figure 2. Galileo SC with a partially deployed HGA
