# Experimental Observations of Damage States in Unnotched and Notched 3D Orthogonal Woven Coupons Loaded in Tension

Wade C. Jackson<sup>1</sup>, Andrew C. Bergan<sup>2</sup>, Nathaniel W. Gardner<sup>3</sup>,  
and Cheryl A. Rose<sup>4</sup>

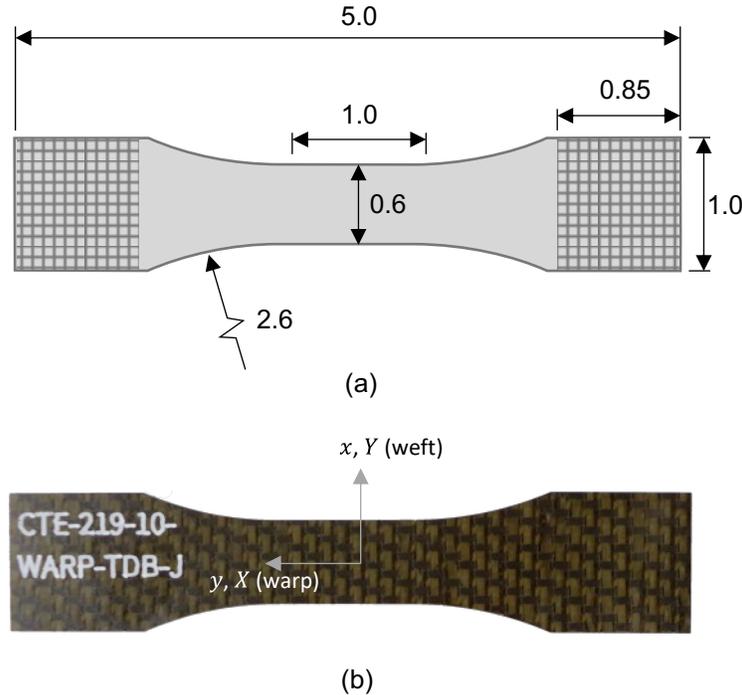
**Fig. 4 Tension dogbone specimen configuration (a) schematic and (b) example photograph, showing the test (lowercase) and material (uppercase) coordinates (right-handedness should not be inferred). The crosshatch pattern in (a) indicates the gripped region. All dimensions are in inches.**

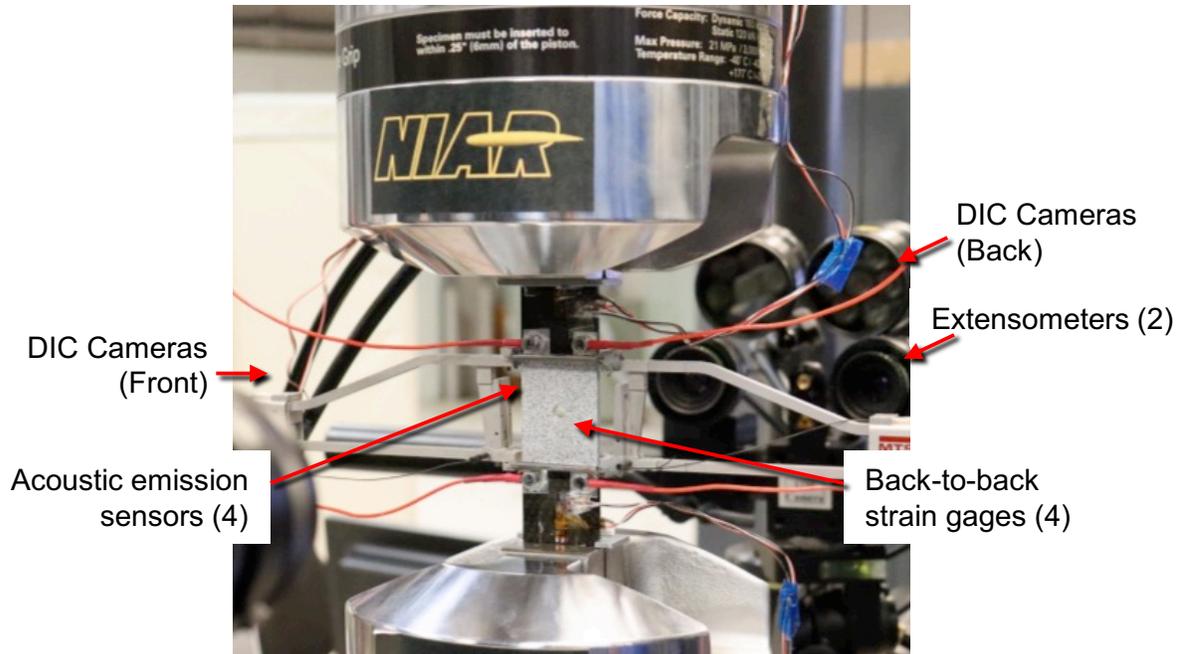
**Fig. 6 OHT test configuration.**

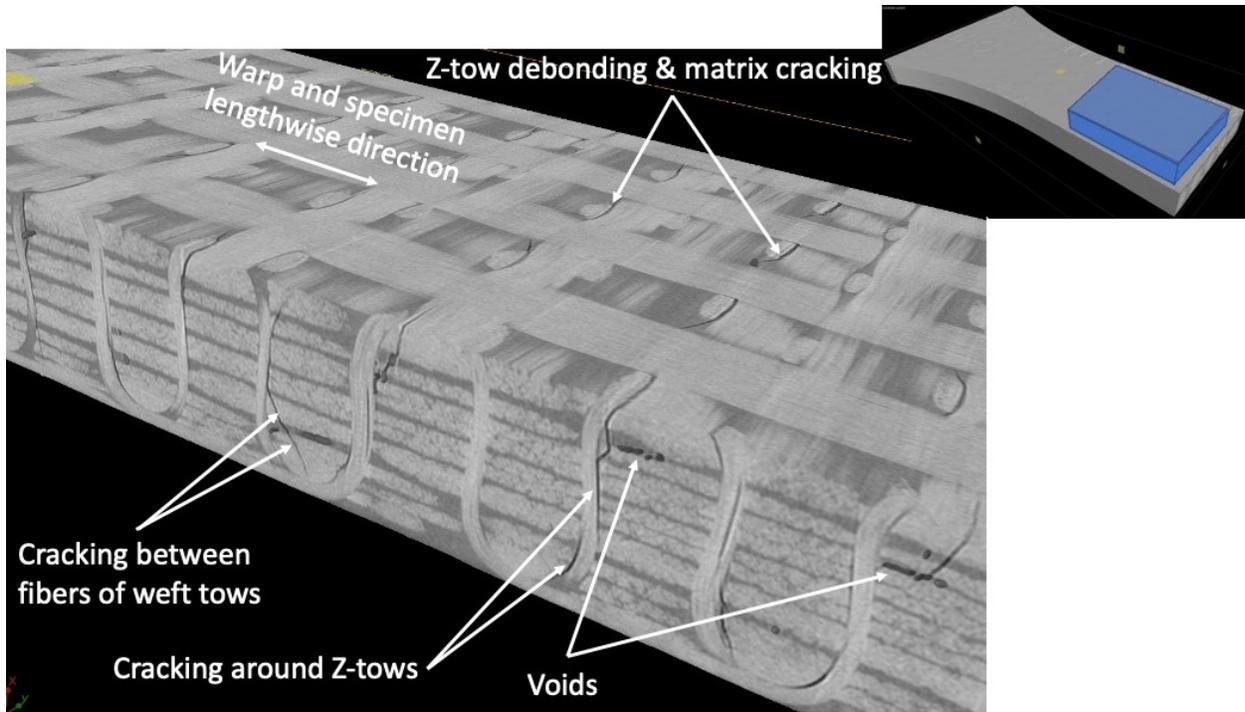
**Fig. 7 Initial defects shown in a X-ray CT image of a 3Z dogbone specimen. Cut-planes on top and edges are shown to display interior damage.**

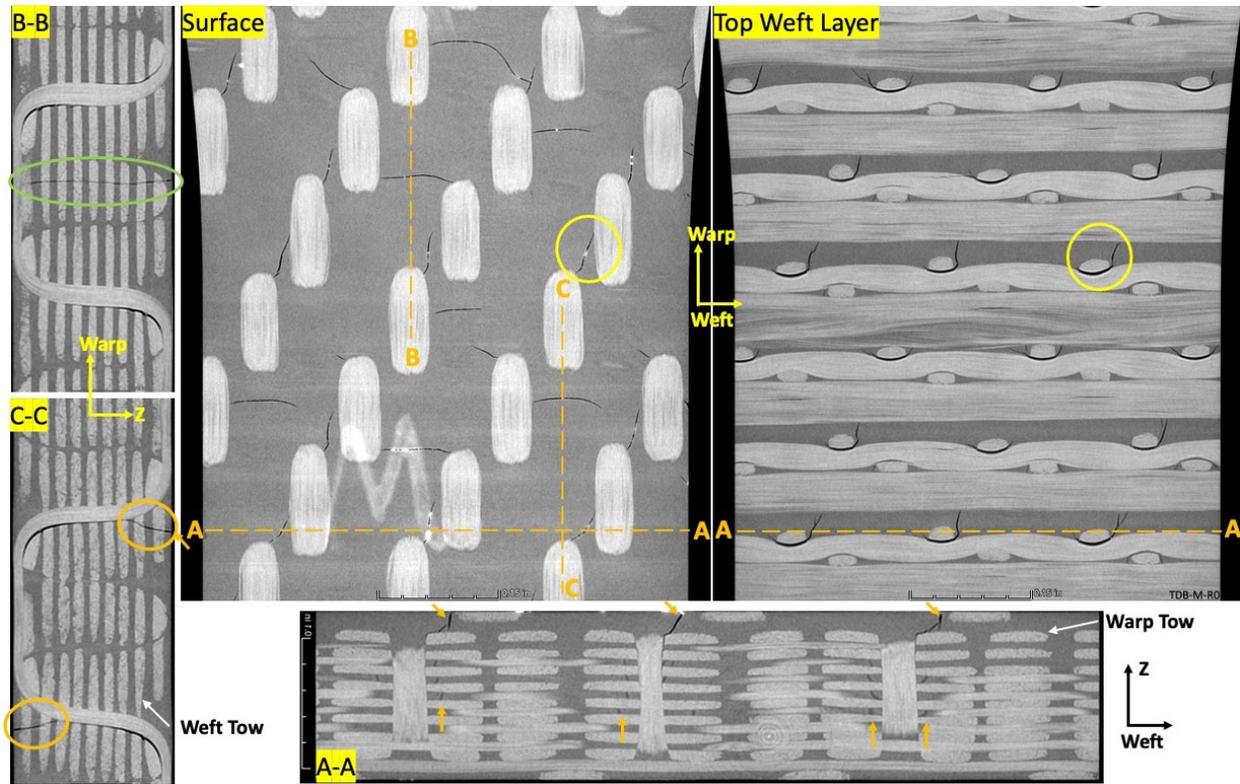
**Fig. 8 X-ray CT images tracing surface cracks for the 1Z architecture.**

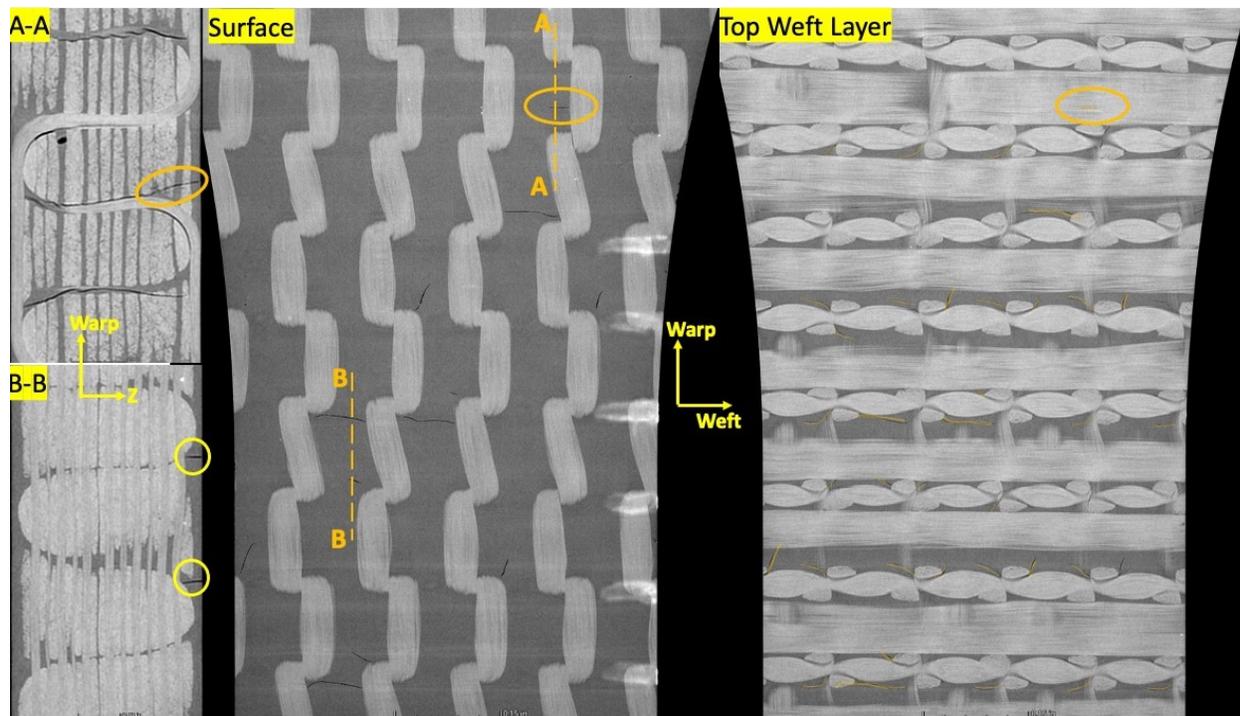
**Fig. 9 X-ray CT images tracing surface cracks for the 3Z architecture.**

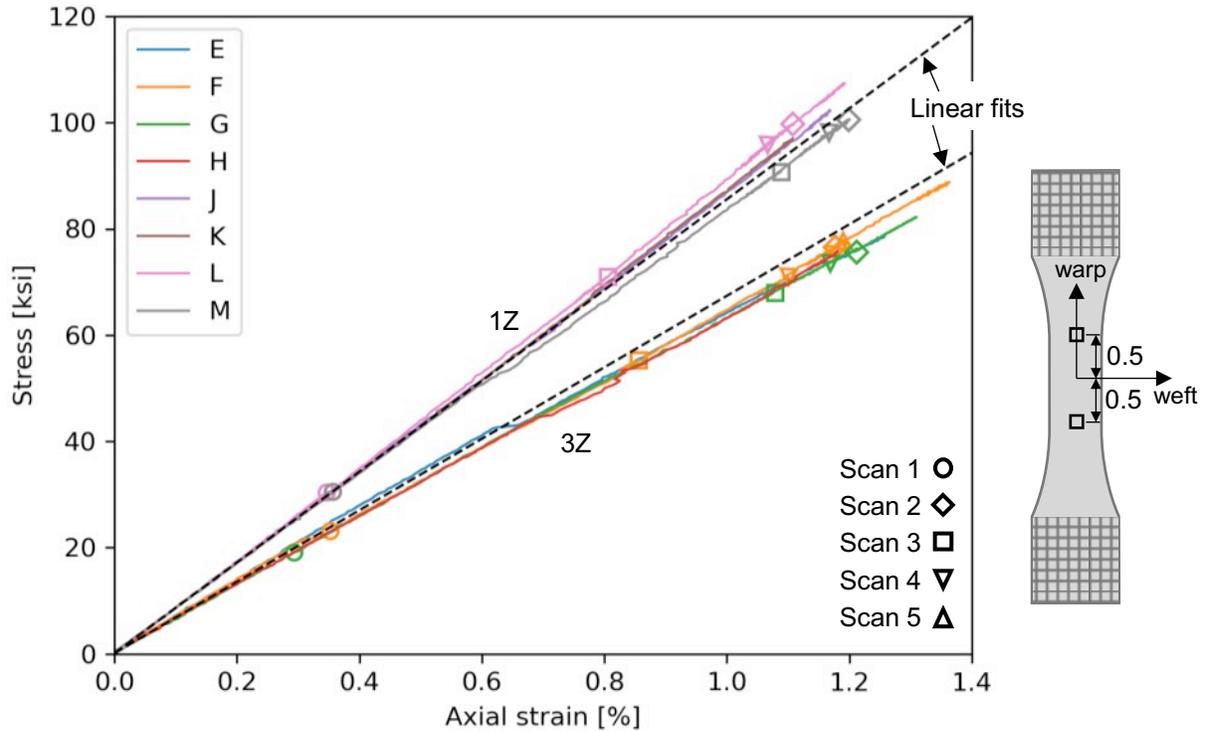
**Fig. 10** Axial stress vs. strain response for the eight TDB specimens from DIC measurement over a 1-inch gage length. Dimensions are in inches.

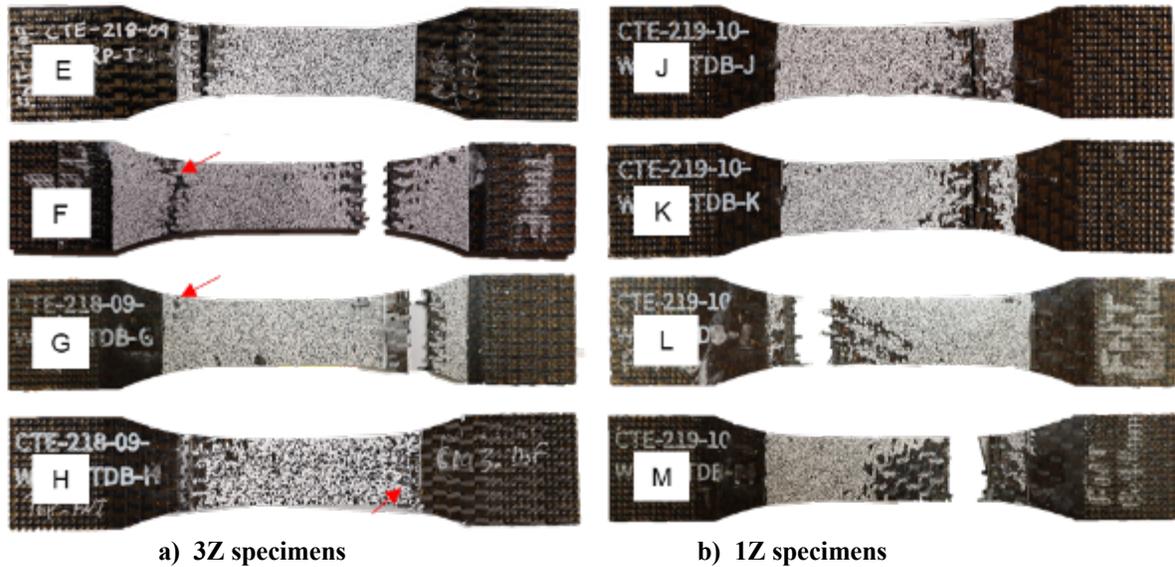
**Fig. 11 Post-failure photographs of the eight TDB specimens. Red arrows mark secondary damage that likely occurred as a result of the stress wave after the primary failure.**

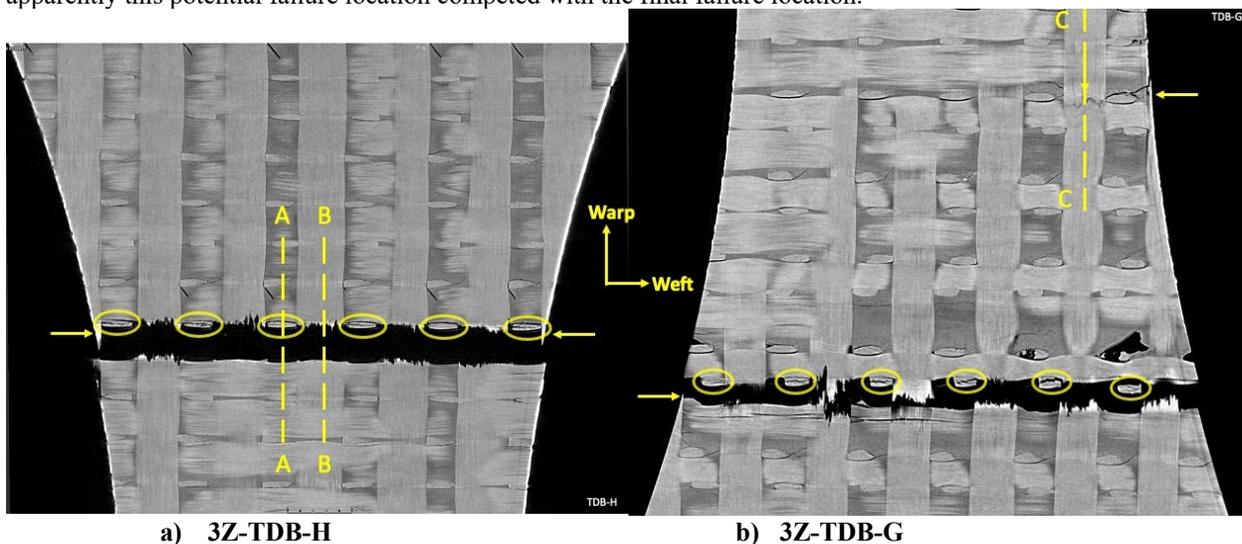
**Fig. 12 X-Ray CT images showing interior fractured warp tows across the width of specimen a) 3Z-TDB-H and b) 3Z-TDB-G. Warp-direction cross sections are shown in Fig. 13.**

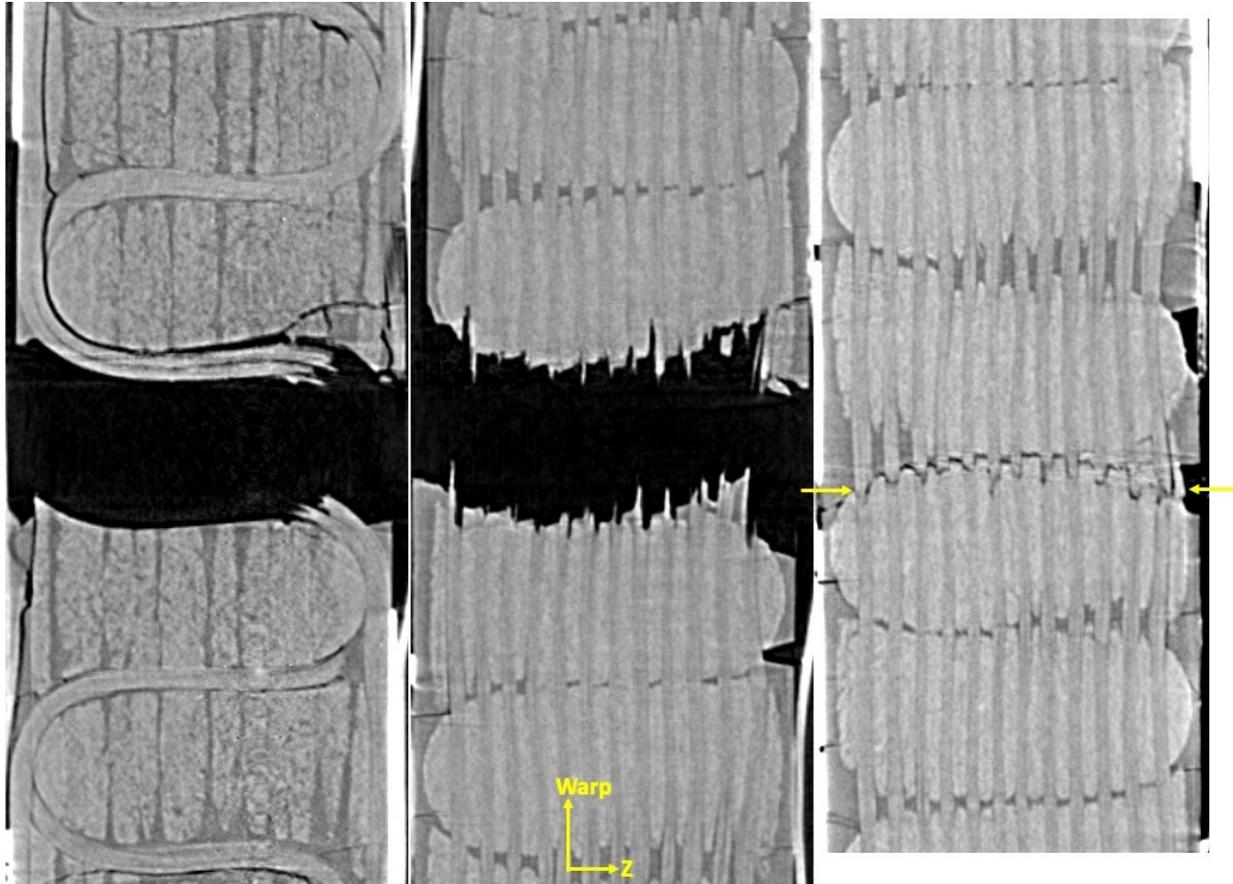
a) TDB-H Section A-A

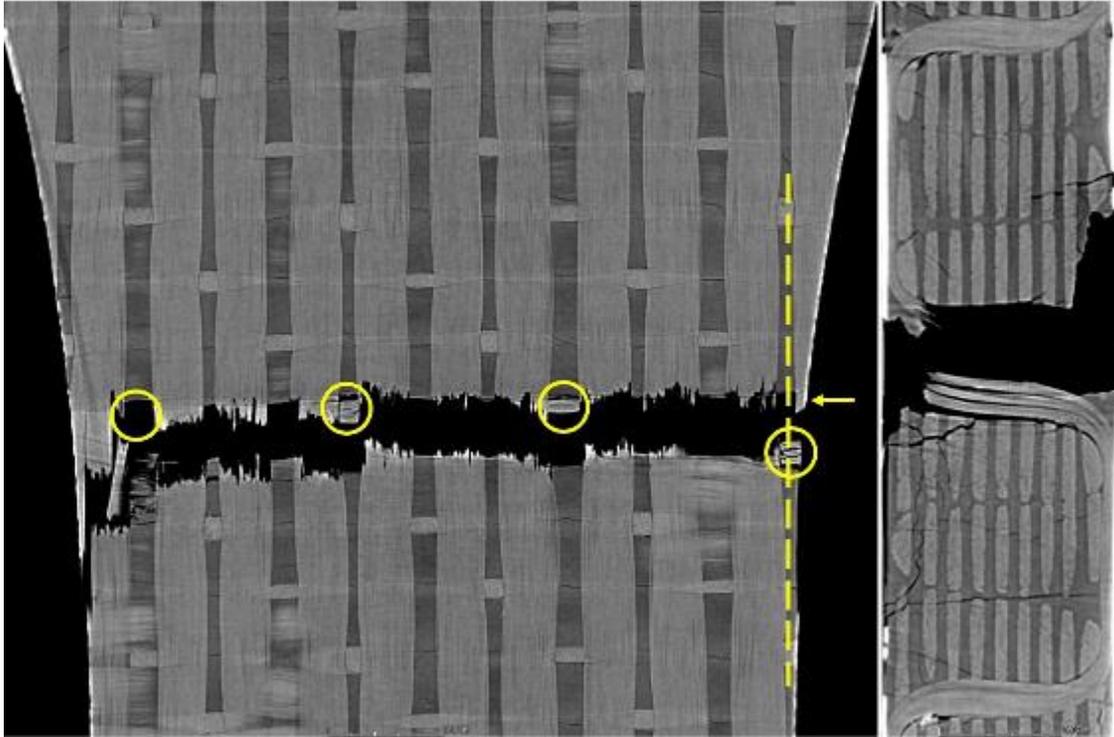
a) Slice showing warp tow fracture near mid-thickness

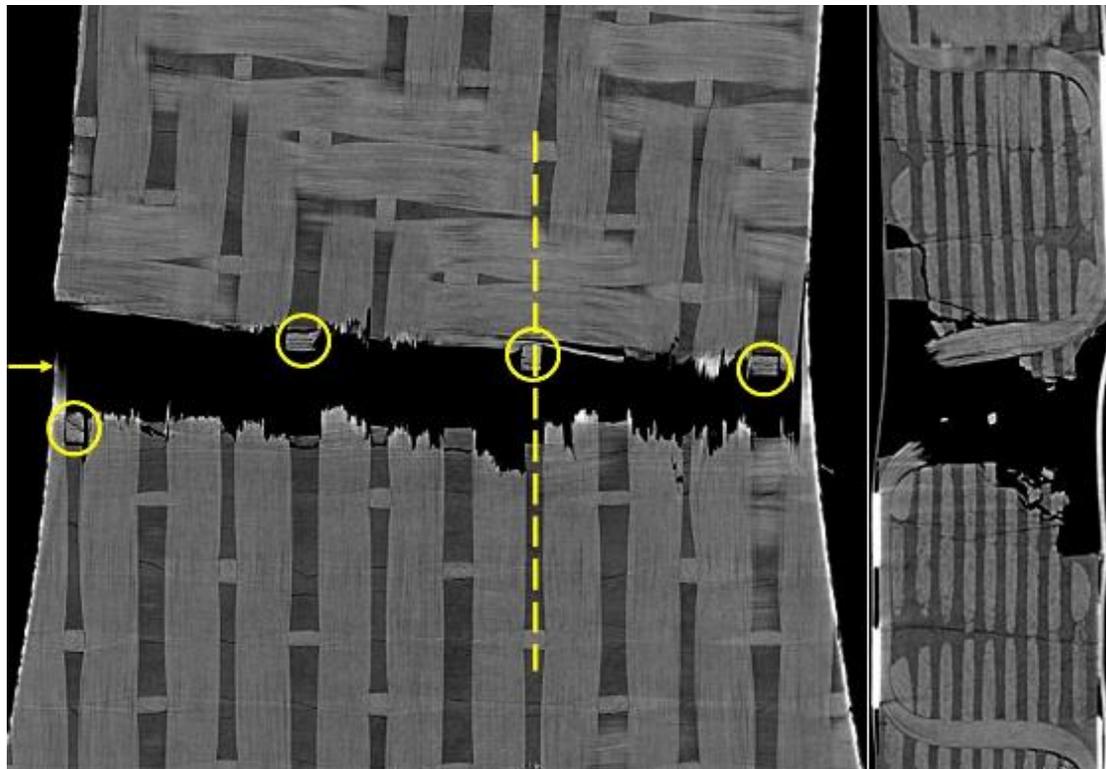
a) Slice showing warp tow fracture near mid-thickness

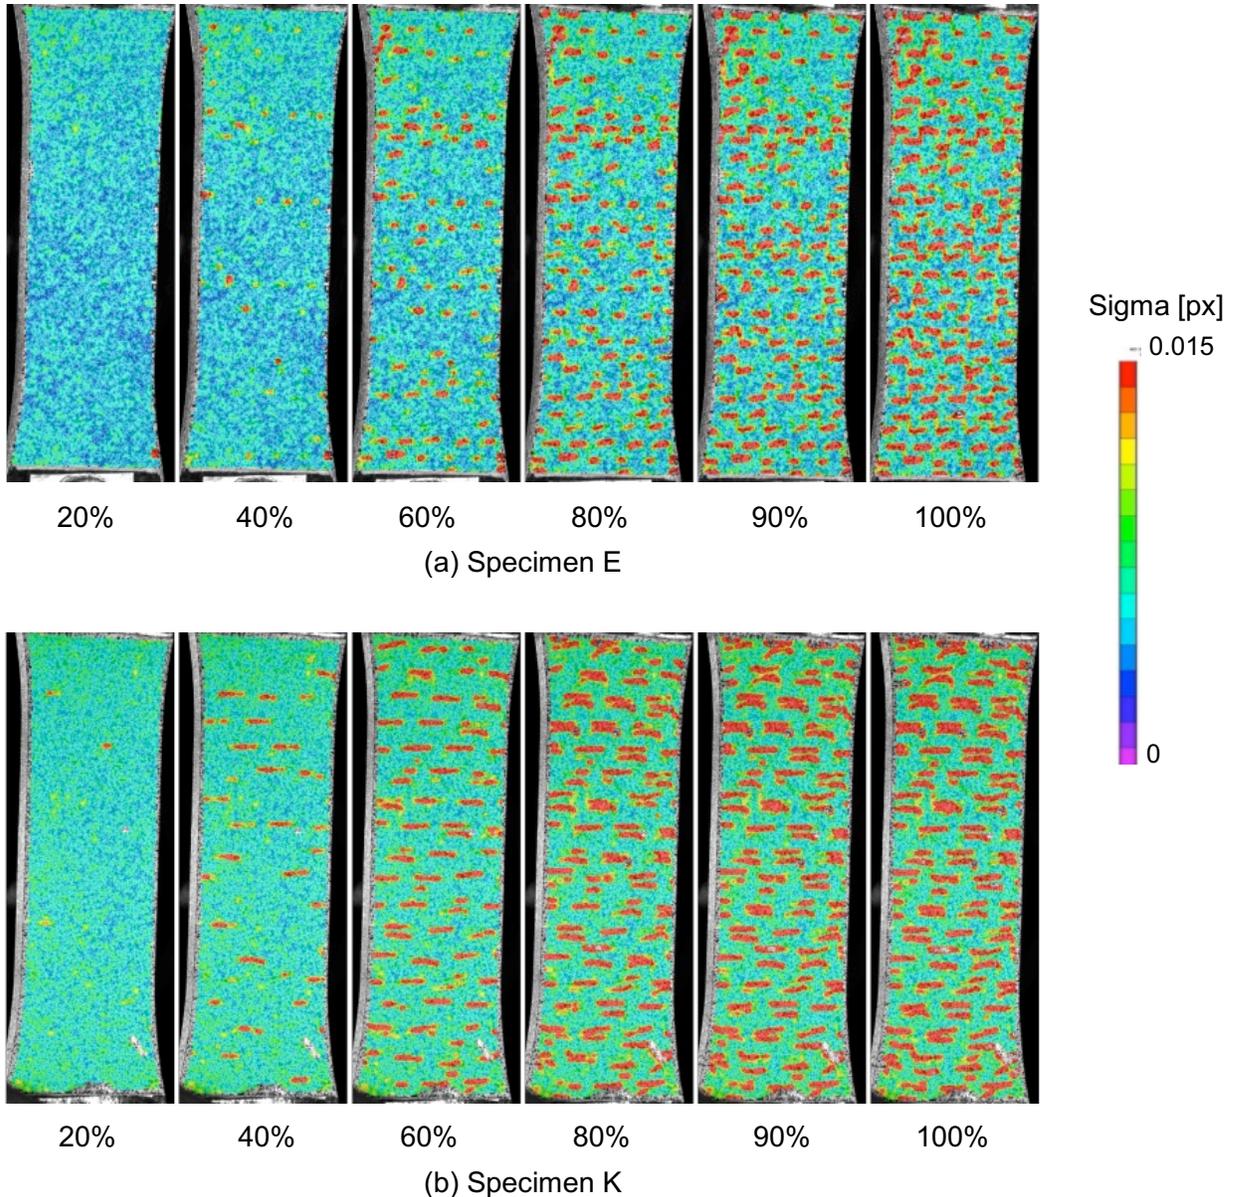
**Fig. 16 DIC uncertainty coefficient contour plots for two TDB specimens, with color scale selected to highlight surface cracking.**

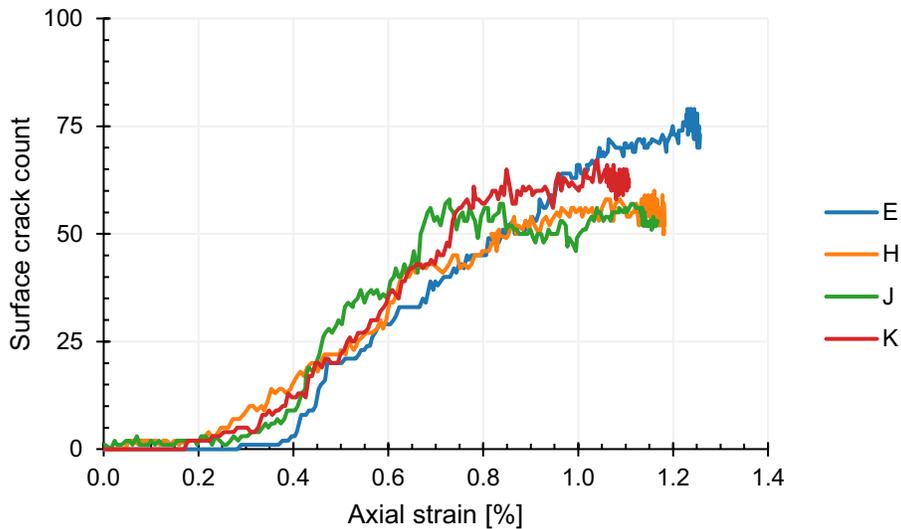
**Fig. 17 Results of crack counting algorithm showing surface crack accumulation through the load history.**

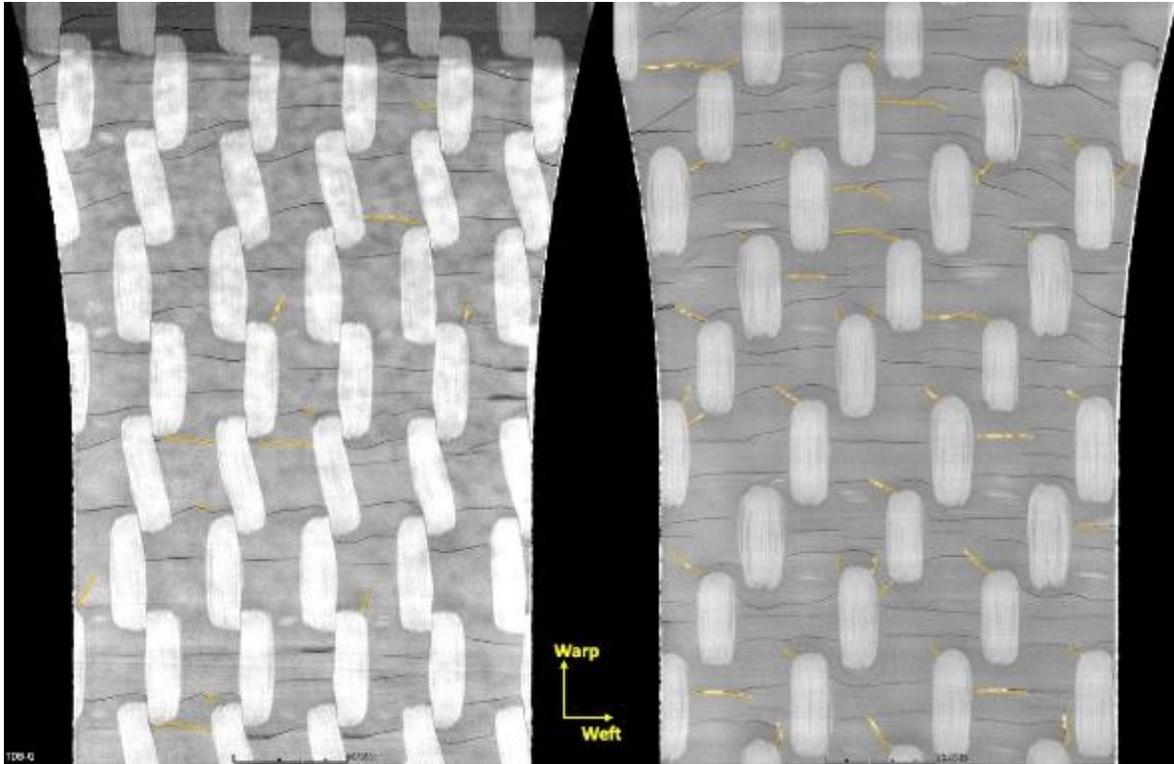
a) 3Z-TDB-G at 93% of failure load                      b) 1Z-TDB-M at 100% of failure load  
**Fig. 18 Surface cracking shown in X-ray CT images. Manufacturing cracks are highlighted in orange.**

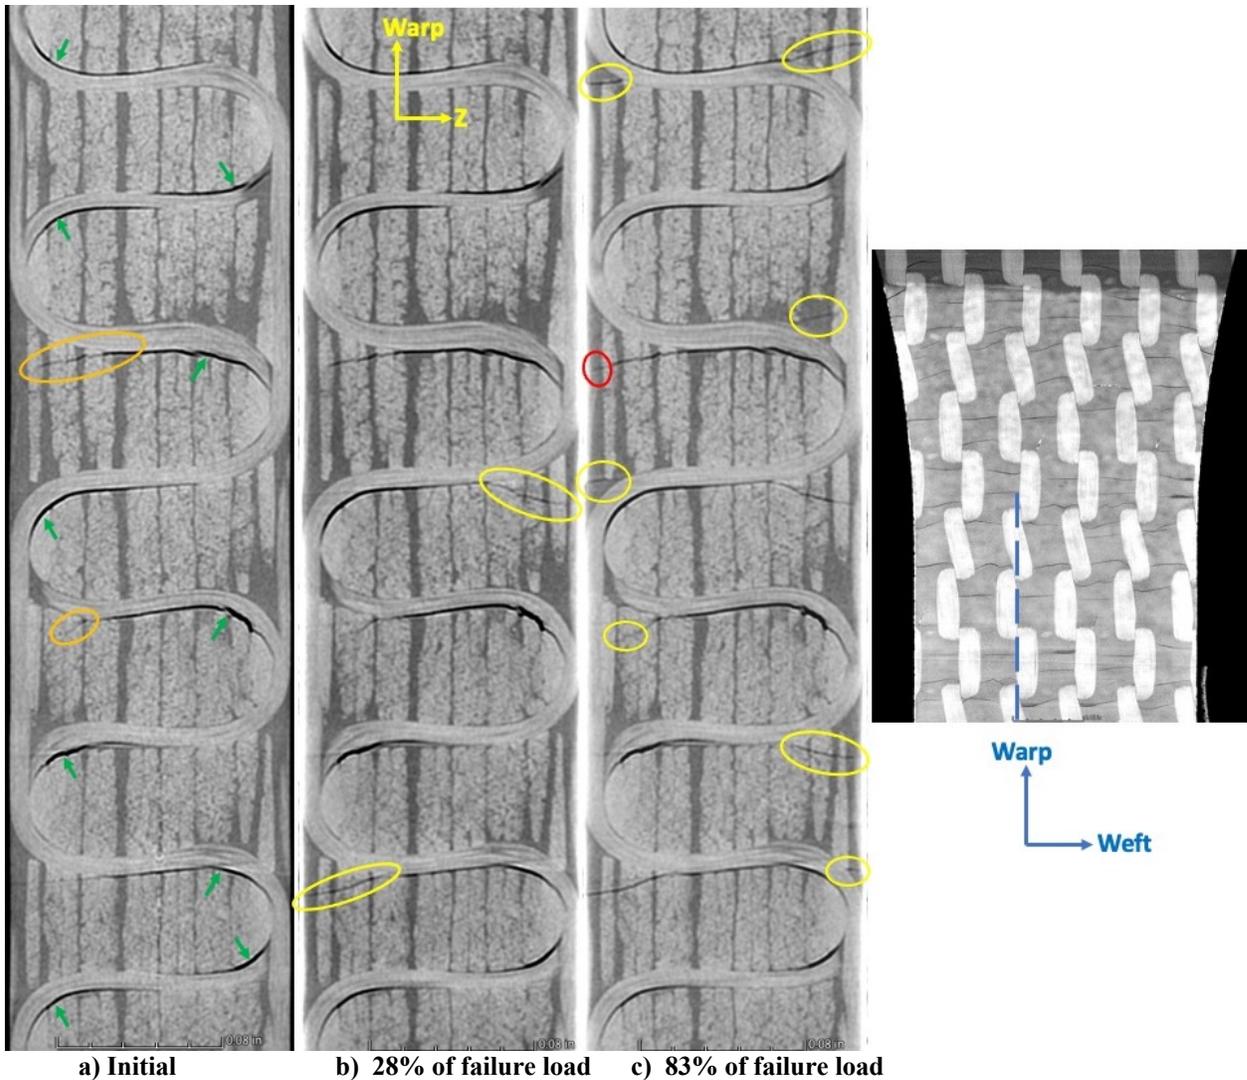
**Fig. 19 Interior cracking 3Z-TDB-G shown in X-ray CT slices between the warp tows. Surface image shows the slice location. Orange circles indicate initial damage. Green arrows indicate initial Z-tow debonding. Yellow circles indicate new damage development.**

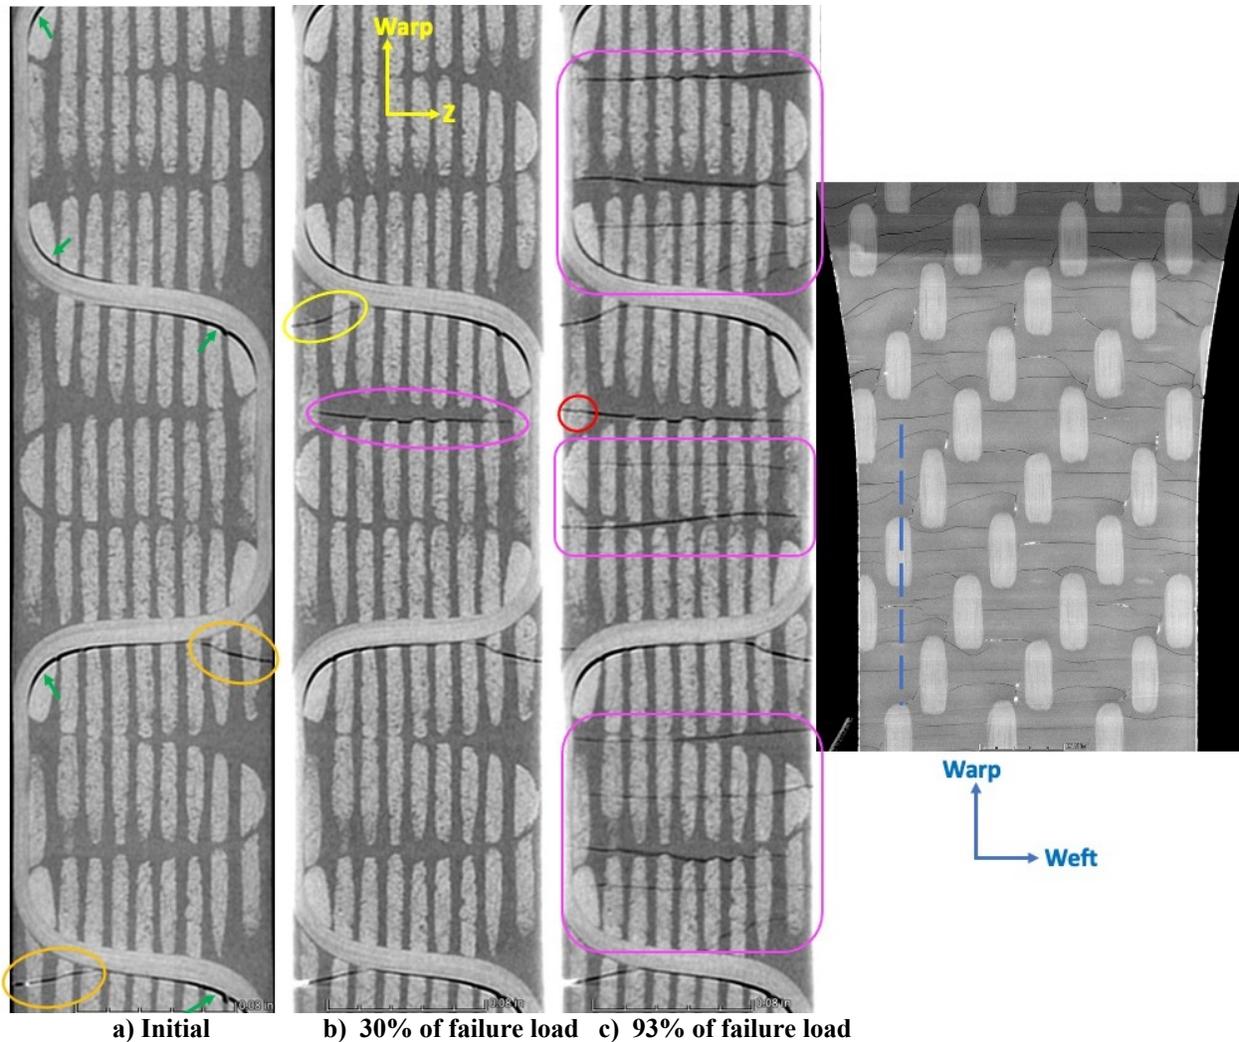
**Fig. 20** Interior cracking 1Z-TDB-M shown in X-ray CT slices between the warp tows. Surface image shows where slices were extracted. Green arrows indicate debonded Z-tows. Orange circles indicate initial cracks. Yellow and purple shapes indicate new damage.

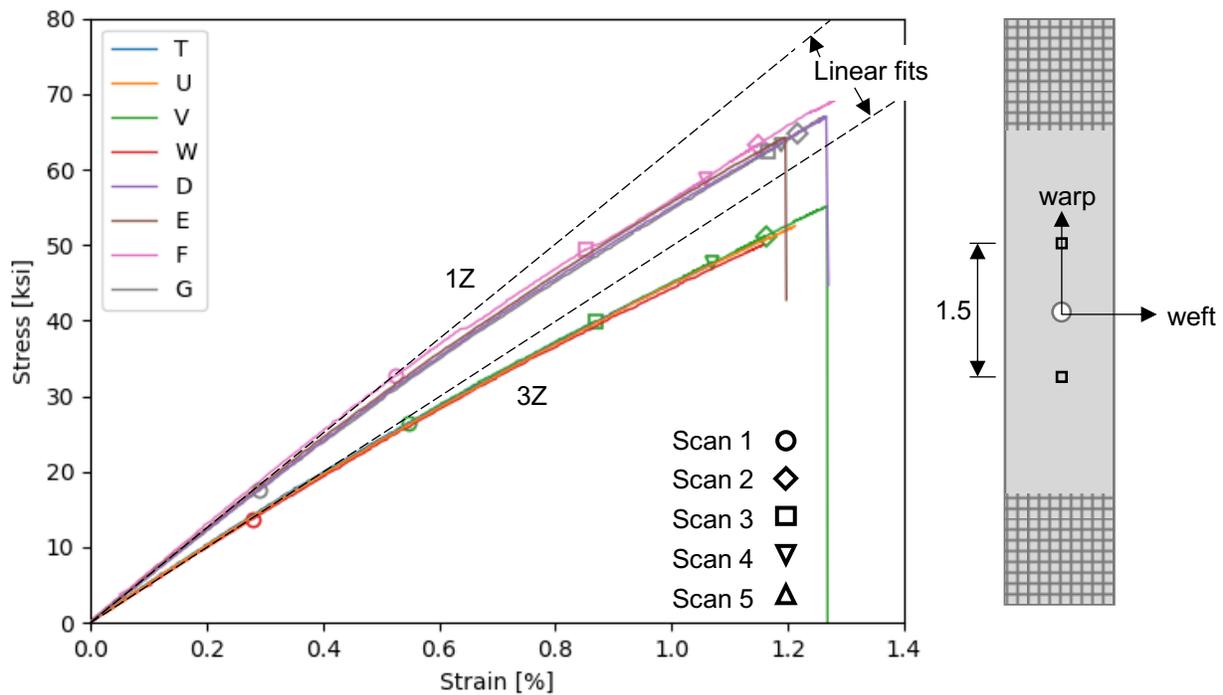
Fig. 21 Axial stress vs. strain from DIC measurement over a 1.5-inch gage length. The DIC data are extracted averaging over 0.001 in<sup>2</sup> regions.

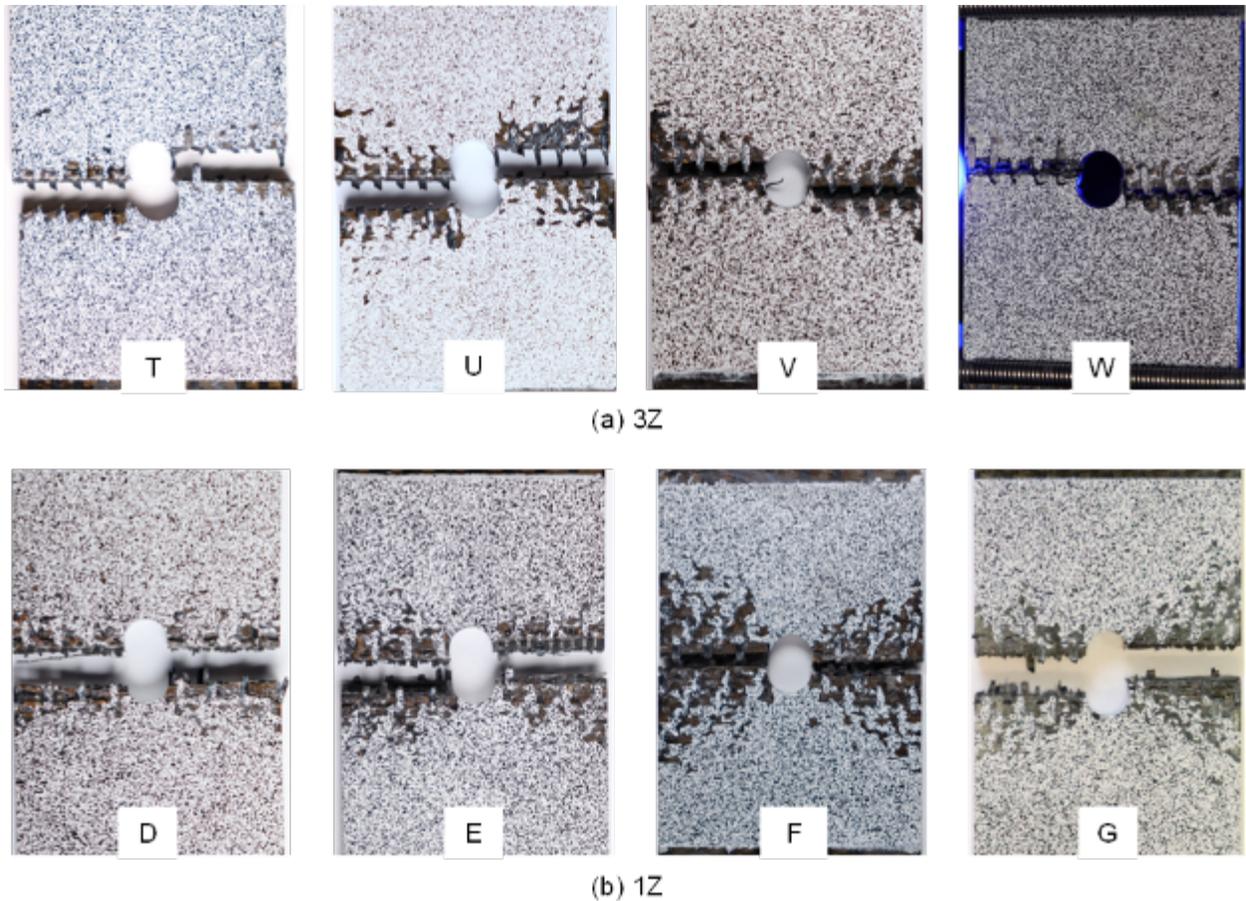
**Fig. 22 Post-failure photographs of the eight OHT specimens**

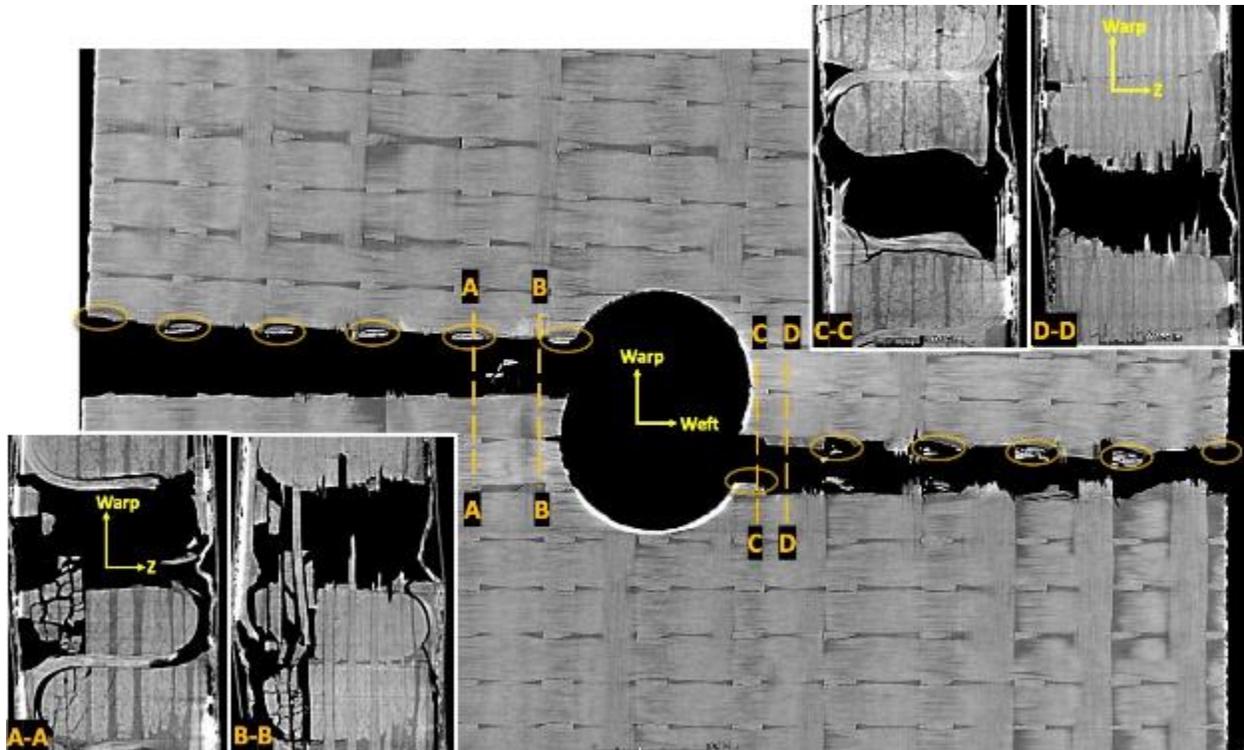
**Fig. 23 X-ray CT failure images of 3Z-OHT-V. The locations of the Z-tows along the fracture are circled.**

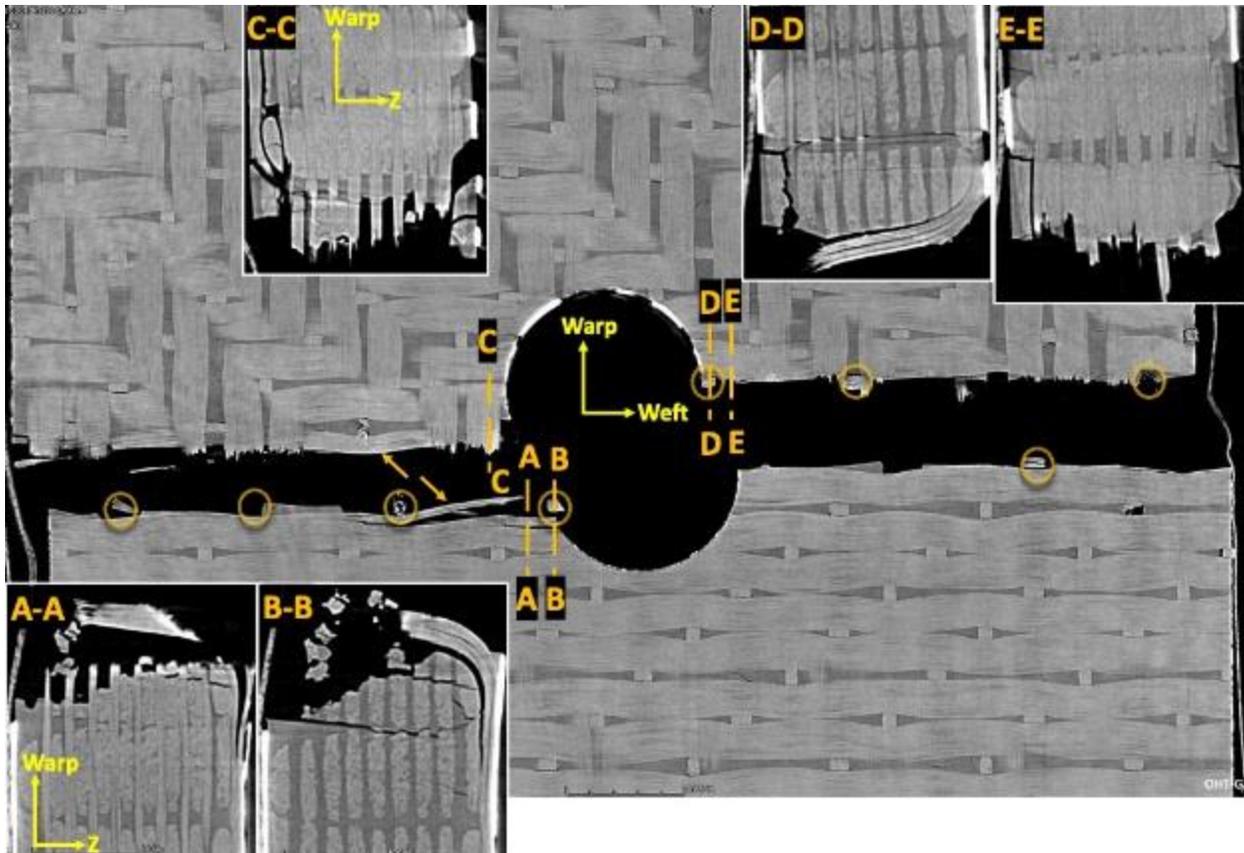
**Fig. 24 X-ray CT failure images of 1Z-OHT-G. The locations of the Z-tows along the fracture are circled.**

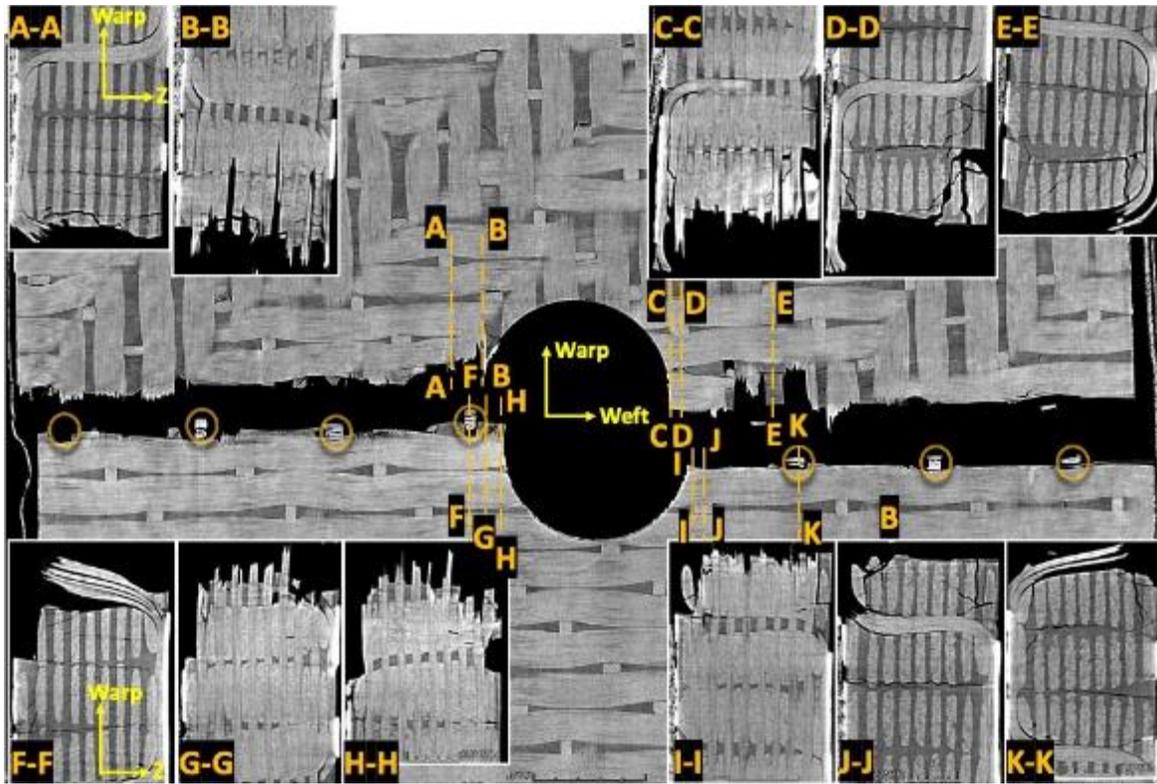
Fig. 25 X-ray CT failure images of 1Z-OHT-F. The locations of the Z-tows along the fracture are circled.

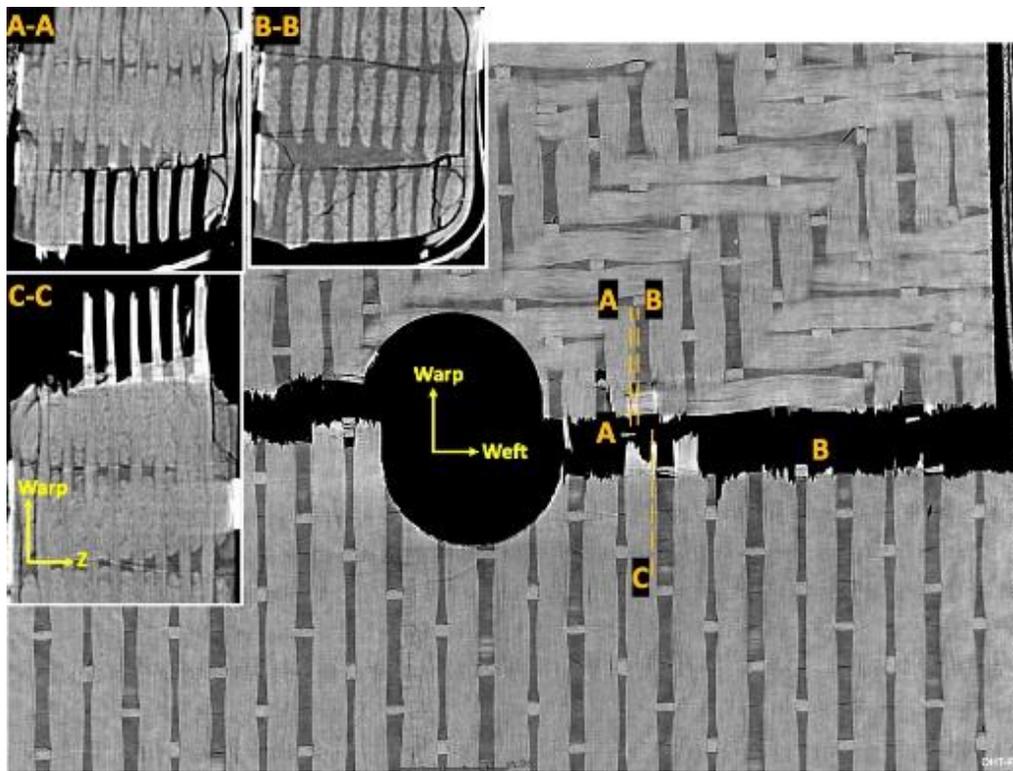
Fig. 26 X-ray CT failure images of 1Z-OHT-F highlighting fracture warp tows that have pulled out.

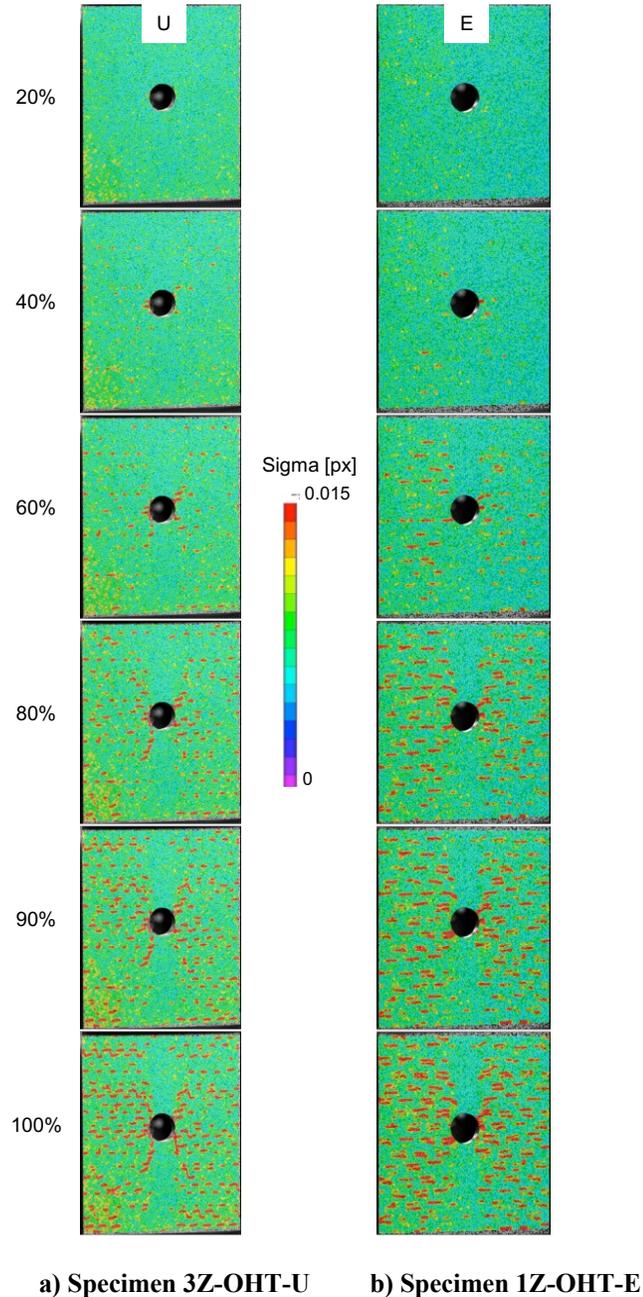
**Fig. 27 Comparison of DIC uncertainty coefficient contour plots for OHT specimens from a) 3Z and b) 1Z panels. Loading direction is vertical.**

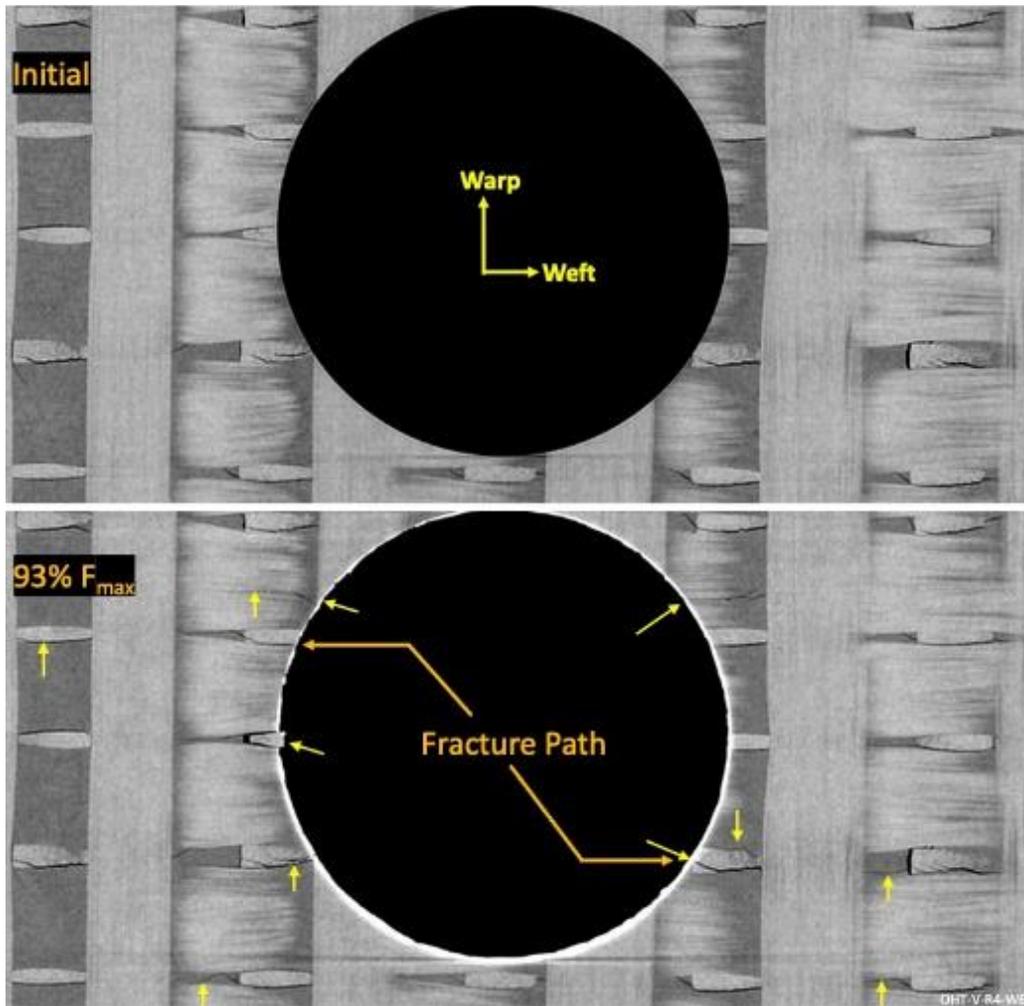
Fig. 28 X-ray CT failure images of 3Z-OHT-V. Damage from loading is marked with arrows.
