# Experimental Observations of Damage States in Unnotched and Notched 3D Orthogonal Woven Coupons Loaded in Tension

Wade C. Jackson<sup>1</sup>, Andrew C. Bergan<sup>2</sup>, Nathaniel W. Gardner<sup>3</sup>,  
and Cheryl A. Rose<sup>4</sup>

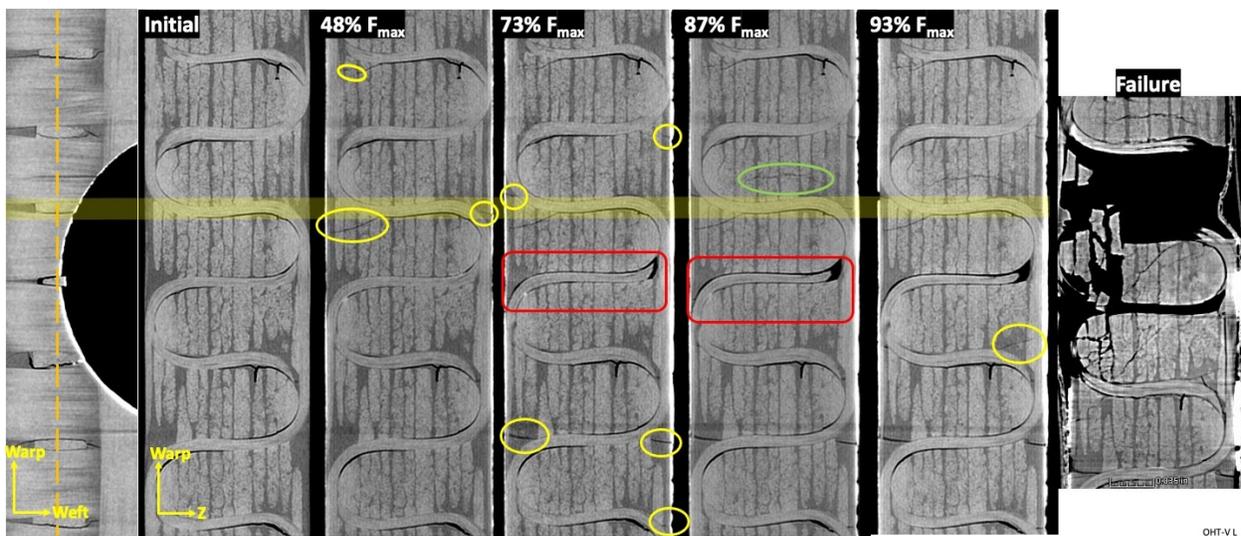
Fig. 29 X-ray CT progressive damage images near the left side of the hole for specimen 3Z-OHT-V. The locations of damage growth are circled.

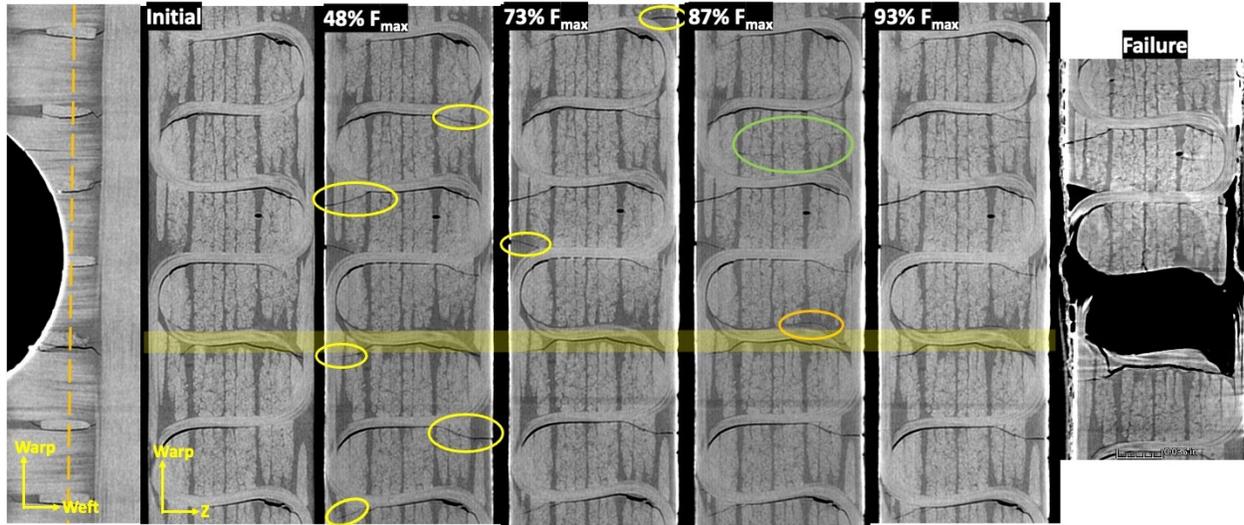
**Fig. 30** X-ray CT progressive damage images near the right side of the hole of 3Z-OHT-V. The locations of damage growth are circled.

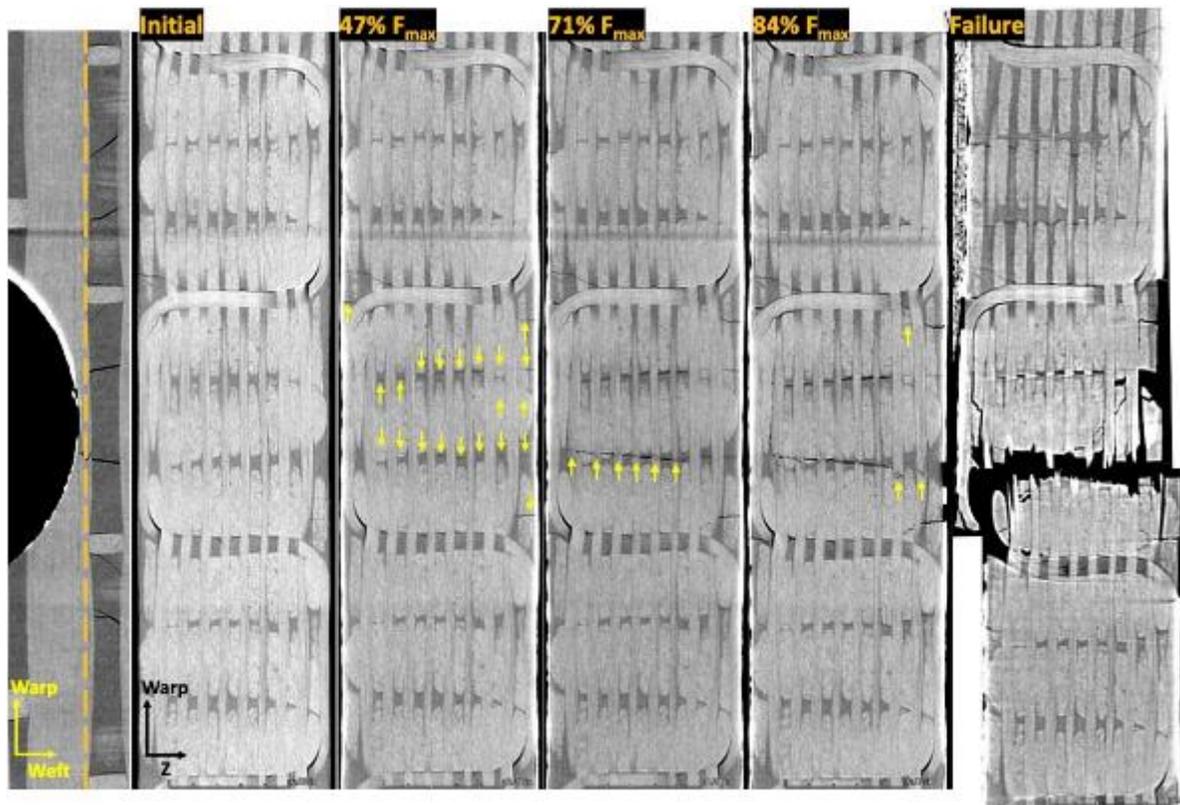
**Fig. 33** Through-thickness X-ray CT sections in the warp tow showing damage progression for specimen 1Z-OHT-F. The locations of additional damage from the previous run are indicated by arrows.

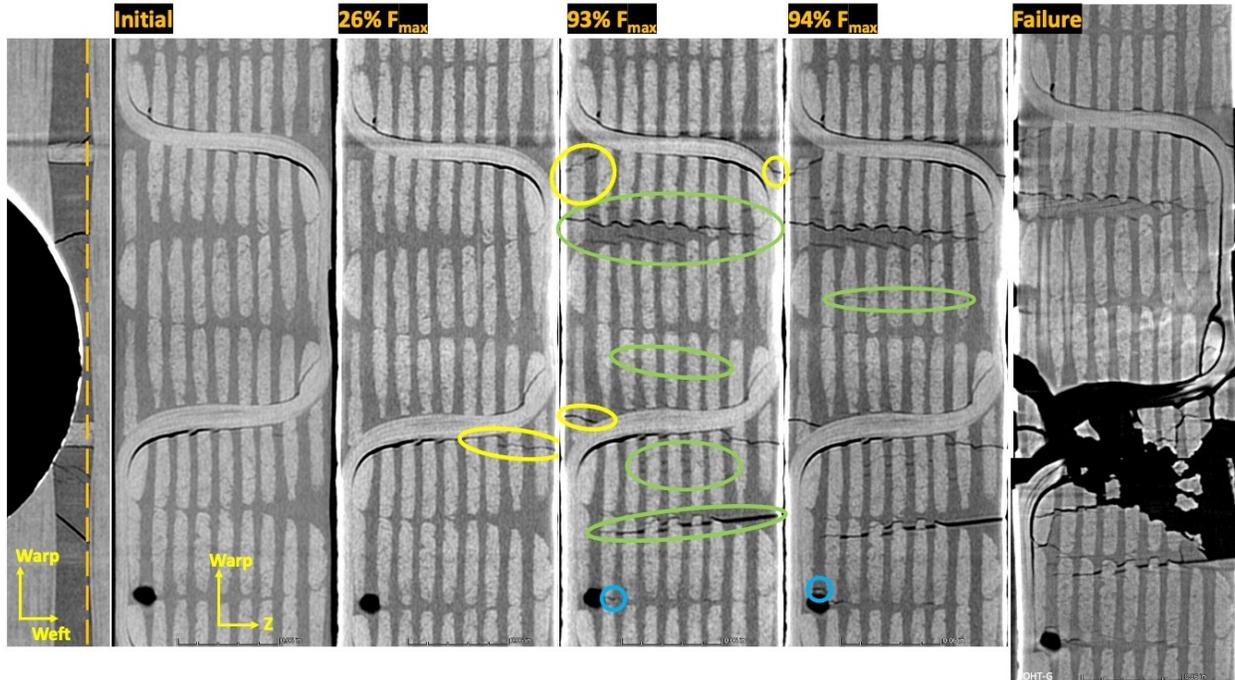
**Fig. 34 Through-thickness X-ray CT sections in the warp tow gap showing damage progression for specimen 1Z-OHT-G. The locations of additional damage from the previous run are circled.**
