*Interim Report I*

**5 Inch Thick 2219-T87 Plate Low Ductility Investigation**

– Material analysis on broken tensile samples

EM31/NASA-Marshall Space Flight Center

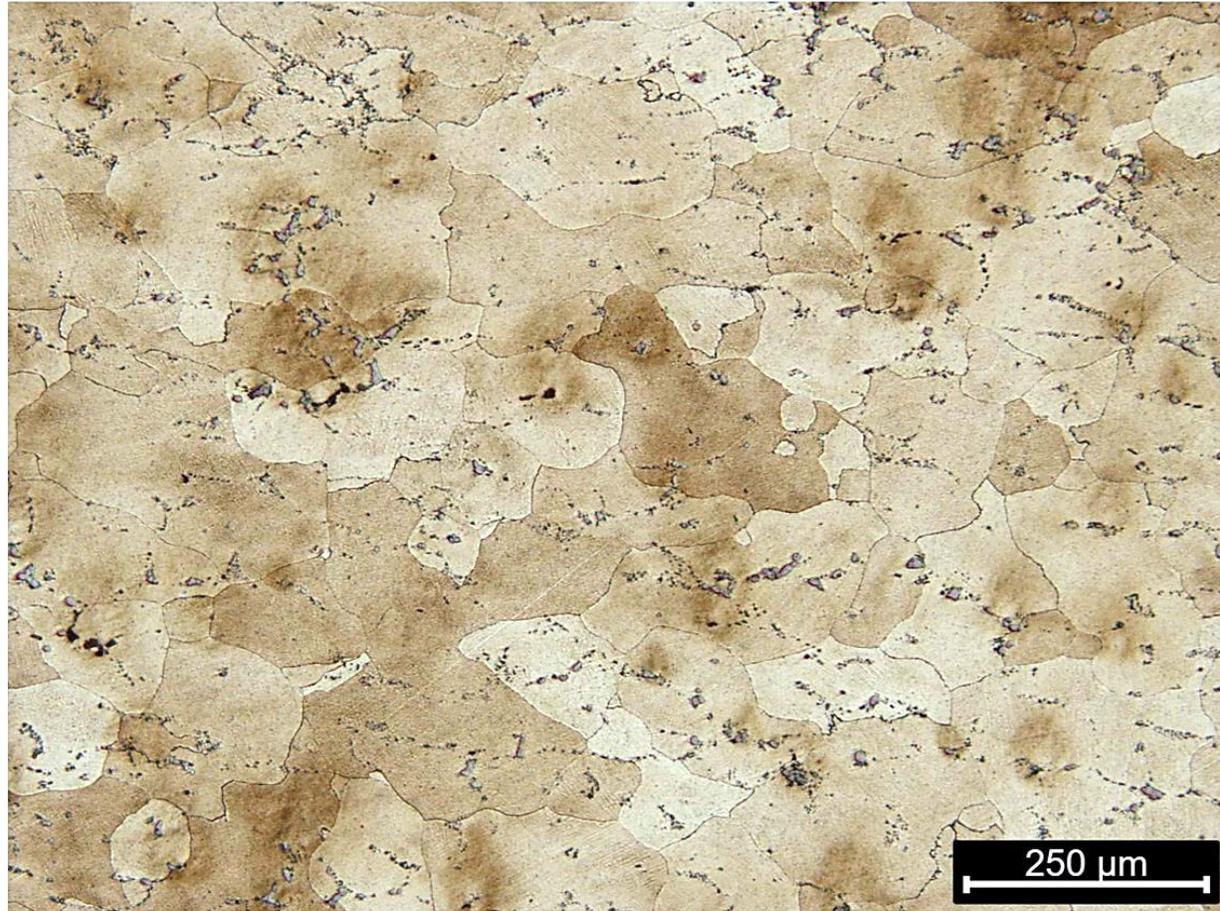
720-2 LN2 – 7.23%

Higher Rx, smaller GS, fewer dendritic cells

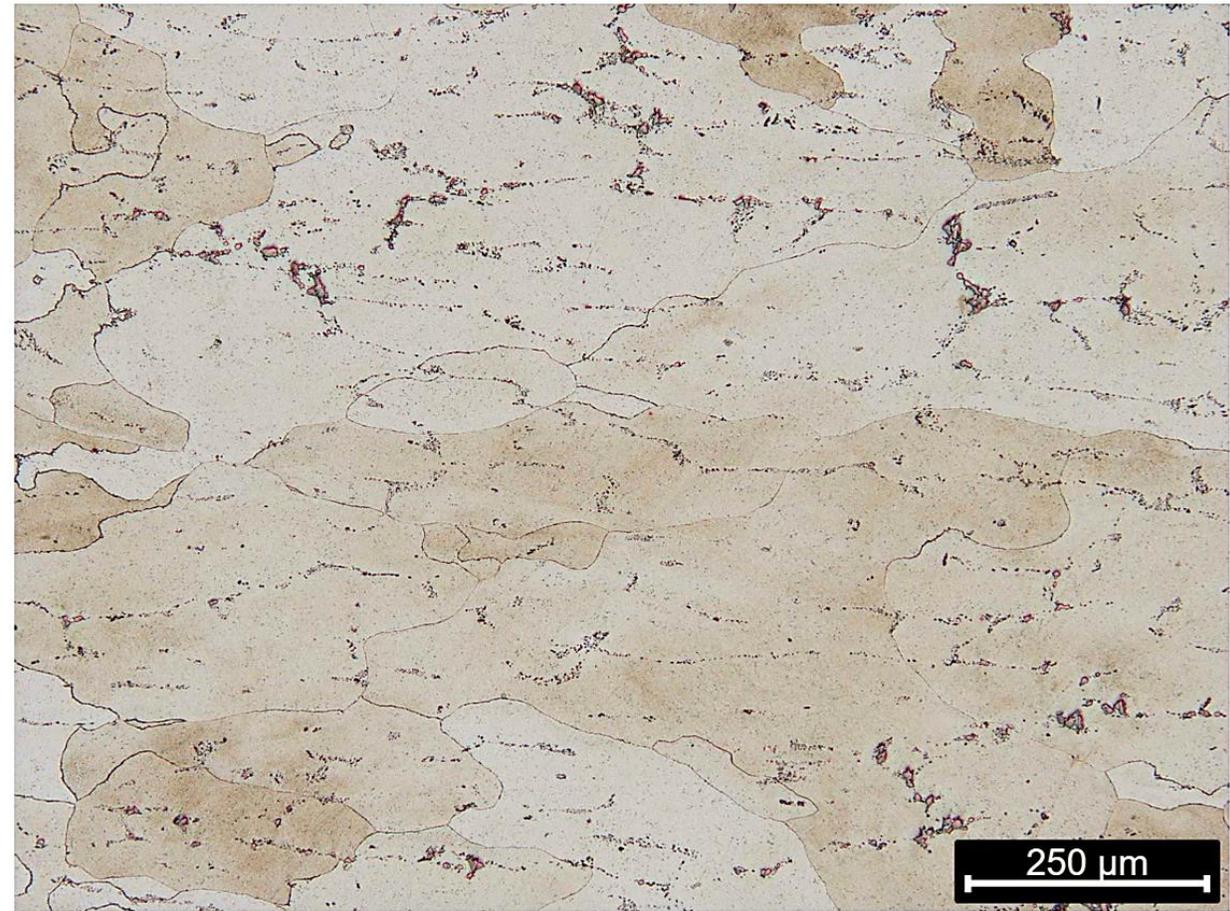
723C-6 LN2 – 1.25%

Lower Rx, larger GS, distinct prior dendritic structure

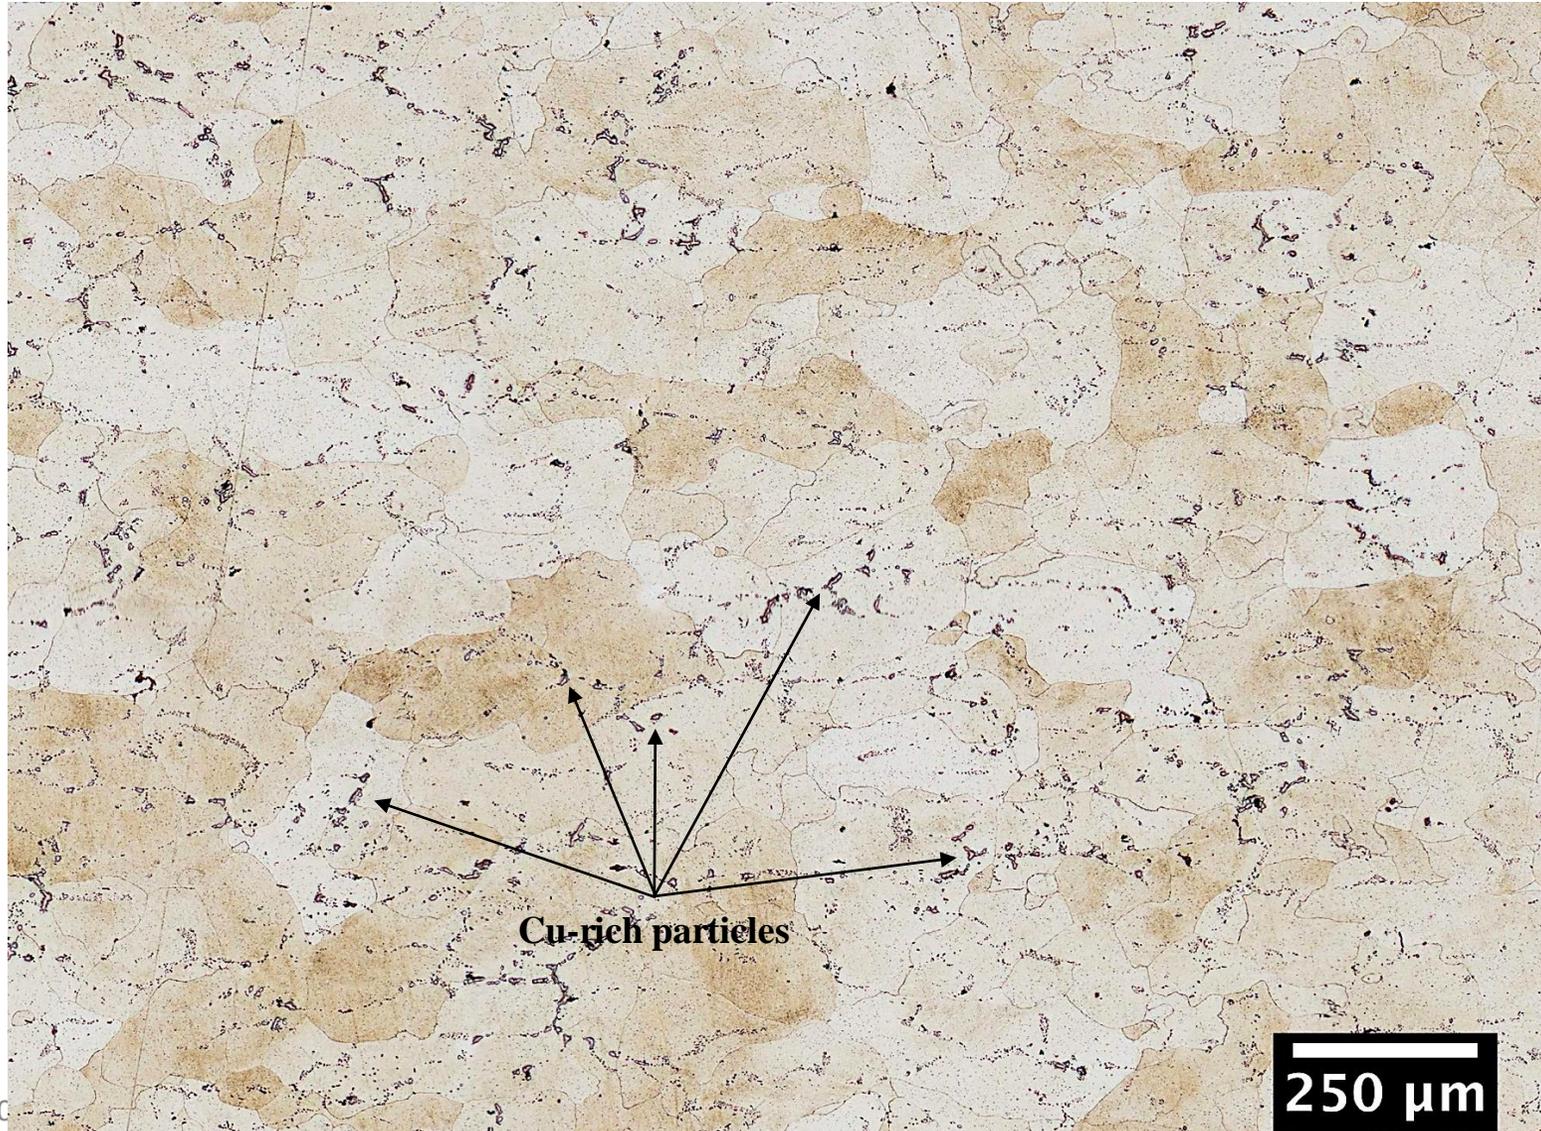
720-2 LN2 – 7.23%

1. The small (pinkish) particles are Cu-rich  $\theta$  phase,  $\text{Al}_2\text{Cu}$
2. More uniform distribution of Cu-rich particles ( $\text{Al}_2\text{Cu}$ - $\theta$  phase)
3. No clear sign of coarse Cu-rich particles at prior dendritic boundaries

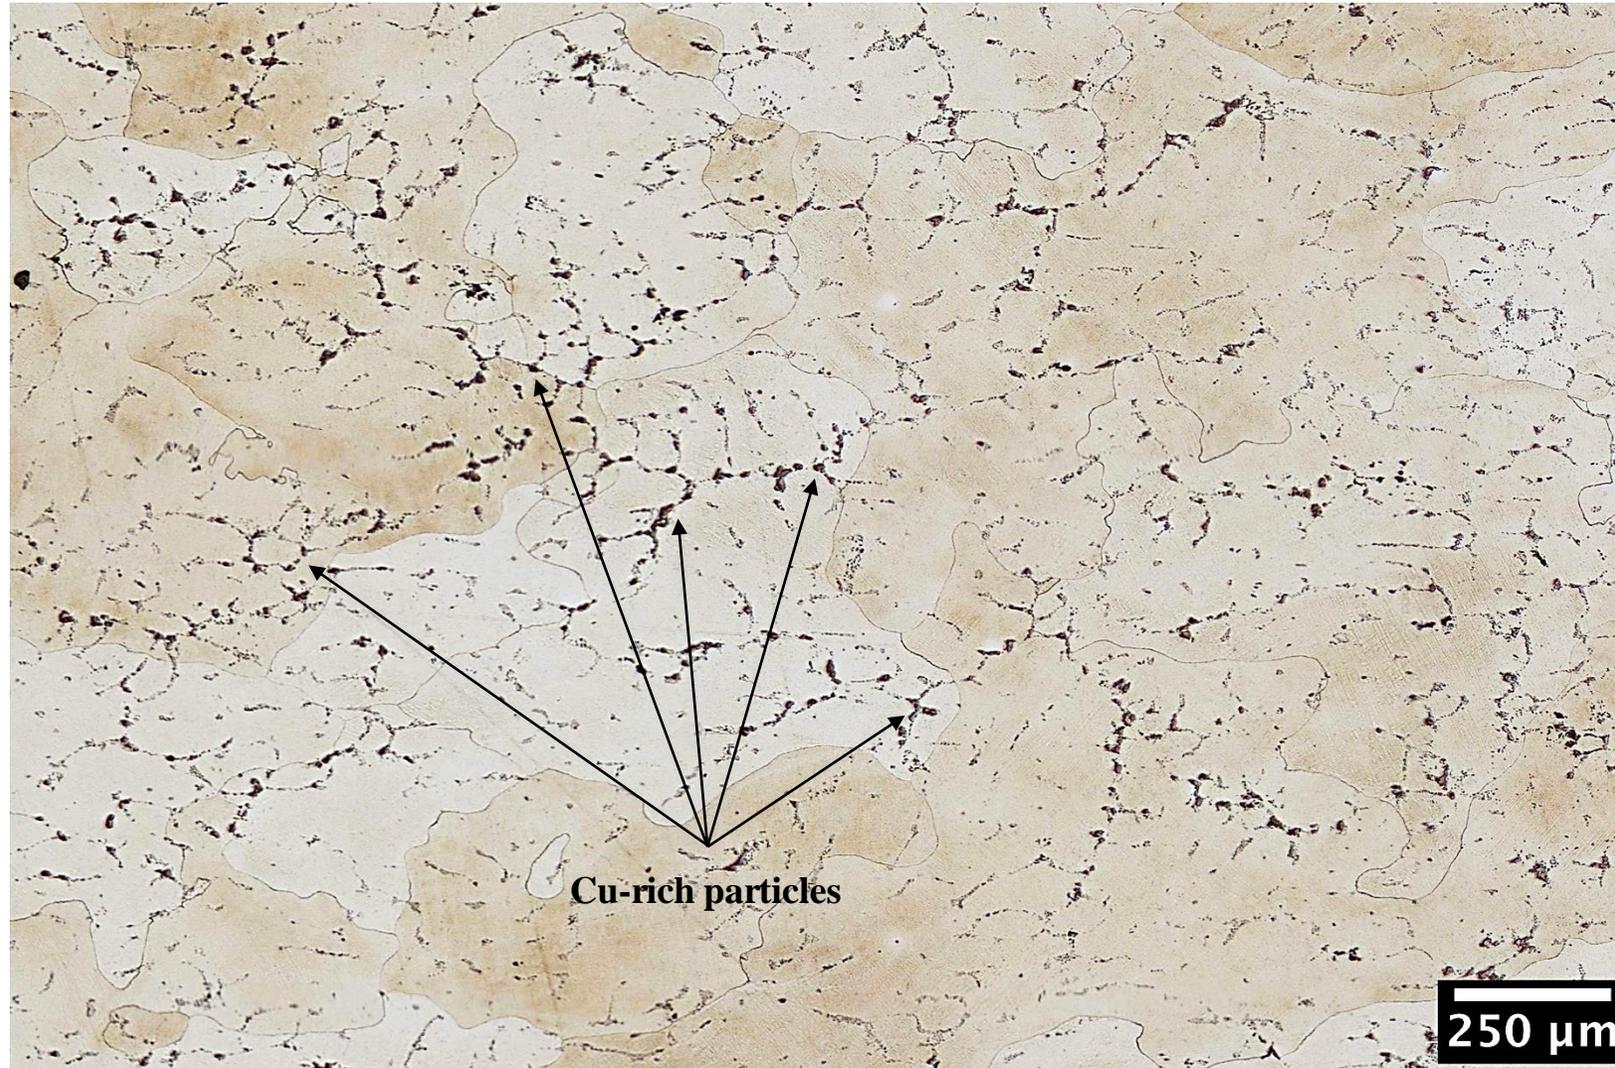
722C-5 LN2 – 1.0%

1. The small (pinkish) particles are Cu-rich  $\theta$  phase,  $\text{Al}_2\text{Cu}$
2. Non-uniform distribution of Cu-rich particles ( $\text{Al}_2\text{Cu}-\theta$  phase)
3. More coarse Cu-rich particles are present along the prior dendritic boundaries

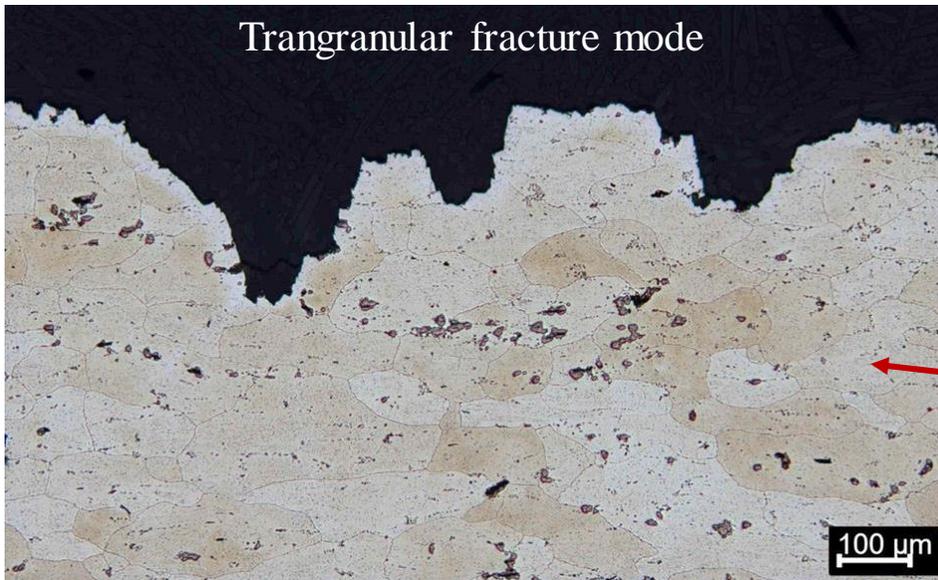
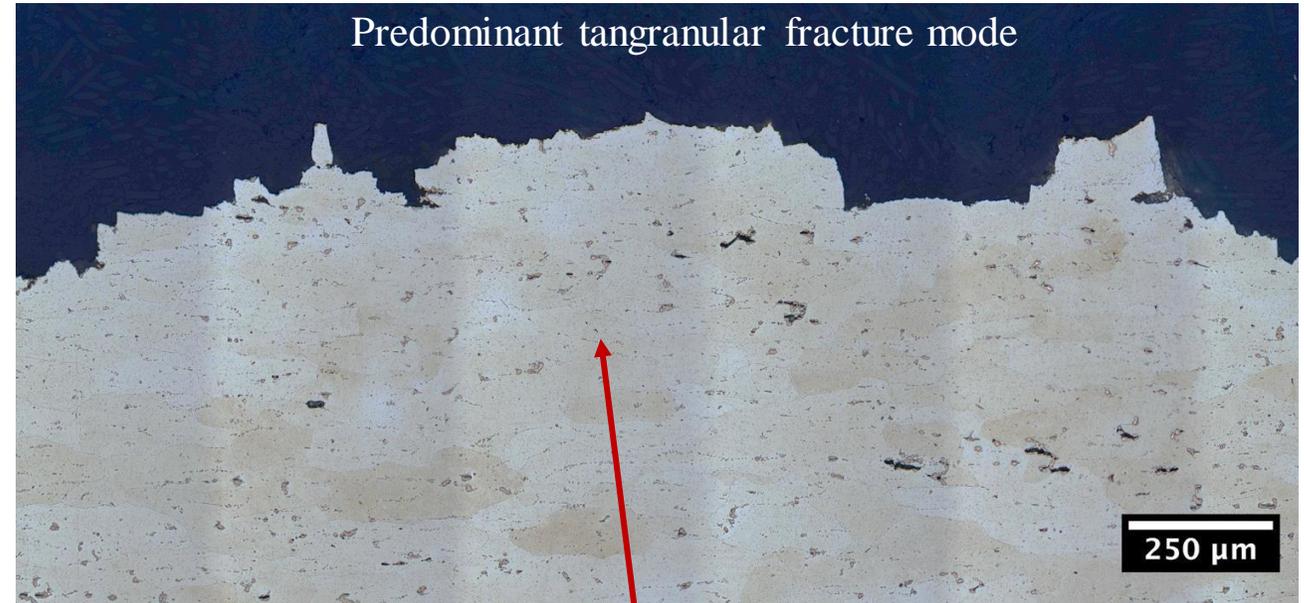
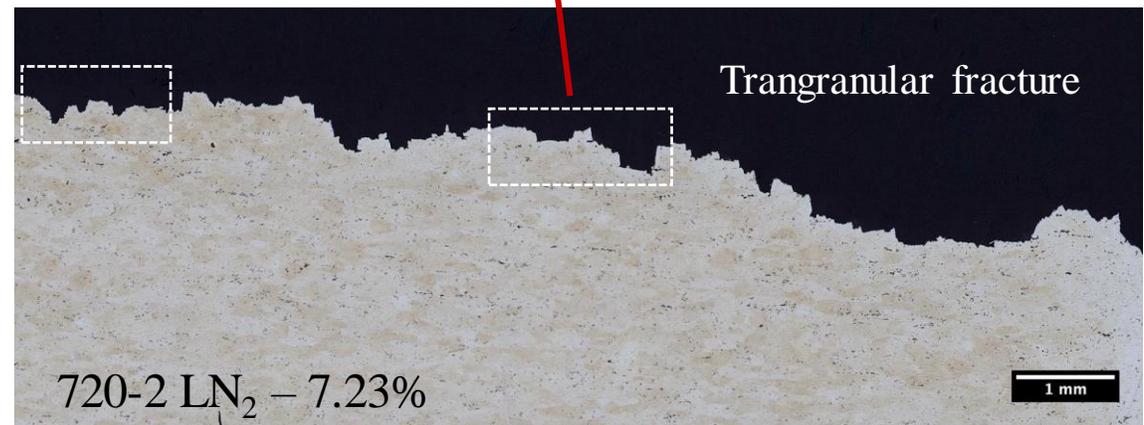
1. Predominant transgranular fracture mode
2. No sign of continuous cracking along grain boundaries

No sign of brittle fracture

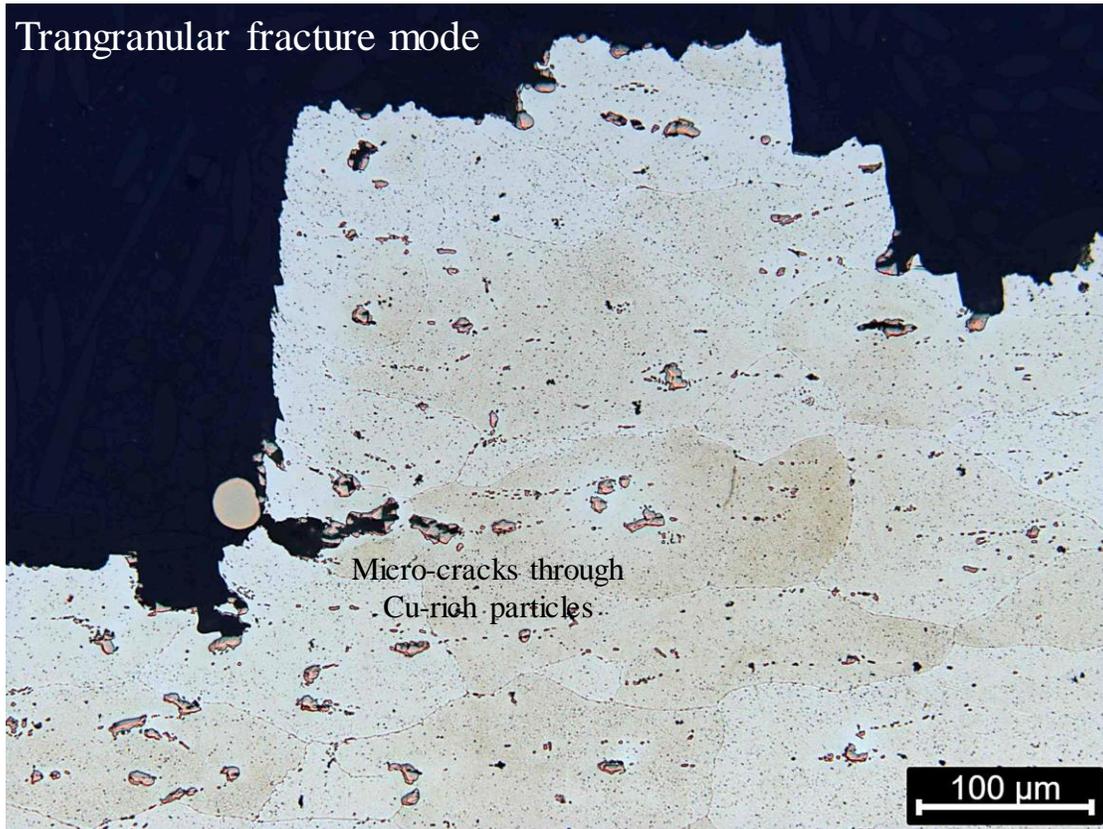
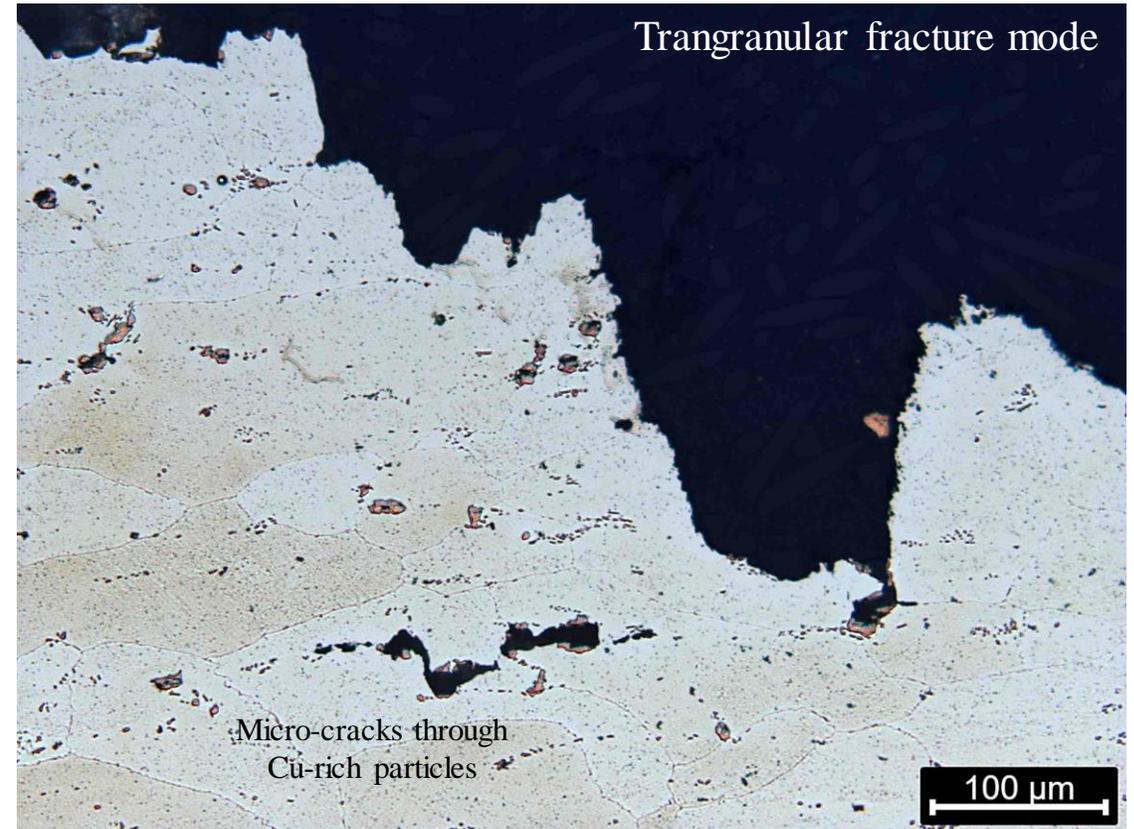
720-2 LN<sub>2</sub> – 7.23%

Signs of ductile fracture

1. Predominant transgranular fracture mode, No sign of continuous cracking along grain boundaries
2. Some isolated micro-cracks, but micro-cracks do not connect through broken Cu-rich particles

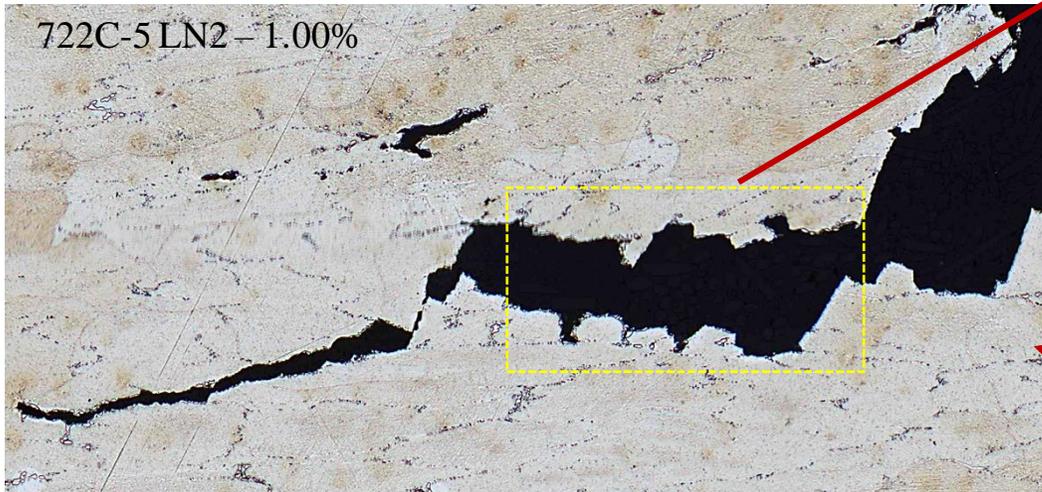
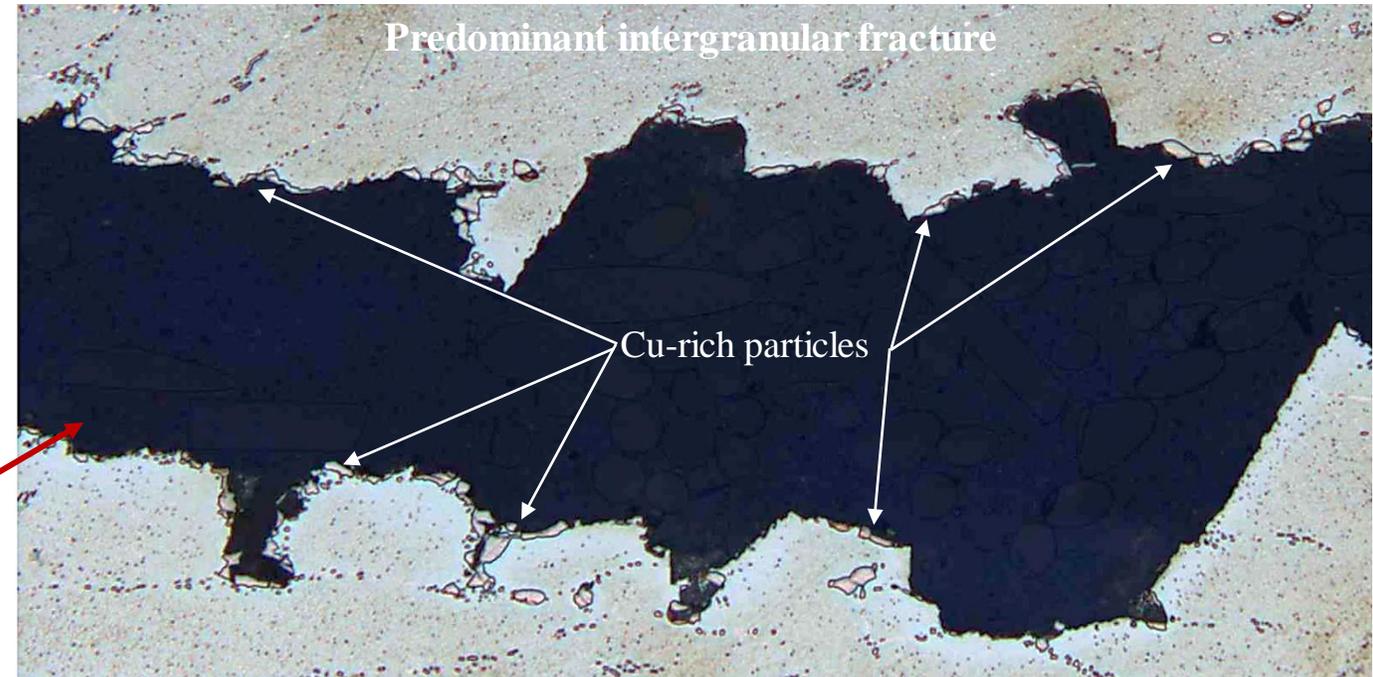
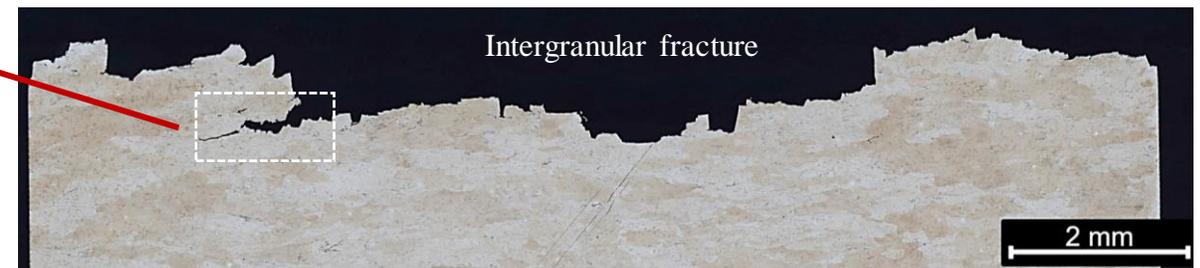
1. Predominant Intergranular fracture mode
2. Clear signs of continuous cracking on Cu-rich particles along grain boundaries

Signs of brittle fracture

Fracture path along Cu-rich particle boundary

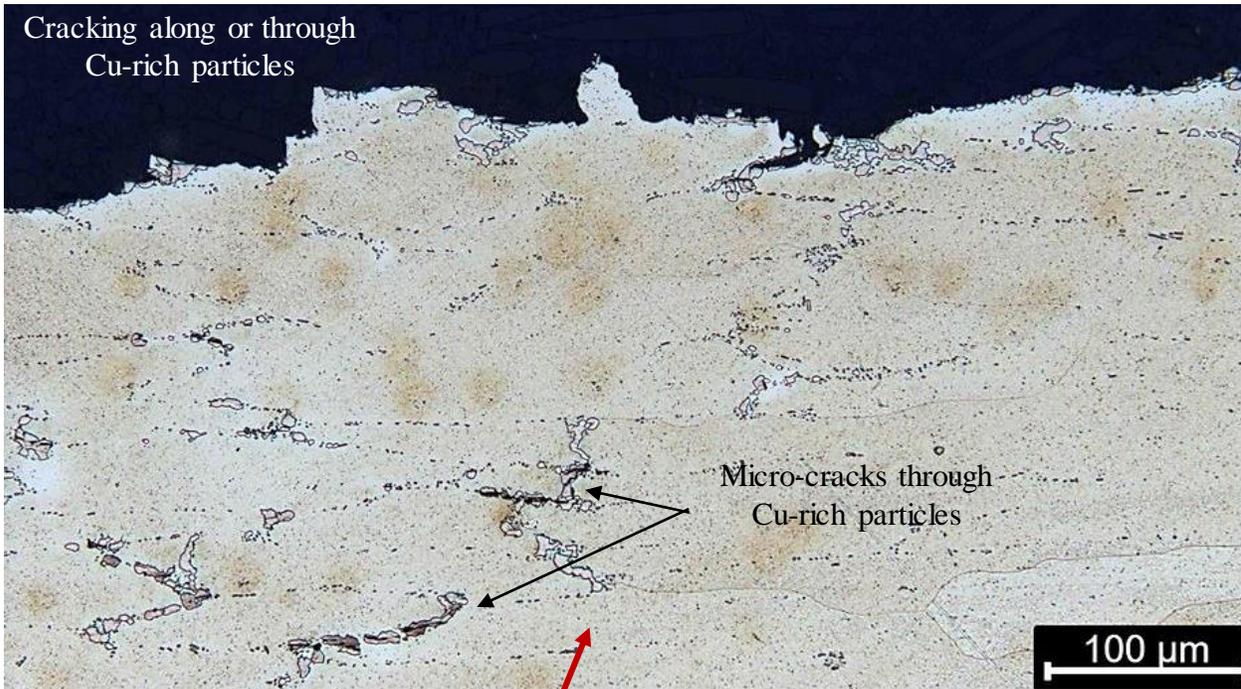
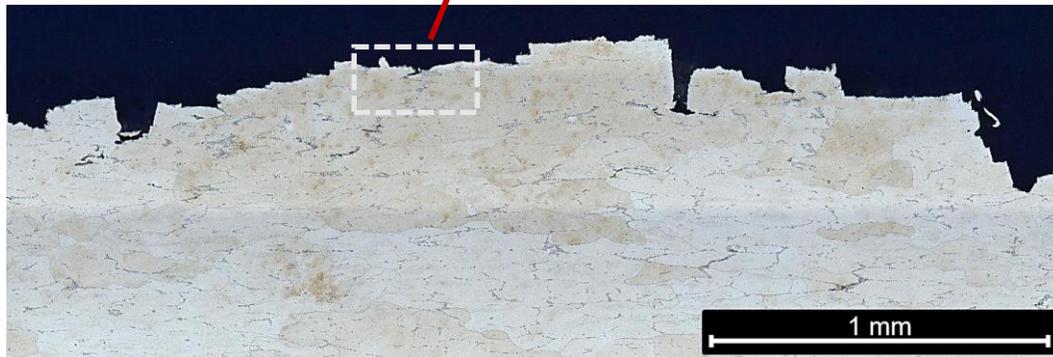
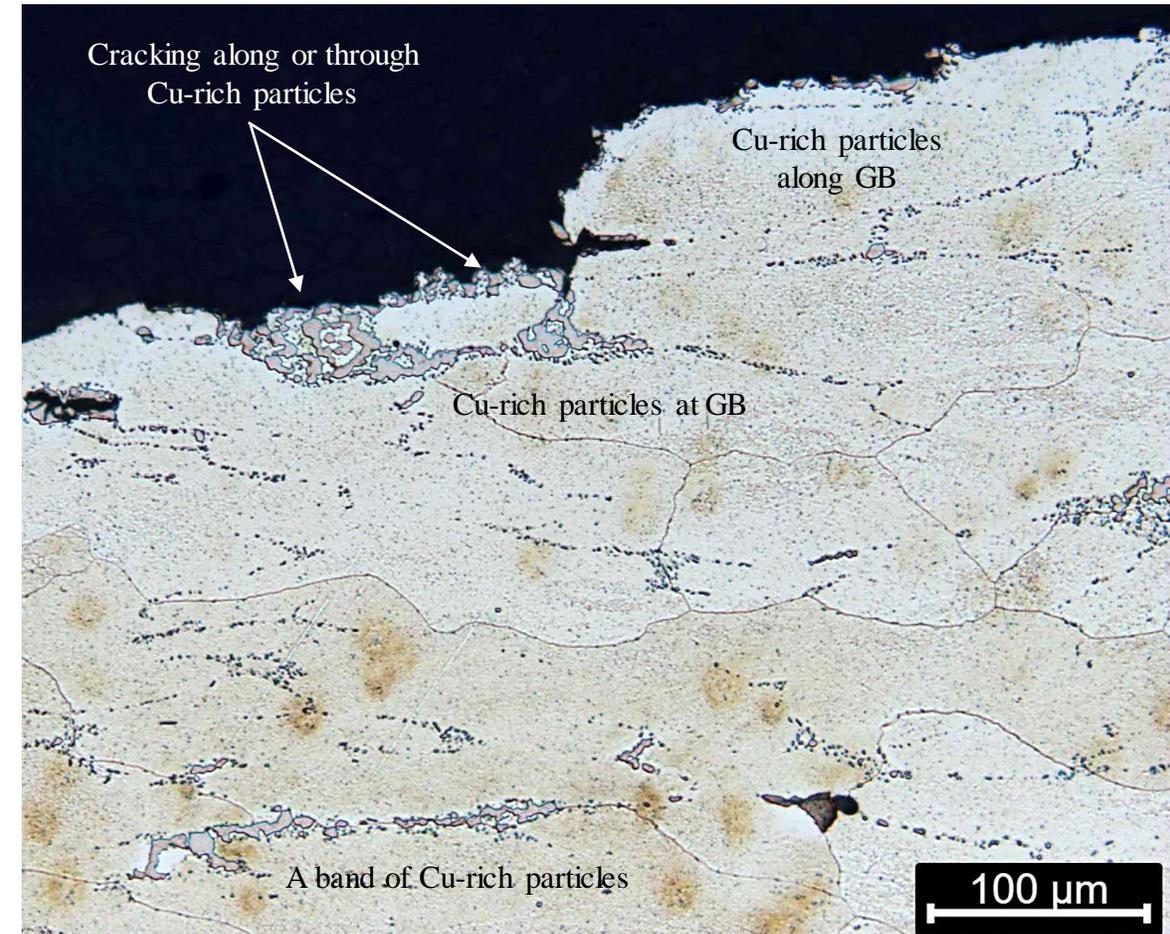
## Signs of brittle fracture

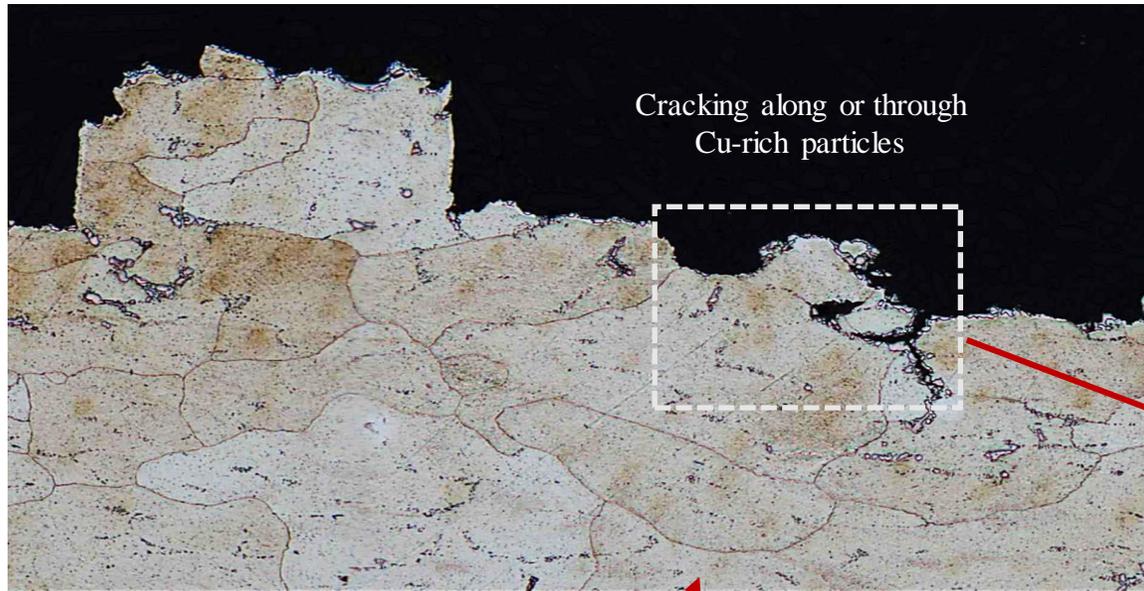
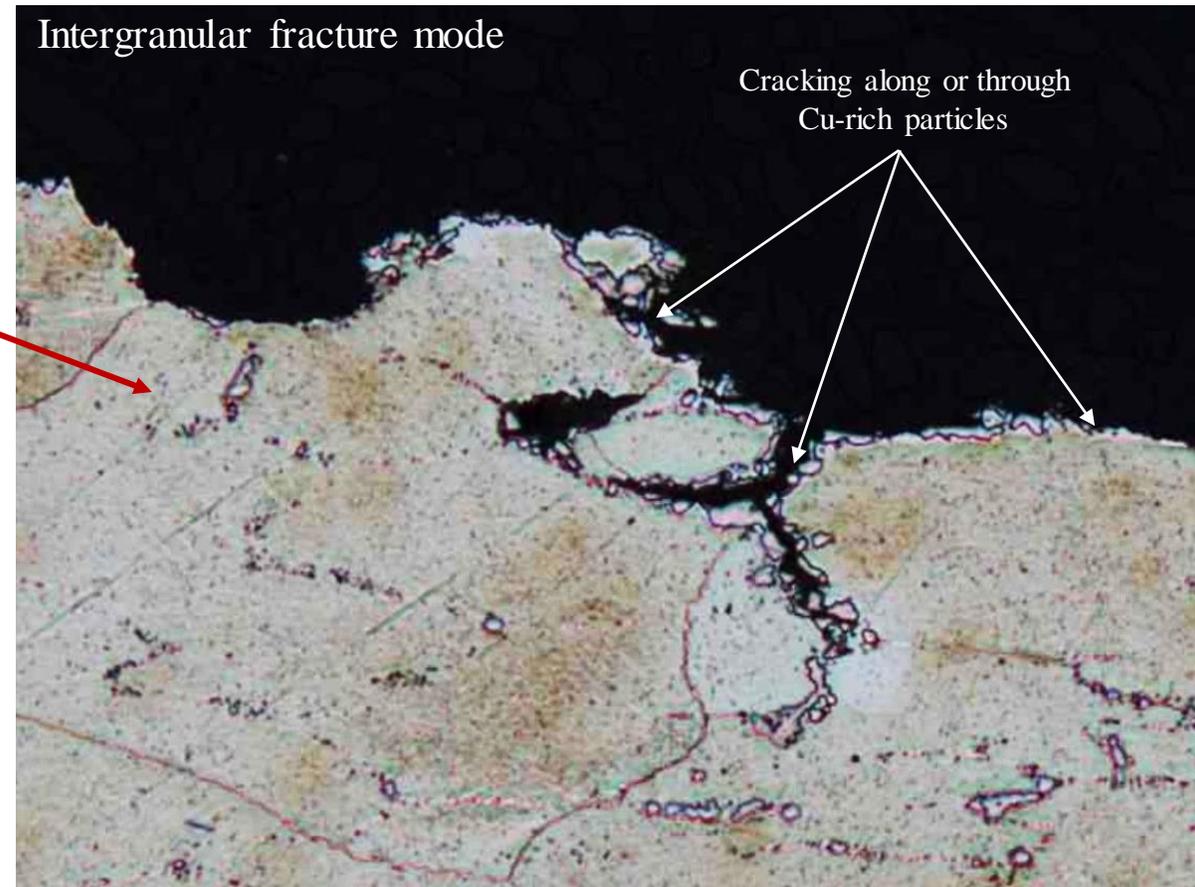
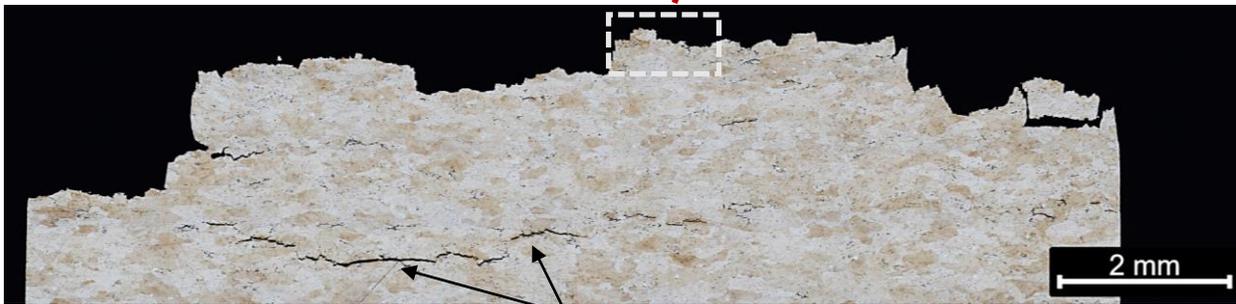
Signs of brittle fracture

Long subsurface cracks  $\perp$   
to the tensile direction

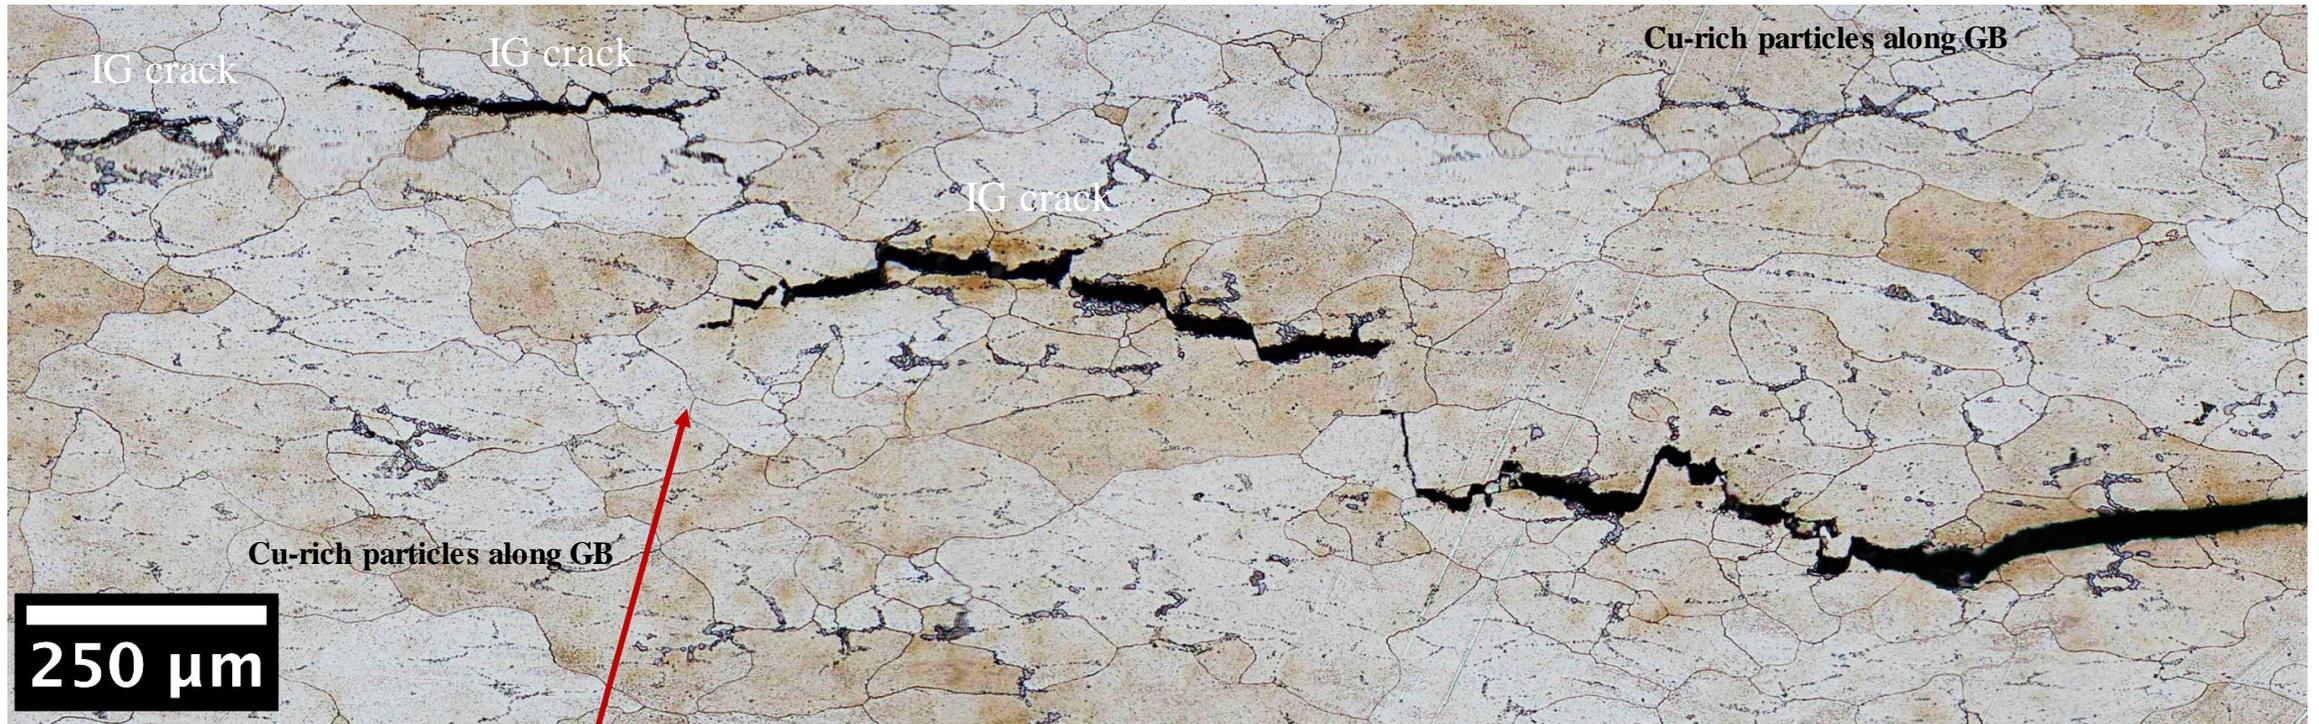
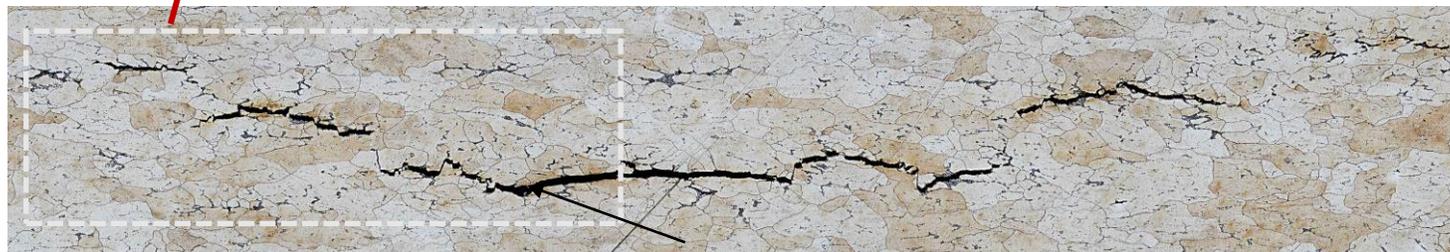
Predominant intergranular fracture mode

Cracking through GB and Cu-rich particles

Long subsurface cracks  $\perp$  to the tensile direction

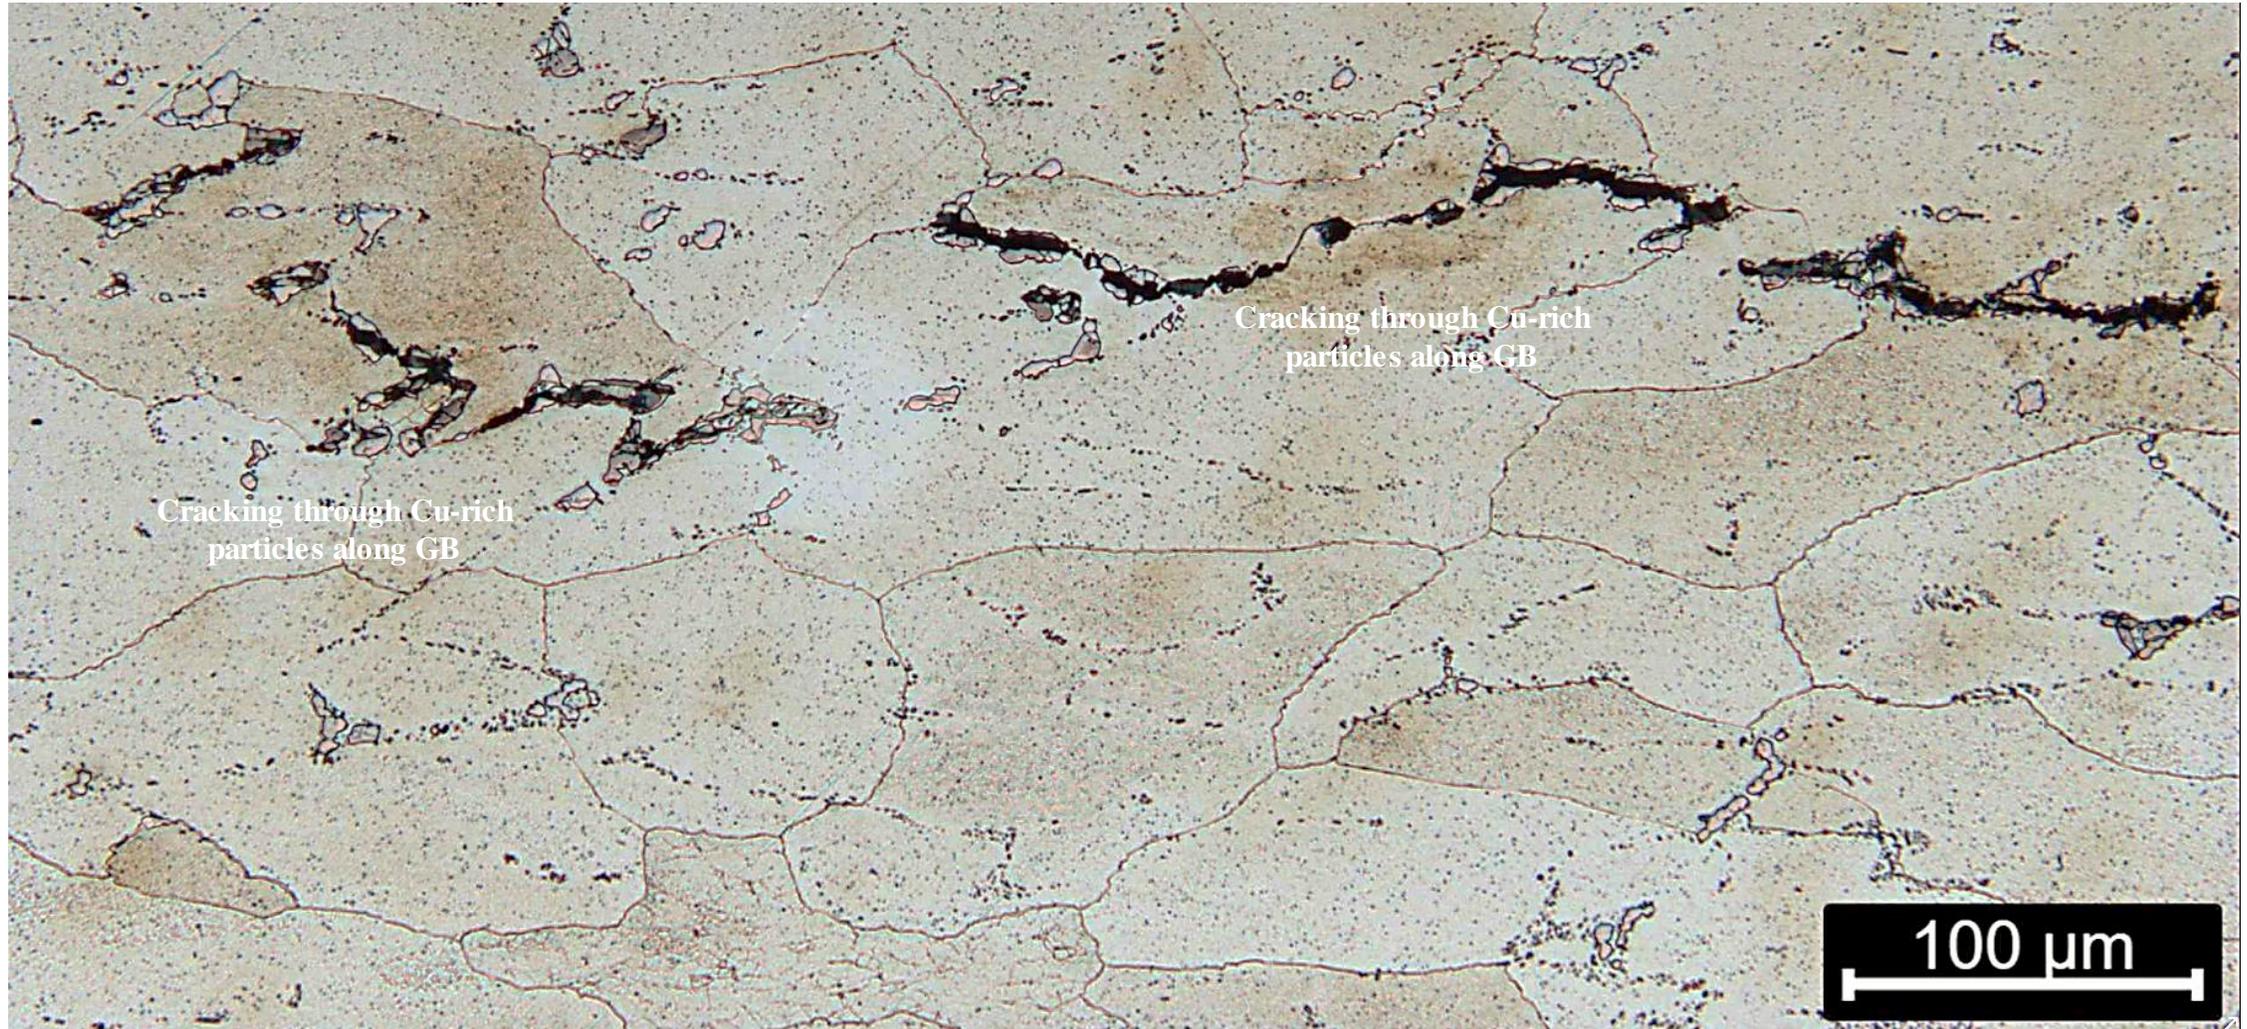
Predominant intergranular fracture mode

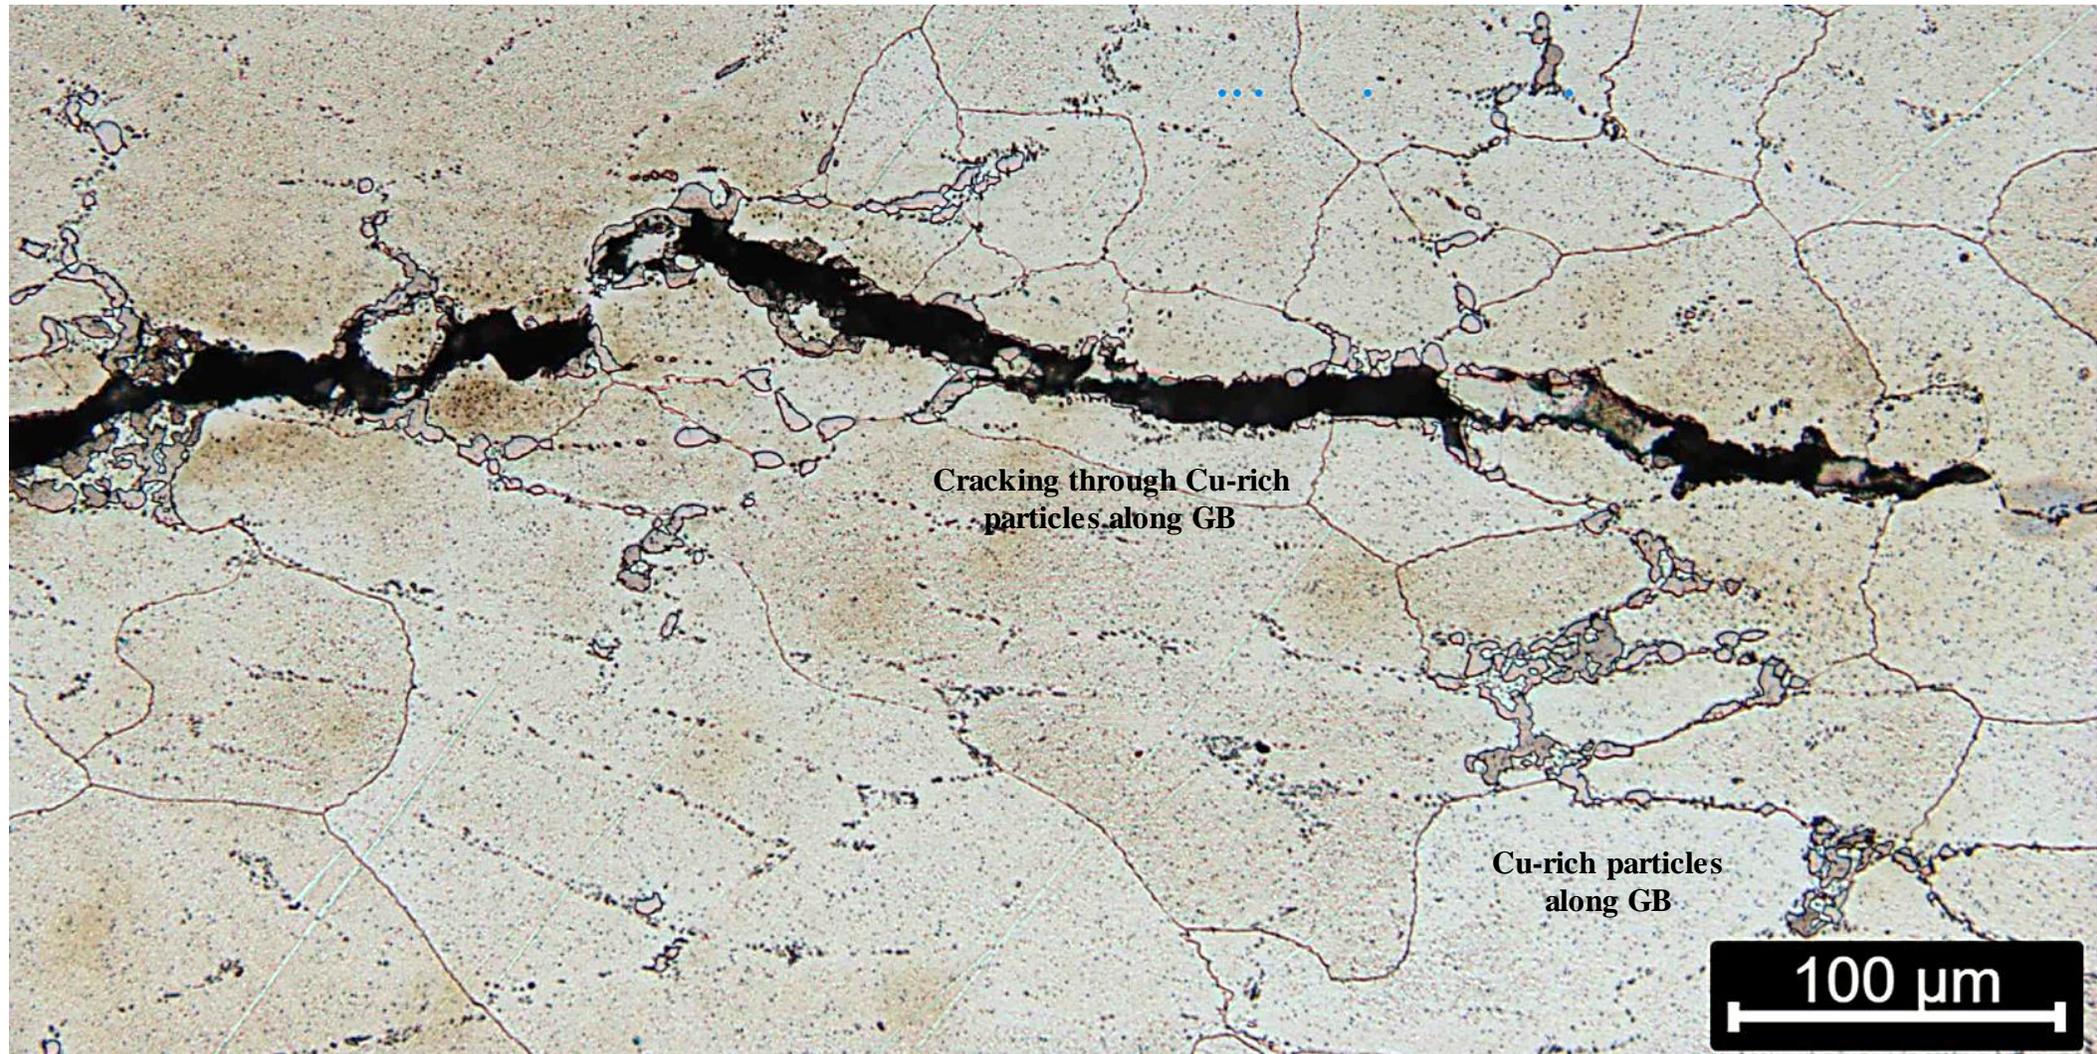
Predominant intergranular fracture mode
