*Interim Report I*

**5 Inch Thick 2219-T87 Plate Low Ductility Investigation**

– Material analysis on broken tensile samples

EM31/NASA-Marshall Space Flight Center

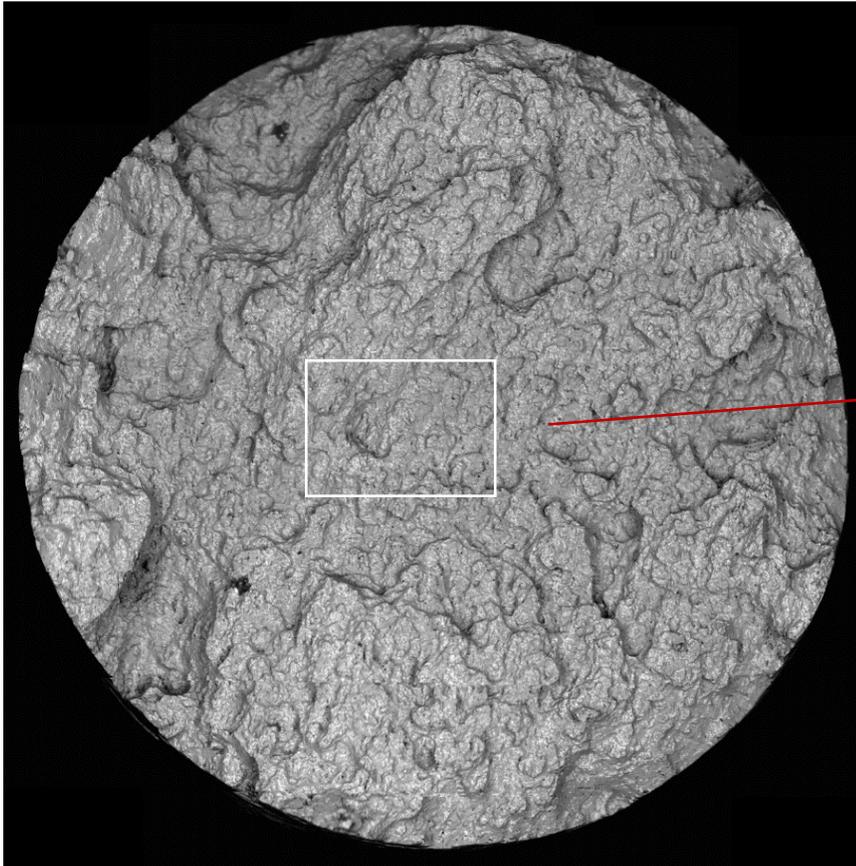
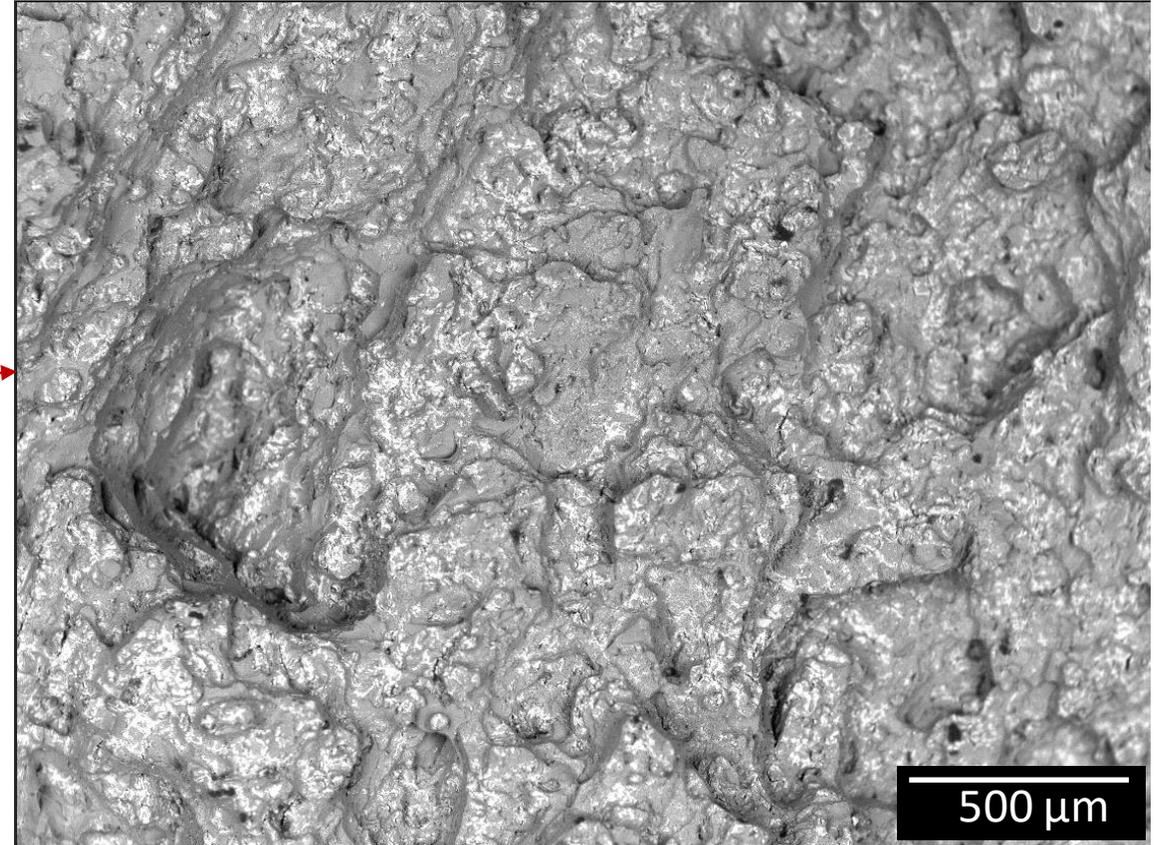
720-2 LN2 – 7.23%

White particles are Cu-rich precipitates

Distribution of Cu-rich particles in Al-matrix

Cu-rich particles are finer and have more uniform distribution

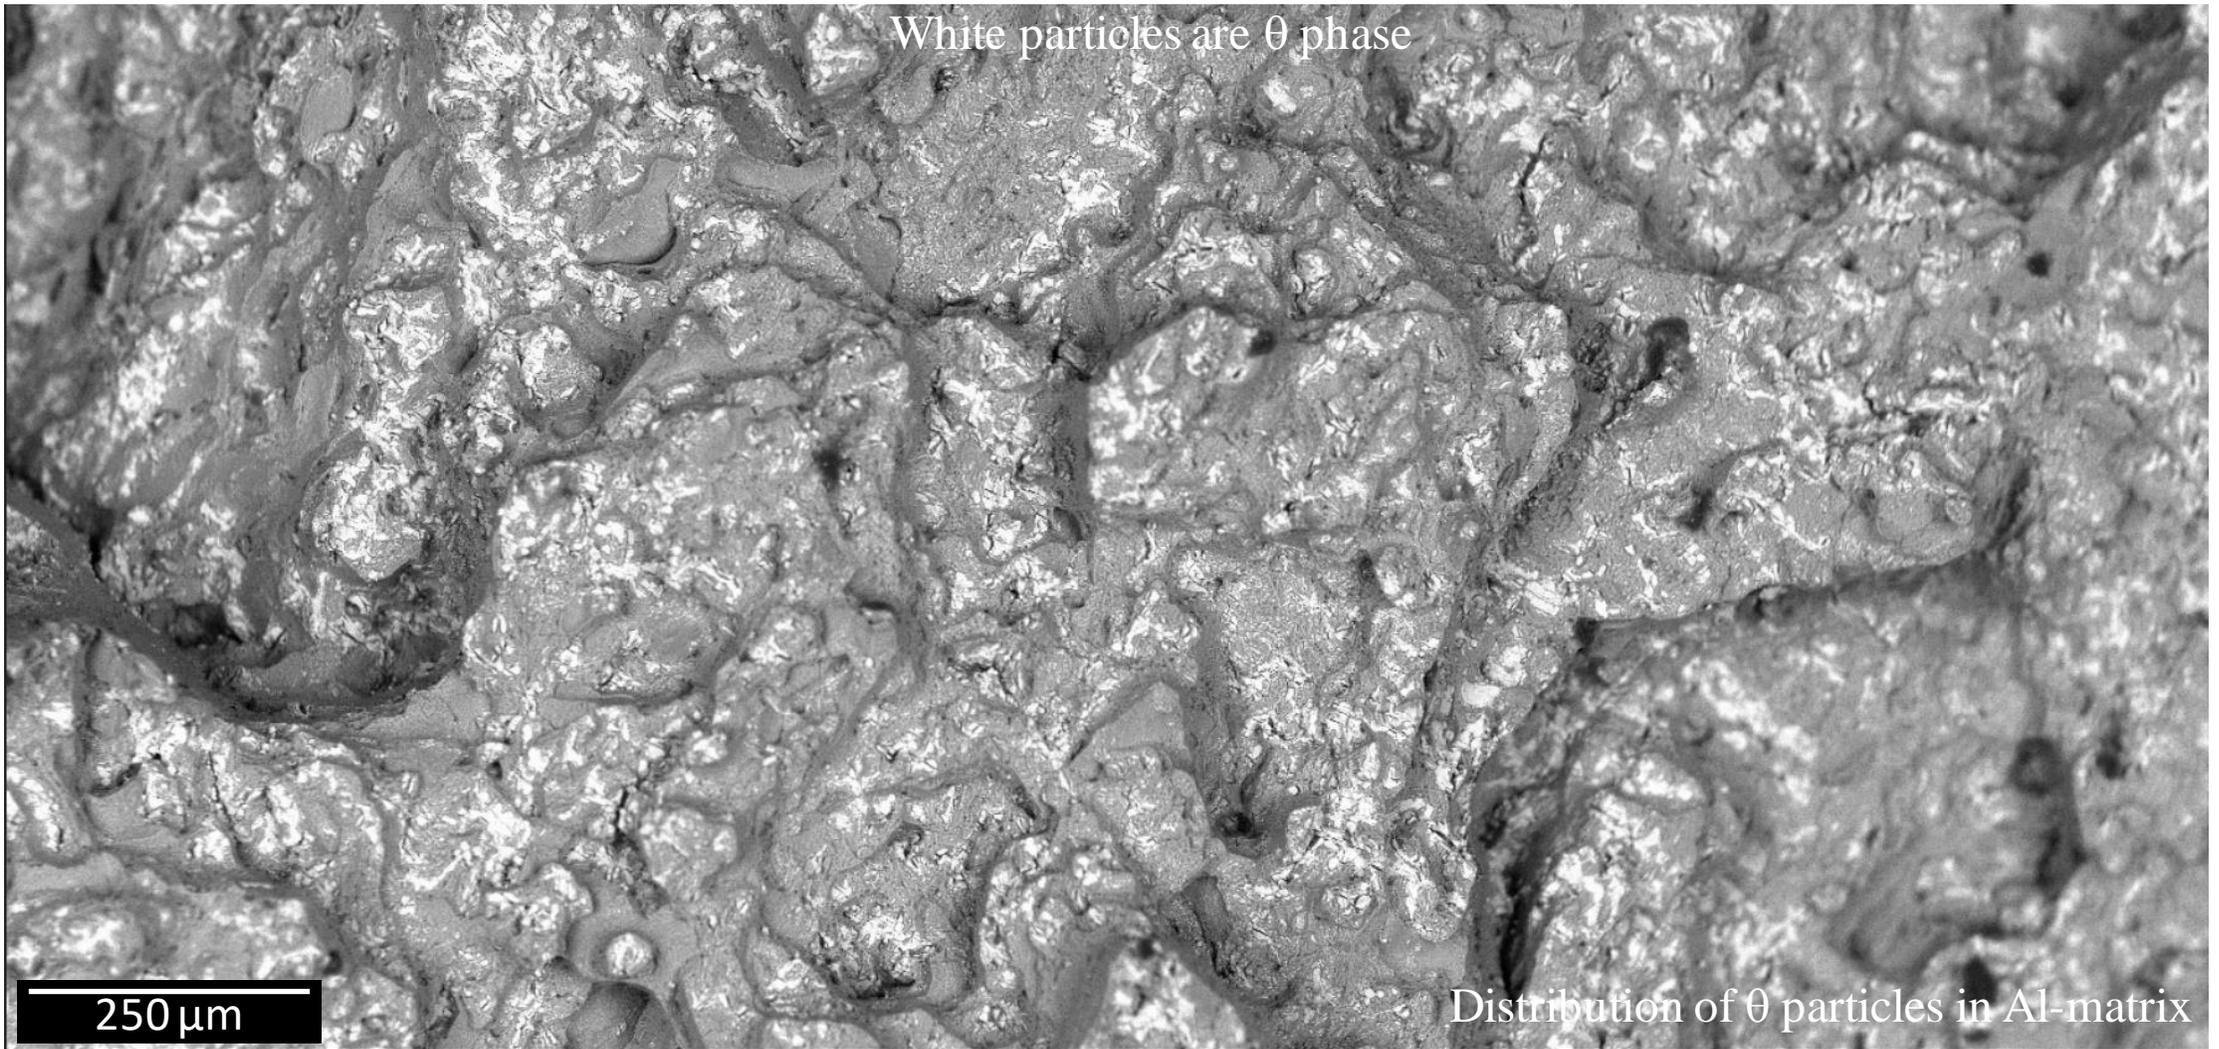
Cu-rich particles have more uniform distribution

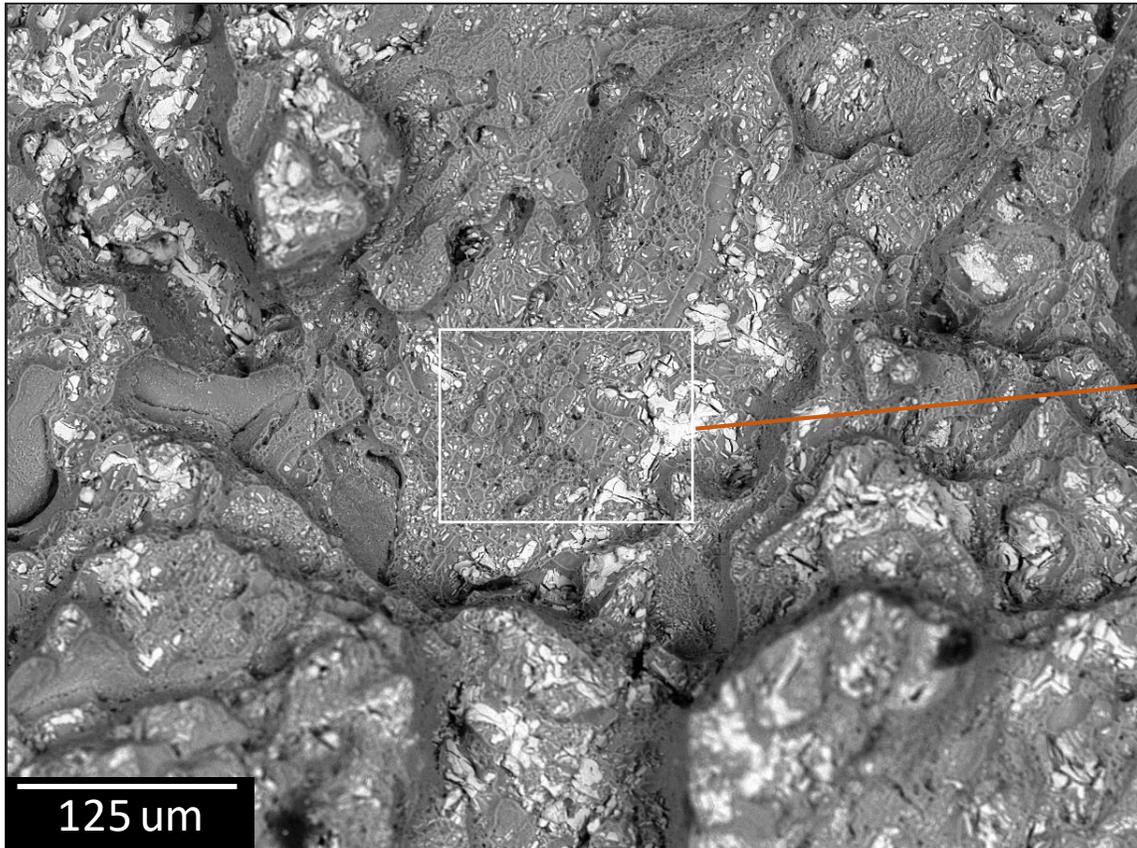
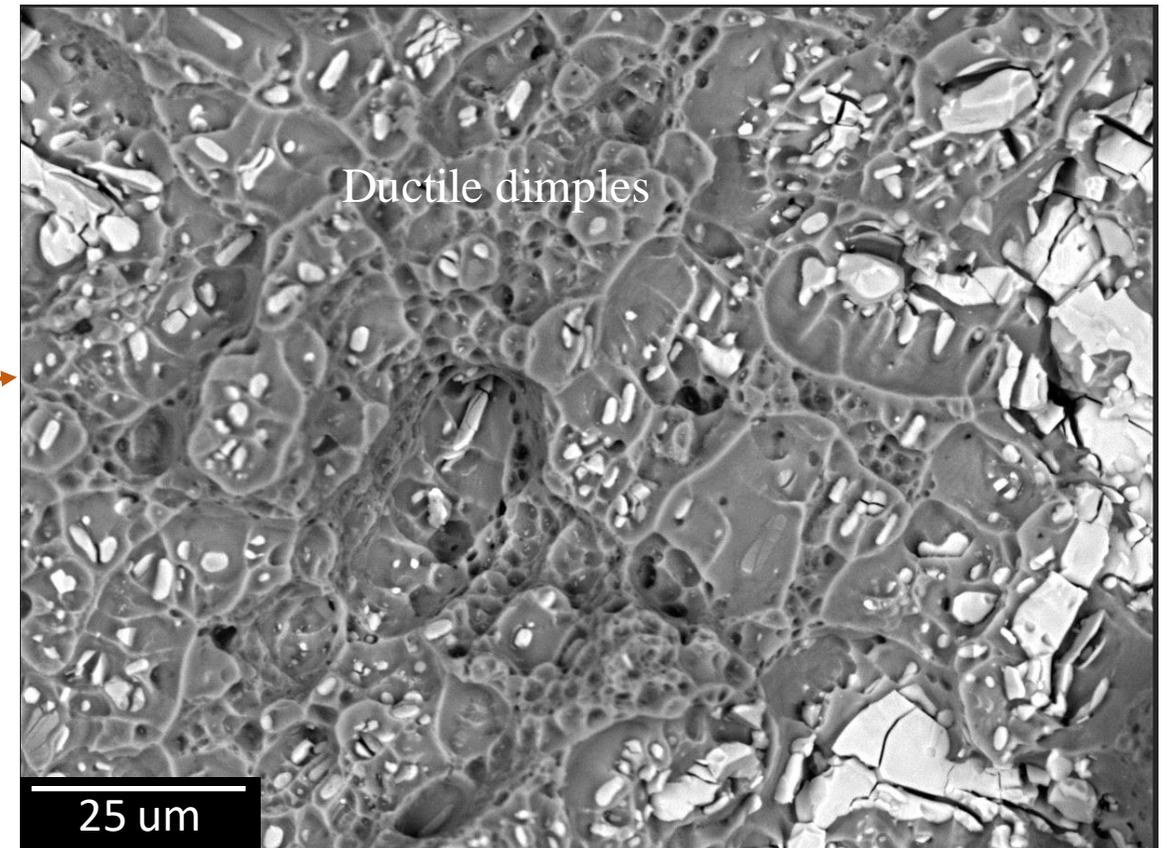
720-2 LN2 – 7.23%

Distribution of Cu-rich particles in AL-matrix

White particles are Cu-rich precipitates

Most Cu-rich particles are in dimples

1. Cu-rich particles are finer and have more uniform distribution, signs of ductile fracture
2. Fine Cu-rich particles are in the middle of dimples, indicative of higher ductility

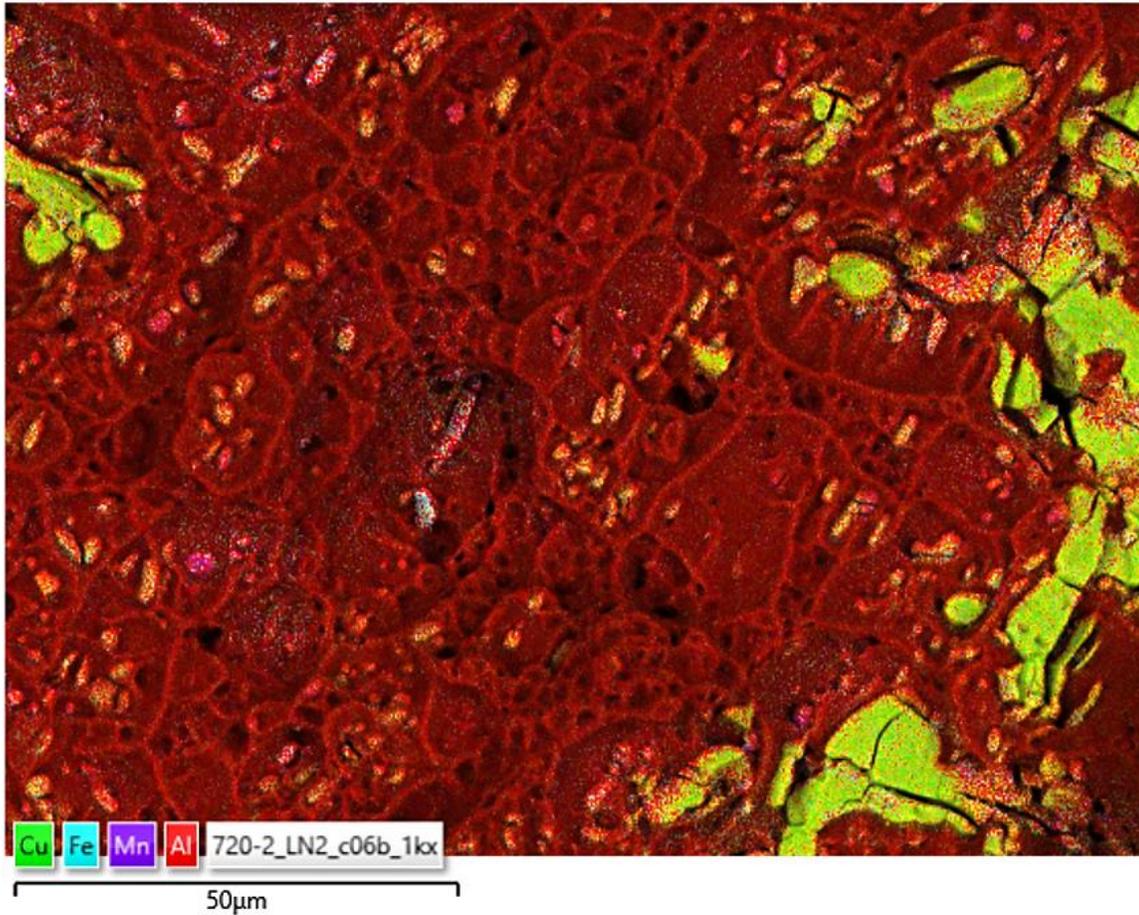
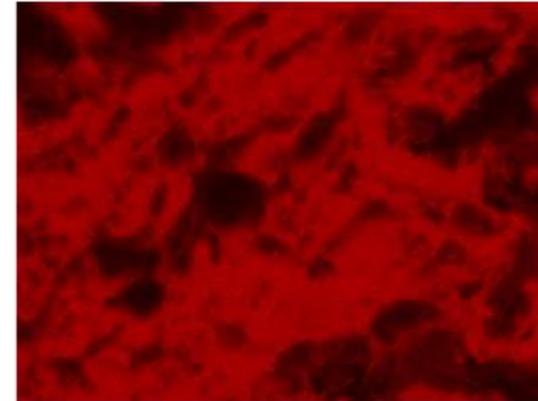
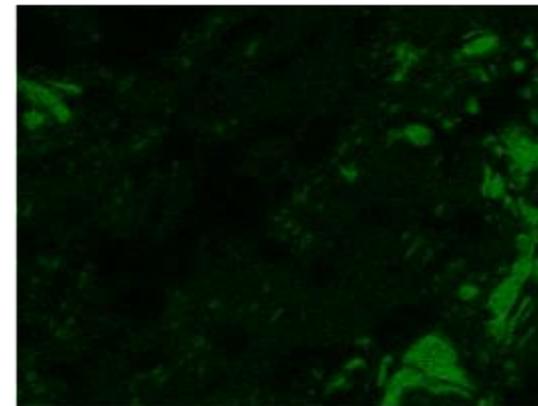
720-2 LN2 – 7.23%

EDS confirms the white particles in SEM image (green color on x-ray map) are Cu-rich

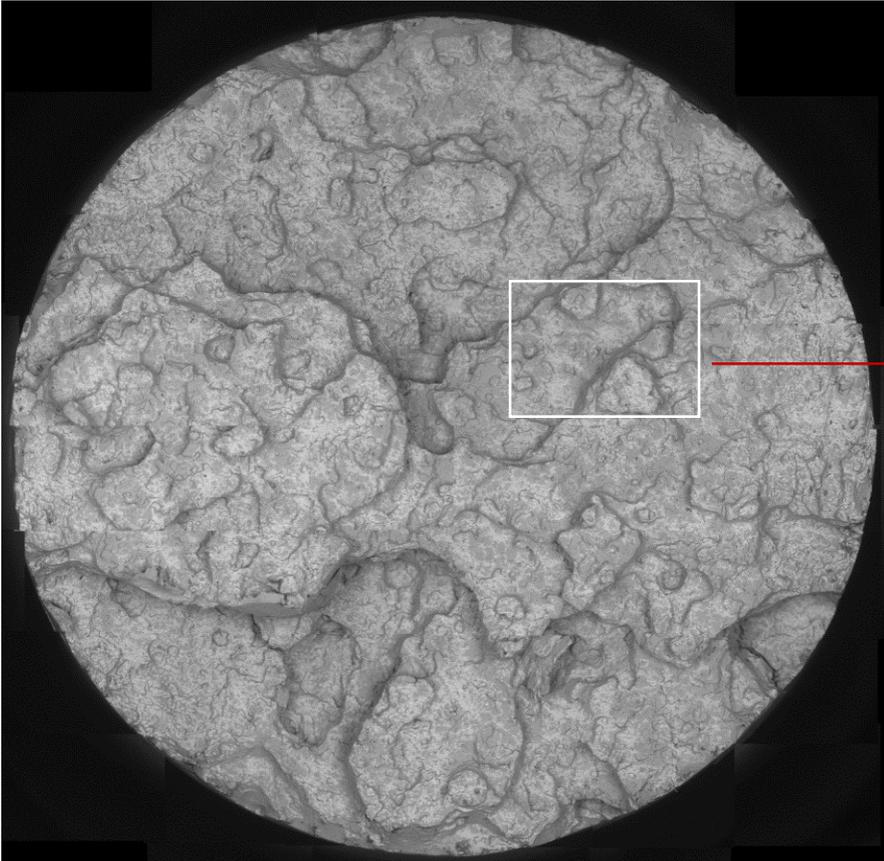
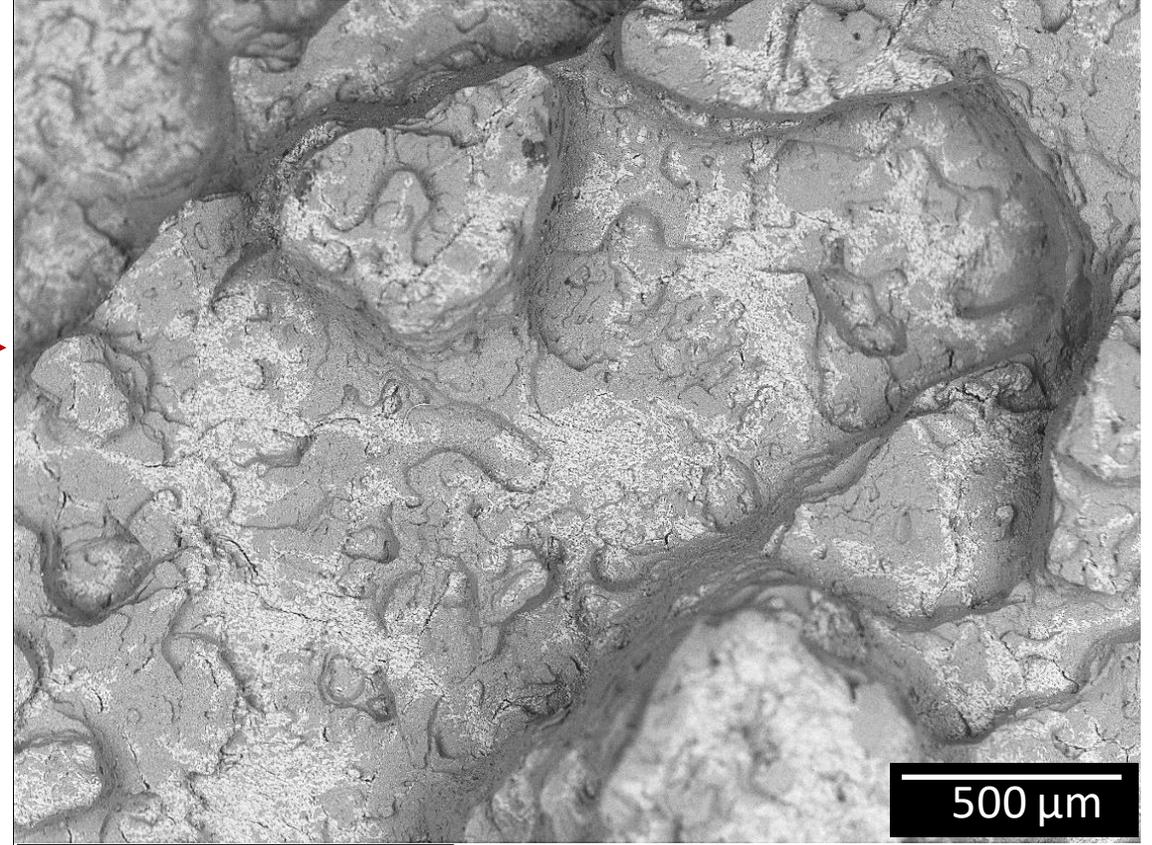
722C-5 LN2 – 1.00%

White particles are Cu-rich precipitates

Distribution of Cu-rich particles in AL-matrix

Cu-rich particles are coarser and have non-uniform distribution

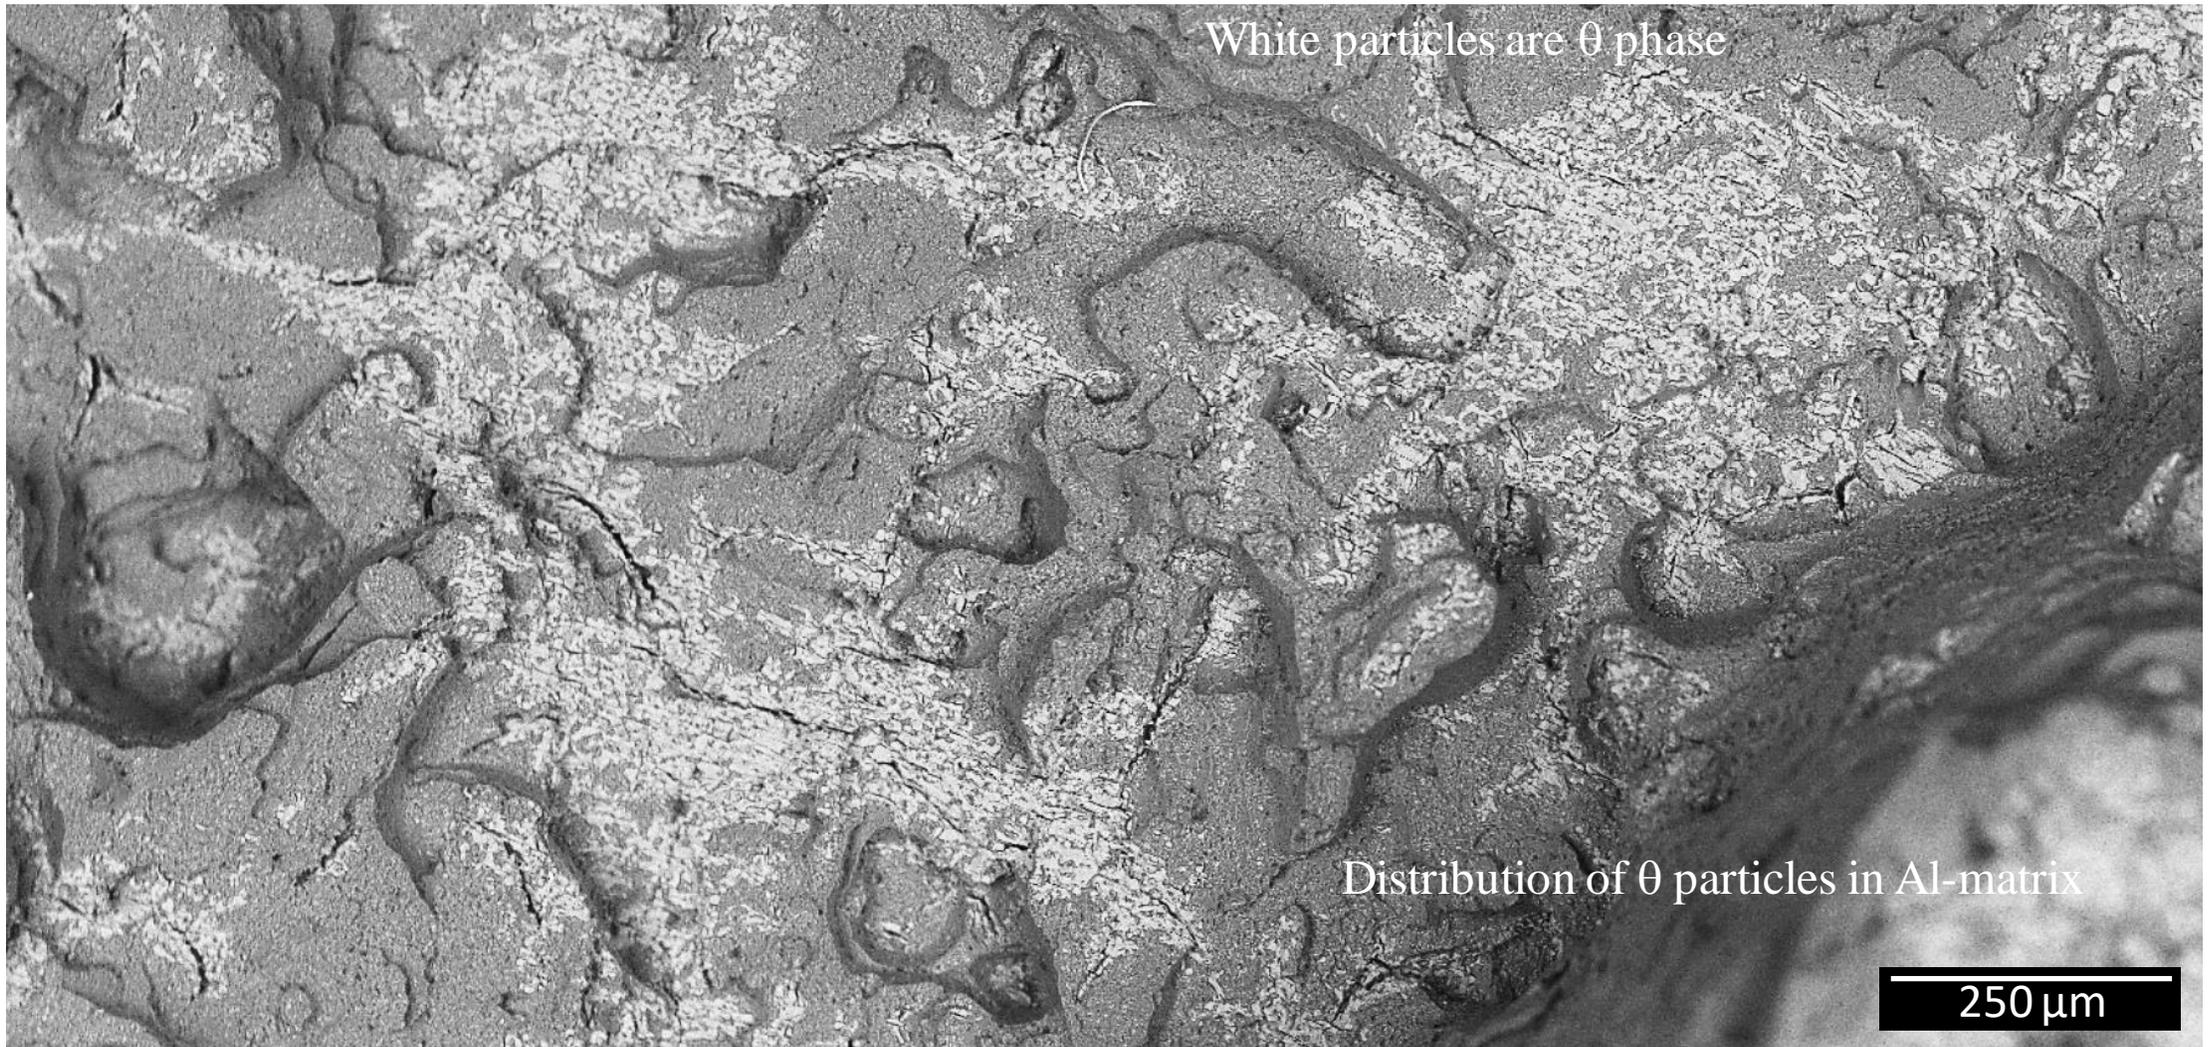
Cu-rich particles have non-uniform distribution

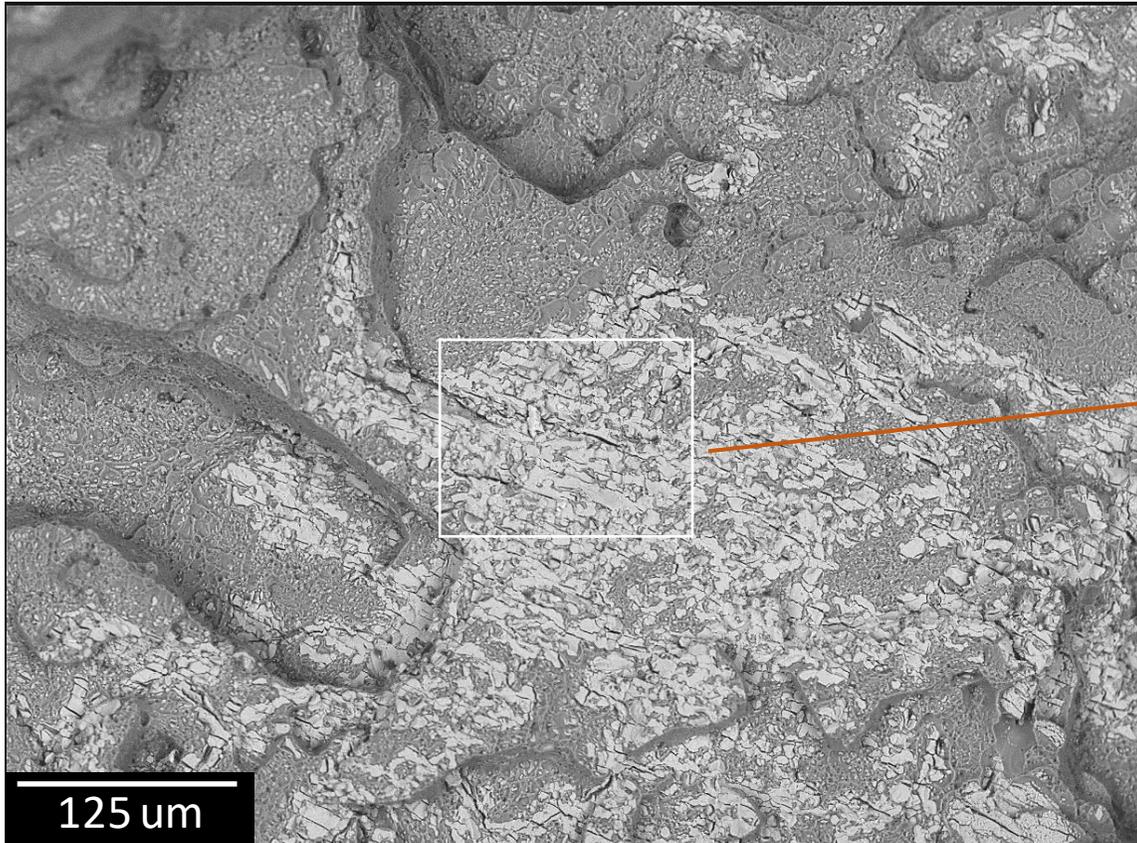
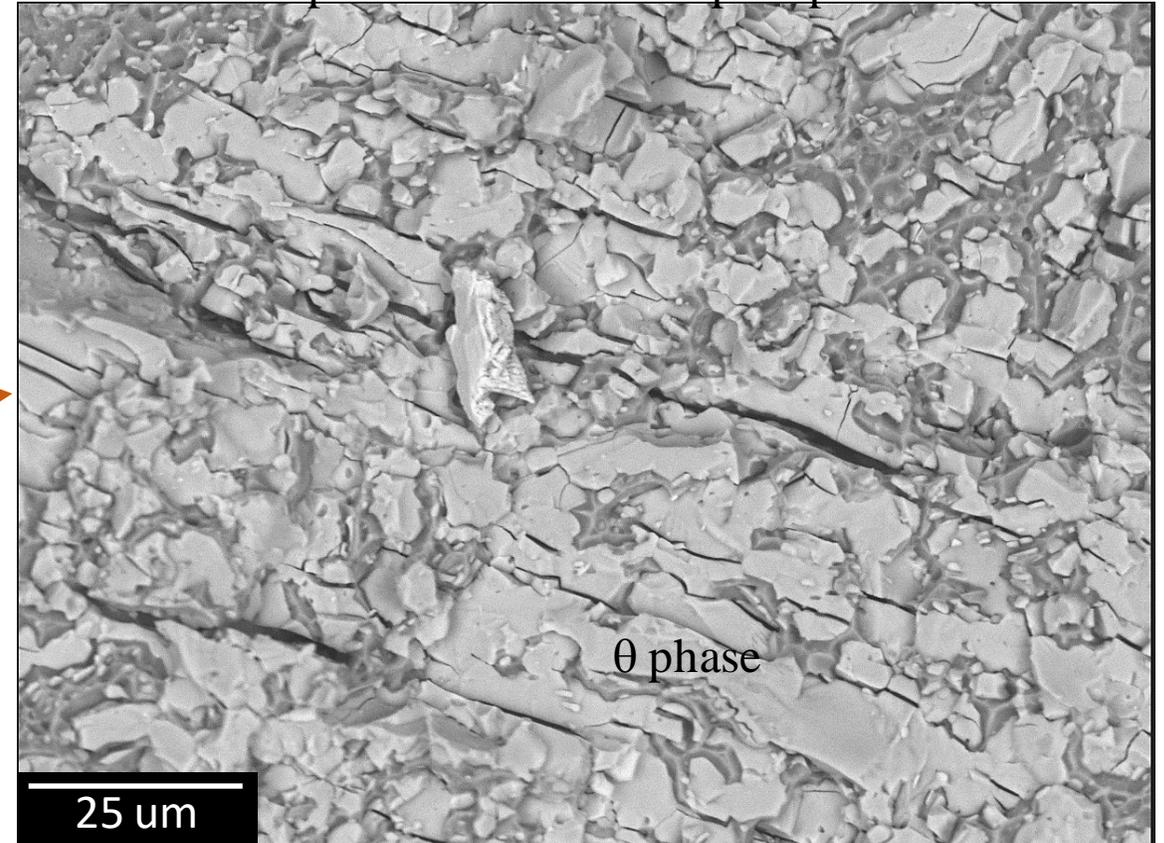
722C-5 LN2 – 1.00%

Clusters of Cu-rich particles with micro-cracks

Cracking along or through Cu-rich particles

1. Cu-rich particles are coarser and have a tendency to aggregate together
2. Cu-rich particles are hard and brittle, acting as stress risers during tensile deformation
3. Many micro-cracks are present in the regions that have numerous Cu-rich particles

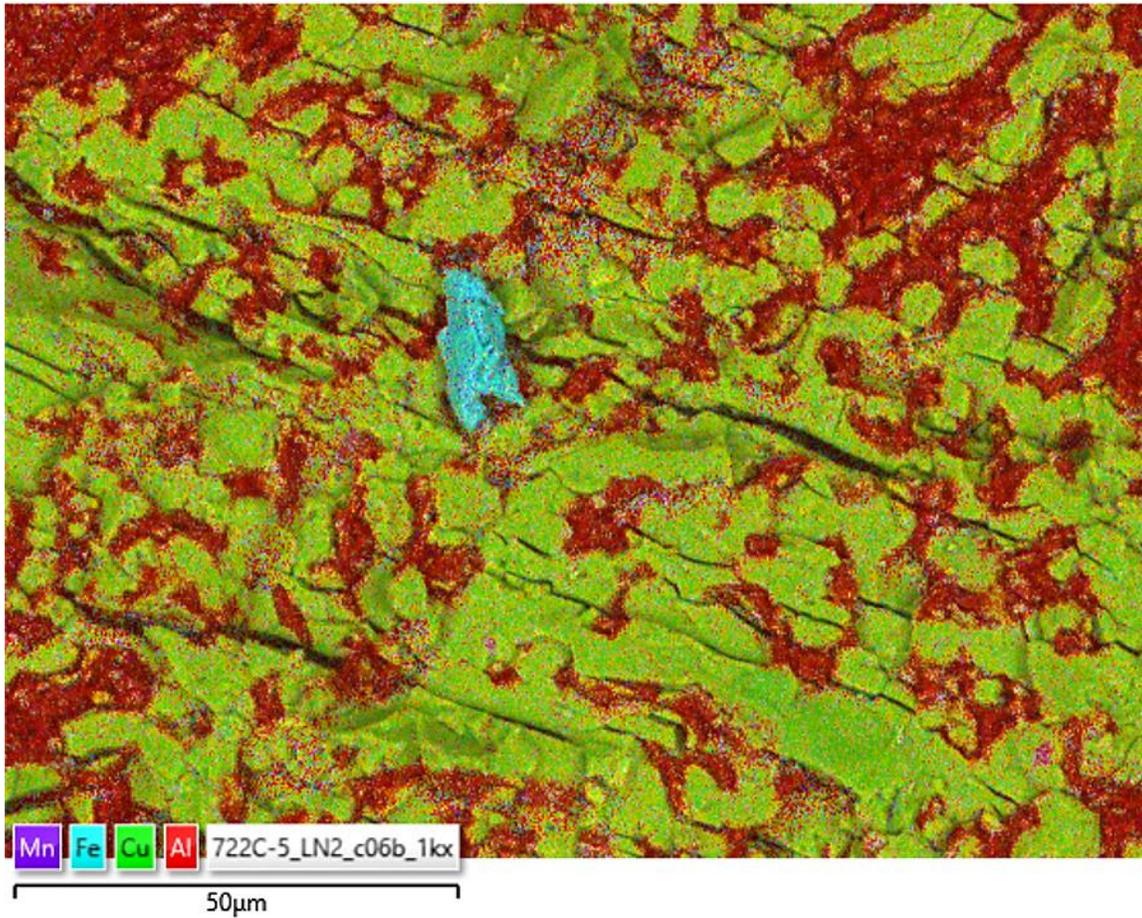
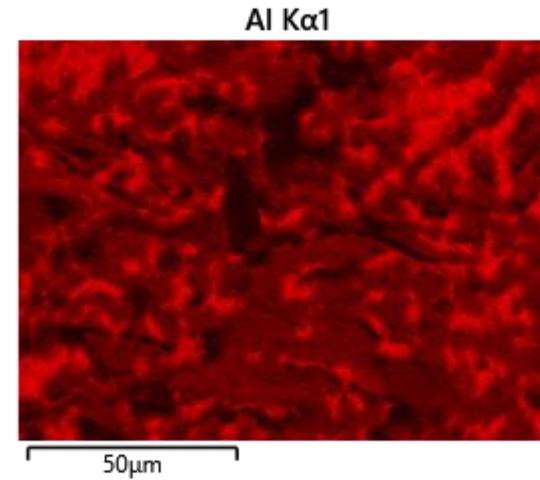
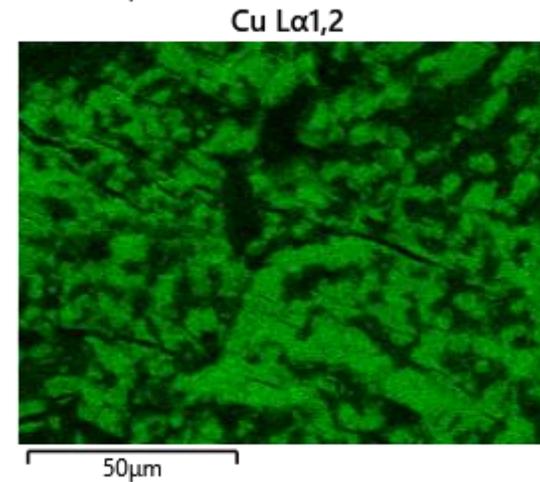
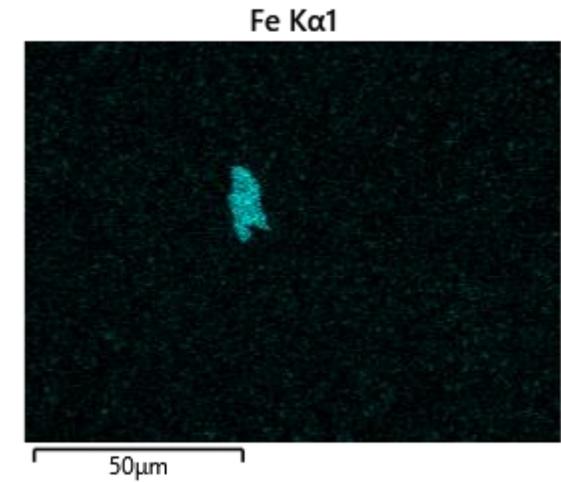
722C-5 LN2 – 1.00%

EDS confirms the white particles in SEM image (green color on x-ray map) are Cu-rich

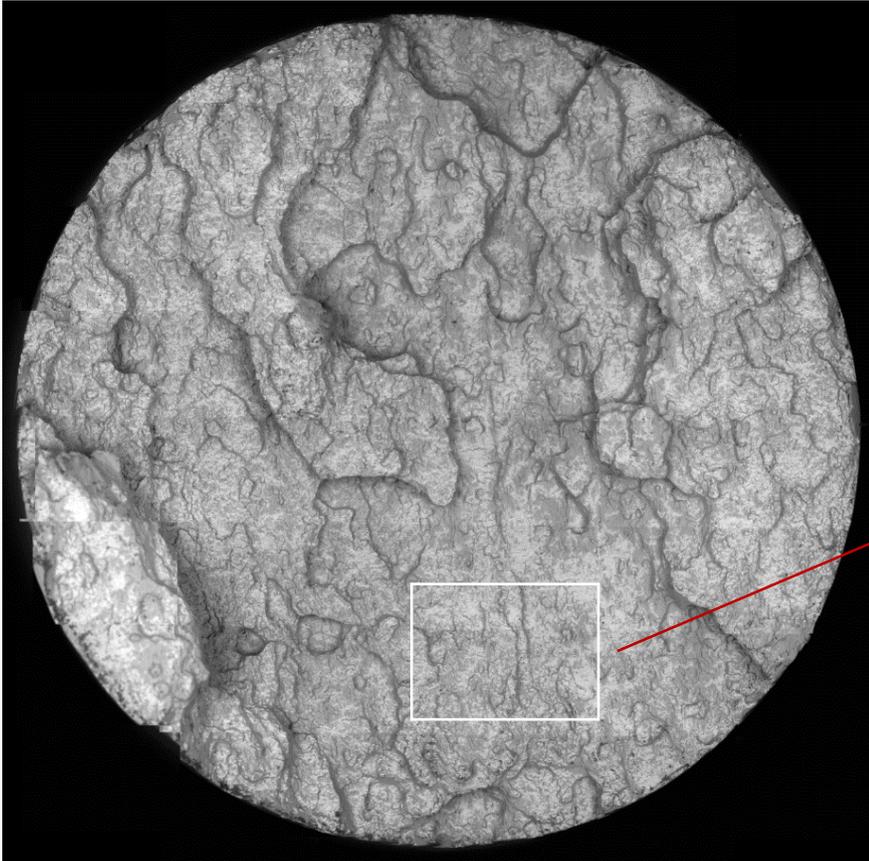
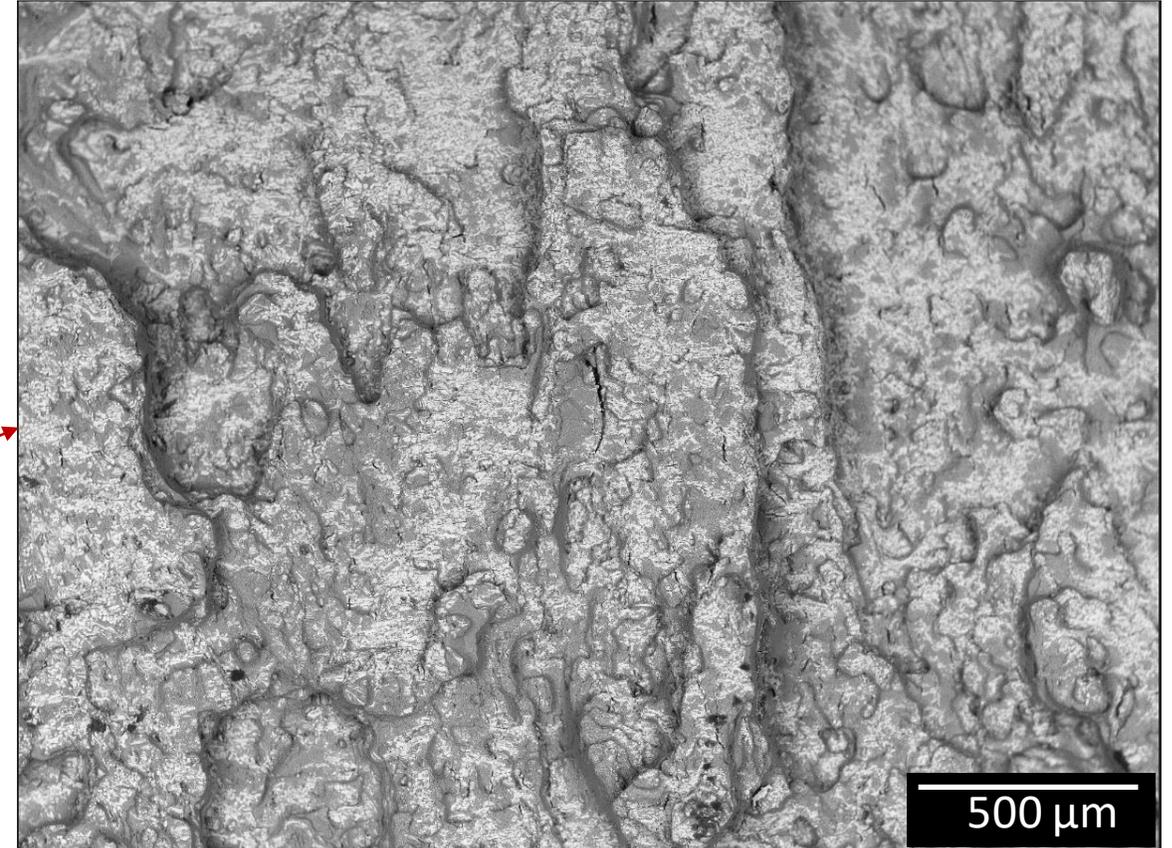
723C-6 LN2 – 1.25%

White particles are Cu-rich precipitates

Distribution of Cu-rich particles in AL-matrix

Cu-rich particles are coarser and have non-uniform distribution

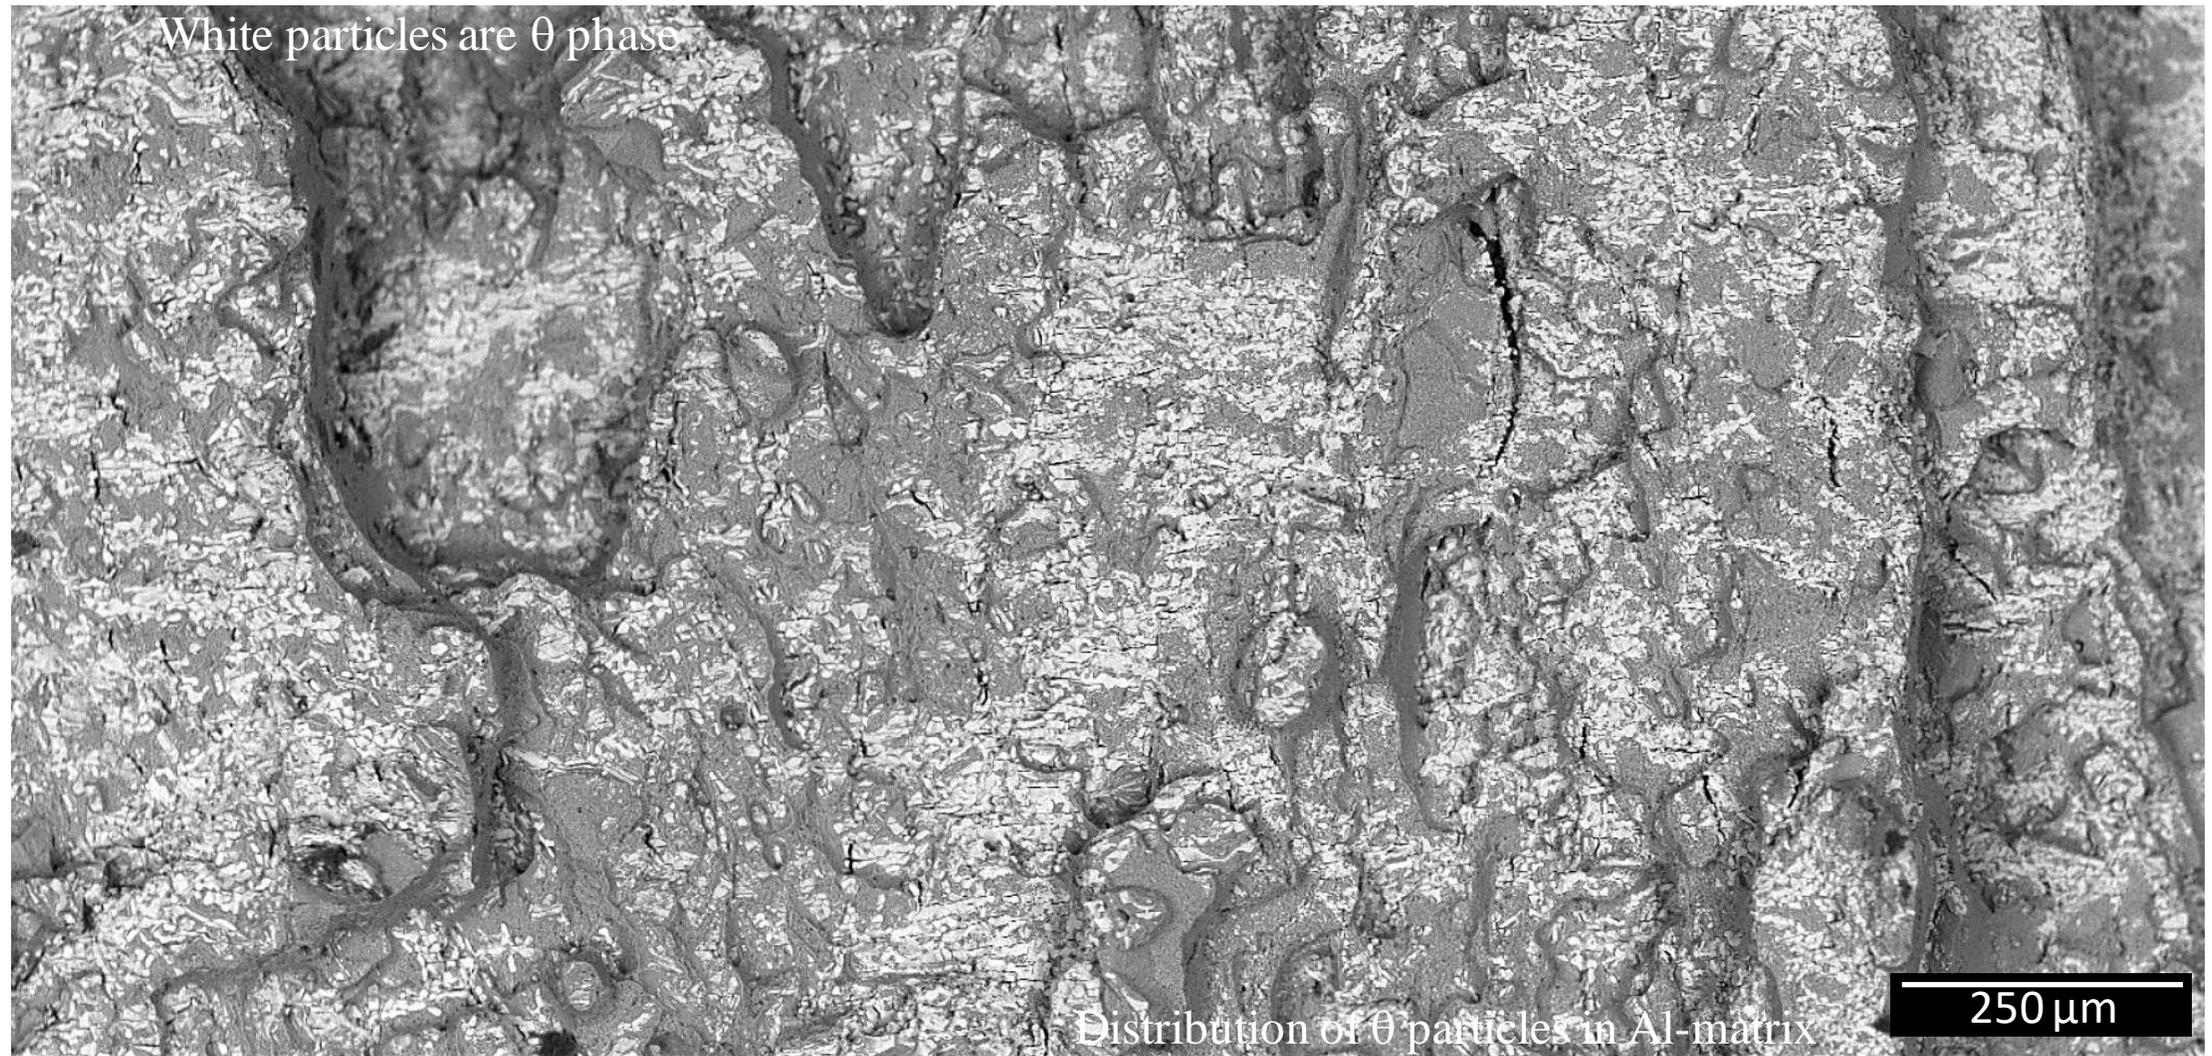
Density of Cu-rich particles is unusually high in this region

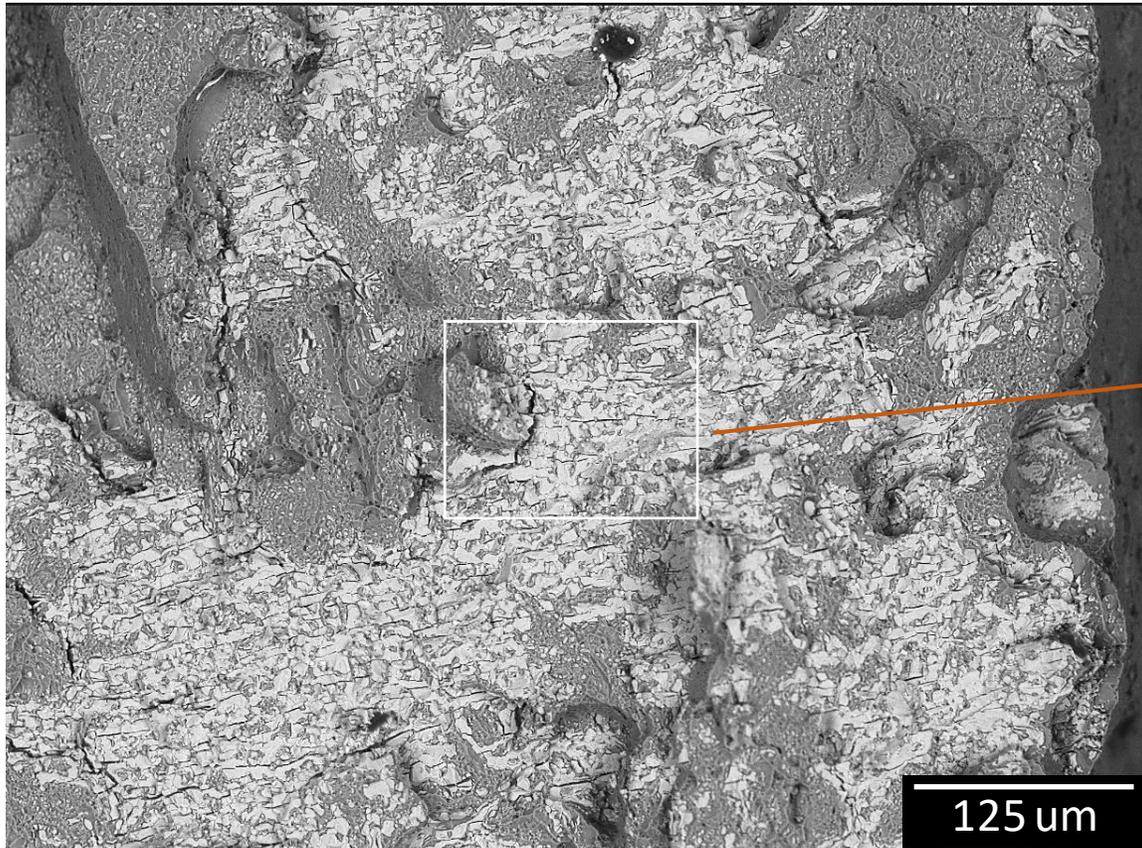
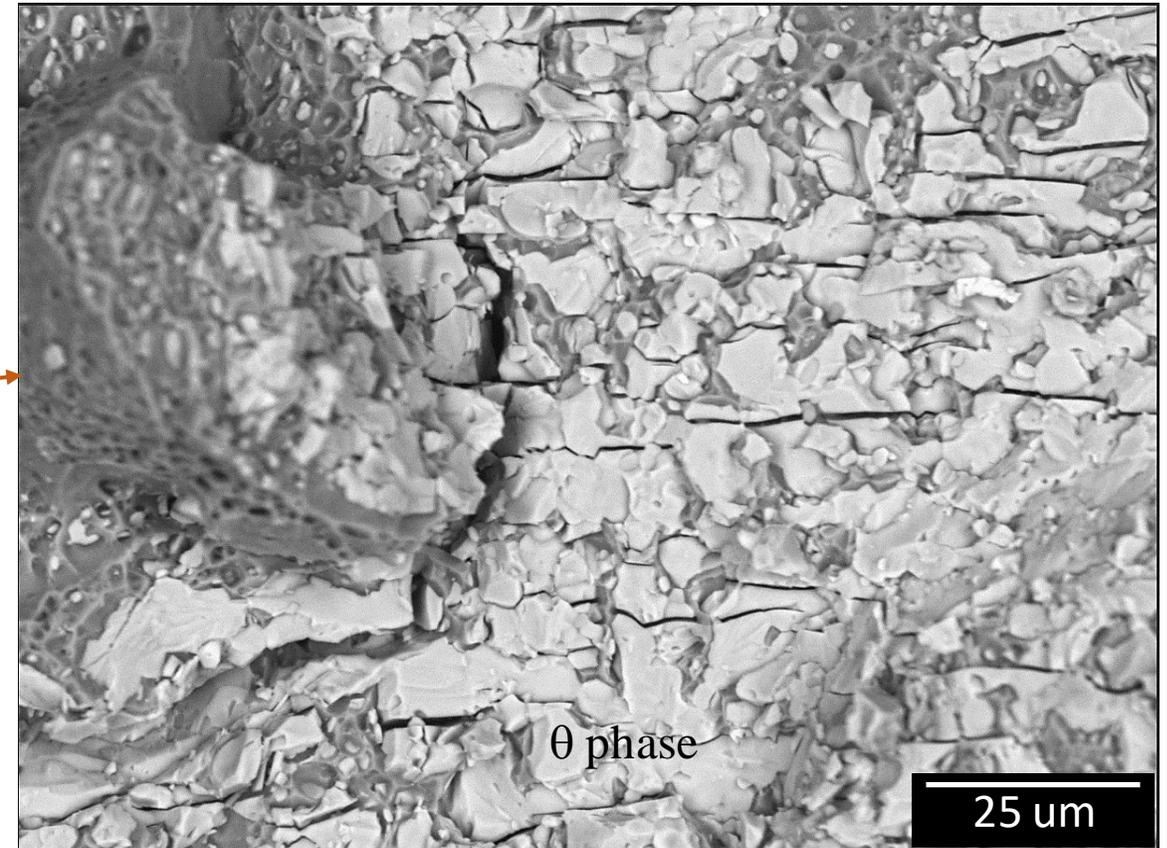
723C-6 LN2 – 1.25%

Clusters of Cu-rich particles with micro-cracks

Cracking along or through Cu-rich particles

1. Cu-rich particles are coarser and have a tendency to aggregate together
2. Cu-rich particles are hard and brittle, acting as stress risers during tensile deformation
3. Many micro-cracks are present in the regions that have numerous Cu-rich particles
