*Interim Report I*

**5 Inch Thick 2219-T87 Plate Low Ductility Investigation**

– Material analysis on broken tensile samples

EM31/NASA-Marshall Space Flight Center

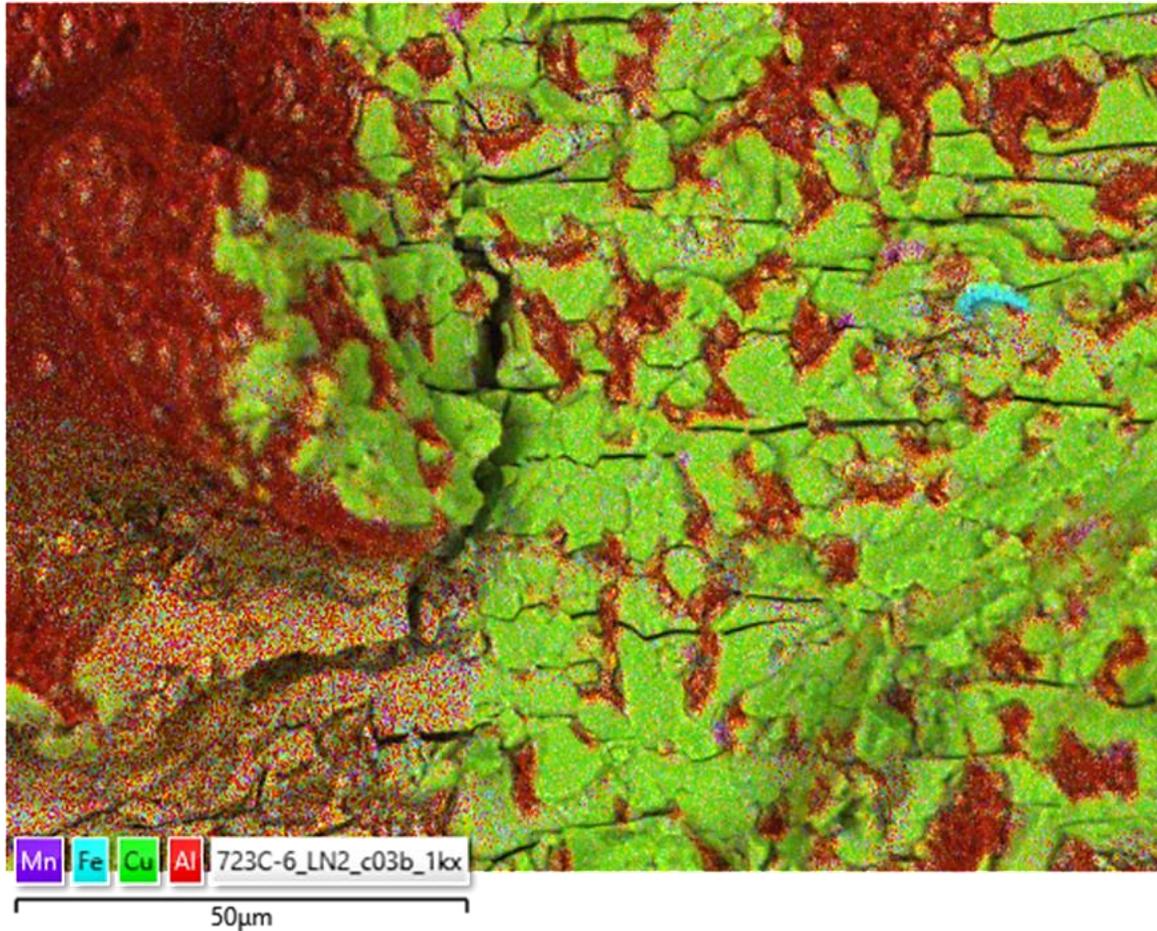
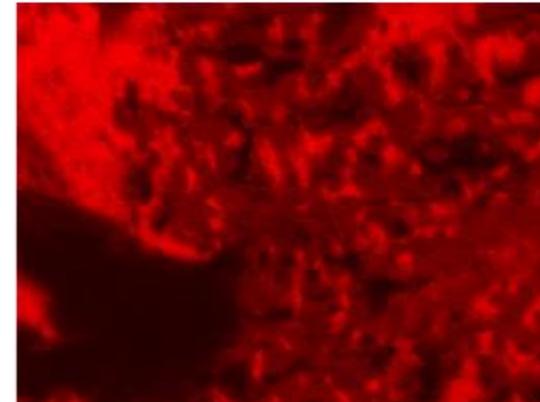
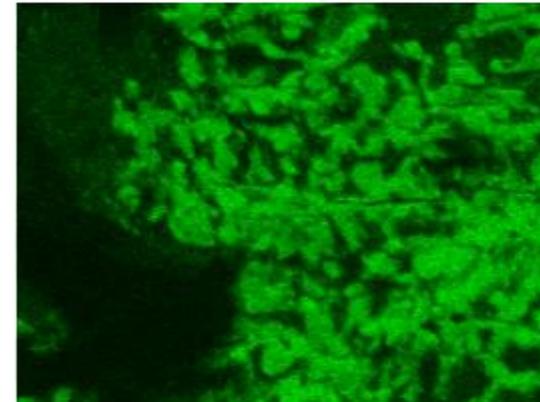
723C-6 LN2 – 1.25%

EDS confirms the white particles in SEM image (green color on x-ray map) are Cu-rich
