Study of Spacecraft Deployables Failures

Alejandro Rivera
Deployables Analysis Engineer
NASA Goddard Space Flight Center

Space Systems Anomalies and Failures (SCAF) Workshop 2022

January 11th, 2022

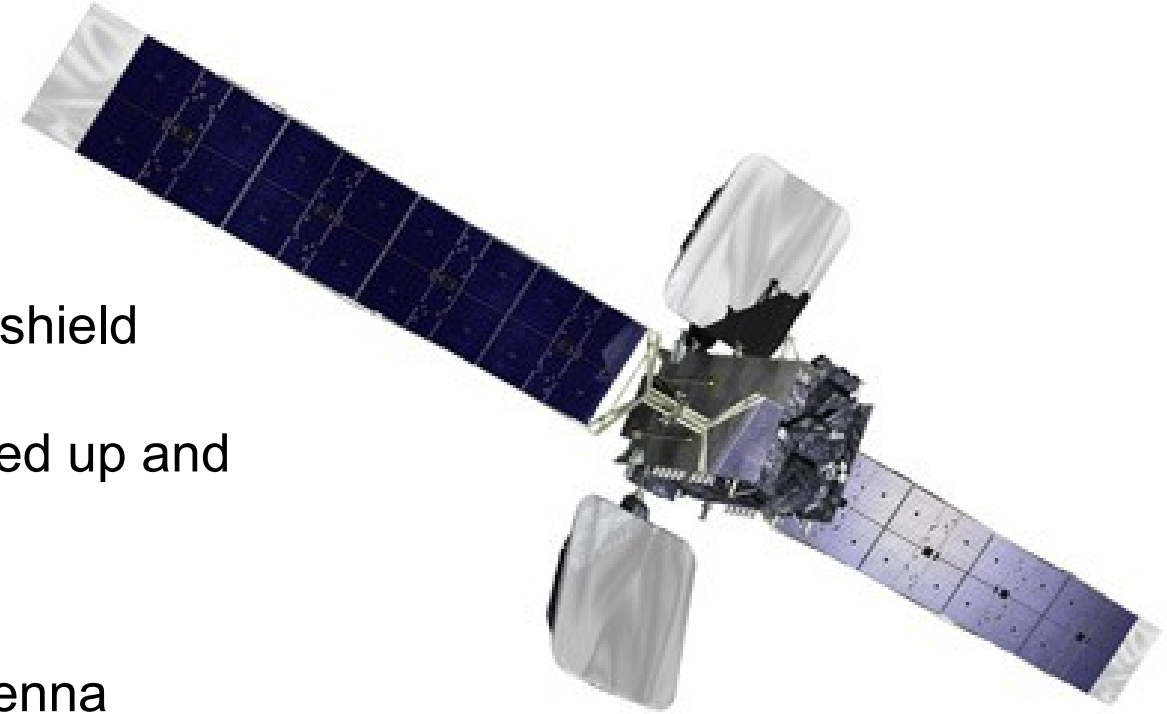
Thermal Blankets / Shields Interferences Dawn / Intelsat 28

Anomaly #1: Ku-band antenna fails to deploy

Cause: deployment mechanisms interference with sunshield

Anomaly #2: unable to deploy its C-band reflector antenna

Cause: antenna's spring-loaded deployment mechanism got caught in the billows of its sunshield

Consequences: Mission Life reduced by 2 years

Resolution: motor-driven deployment mechanism moved up and down to free antenna from sunshield

Resolution: Shaking of the SC unsuccessful

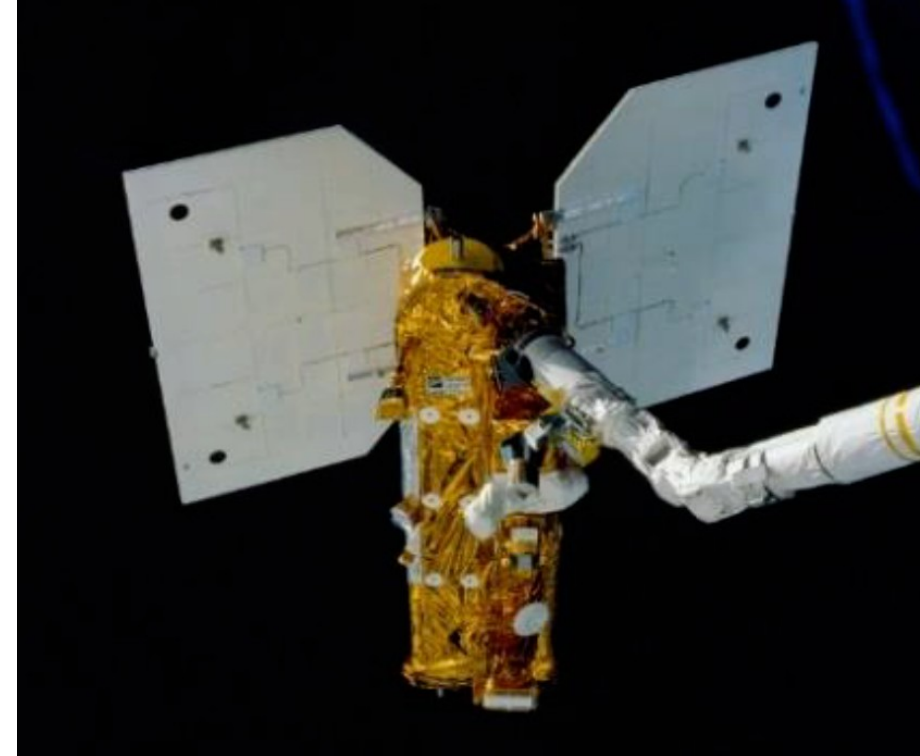
Anomaly: One of the Solar Arrays failed to deploy

Cause: MoS₂ exposed to excessive humidity before launch resulting in excessive bearing friction in the space environment

Trouble shooting: exposure to sun until temperature above 0 °C

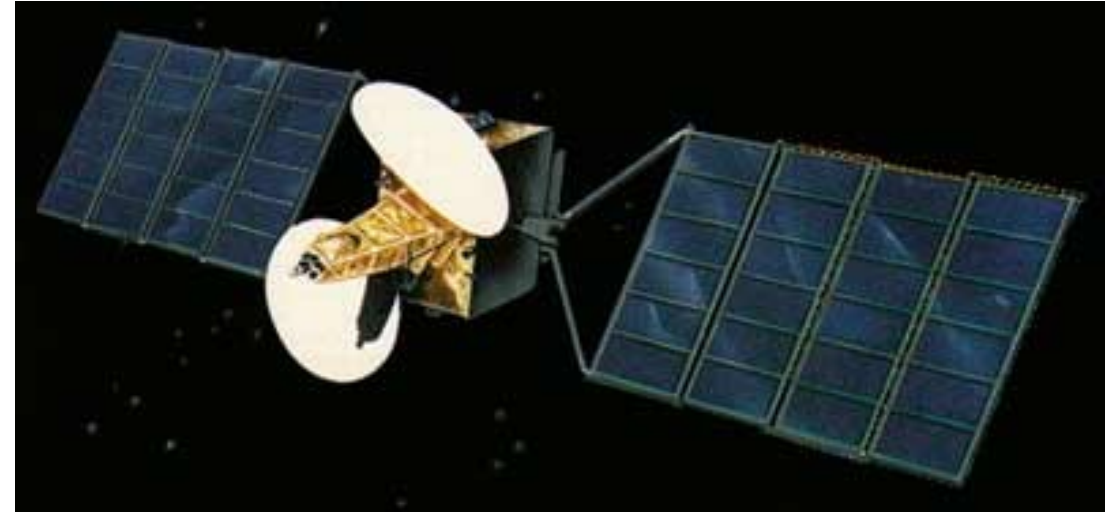
Anomaly: One of the Solar Arrays failed to deploy

Cause: Some of the hold down clips used to secure the SA panel during ground handling were not removed

Consequences: SC placed on a graveyard orbit. Total Mission Loss

Trouble shooting: Attempts to free it by spinning or shaking the satellite not successful.

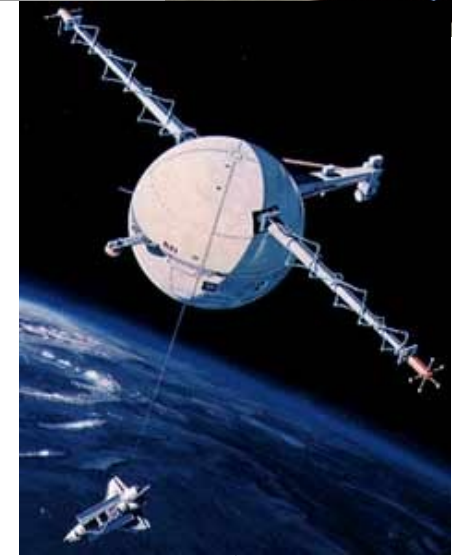
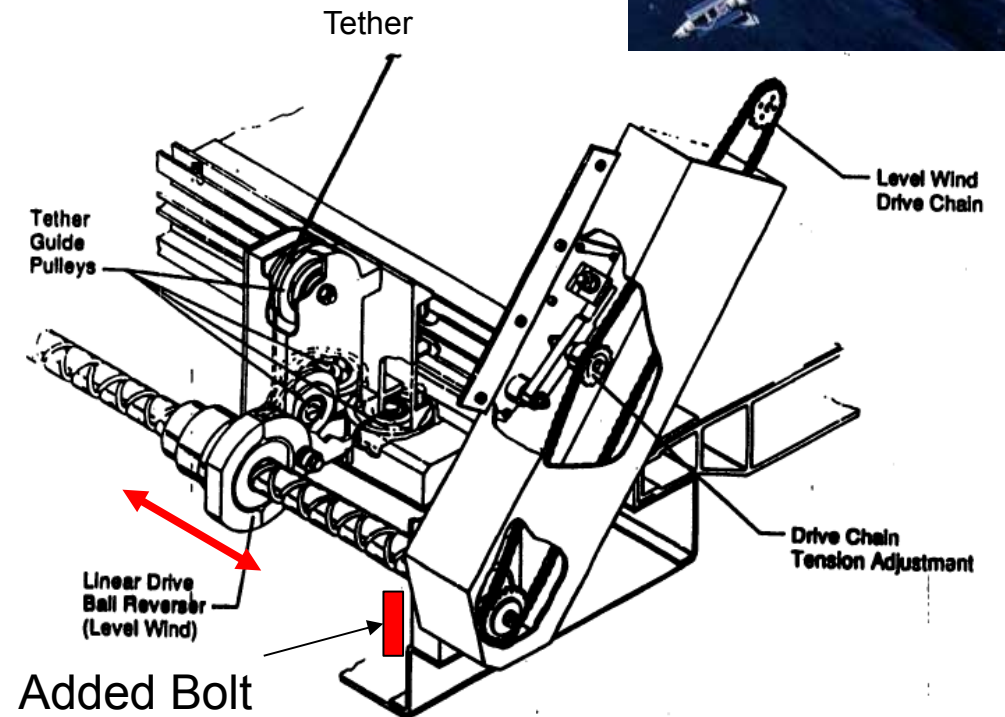
Last Minute Changes Tethered Satellite System (TSS-1)

Anomaly: Reel-out mechanism jammed. Tether only released to about 256 m out of the planned 20.1 Km.

Cause: Bolt added for structural margin to address a last minute concern interfered with the reel out mechanism. Protruding bolt interfered with a traveling ball nut and thwarted satellite deployment.

Consequences: **Total Mission Loss**

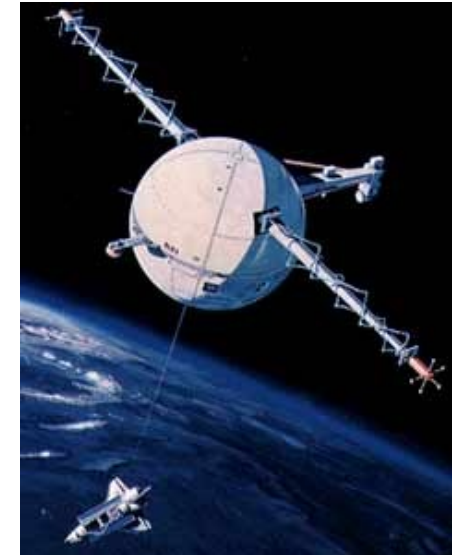
Space Environment Tethered Satellite System (TSS-1R)

Anomaly: Five hours after deployment began on February 25, 1996, with 19.7 km (of 20.7 planned) of tether released, the tether cable suddenly snapped near the top of the deployment boom (within 12 m). The TSS satellite separated from the orbiter and shot away into a higher orbit

Cause: The TSS-1R Mission Failure Investigation Board established that the tether failed as a result of arcing and burning of the tether (electrical discharge through a break in the insulation), leading to a tensile failure after a significant portion of the tether had burned away.

Consequences: TSS instruments could be re-activated and produced science data for three days until battery power ran out

Partial Mission Loss

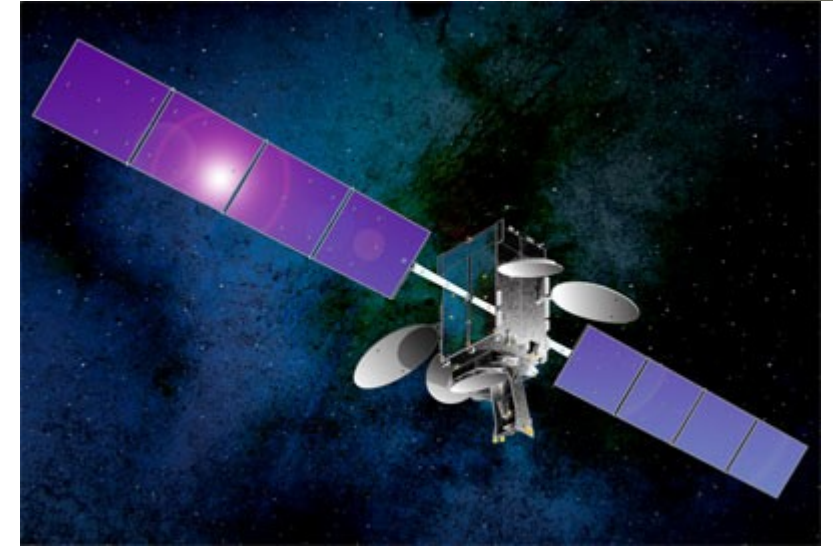
SA Explosive Decompression Telstar14, 14R, Intelsat 19

Anomaly: SA partially deployed (14, 14R) or failed to deploy (IS-19)

Cause: Inadvertent solar array pressurization and explosive decompression damaged the arrays' deployment mechanism

Consequences: all of them remained in service but with serious reductions in capacity

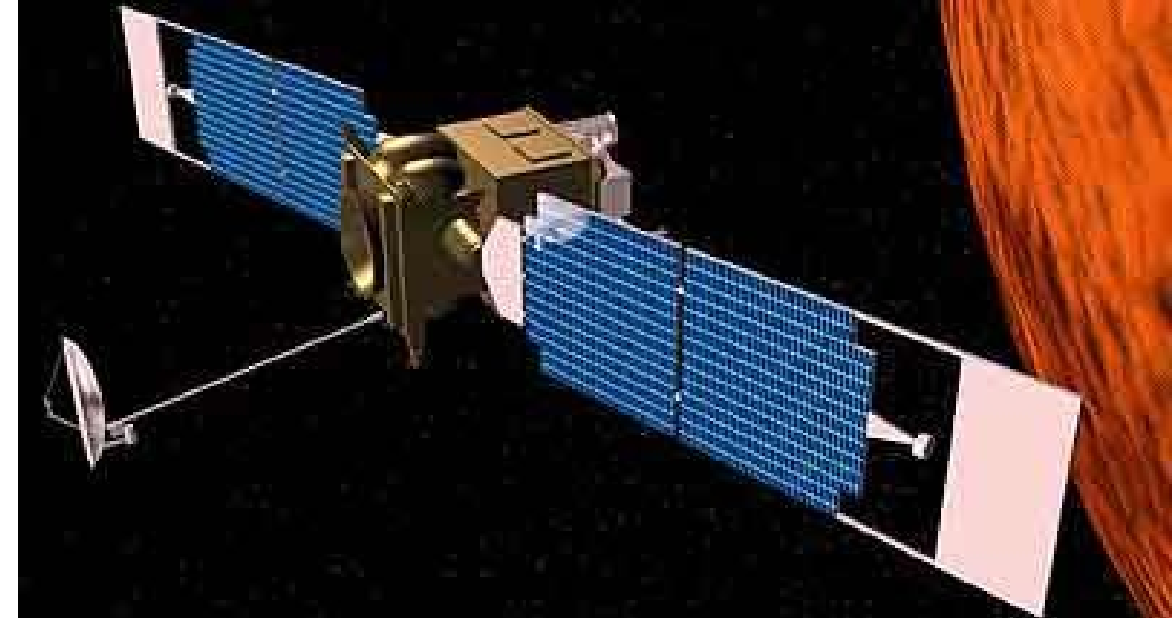
Anomaly: Solar Array fails to latch

Cause: input shaft of the damper sheared during SA deployment as input torque to damper was applied via a 'damper arm' which also applied a shear force the damper was not designed for.

Consequences: Aerobraking maneuvers had to be modified to put less pressure on solar panels.

New aerobraking schedule delayed reaching final polar science mapping orbit by 1 year.

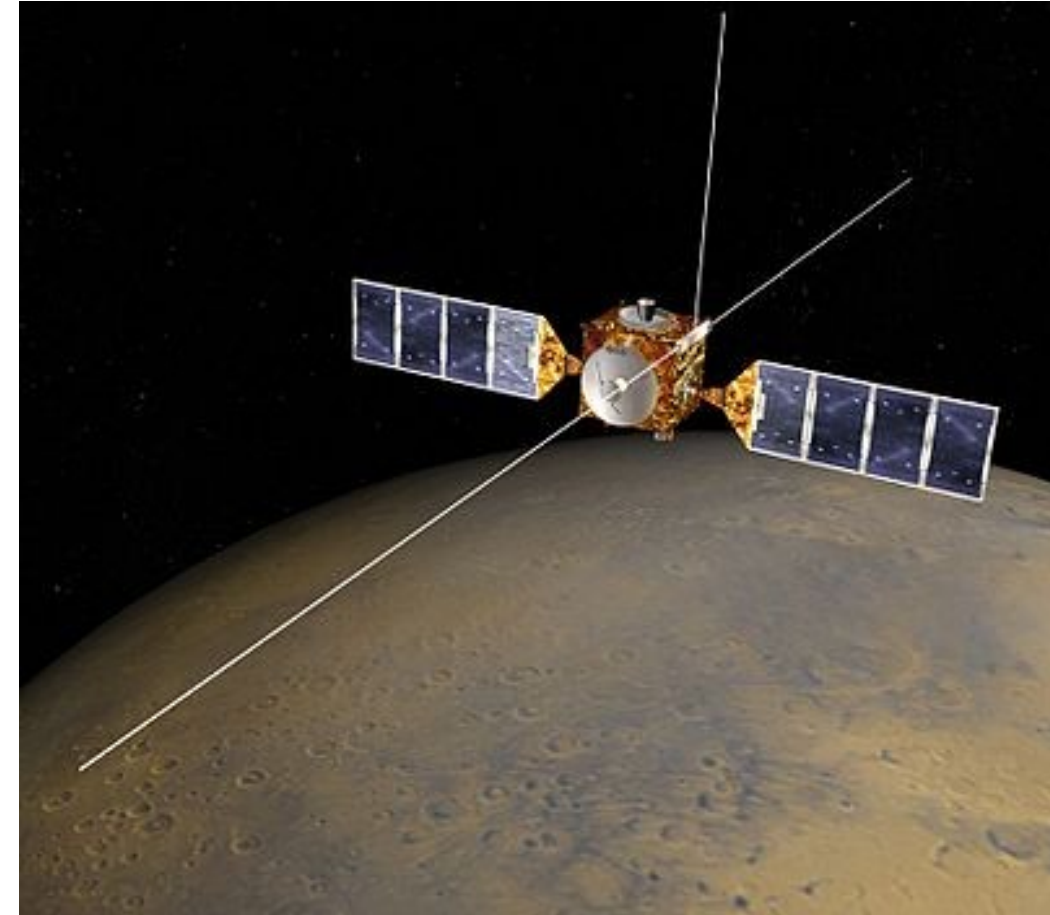
Anomaly: MARSIS antenna booms' deployments delayed

Cause: Simulation enhancements on similar antenna indicated potential risk that booms could back lash and damage SC

Trouble shooting: additional contingency simulations performed to assess risks; Mitigation scenarios defined.

Resolution: 1st boom failed to deploy until after exposure to sun; 2nd and 3rd deployed successfully.

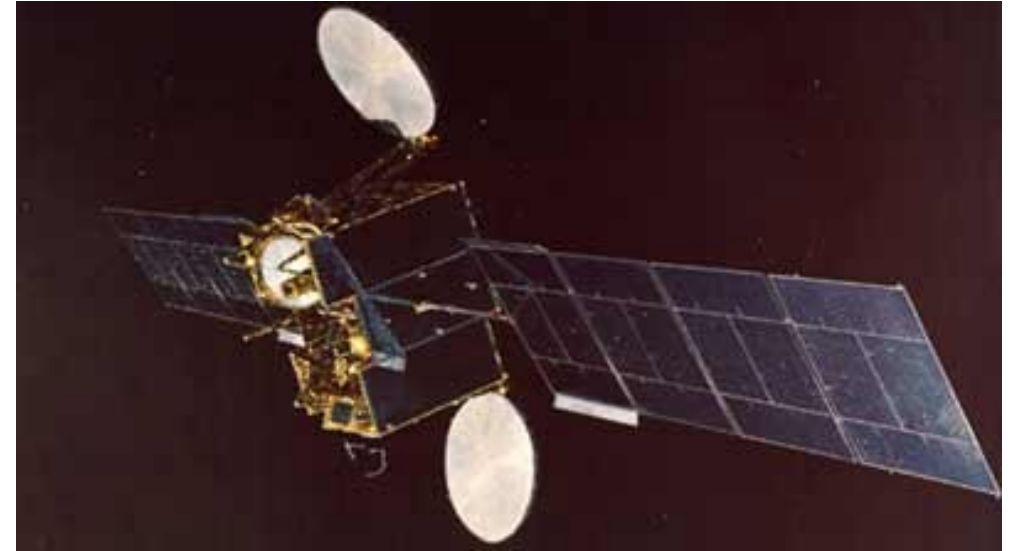
Anik E2

Anomaly: Ku-Band Antenna deployed after 2 days
C-Band Antenna did not fully deploy

Cause: Thermal blanket interference

Consequences: Rescue maneuvers used a year's worth of fuel

Trouble shooting: long list of SC contingency maneuvers supported by remarkable ground team analysis and technical ingenuity

Resolution: C-band antenna deployed and mission saved

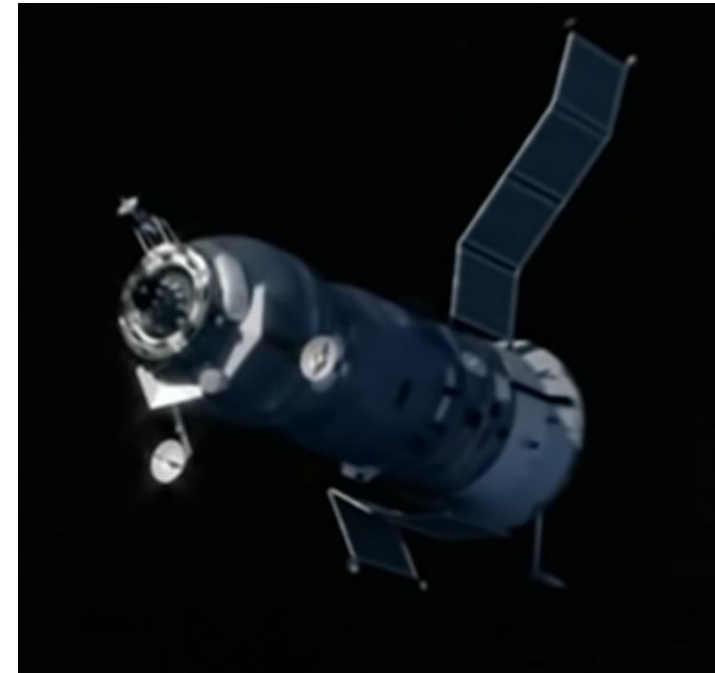
Anomaly: Left Solar Array and backup antenna of telemetry system did not deploy; Cover of star sensor did not open due to obstruction of the undeployed SA.

Cause: SA deployment mechanism stuck

Consequences: lack of power forced premature re-entry. Due to asymmetry of SC with just one SA opened, attitude control thrusters were not able to maintain proper orientation during braking maneuver and deviation from the nominal attitude exceeded 8 degrees. Reentry capsule descended on a ballistic trajectory and without an aerodynamic lift. Re-entry capsule crashed and burned killing Komarov.

Trouble shooting: without star sensor Soyuz-1 could not maintain attitude control necessary for stabilization. Automatic and manual attempts by cosmonaut Vladimir Komarov to stabilize the SC failed. Komarov even knocked with his feet on the left side of the SC where the deployment mechanism was located.

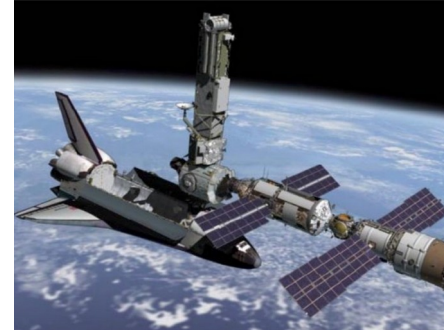
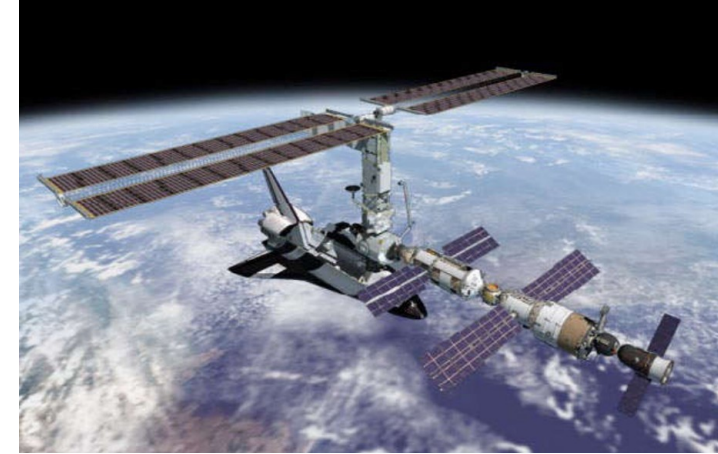
International Space Station

Anomaly: Two rows of SA panels at the ISS Port Wing stuck together.

Cause: Snagging

Trouble shooting: Endeavour astronauts had to deploy the second of two 120ft x 38ft solar wings. The deployment which took several hours was completed, after two rows of solar panels stuck together were shaken loose by slightly retracting, then extending the arrays again.
