# Arecibo Observatory Auxiliary M4N Socket Termination Failure Analysis

NASA Engineering & Safety Center  
February 16th, 2022

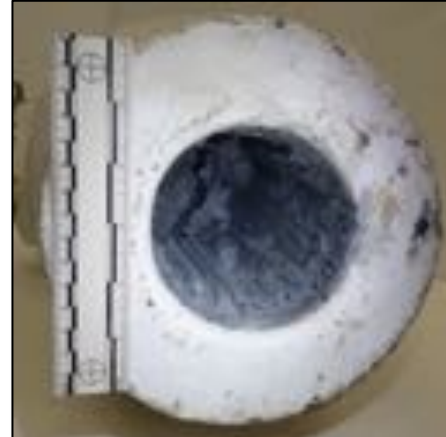
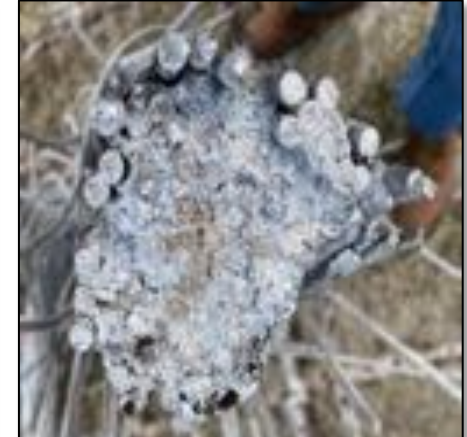
Aux M4N Failed Socket

Pulled-out wires/core

- **August 10, 2020:** Aux M4N cable on the north side of Tower 4 failed. Cable was a primary component of the system used to suspend the large, steel-framed platform (feed platform) above the telescope reflector dish.
- **November 6, 2020:** One of four original main cables of Tower 4 failed. Second cable failure was one of the original main cables, which had a different structural strand construction and cable termination.
- **December 1, 2020:** Second original main cable at Tower 4 failed, causing a chain reaction of failures and load imbalances in the suspension cable system that led to total collapse of the observatory.

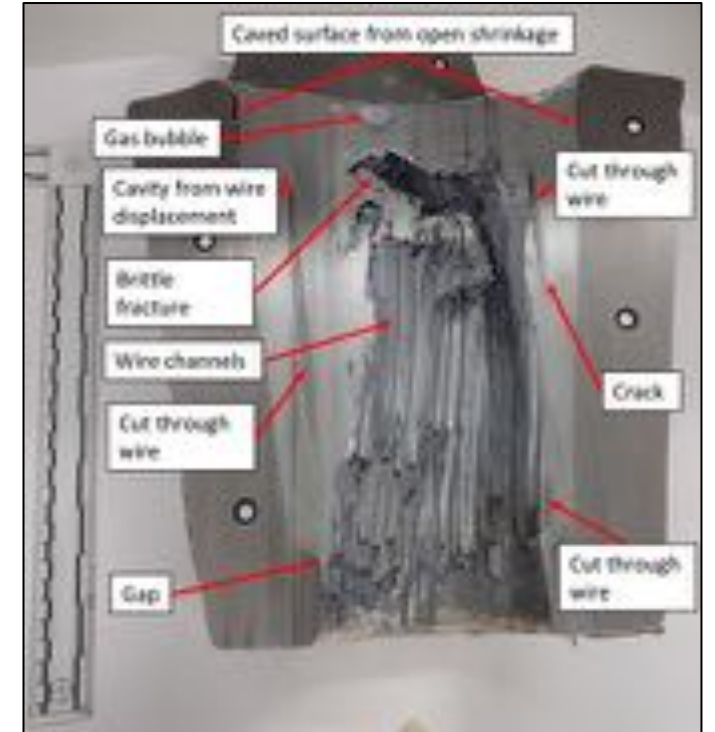
- **As-received socket housing and cable met spec/reqt's, but contained some defects analyzed for potential contribution:**
  - Zinc porosity
  - Solidification gas bubbles near the casting cap surface
  - Poor wire/zinc bonding at the wire ends
  - Brittle fracture region
  - Cracks throughout the bulk zinc
  - Five of 126 wires had surface defects in vicinity of fracture:
    - At least two were influential in their fracture; one of two probably HAC.
  - Three of 126 wires found to be mixed-mode fractures, in part HAC.
  - FEM evaluated the effects of voids/defects (discussed later)

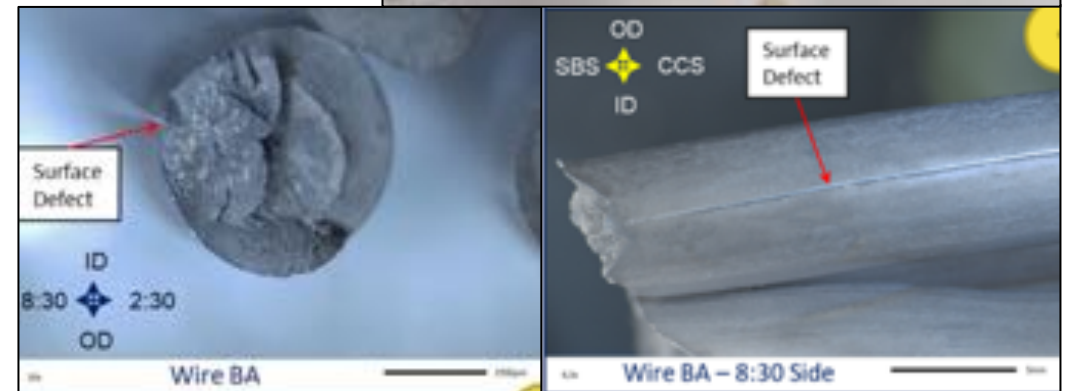
- Most features inconsequential to failure progression (more discussion to follow)
- Surface defects on a few outer wires may have contributed to wire failure initiation and progression

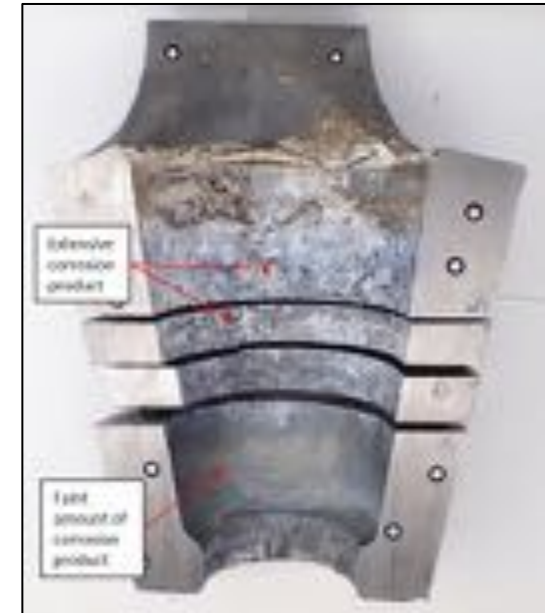
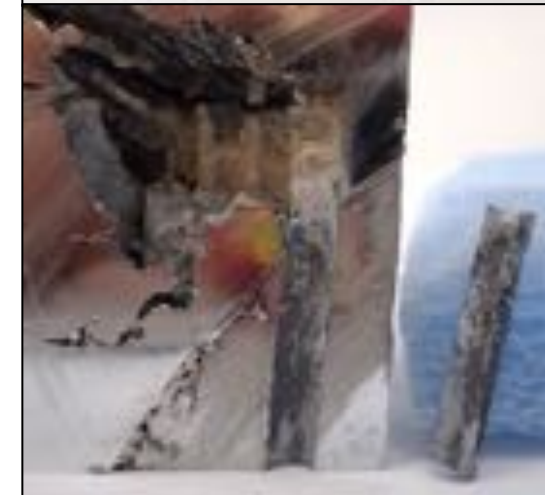
- **Moisture pathways caused corrosion throughout the socket**
  - Mastic coating cracks, between the socket inner wall and the zinc outer wall, along wires protruding through the zinc outer wall, along cracks in the zinc, and along other wires.

- **Steel + zinc  $\rightarrow$  galvanic coupling  $\rightarrow$  accelerated amount of zinc oxide, uncoupling caused trace iron oxide.**
  - Worst between the steel socket and zinc casting, upper two-thirds.

- Next worst was along the wire ends, notably at the wire imprint region.
  - Then along some wires near their fractured ends.
  - Least was between the steel socket and zinc casting, in the lower third.

- **Where no steel present, zinc oxide product found in varying quantities.**
  - Worst was in the gas bubbles near the casting cap.
  - Next was along cracks in the bulk of the zinc casting.

- Then along ridges in the brittle fracture region.
  - Least was over the exposed zinc surfaces in the cavity a few inches away from the rear of the cavity (wire channels) and over faceted regions of the brittle fracture region.

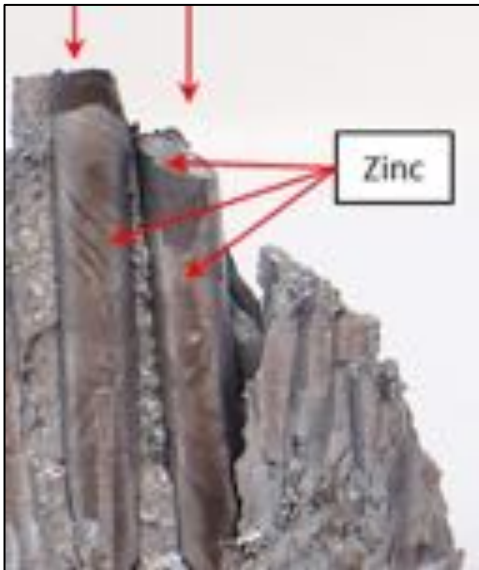
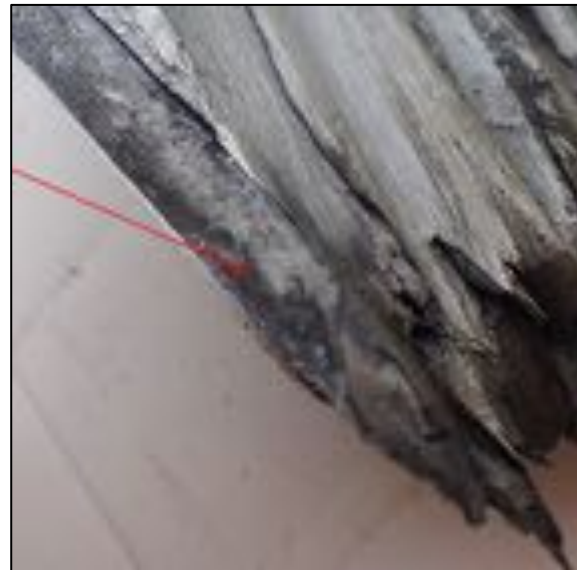
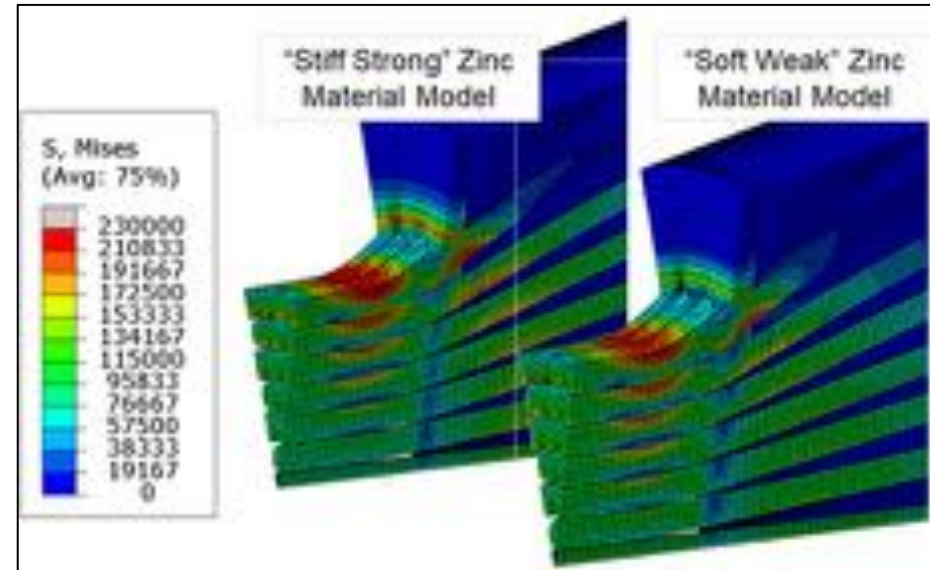
- **Analysis of contribution to socket failure:**
  - Percent metal loss to the overall zinc and steel structure was negligible.
  - No appreciable difference to wire/zinc bond strength from corrosion along wires.
  - Minimal effects on wire stresses based on a finite element model sensitivity study of varying conditions between the socket housing and the zinc.
  - Negligible effects on maximum predicted wire stress due to voids/defects near the casting cap.

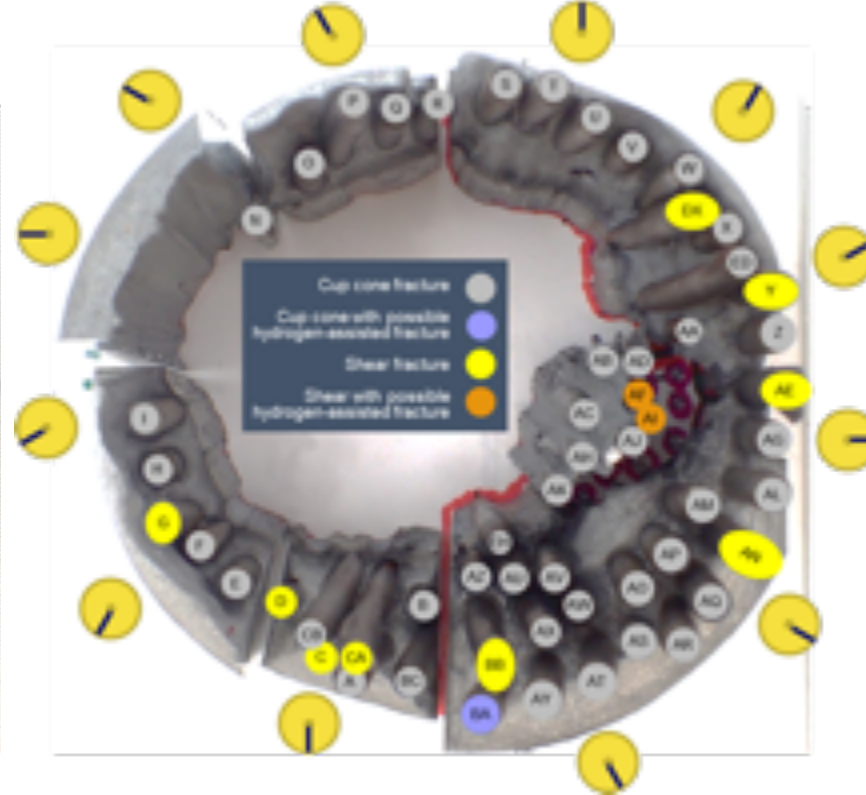
Fracture Classification

- Cup Cone
- Cup Cone/HAC
- Shear
- Shear/HAC
- Intact

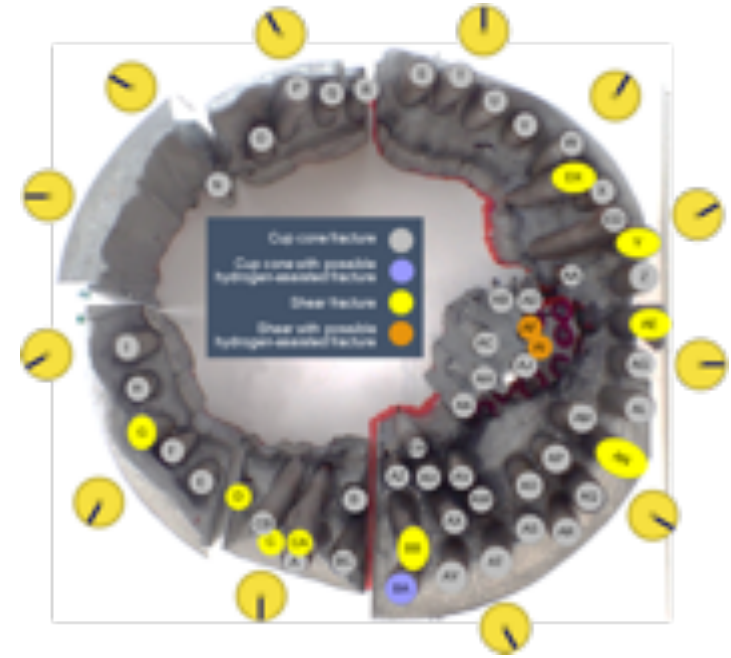
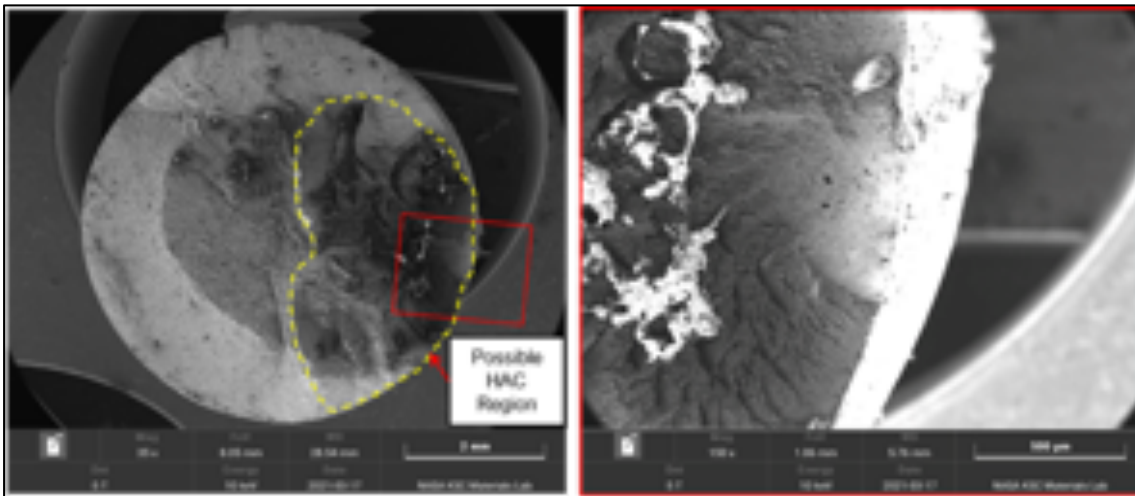
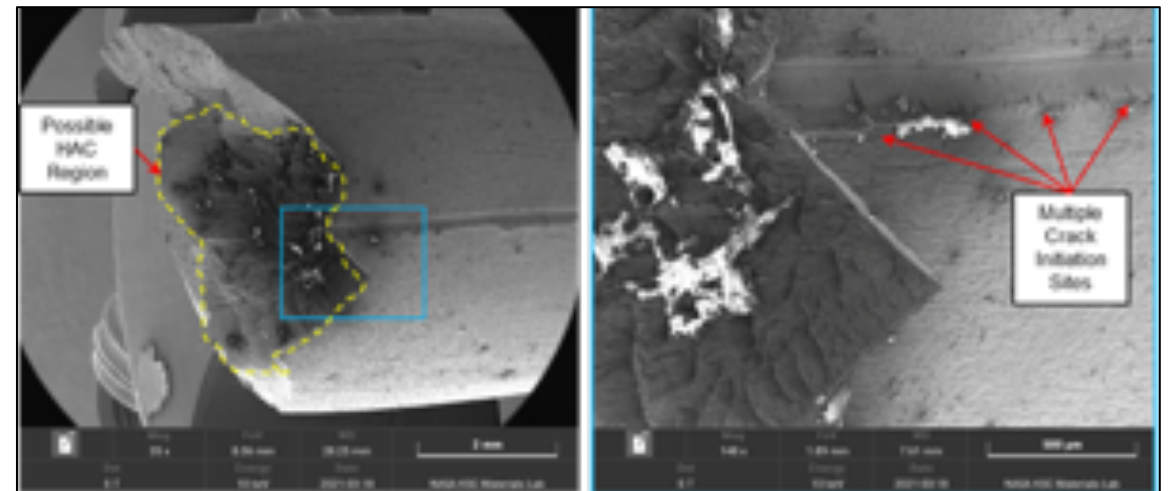
*HAC is caused by diffused hydrogen accumulating at stress concentrations and further decreasing strength capacity of the wires, which can lead to wire cracking.*

- HAC can accelerate failure, especially when subject to sustained loading, and has negative structural margins over the entire service life.
- Three wires exhibited mixed-mode fractures, with one mode being progressive failure, probably HAC.

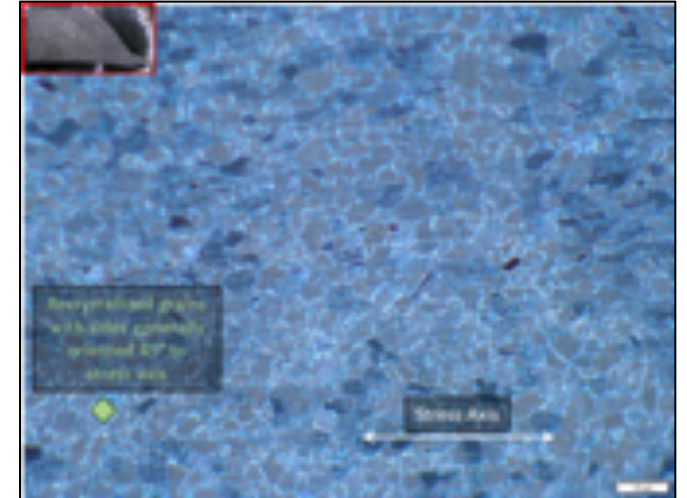
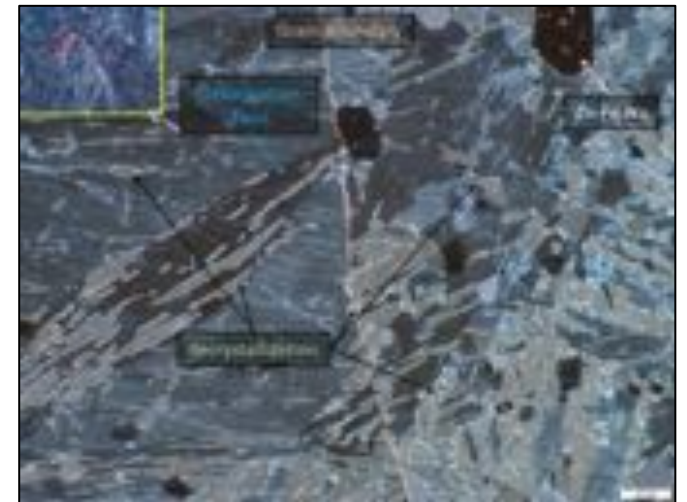
## Recrystallization is evident within the zinc grains:

- Between the socket and cable section:
  - Adjacent to the zinc failure, grains are fully recrystallized.
  - Closer to the socket, the zinc grains were also recrystallizing.
  - Wide dispersion of recrystallization suggests that recrystallization was not due to heat dissipation from the core pullout failure event.
- Intermittent, non-connected cracks were found in the fully recrystallized region, which appear to be predominantly intergranular; if related to creep, cracks suggest that creep failure was a slow process.

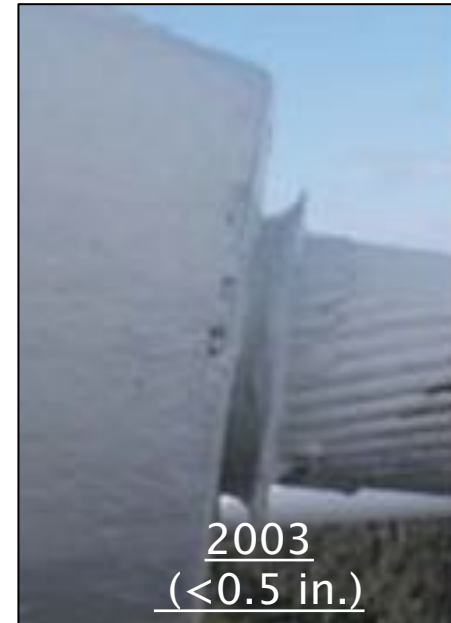
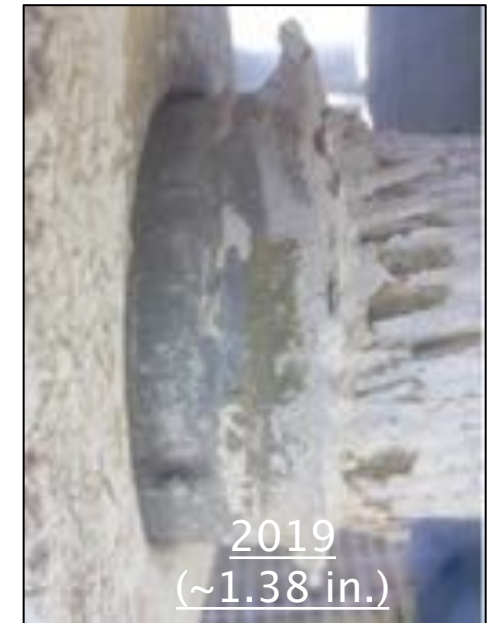
- Forensic evidence confirms contribution of slow zinc creep
- High % of deadload and low structural margin activated creep behavior in the zinc
- Inspection photos showing zinc extrusion confirm cumulative damage

**Inspection Photos showing Zinc Extrusion**  
**(representative Aux sockets)**

- Periodic inspection found progressive zinc extrusion, increasing from <0.5 inch to 1.375 inches in 2019. Pass/fail criteria were not available, but industry experts and guidance indicate that 2019 measurements showed damage and a failing condition.

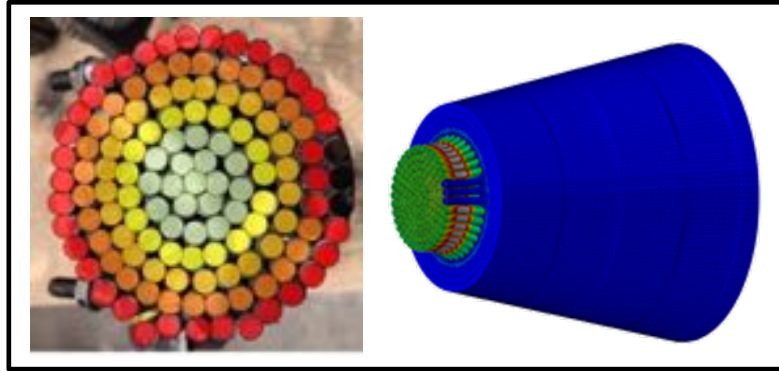
Highest stress and lowest margin in RED  
Three initial wire failures in black (left)  
Modeling Simulation of initial wire failures (RIGHT)

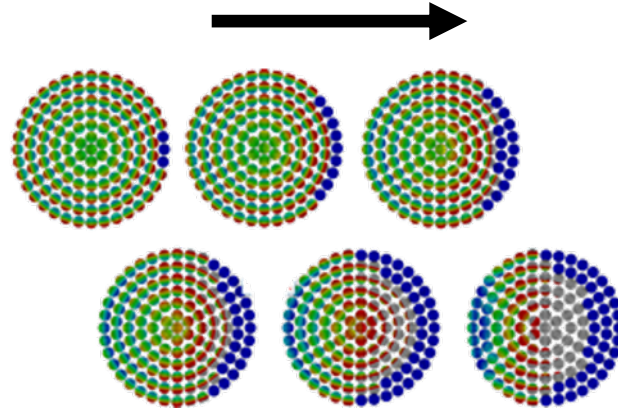
Analytical progression of wire breakage  
advancing radially and inward from outside

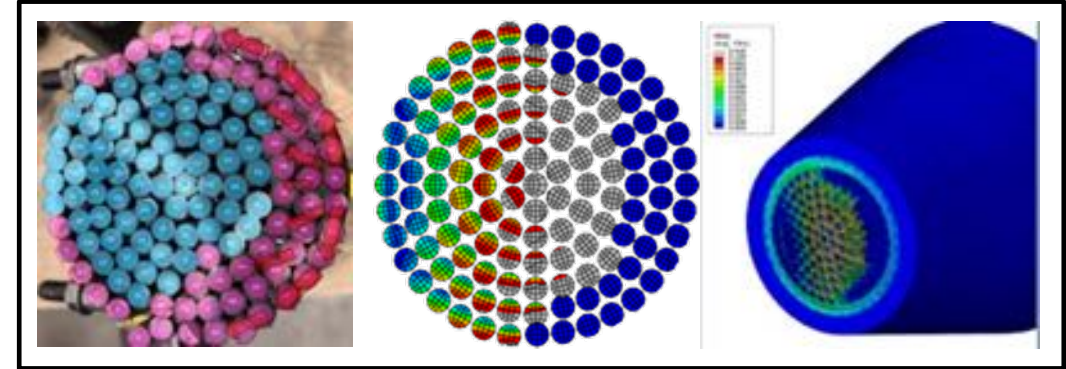
Comparison of forensics (left) with modeling  
predictions just prior to failure (center/right)

- Analysis examined loads/stresses, and pattern of progressively failing wires adjacent to the socket termination. (LEFT)
- Varied number of failed wires to represent post-fracture configuration. (CENTER)
- Analytical progression of failure qualitatively matches forensics analysis including final zinc overload/cable core pullout. (TOP/BOTTOM RIGHT)

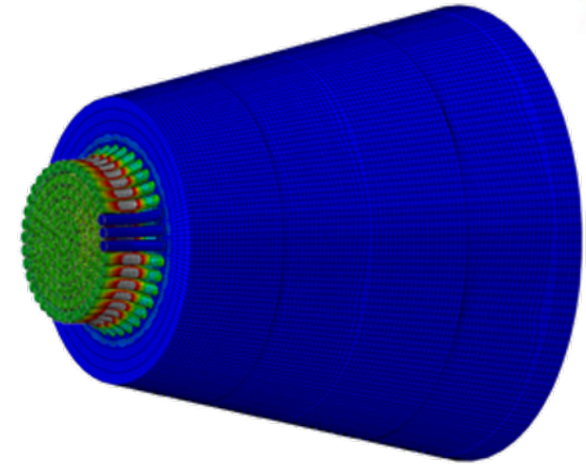
Fully circumferential 3D FEM showing three “failed” disconnected wires corresponding to same three wires indicated at 3 o’clock side in below image

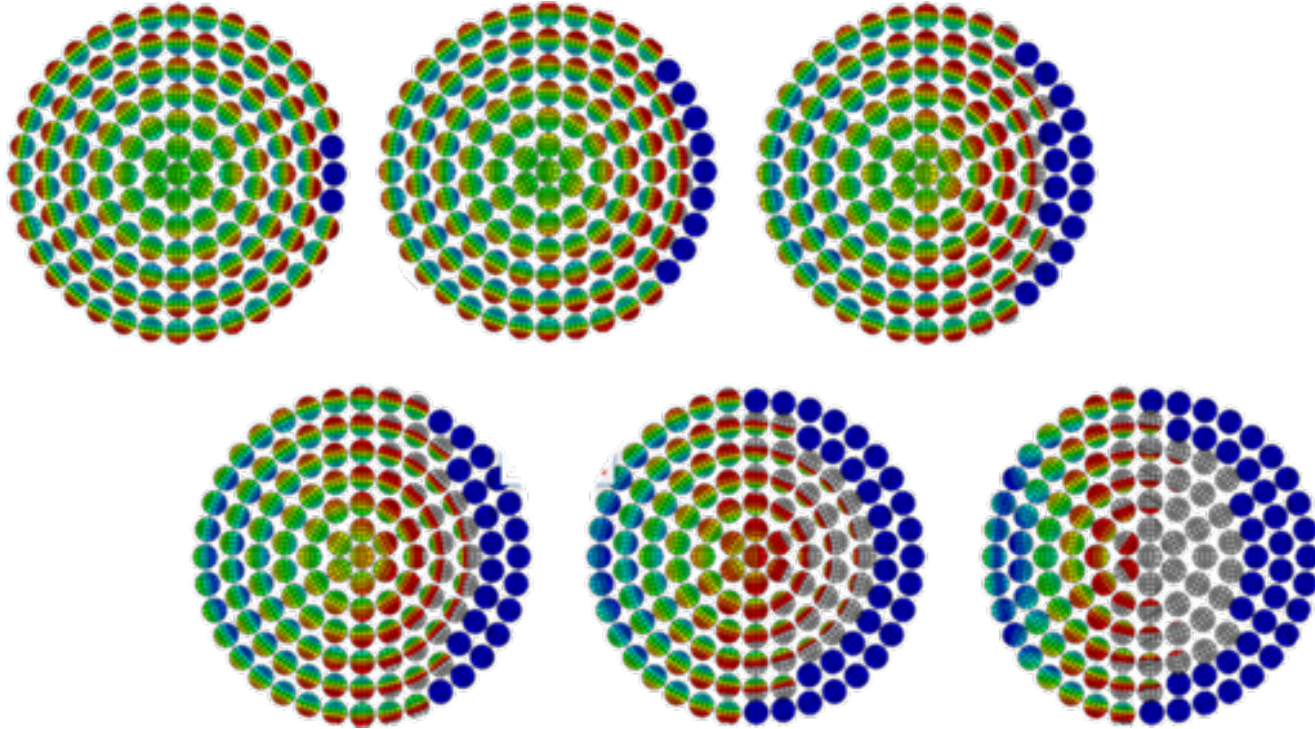
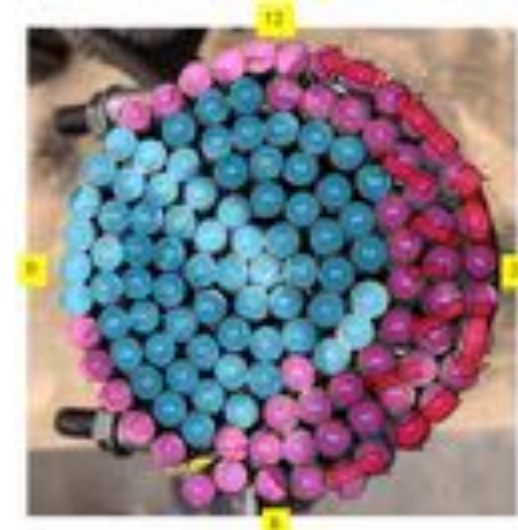
Forensic analysis ID'd which wires fractured (pink) vs. those that pulled out with cable core (blue)

Two-dimensional cross-section of stresses at wire outlet show increasing stress as more wires fail, with tendency to fail radially and circumferentially; Stress increase for first three failed wires is ~5% to adjacent wires.

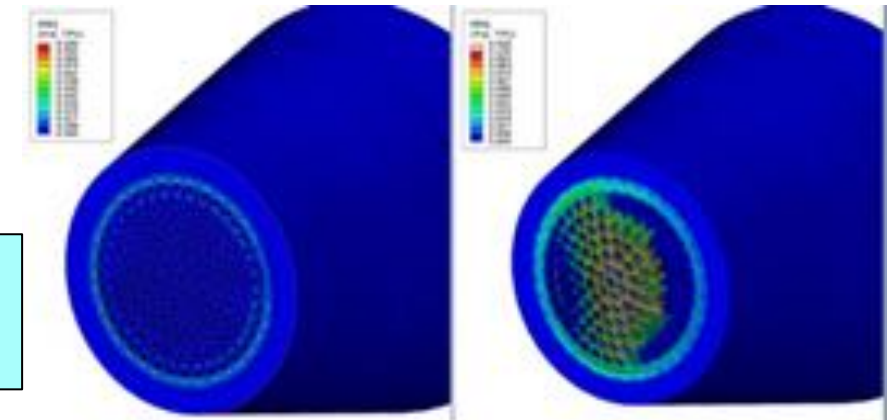
Plastic strain in zinc is significantly increased after 38 wire failures; transition of failure mode to zinc overload
