## **ANALYSIS OF HYPERVELOCITY-IMPACTED THIN FILMS FOR SPACE APPLICATIONS**

**Melissa A. Ward<sup>1</sup>, Phillip D. Anz - Meador<sup>1</sup>, Heather M. Cowardin<sup>2</sup>**

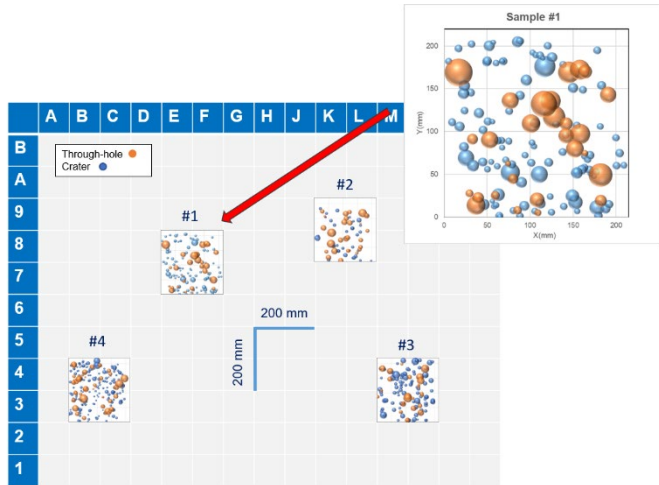
(FEP). Each layer is 0.126 mm thick, and inner layers are made of embossed, aluminized polyimide that is 0.0108 mm thick [2]. Four random samples of approximately 200 × 200 mm in size were chosen for analysis in 2019 [1]. On the four samples a total of 623 features (craters and penetrations) ranging from 0.009 mm to 3.724 mm in diameter were recorded. The locations of these samples and their craters/penetrations are identified in Fig. 1.

**FIGURE 1:** LOCATIONS OF PENETRATIONS (ORANGE) AND CRATERS (BLUE) ON THE FOUR SAMPLES EXCISED FROM THE BAY 5 MLI [1]. THE SIZE OF THE BUBBLE, AS DEPICTED IN THE INSET, IS PROPORTIONAL TO THE SIZE OF THE FEATURE.

No impact features were found to make it through all 17 layers. The maximum number of layers penetrated through the MLI layers was determined to be eight, and labeled from L1 through L8, as shown in Table 1. For purposes of this paper, the samples from the HST Bay 5 MLI with impact penetrations will be termed ‘flown’ HST MLI. A summary of features found, and the number of layers penetrated are listed in Table 1.

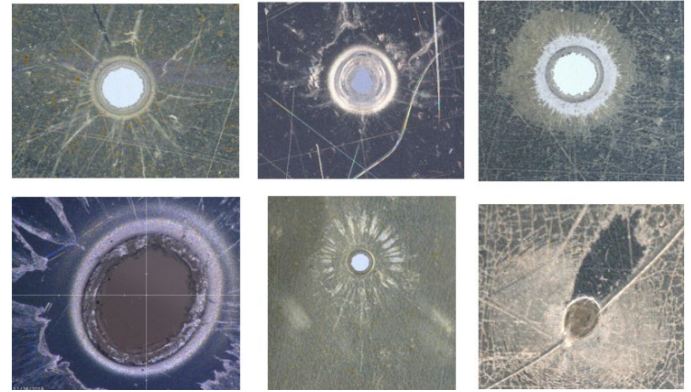
Common impact signatures occurring on all samples included ray patterns, melt, spallation, delamination, radial cracking, and blown-away coating. Radial cracking was found only on the flown HST MLI; which could be from thermal cycling along with electron and proton radiation from the space environment [4]. All other impact signatures were found on both flown HST MLI and ground-tested MLI. A classification system for the common impact signatures on thin films is being developed. Examples of some common impact signatures are shown in Fig. 3.

**FIGURE 3:** COMMON IMPACT SIGNATURES ON THE MLI SAMPLES. FROM LEFT TO RIGHT, TOP ROW TO BOTTOM ROW (X: MAGNIFICATION): 50X INSTANCE OF RAY PATTERN, 100X INSTANCE OF MELT, 50X INSTANCE OF SPALLATION, 150X INSTANCE OF DELAMINATION, 20X INSTANCE OF BLOWN AWAY COATING, AND 100X INSTANCE OF RADIAL CRACKING.

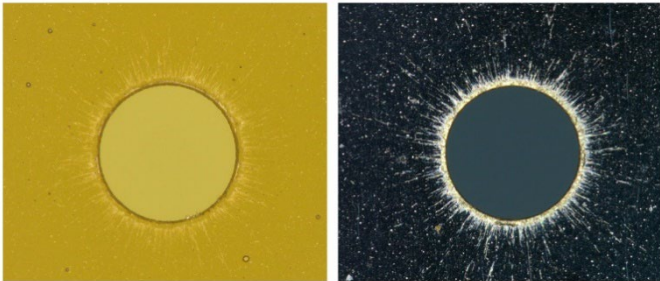
The ITO/VDA film's impact signatures included ray patterns and blown away coating, similar to MLI impact signatures. Figure 5 shows examples of ITO and VDA impact holes after impact with a SS projectile.

**FIGURE 5:** LEFT: ITO-COATED-POLYIMIDE IMPACT HOLE WITH RAY PATTERN. RIGHT: VDA-COATED-POLYIMIDE WITH IMPACT HOLE RAY PATTERN AND BLOWN-AWAY COATING (GOLD AREA). MAGNIFICATION: 100X, PROJECTILE SS.

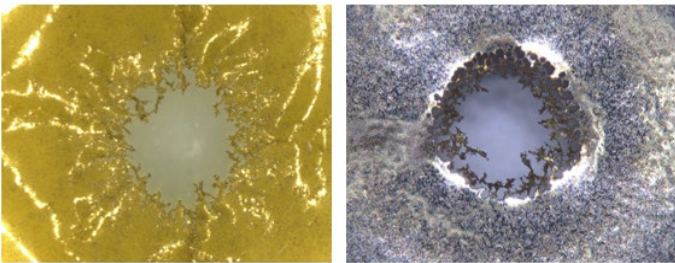
Although the ITO/VDA-coated-polyimide films have different coatings and coating thicknesses, when compared to each other, their impact signatures are very similar. An example resultant impact hole for both ITO and VDA film shot with an Al 1.7 mm projectile (same velocity and angle) is shown in Fig. 6. Note the material fragmented or melted in a lace pattern.

**FIGURE 6:** THE RESULTANT IMPACT HOLE IN BOTH AN ITO (LEFT) AND VDA (RIGHT) SAMPLE. MAGNIFICATION: 20X, PROJECTILE AL.

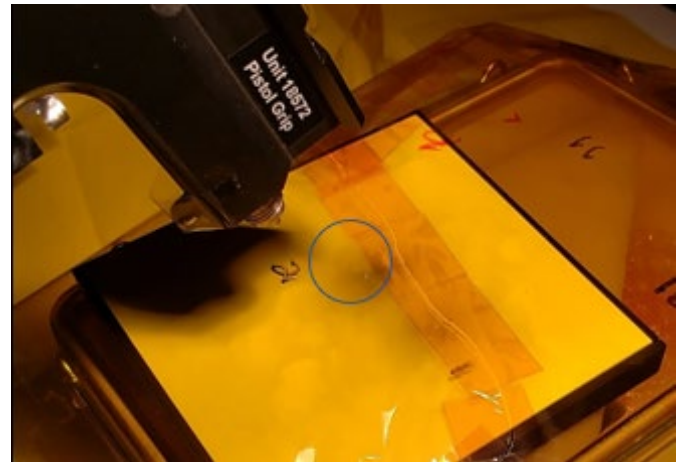
**FIGURE 7:** IMAGE OF PISTOL GRIP OPTICAL FEED FROM SPECTROMETER BEING USED ON IMPACTED ITO-COATED-POLYIMIDE. NOTE POSSIBLE REFLECTANCE VARIATION DUE TO HVI TEST GUNPOWDER SOOT (BLUE CIRCLE).

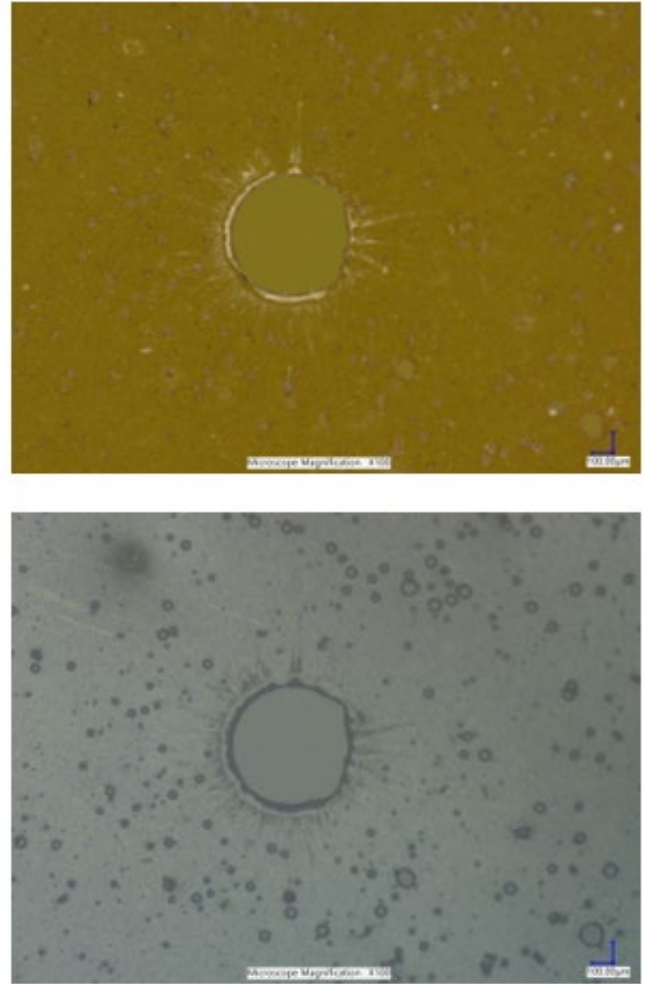
**FIGURE 9:** A COMPARISON OF A PENETRATION HOLE IN BROADBAND VISIBLE LIGHT (TOP) AND POLARIZED LIGHT (BOTTOM). THIS SAMPLE PENETRATION WAS IMAGED AT 100X. PENETRATIONS OF SECONDARY DEBRIS FROM THE SHOCKED PROJECTILE ARE CLEARLY VISIBLE.

While ray structures were evident in the polarized light imaging, no other large scale, pronounced features attributable to the penetration appear present; note that the rays were evident in the broadband image, and are similar to those present in Fig. 5. Rays appear to be present on the first surface penetrated (front) but not on the rear surface. The same penetration feature was observed at 20X and is compared (broadband visible light and polarized light) in Fig. 10.

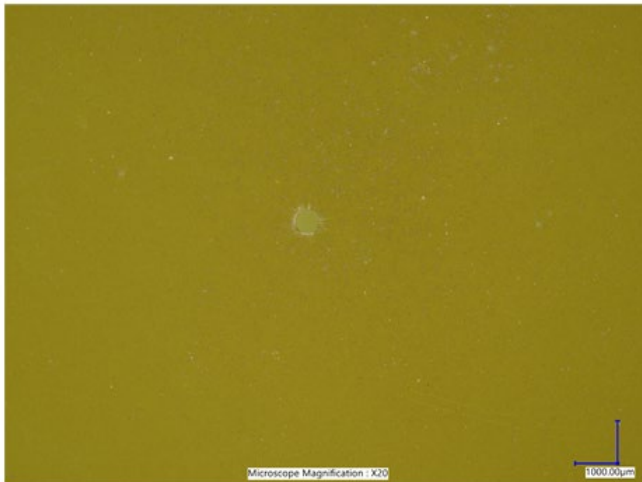
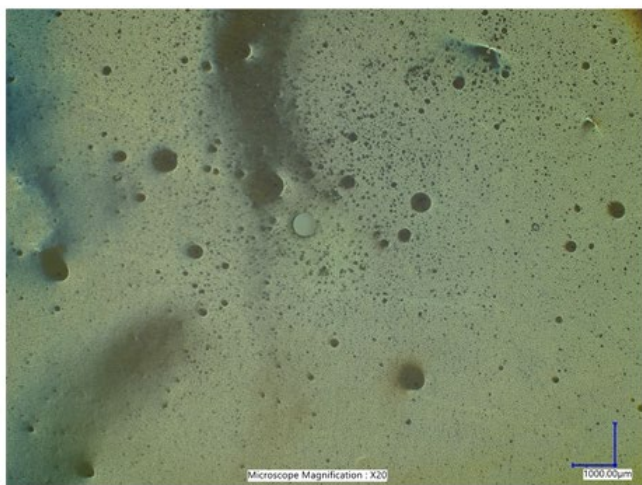
**FIGURE 10:** FIGURE 9'S IMPACT FEATURE IMAGED AT 20X MAGNIFICATION. ANGLE BETWEEN ANALYZER AND POLARIZER APPROXIMATELY 26°. BOTTOM: LARGE IRREGULAR DARK FEATURES ARE DUE TO SAMPLE FLEXURE.

In this instance, large features with no apparent broadband analogue feature are evident, manifesting as the dark, generally circular features in the vicinity of the penetration (other, more linear features are either scratches due to manufacture or handling, are attributable to sample flexure, or remain to be investigated). Attribution to the event is demonstrated by the frequency of occurrence decreasing with radial distance from the projectile penetration hole and their absence on the pristine control sample. While some features, perhaps internal to the layer, appear and disappear as the analyzer is rotated over (0°, 90°) these circular features were constant. As some "soot" was also evident in the vicinity of the penetration, both sides of the sample were wiped with isopropyl alcohol, using a clean glass slide placed over the penetration to protect one half of the imaged area from cleaning for visual reference, as depicted in Fig. 11.

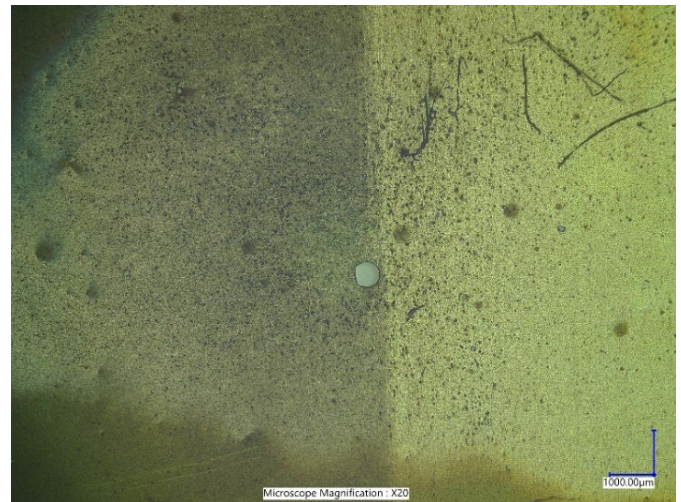
**FIGURE 11:** RIGHT: THE IMPACT LOCATION CLEANED WITH ISOPROPYL ALCOHOL WIPES. THE LEFT PORTION WAS PROTECTED DURING CLEANING TO PROVIDE A VISUAL REFERENCE. THE PROTECTED LEFT SIDE IN THIS TRANSMISSION IMAGE DEMONSTRATES THE PRESENCE OF SOOT AS NOTED IN SECTION 3.2 SPECTROSCOPY ANALYSIS.

These dark features remain, indicating they are not soot or other HVI range products, but indelible features. Higher magnification imagery indicated that many of the dark circular features had one, very small penetration located within its boundary, however, indicating a possible association with HVI by-products of spall or ejecta.

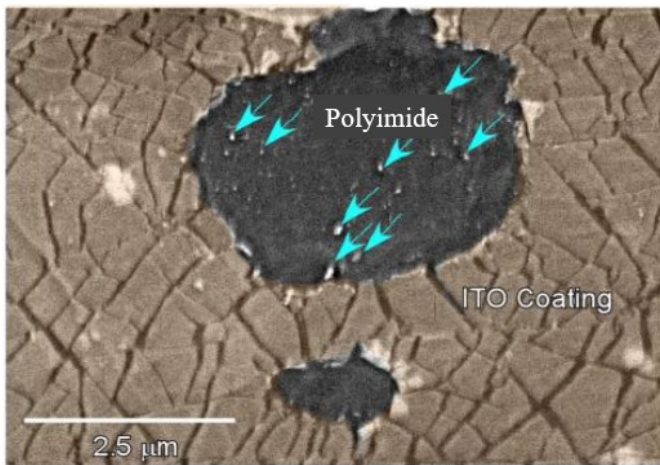
All samples, excepting sample D (SS), had ITO coating detached or removed from the polyimide film in the immediate vicinity of the impact, as shown in Figs. 12 and 13. The VDA-coated sample was not analyzed but is unlikely to experience damage similar to the ceramic ITO; however, this awaits confirmation.

**FIGURE 12:** LOW ANGLE BACKSCATTER ELECTRON IMAGES OF THE ITO COATING SHOWING SOME REGIONS HAVE BEEN REMOVED FROM THE UNDERLYING POLYIMIDE. THE COATING DISPLAYS A CHARACTERISTIC MOSAIC PATTERN. CYAN ARROWS IN THE TOP VIEW HIGHLIGHT CONTAMINANT PARTICLES, MOST OF WHICH ARE CALCIUM-BEARING.

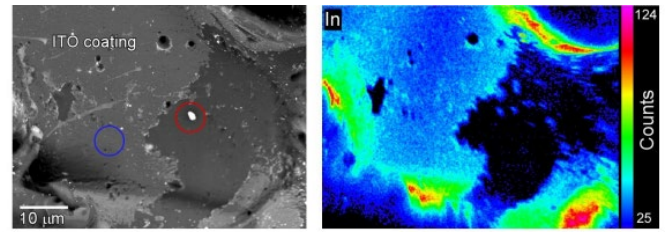
**FIGURE 13:** LEFT: POLYIMIDE SURFACE LOCATED NEAR THE CENTER IMPACT HOLE OF SAMPLE B RETAINED SOME ITO COATING (SMOOTH, DARK REGIONS ARE RELATIVELY FREE OF COATING). RIGHT: ELEMENT MAP OF THE REGION AT LEFT SHOWING THE DISTRIBUTION OF INDIUM FROM THE ITO COATING.

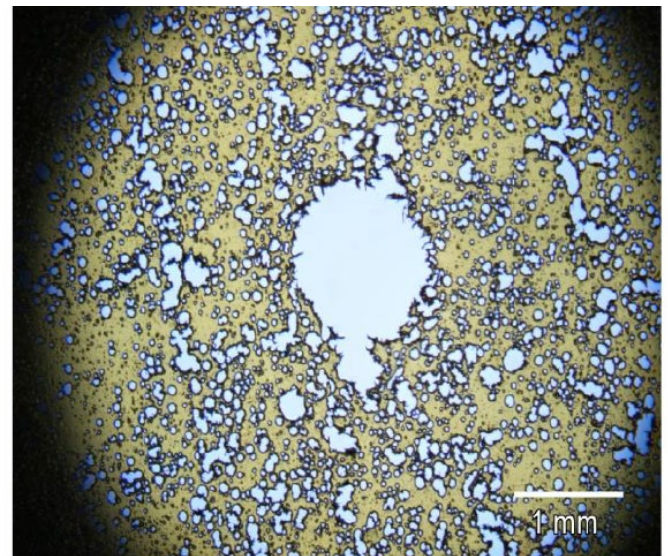
Select samples displayed the effects of spallation. Figure 14 depicts such damage for sample B. Damage from up-range spallation and down-range ejecta, in fact, appears a common effect for these samples.

**FIGURE 14:** TRANSMITTED LIGHT IMAGE OF SAMPLE B. HOLES AND PITS/CRATERING NEAR THE CENTRAL PENETRATION ARE LARGER IN SIZE AND BECOME PROGRESSIVELY SMALLER WITH INCREASING DISTANCE FROM THE PRIMARY PENETRATION HOLE.
