# ISS EVA 23 Lessons Learned

Date of Mishap: July 16, 2013

**Chris Hansen**, Chairman – Mishap Investigation Board  
Manager, EVA Office, Johnson Space Center

NASA Johnson Space Center, September 26th, 2019

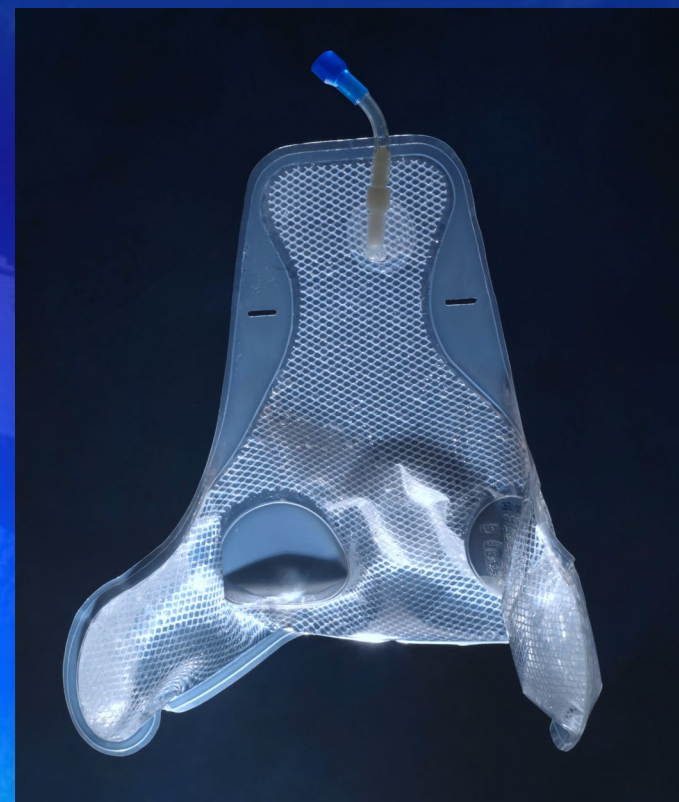
# EVA 22 – one week earlier...

- EVA 22, Luca's first EVA, began with Chris and Luca one week earlier on July 9th, 2014
- The EVA was completed with no issues, however, during repress Luca noticed water in his helmet
- When his helmet was removed, almost ½ liter of water was discovered
- Subsequent conversations led to an assumption that water had leaked from Luca's drink bag during his time in the airlock, so the drink bag was replaced prior to EVA 23
- Later investigation determined that the drink bag was not the source of the water in Luca's helmet, but other possible failures were not investigated, and EVA 23 proceeded on time one week later

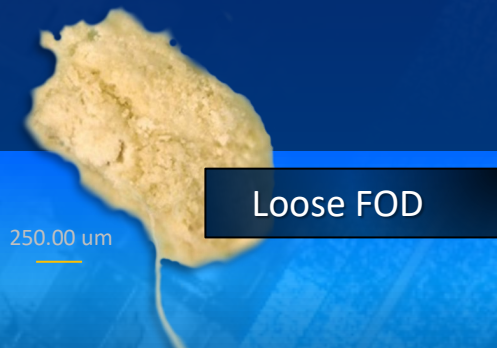
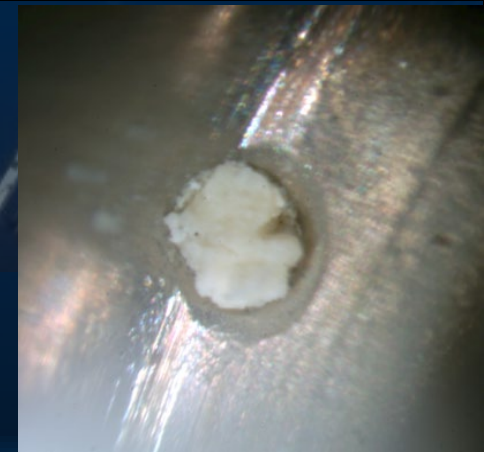
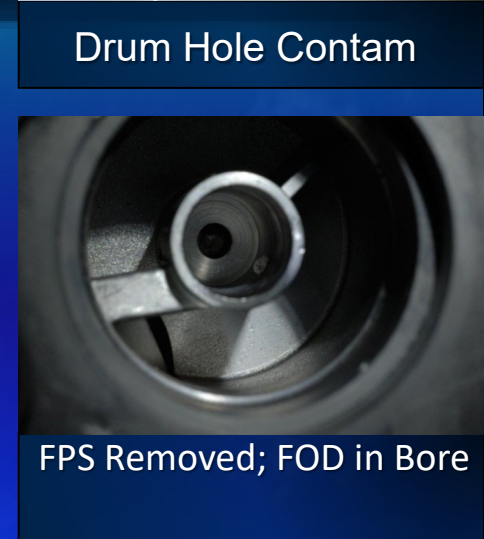
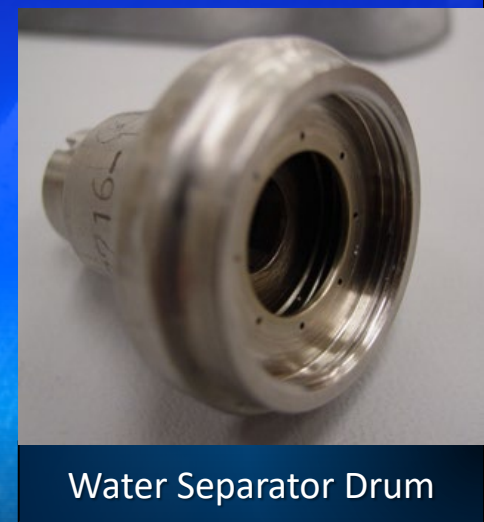
# Summary of Investigation Findings

- Numerous suit components were replaced and tests were performed to determine anomaly was in the suit's fan pump water separator (FPS)
- Silica-based contamination in the water separator blocked holes resulting in water back-flowing into the ventilation loop
  - Silica quantity and precipitation in the water separator never seen before
  - Water separator is basically a centrifuge which facilitates precipitation of contaminants

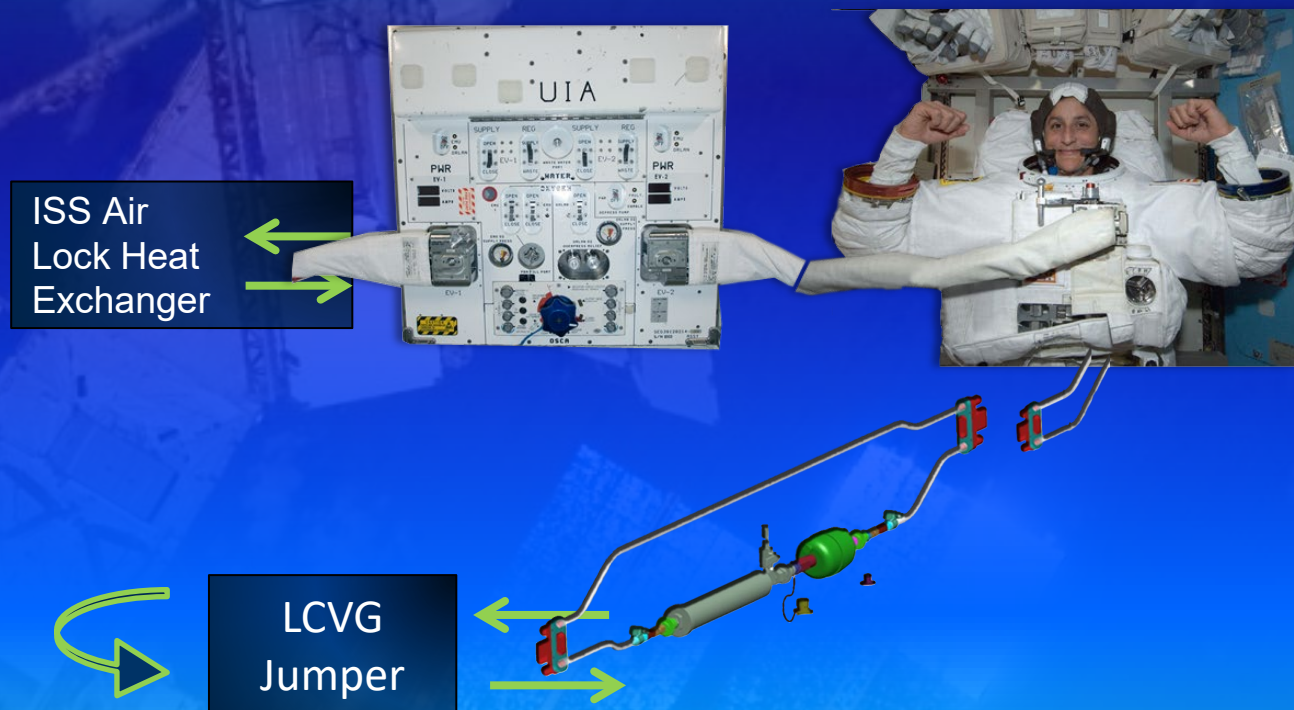
# Silica Source

- Ion exchange beds found to be source of silica
- Suit coolant loop is “scrubbed” with an ion exchange bed every 90 days and before/after a series of EVAs
- Removes contaminants like nickel that shed from the suit and Airlock heat exchanger

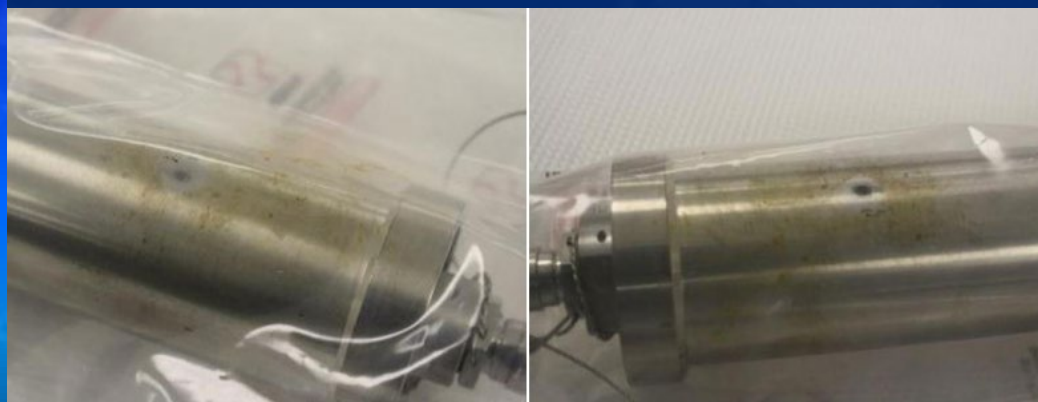
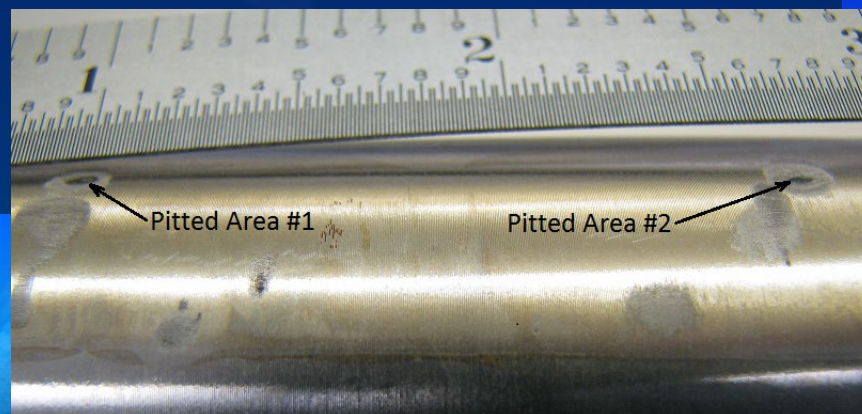
# Ion Bed Contamination

- Premature saturation of Ion Beds and subsequent use with Luca's suit resulted in release of high concentration of silica into water loop
  - Ion bed saturation resulted from insufficient quality of water used during ground processing
  - Multiple ion beds used on-orbit were later found to have been contaminated
    - » Anomalous water condition likely spanned 8+ years
  - Lot of ion beds built in December 2013 corroded due to water contamination
