Metal Additive Manufacturing for Rocket Engines: Successes and Failures

Paul Gradl

National Aeronautics and Space Administration (NASA)

21 March 2023

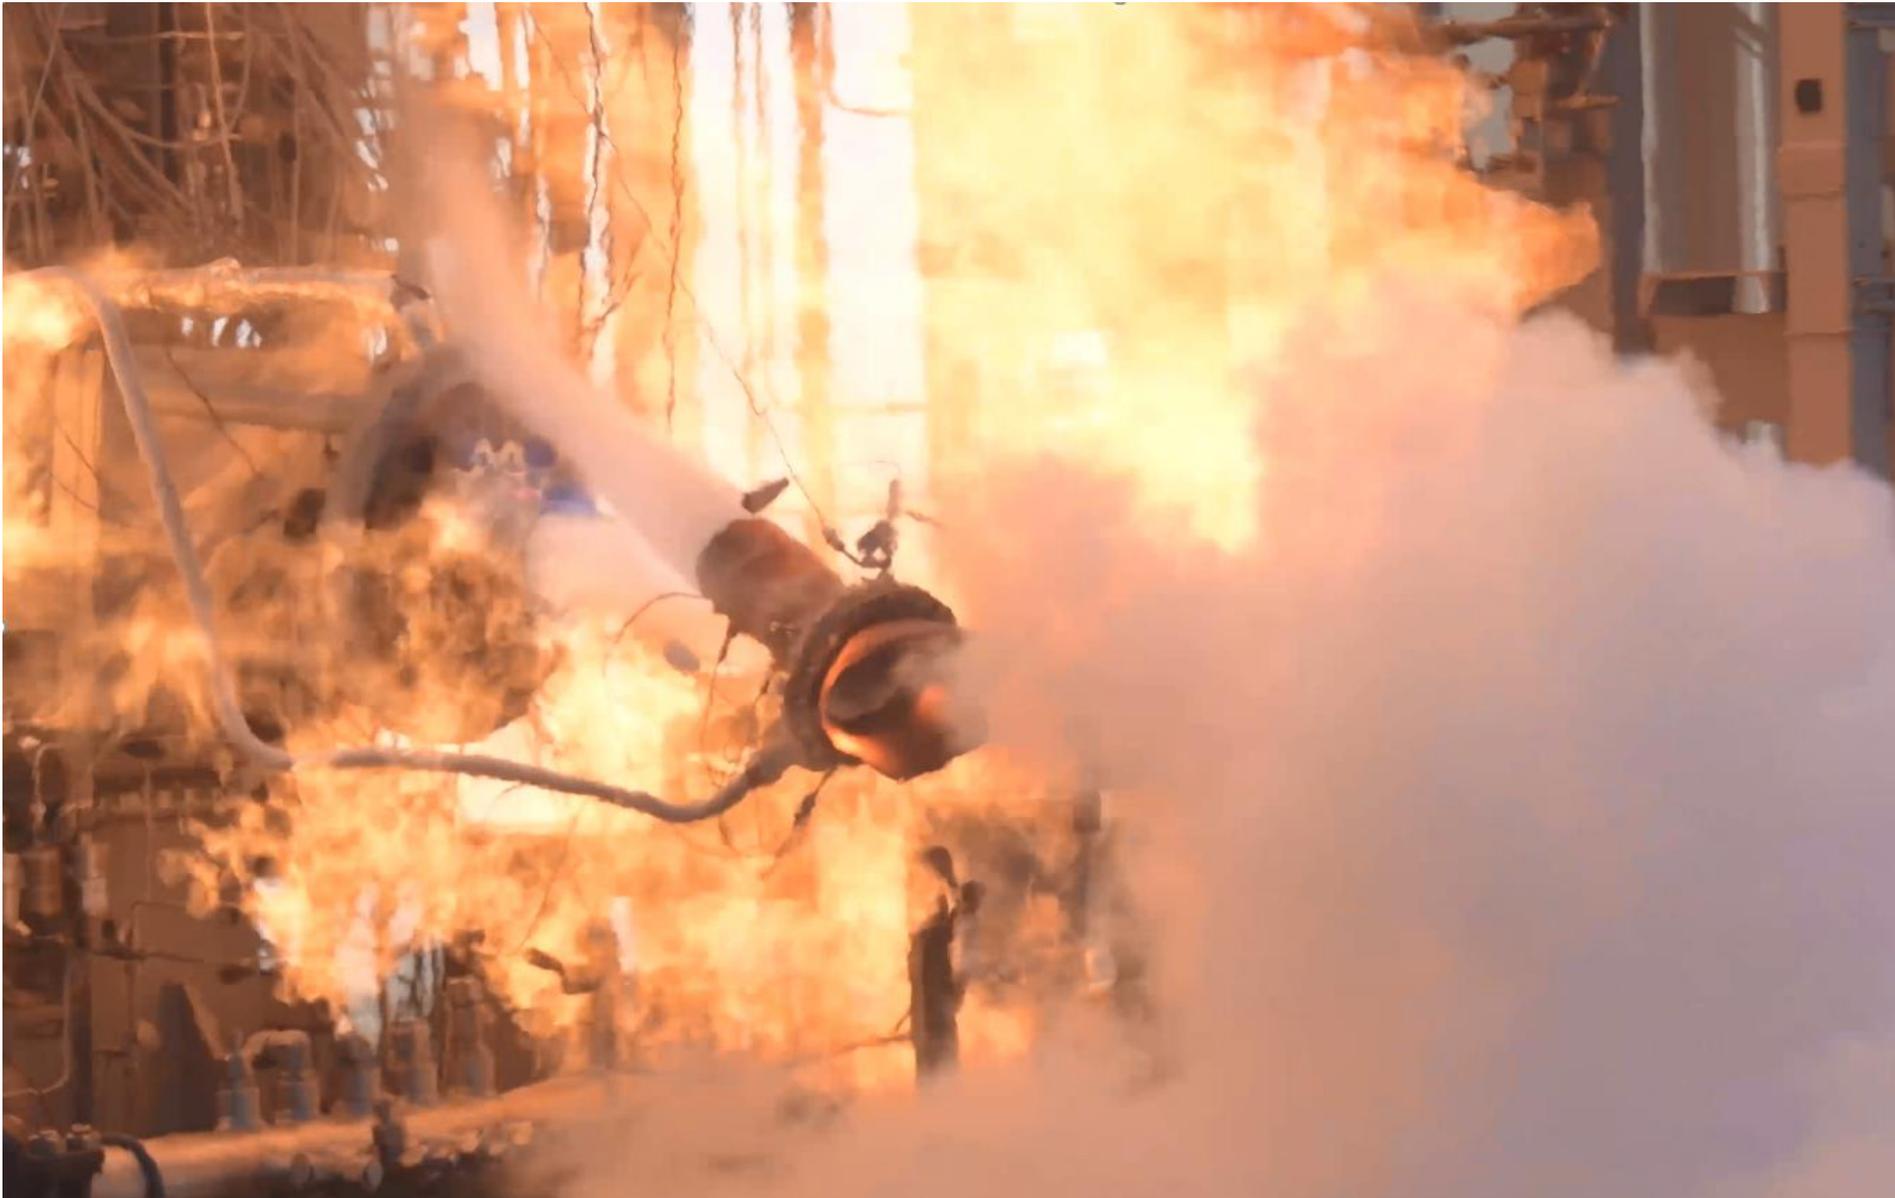
Separated Chamber

- Tested in early 2021
- Location: MSFC Test Stand 115
- L-PBF GRCop-42 chamber
 - 8 starts and 83.3 seconds total before separation.
 - No issues observed in prior chamber test data.
- Carbon-Composite experimental nozzle
 - Untested and possessed a noticeable crack.
 - Deemed an acceptable risk for test.

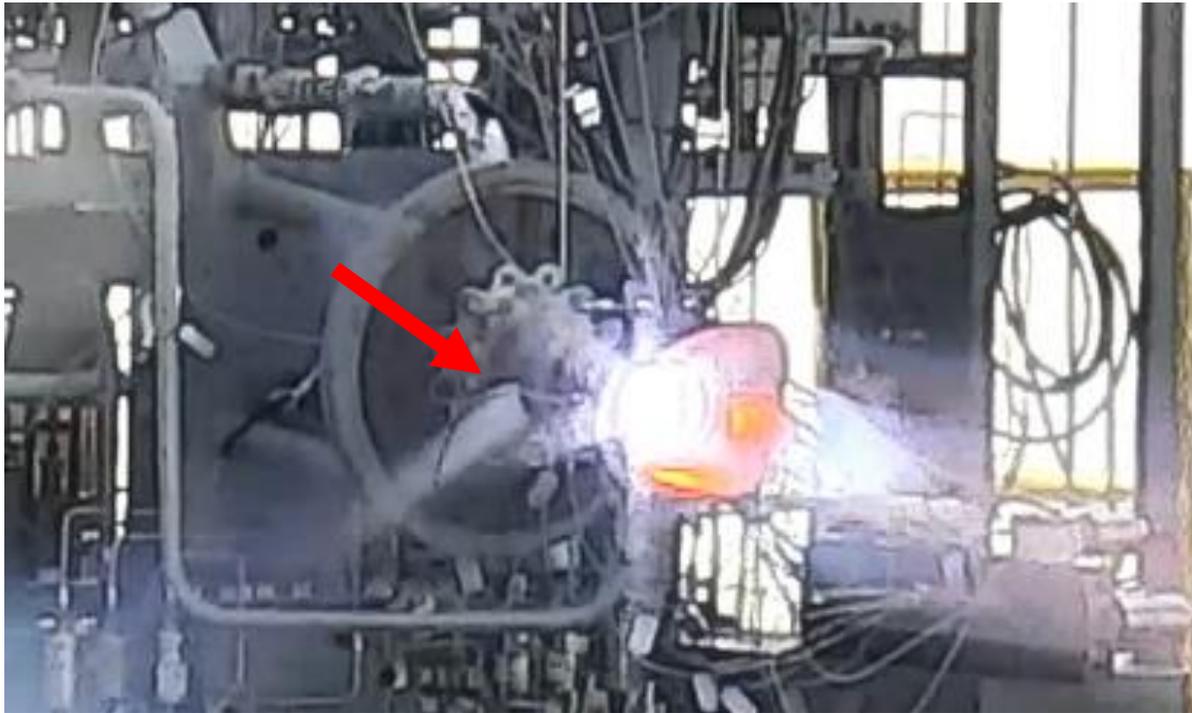
C2 - separated chamber (9 starts)

PK129 Test 18

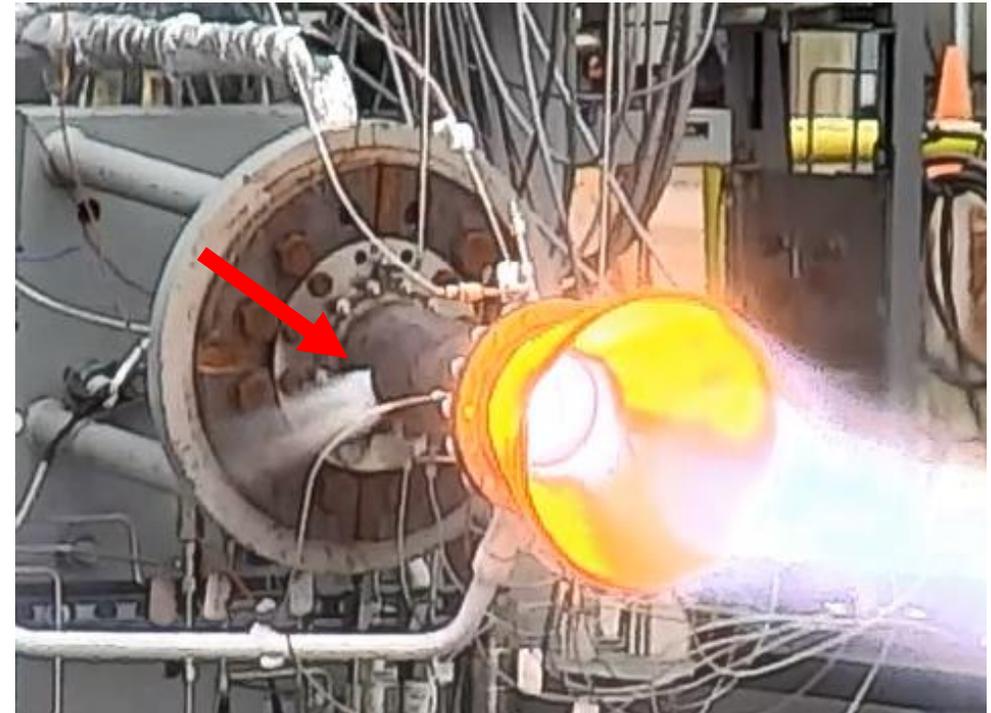
C3 - 51 start chamber (full life cycle)

PK129 Test 13

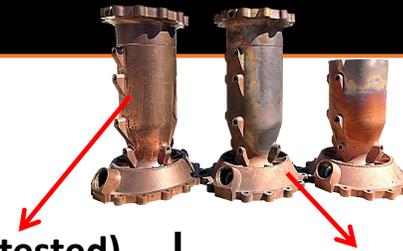
- Unpolished external surfaces.
- Top (power outage) and bottom (powder overflow) witness lines did not appear to have many detrimental defects.
- Middle witness line on chamber 1, there were some large lack of fusion defects that appeared to line up with the restart line.
- Chamber 3 – no defects visible at the surface beyond the crack that had already developed after test.

Middle witness line: C1 (untested)
Surface was polished using CMP

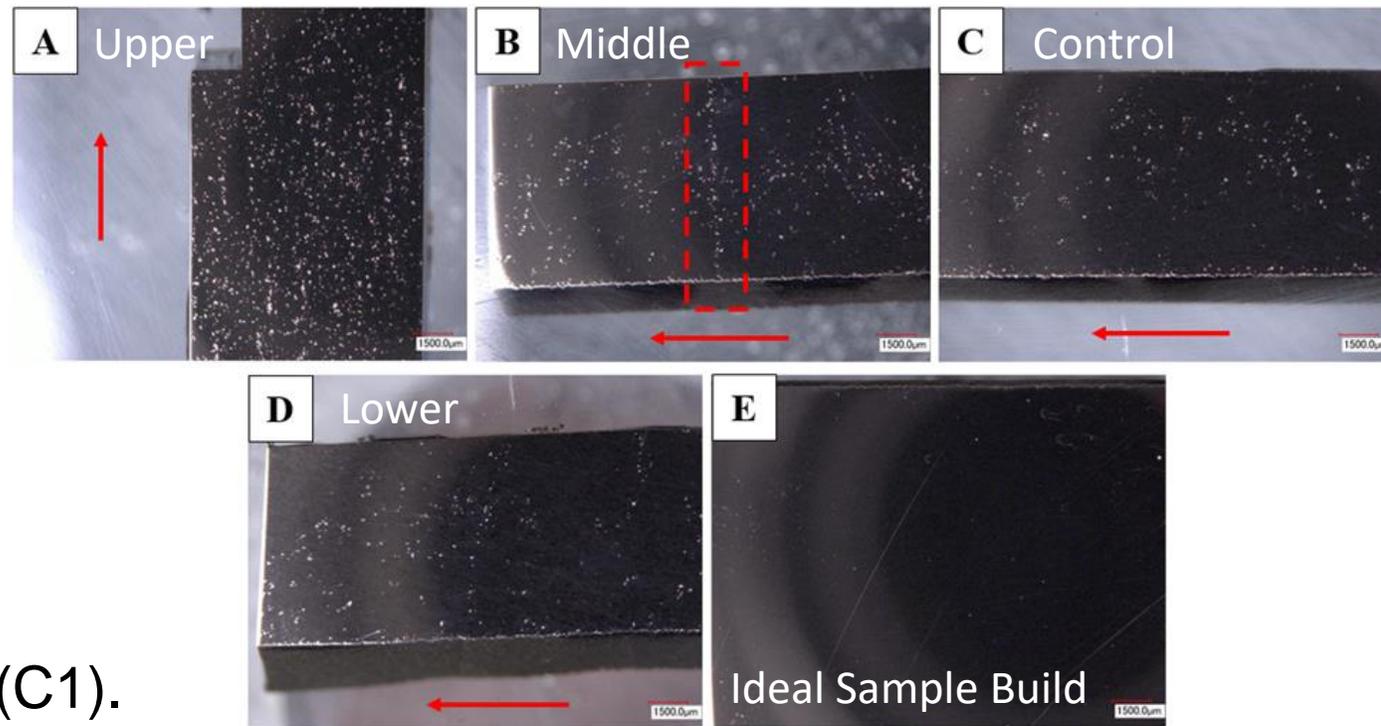
Label	Section	Porosity
A	Upper Witness Line	0.748%
B	Middle Witness Line	1.906%
C	Control Section	0.511%
D	Lower Witness Line	1.743%
E	Tensile Bar	0.006%

- Samples taken from un-tested chamber (C1).
- Tensile bar built separately as part of investigation.
- Proper HIP of chambers was confirmed.
- Porosity is evident throughout samples.
- Clear congregation of porosity around witness lines.
- Porosity reduces load bearing capacity (reduced area) and can act as stress concentrators/crack initiators.

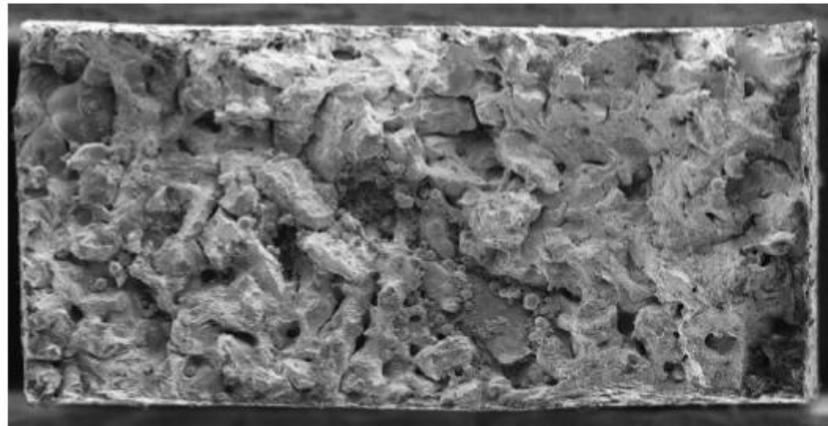
1T1B

- Granular fracture surface, indicating a brittle fracture
- Irregular shape porosity, indicating lack of fusion

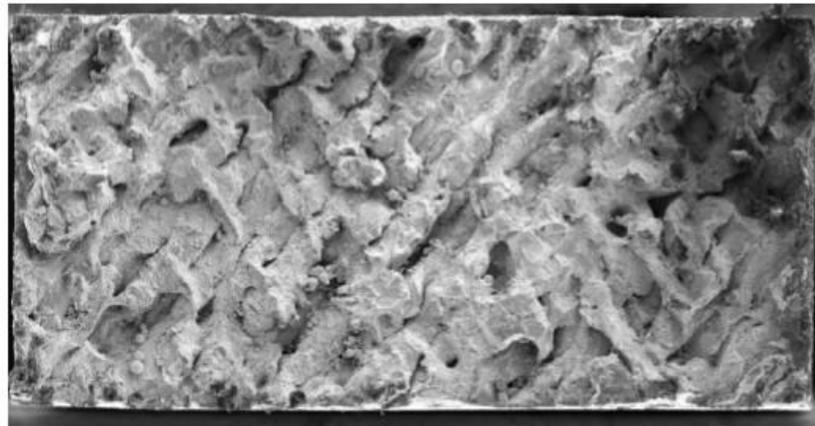
1T2B

- Granular fracture surface, indicating a brittle fracture
- Laser scan pattern clearly visible

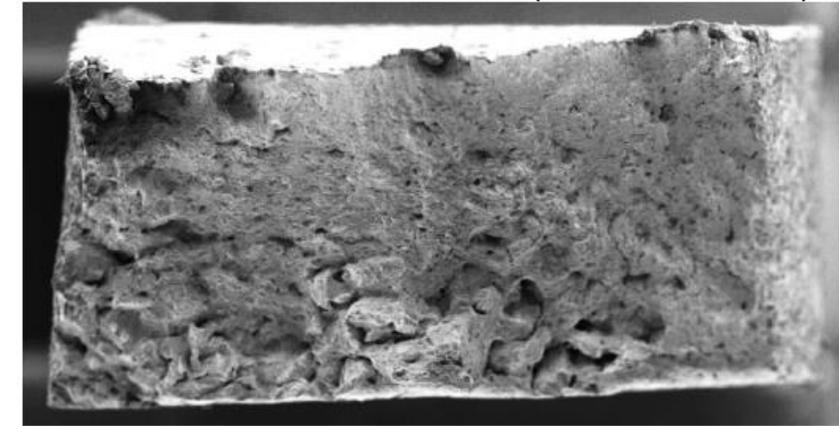
1T3B (Chamber Control)

- Overloaded fracture surface and necking, indicating a more ductile fracture
- Less porosity compared to witness lines

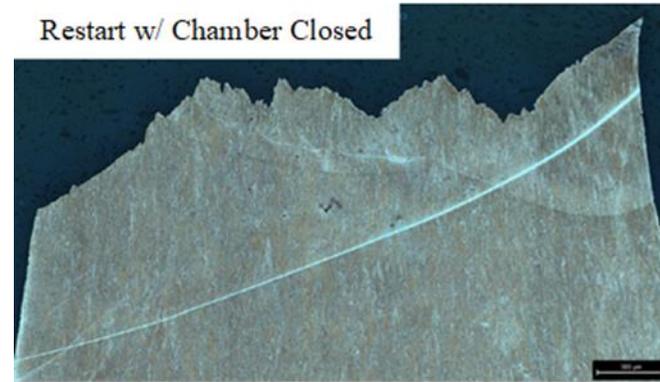
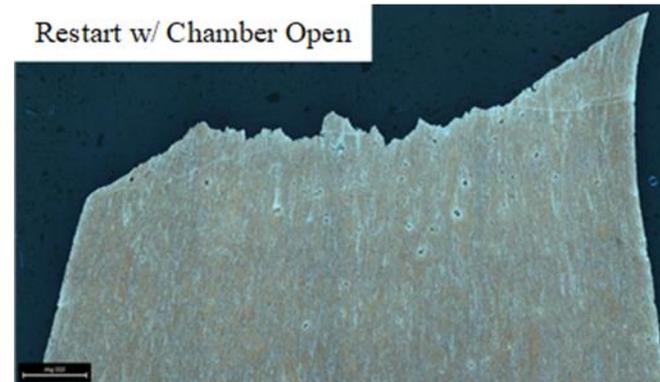
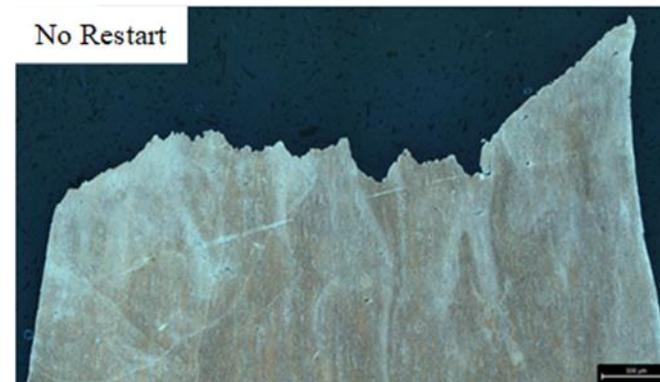
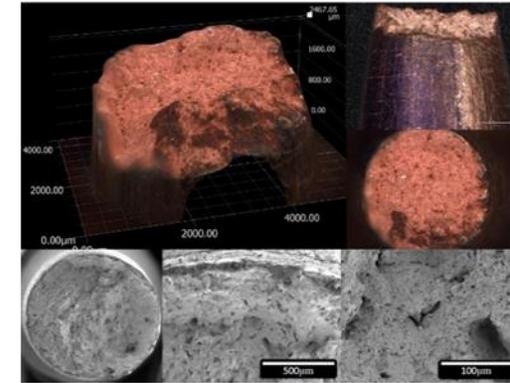
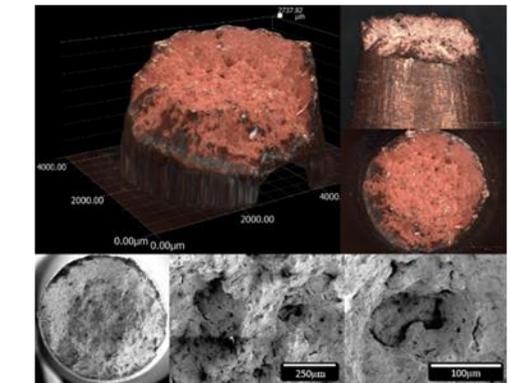
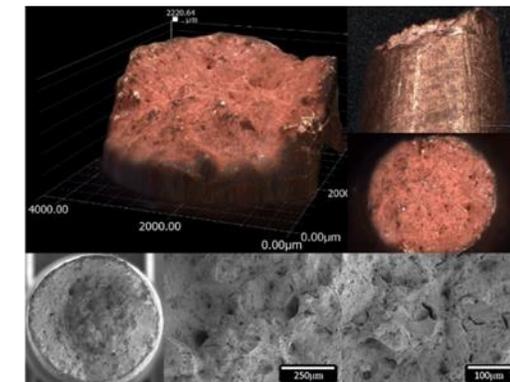
- 3 witness test bars from tensile simulating build stoppages
- Observations:
 - No major differences between fractures
 - Typical cup-cone fracture surfaces common for ductile metals
 - Fracture surfaces had elongated grains
- Conclusions:
 - Similar fractures track with similar properties observed in bars previously

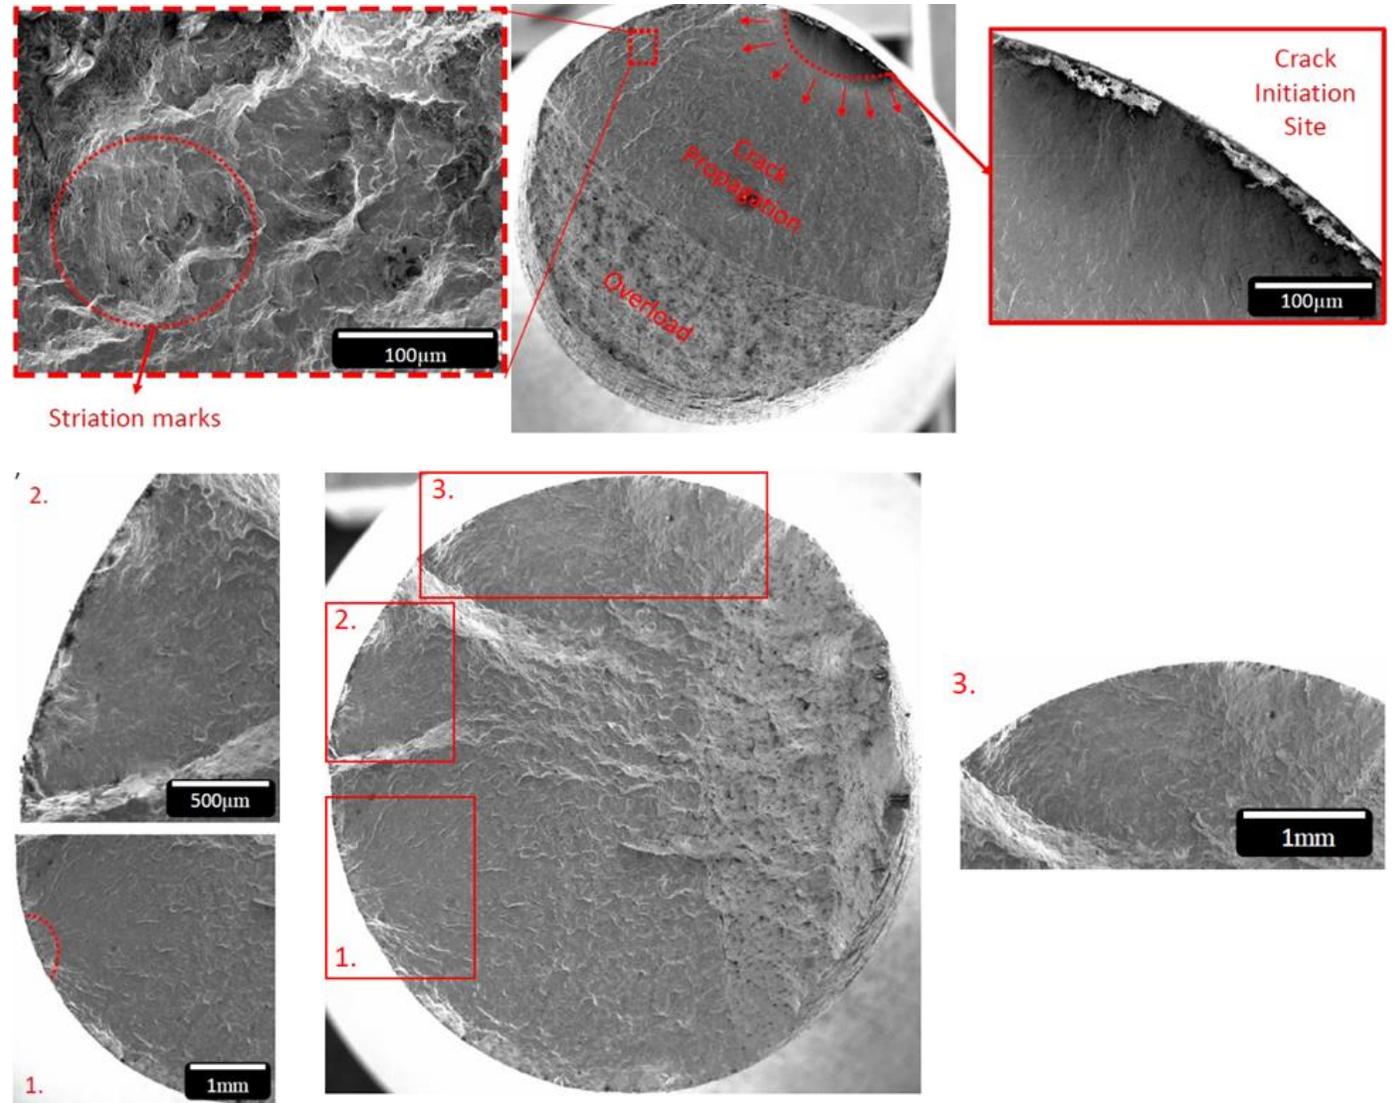
- 3 test bars from LCF
 - Fracture surfaces smeared b/c LCF had fully reversible cycles
 - Closed chamber restart bar never fully fractured
- Observations:
 - Open restart: flat surface before overload failure transition, secondary crack below primary crack
 - No restart: three separate cracks jogged together
