# Space Environmental Damage Assessment on Sail/Deorbit Materials in Low Earth Orbit

The 6<sup>th</sup> International Symposium on Space Sailing, June 8, 2023, New York, NY

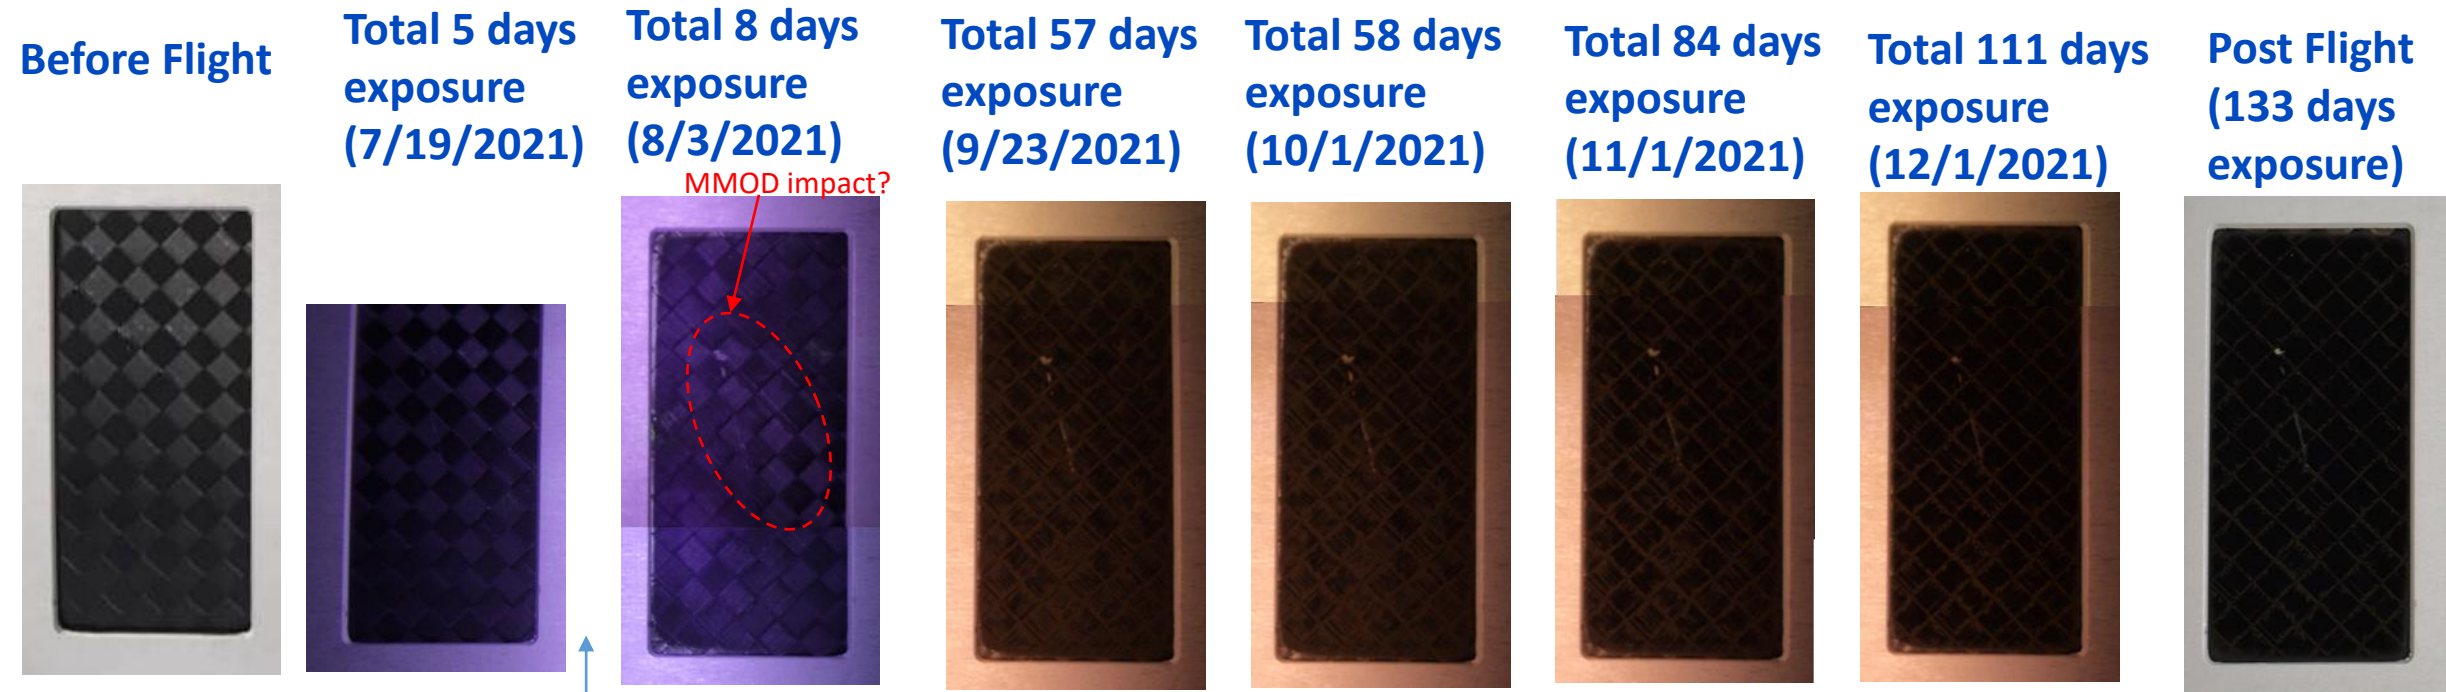
# In-Flight Image [Epoxy PMT F7/M30S-1 (M14-BK-R10), Ram]

MMOD impact?

Surface started to change from shiny to dull

*Significant erosion on the sample surface was found after total 133 days exposure in Ram direction. Micrometeoroids and orbital debris (MMOD) suspected impact damage was found.*

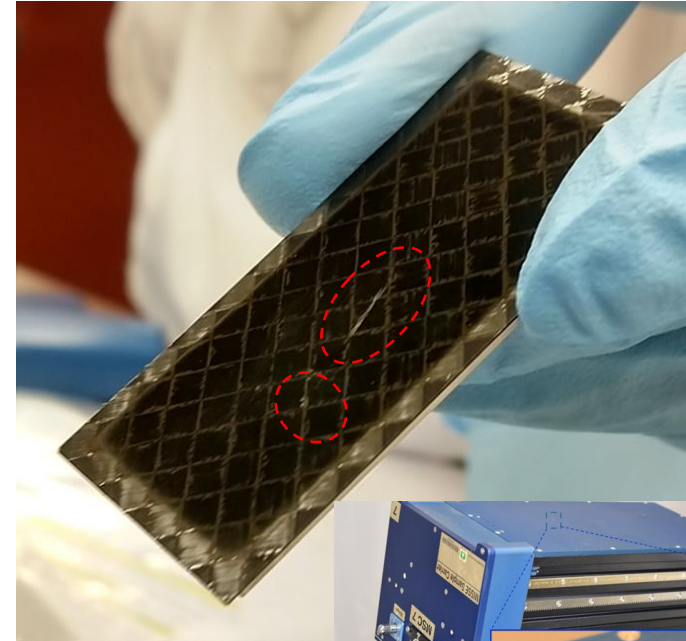
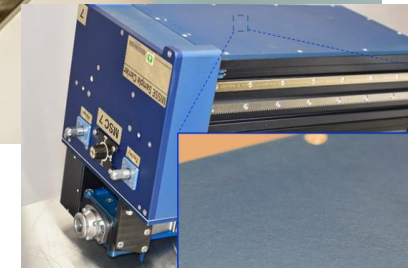
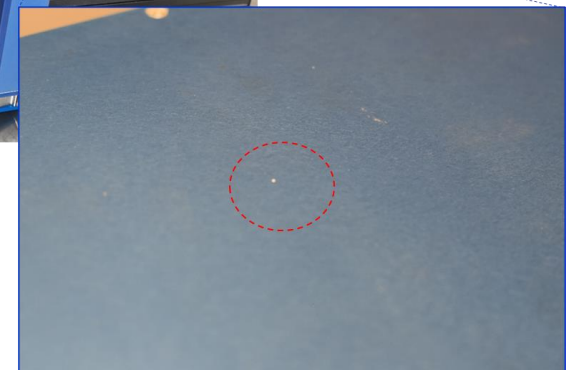
# Post-Flight Image [Epoxy PMT F7/M30S-1 (M14-BK-R10), Ram]

Exposed surface was  
eroded and became matte

Edge and 2<sup>nd</sup> layer  
kept shiny surface

*Significant erosion on the sample surface was found after total 133 days exposure in Ram direction. MMOD suspected impact damage was found.*

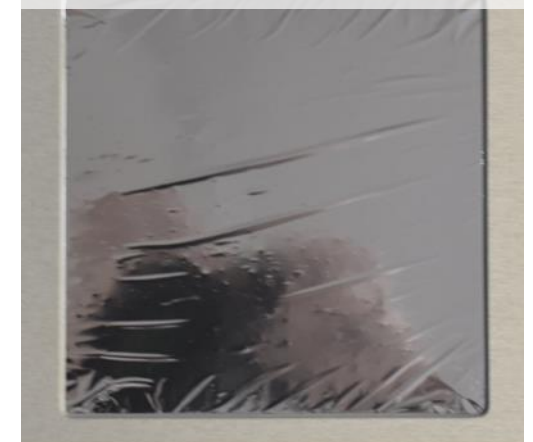
# In-Flight Image [Al-Met PEN (M14-BK-R7), Ram]

No significant change except some wrinkles was found after total 133 days exposure in Ram direction. Sample was shrunk and taut

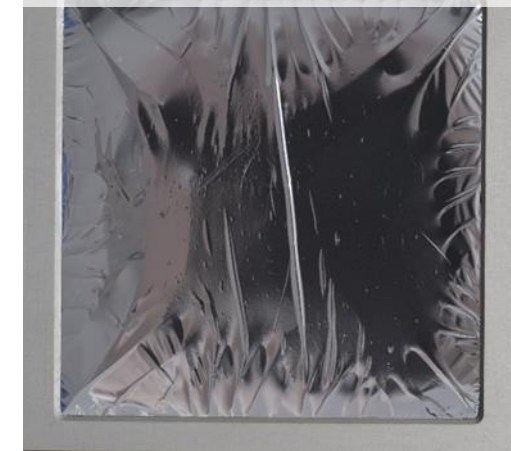
# In-Flight Image [Al-Met PEN (M14-BK-Z3), Zenith]

*Significant change in wrinkle was found after total 15 days exposure in Zenith direction. Sample was shrunk and taut.*

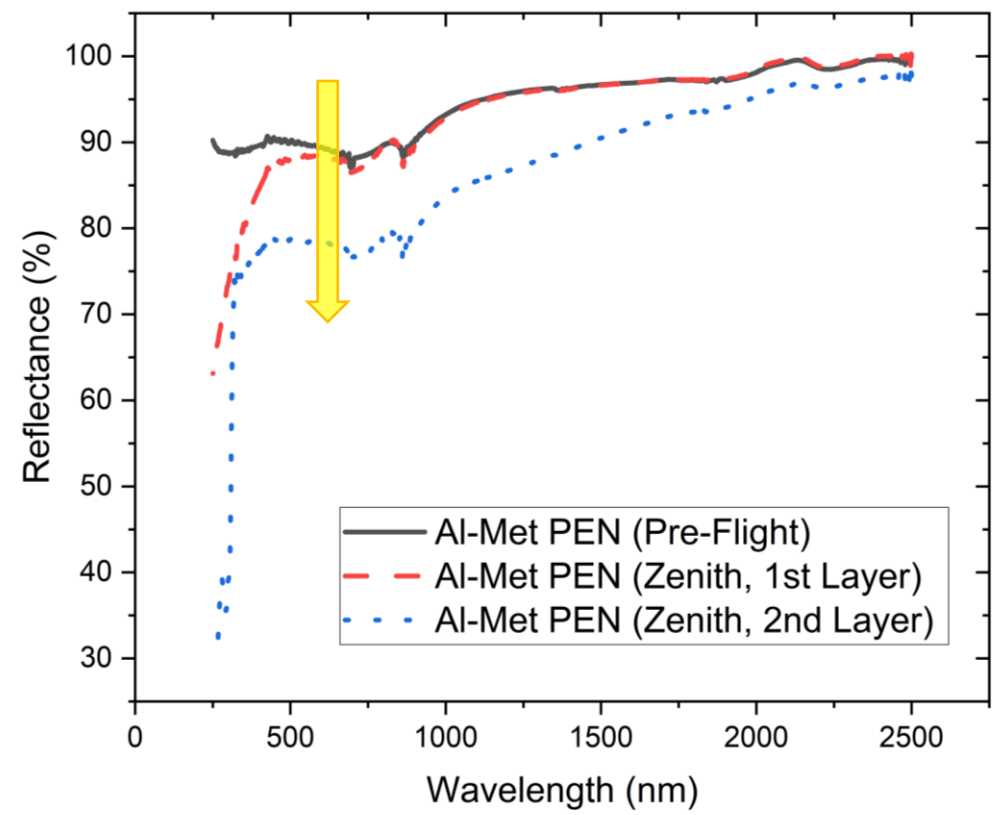
# Post-Flight Image [Al-Met PEN (M14-BK-Z3), Zenith]

*Hydrogen blistering  
by solar particles  
(proton radiation)?*

*No visible change on the first layer (direct exposure to space) but visible foggy (diffuse reflective) mark on the second layer and reduction in reflectance was found*

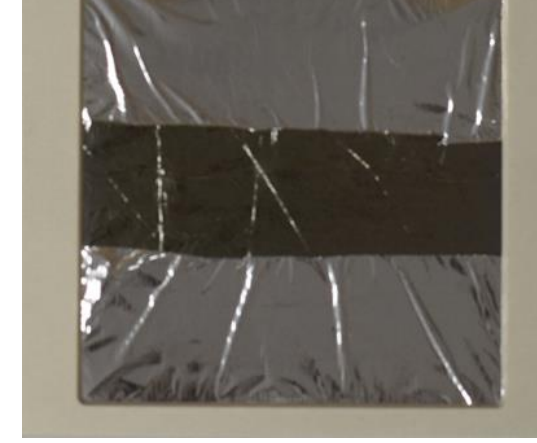
# In-Flight Image [Seamed Met PEN (M14-BK-Z5), Zenith)

*Significant change in wrinkle was found after total 15 days exposure in Zenith direction. Sample was shrunk and taut, but no visible delamination/bubbles on the seamed joint was found.*

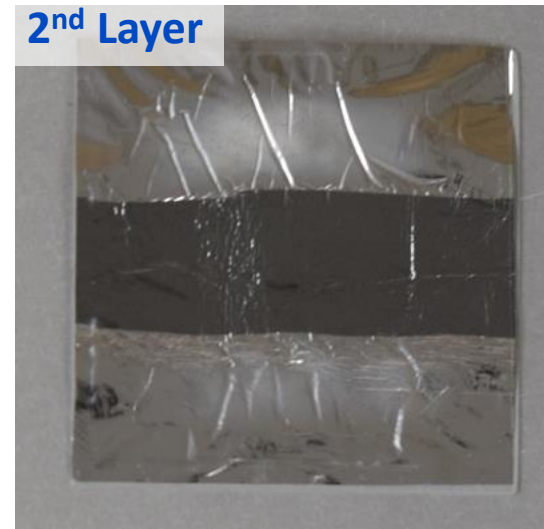
# Post-Flight Image [Seamed Met PEN (M14-BK-Z5), Zenith)

*No visible change in reflectiveness on the first layer (direct exposure to space) but some foggy (diffuse reflective) mark on the second layer was found.*

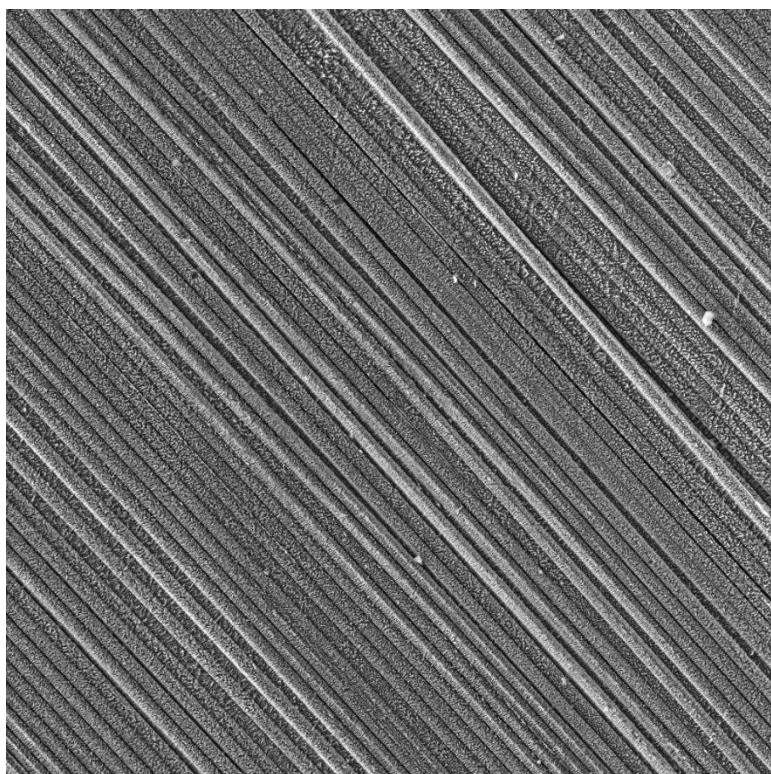
Post-Flight: Ram

*Dried carbon fiber (CF) morphology was found with Ram sample*

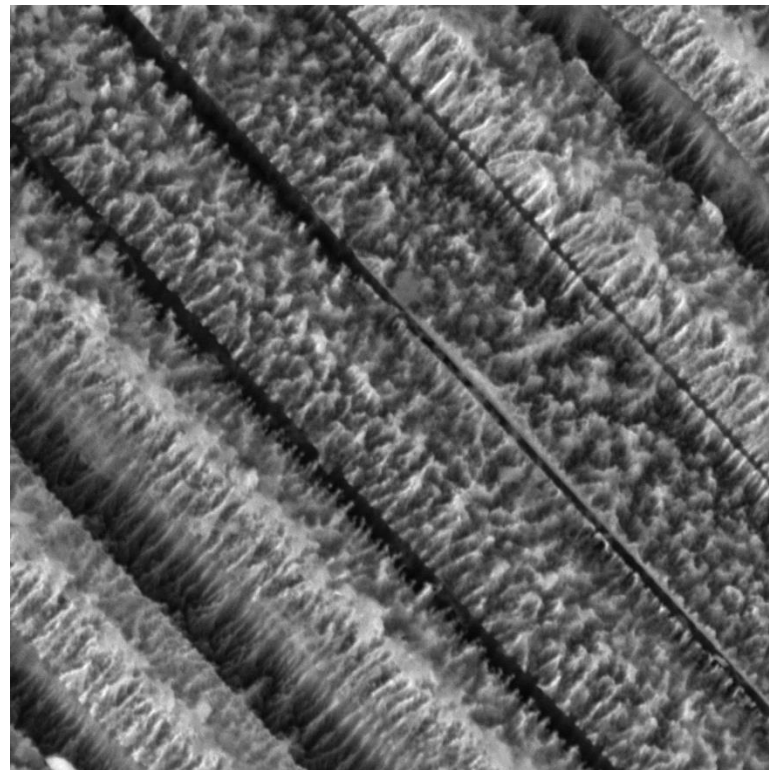
**Post-Flight: Ram**

*Severe erosion on CF surface was found with Ram sample*

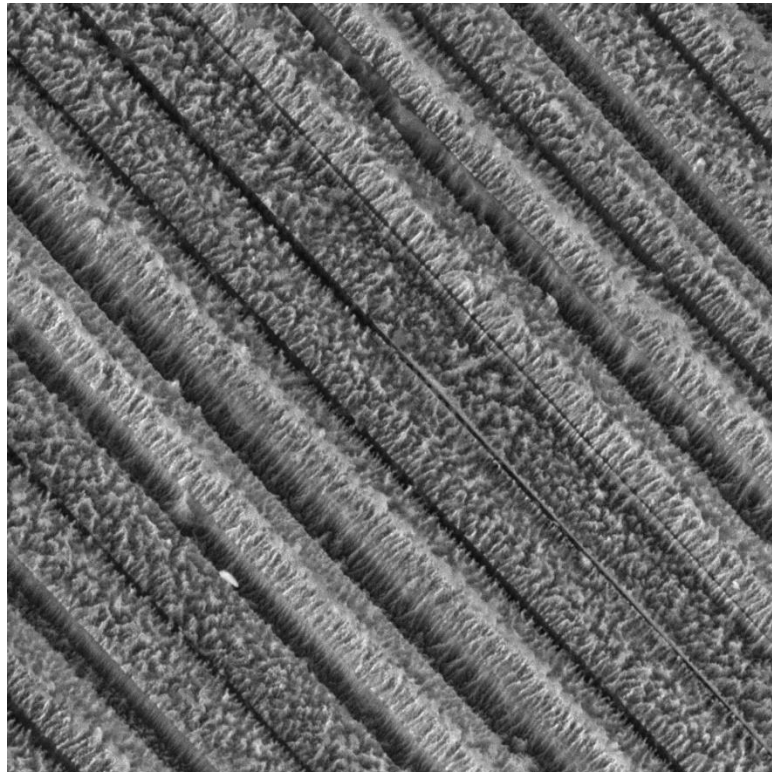
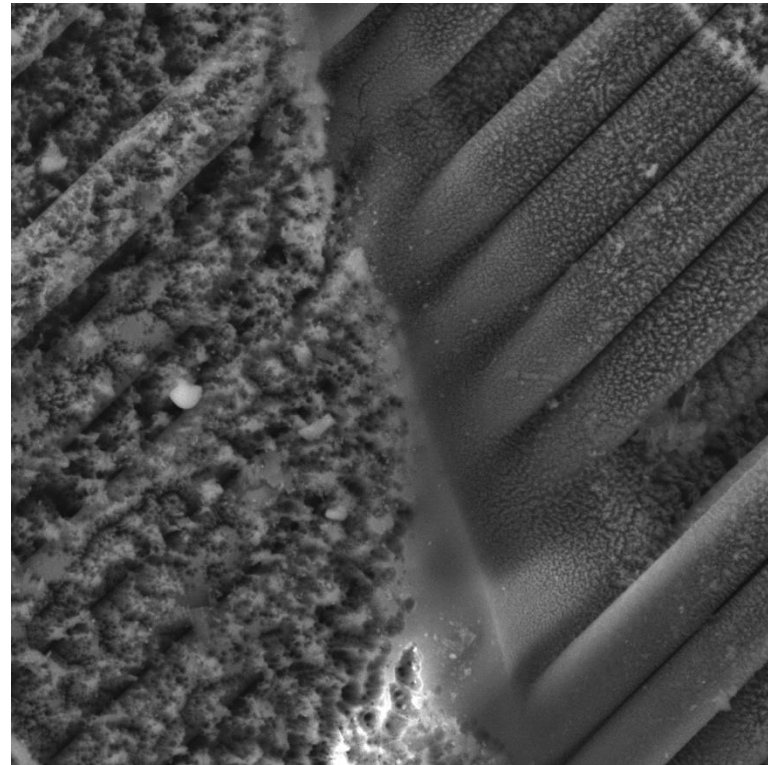
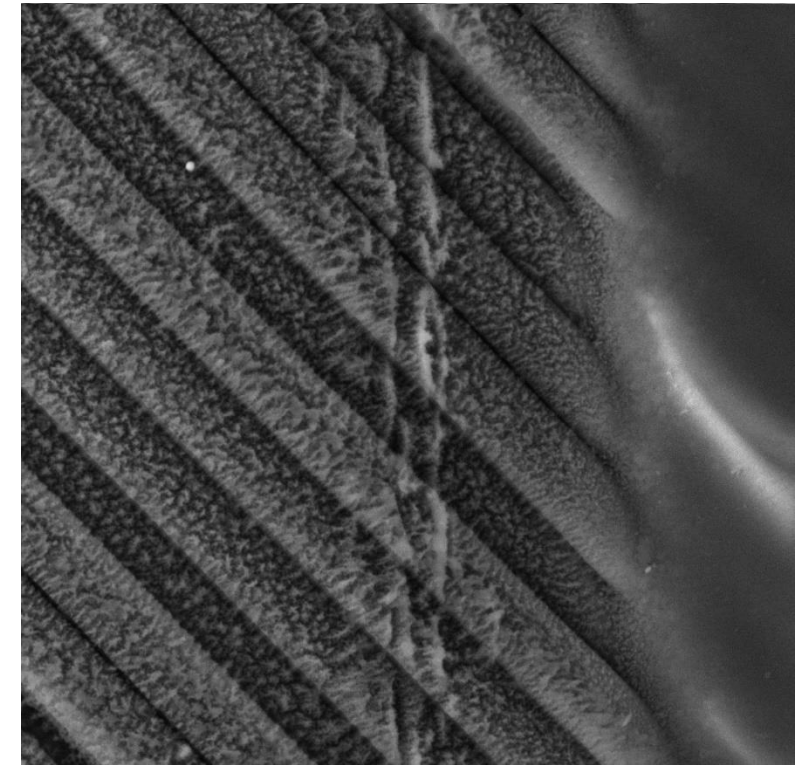
*Severe erosion on CF surface was found with Ram sample*

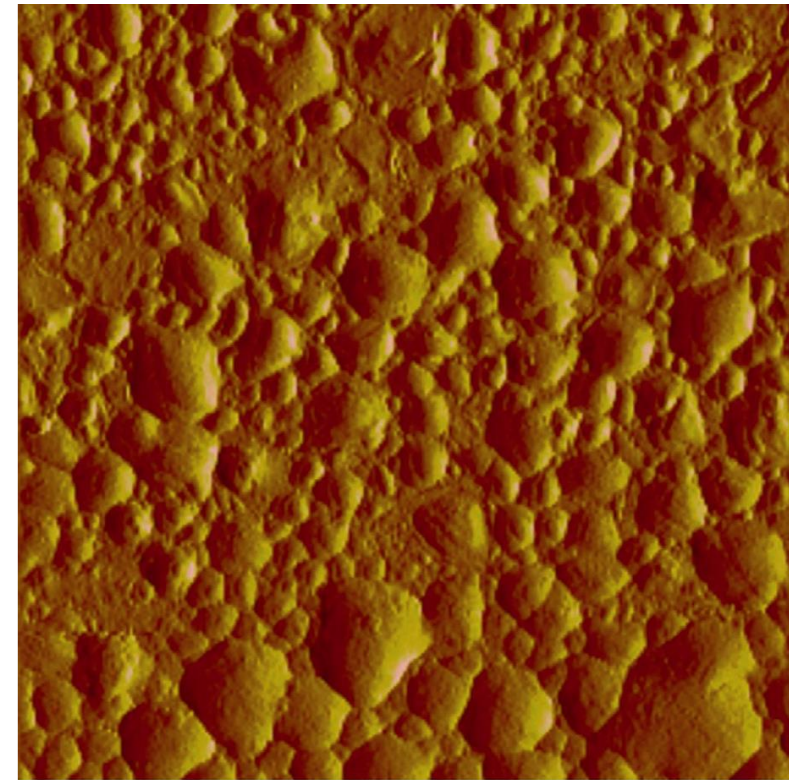
Post-Flight: Zenith

Hydrogen Blistering on Aluminum layer of Metallized PEN film by proton radiation

Foggy diffusive reflection of the 2<sup>nd</sup> layer of Met PEN on Zenith is similar to the hydrogen blistering by proton radiation (<2.5 keV)

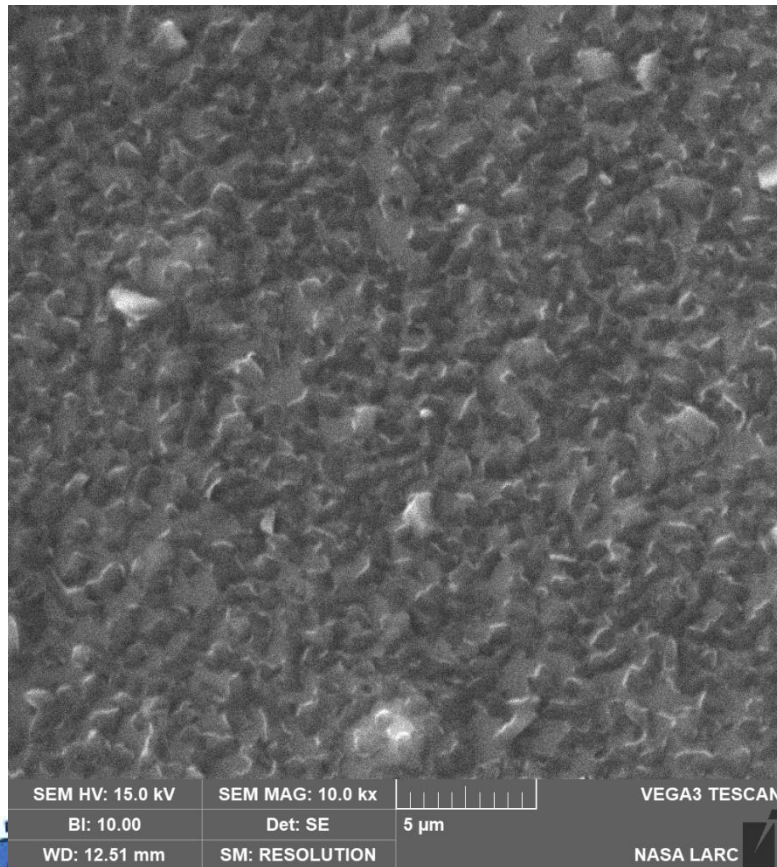
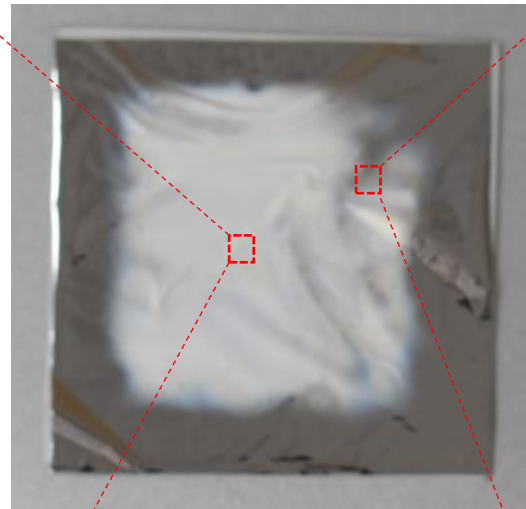
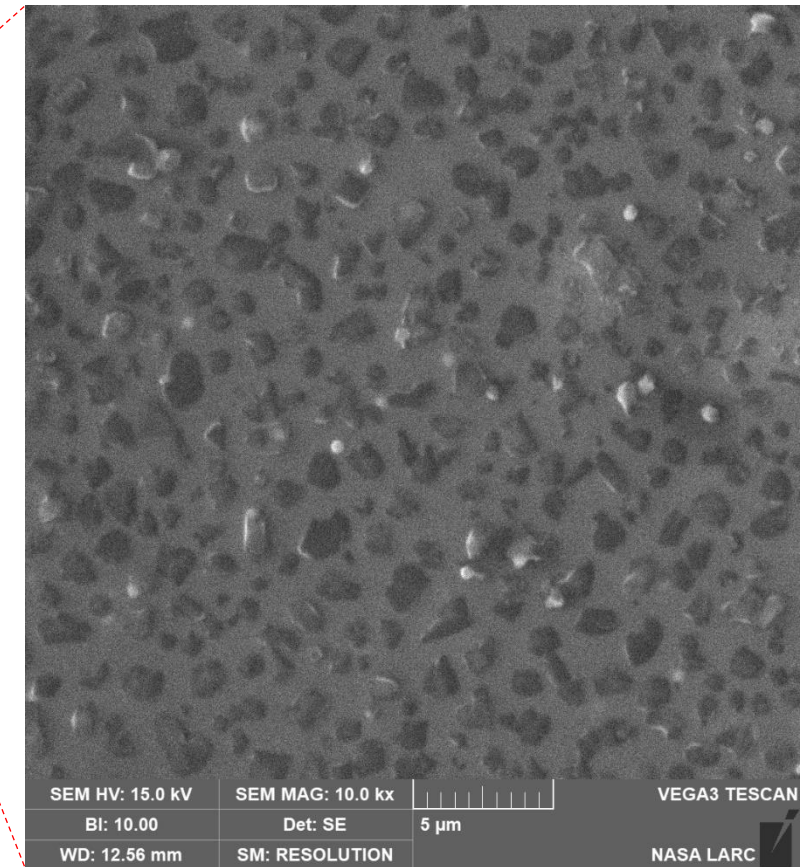
Post-Flight: Zenith

Hydrogen Blistering like morphology was found in the 2<sup>nd</sup> layer

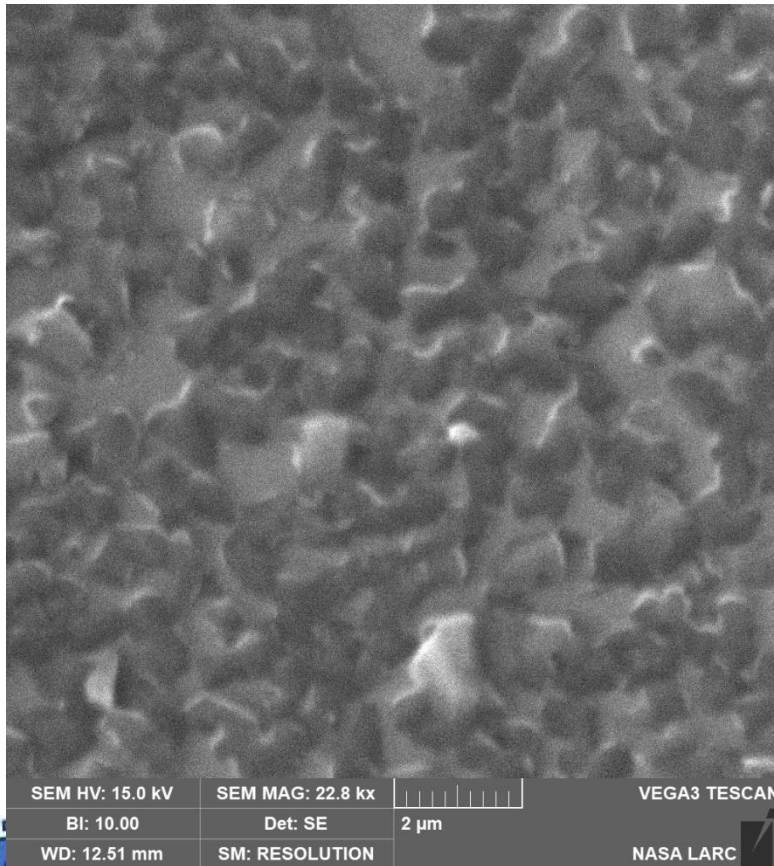
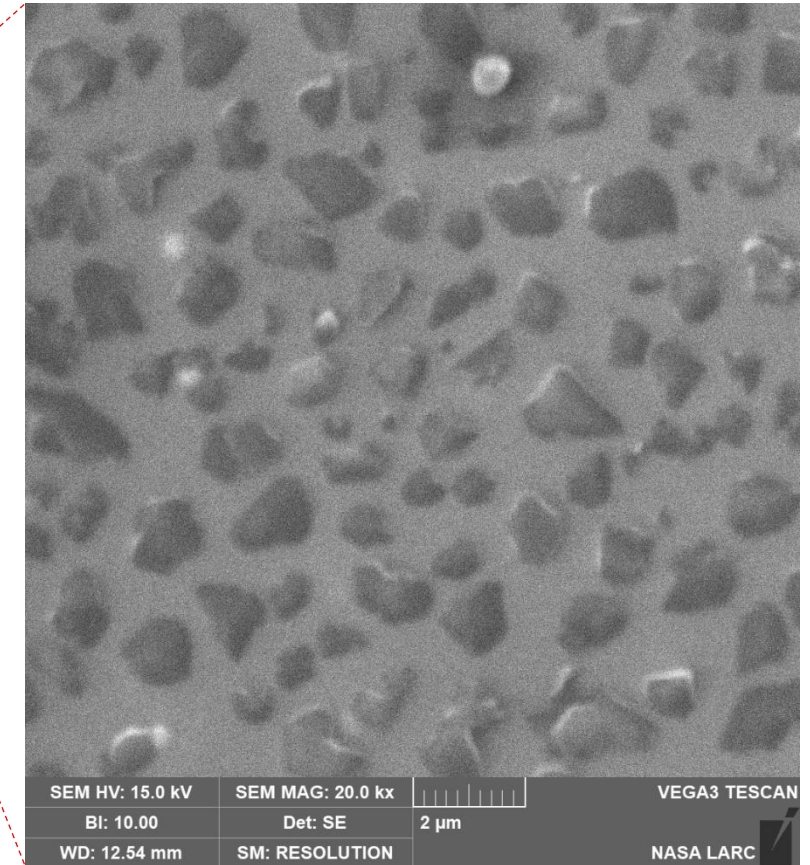
Post-Flight: Zenith

1<sup>st</sup> Layer (space exposed)  
PET (12.7μm) liner  
2<sup>nd</sup> Layer

Polyethyleneterephthalate (PET) liner might work as a proton moderator to create hydrogen blistering

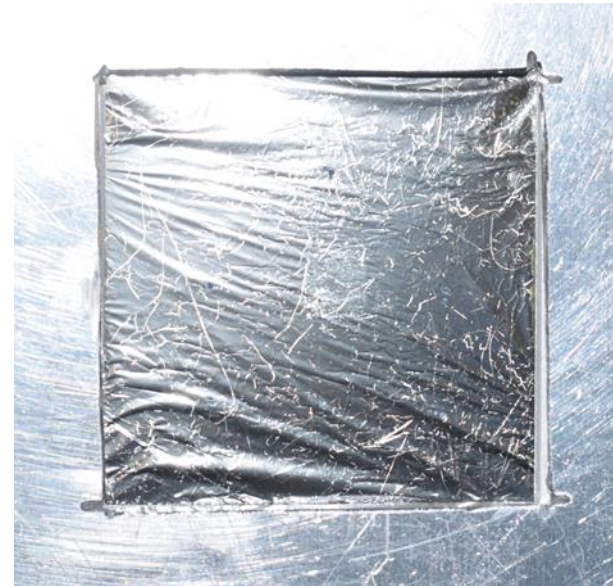
1 Sun (AM0),  
23 days  
(551.3 ESH)

*Sample was stretched and taut, Blue marking was faded.  
Many wrinkles were created. Fine cracks on chrome layer were found.  
No rupture occurred after about 551 ESH.*

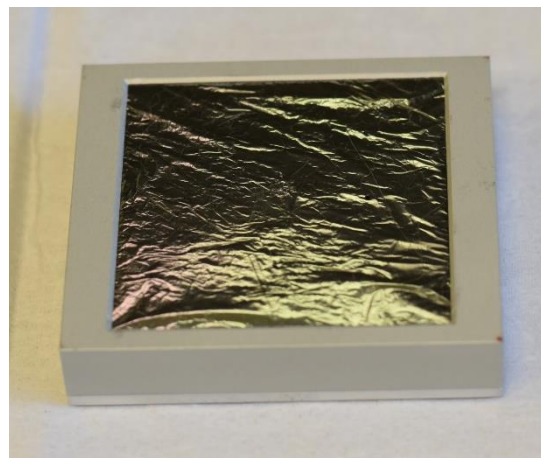
*Wrinkles were found, but No Crack/Rupture was created by UV/Vis/NIR*

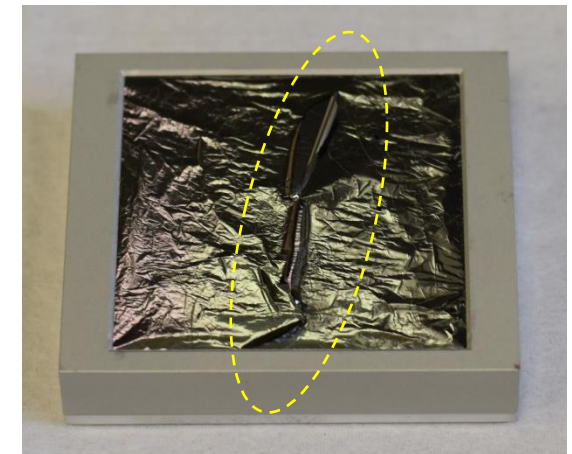
*Crack/Rupture was reproduced by Oxygen Plasma*

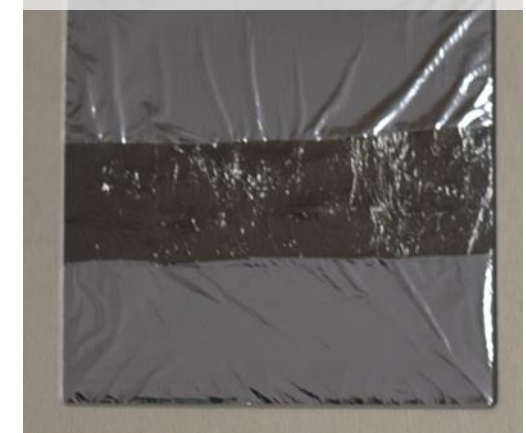
# In-Flight Image [Seamed Met PEN (M14-BK-R9), Ram]

*No significant change was found after total 133 days exposure in Ram direction. Sample was slightly shrunk and taut.*
