Thermochemical/Thermomechanical Synergies in High Temperature Particle Erosion of CMAS Exposed EBCs

Jamesa L. Stokes¹, Michael J. Presby¹, Rebekah I. Webster¹,
John A. Setlock², Bryan J. Harder¹

¹NASA Glenn Research Center

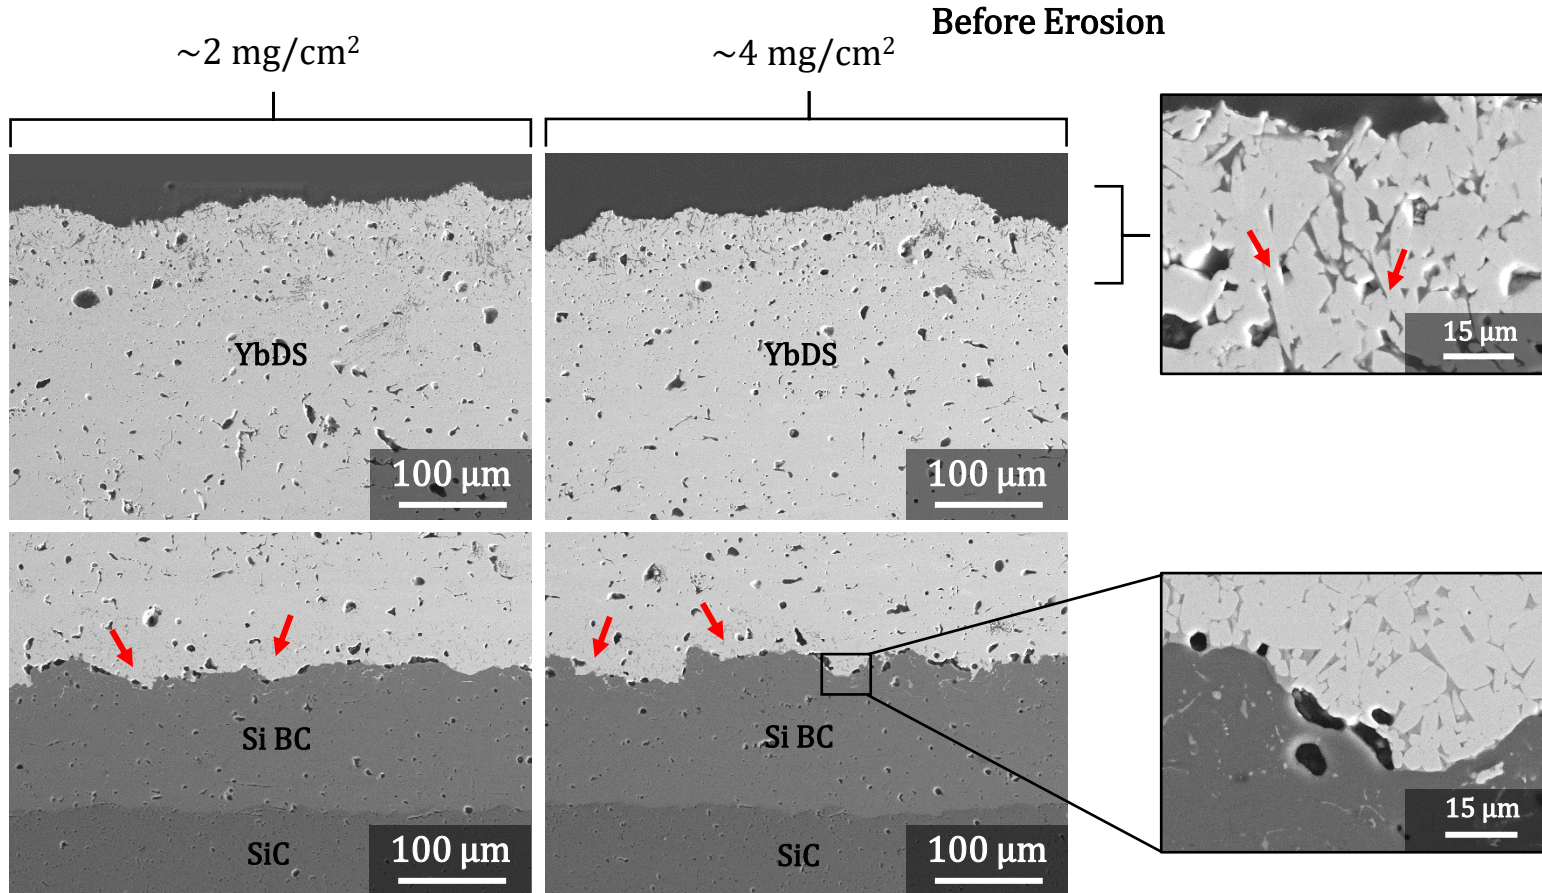
Results - $\sim 2 \text{ mg/cm}^2$ and $\sim 4 \text{ mg/cm}^2$

- No residual CMAS was observed
- Pockets of CMAS interspersed with elongated grains having composition consistent with the formation of $\text{Ca}_2\text{Yb}_8(\text{SiO}_4)_6\text{O}_2$ apatite
- Pockets of CMAS were observed near the bondcoat

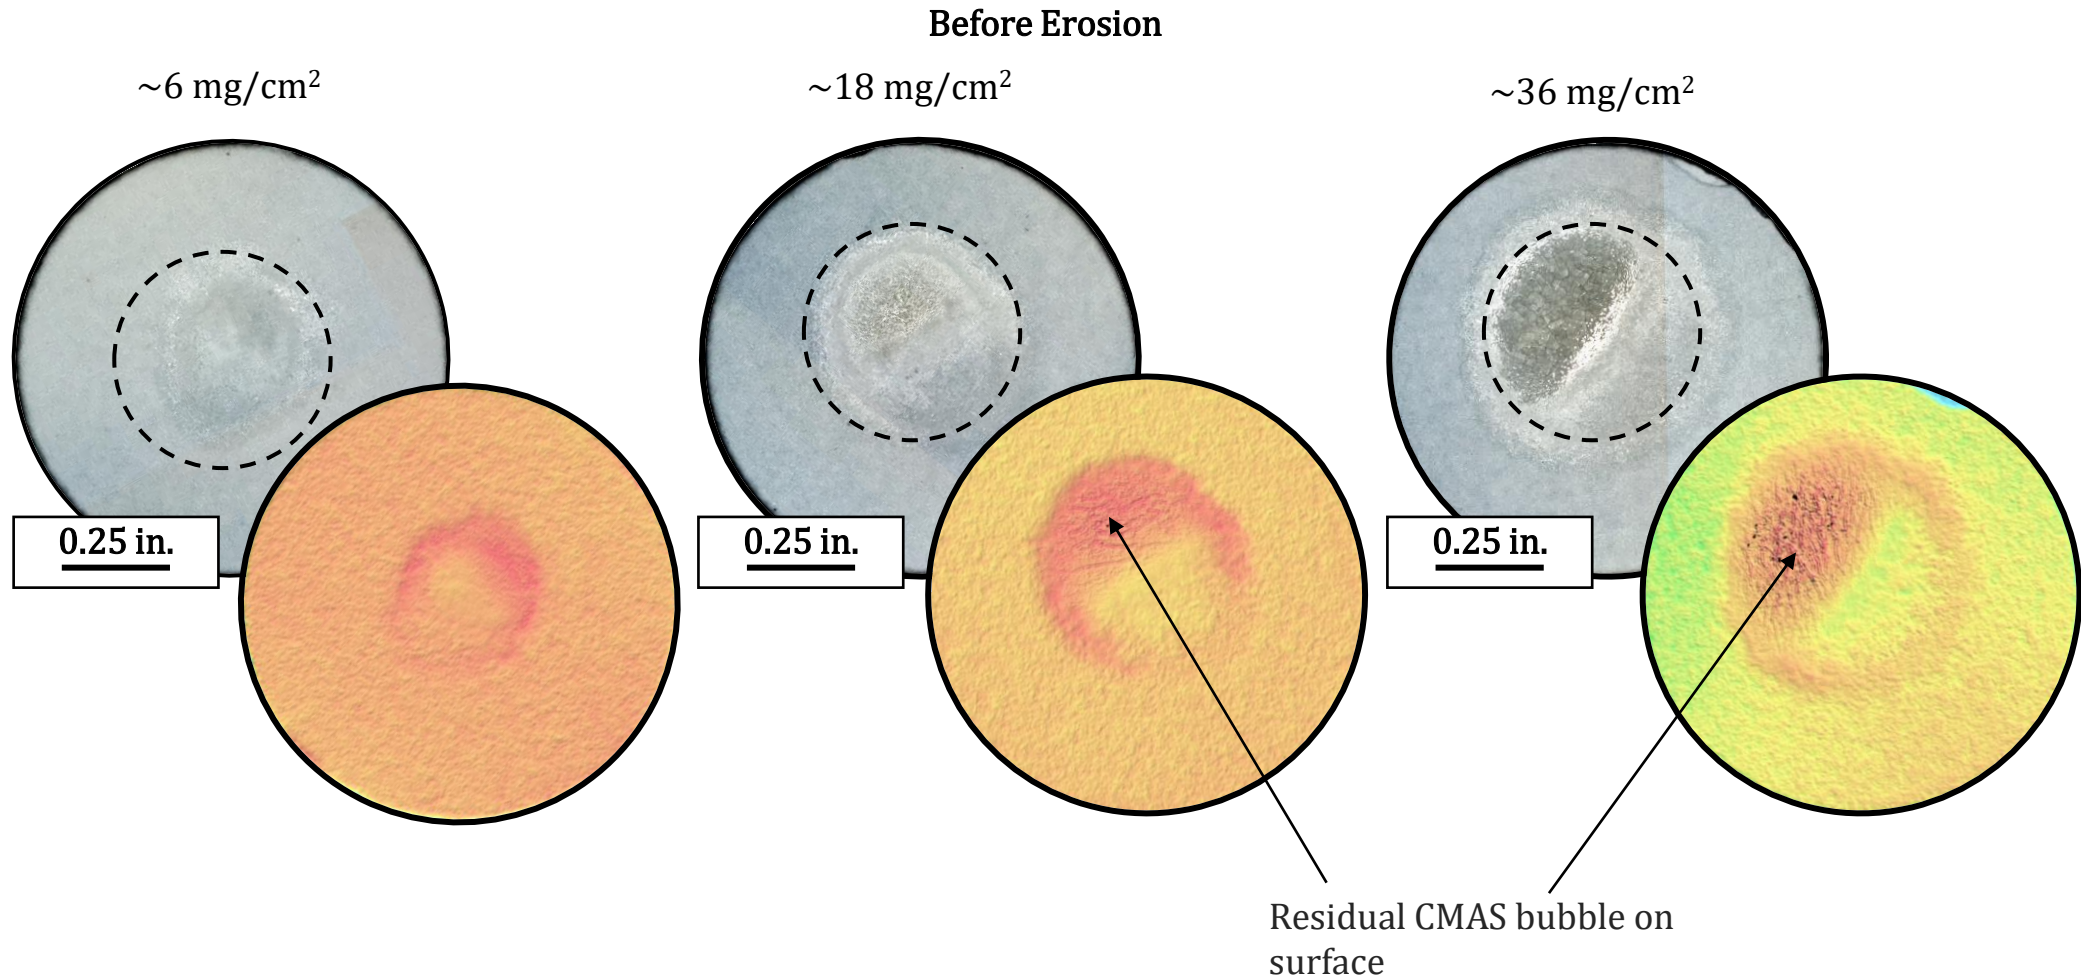
Results - $\sim 6 \text{ mg/cm}^2$, $\sim 18 \text{ mg/cm}^2$, and $\sim 36 \text{ mg/cm}^2$

- Thicker layer of apatite formation with increased loading
- Crystallization of residual CMAS to anorthite ($\text{CaAl}_2\text{Si}_2\text{O}_8$)
- CMAS pooling between grains at bondcoat consistent with lower loading samples
- Large crack through the bondcoat in $\sim 18 \text{ mg/cm}^2$ and $\sim 36 \text{ mg/cm}^2$ samples, extending from the middle of the coating to the edges of CMAS bubble.

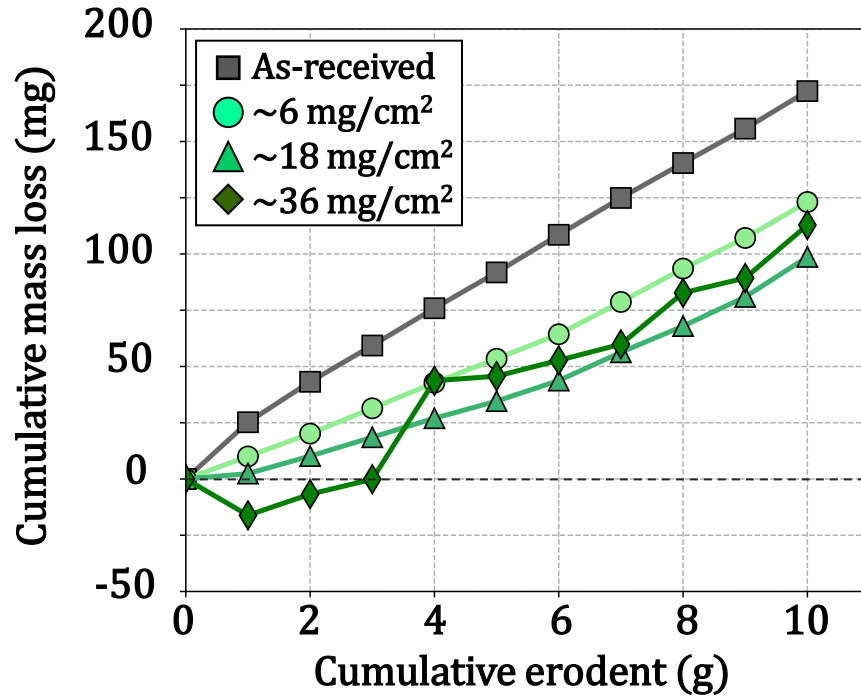
- With increasing loading of CMAS up to $\sim 18 \text{ mg/cm}^2$, cumulative mass loss decreased.
- $\sim 6 \text{ mg/cm}^2$ and $\sim 18 \text{ mg/cm}^2$ exhibited slightly non-linear mass loss behavior
- $\sim 36 \text{ mg/cm}^2$ sample exhibited an initial mass gain up to approximately 3 g of erodent followed by mass loss.

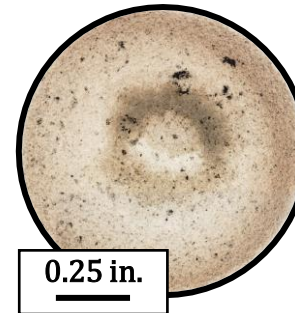
$\sim 6 \text{ mg/cm}^2$

- Sample darker in areas with residual CMAS

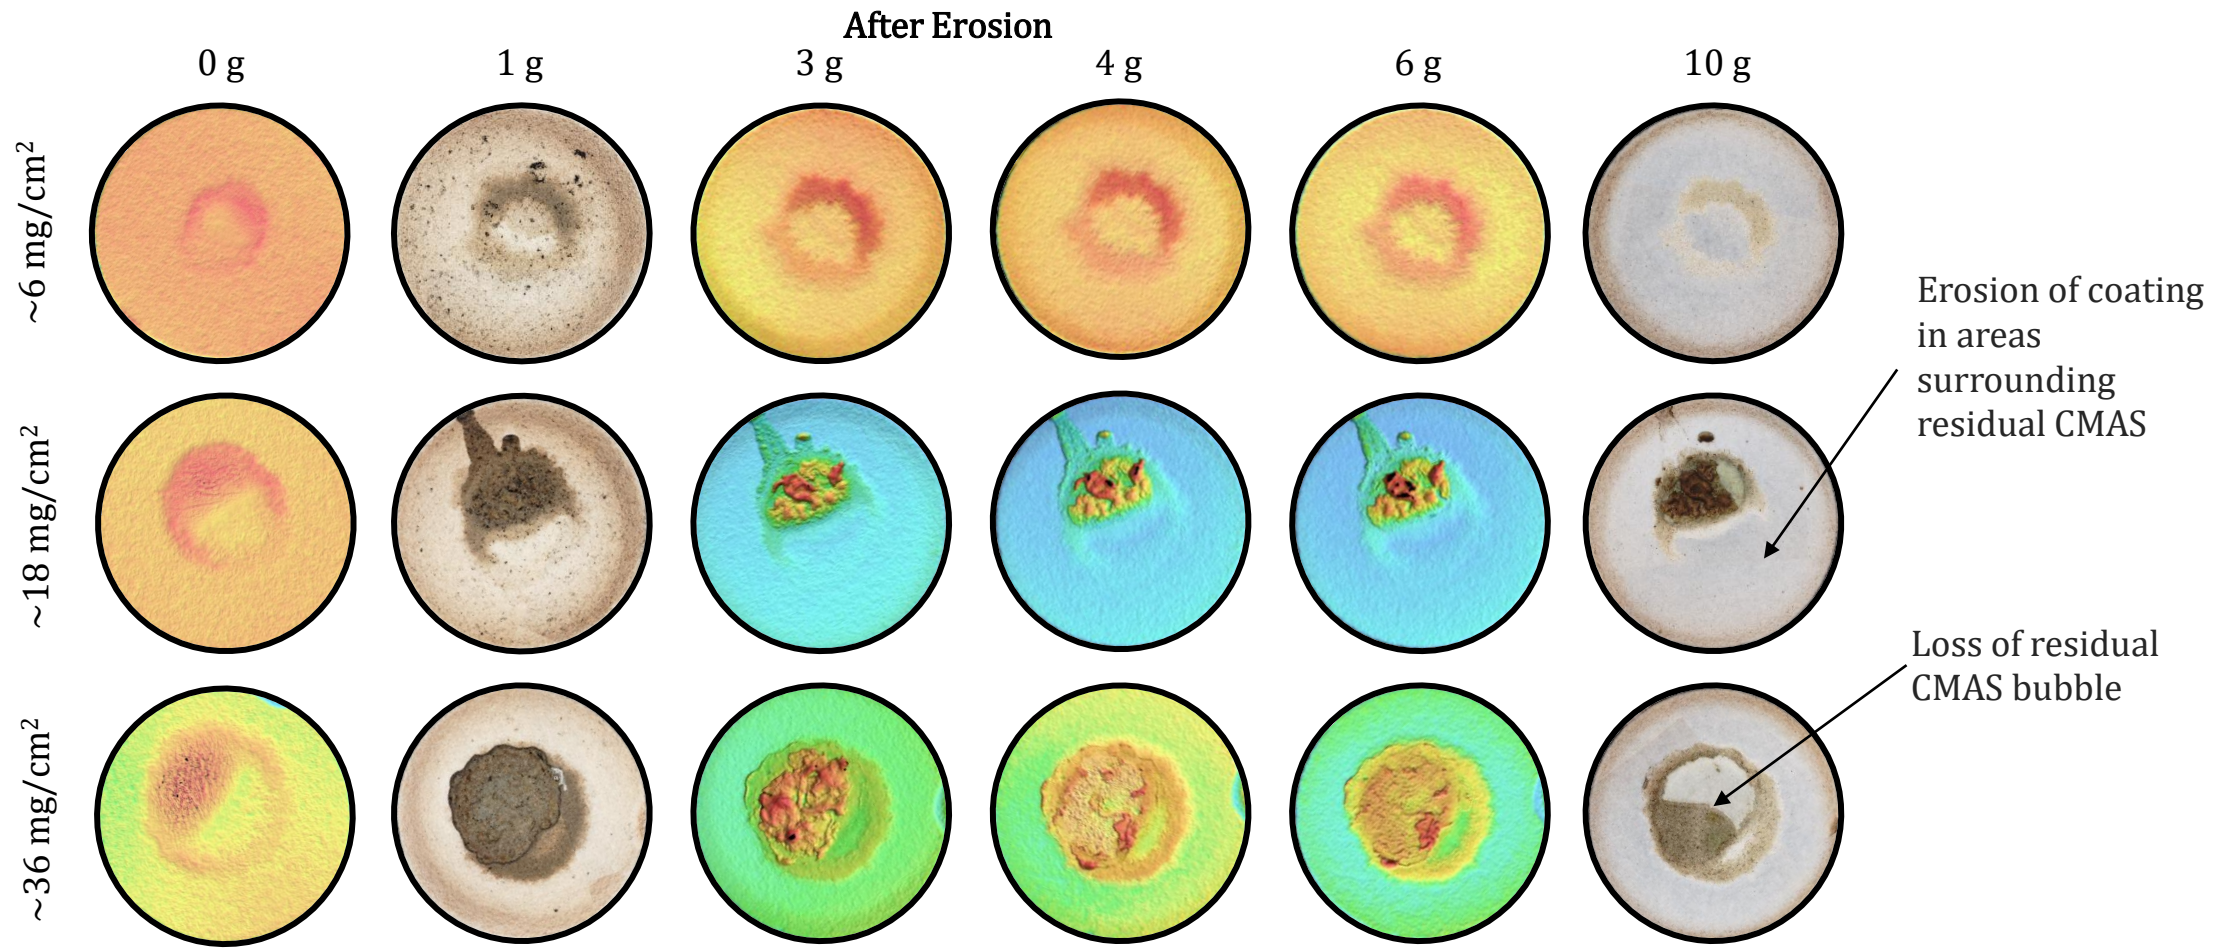
- SEM cross sections show large cracks throughout bond coat; cracks were much wider in $\sim 36 \text{ mg/cm}^2$ sample after erosion testing.
- Bubbling and rumpling of residual CMAS due to burner rig exposure

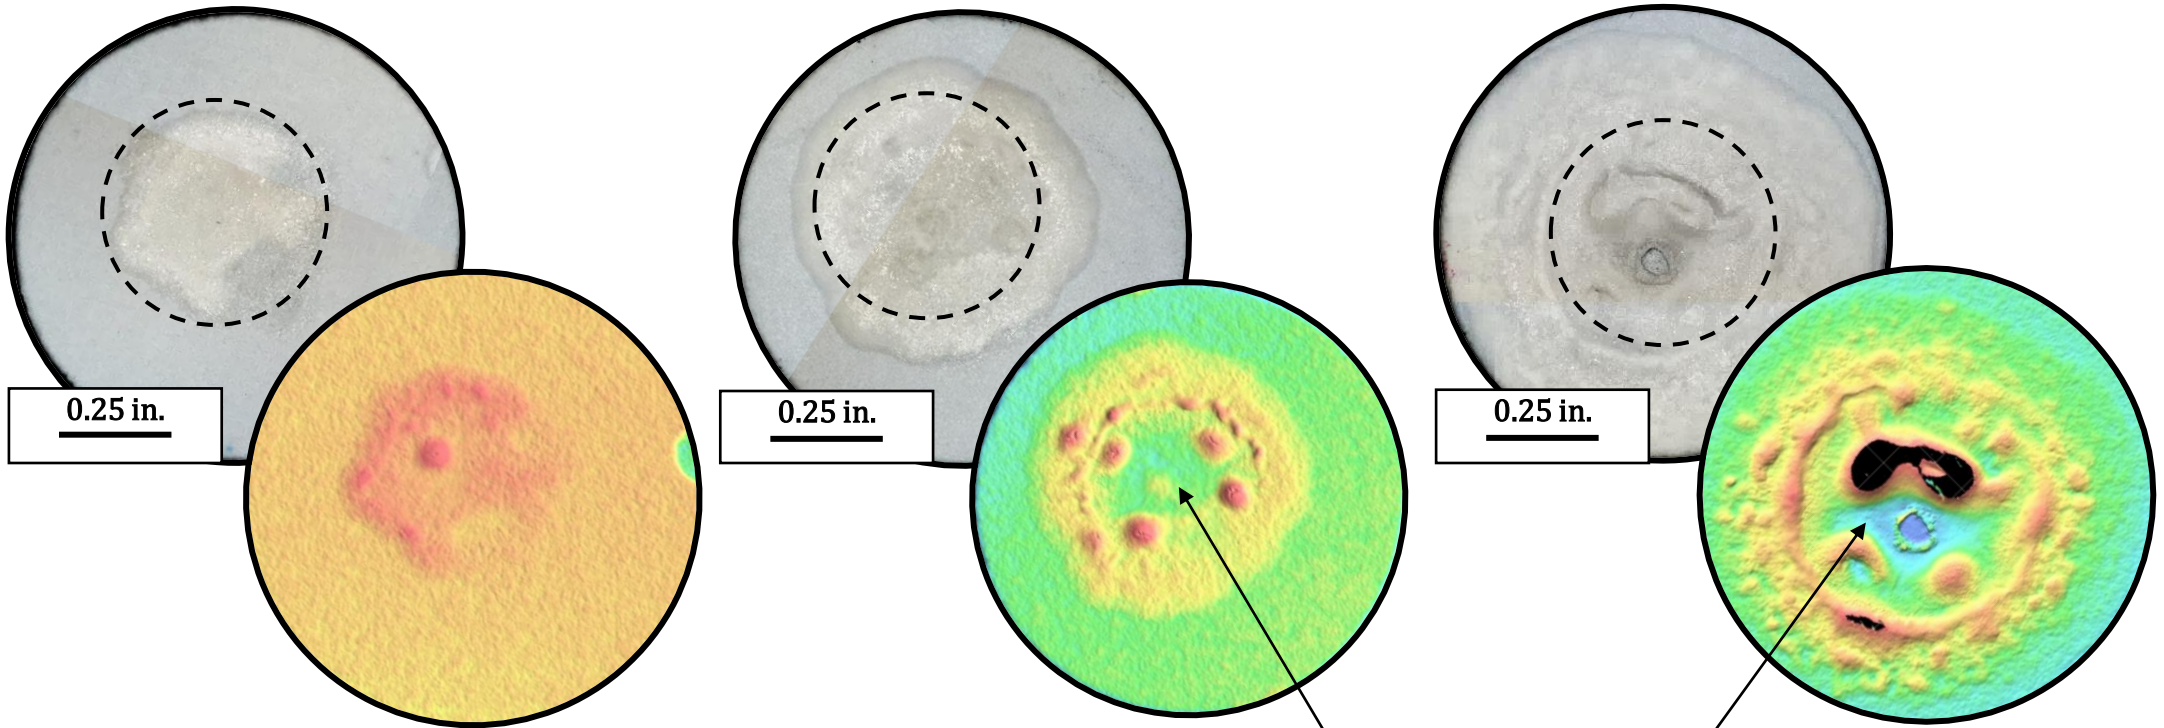
100 hours

Radial spreading of affected area after heat treatment

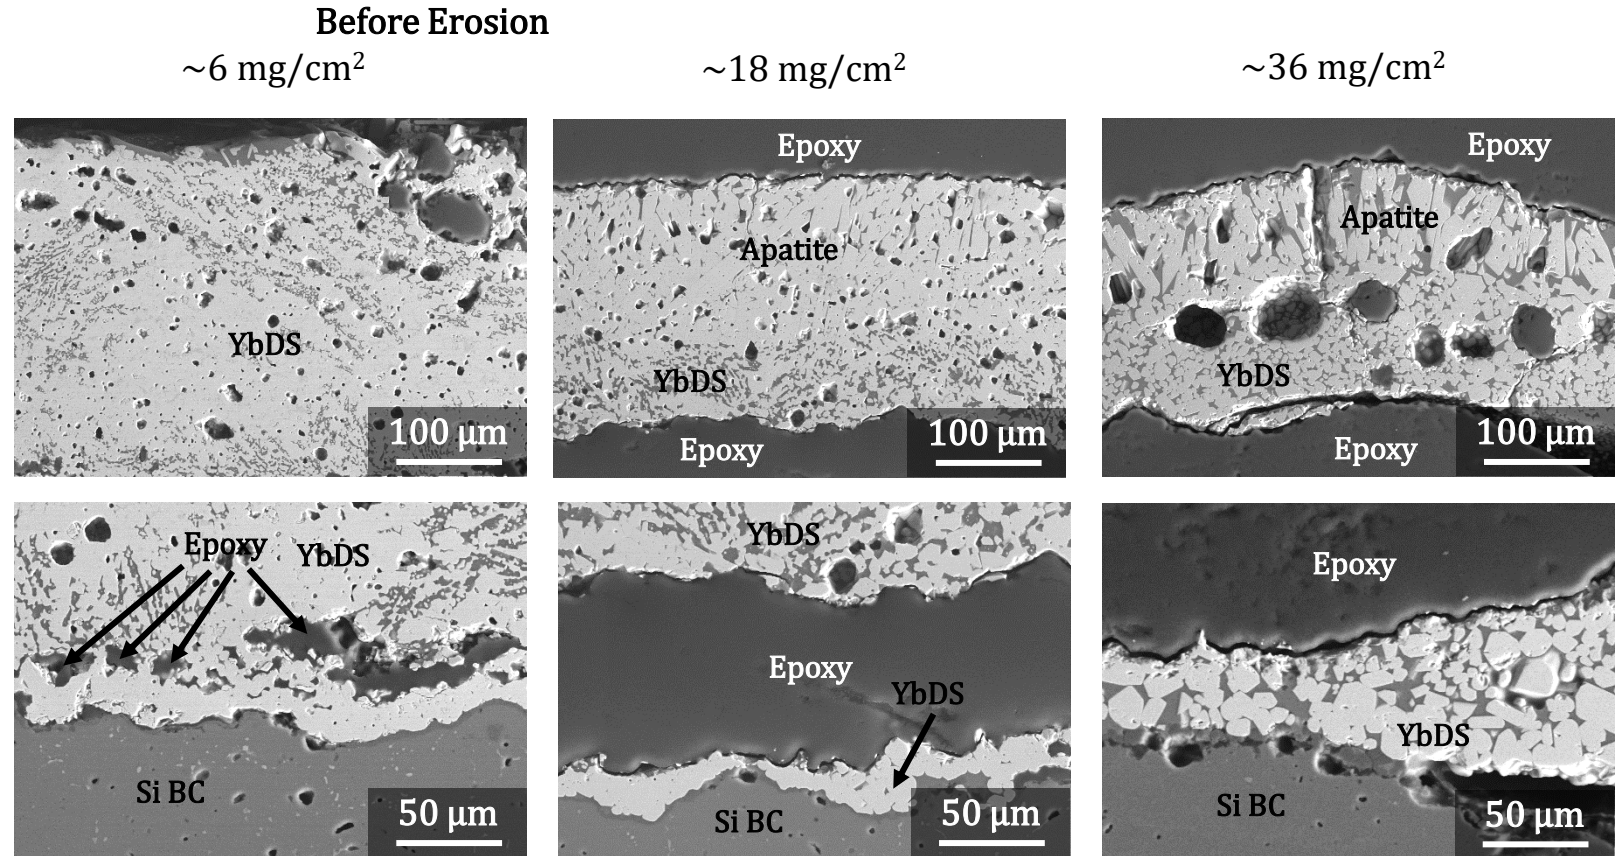
- No residual CMAS on surfaces of coatings
- Apatite and YbDS grains coarsened after 100 hours
- Less apatite grains visible in $\sim 6 \text{ mg/cm}^2$ sample after 100 hours compared to shorter exposure
- Large void formation at bond coat interface and delamination of coating
- Pockets of CMAS between grains at bondcoat interface have grown in size

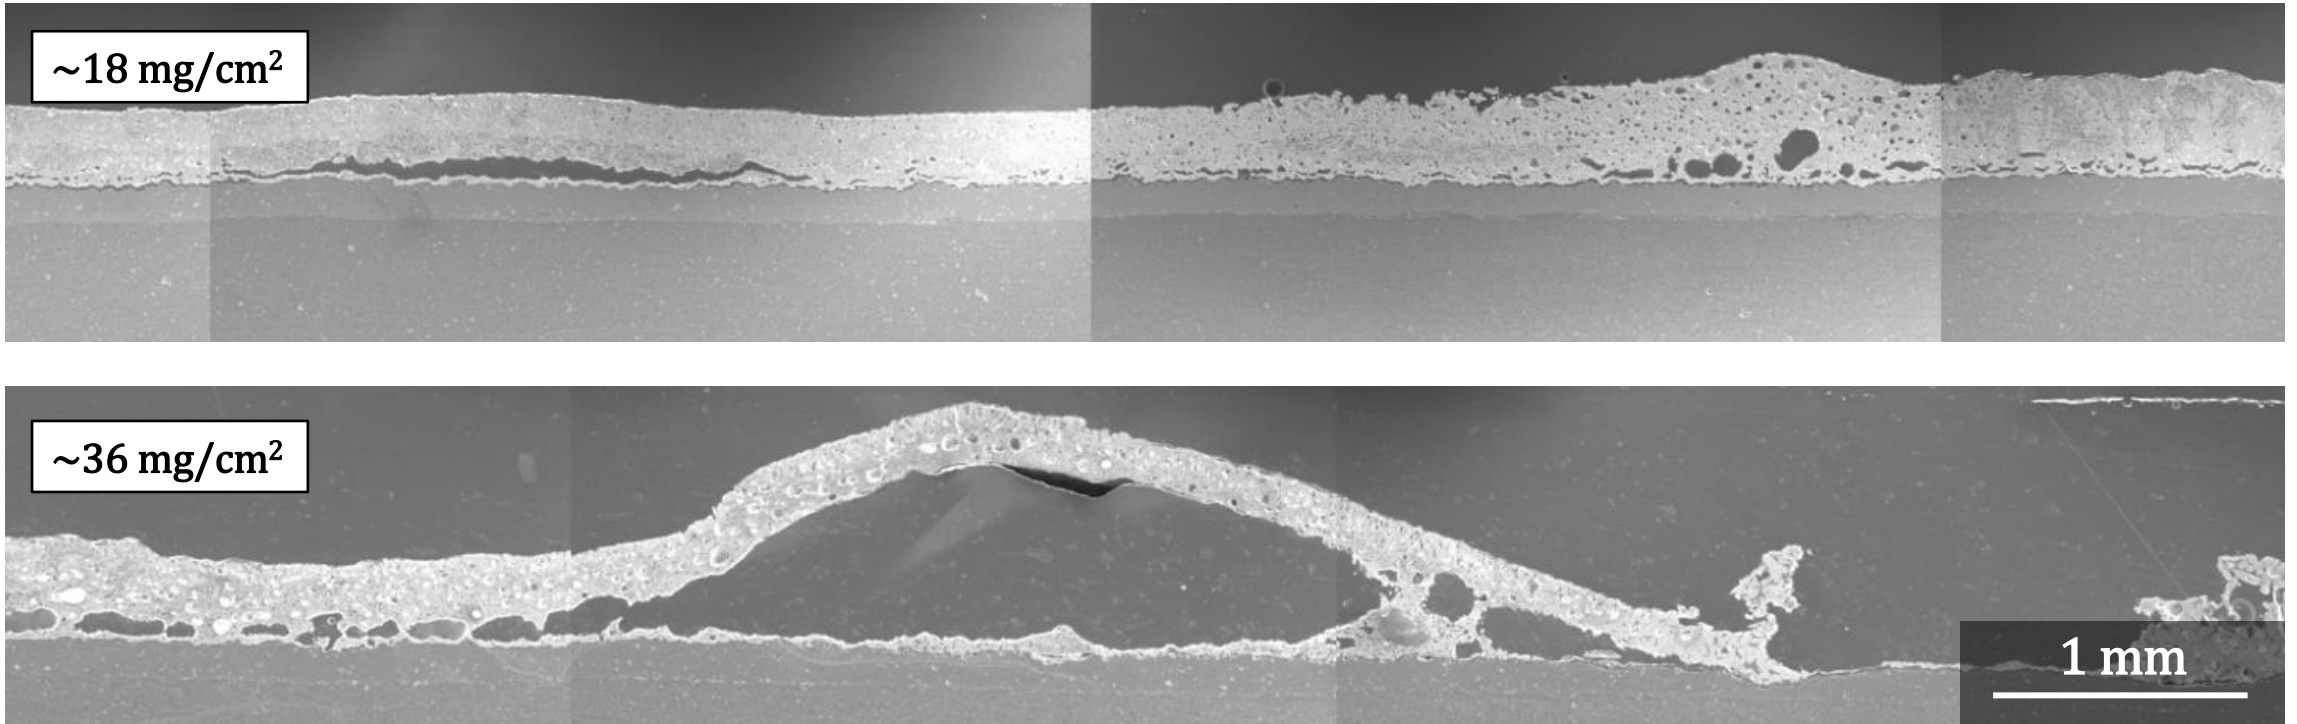
Before Erosion

- SEM cross sections show bubbling and rumpling of residual CMAS due to longer furnace heat treatment time

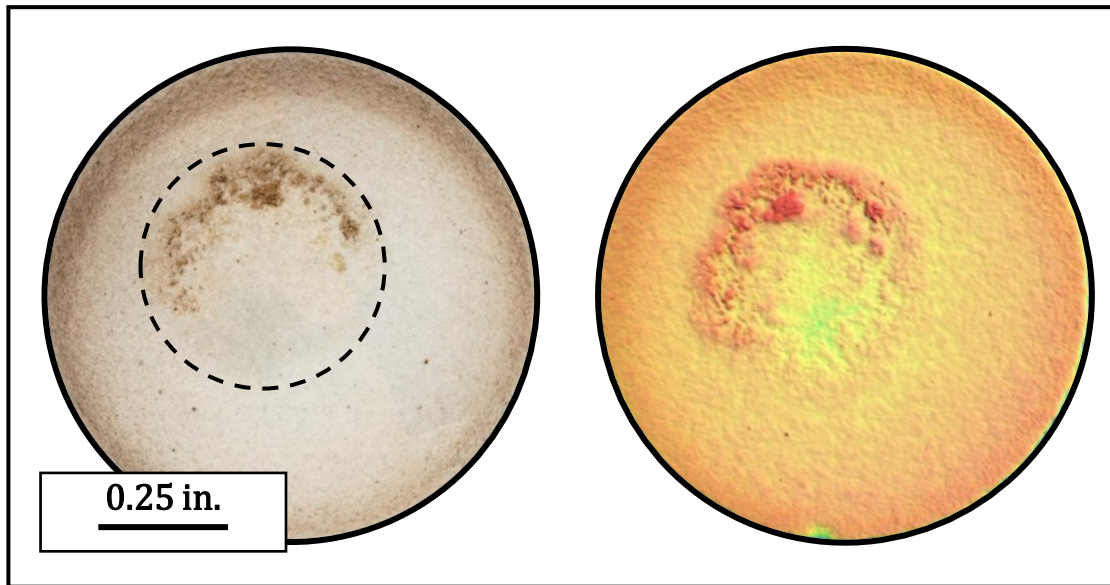
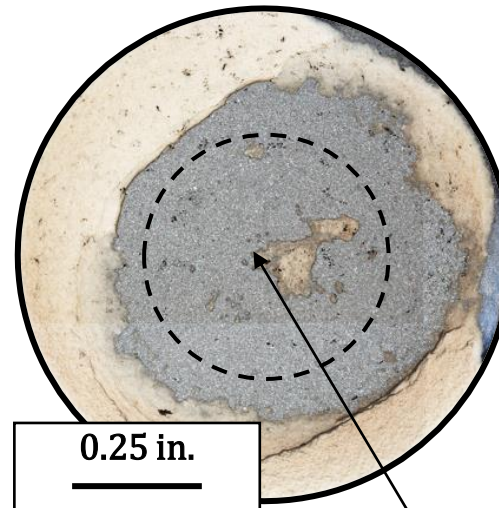
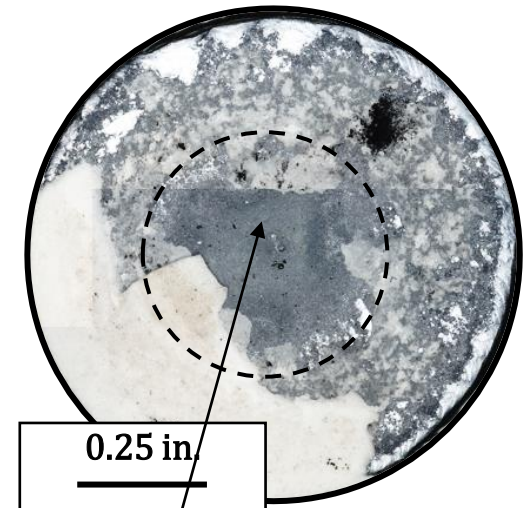
After Erosion

Catastrophic failure upon heating in burner rig

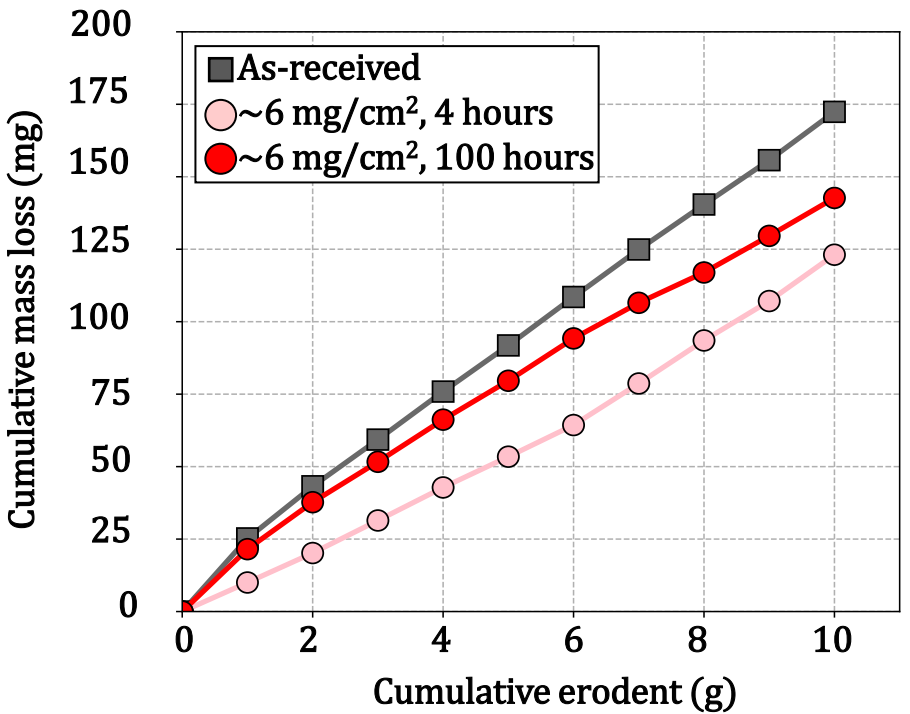
- With increasing exposure time at $\sim 6 \text{ mg/cm}^2$, there was cumulative mass loss increase.

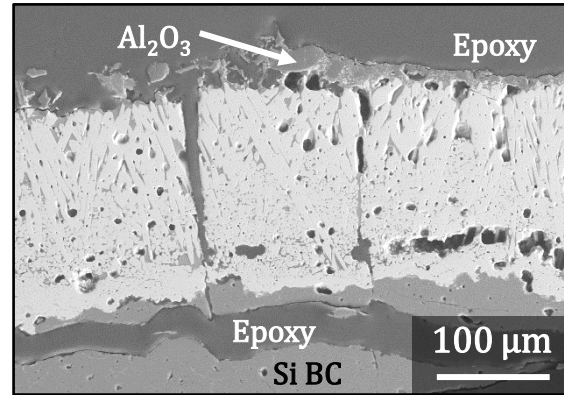
Catastrophic mass loss/coating failure

Spallation of residual CMAS and coating more likely with increased CMAS loading and heat treatment time

- Thermal shock and thermal expansion mismatch
