==== Goddard Space Flight Center =====

Some not-so-intuitive lessons from key on-orbit failures and anomalies since 2005

**Jesse Leitner
Chief SMA Engineer
NASA GSFC, Code 300**

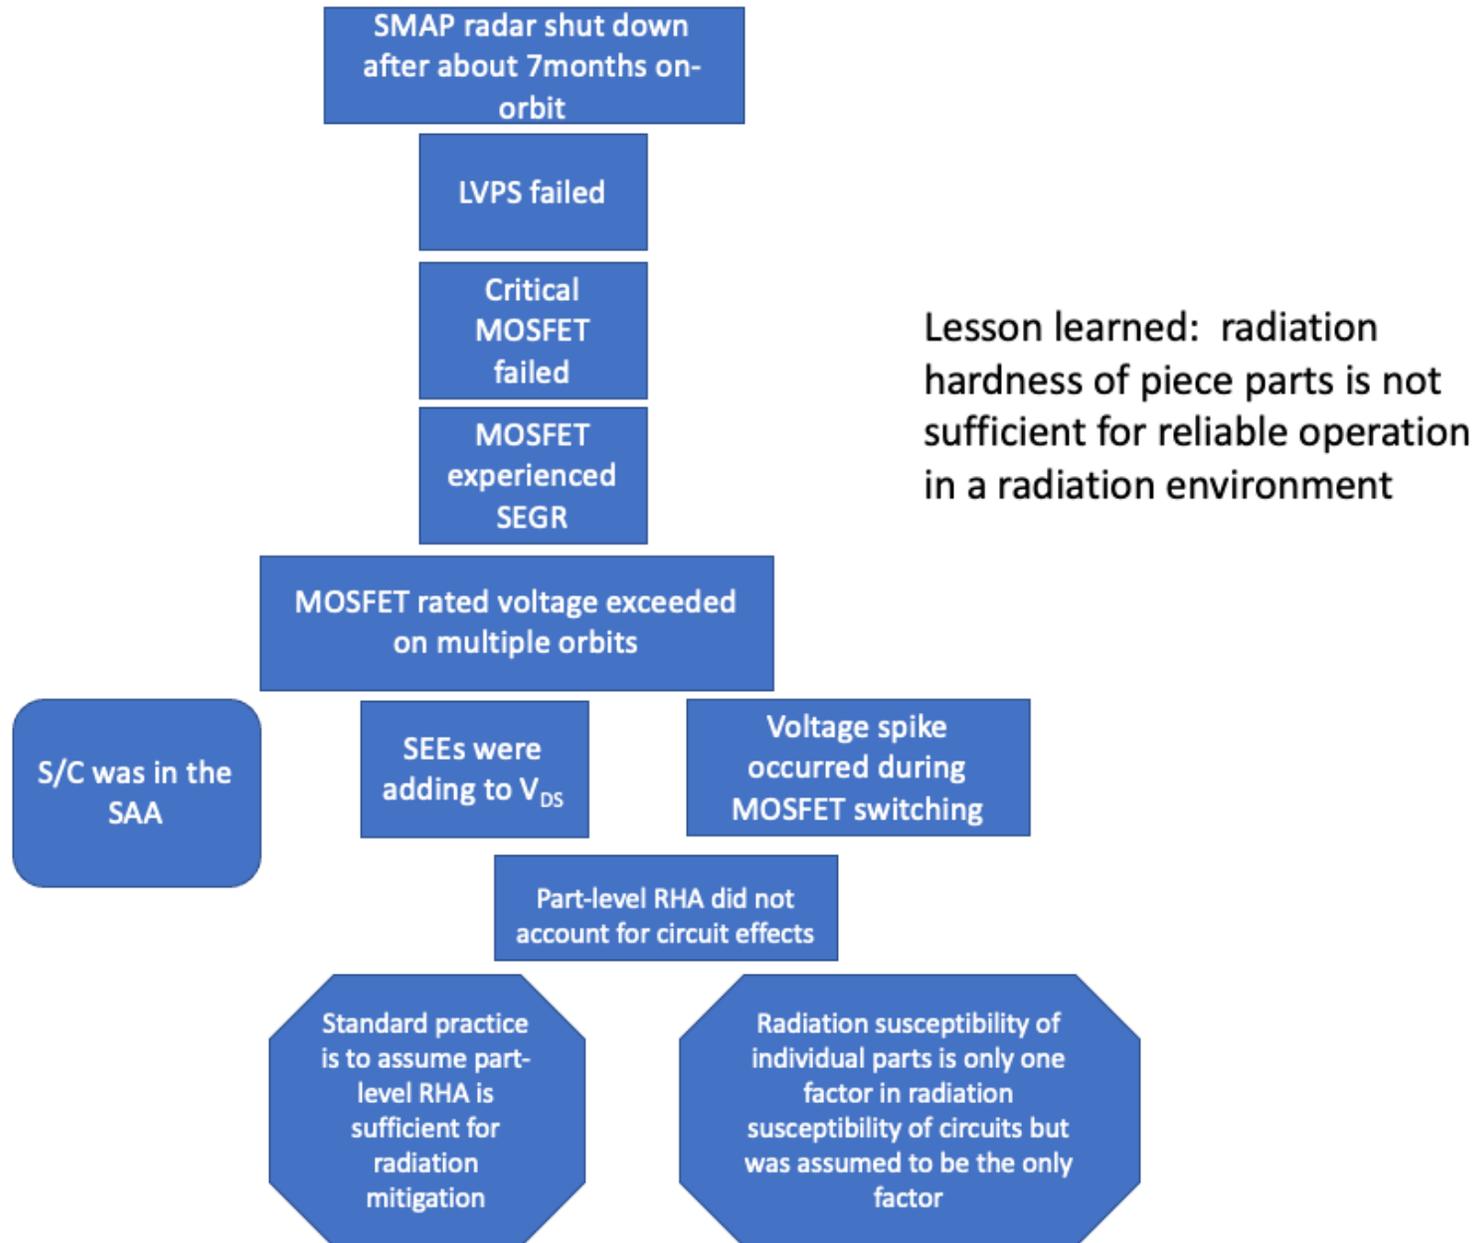
SMAP failure Event and Causal Factor Tree

- In 2015, several months into the science phase of NASA's Soil Moisture Active Passive (SMAP) mission, the SMAP active radar (SAR), the primary payload, stopped gathering science measurements shortly after the spacecraft entered the South Atlantic Anomaly (SAA). After a month and a half of troubleshooting and attempts to restart the radar, NASA declared a Type A mishap and convened a NASA Mishap Investigation Board (MIB). In parallel, the implementing center, JPL, convened its own failure review board (FRB). (The JPL board was very effective at getting to the detailed technical causes).

- The project depended on the radiation-hardness of all the parts in the system, but did not consider the circuit effects that combined with the single event effects in the SAA.

- These circuit effects coupled with radiation effects to exceed the rated voltage within the rad-hard part, ultimately resulting in single event gate rupture.

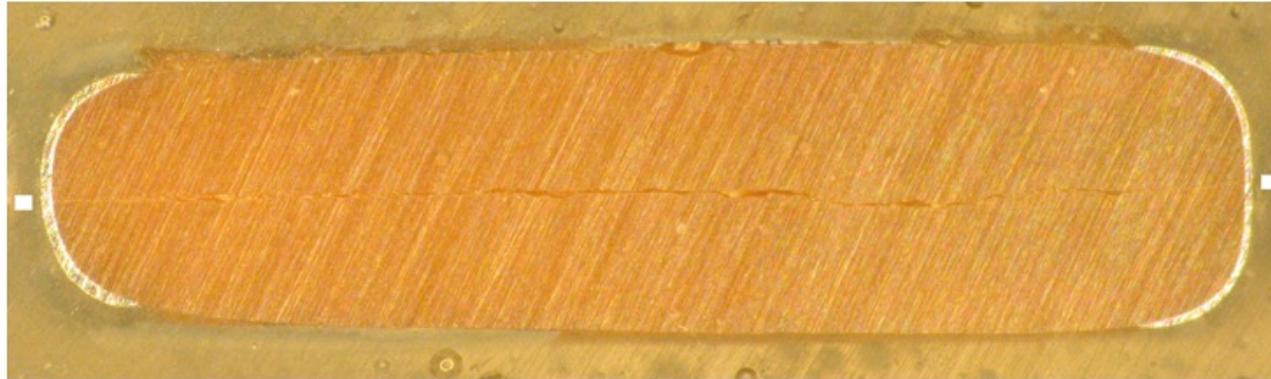
- Initial cross sectioning at the 5-percent cross section level found a delamination spanning between capacitor terminations. The anomaly was examined microscopically and photo-documented. Cross sectioning continued to approximately the 10-percent level, at which the delamination was fully revealed and seen to extend from termination to termination of the capacitor.

Figure 1. A delamination spanning between terminations was found at the 10-percent level. Square dots in the image above mark the ends of the crack. Note that the cross section plane is near the end of the part and does not reveal the electrodes.

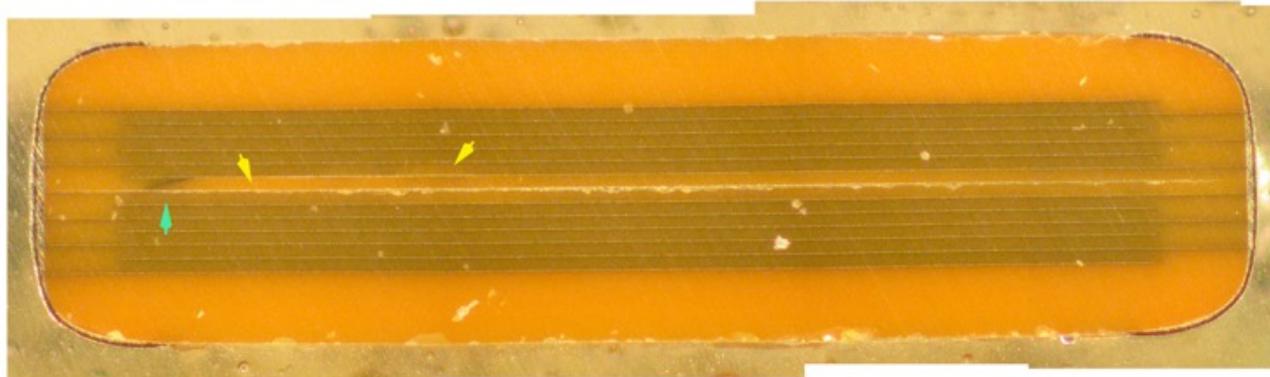
Figure 2. The 21-percent level with polish first reveals the electrode structure and simultaneously revealed a diagonal crack, marked by a green arrow, bridging between the center, and an adjacent electrode. This location is considered a likely candidate for the failure site. Yellow arrows mark a difference in layer color later shown to be caused by internal light reflection from a discontinuity in the dielectric. EDS found no material difference between the layers.

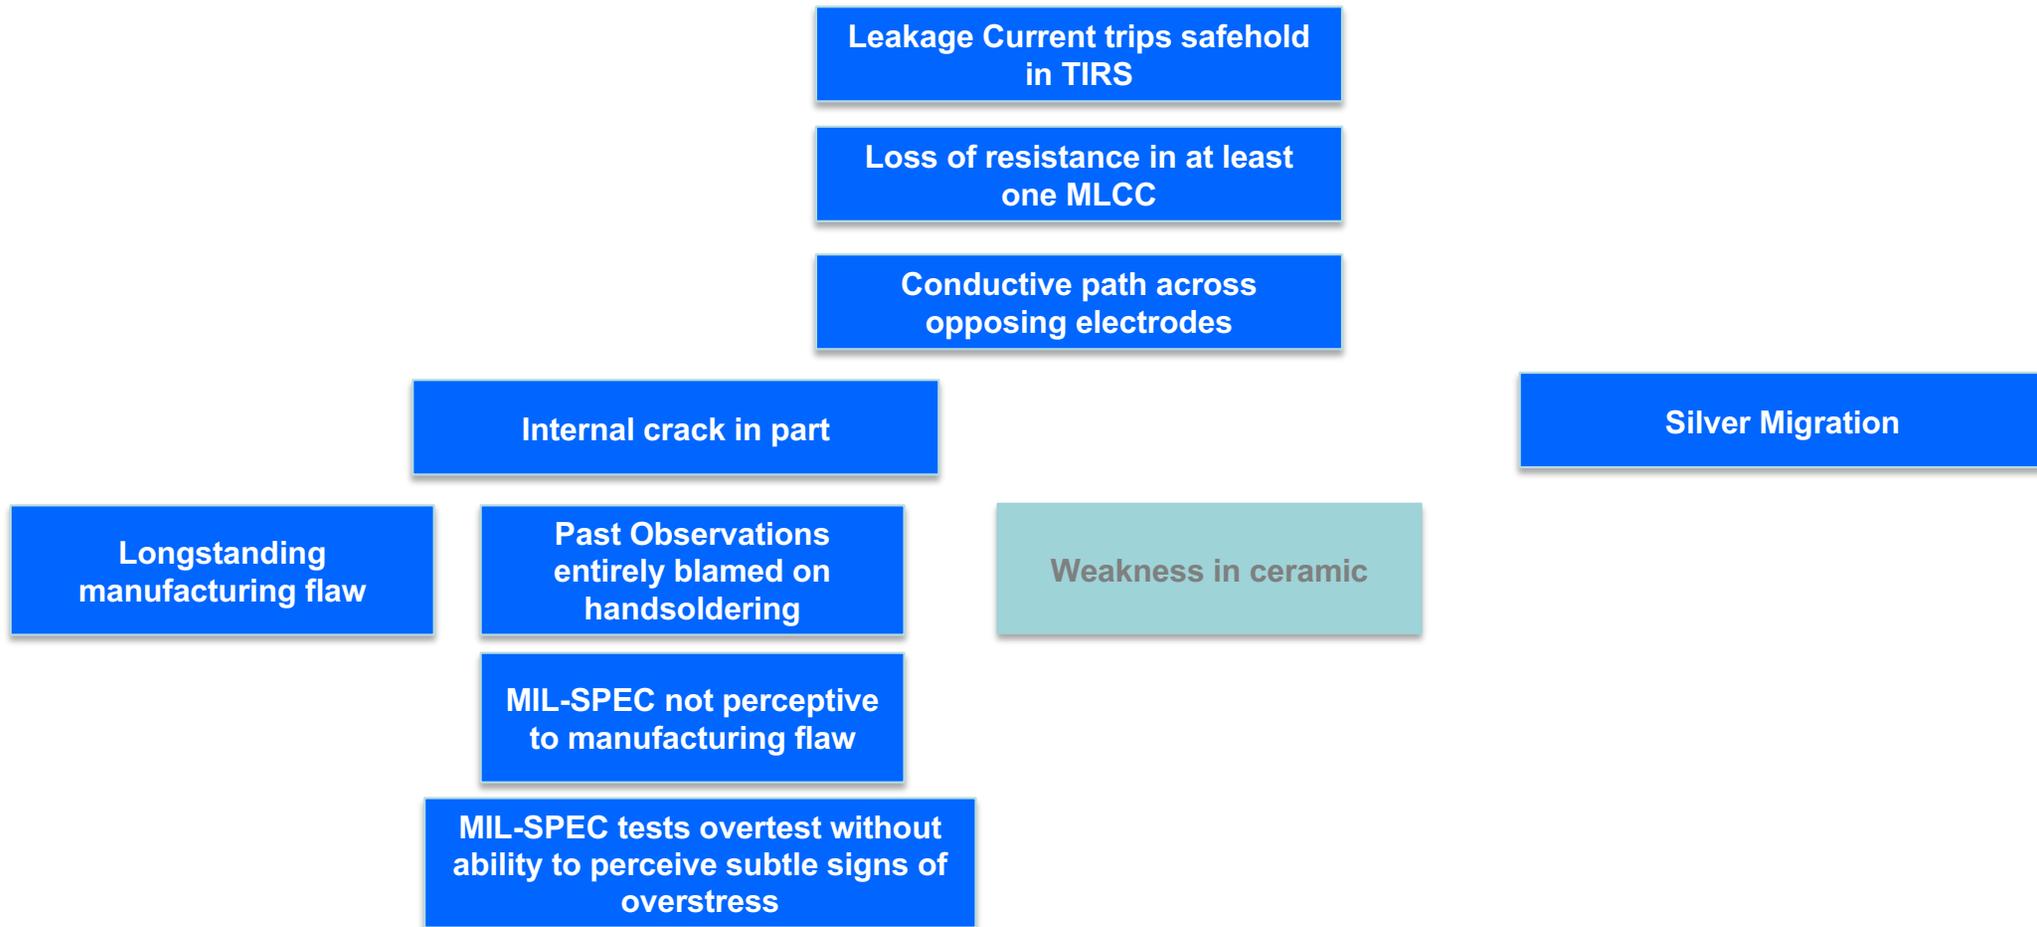
Fault Tree from alert

Root Cause 1: MIL-SPEC Level 1 Assurance is neither necessary nor sufficient to assure parts to be good for use.

Additionally, in some cases, weaker parts may be overtested without knowing overtest has caused overstress

Root Cause 2: Per standard Agency and GSFC practices, parts were tested in non-flight conditions. Testing at the piece part level did not expose the manufacturing flaw, which only appeared after installation. Piece-part testing per the MIL-SPEC was ineffective and gave a false sense of confidence.
