NASA/TP-20230012154
NESC-NPP-22-01775

Software Error Incident Categorizations in Aerospace

*Lorraine E. Prokop/NESC
Langley Research Center, Hampton, Virginia*

August 2023

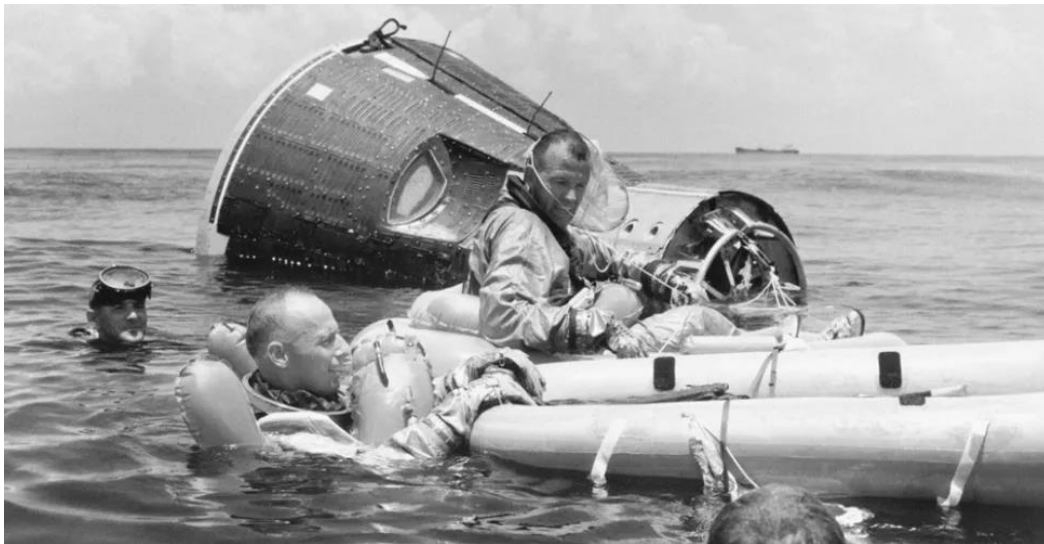
Figure 3. Gemini 5 Astronauts training for landing recovery.

- 3) Year: 1965
System: Gemini 5
Title: Data error of earth rotation lands Gemini 5 short
Result: Landed 130 km short, crew manually compensated
Description: Although the computer was operating properly, a programmer had entered the rate of the Earth's rotation as 360° per 24 hours instead of 360.98° [4, p. 262]. The crew compensated for the computing error, landing 80 miles (130 kilometers) short of the planned landing point in the Atlantic Ocean. The astronauts controlled the reentry, creating drag and lift by rotating the capsule. This is an example of erroneous data causing software misbehavior. A depiction of the crew for the Gemini 5 space flight, astronauts Charles Conrad Jr., (in water) and L. Gordon Cooper Jr. (in raft), is shown in Figure 3.

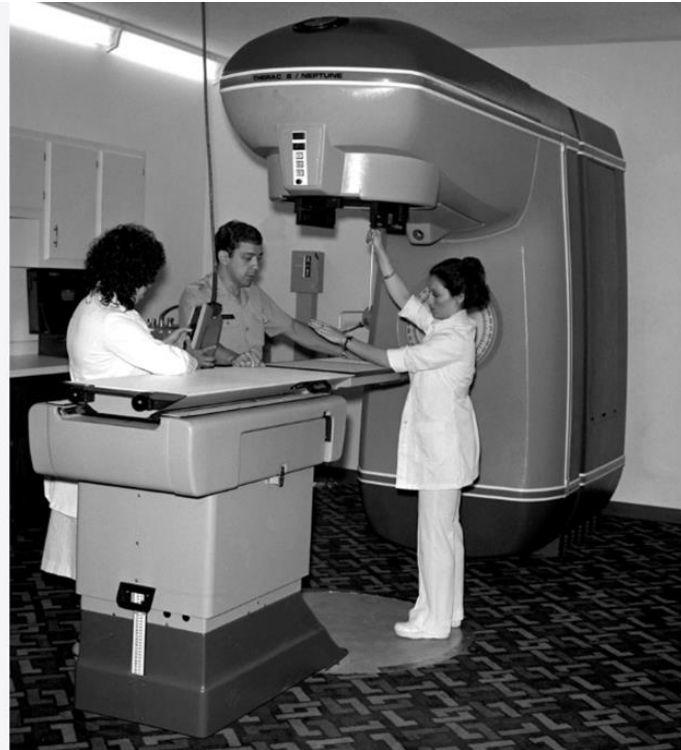
Figure 4. Therac Radiation Therapy Machine.

- 8) Year: 1985-87
System: Therac-25
Title: Radiation therapy machine output lethal doses caused by user input speed
Result: Four deaths, two chronic injured
Description: Six accidents between 1985 and 1987 provided patients with massive overdoses of radiation. Because of concurrent programming errors, it sometimes gave patients radiation doses that were hundreds of times greater than normal, resulting in death or serious injury. These accidents highlighted the dangers of software control of safety-critical systems, and they have become a standard case study in health informatics, software engineering, and computer ethics. An image of the Therac-25 is shown in Figure 4, and further documentation can be found in [10].

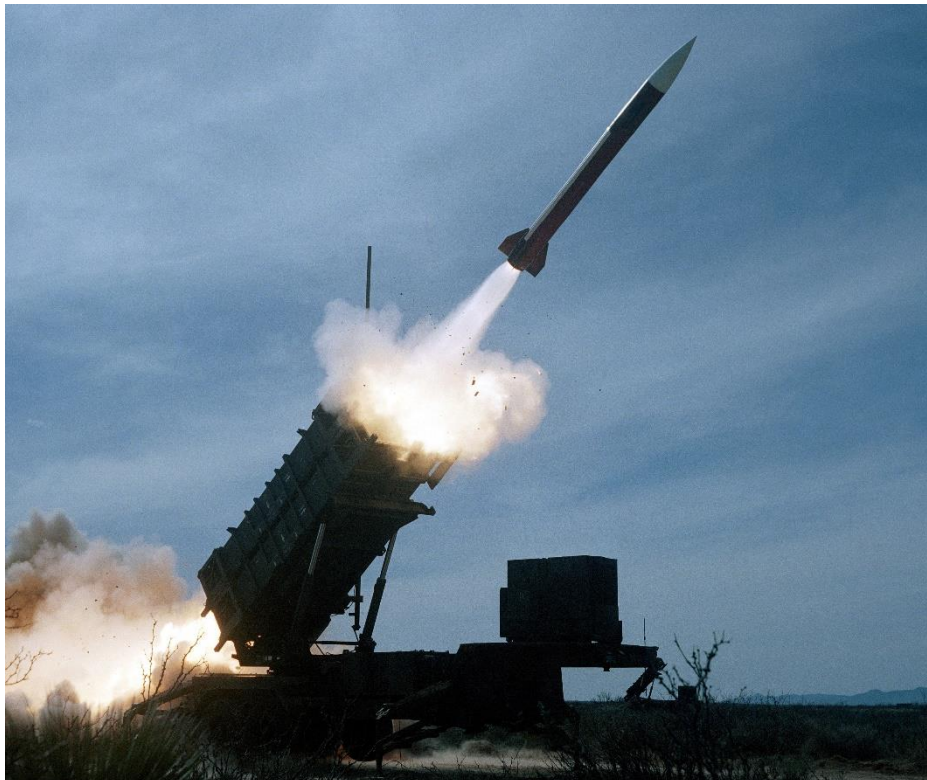
Figure 5. Patriot Missile.

- 12) Year: 1991
System: Patriot Missile
Title: Failed target intercept due to 24-bit rounding error growth over time
Result: Failed to intercept incoming scud missile, resulting in American barracks being struck, 28 soldiers killed, 100 injured
Description: A 1970s 24-bit legacy code rounding error in time conversion led to time inaccuracies in predicting incoming missile range prediction. The truncation error grew larger the longer software was run and led to loss of precision. Time was calculated since boot, and in this case, the Patriot battery had been up approximately 100 hours which resulted in a time error of about 0.34 seconds. In trying to intercept a scud moving at 1,676 meters per second, this error placed the scud outside of the Patriot’s tracking ability. An image of a patriot missile is shown in Figure 5, and further documentation can be found in [15].

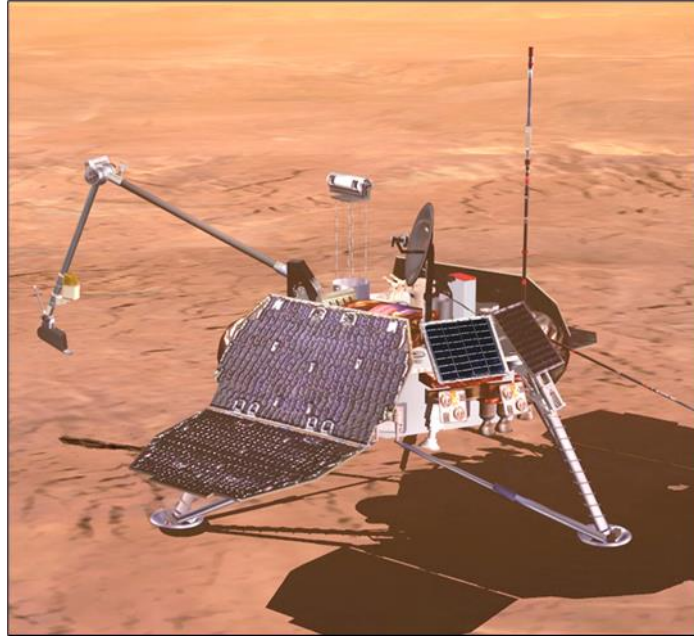
Figure 6. Mars Polar Lander.

- 20) Year: 1999
System: Mars Polar Lander
Title: Premature shut down of landing engine due to misinterpretation of landing signature
Result: Loss of Vehicle/mission
Description: A “jolt” of landing micro-switches during landing gear deployment was misinterpreted as an actual landing, and engines were prematurely shut down. The software was intended to include logic that would discount touchdown indications prior to the enabling of the touchdown sensing logic, but this code was not correctly implemented. Thus, the software accepted this spurious touchdown indication as valid. A rendition of the Mars Polar Lander is shown in Figure 6, and further information can be found in [27,28].

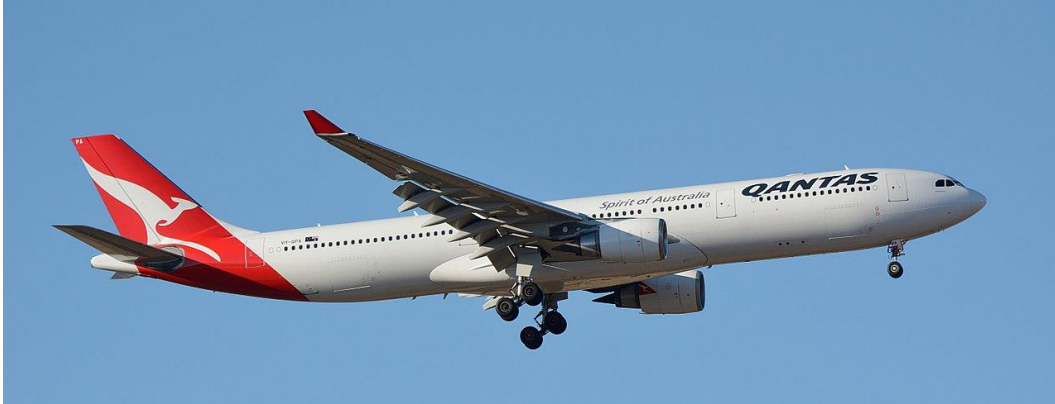
Figure 7. Qantas Flight 72.

- 34) Year: 2008
System: Qantas Flight 72, Airbus A330-303
Title: Sensor input spikes caused autopilot to pitch-down, resulting in crew and passenger injuries
Result: One crew member and 11 passengers suffered serious injuries
Description: One of the aircraft's three air data inertial reference units (ADIRU 1) exhibited a data-spike failure mode, during which it transmitted a significant amount of incorrect data to the autopilot without it being flagged invalid. The design never considered these spiked data and resulted in systems warning irregularity, including contradictory stall and overspeed warnings, and issued an uncommanded pitch down. The Australian Transport Safety Bureau (ATSB) investigation found this to be a previously unknown software design limitation of the Airbus A330's fly-by-wire flight control system software. A depiction of the stages in the flight is shown in Figure 7, and further documentation can be found in [51].

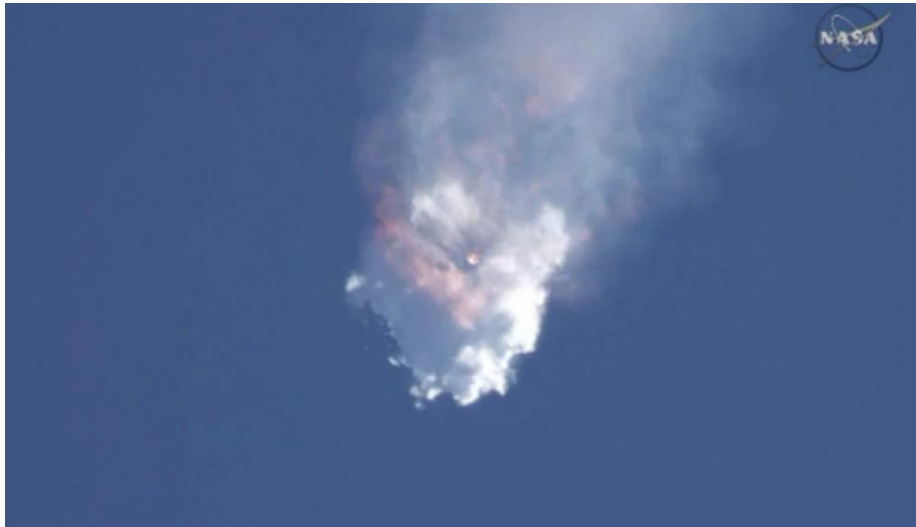
Figure 8. CRS-7 Mishap.

- 38) Year: 2015
System: SpaceX CRS-7
Title: Opening chutes unavailable after launch vehicle failure
Result: Possibly could have saved Dragon capsule from crash landing
Description: After launch vehicle failure, an attempt to save the Dragon vehicle by opening the chutes failed because software for handling this situation was absent from the program. Code to open the nose cone and command chutes to open were disallowed in the current state. Consequently, the vehicle was destroyed by a crash-landing into the ocean. The code was changed after the flight to handle this contingency situation [56]. A figure of the launch explosion is shown in Figure 8.

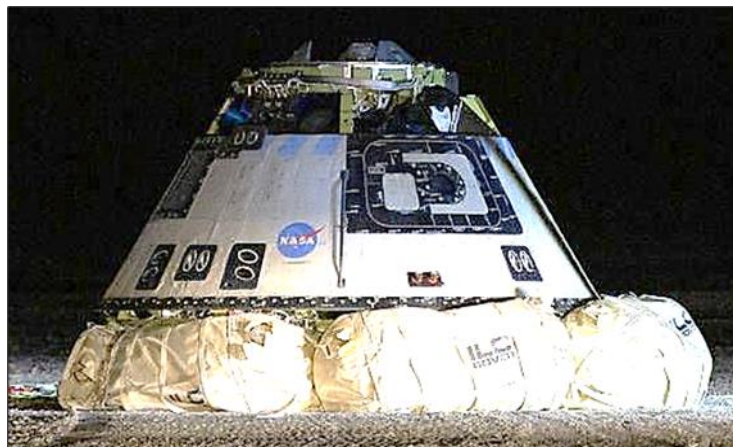
Figure 9. Boeing OFT Landing.
(Credit: NASA)

- 42) Year: 2019
System: Boeing Orbital Flight Test (OFT)
Title: Incorrect MET caused no ISS rendezvous and uncovered other latent software errors
Result: Failed ISS rendezvous, multi-year program delay
Description: An error with the Mission Elapsed Timer (MET) 31 minutes into flight, which was polled from the Atlas V booster nearly 11 hours prior to launch caused the spacecraft to burn into an incorrect orbit and use excess fuel, preventing ISS rendezvous. Investigation into the MET problem uncovered other errors which would likely have led to spacecraft loss upon return but were prevented by ground commanding enabling a safe landing (see Figure 9). NASA stated: "Breakdowns in the design and code phase inserted the original defects. Additionally, breakdowns in the test and verification phase failed to identify the defects preflight despite their detectability. While both errors could have led to risk of spacecraft loss, the actions of the NASA-Boeing team were able to correct the issues and return the Starliner spacecraft safely to Earth." Further documentation may be found in [62,63].
