NASA/TM–202300012644

A Summary of Structural Test and Simulation Results for Hawker 4000 Composite Fuselage Hardware

*Justin D. Littell, Jacob B. Putnam, and Nathaniel W. Gardner
Langley Research Center, Hampton, Virginia*

December 2023

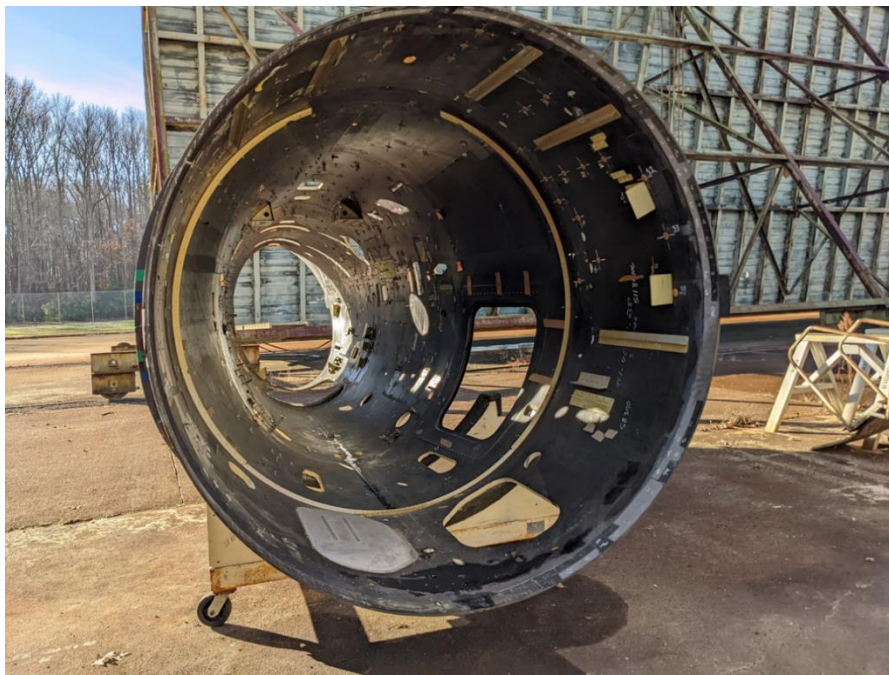
Figure 2 - Hawker 4000 interior view.

There were two large holes on the belly in the foreground of the picture are noted, along with a large square hole on the right side of the picture. There are other numerous smaller holes that are also present, which were also made at the time of manufacture.

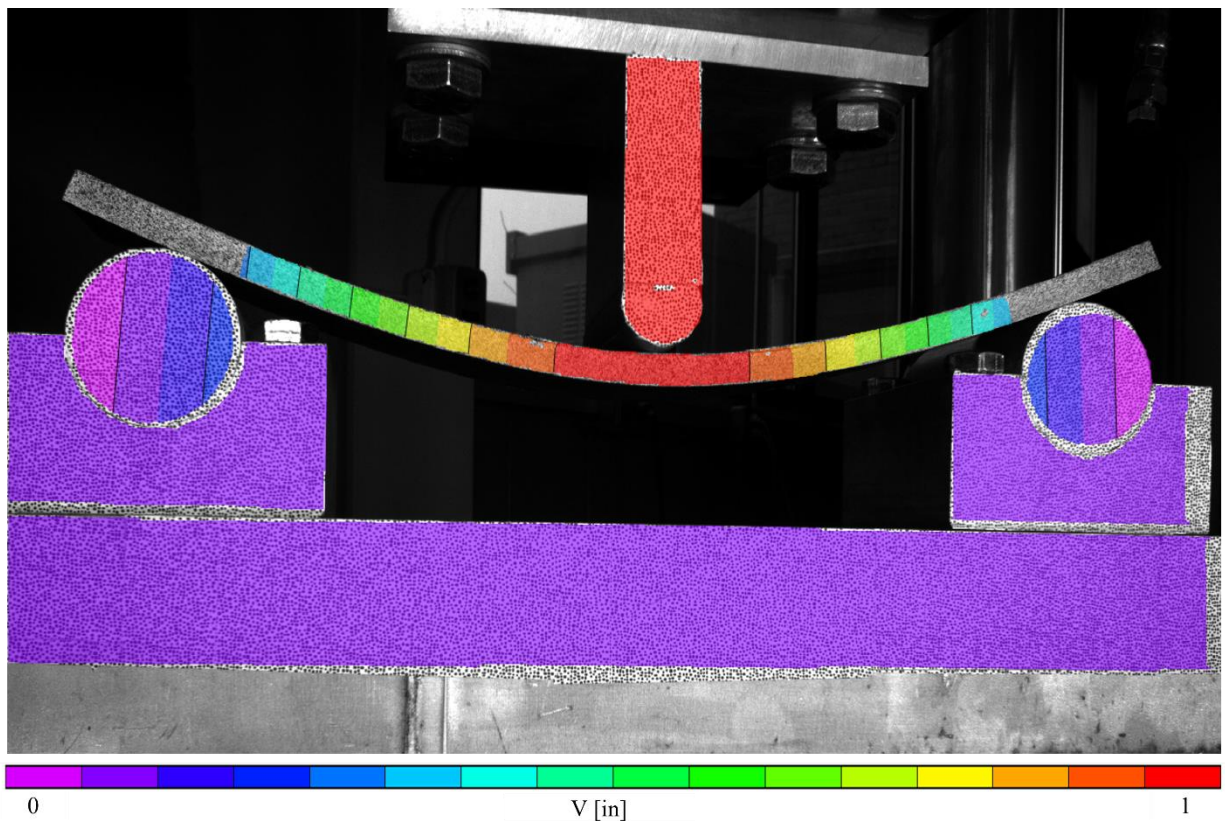
The maximum displacement contour plot just prior to the initial damage/failure and subsequent load drop observed in Figure 16 is shown in Figure 17 for Specimen 8278. The displacement in the specimen is uniform and symmetric which is denoted by an examination of the color iso-lines.

Figure 17 – Maximum displacement just prior to initial damage (Convex – 8278).

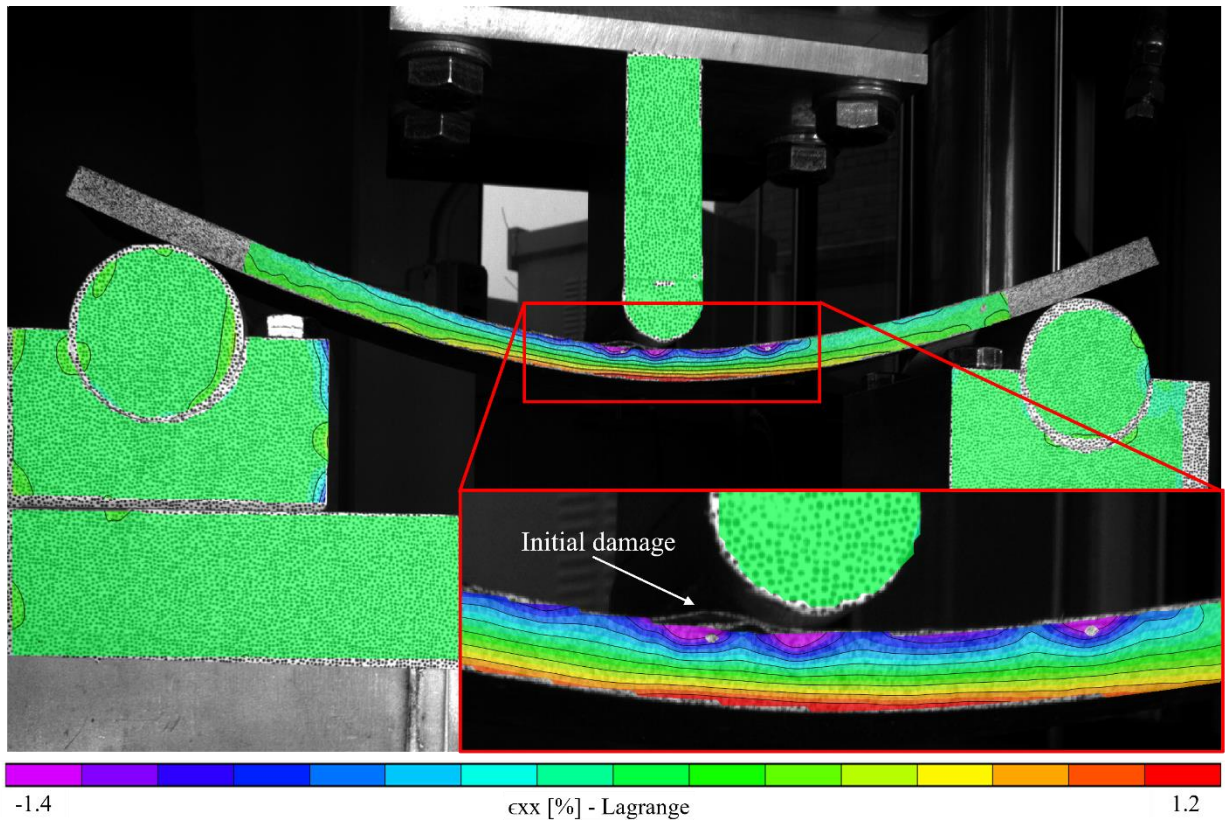
The corresponding axial bending strain, ϵ_{xx} , just prior to the load drop (initial damage) is shown in Figure 18. After the peak load, all specimens exhibited a “stair step” type of behavior where the load would stagger downward in defined steps toward zero. The strain developed in the specimen was primary on the outer edges, which was due to the bending loading condition. The initial damage appeared in the upper edge of the specimen, which exhibited compressive (negative) strain, while the lower edge exhibited tensile (positive) strain. The strain distribution was approximately equal and opposite between the upper and lower edges, with a zero-strain neutral axis in the middle.

Figure 18 – Maximum axial bending strain, ϵ_{xx} , just after initial damage (Convex – 8278).

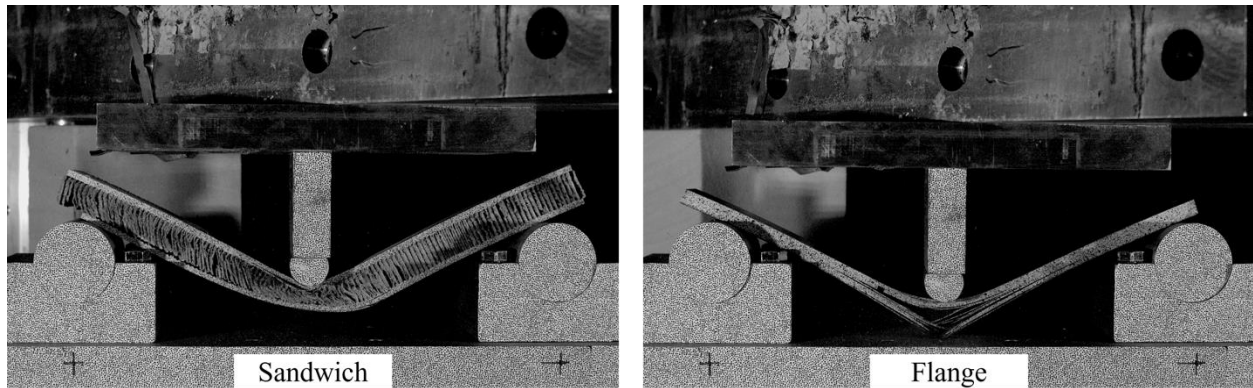
The data show the sandwich panel with unfilled honeycomb core was able to withstand a dynamic impact force of approximately 800 lb. prior to damage initiation (core crushing and/or core shear failure), while the composite flange panel was able to withstand approximately twice the impact load before damage initiation (cracking and fiber delamination) began. The damage initiation and failure observed for both types of specimens can be seen in Figure 31. For the sandwich specimen, post-peak damage continued which primarily consisted of crushing of the core at a sustained load of approximately 400 lb. The post-peak damage consisted primarily of tensile fiber failures on the bottom edge of the specimen.

Figure 31 – Damage progression and failure during dynamic three-point bend test.

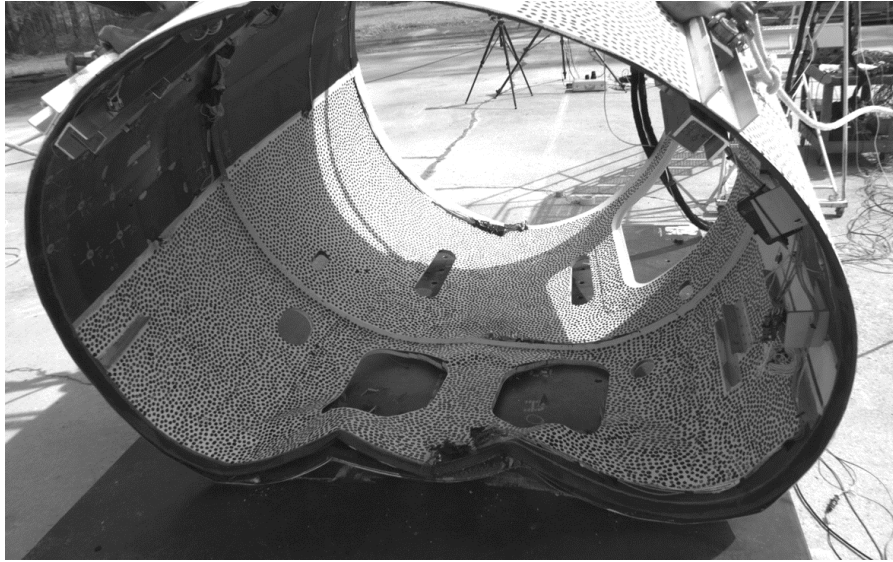
The majority of the visible damage occurred in the forward half of the test article, at points starting at the impact location and extending aft until the center ring. At the impact location, the composite exhibited complete tensile failure on either side of the impact point, indicated by the breaking of the inner fibers, protruding inward, forming a “w” shape over a significant portion of the belly forward edge. Note the accelerometer suite measuring accelerations at the forward belly locations were fastened using a through-bolt through the skin. This fastening method created an artificial restraint that restricted any potential delamination that occurred at the point of impact. Detail of the forward edge delamination is shown in Figure 47.

Figure 47. Internal view at time of maximum deflection.

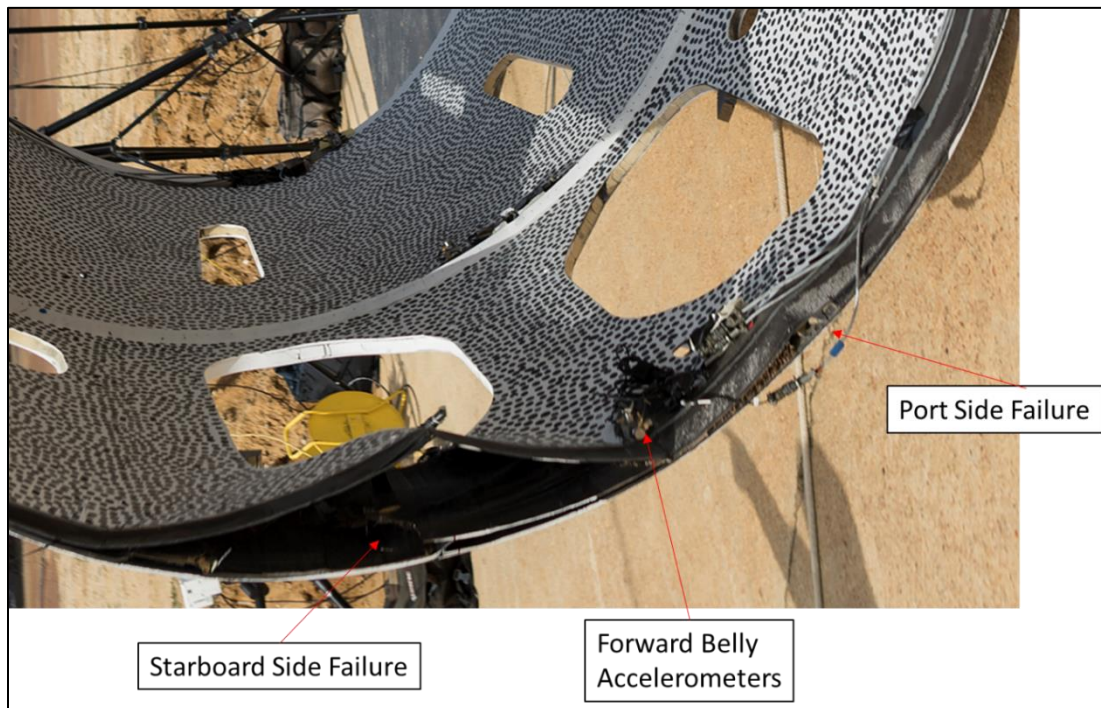
Immediately after the test article came to rest, the post-test inspections began. Other areas in the forward half of the test article also exhibited visible delamination, including many locations around the two centerline openings. The two large openings on the belly near the forward impact location exhibited the most serious extent of the damage. Much of the opening delaminated, allowing numerous pieces of the center foam to break free. These failures are shown in Figure 48.

Figure 48 - Belly skin failure at impact point.

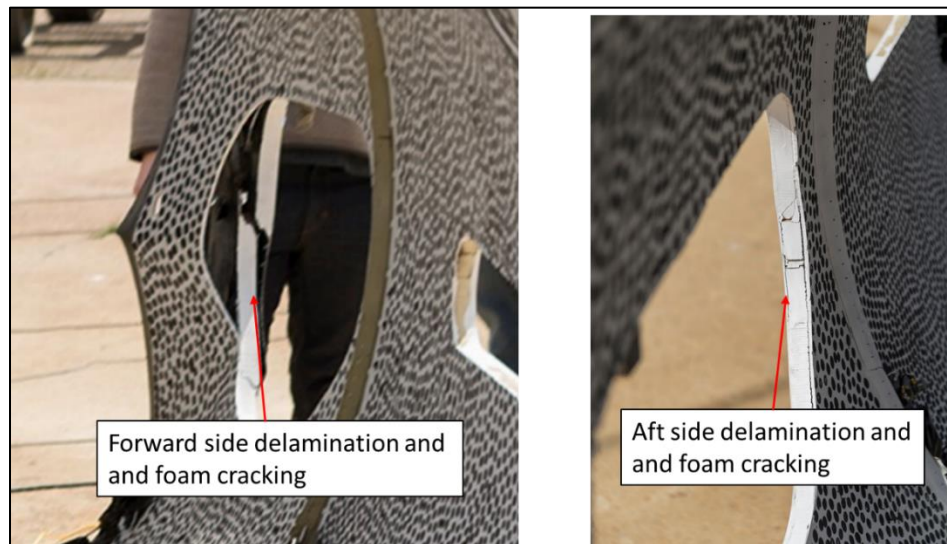
Additional delamination can be seen on the aft side of the forward holes. Around the middle stiffener area, the deformations causing the skin to protrude inward appear to have initiated. However, either due to the metallic ring stiffener being present or the lack of substantial residual kinetic energy remaining in the test article, a full inversion was not observed

Figure 49 - Starboard side belly opening. Forward view (left) and aft view (right).

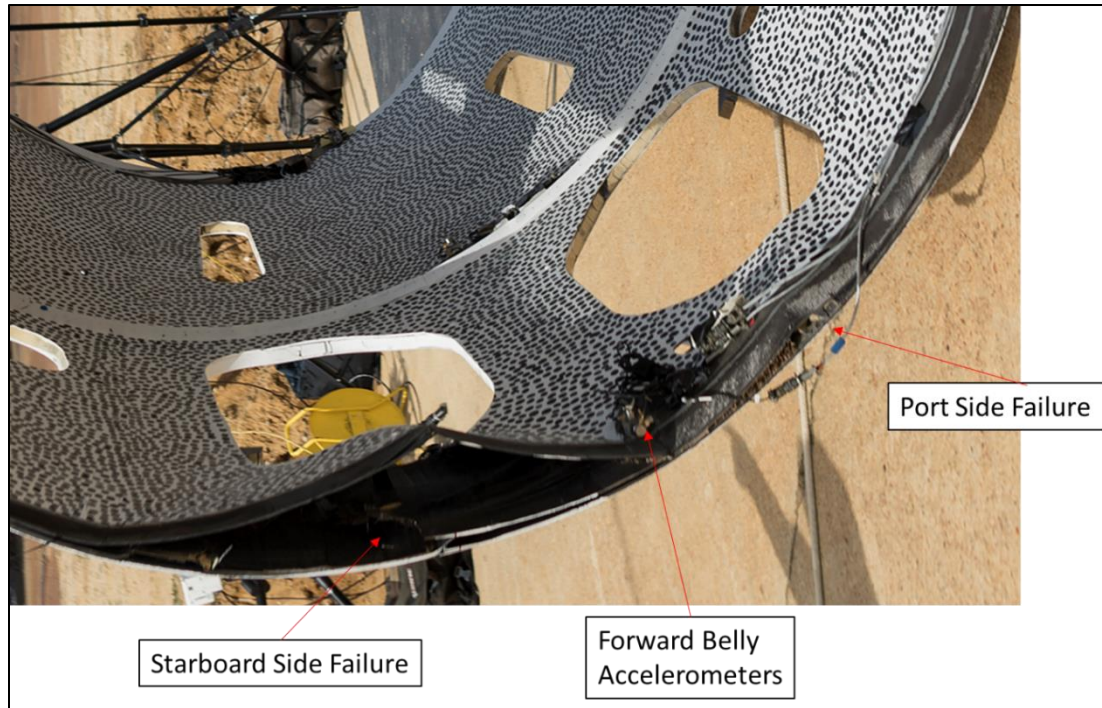
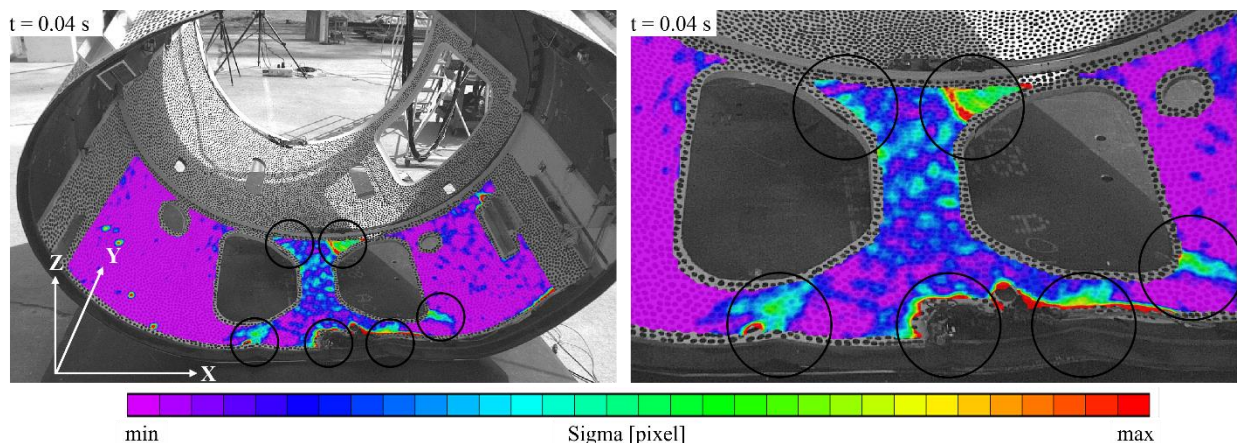
, highlights the significant amount of damage and failures located in the forward belly section, noted by the areas of green/red.

Figure 50 – Delamination and damage propagation observed in the inner mold line (IML) of belly.

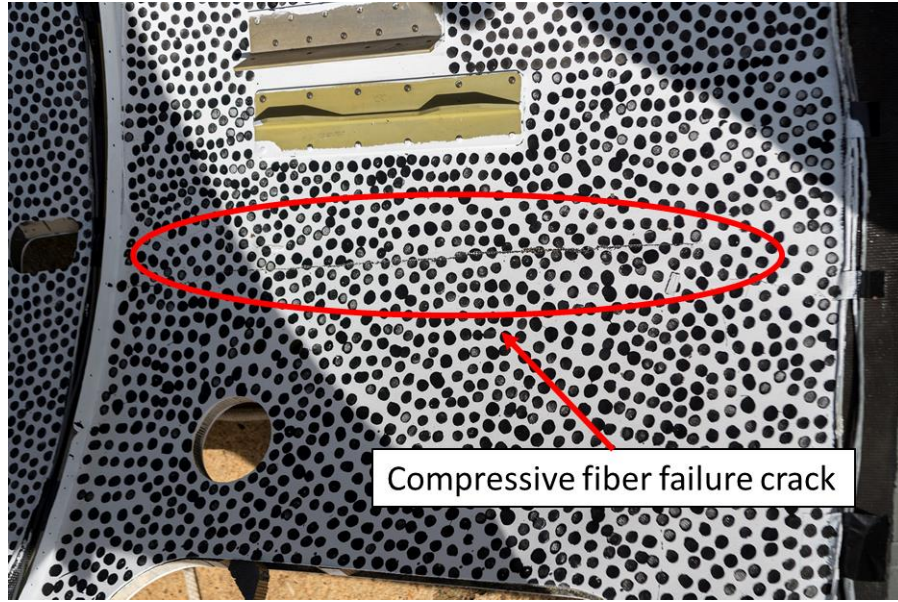
Additional compression failures occurred on the port side of the test article, approximately midway up the vertical height. These failures are visible noted by a longitudinal crack in the inner sandwich facesheet composite approximately 10-in. long halfway between the port belly opening and the mid-plane of the test article. These cracks appeared on both sides of the test article in the same approximately location. A compressive failure crack on the port side can be observed in Figure 51.

Figure 51 - Compressive fiber failure cracking (Port side).

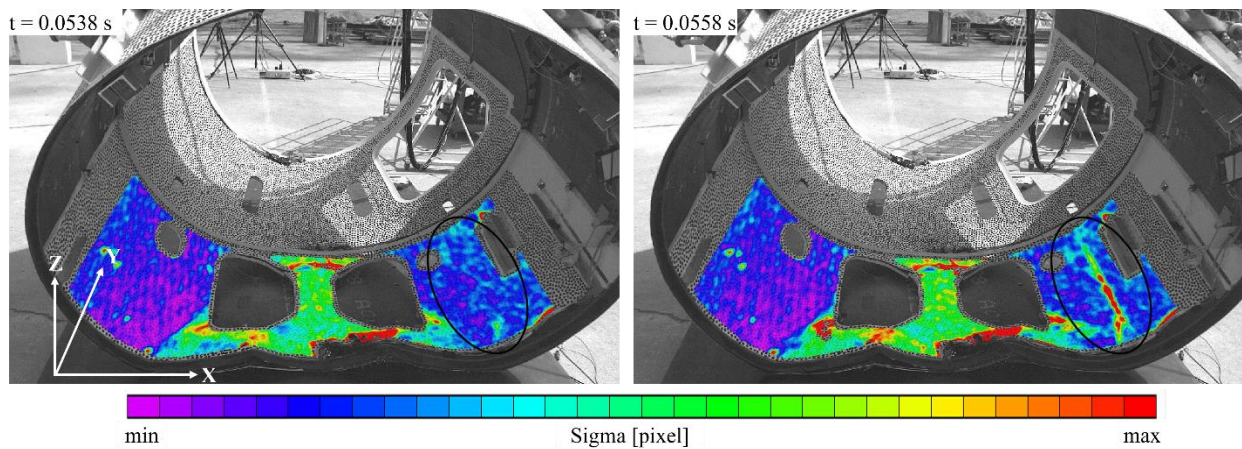
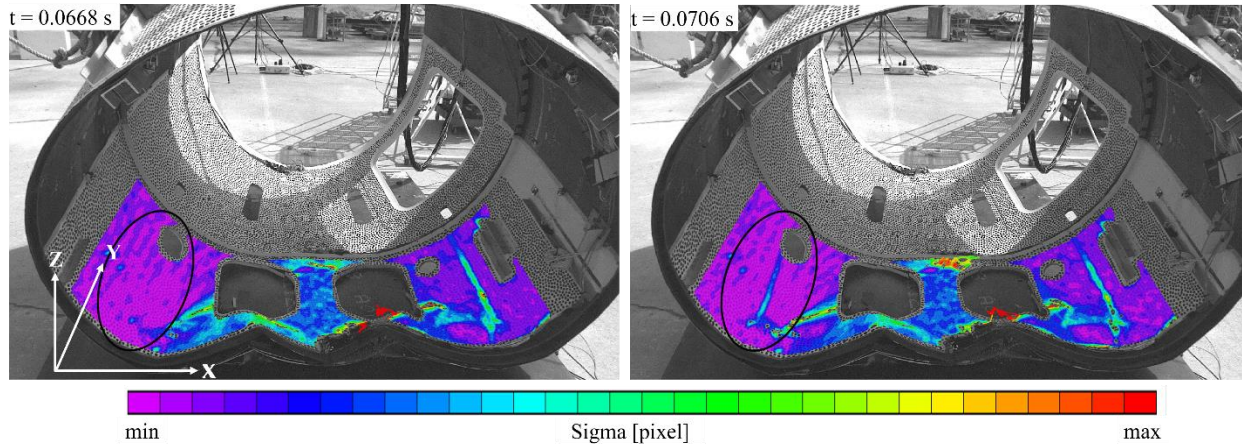
Utilizing the computed Sigma variable within the 3D-DIC software, these compression failures become more pronounced, and are easily observed, along with the time at which initiation occurred. The compressive failures on both the port side and starboard side of the belly interior using the Sigma variable, which is noted by the blue/green symmetry in the Sigma results. The time at which the compressive failures occurred is also shown, approximately 0.0538 s. and 0.0668 s. after impact for the port side and starboard side, respectively. The Sigma variable depicting the compression failures in the sidewalls are shown in Figure 52.

Figure 52 - Compressive fiber failure cracking observed in the belly post-impact. Port side (top) and starboard side (bottom).

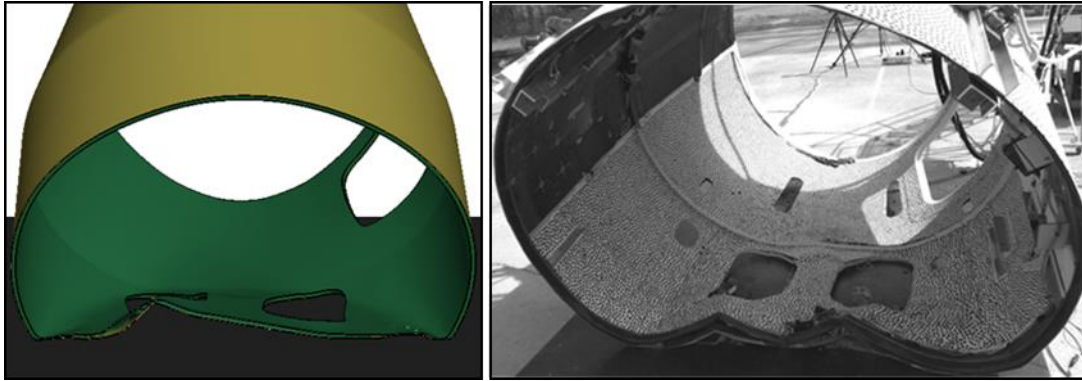
Figure 66 – Composite damage observed in Forward Section test and model prediction.

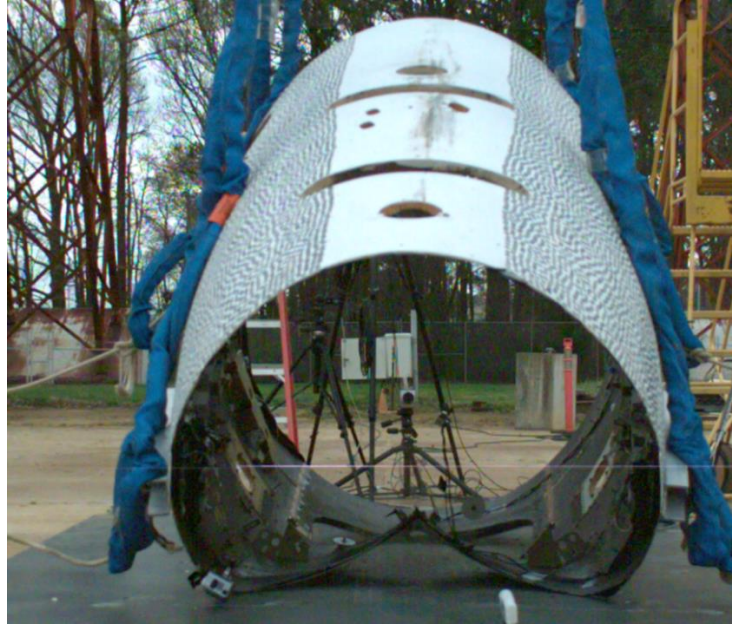
Figure 79 – Aft Section internal view showing belly failure.

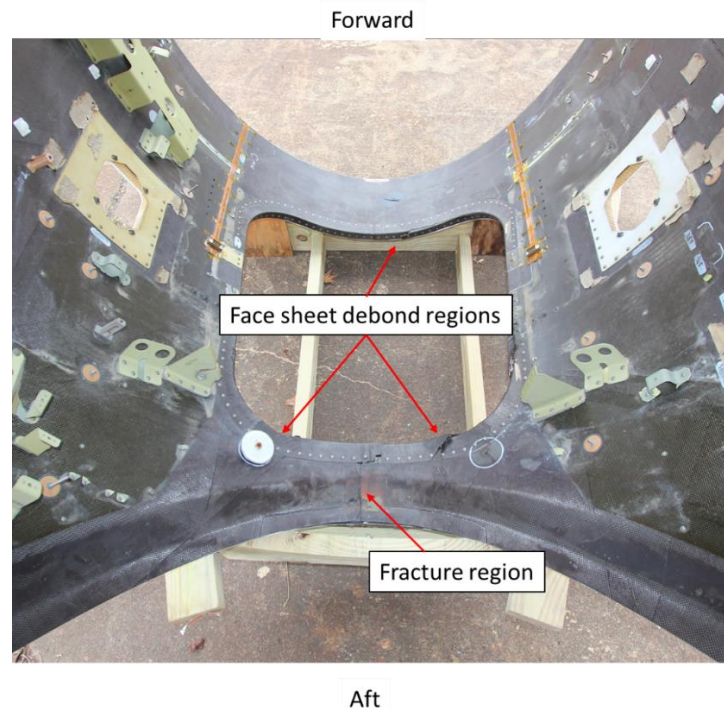
Figure 80 – Composite failures on belly.

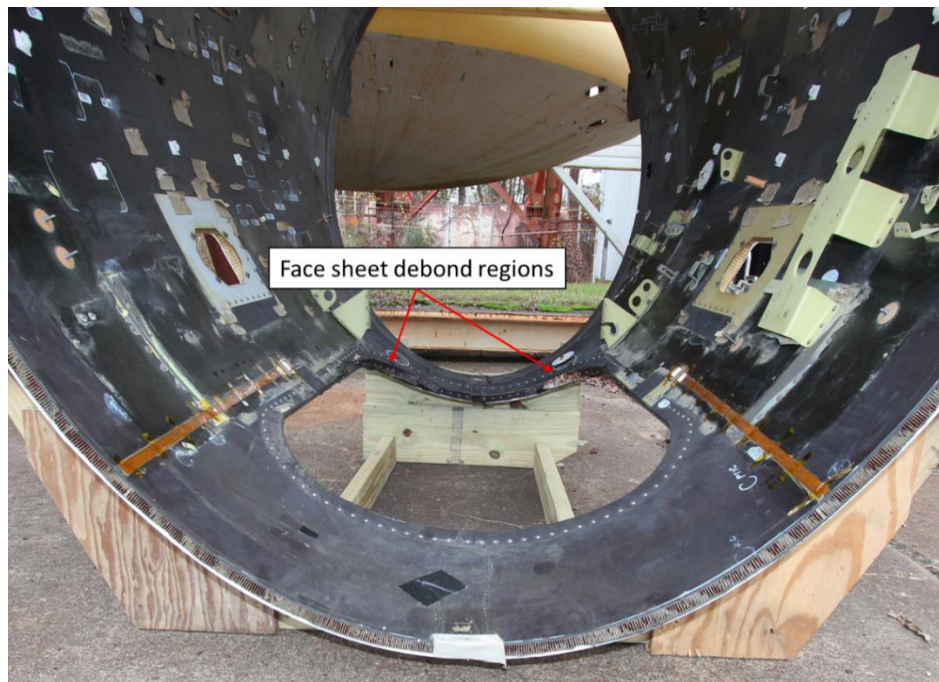
Figure 81 – Composite failures on belly. Forward viewing aft.

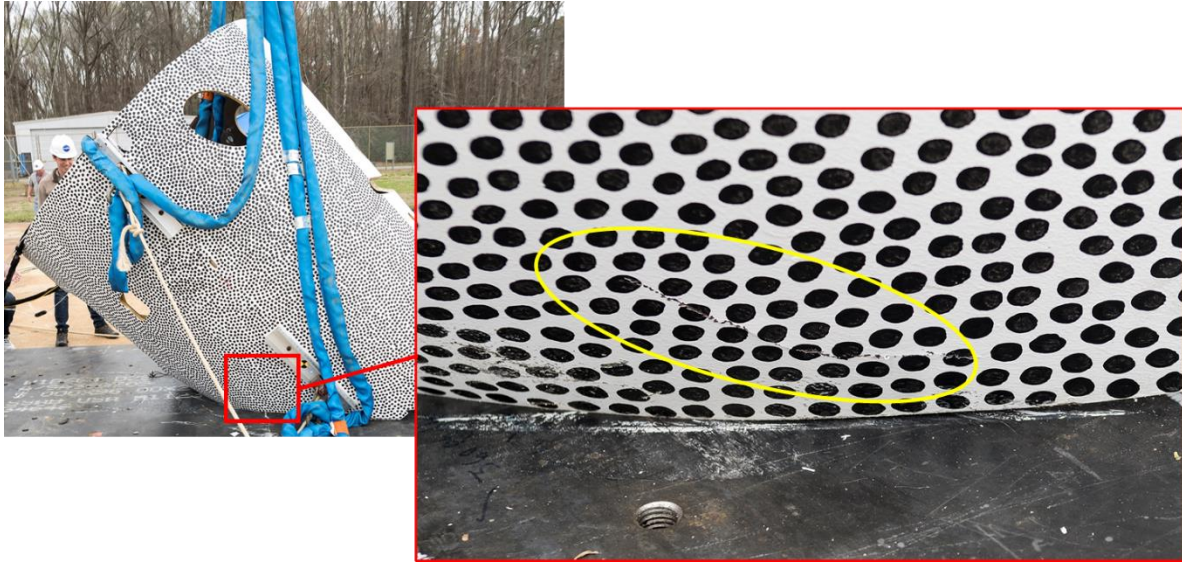
Figure 82 – Composite sandwich outer layer tensile fiber failure.

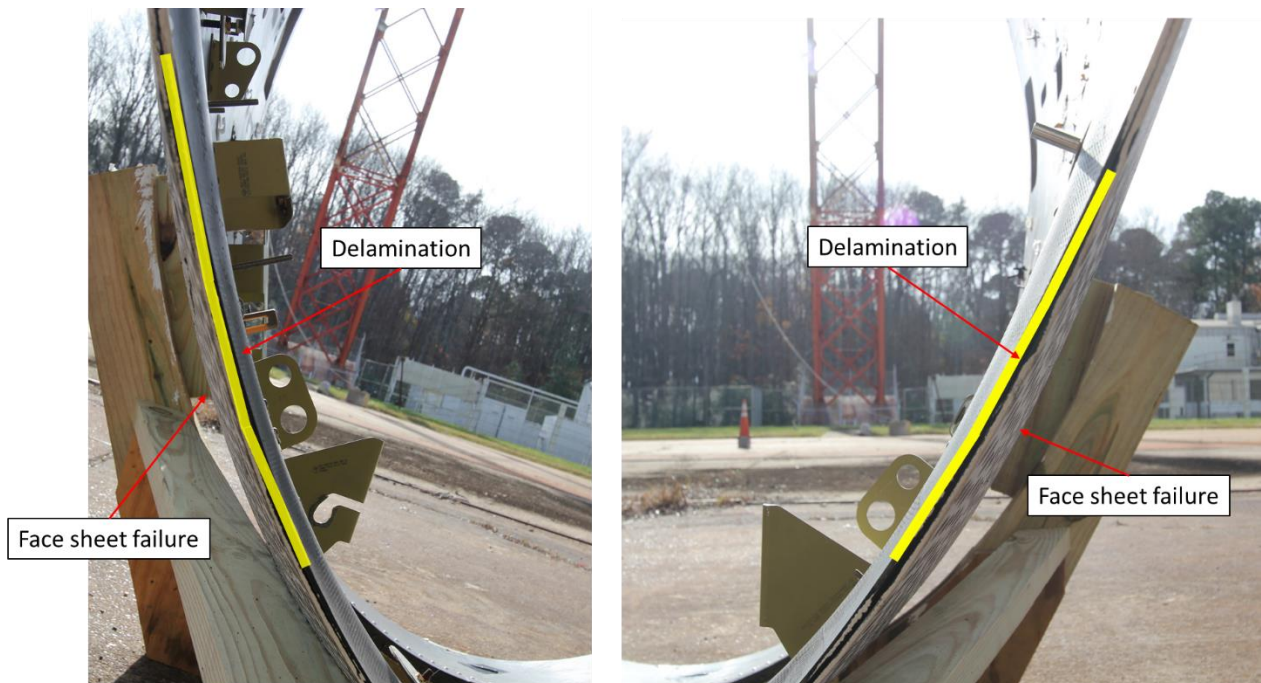
Figure 83 - Edge delamination. Port side (left) and starboard side (right).

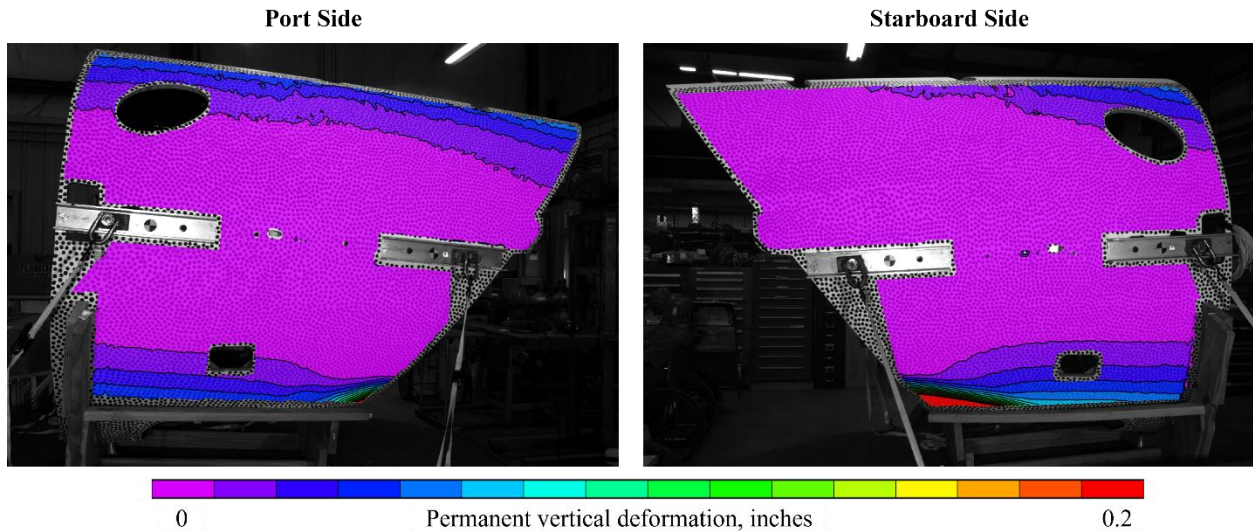
Figure 88 – Permanent vertical deformations. Port side (left) and Starboard side (right).

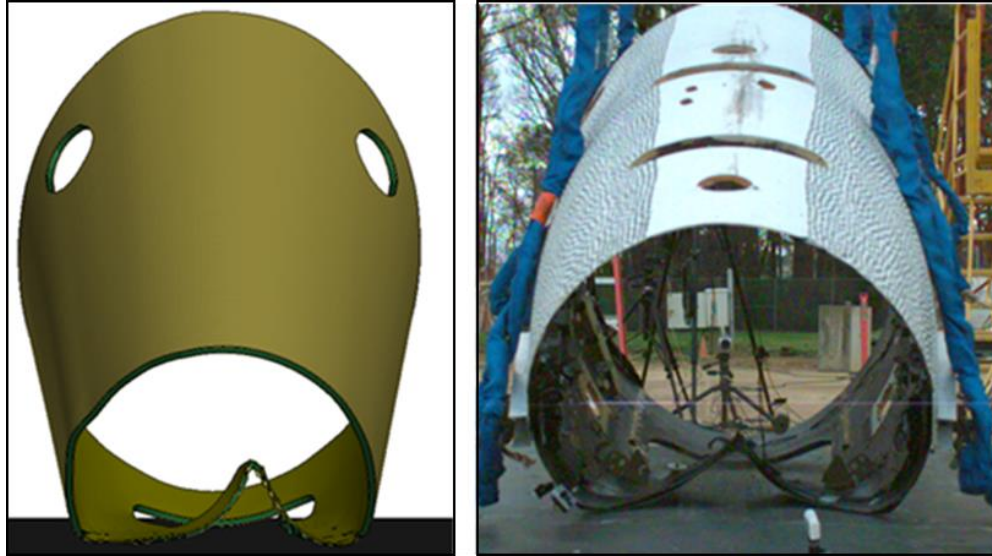
Figure 91 – Composite damage observed in Aft Section test article and predicted in Aft Section FE model.
