SpaceX Dragon Spacecraft Post Flight MMOD Inspection Campaign

Abstract

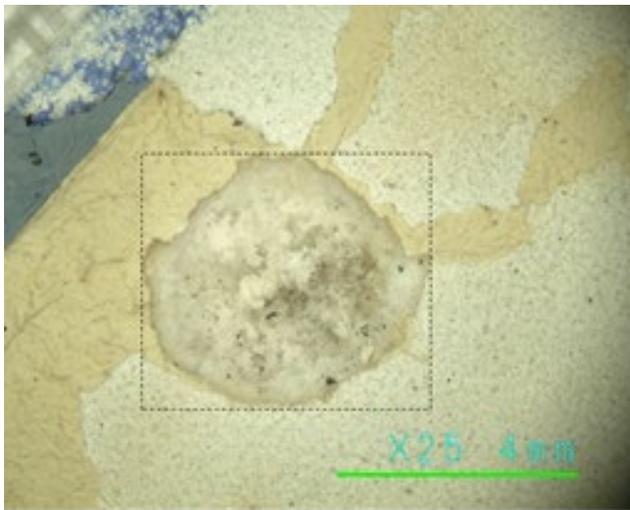
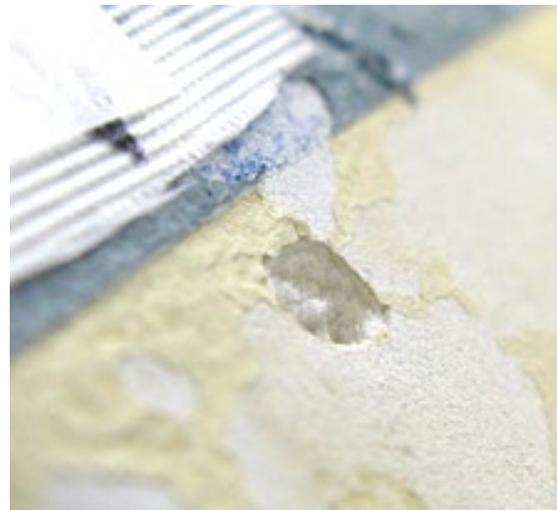
Fig. 5 provides two views of the 4.79 x 4.26 mm damage site observed in the SPAM TPS of the Dragon 1 spacecraft used for the CRS-13 mission. The image on the left is a perpendicular view of the feature with the light source positioned directly above. The image on the right was acquired with a different instrument positioned at angle to the spacecraft surface using ambient room light. This oblique view provides insight into the asymmetric nature of the crater shape, which had a measured depth of 1.38 mm. The SEM/EDX results of iron, nickel and chromium indicate that a high-density (steel) orbital debris projectile produced this damage feature.

Figure 5A: CRS-13 impact feature #14 in SPAM
(perpendicular view)

Figure 5B: CRS-13 impact feature #14 in SPAM
(oblique view)

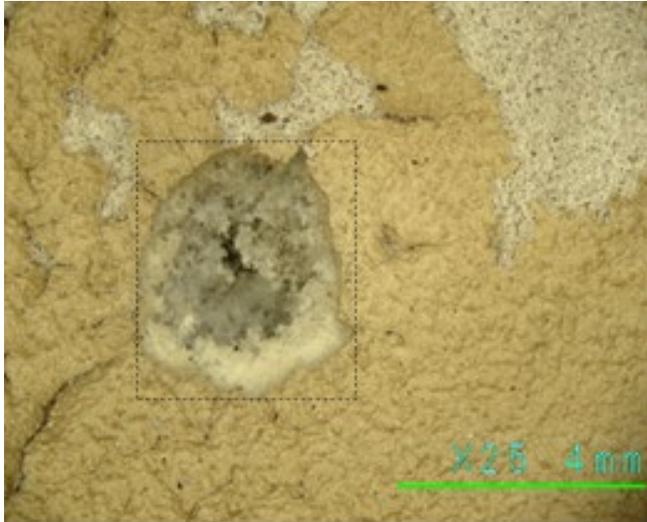
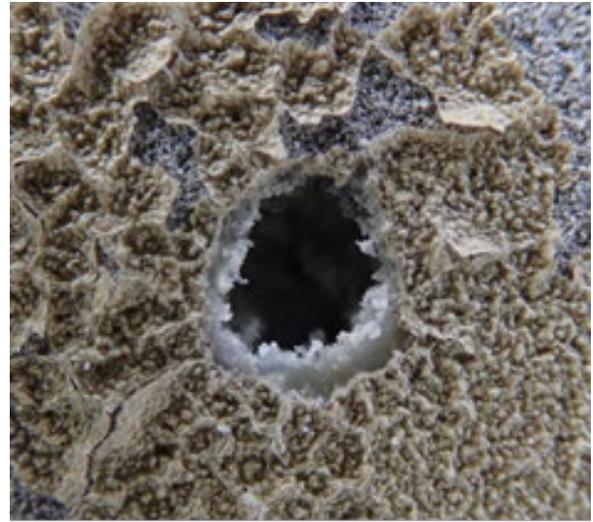
Figure 6A: CRS-15 impact feature #3 in SPAM
(perpendicular view)

Figure 6B: CRS-13 impact feature #3 in SPAM
(perpendicular view, wide-ring light source)

Fig. 6 provides two views of another SPAM impact feature with entry hole dimensions of 4.15 x 3.51 mm and a depth of 2.17 mm observed on the CRS-15 Dragon 1 spacecraft. The image on the left is a perpendicular view of the feature with the light source positioned directly above. The image on the right was acquired at the same orientation but used a different light source. The SEM/EDX results of sulphur, iron and nickel indicate that a high-density meteoroid projectile produced this damage feature.
