NOAA-17 Breakup Engineering Investigation

Scott Hull ¹, Tupper Hyde ¹, and J.-C. Liou ²

Abstract

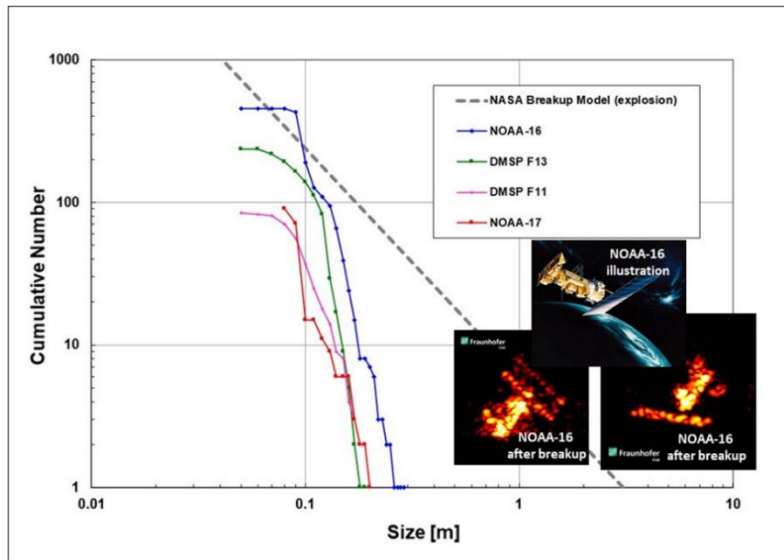
The physical size of a tracked fragmentation debris can be estimated from its Radar Cross Section (RCS), based on the NASA radar Size Estimation Model (SEM). Figure 2 shows the cumulative size distributions of fragments from the four breakups. Most of the fragments are between approximately 8 and 20 cm in size. The four fragment clouds have similar distributions. The gray dashed line is the power-law fragment size distribution predicted by the NASA Standard Satellite Breakup Model for the full explosion of a spacecraft, which is very different from the breakup size distributions. The cumulative size distributions seem to suggest that those fragments were generated from similar “localized, component-level” breakups. The spacecraft remained mostly intact after the localized breakups. This is consistent with radar images provided by the German Fraunhofer Society to NOAA after the breakup of NOAA-16. Although 458 fragments were detected and tracked by the SSN after the breakup of NOAA-16, the radar images show the spacecraft remained mostly intact afterward.

Fig. 2: Cumulative size distributions of the Big Four event fragments. The gray dashed line is the NASA Standard Satellite Breakup Model for a full explosion of a spacecraft. German Fraunhofer Society provided the radar images of NOAA-16.

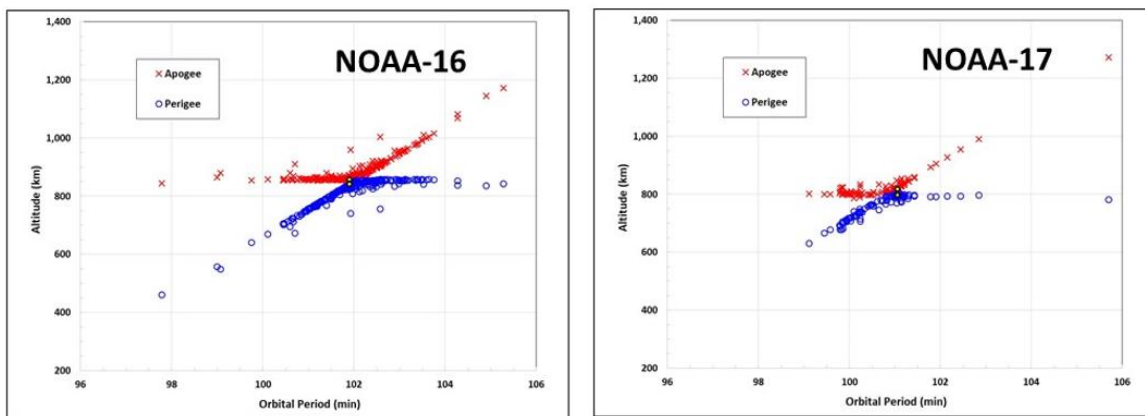
A Gabbard diagram provides useful information on evolution of a fragment cloud. The diagram simply plots apogee altitudes and perigee altitudes of fragments against orbital periods at a given epoch. Figure 3 shows the Gabbard diagrams for NOAA-16 and 17 three months after breakup. The spread along the cross pattern is an indication of the velocities of the fragments (relative to the parent object).

The similarity suggests that the nature and the intensity of the breakups were similar. The diagrams for DMSP F11 and F13 also appear very similar.

Fig. 3: Gabbard diagrams of the fragment clouds of NOAA-16 and 17 about 3 months after the breakups.

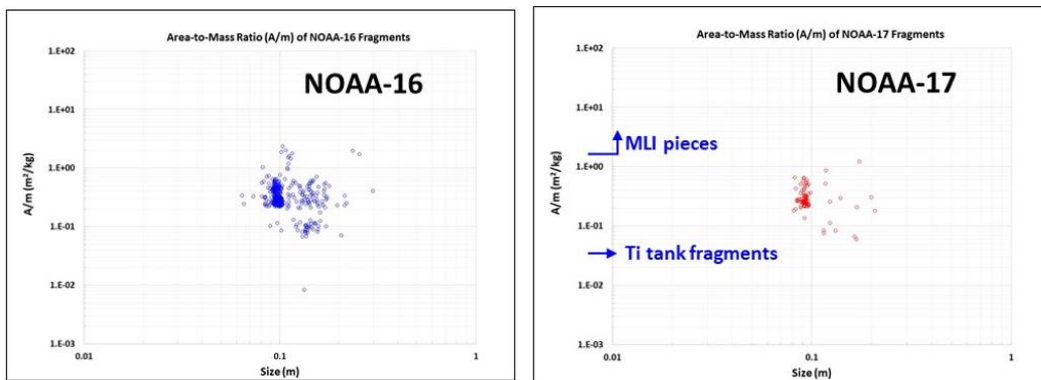
One can analyze the orbital history of a fragment to examine how its orbit was affected by the atmospheric drag to estimate its effective area-to-mass ratio (AMR). Figure 4 shows the AMR distributions from NOAA-16 and 17. For NOAA-16, there are two obvious concentrations between 0.2 and 0.3 m^2/kg . There is a secondary concentration at about 0.4 to 0.6 m^2/kg . Similarly, NOAA-17 fragments share comparable concentrations. The histogram in Fig. 5 is another way to see the concentrations where all four fragment clouds have the same peak at 0.2-to-0.3 m^2/kg . For perspective, most intact spacecraft have an AMR near 0.01 m^2/kg .

Fig. 4: AMR distributions of the fragment clouds for NOAA-16 and 17.

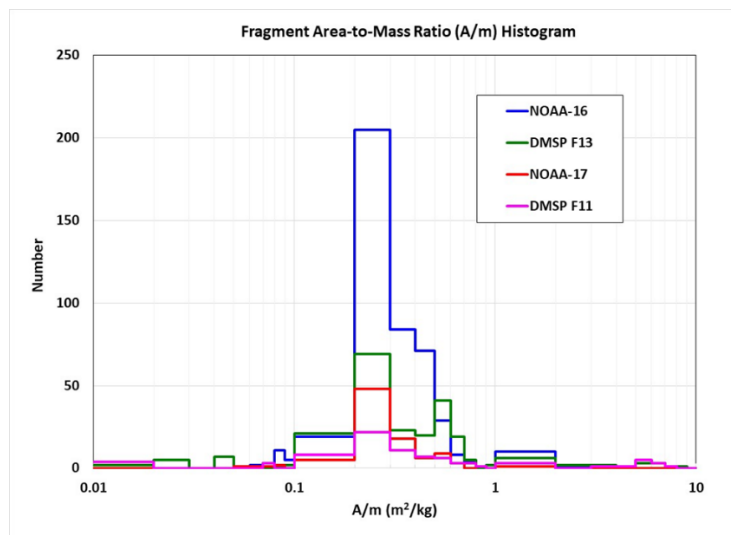
An AMR below $0.1 \text{ m}^2/\text{kg}$ is typically an indication of metallic fragments. For example, using the NOAA-17 propulsion tank specifications, including the titanium material property and the thickness of the tank wall, one can calculate the AMR of titanium tank fragments would be about $0.03 \text{ m}^2/\text{kg}$, as indicated by the blue arrow on the NOAA-17 plot. Clearly, most fragments from the four breakups are not consistent with propulsion tank pieces. Fragments with AMRs significantly higher than about $1 \text{ m}^2/\text{kg}$ are likely to be thermal blanket pieces. Fragments with AMRs between 0.1 and $1 \text{ m}^2/\text{kg}$ are not as heavy as metallic pieces and not as light as thermal blanket pieces. They are similar in nature to lightweight composite materials. The two AMR concentrations observed suggest that fragments from the four events share similar physical properties and that they belong to two distinct material types.

Although the quantities of the tracked fragments from NOAA-16 and NOAA-17 differ by close to a factor of five, the concentrations of the fragments line up very well in size, between 9 and 10 cm. This is another indication that fragments from the two breakups are similar in size and material type. It is likely that they were generated in a similar manner from the same component(s).

Fig. 5: AMR distribution histogram. All four fragment clouds share the same peak at 0.2-to-0.3 m^2/kg .

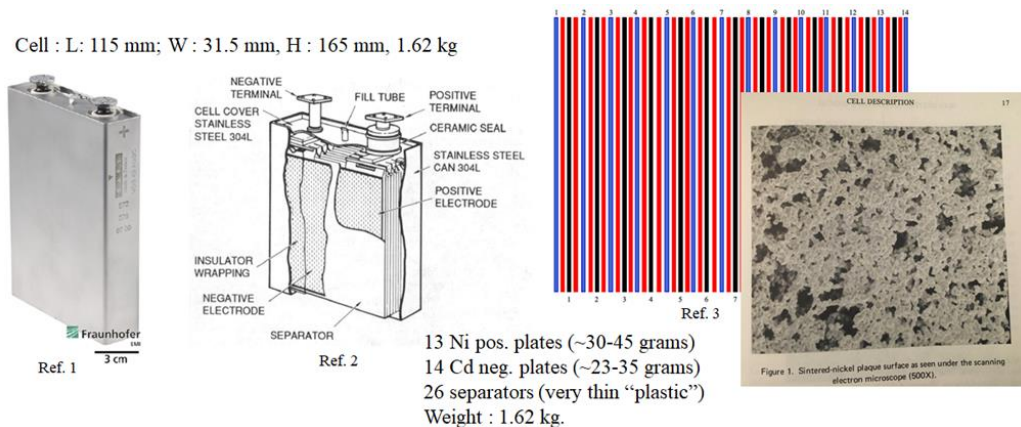
The sealed SAFT battery cell construction consists of 13 nickel electrode plates (~30-45 grams each); 14 cadmium electrode plates (~23-25 grams each); and 26 thin “plastic” separators used to electrically isolate the plates. During manufacturing, cells are filled with potassium hydroxide . The terminal seals are ceramic-to-metal compression type seals. The 304 stainless steel cell case is electrically neutral. The cell was qualified as a leak-before-burst design, but it is thought that rapid overcharging could increase cell internal pressure rapidly which may cause a cell to eventually burst. The positive and negative electrodes are very thin metal with a very porous metal salt that is baked onto the surface. The porous surface on a very thin metallic substrate also puts the potential AMR of scattered plates closer to debris measurements of AMR. Other SAFT battery cell details can be seen in Fig. 6. Note that there are 27 plates per battery, so that rupture of an entire four cell row could release approximately the same quantity of cells as the number of observed debris objects.

Fig. 6: SAFT 40Ah Ni-Cd cell construction details.

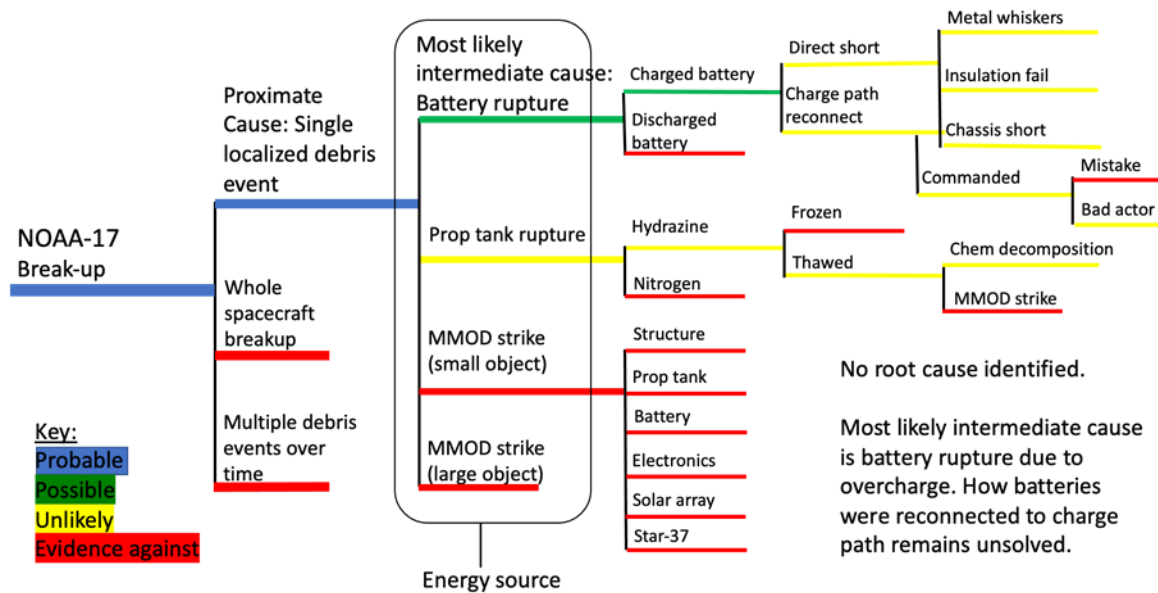
Throughout the investigation, the fault tree of possible causes for the breakup was colored in as more was learned. The proximate cause for the breakup is a single, localized debris event; there is evidence against a whole spacecraft breakup and no additional debris events. The most likely intermediate cause is the rupture of a battery pack, as shown in Fig. 7. There was no root cause found as the decommissioning telemetry clearly showed the batteries were disconnected from the charge path as intended. Several short circuit or sneak path modes of reconnecting solar array current to at least one battery were investigated and none found to have any evidence to support. So it remains a mystery how a battery could become overcharged after being disconnected. Tank rupture remains on the unlikely list since it could not be exonerated with evidence but the debris generated is not consistent with other known tank ruptures.

Fig. 7: The likely cause fault tree has been colored in based on the results of the investigation.

1. Implement auto-decommissioning software on all remaining operational related spacecraft.
2. At decommission, leave all battery discharge paths connected.
3. Seek tumble rate information for the whole fleet on a periodic basis to better inform investigations of subsequent breakups.
4. Consider further investigation to find root cause of NOAA-16, 17 breakups.
5. For future designs, ensure passivation includes energy generation as well as storage.
6. Consider active debris removal (ADR), consistent with US & NOAA/NASA policies
