Orion Artemis I As Flown MMOD Analysis

2nd International Orbital Debris Conference

Kevin D. Deighton | Jacobs CLG
JSC-XI5 (JETS II) Hypervelocity Impact Technology (HVIT) Team

Post-Flight Inspection

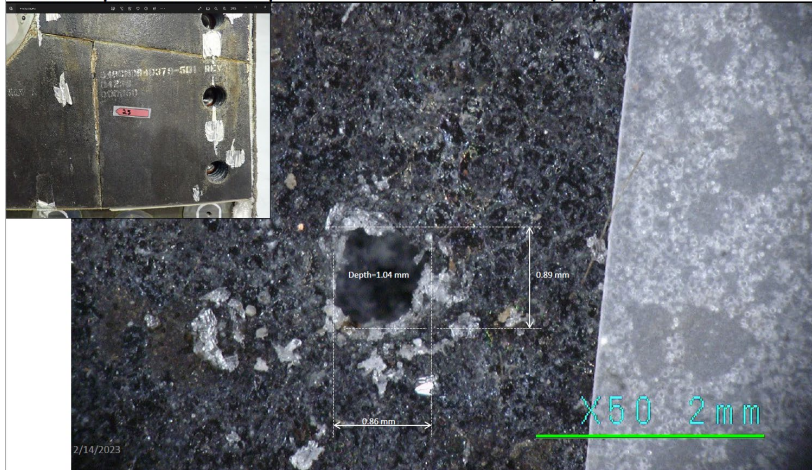
Artemis I | ROI #25 Panel D | Feature Size = 0.89 x 0.86 mm, Depth = 1.04 mm

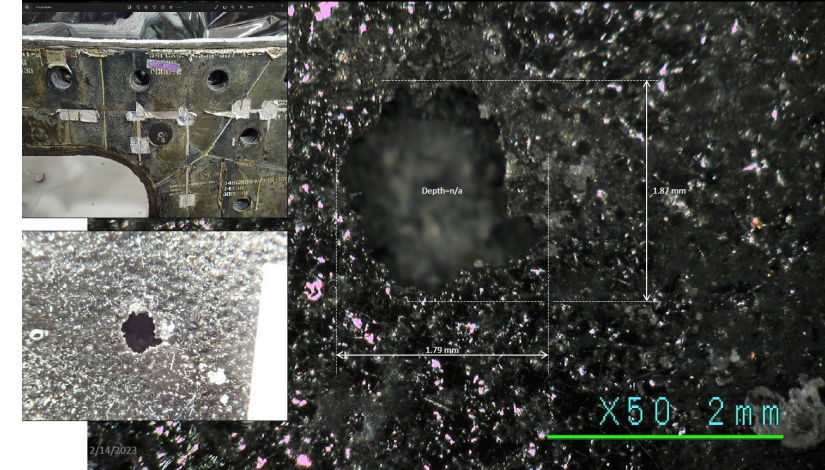
Artemis I | ROI #29 Panel D | Feature Size = 1.87 x 1.79 mm, Depth = n/a

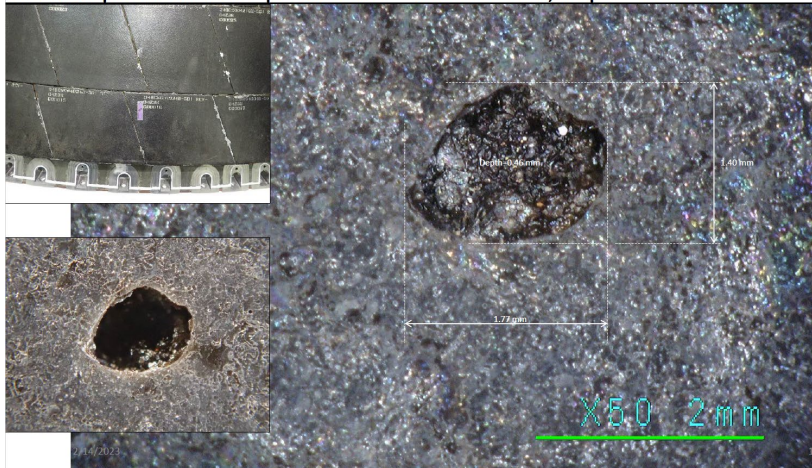
Artemis I | ROI #34 Panel C | Feature Size = 1.40 x 1.77 mm, Depth = 0.46 mm

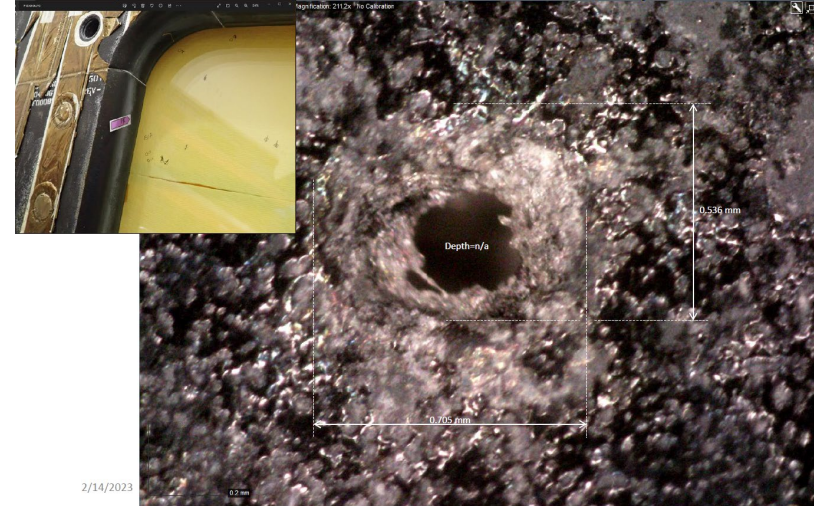
Artemis I | ROI #14 Panel F | Feature Size = 0.71 x 0.54 mm, Depth = n/a

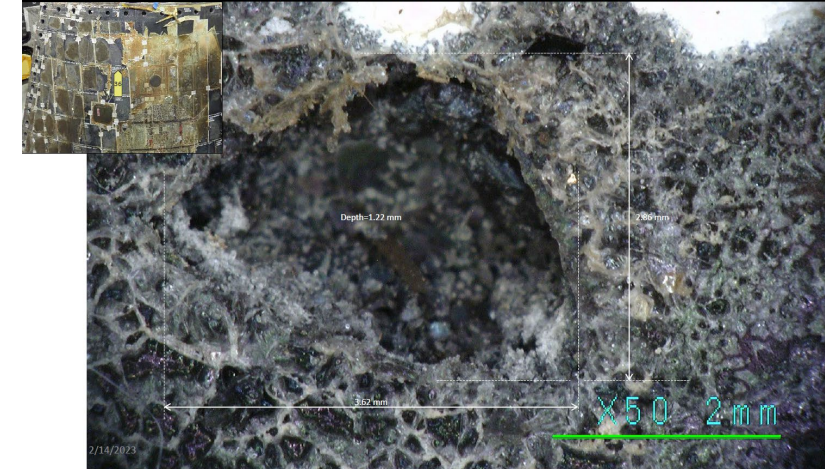
Artemis I | ROI #36 Panel I | Feature Size = 2.86 x 3.62 mm, Depth = 1.22 mm

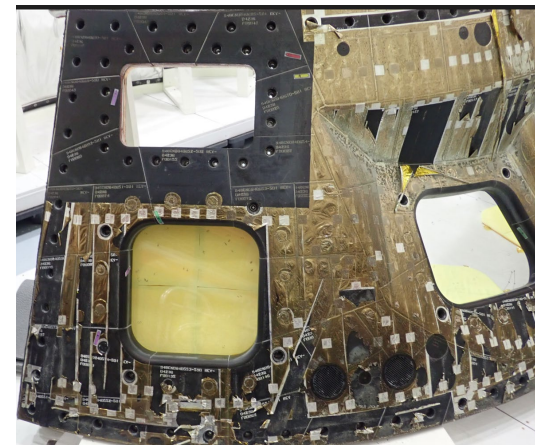
Panel F

- Reflective tape was applied to the thermal tiles to achieve various desired properties for the flight
- Most of the tape burned off during reentry
- Some tape remained, especially on Panel F, where the main windows are located
 - Scattered small squares of tape remained across the whole capsule (shown on Panel E)
- A Bumper analysis was performed to calculate the number of tape damages expected to be caused by MMOD
 - Analysis included adjustment for how much tape remained

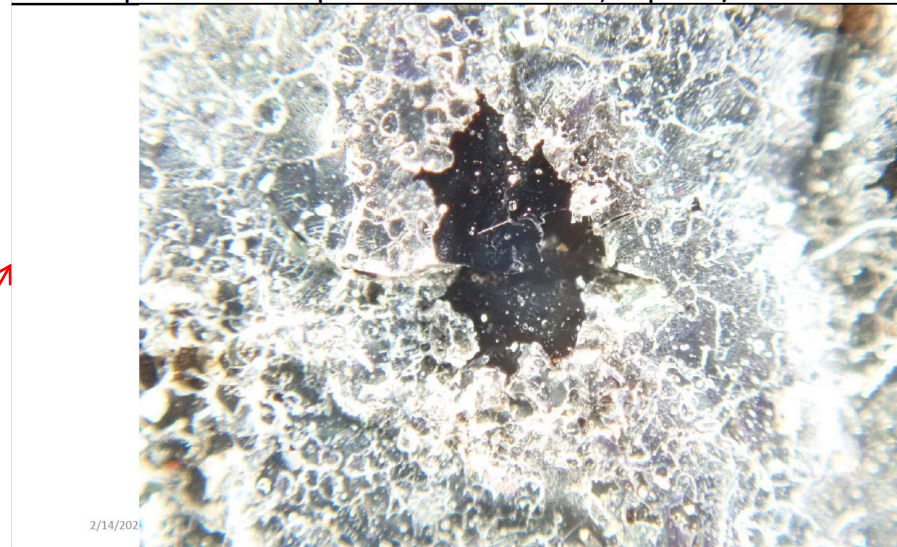
Artemis I | ROI #26 Panel D | Feature Size ≈ 1 x 0.5 mm, Depth = n/a

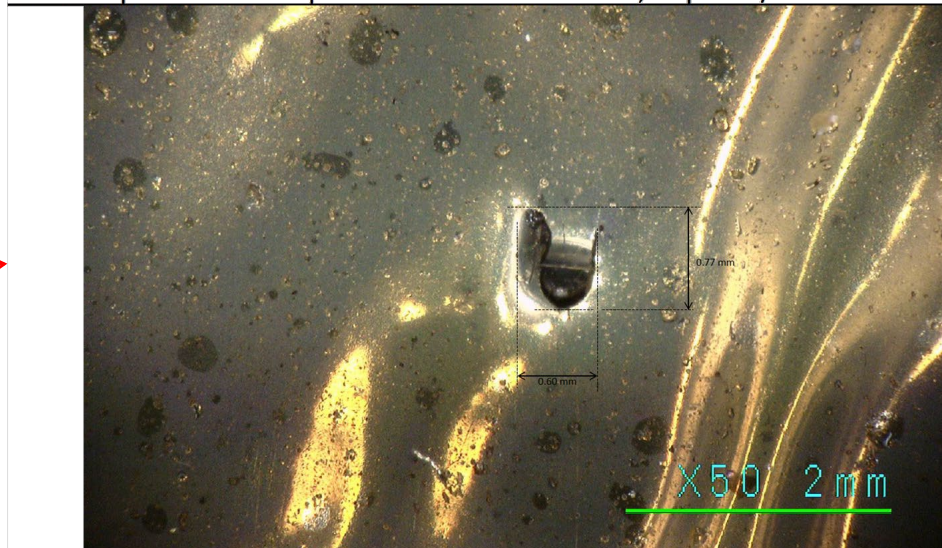
Artemis I | ROI #13 Panel F | Feature Size = 0.77 x 0.60 mm, Depth = n/a

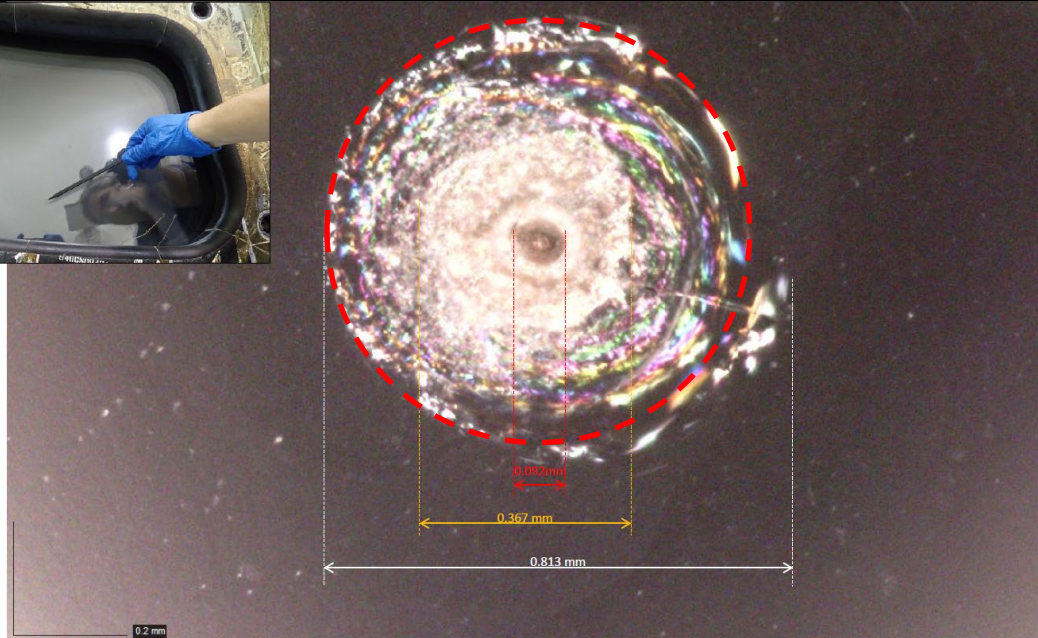
Artemis I | -Y Fwd Window (1) | Central Pit Depth = 0.0356 mm (KSC MIT measurement of dental mold)

Diameter = 0.730 mm

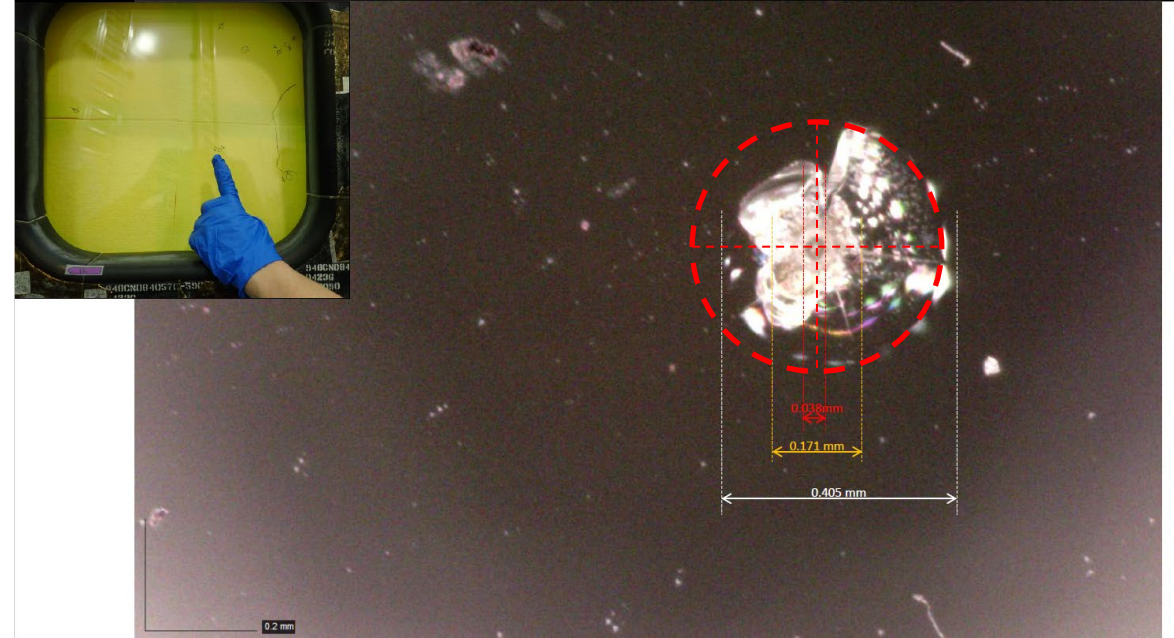
Artemis I | +Y Side Window (2) | Central Pit Depth = 0.0279 mm (KSC MIT measurement of dental mold)

Diameter = 0.428 mm

Based on radius determined from maximum glass damage
Assumption: impact obliquity or other factors artificially clipped extent of damage in some directions
