# Risks from Small Orbital Debris

Eric L. Christiansen  
Jim Hyde, Josh Miller, Alan Davis, Frankel Lyons  
JSC-X15 Hypervelocity and Orbital Debris Branch  
NASA Johnson Space Center

2<sup>nd</sup> International Orbital Debris Conference  
December 4, 2023

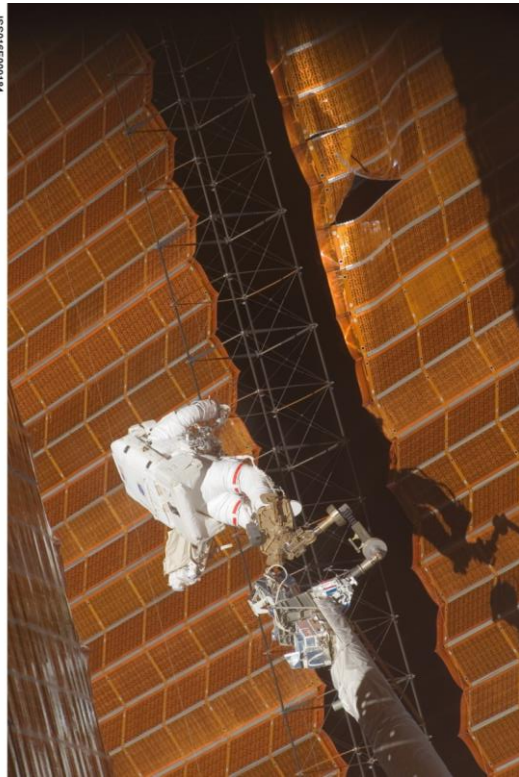
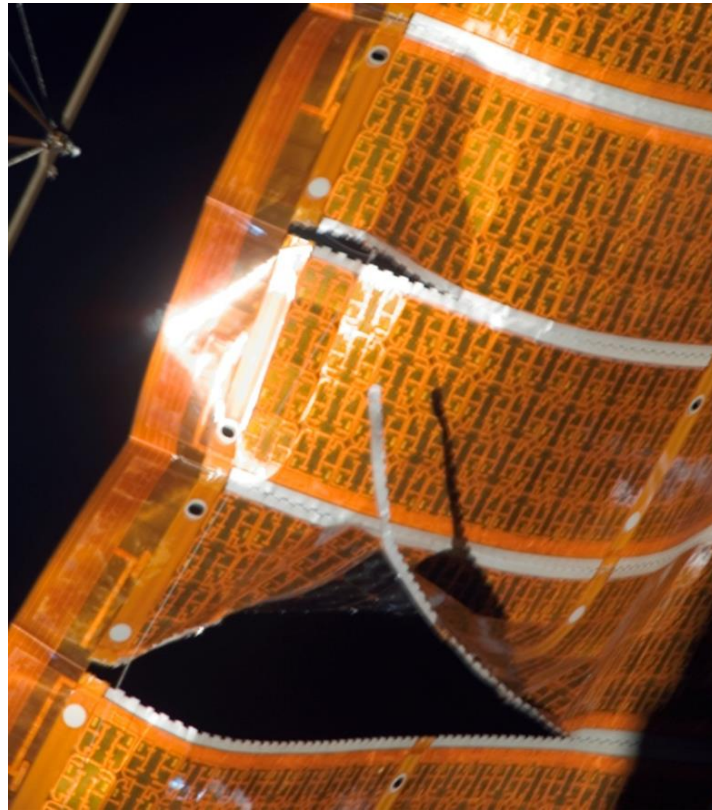
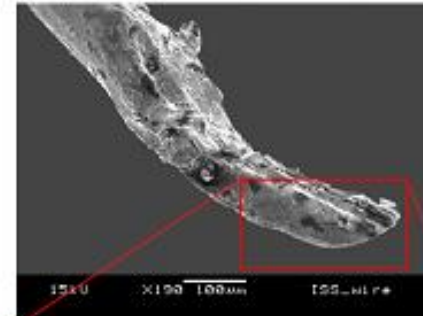
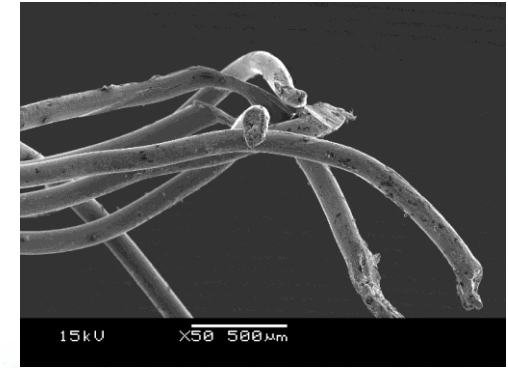
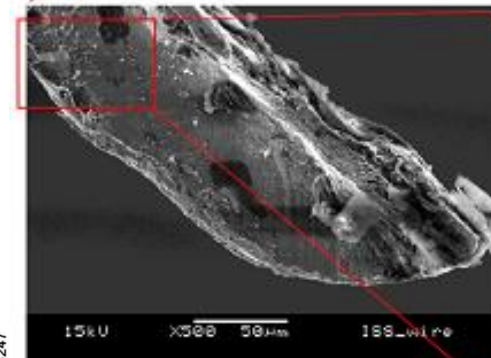
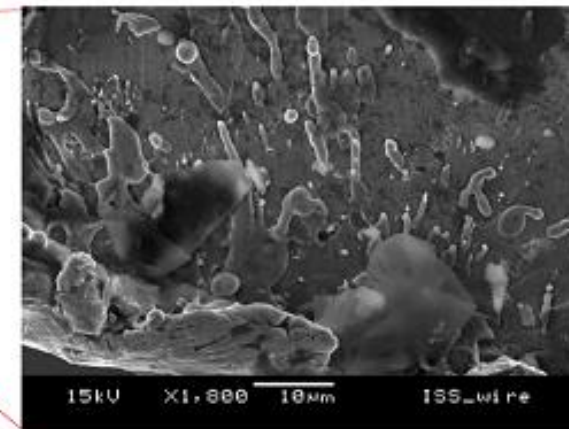
- **ISS has experienced impact damage from small MMOD with real consequences: repair & replacement, crew time, loss of capabilities, etc.**
  - **Example 1:** During STS-120 two solar array wings were removed from Z1 truss and relocated to P6 location. During re-deployment, the 4B solar array wing was torn in two places, due to a snagged guide wire. The guide wire was removed and “cuff-links” added to stabilize the array.

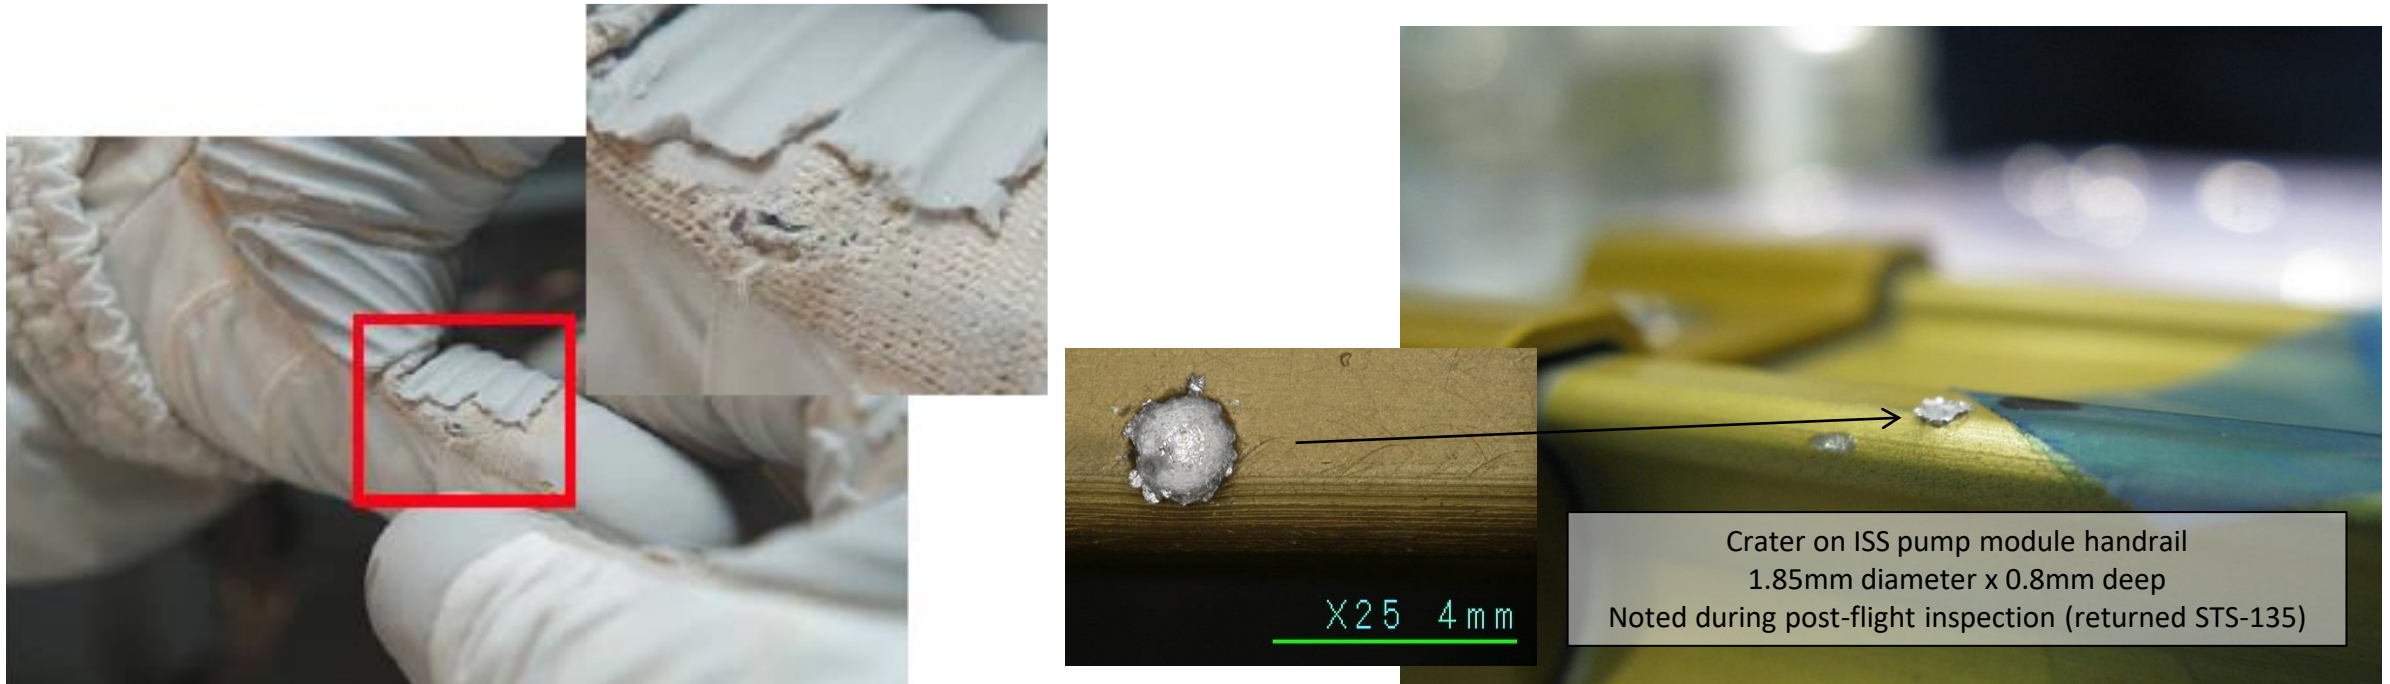
- **Example 2:** An EVA was terminated early on STS-118 due to glove cuts caused by sharp edges created by a small MMOD strike to a handrail.
  - Source of glove damage found to be a small crater on an airlock handrail (where the crew exits for EVAs)
  - Tape was initially used to cover the crater, but later a clam-shell device was placed around the crater. In addition, the EMU gloves were modified (toughened) with Kevlar to reduce cut glove potential. Inspections of handrails for craters performed now from ISS photos.

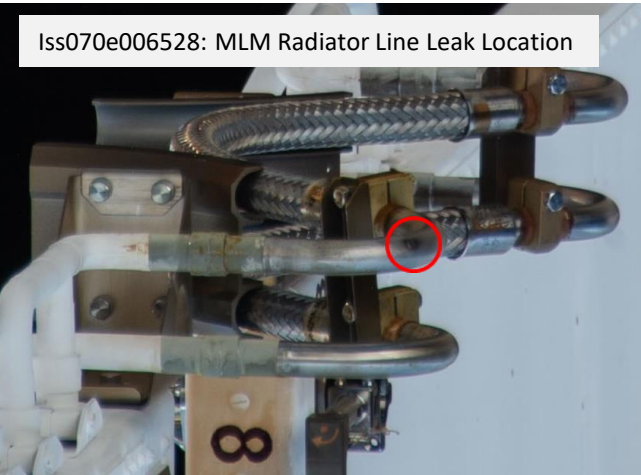
Iss070e006528: MLM Radiator Line Leak Location

- **Example 3: Russian module radiator leak that occurred in Oct. 2023**
  - Leak of radiator interconnect line on the Multipurpose Laboratory Module (MLM) could be due to small MMOD particle: 0.36mm diameter steel projectile at 10 km/s results in observed 1.3mm diameter hole in the radiator line

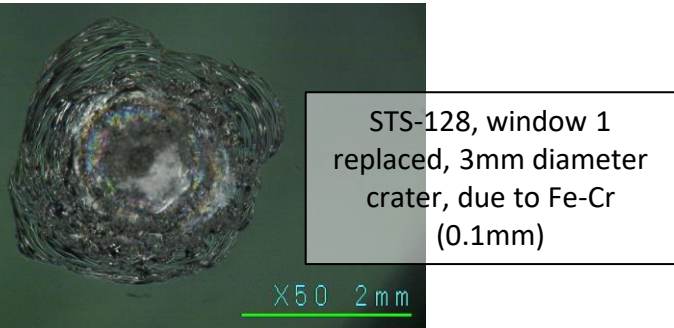
STS-128, window 1 replaced, 3mm diameter crater, due to Fe-Cr (0.1mm)

X50 2mm

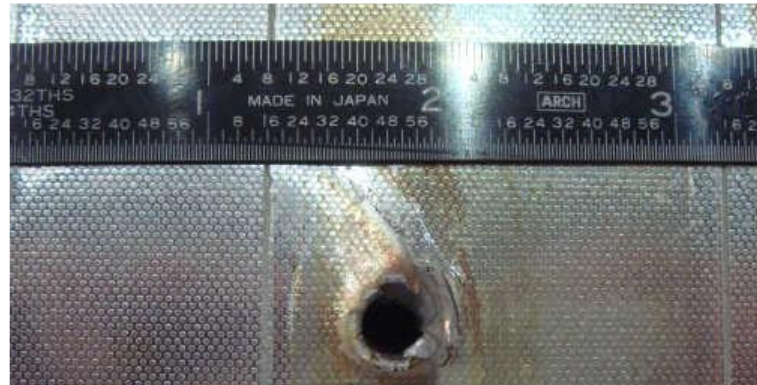
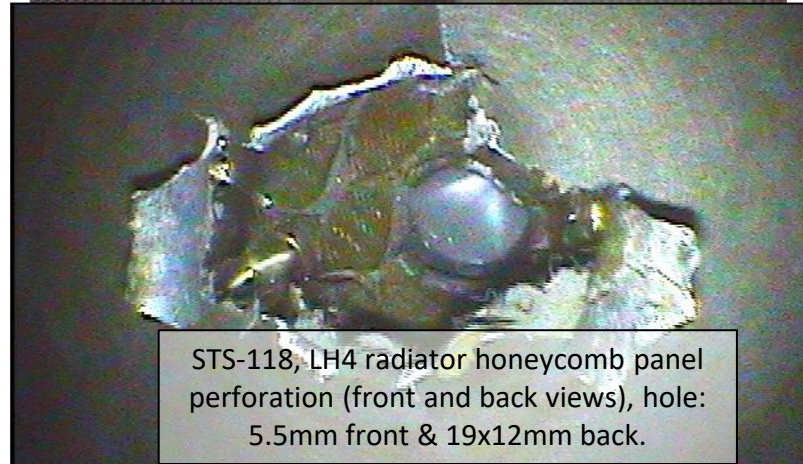
STS-118, LH4 radiator honeycomb panel perforation (front and back views), hole: 5.5mm front & 19x12mm back.

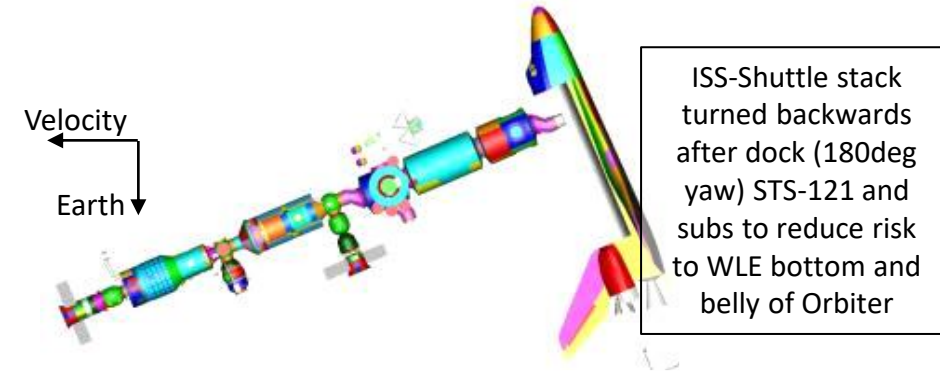
ISS-Shuttle stack turned backwards after dock (180deg yaw) STS-121 and subs to reduce risk to WLE bottom and belly of Orbiter

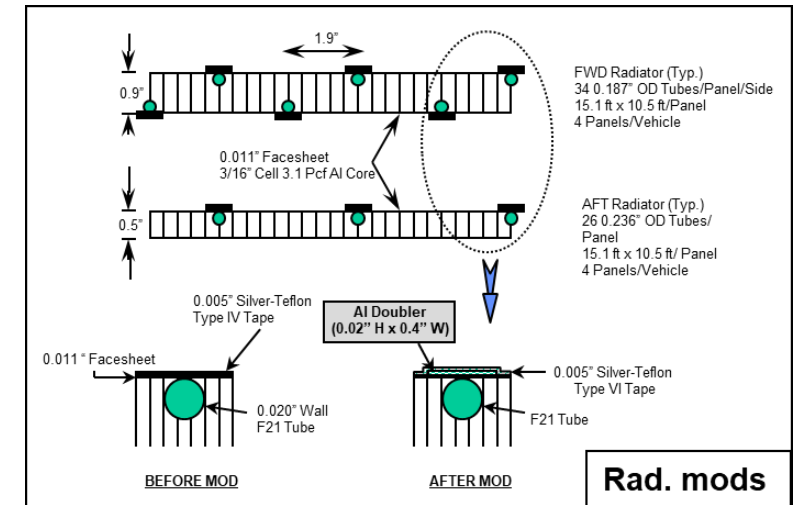
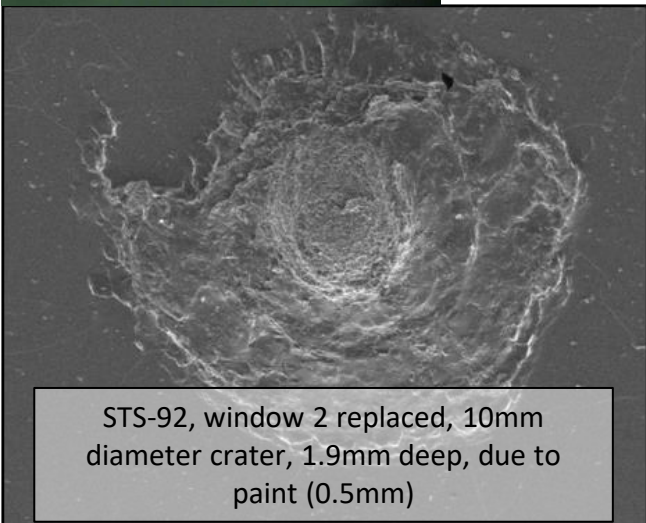
STS-92, window 2 replaced, 10mm diameter crater, 1.9mm deep, due to paint (0.5mm)

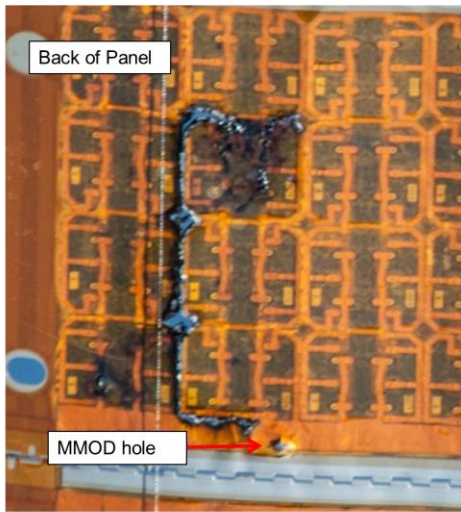
ISS P4 Photovoltaic Radiator exit hole

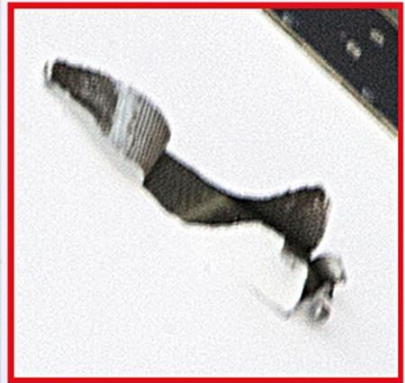
Service Module window #7, damage 3mm to 5mm

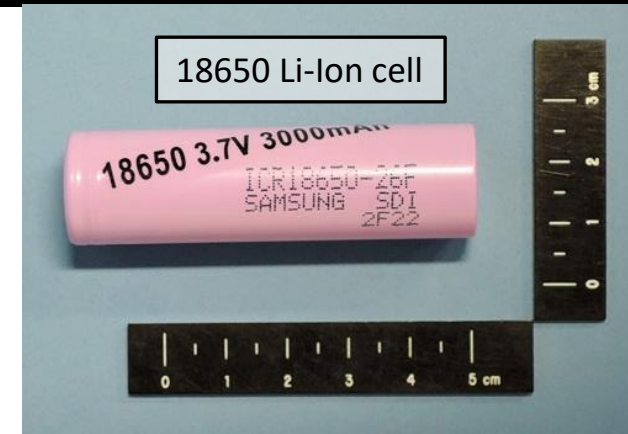
HITF17049  
1.0mm Al @  
6.95 km/s

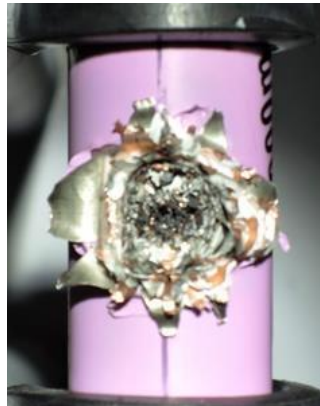
HITF17050  
2.0mm Al @ 6.89 km/s

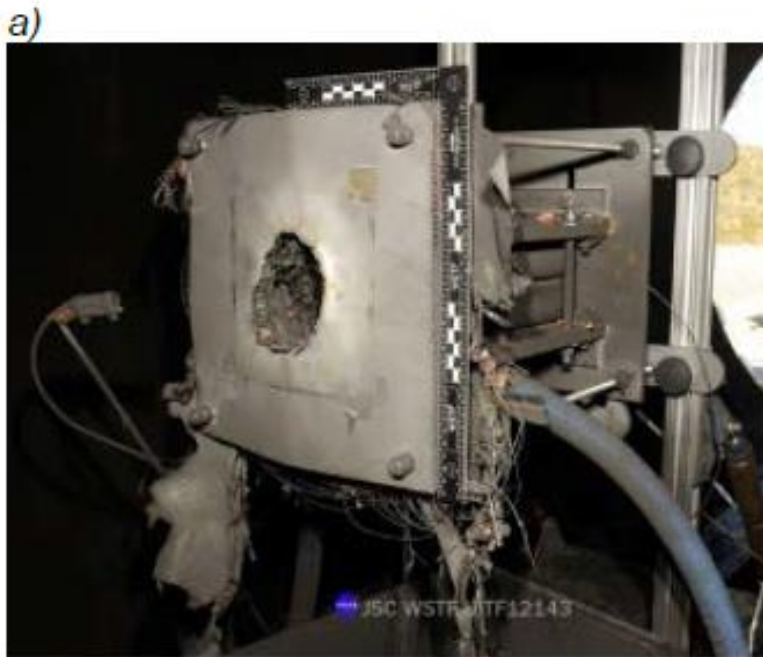
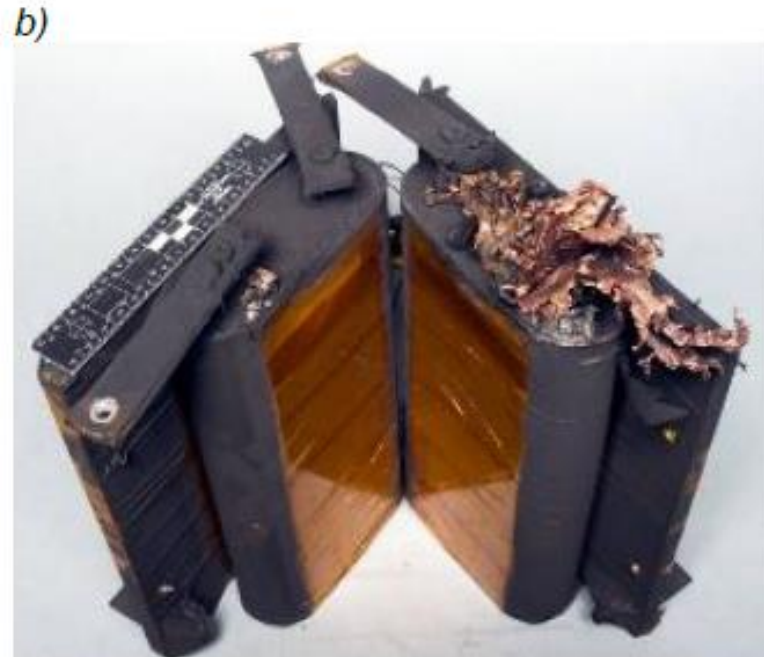
**Energetic response to hypervelocity impact: cell did not rupture, but internal contents were ejected from cell and littered chamber floor**

Post-test photos from HITF-12143, 1cm diameter Al @ 6.86 km/s

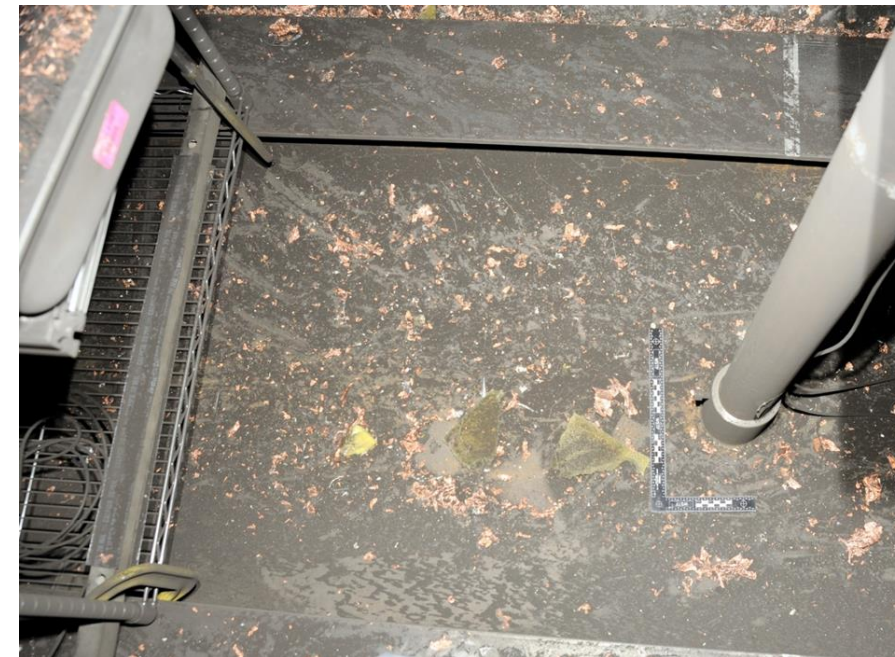
Post-test photos of test chamber floor after test HITF-12143

*Figure 1.2-2. After test imagery of HITF12143 a) shield with 9.5cm diameter through-hole, and b) cell close-up with impacted cell on right showing molten material from cell interior that was ejected and deposited on exterior of cell.*

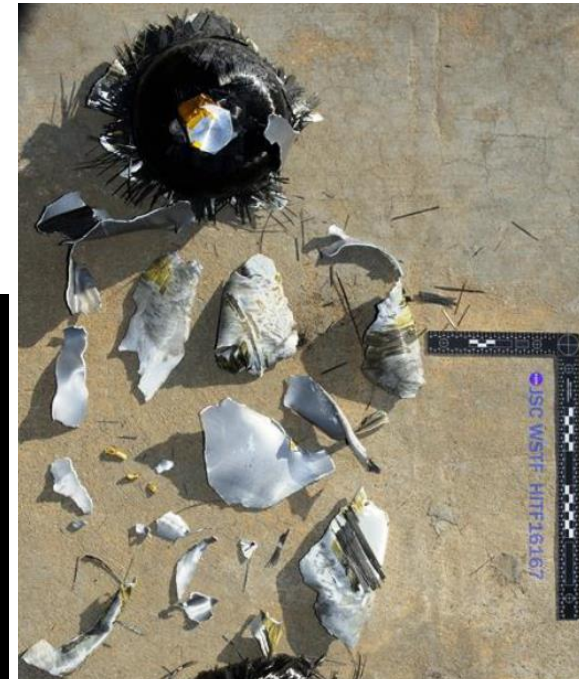
Leak failure mode (tank type 1)  
1.7mm Al @ 7.23 km/s, 45deg

Burst failure mode (tank type 1)  
1.7mm Al @ 7.01 km/s, 0deg

Debris from COPV burst test (largest debris) represents secondary impact hazard to other spacecraft hardware

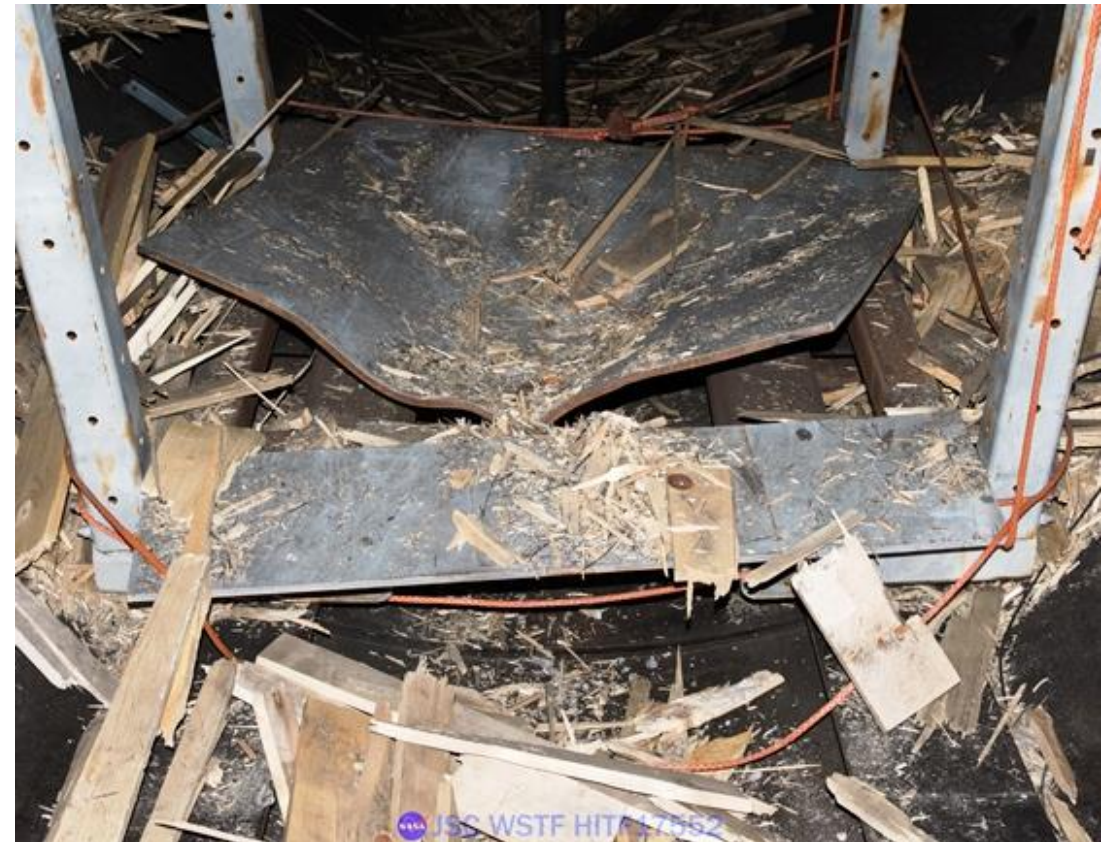
After Test HITF17552

HVIT17552: 5.0mm Al @ 6.82 km/s, 0deg  
(note: buckling of 5/8" thick steel plate under the test article)

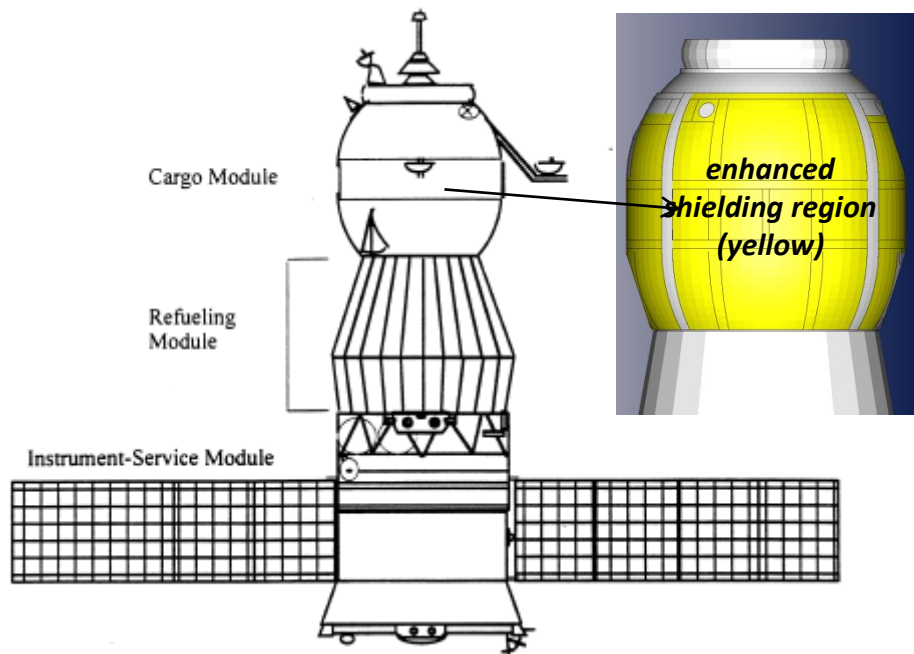
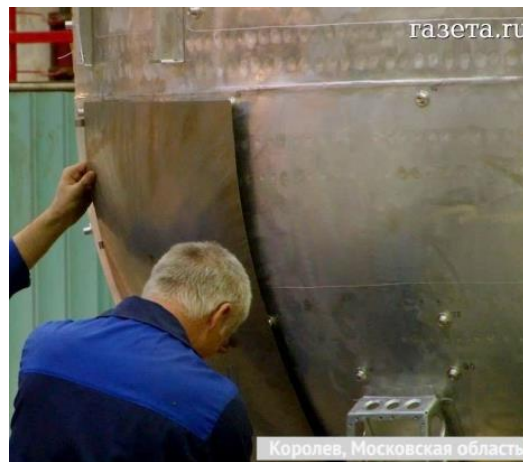
- **Example 3: Soyuz/Progress vehicle shielding**
- Originally, the pressure shell of the Soyuz Orbital Module and Progress Cargo Module were covered by a thermal blanket and were vulnerable to perforation by 1mm diameter aluminum debris particles impacting at typical ISS impact conditions (10 km/s)
- In 2012-2015, RSC-Energia added an aluminum bumper with standoffs to these vehicles, and the outer thermal blanket also augmented with additional materials and added over the bumper which improved protection to 2mm diameter aluminum debris...which decreased MMOD risk by 3-5 times depending on vehicle location.

Bumper shield and Standoffs being added to outside of Soyuz Orbital Module and Progress Cargo Module.

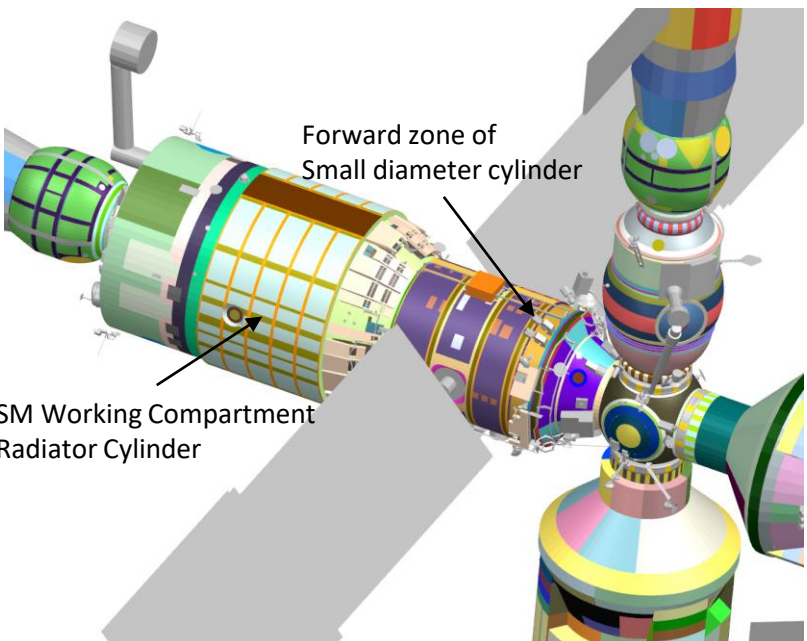
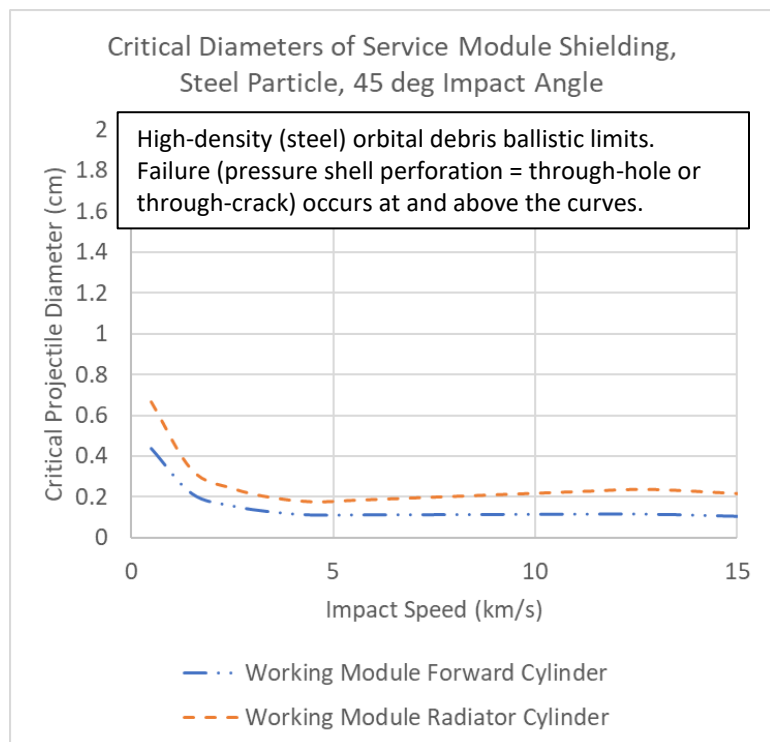
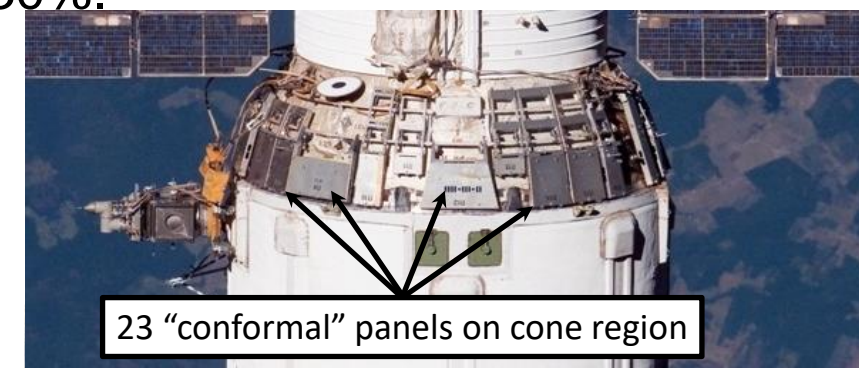
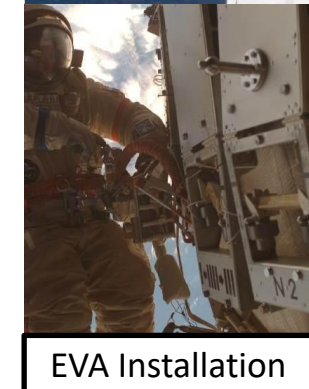
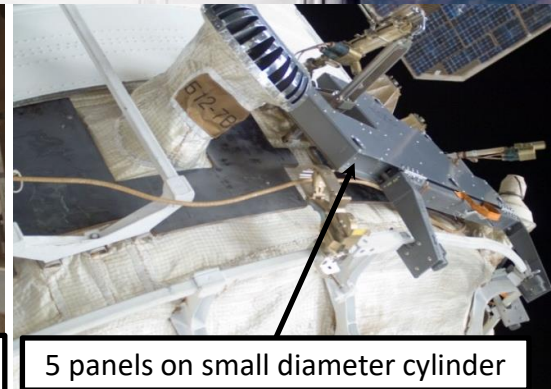
- Areas of the Zvezda Service Module are protected by body mounted radiators with short (2 cm) standoff between the outer radiator bumper and the pressure shell of the module.
  - Perforation of the pressure shell will occur with projectiles larger than 1-2mm steel debris and 2-4mm aluminum debris.
- In 3 missions between 2002 and 2012, a total of 28 augmentation shield panels were added by EVA to exterior areas of the Service Module to reduce MMOD risk by 30%.

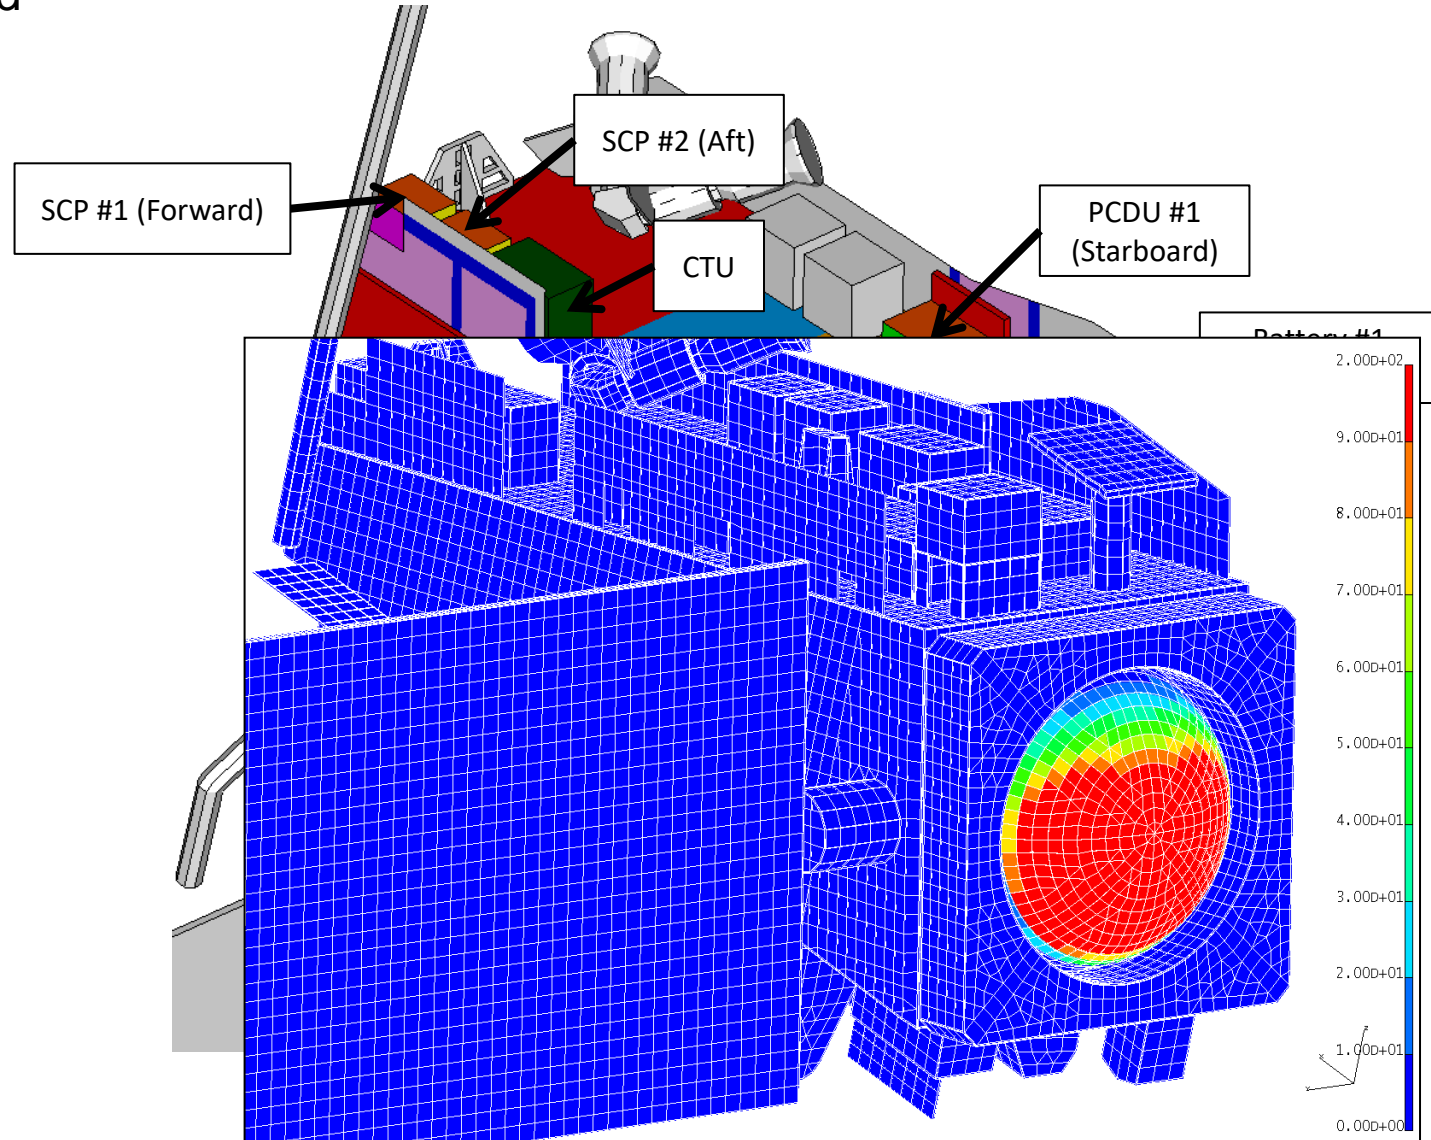
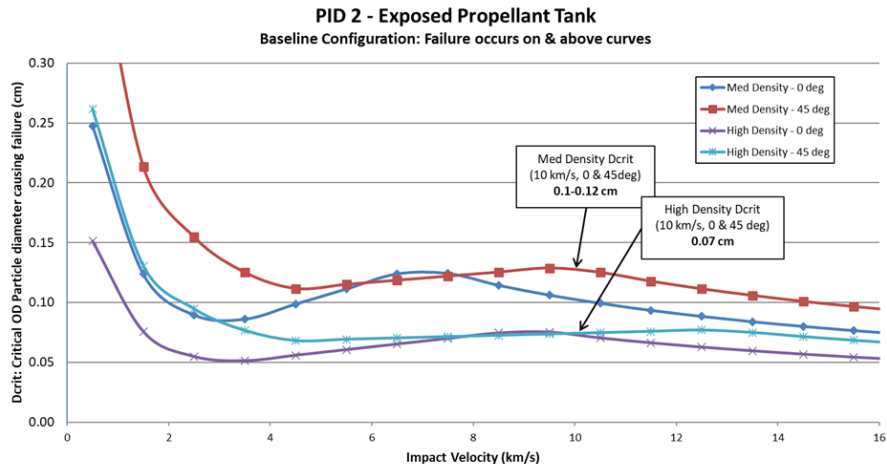
- Satellite MMOD risk is driven by lightly shielded items that are vulnerable to 1mm orbital debris
- Example: Orbital debris risk for the JPSS-1 satellite was initially driven by a non-shielded area of the propulsion tank at aft-end of the spacecraft
- The ballistic limit curves below illustrates this region is vulnerable to 1mm-1.2mm medium density orbital debris at 10 km/s, and 0.75mm high-density orbital debris at same speed
- This vulnerable area was augmented with a cover for JPSS-1 and JPSS-2
