# **STS-1 FORWARD RCS OXIDIZER TANK SUBSYSTEM STRUCTURAL FAILURE ASSESSMENT**

**K. Chauncey Wu  
Science Office for Mission Assessments  
NASA Langley Research Center  
[k.c.wu@nasa.gov](mailto:k.c.wu@nasa.gov)**

**CoSEM CDT  
University of Bristol  
June 3, 2024**

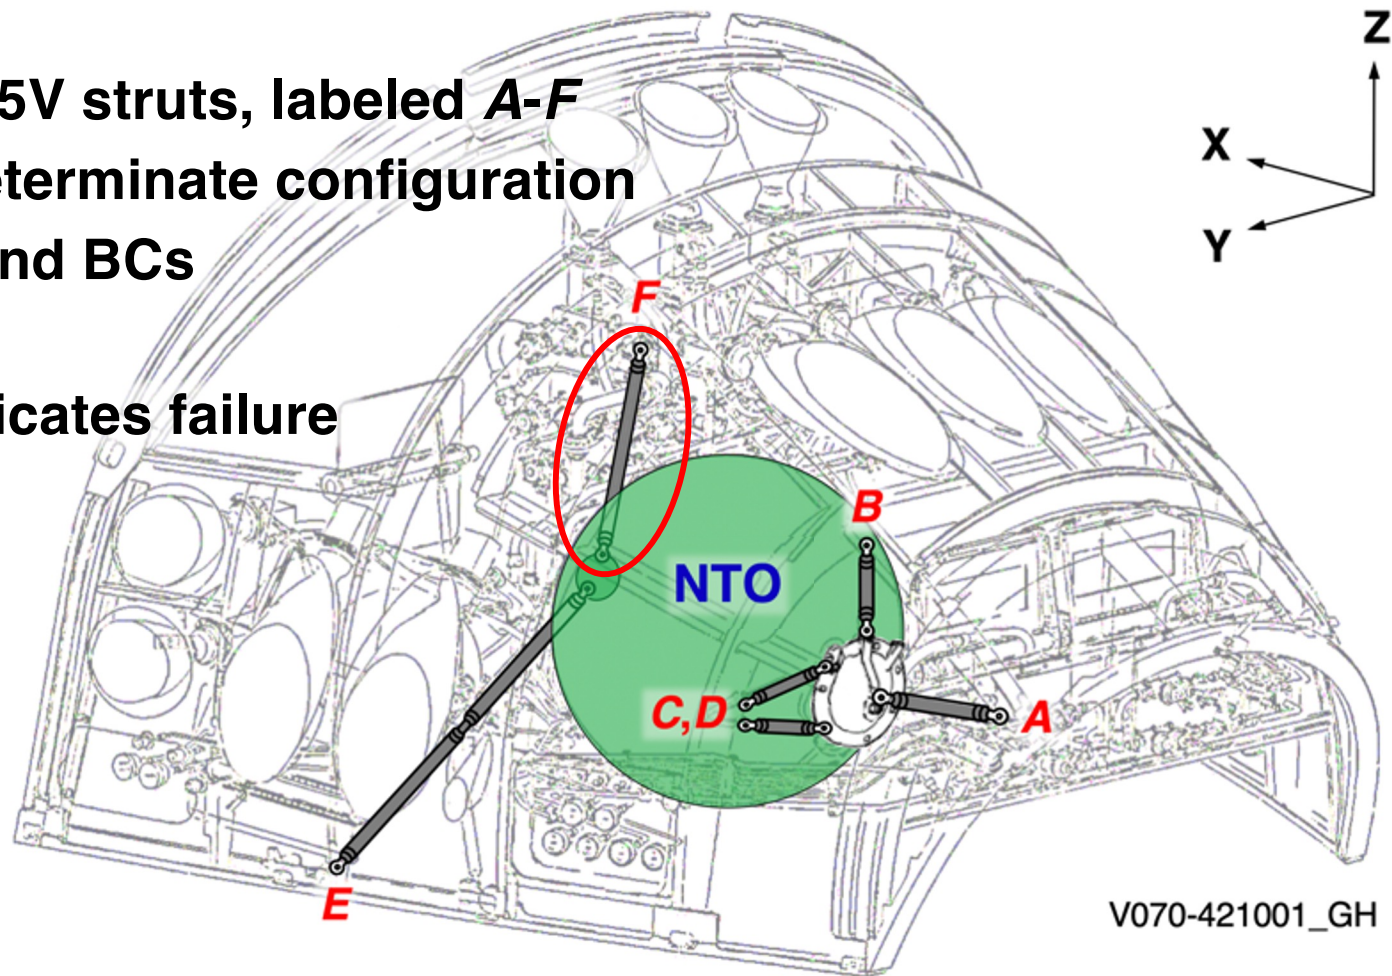
# FRCS Oxidizer Tank Subsystem

Six Ti-3Al-2.5V struts, labeled **A-F**  
Statically determinate configuration  
All pinned-end BCs

IFA V-58 indicates failure  
of **Strut F**

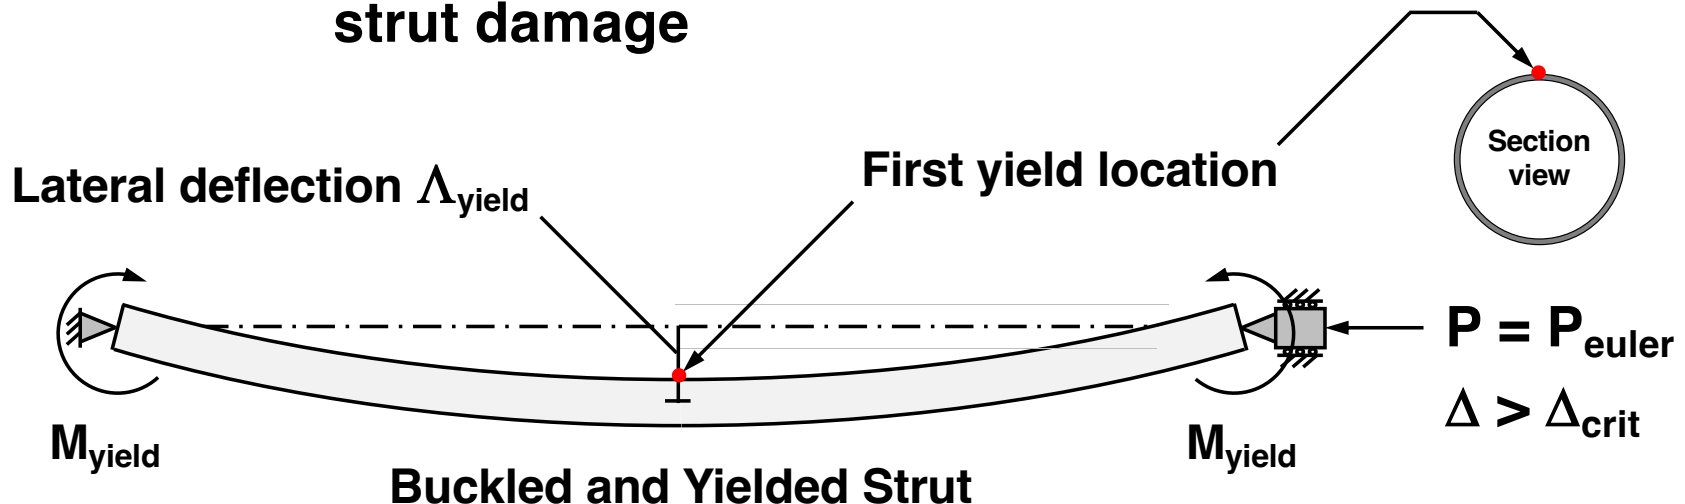
## NTO Strut $F$ Structural Analysis (2)

- Strut  $F$  deformation noted post-flight  
=> Material yield in deep postbuckling
- Calculate bending moment for **first yield** at strut mid-span,  $M_{\text{yield}} = 1870$  in-lbf
- **Lower-bound estimate** for observed strut damage

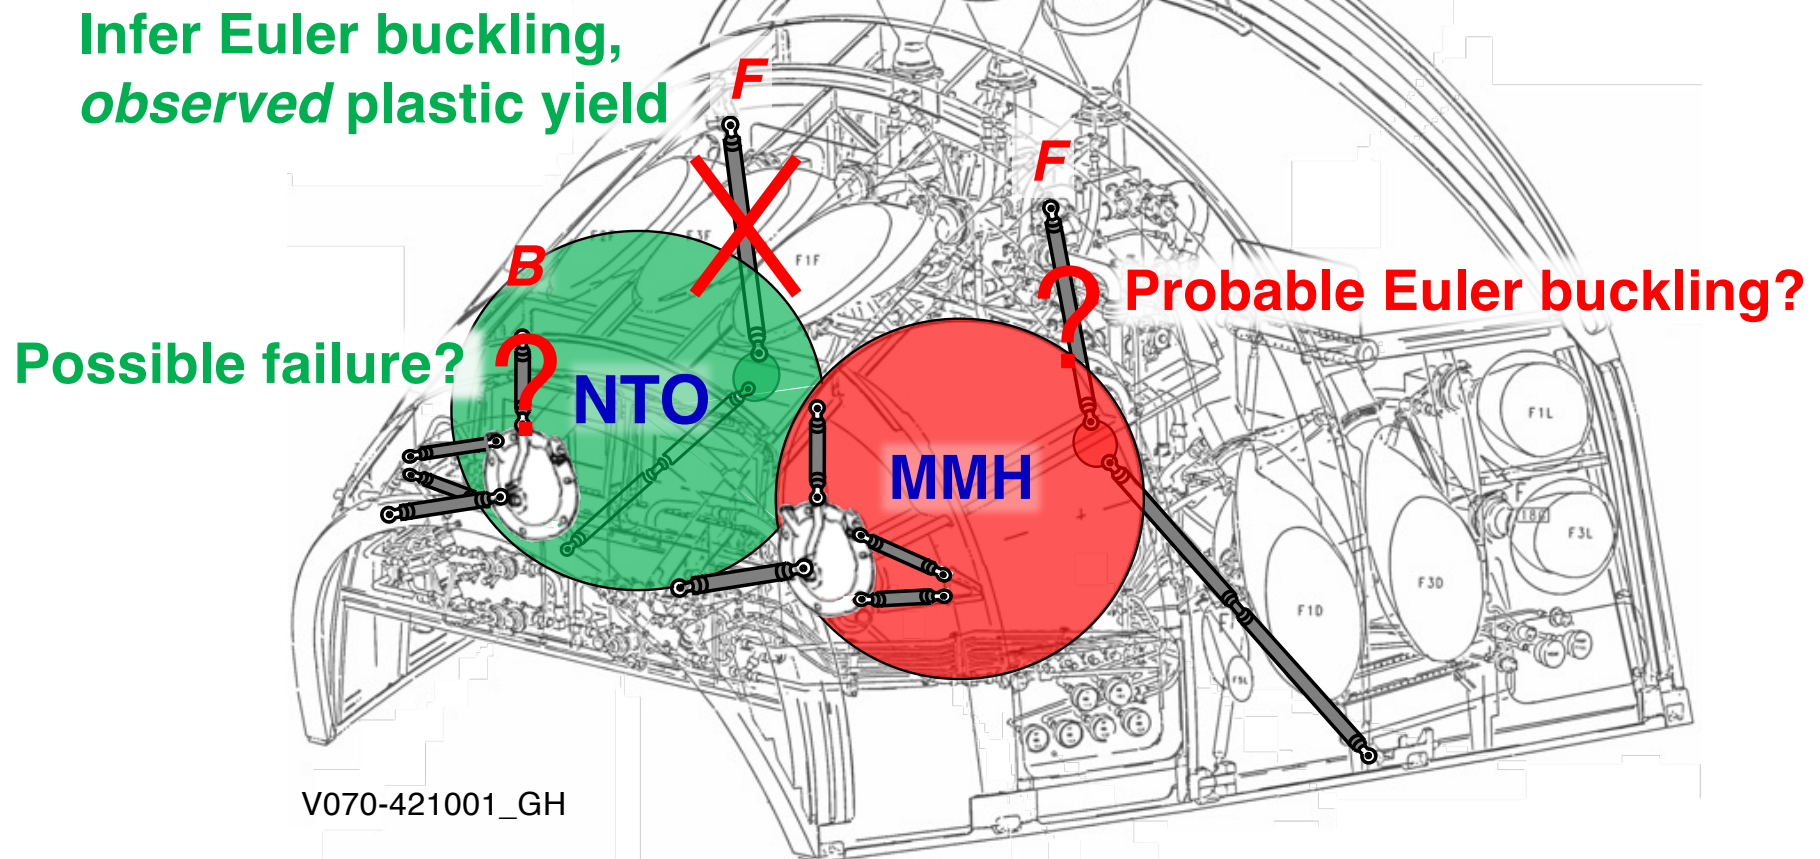
# FRCS Failed Support Struts

- Forward RCS NTO Strut *F* damage found during STS-1 post-flight inspection
- Classical analyses of Strut *F* performed to estimate strain energies for Euler buckling and initial yield
- Nonlinear structural analyses validate Strut *F* Euler buckling and plastic yielding
- Additional analyses suggest *possible* NTO Strut *B* failure, and *probable* MMH Strut *F* failure
- Mitigations for STS-2 and all subsequent flights
  - Boron-epoxy stiffeners added to all Struts *B* and *F*
  - Increased pad water suppression and injection
- No recurrence over next 30 years and 134 flights!

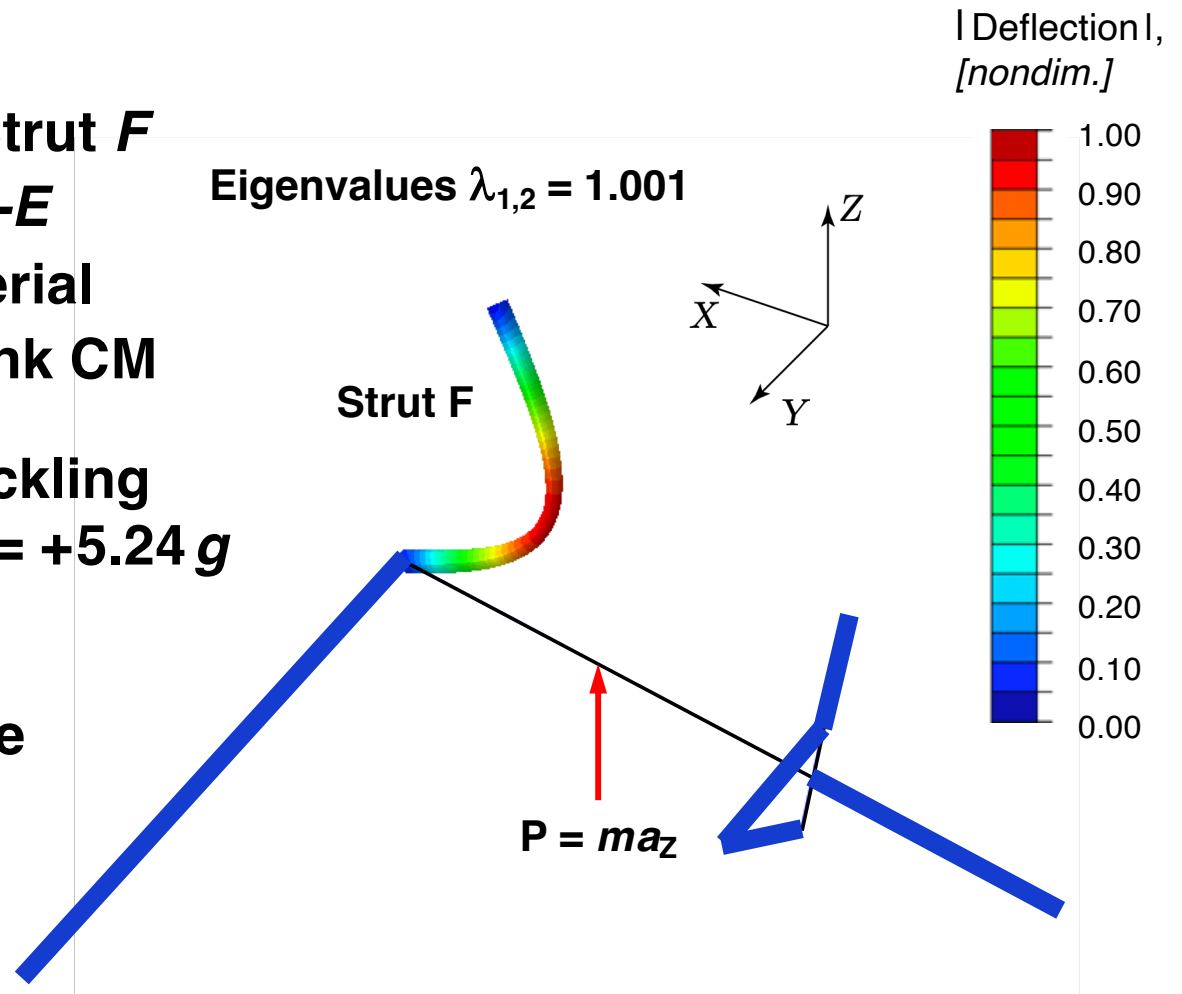
# Linear Static and Buckling Analyses

## Compute Strut *F* Euler buckling

$P_F^{cr} = -4142 \text{ lbf}$  from  $a_z = +5.24 g$   
applied at tank CM

Abaqus FE results validate  
closed-form analyses
