# Tow-steered Composite Panels with Defects and an Initial Analysis Framework

Cyrus J. R. Kosztowny

NASA Langley Research Center, Hampton, VA

Presented to the NESC Structures TDT on April 10, 2024

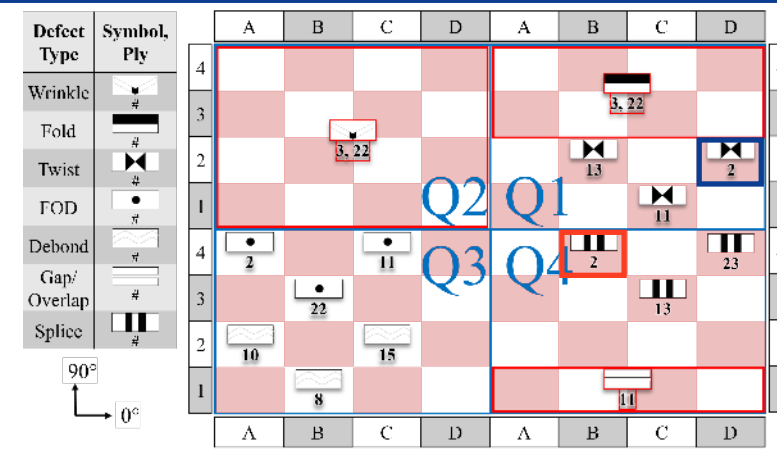
Q1D2 twist in ply 2

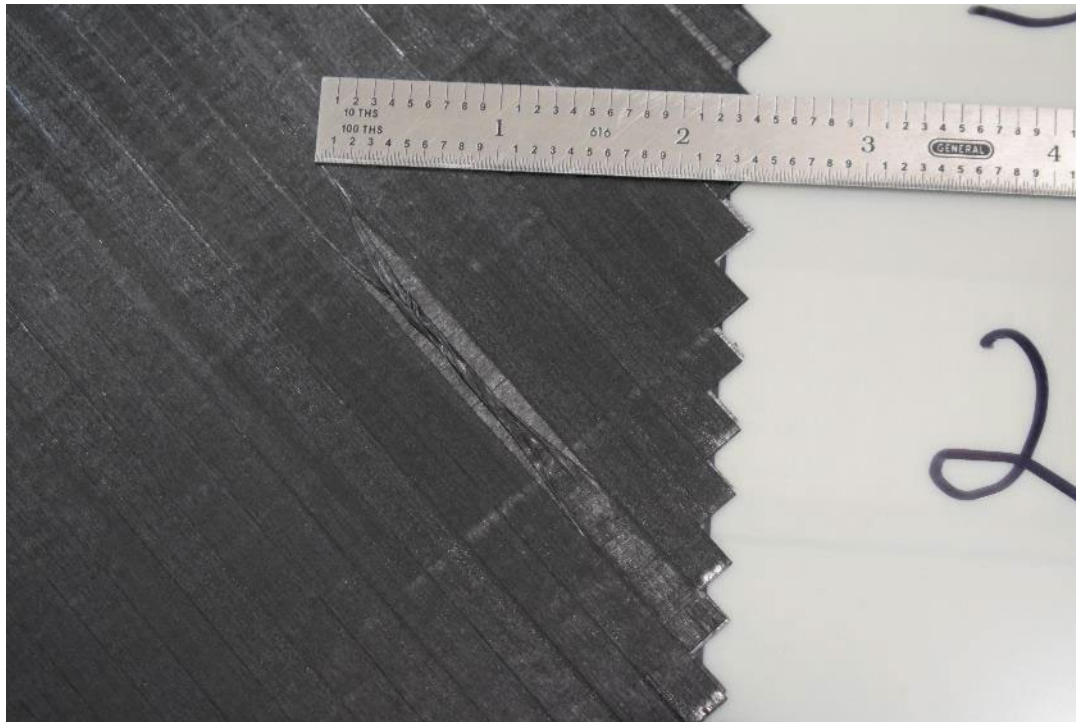
Q4B4 splice in ply 2

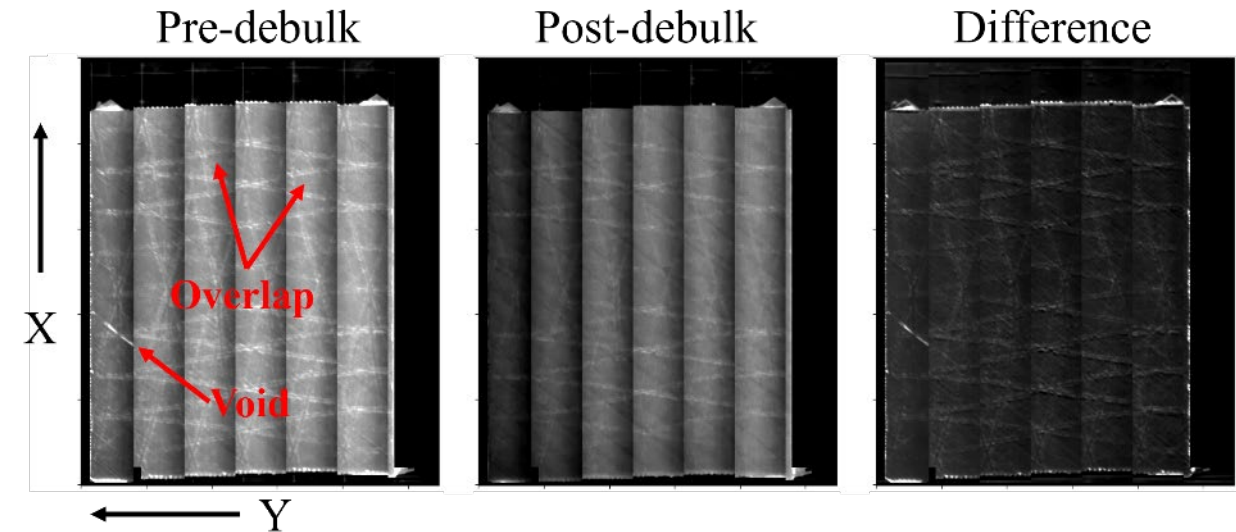
**Panel-1, after 24<sup>th</sup> ply placement**

- Tow overlaps due to steering are apparent
- One void, removed after the second debulk, was observed

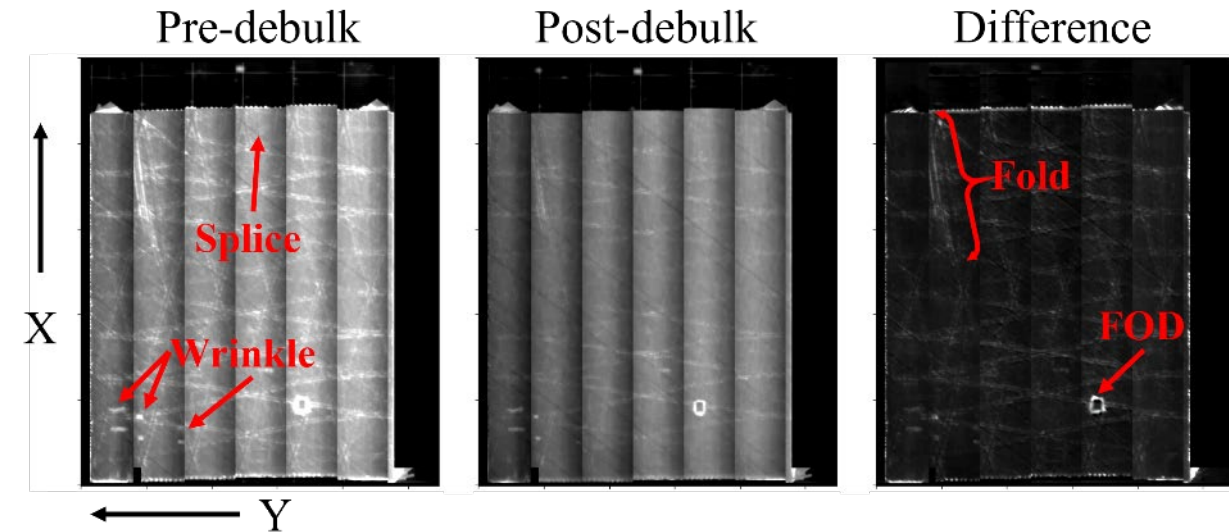
**Panel-2, after 24<sup>th</sup> ply placement**

- Significant fiber bridging observed around FOD
- Twist, splice, wrinkle, overlaps, and folds were detected

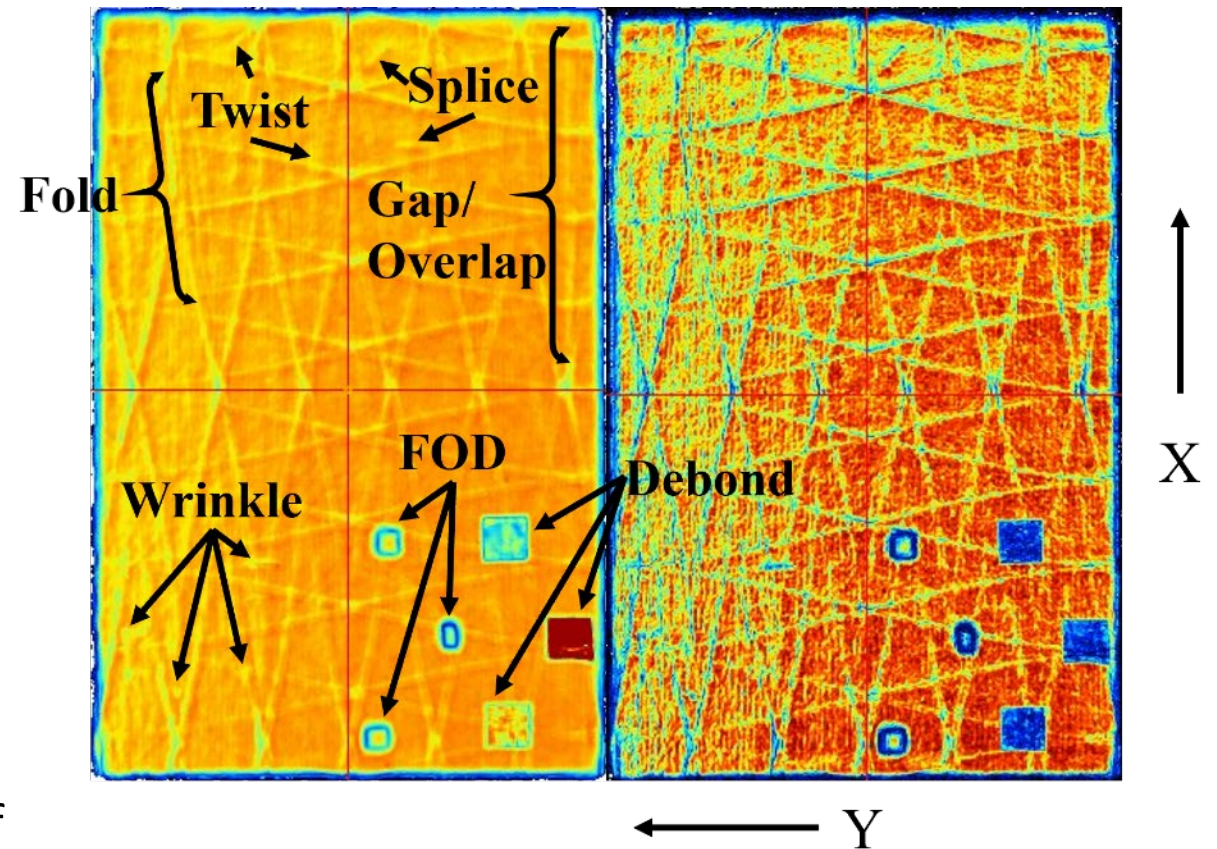
- Panel-2 2.25 MHz scan (left) and 10 MHz scan (right)
- All implemented defects were observed

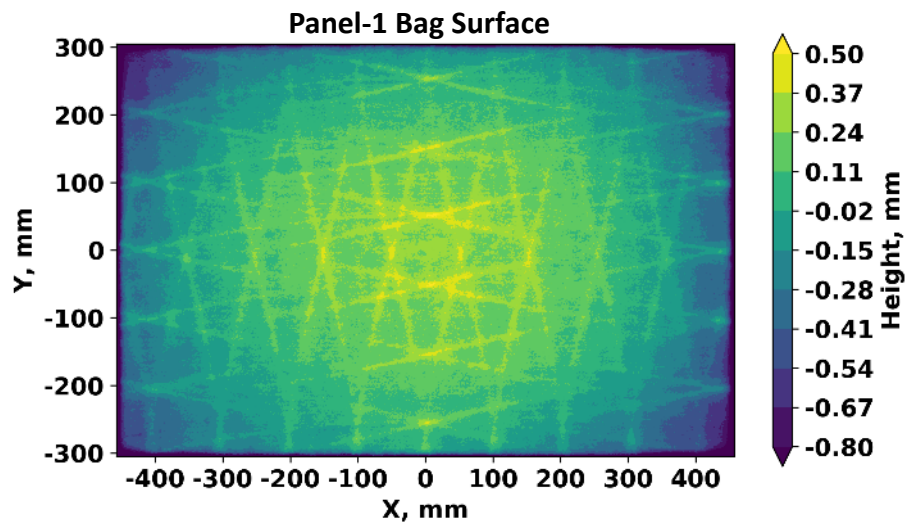
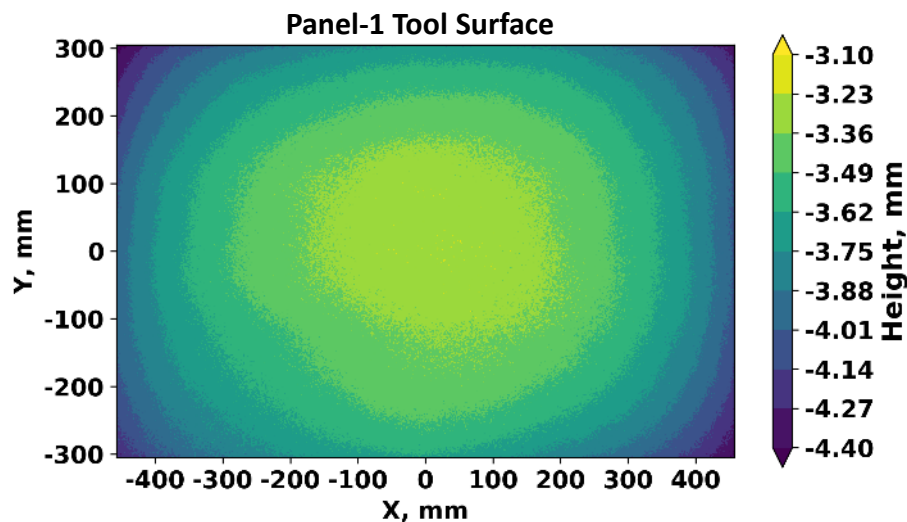
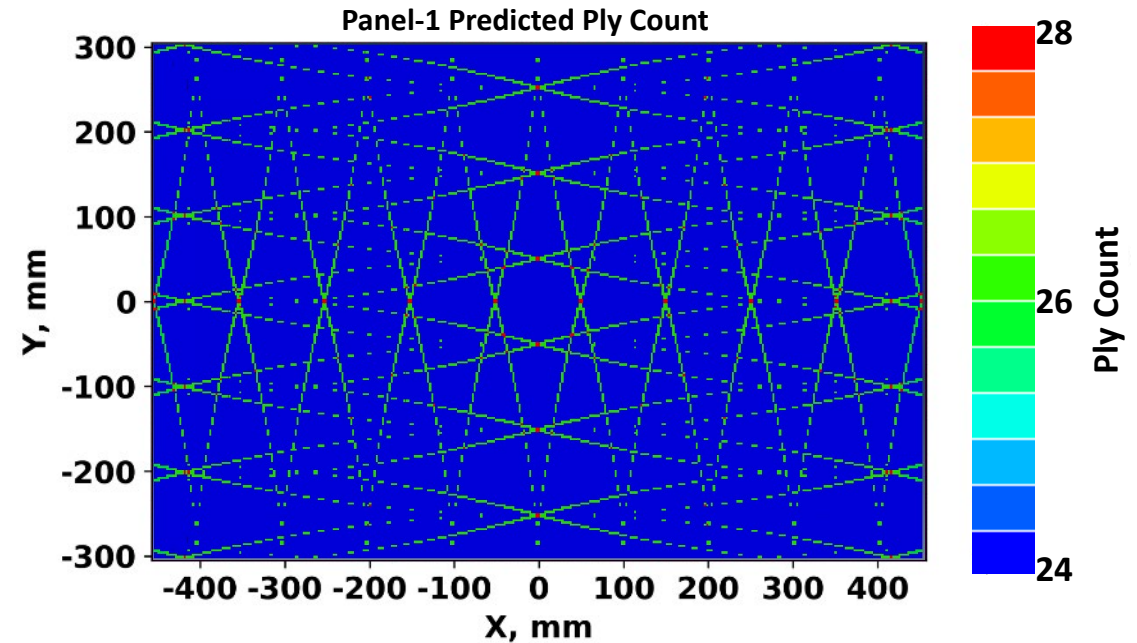
*Bag surface – tool surface = calculated thickness*

- Calculated thickness correlated well with ply count predictions
