NASA Exploration Toilet Hardware Status and Crew Feedback from ISS Artemis-2 Demonstration

Melissa McKinley¹, Melissa Borrego²,
NASA Johnson Space Center, Houston, Texas 77058

The Universal Waste Management System (UWMS), ISS operational nomenclature "Toilet", was initially installed on the International Space Station (ISS) in 2020 with final installation completed in 2021. Technical progress continues to be made with each on-orbit operation and will ultimately culminate with nominal US crew use of the hardware on ISS. During 2023, the Artemis-2 Demonstration was started, and this paper discusses issues encountered, on-orbit troubleshooting, subsequent ground failure investigation and proposed repairs as well as near-term plans to resume the Artemis-2 demo. Also discussed is an update to the commercial-off-the-shelf (COTS) Conductivity Monitor (CCM) which is planned to be flown for the resumption of the demo along with additional UWMS hardware and Toilet Integration Hardware (TIH). An updated design of the commode seat and fecal bag for Artemis-2 UWMS will be demonstrated on ISS and a summary of the hardware is included in the paper. Use of the hardware during the first days of t

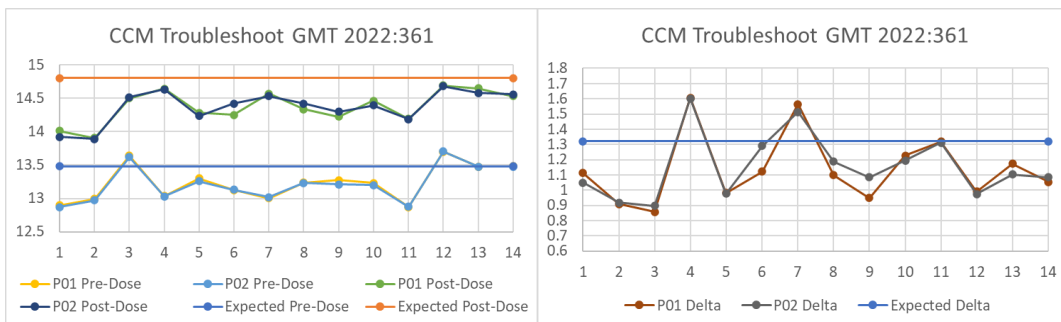
However, there was questionable data in the follow-on attempt to degas the CCM, see Figure 5. Fourteen 'viable' (acceptable amounts of pretreat) manual doses were dispensed during the attempt to degas the inoperable CCM. Pressure readings were similar to previous data seen during the checkout of UWMS in 2021. The average pre-dose pressure was 13.23 psig and the average post-dose pressure was 14.4 psig. The average delta-pressure was 1.15 psig. This indicated that pretreat seems to be present however due to the lower delta-pressure, data is inconclusive on pretreat quality. Crew operations were still possible, however, close monitoring of the quality of the pretreat was necessary.

Figure 5. UWMS separator bowl pressures and Dose Delta Pressures during CCM degas operations.

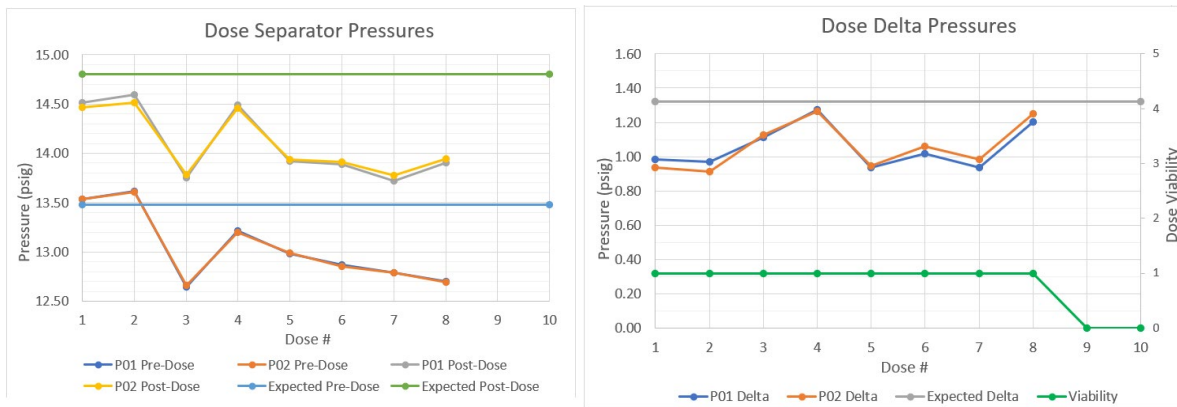
Data summary during the Artemis-2 Demo check out is summarized in Table 2 and can be seen in Figures 6-9. This data shows that pretreat does not appear to be present based on comparison to ground data and previous on-orbit data.

Figure 6. Data from Dose Check #1.

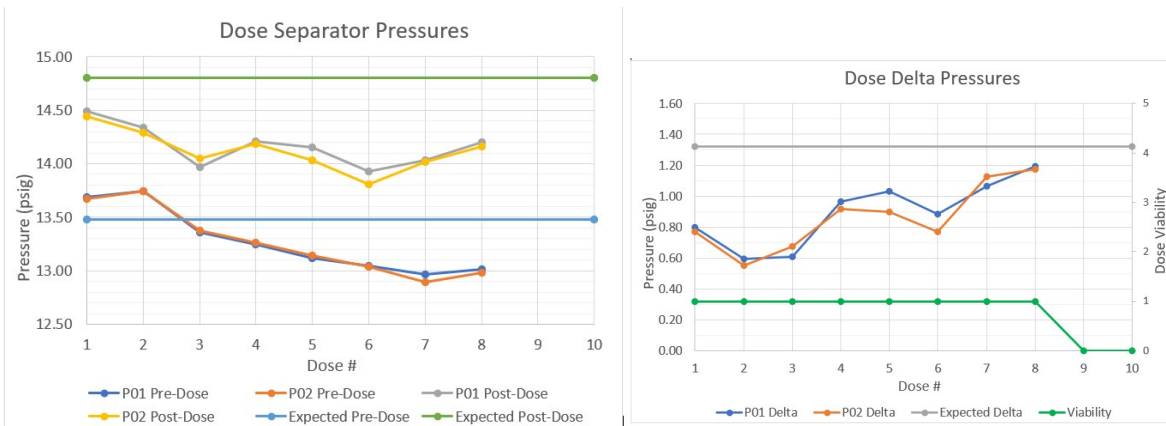
Figure 7. Data from Dose Check #2.

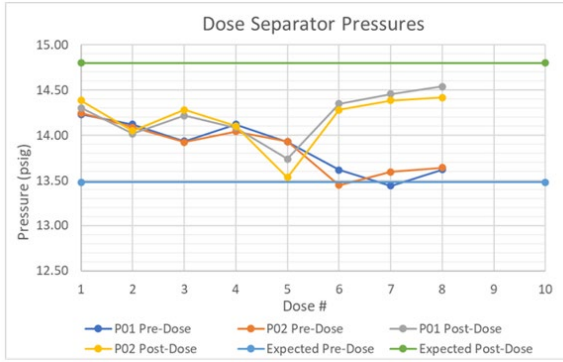
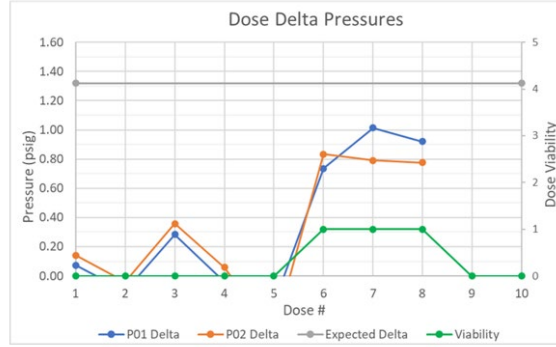
Figure 8. Data from Dose Check #3.

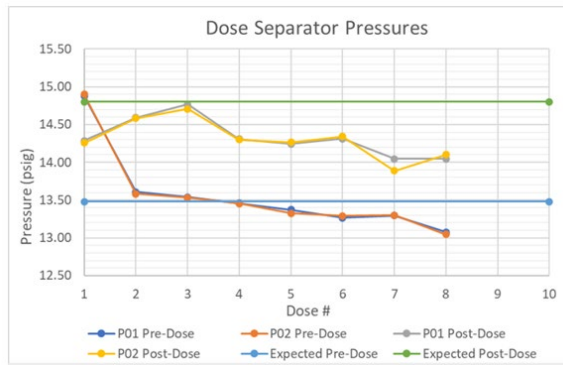
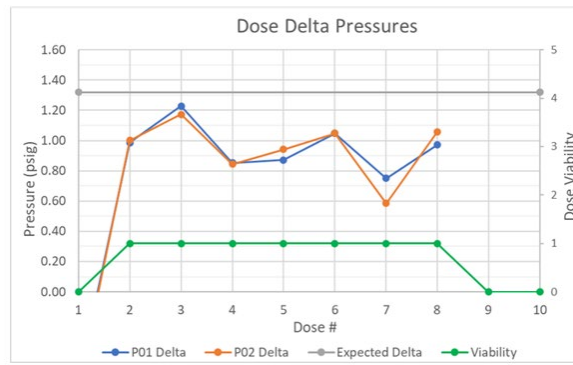
Figure 9. Data from Dose Check #4.

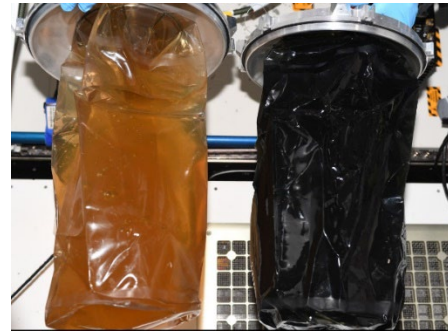
Figure 11. Comparison of UWMS filled EDV (Russian tank) and WHC previously filled EDV. Tank on left contains UWMS urine and does not appear to contain pretreat. Tank on right is a previously filled tank used on WHC (Waste and Hygiene Compartment.)

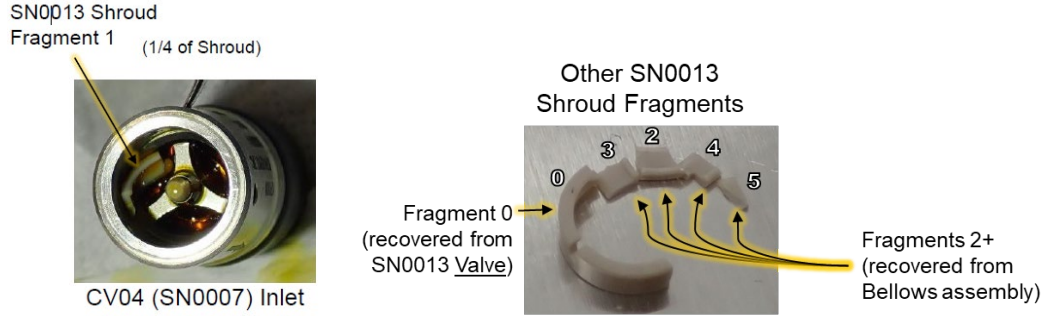
photograph of the inlet of CV04, showing the fractured piece of PEEK shroud (approximately ¼ of the total circumference) with pretreat still present is also shown in Figure 13. Subsequent inspection and disassembly of CV03 at the Raytheon Technology Research Center (RTRC) did confirm that the PEEK piece found in CV04 came from the CV03 shroud. Additional fragments were also recovered from the dose pump bellows assembly after flushing operations.

Figure 13. Inlet of CV04 showing fragment of shroud and remaining pieces of shroud recovered.

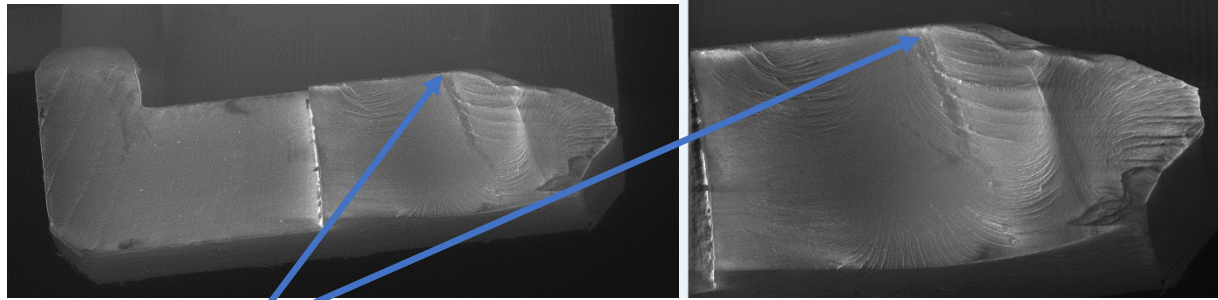
Crack Initiation Site

Figure 14. Optical Scans showing cracking of the PEEK shroud from the UWMS Dose Pump Check Valve that failed on-orbit on ISS during preparations for the Artemis-2 Demo

Optical scans in Figure 14 show the crack initiation site which was not at the notch as originally suspected. “The picture below showing the fracture point & the river flow pattern would be the key finding of our investigation,” per Dr. Kim, JSC Structures and Mechanics Division. The photo “is showing a clear crack initiation point. So, it seems like the crack did not start at the corners.”

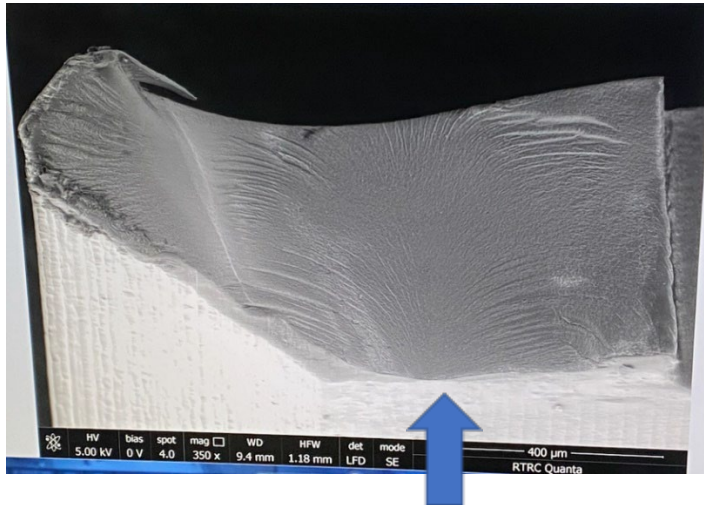
The scans taken at RTRC of the fractured part, Figure 15, first recovered showed a likely initiation of the fracture of the check valve PEEK shroud. The fracture initiation site was not at the corner of the notch and is shown in the picture below. Evidence of embrittlement is seen along the fractured edge. This confirmed earlier findings from JSC.

Figure 15. Scans from RTRC of failed shroud.

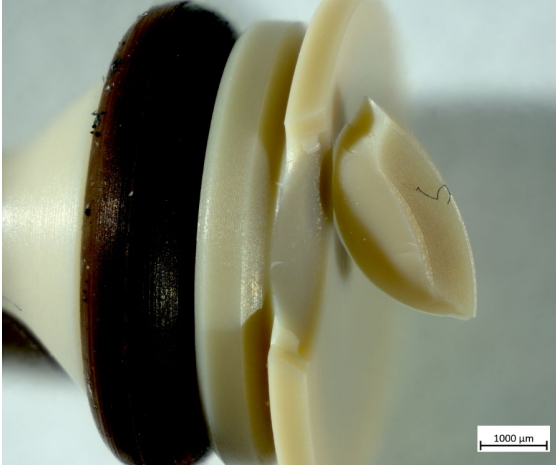
Figure 16. Poppet with broken piece

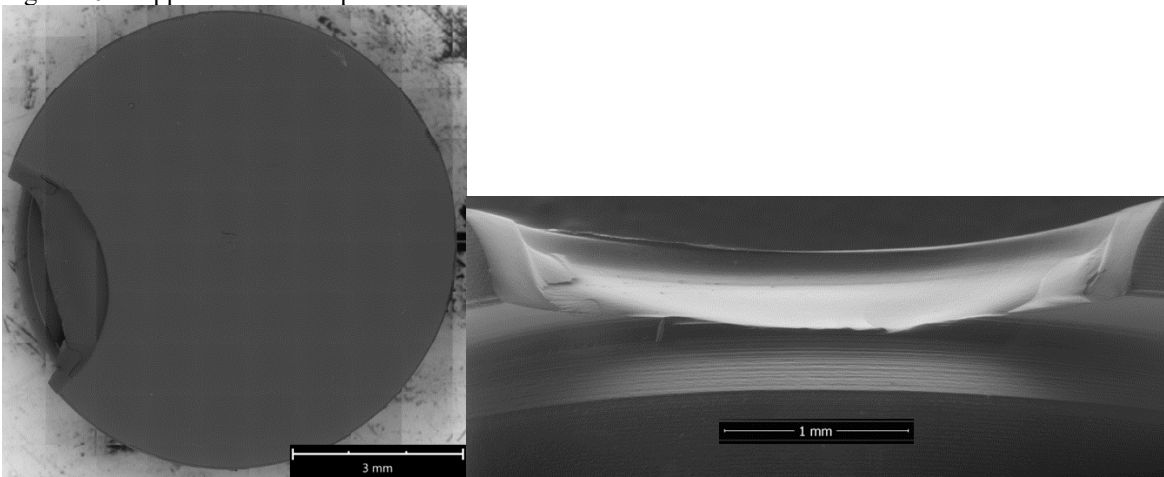
Figure 17. Location of failure in poppet.

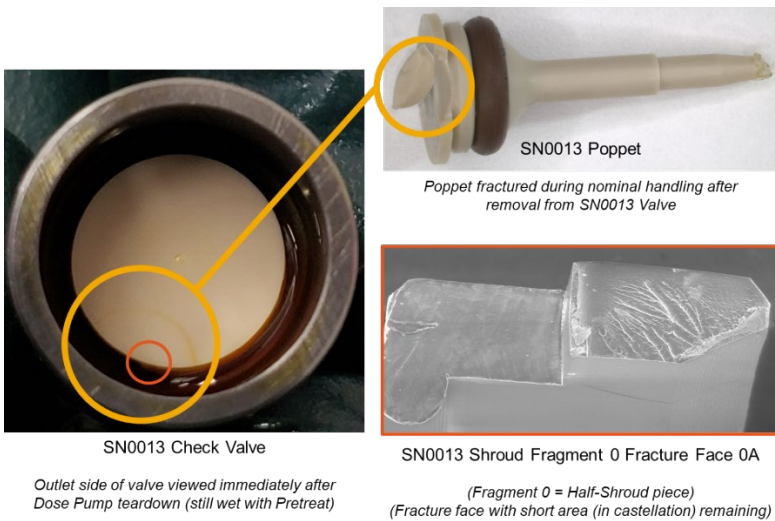
Figure 18. Details of the poppet failure.

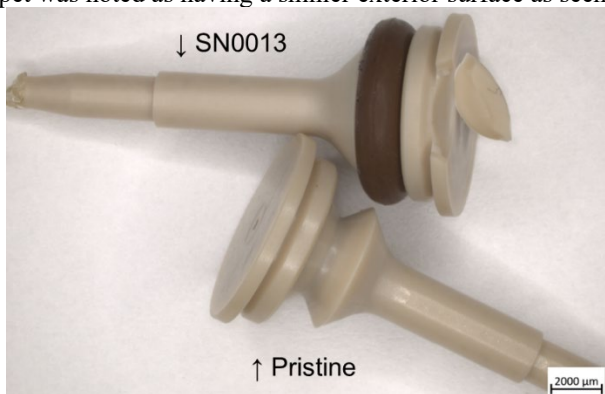
Additional observations made by the RTRC team included that the exterior surface of the failed poppet showed evidence of etching and a matte finish as is seen in the comparison photo of both the poppet from the failed check valve and a pristine version supplied by the vendor. The top poppet is from the failed valve (CV03 S/N 0013) that

was exposed to pretreat, the bottom poppet is the pristine item that has never been exposed to pretreat. The pristine poppet was noted as having a shinier exterior surface as seen in Figure 19.

Figure 19. Comparison of failed poppet to pristine unused poppet showing surface etching.

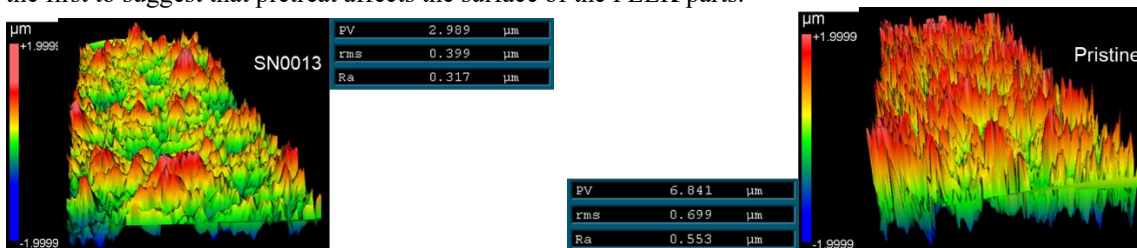
Optical profilometer images, Figure 20 showed a difference in the surface of the PEEK parts indicating the failed part has an altered surface compared to the pristine piece, which also supported the etching theory. This observation was the first to suggest that pretreat affects the surface of the PEEK parts.

Figure 20. Optical profilometer images of a pristine unused poppet surface and the failed poppet showing evidence of etching.

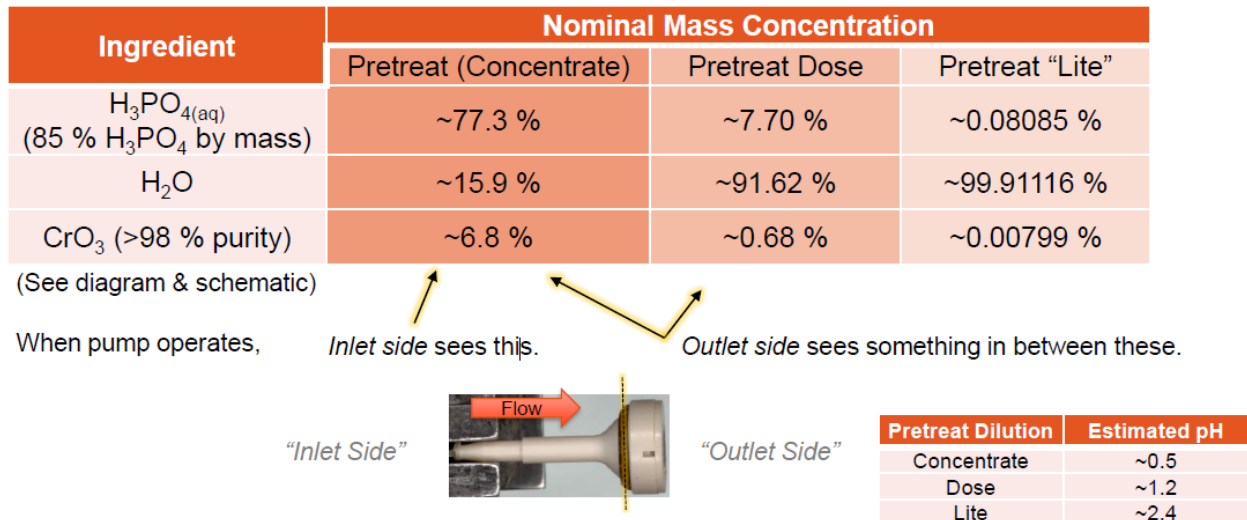
PEEK parts from SN0007 (CV04), downstream of SN0013 (CV03) were also evaluated by Raman spectroscopy. All analyzed components had similar levels of characteristics for resisting chemical attack. Compared to the SN0013 parts, SN 0007 parts have more consistent concentrations of these characteristics. The location of the SN0007 parts may also suggest there is a difference in the characteristics observed due to the chemical environment seen in part of these PEEK parts. This is because the downstream side of the poppet and shroud of CV04 see a lower concentration of acidic solution while the entirety of the CV03 PEEK parts see the pretreat concentrate during use. See Figure 21 for more details.

Figure 21. Details of exposure to pretreat of various locations.
