NASA GSFC EEE Parts

Failure Analysis: Isolating Integrated Circuit Electrical Damage

Eric Galloway

Science Systems and Applications, Inc.

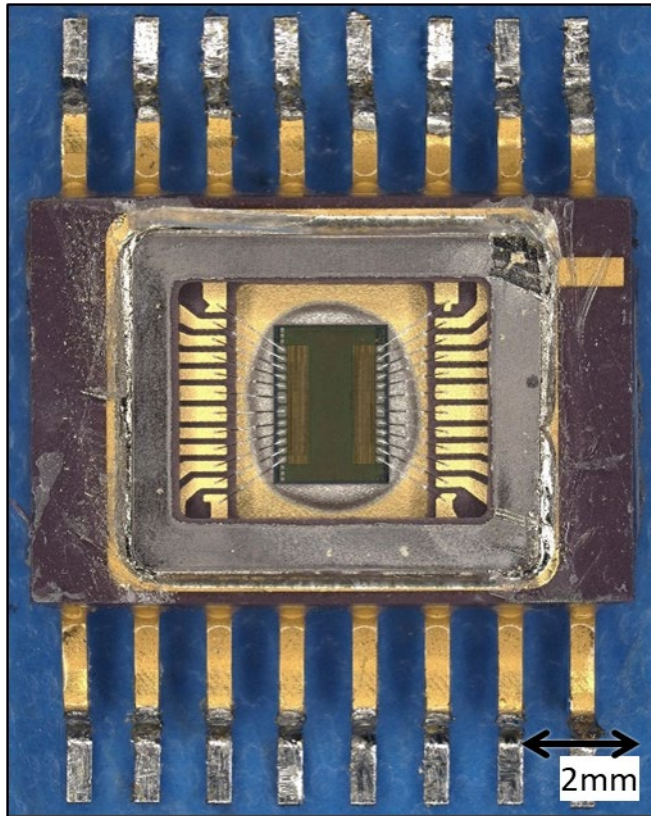
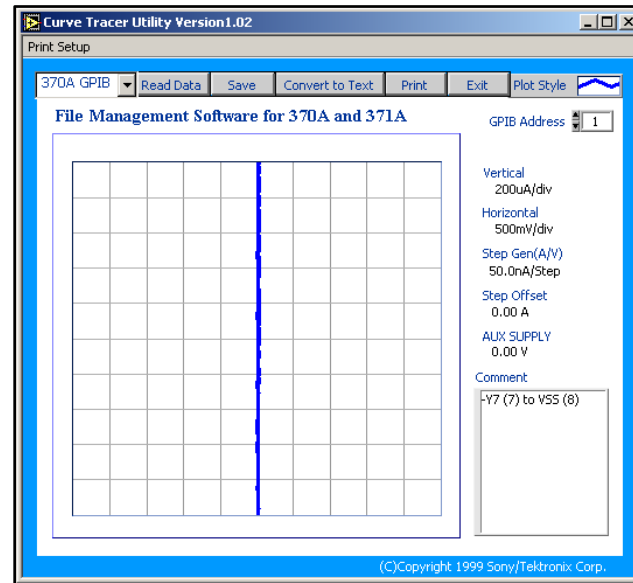
↑ Output to ground short path

- Part description:
 - 3-line to 8-line demultiplexer
- Failure background:
 - During powerup at board-level assembly, an event occurred which led to discovery of high current through a demultiplexer output
- Failure mode:
 - A 3.8Ω short path was discovered between one of the eight outputs and ground
- Interim FA findings:
 - Following delidding, no observable damage or defect to package or die

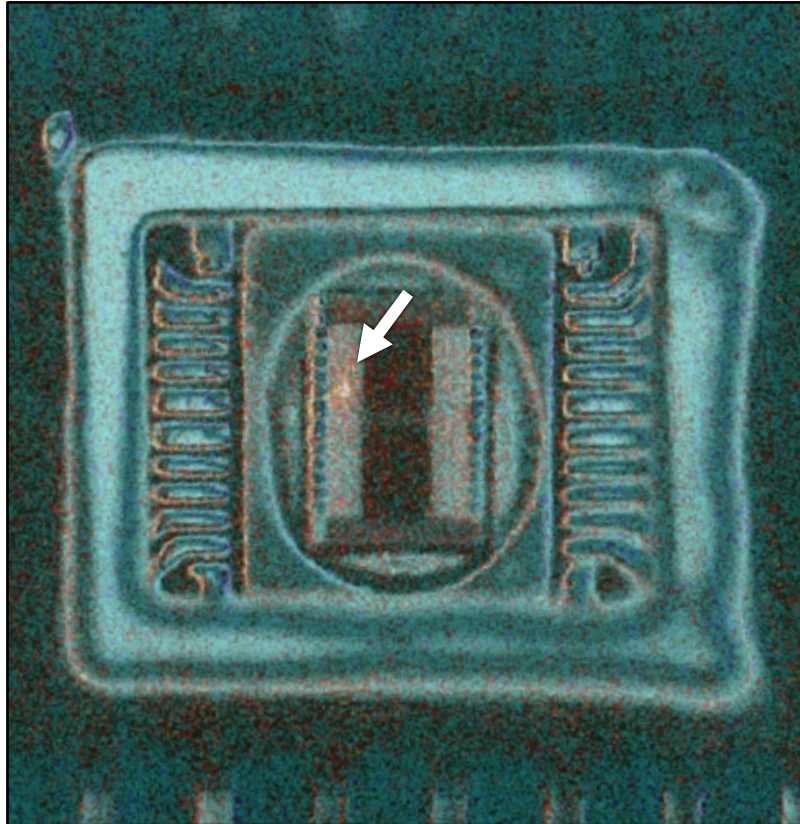
←
Thermal hotspot detected

- Isolation technique (successful):
 - Thermal imaging
 - While biased with an external supply, a thermal camera records heat generation, then subtracts an unpowered frame from the result
 - A hotspot was observed adjacent to the failing output bondpad

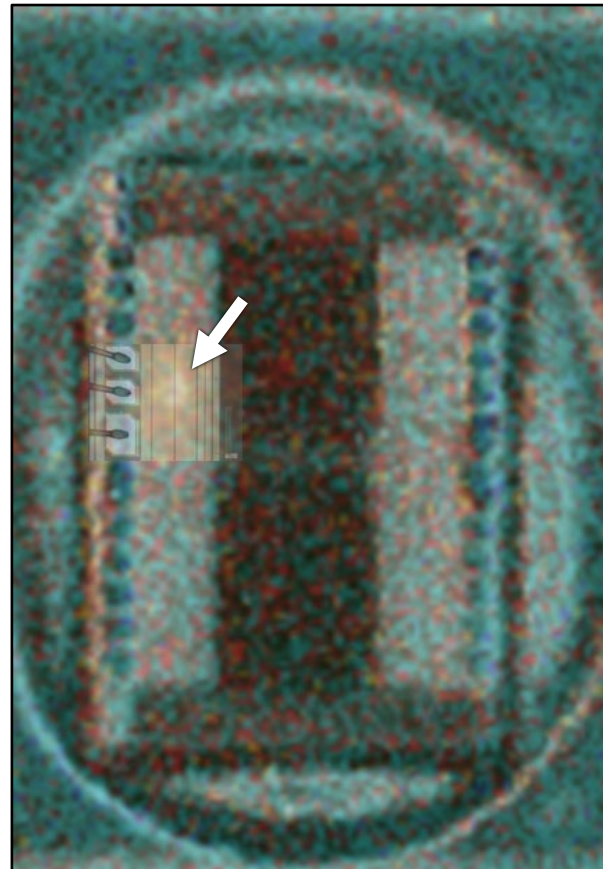
→
*Overlay of optical image places
hotspot next to failing output bondpad*

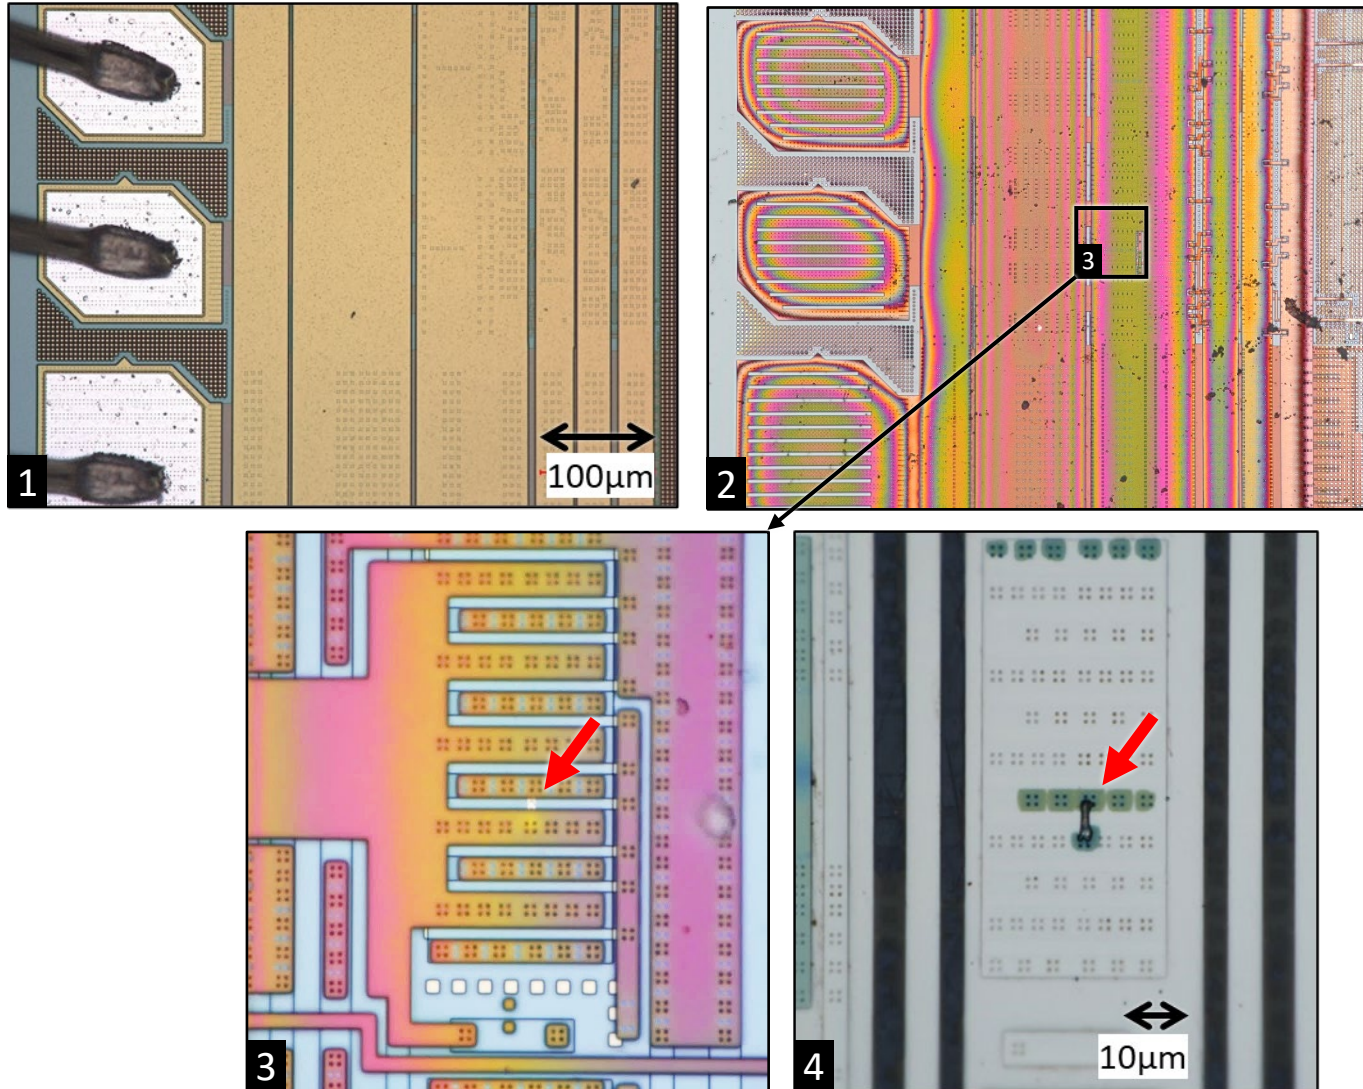
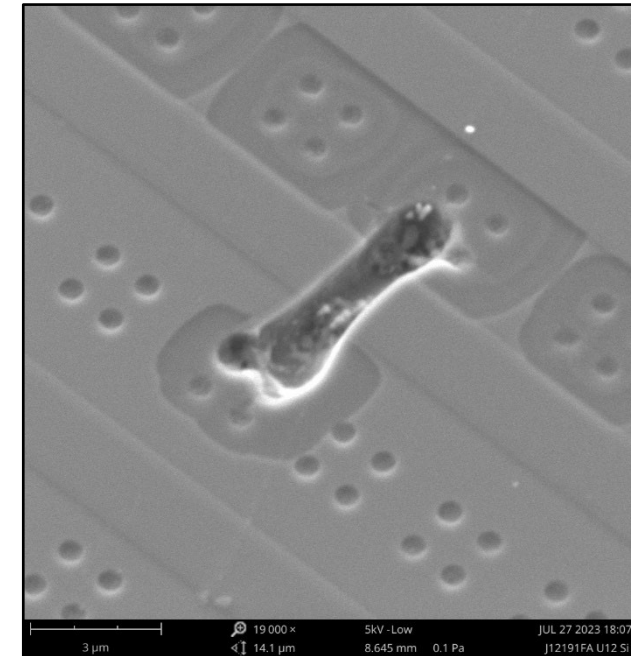
- Deprocessing methods:
 - Plasma etching, planar polishing, chemical etching
- Failure mechanism identified:
 - Electrical overstress (EOS) damage to the output driver circuitry

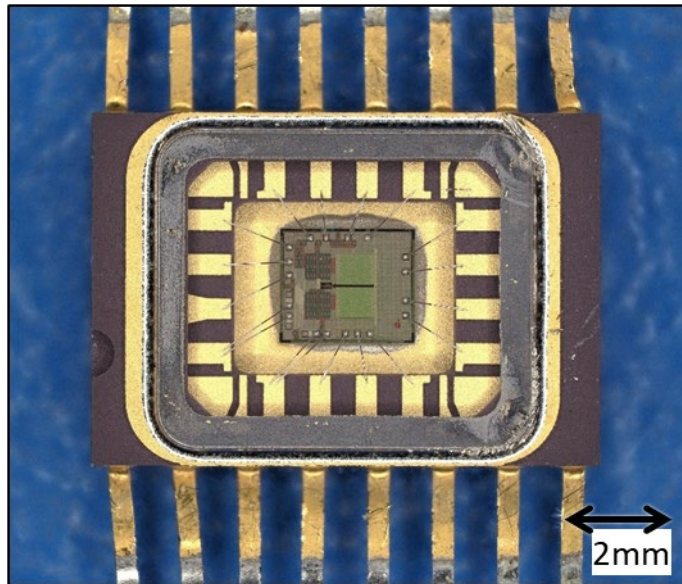
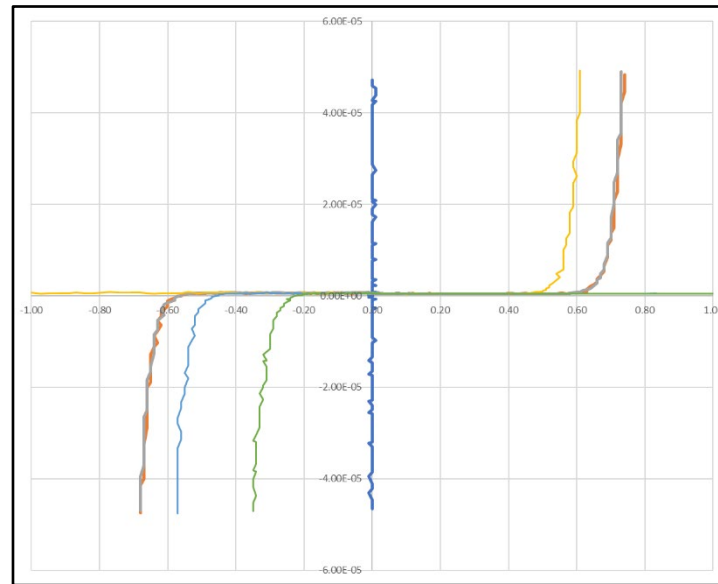
↑ Supply to ground short path in blue

- Part description:
 - Engineering model low-power analog-to-digital converter
- Failure background:
 - During probing of this unit at board-level assembly, the supply rail went into overcurrent mode
- Failure mode:
 - A 4.4Ω short path was discovered between this unit’s analog supply and ground
- Interim FA findings:
 - Following delidding, no observable damage or defect to package or die

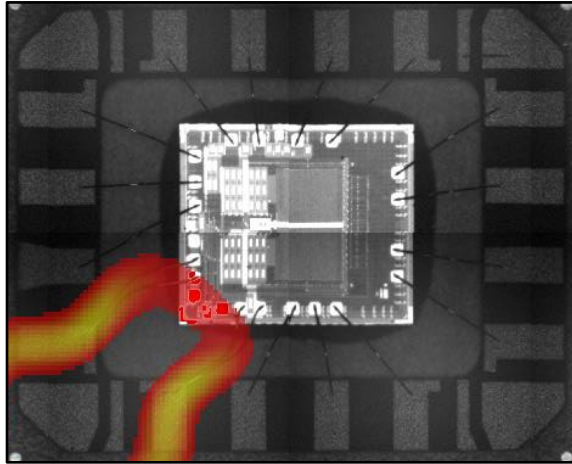
←
SQUID detects current flow, but precise failure site is not resolvable

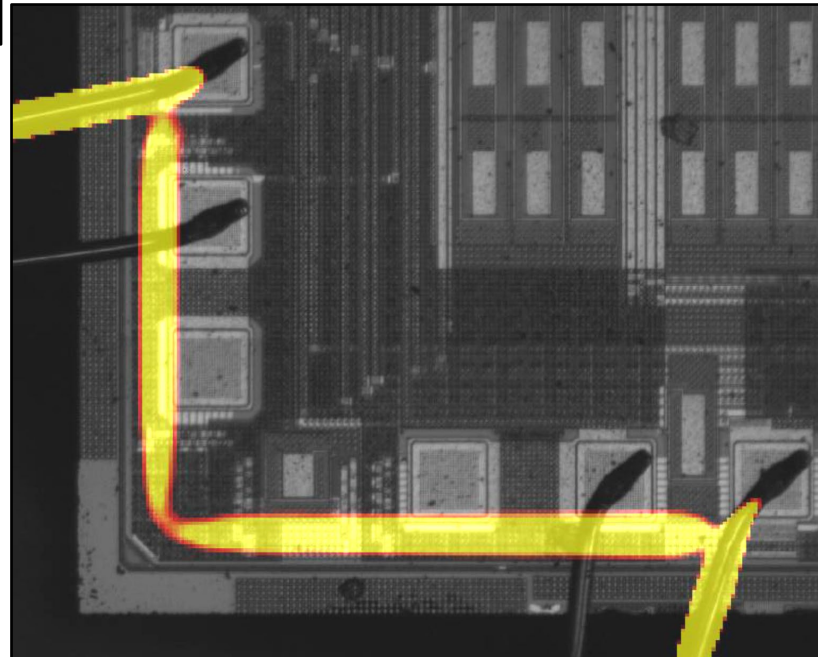
→
GMR detector identifies current path along periphery between supply and ground bondpads

- Isolation technique 1 (unsuccessful):
 - Thermal imaging
 - No hotspot was observed
- Isolation technique 2 (successful):
 - Low-mag magnetic current imaging (MCI) using superconducting quantum interference device (SQUID) detector
 - Improved resolution provided by giant magnetoresistance (GMR) detector
 - A current path was resolved along supply periphery metallization

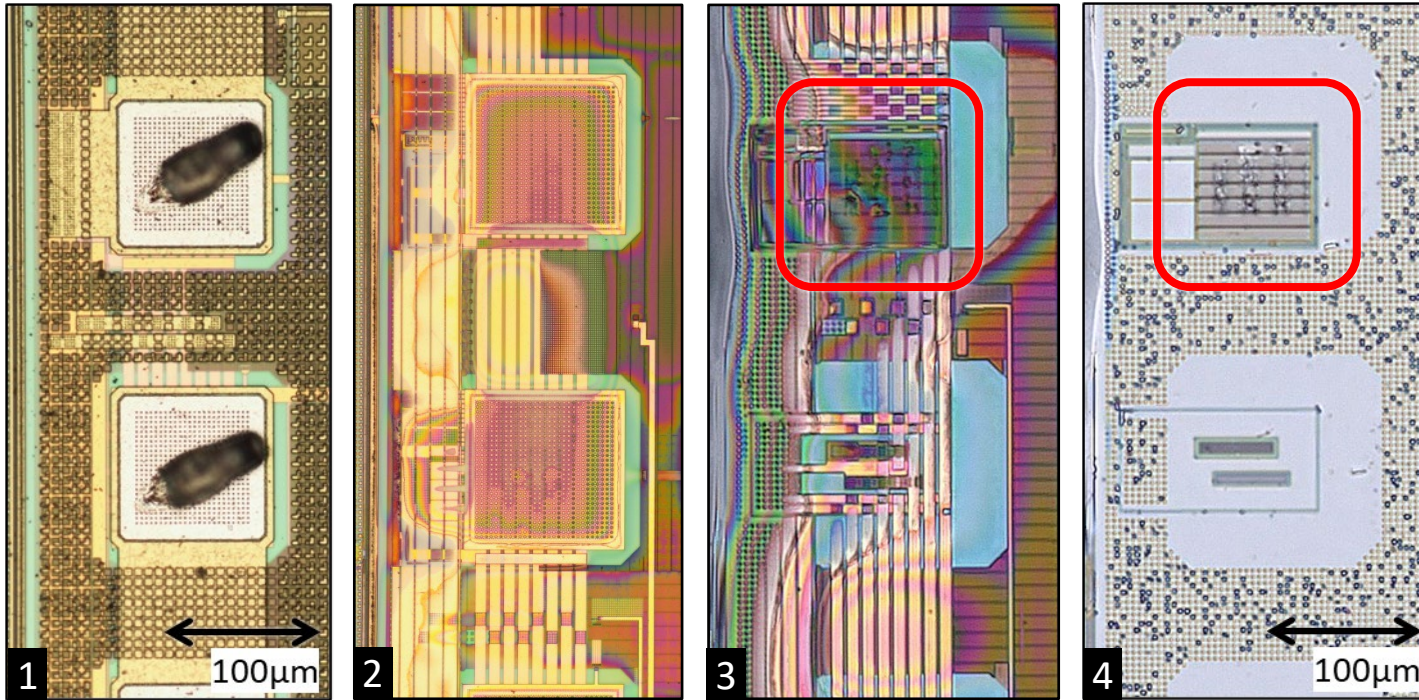
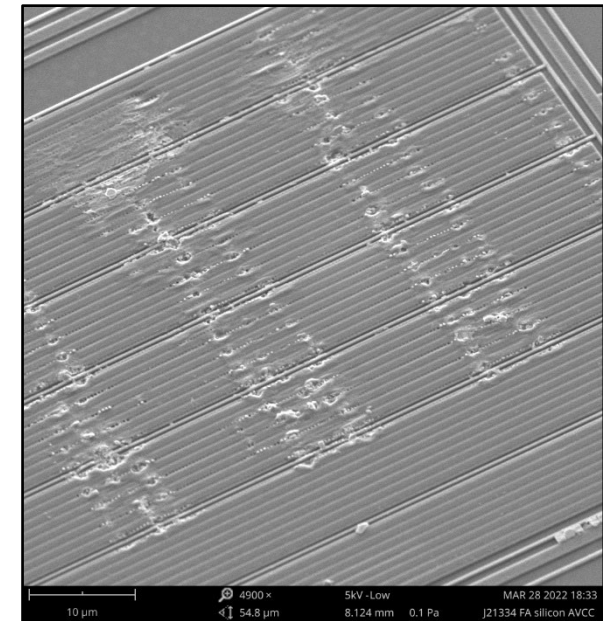
- Deprocessing methods:
 - Plasma etching, chemical etching, planar polishing
- Failure mechanism identified:
 - Electrical overstress (EOS) damage to the analog supply protection circuitry

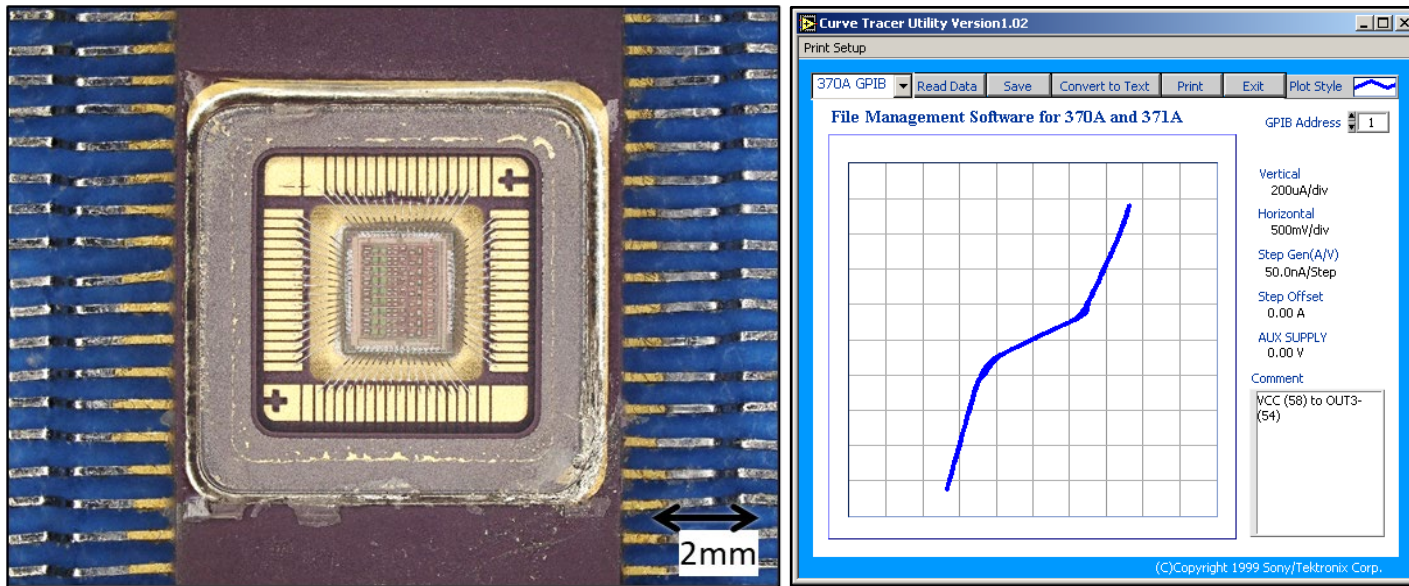
↑ Leakage path from supply to output

- Part description:
 - 8-channel crosspoint switch
- Failure background:
 - During powerup at board-level assembly, low resistance was observed on an output channel
- Failure mode:
 - A 5.0kΩ origin leakage path was discovered between this unit's supply and an output channel
- Interim FA findings:
 - Following delidding, no observable damage or defect to package or die

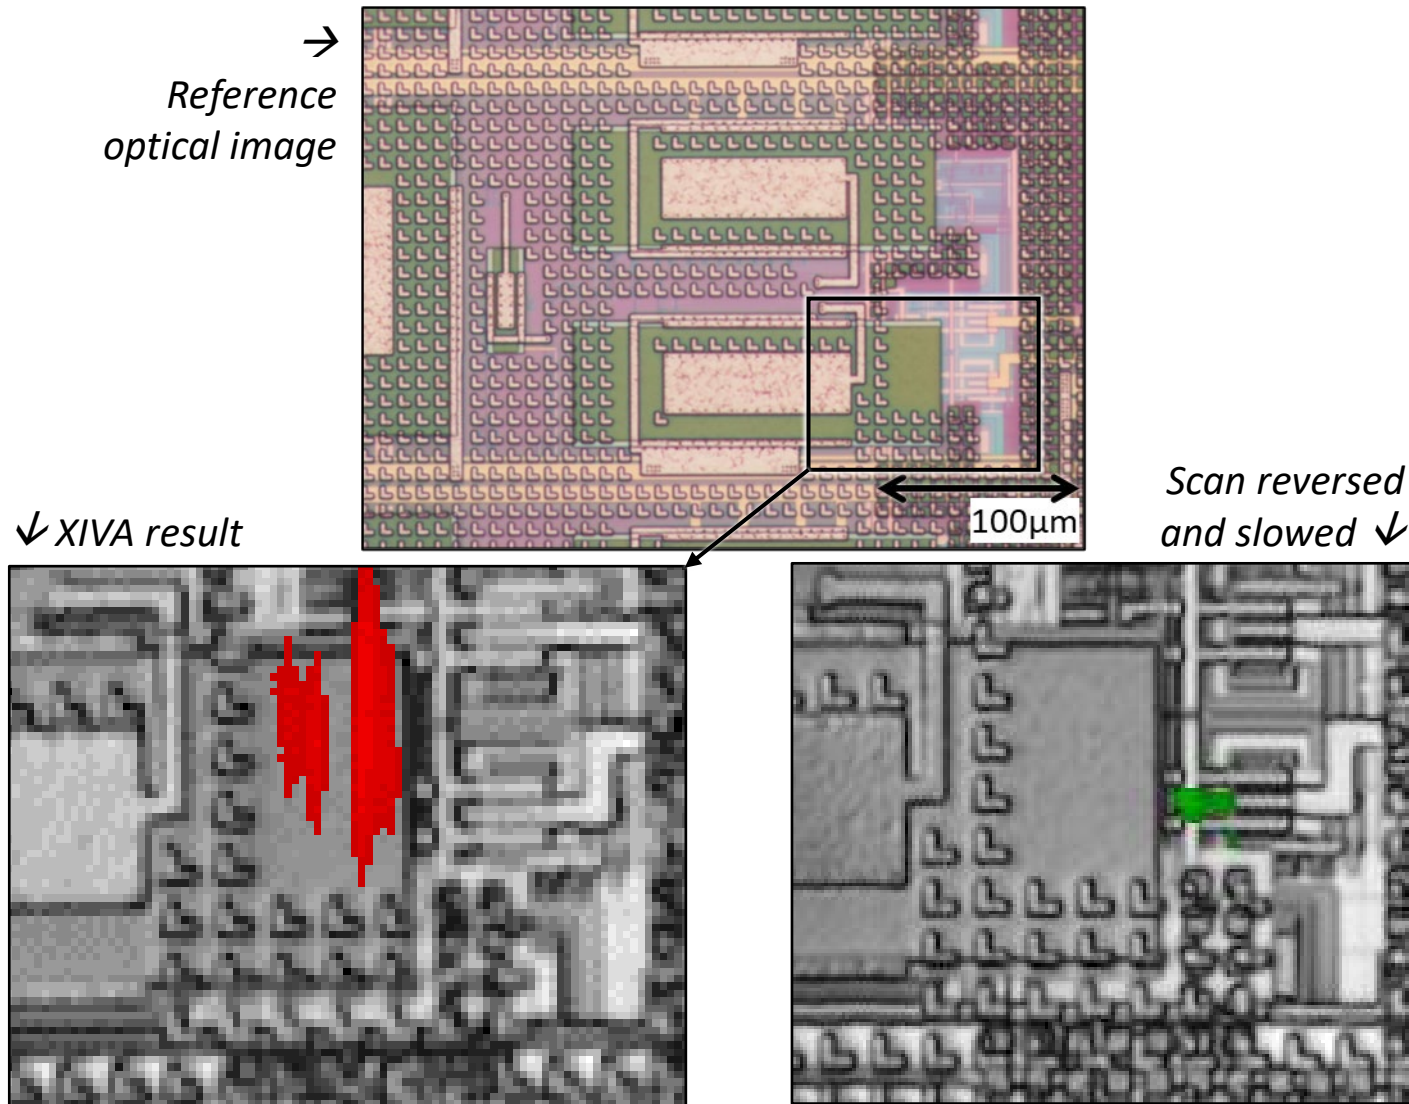
- Isolation technique 1 (unsuccessful):
 - Thermal imaging
 - No hotspot was detected
- Isolation technique 2 (successful):
 - LSIM (laser signal injection microscopy)
 - Several types are used in industry (OBIRCH, TIVA, XIVA, others) varying by laser wavelength and supply biasing method
 - While biased, a thermal laser scans the die surface
 - Locations are marked where the laser affects supply stability
 - Alteration sites were yielded at and beside an interlevel capacitor within a module connected to the failing output

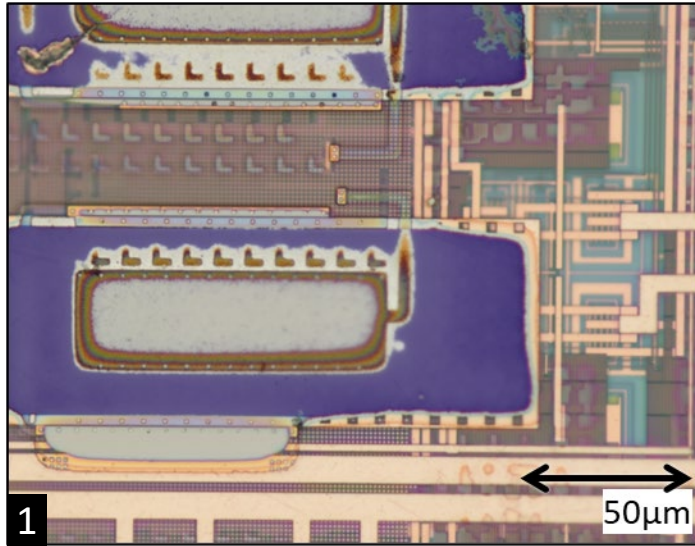
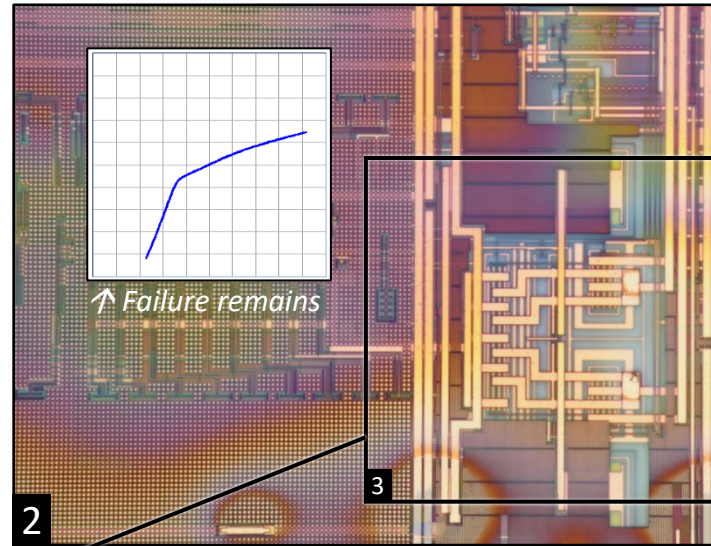
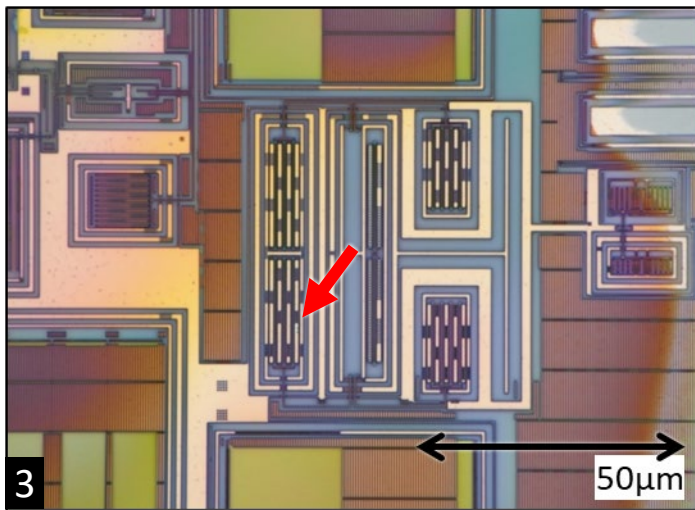
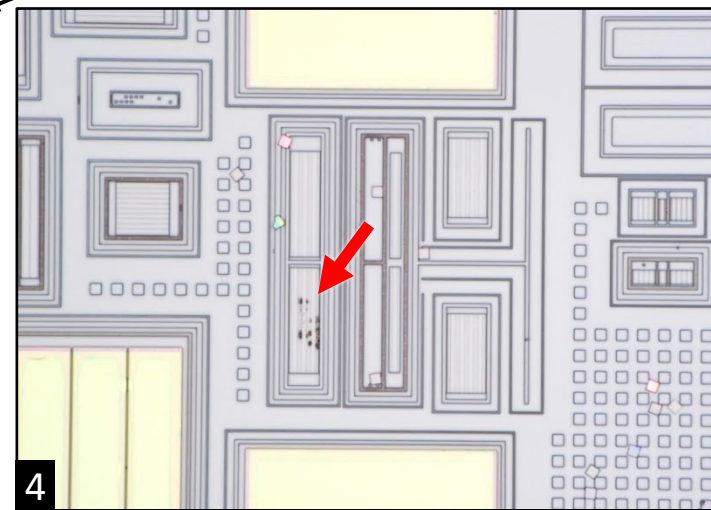
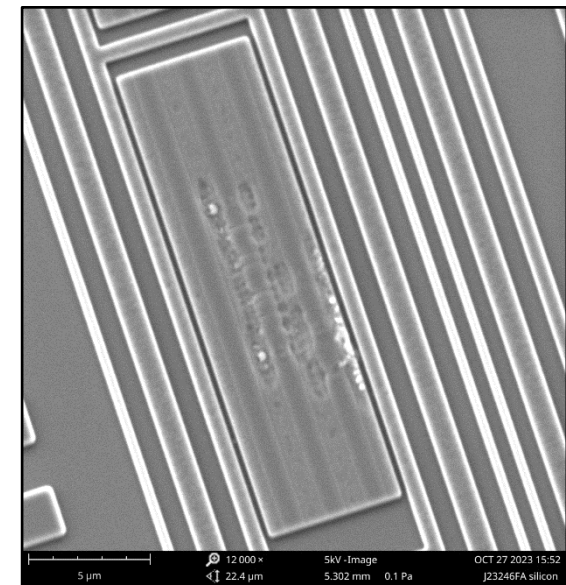
- Deprocessing methods:
 - Plasma etching, planar polishing, chemical etching; internal microprobe curve trace
- Failure mechanism identified:
 - Electrical overstress (EOS) damage to a transistor connected to the failing output signal

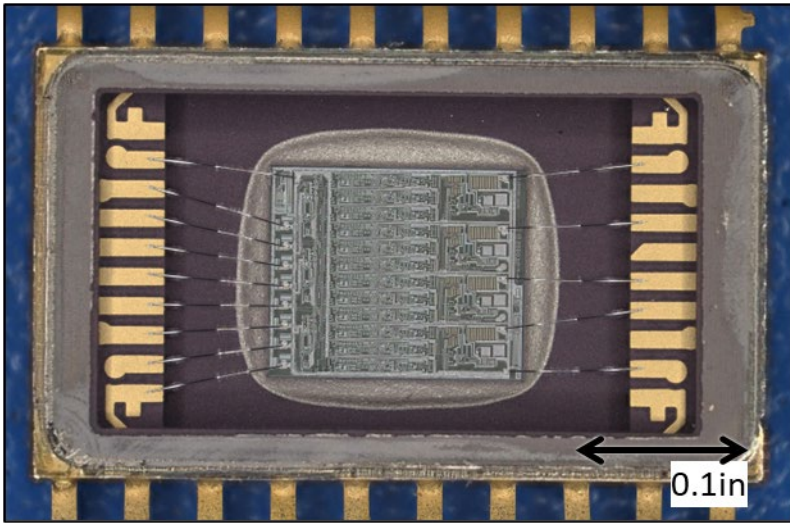
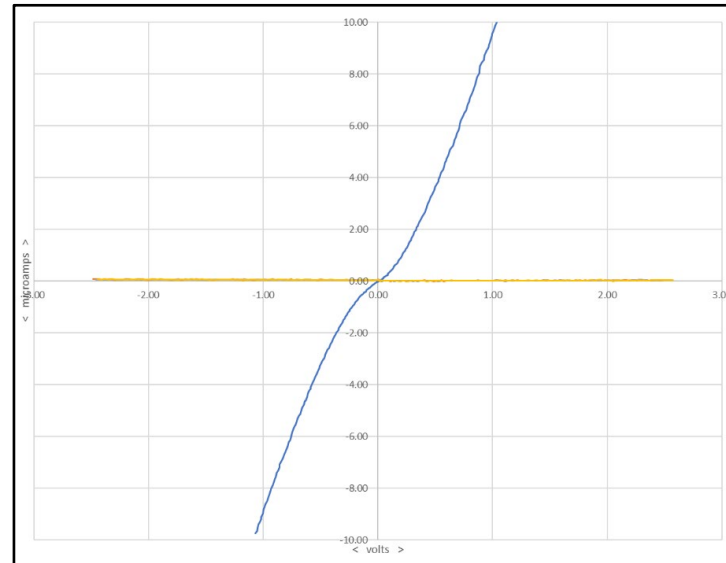
Resistive path between differential input pair

- Part description:
 - 4-channel voltage comparator
- Failure background:
 - Project reported that an input pair combination on this unit on a flight board drew higher than normal current
- Failure mode:
 - A resistive path on the order of 134k Ω was discovered between the differential pairs of an input channel
- Interim FA findings:
 - Following delidding, no observable damage or defect to package or die

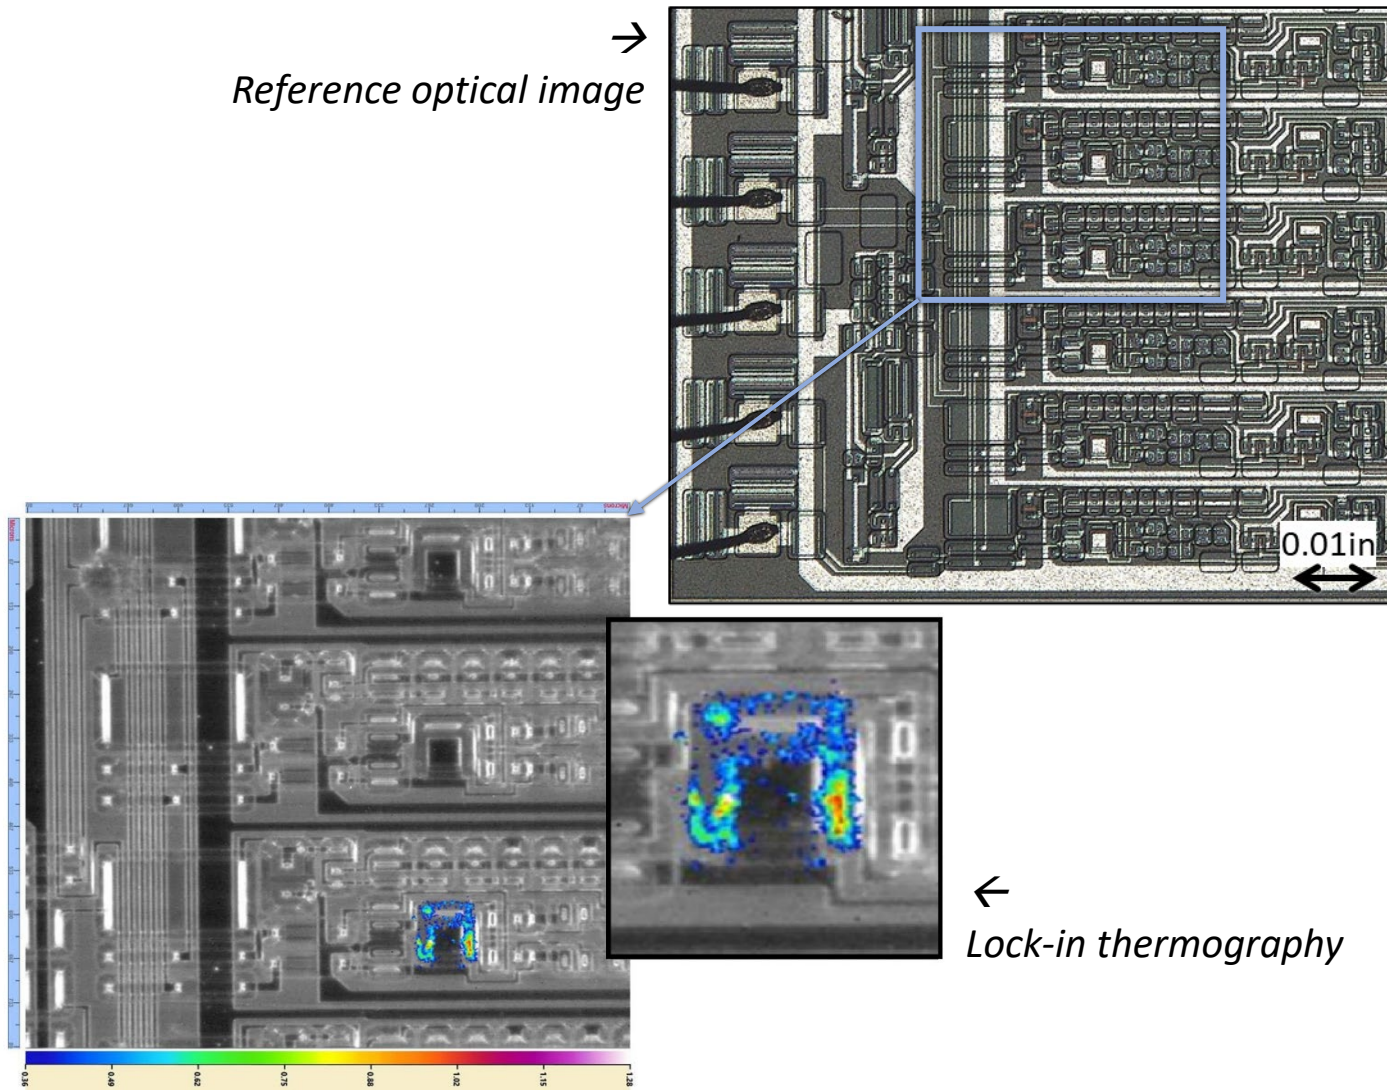
- Isolation technique 1 (unsuccessful):
 - Thermal imaging
 - No hotspot was detected
- Isolation technique 2 (unsuccessful):
 - OBIRCH and XIVA
 - Alteration sites were inconclusive
- Isolation technique 3 (successful):
 - LIT (lock-in thermography)
 - A lock-in modulation system repeatedly applies power to the device, then deactivates
 - A thermal imaging camera monitors for heat dissipation during on cycles and subtracts off cycle dark images
 - Heat detected around a capacitor, particularly the lower right side

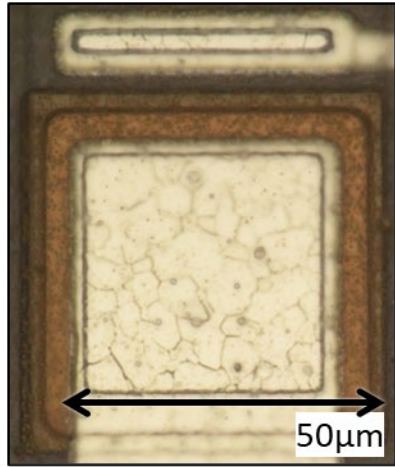
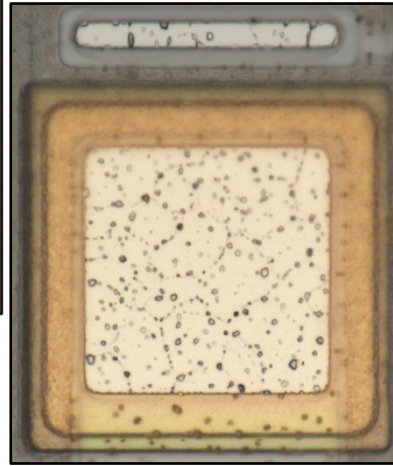
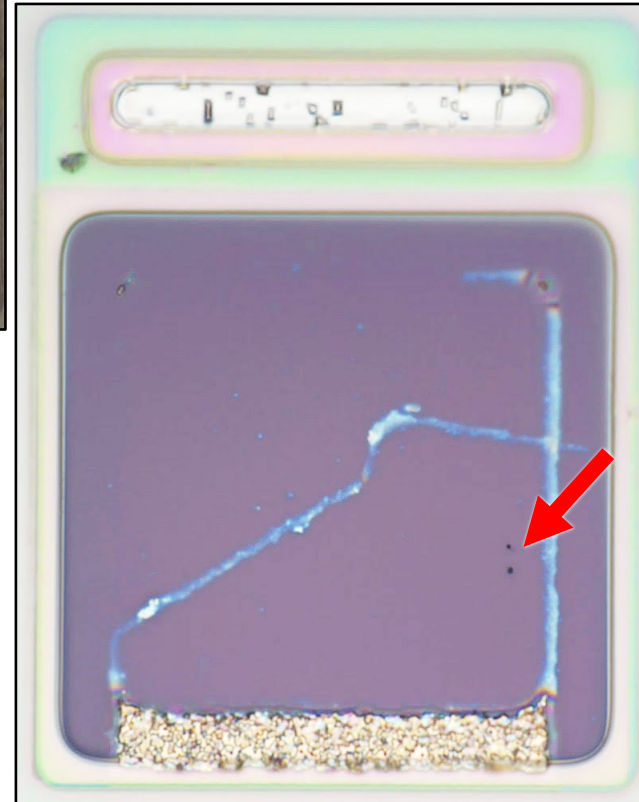
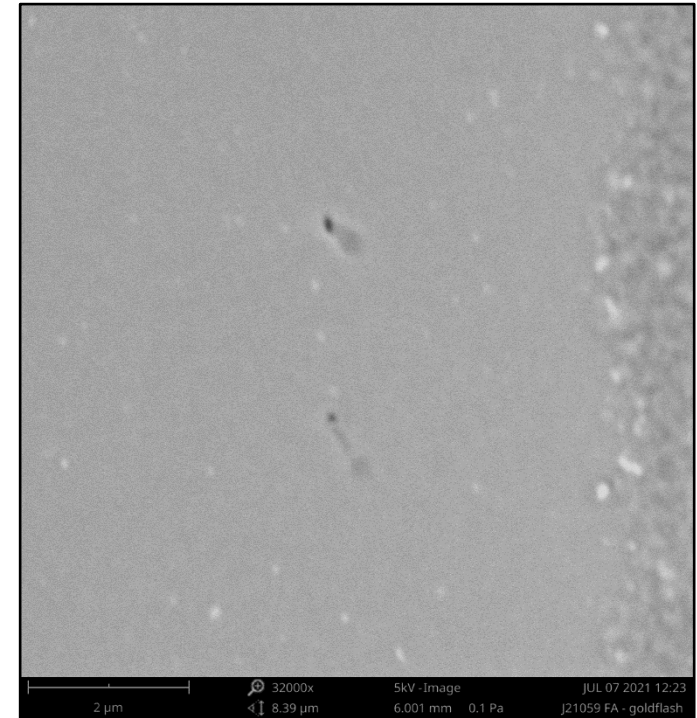
- Deprocessing methods:
 - Plasma etching, chemical etching
- Failure mechanism identified:
 - “Pinhole” electrical damage to gate oxide used as capacitor dielectric
