# Survivability of NASA's 10k RDRE

Tessa M. Fedotowsky<sup>1</sup>, Benjamin Williams<sup>2</sup>, Colton Katsarelis<sup>3</sup>, Shawn Skinner<sup>4</sup>, Thomas Teasley<sup>5</sup> NASA Marshall Space Flight Center, Huntsville, AL 35812

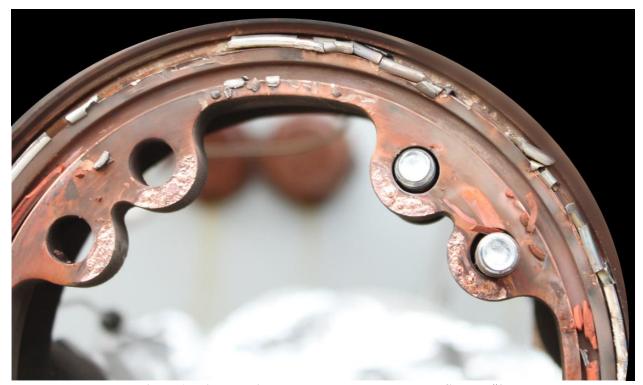
Detailed visual inspection and documentation was completed after each hot fire test. However, the paper will focus on indications observed after hot fire tests #3 and #8. The inspection report post-hot fire test #3 included significant blanching all around the outer body hot wall at the throat, inner body hot wall burn through between 3-5 o'clock at the throat, seal damage between the three components, fusing around the bolt holes of the three components, bolts loosening, and outer body hot wall instrumentation port cracking.

The C-seal between the inner body and injector shattered and the rubber O-ring burned through shown in Figure 1. The fusing around the bolt holes between the injector and outer body is shown in Figure 2. The outer body hot wall static pressure port cracking is shown in Figure 3.

Figure 1. Injector to inner body seal damage post-hot fire test #3.

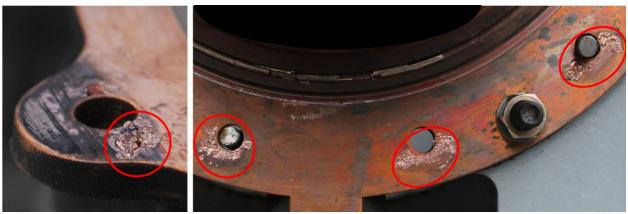
Figure 2. Injector to outer body fusing around bolt holes post-hot fire test #3.

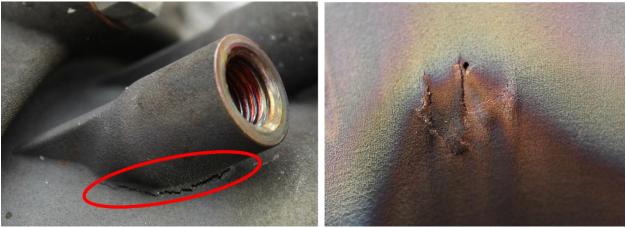
Figure 3. Outer body hot wall static pressure port cracking post-hot fire test #3.

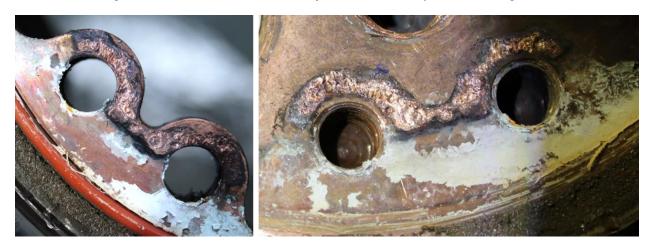
The inspection report post-hot fire test #8 included inner body hot wall burn through between 1-4 o'clock at the throat, seal damage between the three components, fusing around the bolt holes of the three components, and bolt loosening.

The fusing around the bolt holes between the injector and inner body is shown in Figure 4.

Figure 4. Injector to inner body fusing around the bolt holes post-hot fire test #8.

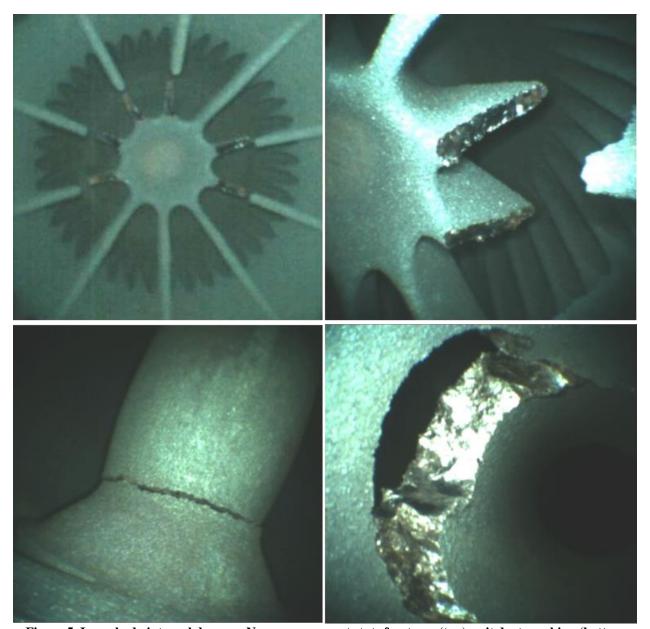
Borescope inspection was completed after testing of both inner bodies which showed significant internal damage as shown in Figure 5. In inner body AR 1.0, six of the nose cone support struts fractured off and two of the struts exhibited cracking in AR 1.0 R2. All four exit ducts AR 1.0 had cracking around the base, three of which were through cracks. In AR 1.0 R2, three exit ducts had cracking around the base, one of which was a through crack. The exit duct with a through crack, rotated and a hole was observed on the exit duct wall.

Figure 5. Inner body internal damage. Nose cone support stuts fractures (top), exit duct cracking (bottom left), and hole in exit duct (bottom right).

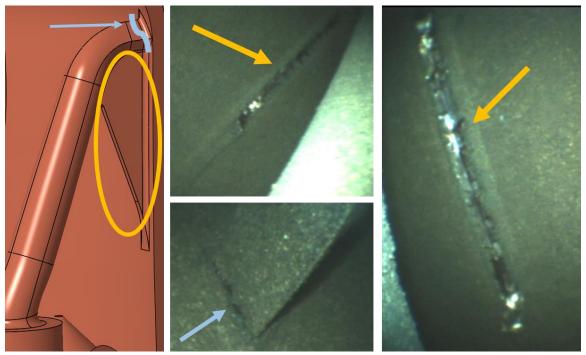
Borescope inspection of inner body AR 1.13 showed hot wall static pressure port damage, shown in Figure 6. The support strut of the instrumentation port had completely fractured off and fell out of the inner body after test and the base of the instrumentation port near the closeout of the channels exhibited cracking.

Figure 6. Inner body hot wall static pressure port internal damage post-hot fire test #1.
