Dynamic Drop Testing of eVTOL Energy Storage Systems Part 2: Deformation and Post-Test Forensics Results

Justin Littell

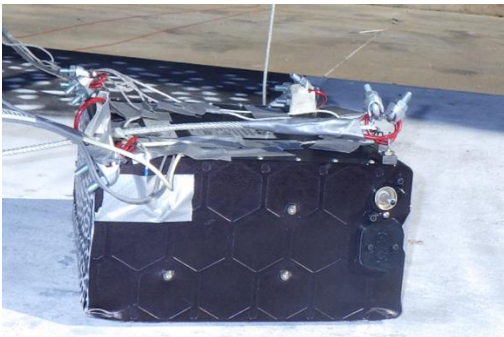
Figure 4 – Flatwise end view, post-test

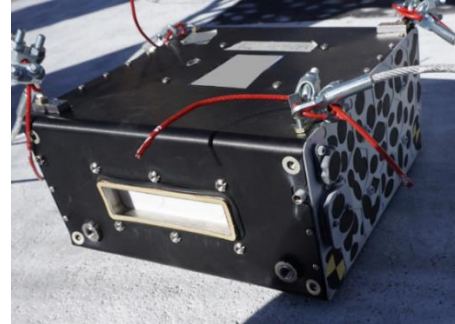
Figure 5 - Flatwise top view, post-test

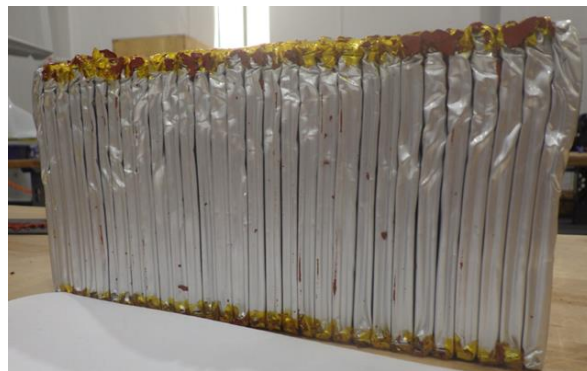
Figure 7 - Flatwise, pouch cell view. Impact side up

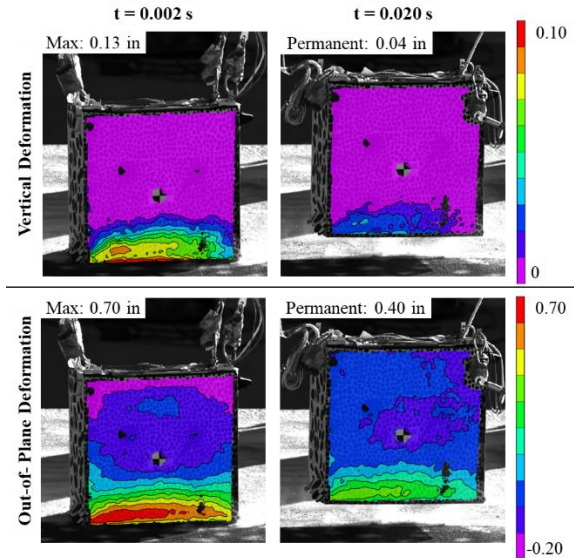
Figure 9 – Rightside Up digital image correlation results

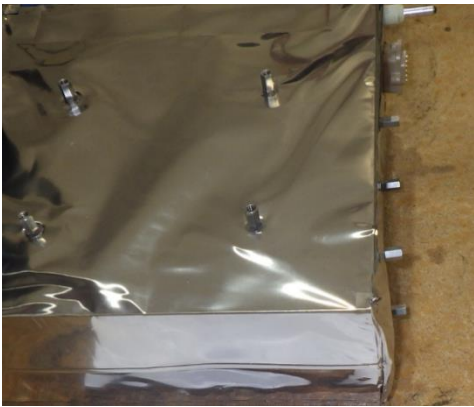
Figure 10 - Rightside up Containment Assembly

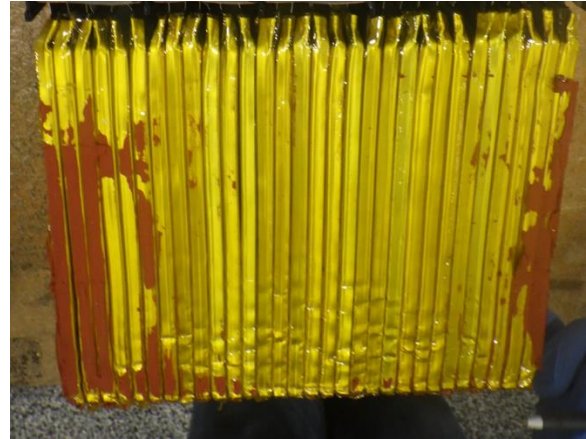
Figure 11 - Rightside up pouch cells. Side view, impact side down

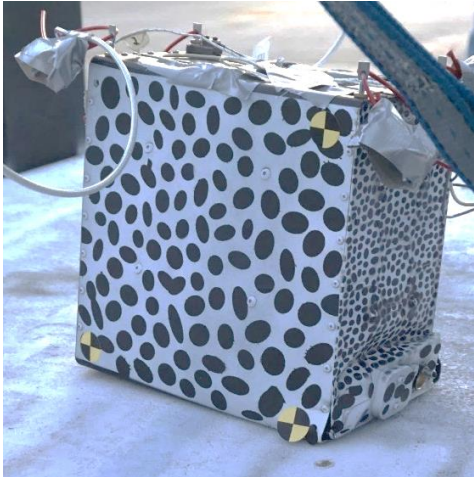
Figure 12 - Upside Down chiller plate side view, post-test

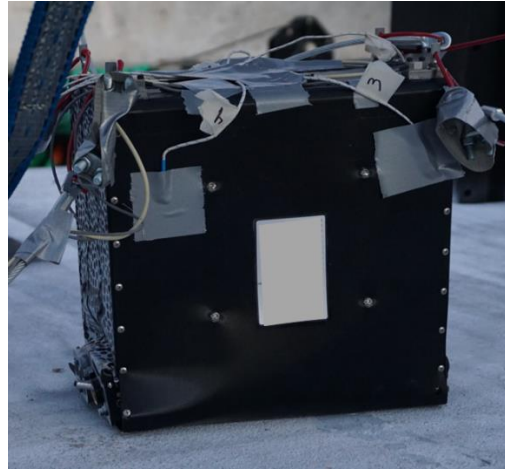
Figure 13 - Upside Down placard side view, post-test

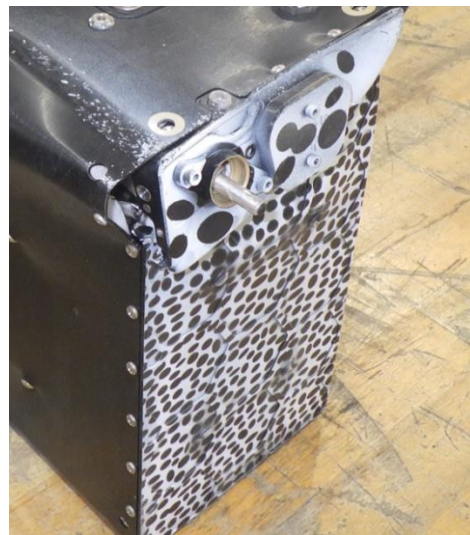
Figure 14 - Upside down corner fastener failure

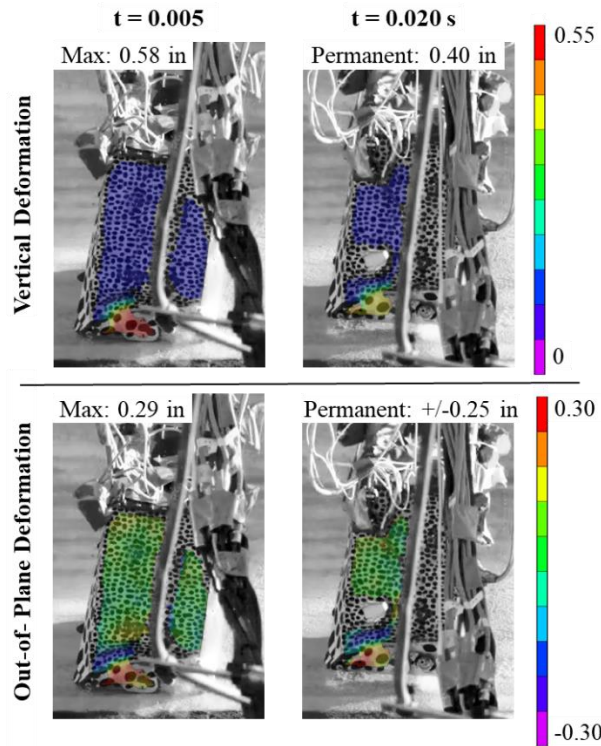
Figure 15 - Upside Down digital image correlation results

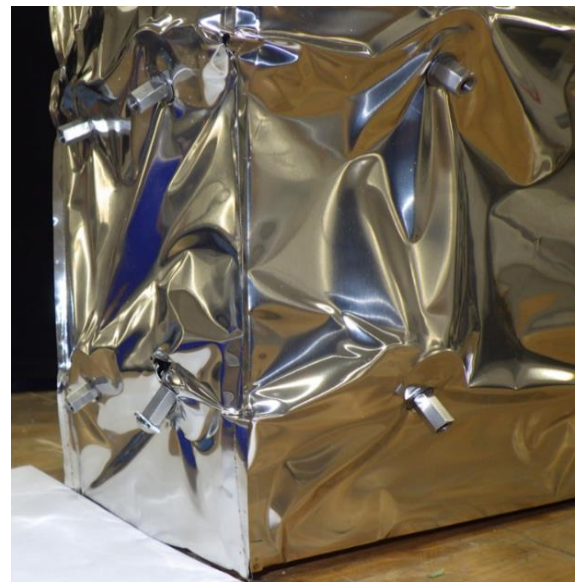
Figure 16 - Upside Down Containment Assembly, standoffs bent, metal breached

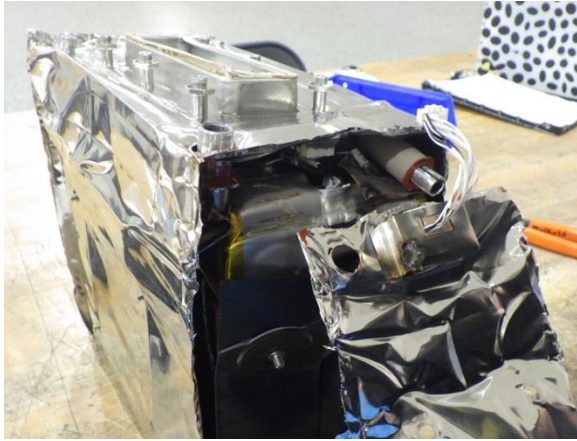
Figure 17 - Upside Down positive electrode area

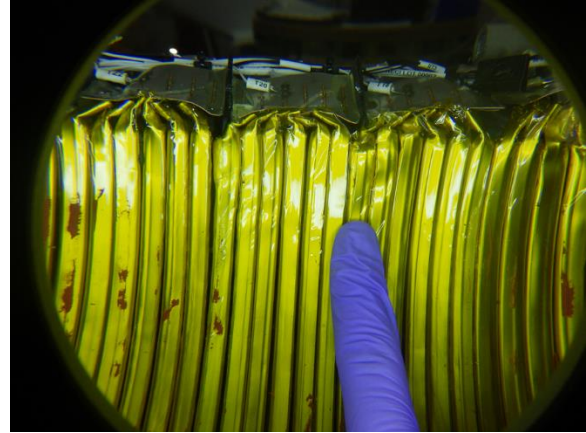
Figure 18 - Upside Down pouch puncture

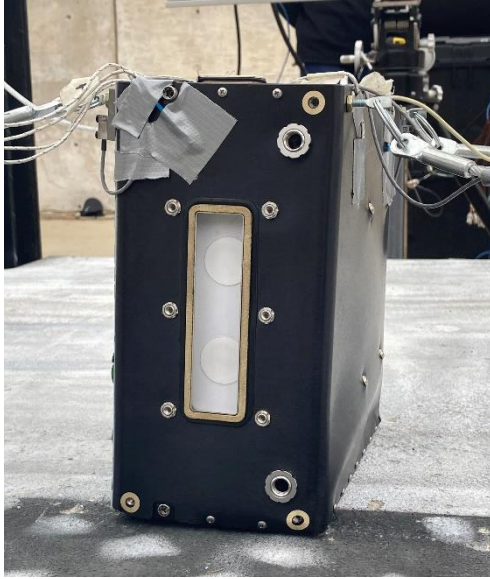
Figure 19 - Sideways post-test

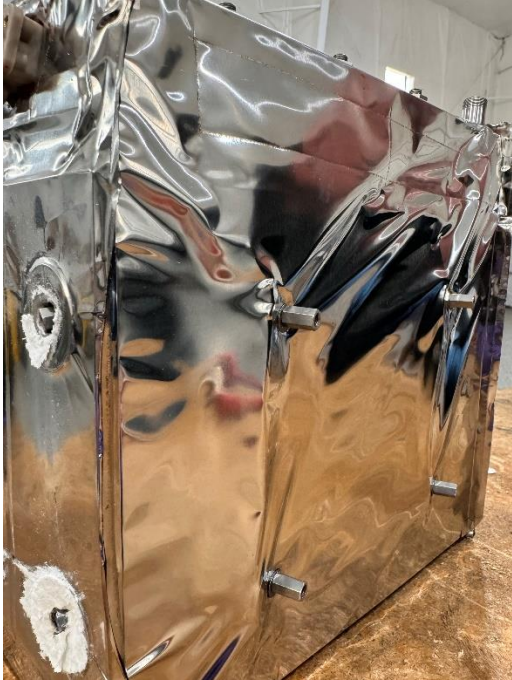
**Figure 21 - Sideways standoff orientation shift.
End face on left, side face on right**

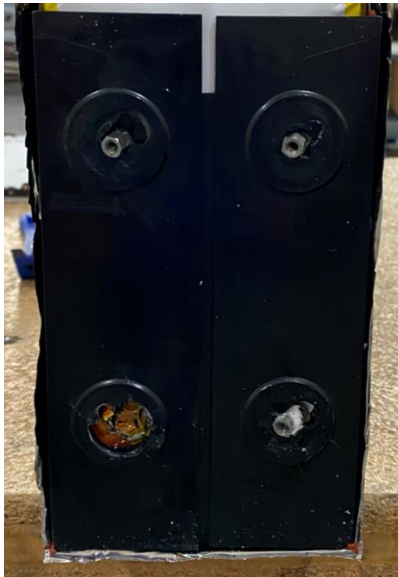
Figure 22 - Sideways Cell Assembly

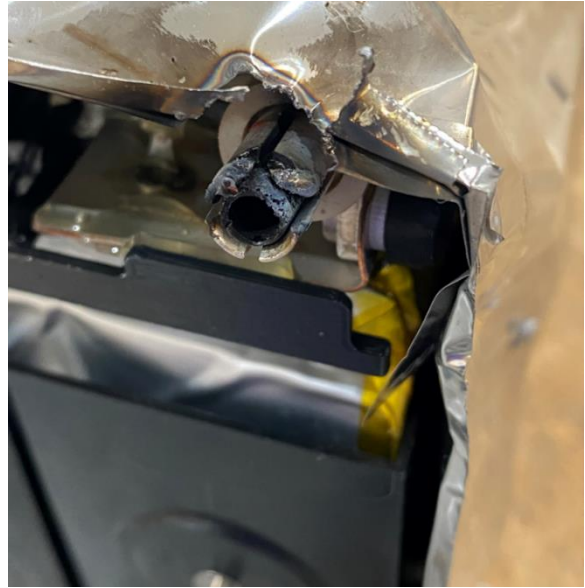
Figure 23 – Sideways negative electrode charring

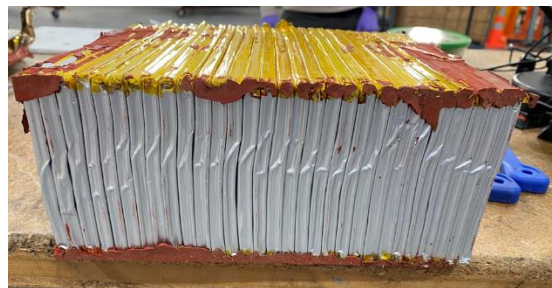
Figure 24 - Sideways pouch cells
